Factual Update

October 29, 2020

Incident Summary

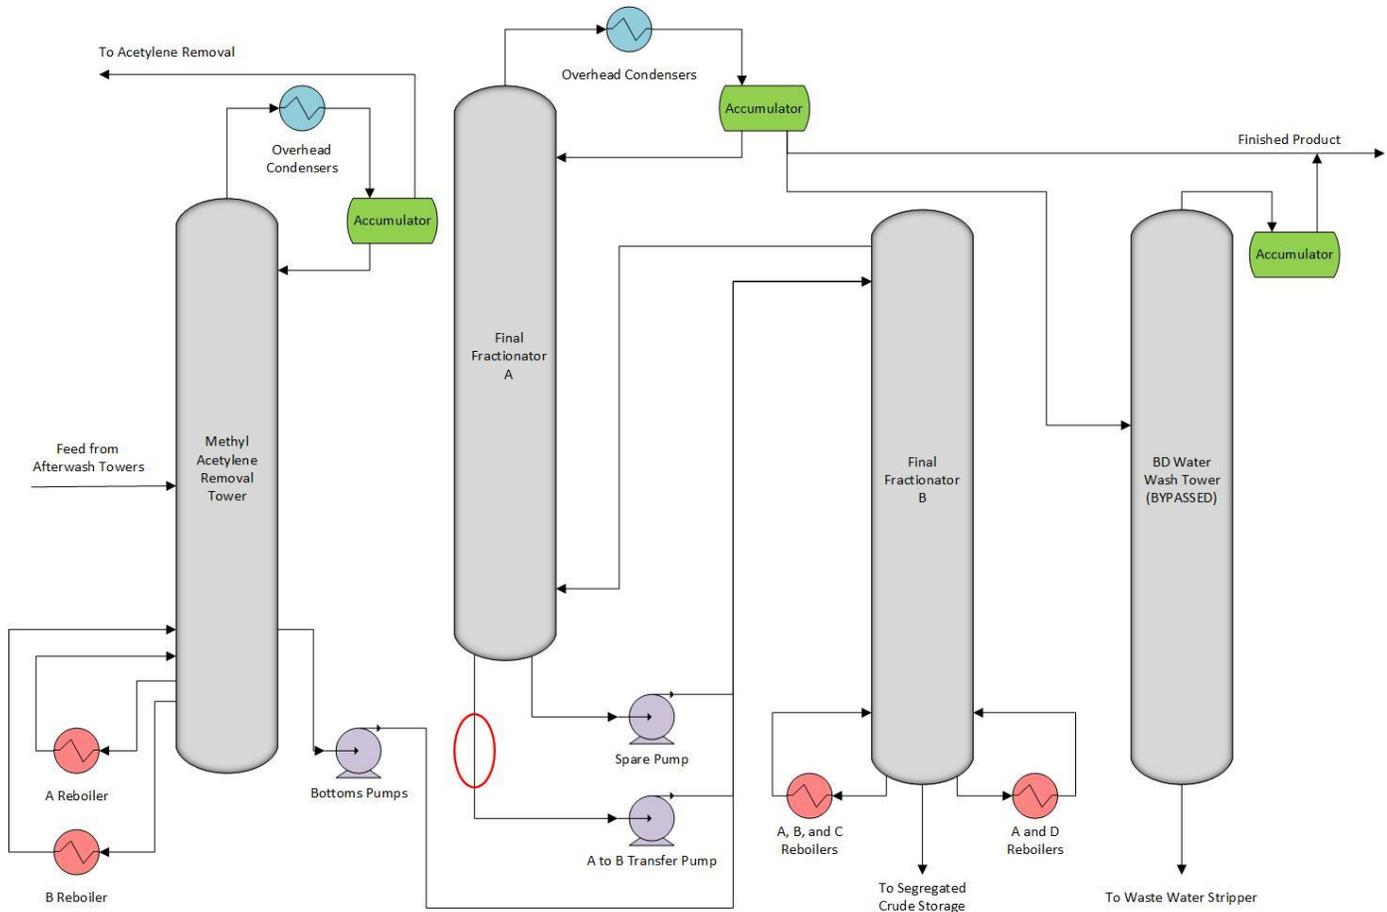
- A simplified process flow diagram of the TPC PNO butadiene post-fractionation process is shown in **Figure 3**. Indicated on the process flow diagram by the red ellipse is the area of interest as the potential origin of the flammable vapor release.^a

Figure 3. Simplified process flow diagram of the TPC PNO butadiene post-fractionation process at the time of the incident. (Credit: CSB)

^a The likely location of release is based on data from the final fractionator A level controller and eyewitness accounts. As of this update, the CSB has not been able to visually confirm the failure location due to the extensive damage at the site.

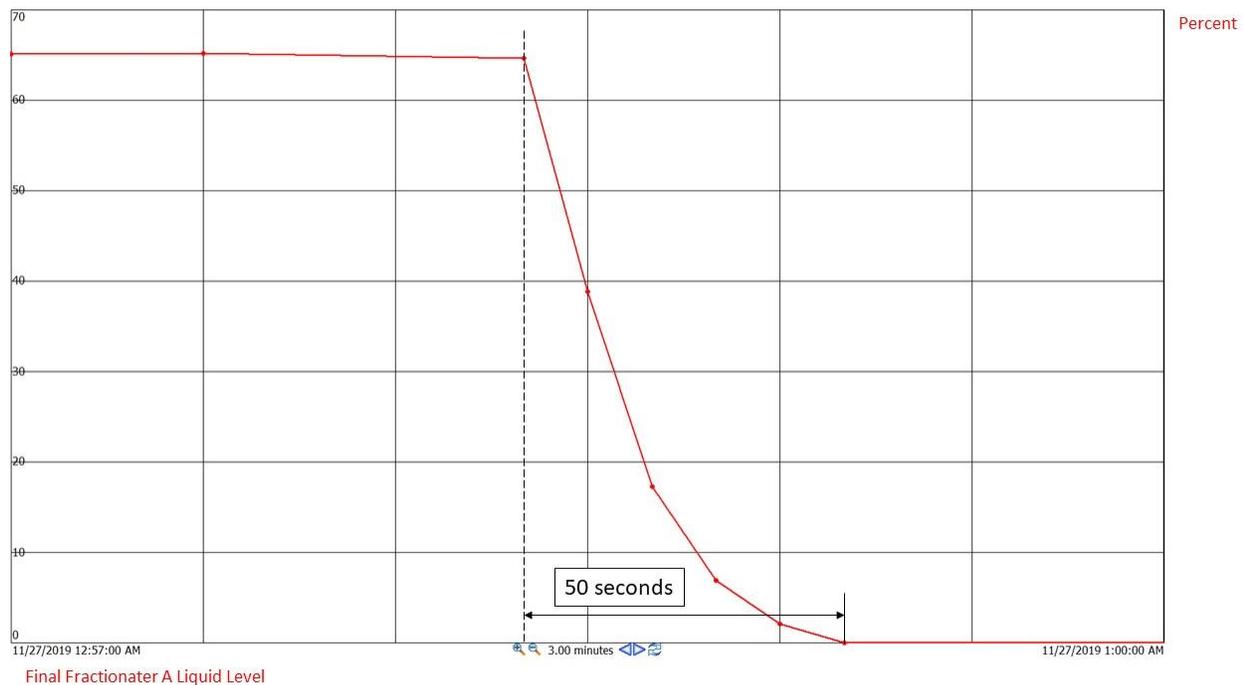
approximately 6,000 gallons. The liquid, which was primarily butadiene,^a emptied from the fractionator in less than a minute (**Figure 4**). The liquid vaporized upon release^b and formed a vapor cloud. Three workers were in the unit at that time. Two of them were facing toward the final fractionator A, and they both told the CSB after the incident that they saw a pipe rupture. Of these two workers, one of them identified the release point (circled in red in **Figure 3**) to be in the suction piping of the final fractionator A to B transfer pump. The third worker, who turned toward the sound of the release after the release occurred, also believed it was the suction piping into the final fractionator A to B transfer pump that failed. The workers' observations are consistent with the unit's recorded process data. The CSB has not yet visually confirmed the failure location due to the extensive damage and unstable structural conditions at the site.

Figure 4. Process data trend graph showing the liquid level (in percent) in the final fractionator A dropping from its operating level to zero in less than a minute. The estimated liquid quantity in the fractionator at the time of the release was 6,000 gallons (30,000 pounds).^d (Credit: CSB)

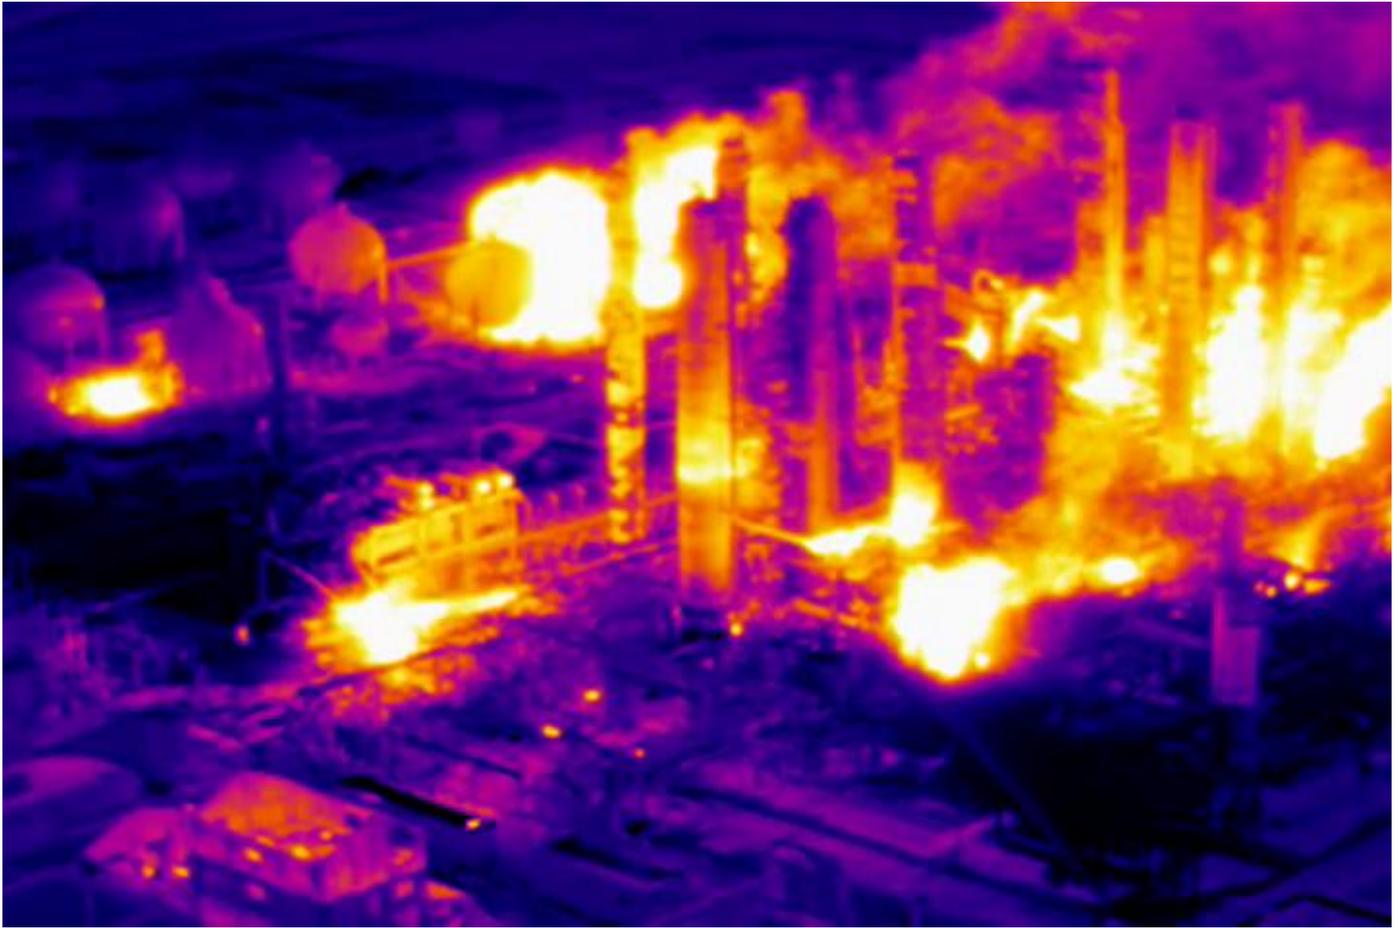
- Immediately following the loss of containment, the three workers quickly departed the unit.
- At 12:56 a.m., the vapor cloud ignited, resulting in an explosion that created a pressure wave that heavily damaged the site and caused damage to buildings, including houses, offsite. Thermal imagery^c provided by TPC shows multiple fires following the explosion (**Figure 5**).

Figure 5. Thermal drone imagery of the TPC PNO facility South Unit taken the morning after the initial explosion. (Credit: TPC)

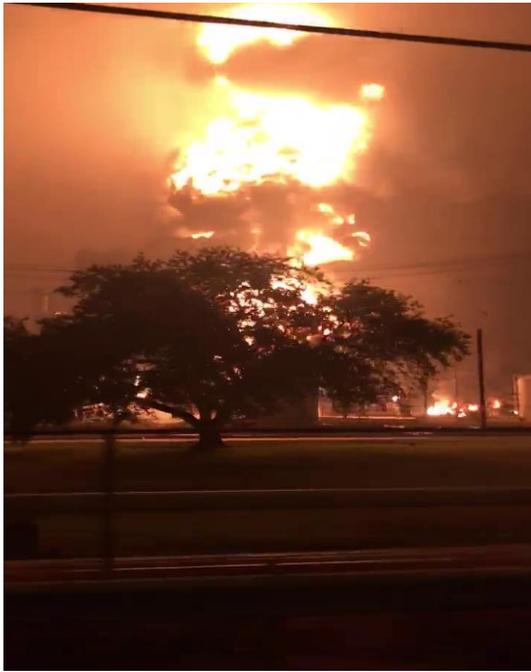
- At least two additional explosions occurred following the initial blast. At 2:40 a.m., a cell phone recording captured an additional explosion (**Figure 6**). That afternoon at 1:48 p.m., another explosion propelled one of the facility's towers into the air (**Figure 7**). The tower landed within the confines of the TPC PNO facility. In addition to the propelled tower (later identified as an out-of-service debutanizer), four additional towers (**Figure 8**) fell as a result of the blast and/or fires: the final fractionator A, an extractive distillation absorber, an out-of-service water wash tower, and the depentanizer.

Figure 6. Explosion at 2:40 a.m. on November 27, 2019 captured by cell phone video (Credit: TPC)

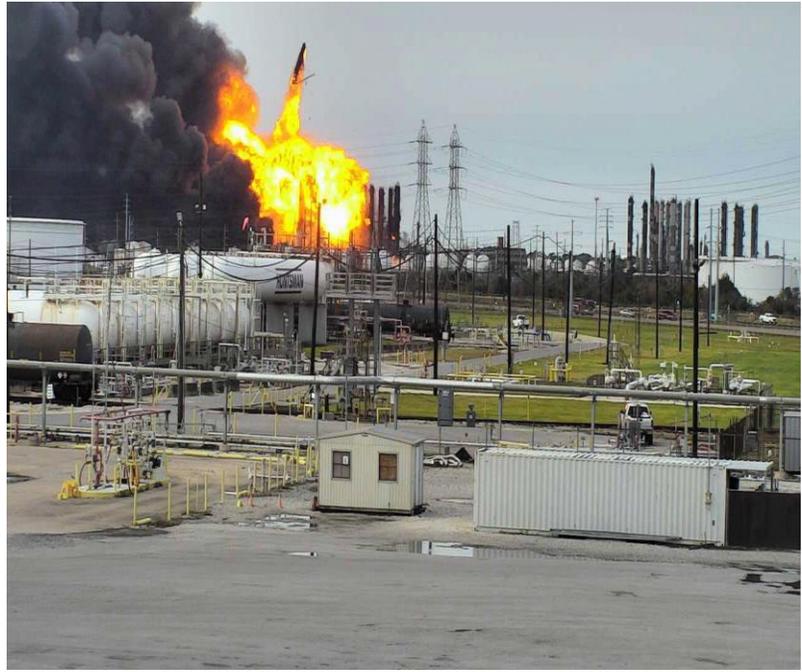
Figure 7. Explosion at 1:48 p.m. on November 27, 2019 which propelled one of the South Unit towers. (Credit: Huntsman Corporation)

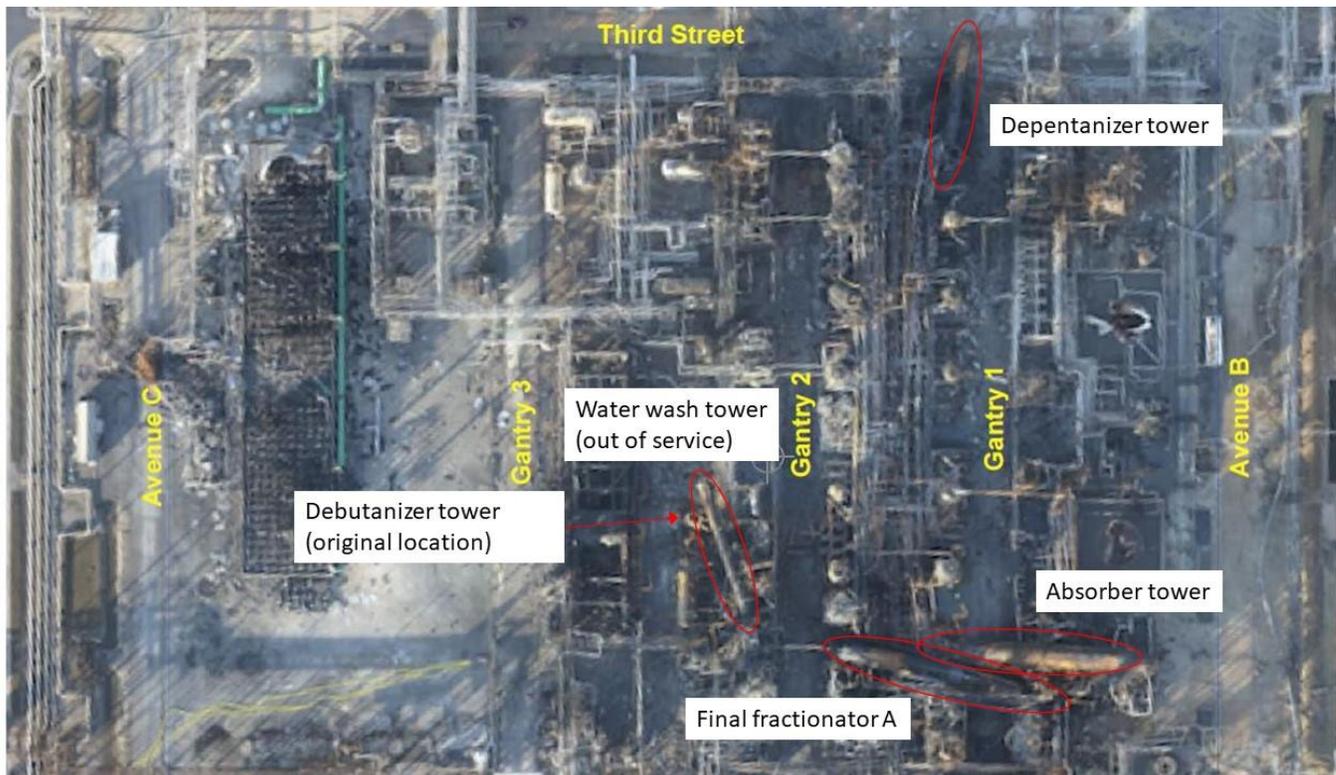
Figure 8. Overhead depiction of TPC PNO South Unit showing the locations of the fallen towers. (Credit: TPC)

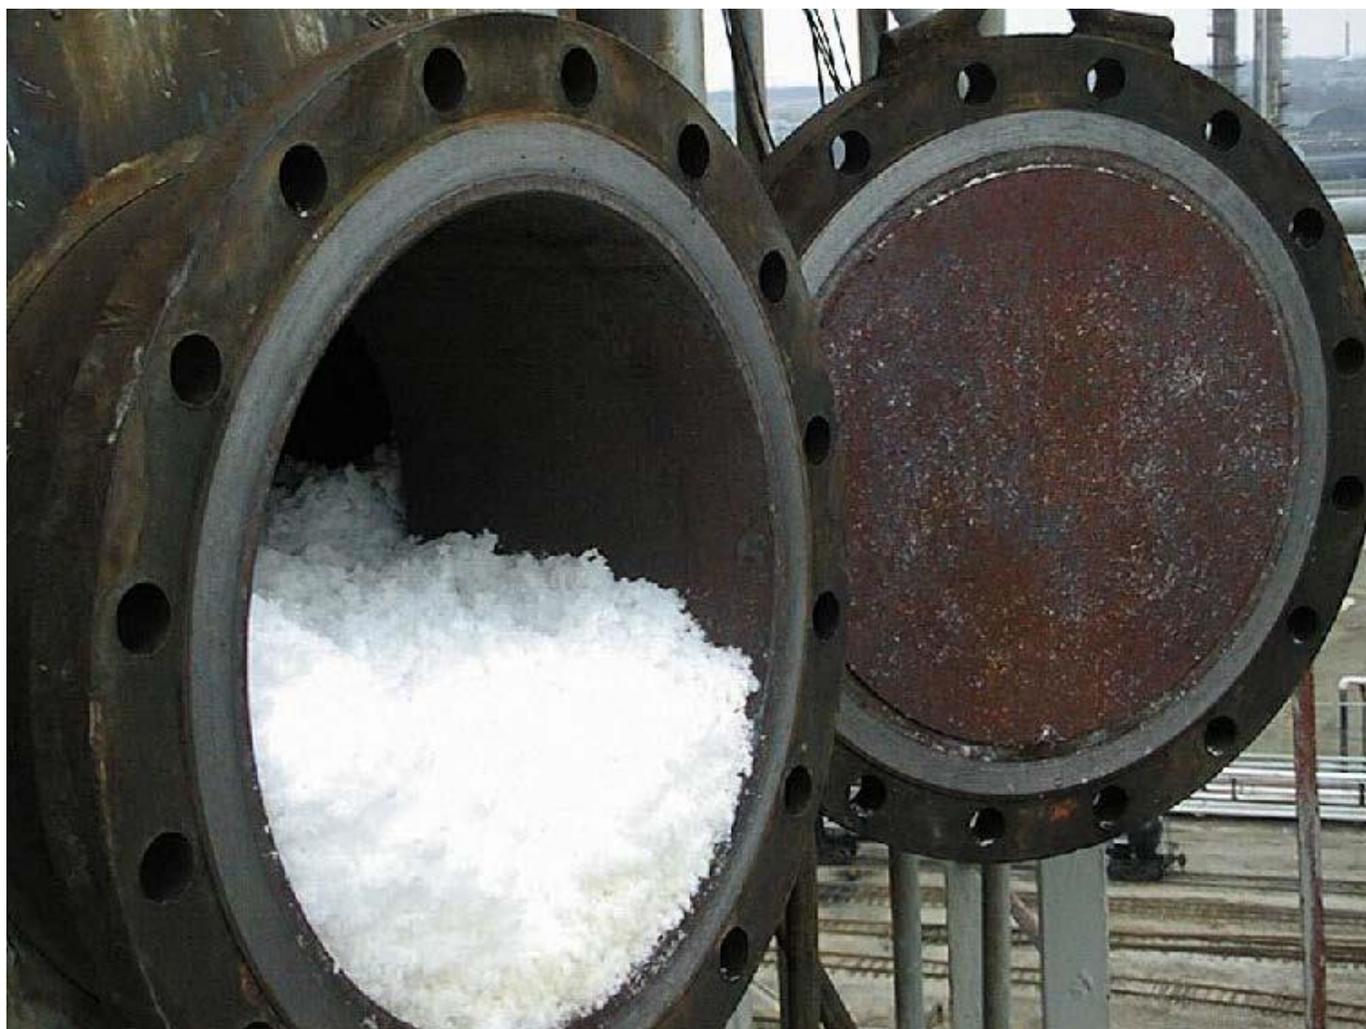
- A solid substance called “popcorn” polymer^a (**Figure 9**) can form in process vessels containing a high concentration of butadiene. Popcorn polymer is a hard, porous, opaque material created when oxygen reacts with butadiene in various areas of a butadiene production plant [11, p. 830]. Popcorn polymer formation involves two phases: initiation (seed formation) and propagation to polymer chains (seed growth) [11, p. 830]. Oxygen reacts with butadiene to form peroxides; butadiene peroxides react with butadiene to form popcorn polymer [8, pp. 8-9].

Figure 9. Popcorn polymer in a manhole from another undisclosed butadiene unit, published in the Butadiene Popcorn Polymer Resource Book. (Credit: International Institute of Synthetic Rubber Producers Inc. [12, p. 261])

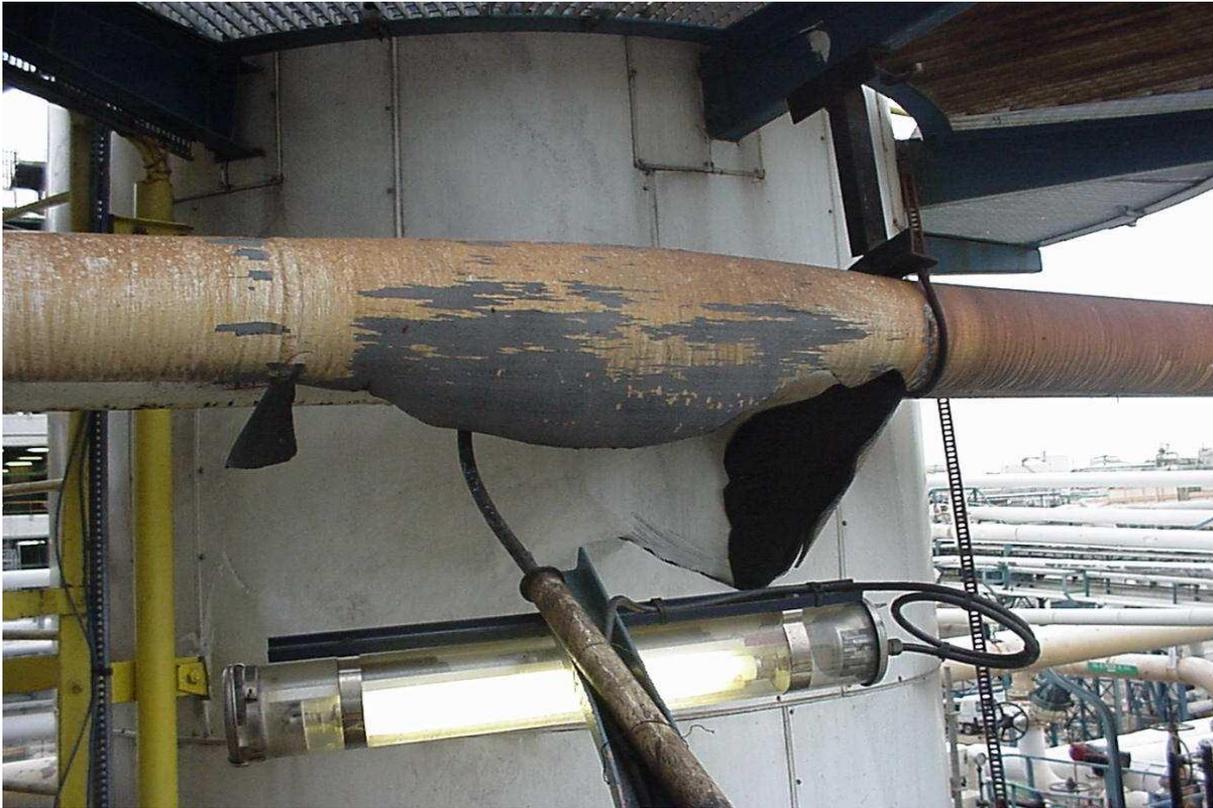
- High internal strain inside the popcorn polymer chains causes them to rupture and form new polymer seeds, thereby increasing the total volume of popcorn polymer as the process repeats [8, pp. 8-9]. This large increase in volume can produce enough pressure to swell or crack steel equipment. Throughout the industry, the buildup of popcorn polymer historically has caused equipment ruptures leading to loss of containment. **Figure 10** shows a pipe rupture caused by the buildup of popcorn polymer in another butadiene unit at the Lavera petrochemical complex located in Martigues, France in 2000 [12, pp. 154-159]. **Figure 11** shows another pipe rupture, which occurred at the PNO facility in 1999.^a

Figure 10. Pipe rupture caused by popcorn polymer in a butadiene unit in the Lavera petrochemical complex. (Credit: French Ministry of the Environment [12, p. 157])

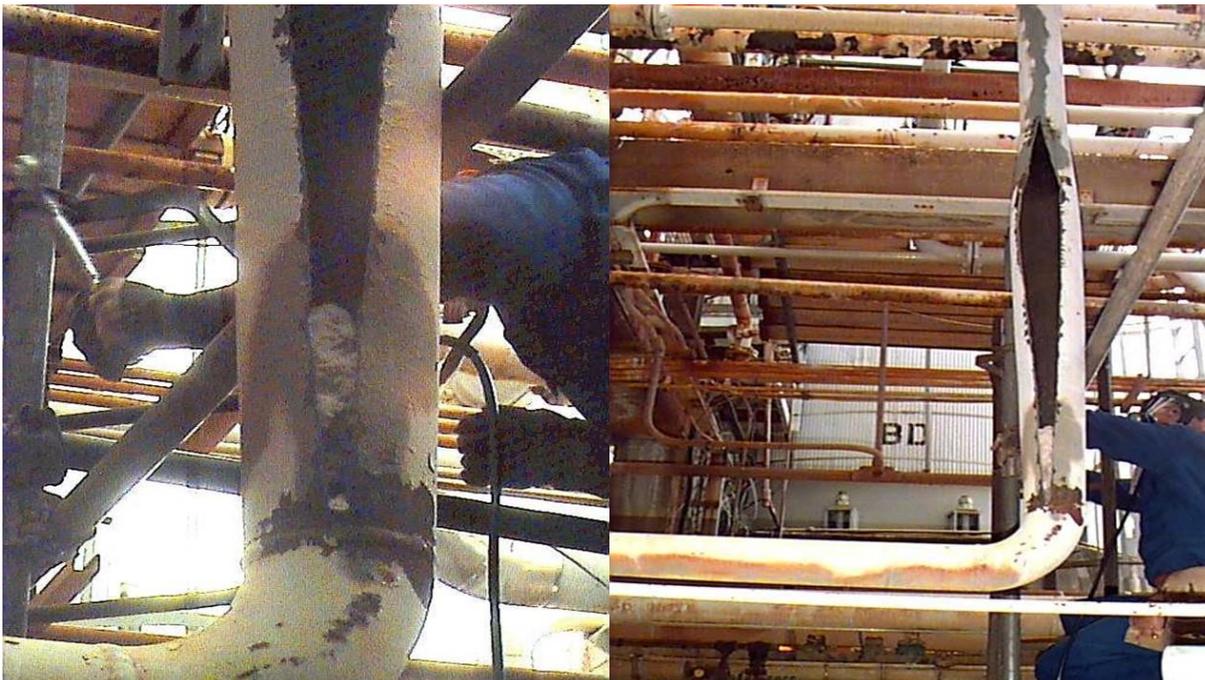
Figure 11. On July 29, 1999, a section of pump suction piping ruptured at the Huntsman PNO facility. Huntsman Corporation owned the facility until TPC acquired it in 2006. (Credit: TPC)

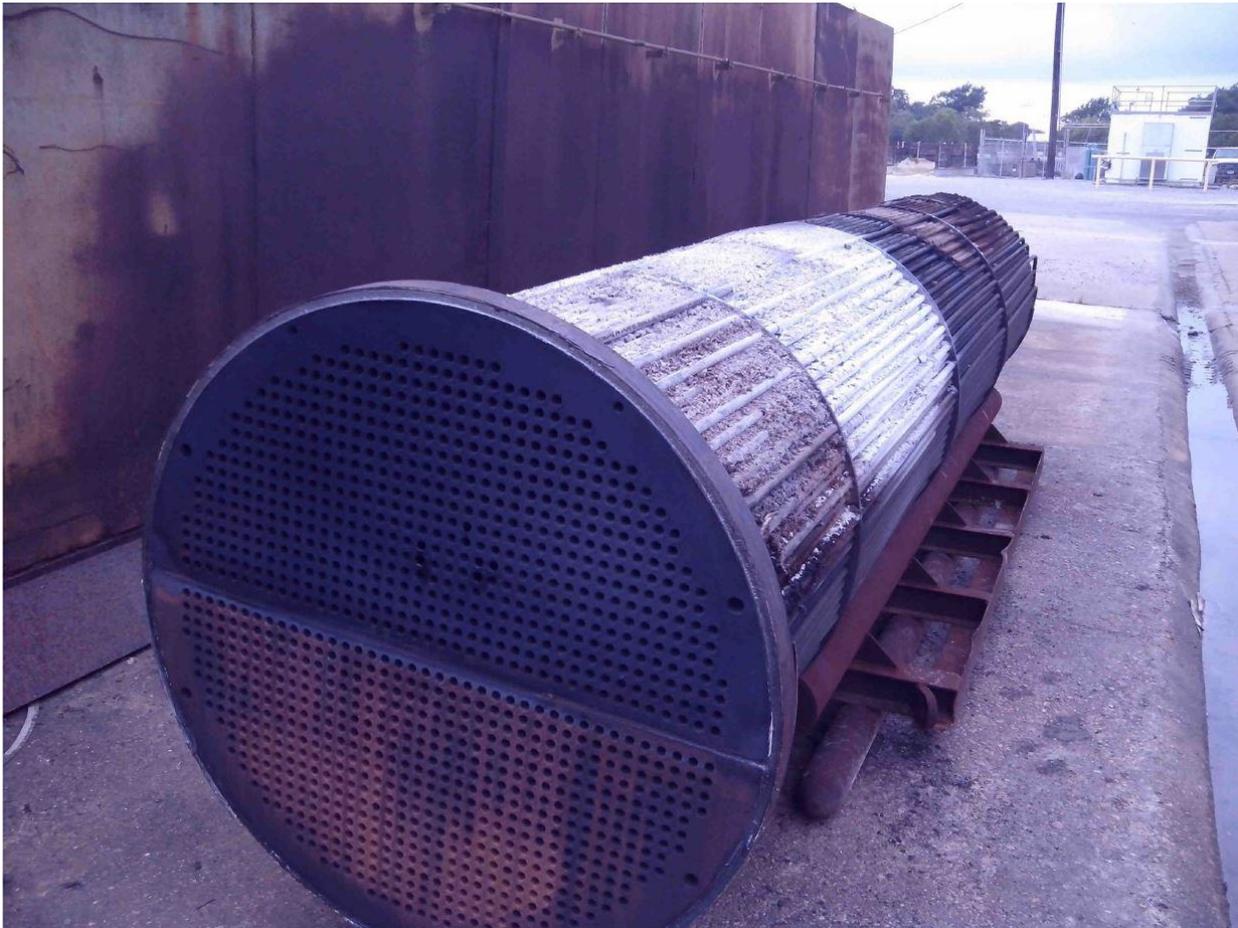
- Popcorn polymer was known to form in the South Unit before the incident. **Figure 12** shows a heat exchanger bundle pulled from one of the methyl acetylene removal tower reboilers on or around September 10, 2019. A TPC employee also noted that the emergency pressure-relief valve on this bundle “was plugged solid with popcorn and polymer.” **Figure 13** shows multiple locations where the TPC PNO facility has experienced polymer fouling problems since July 2019.

Figure 12. Polymer found on methyl acetylene removal tower reboiler bundle pulled on or around September 10, 2019. (Credit: TPC)

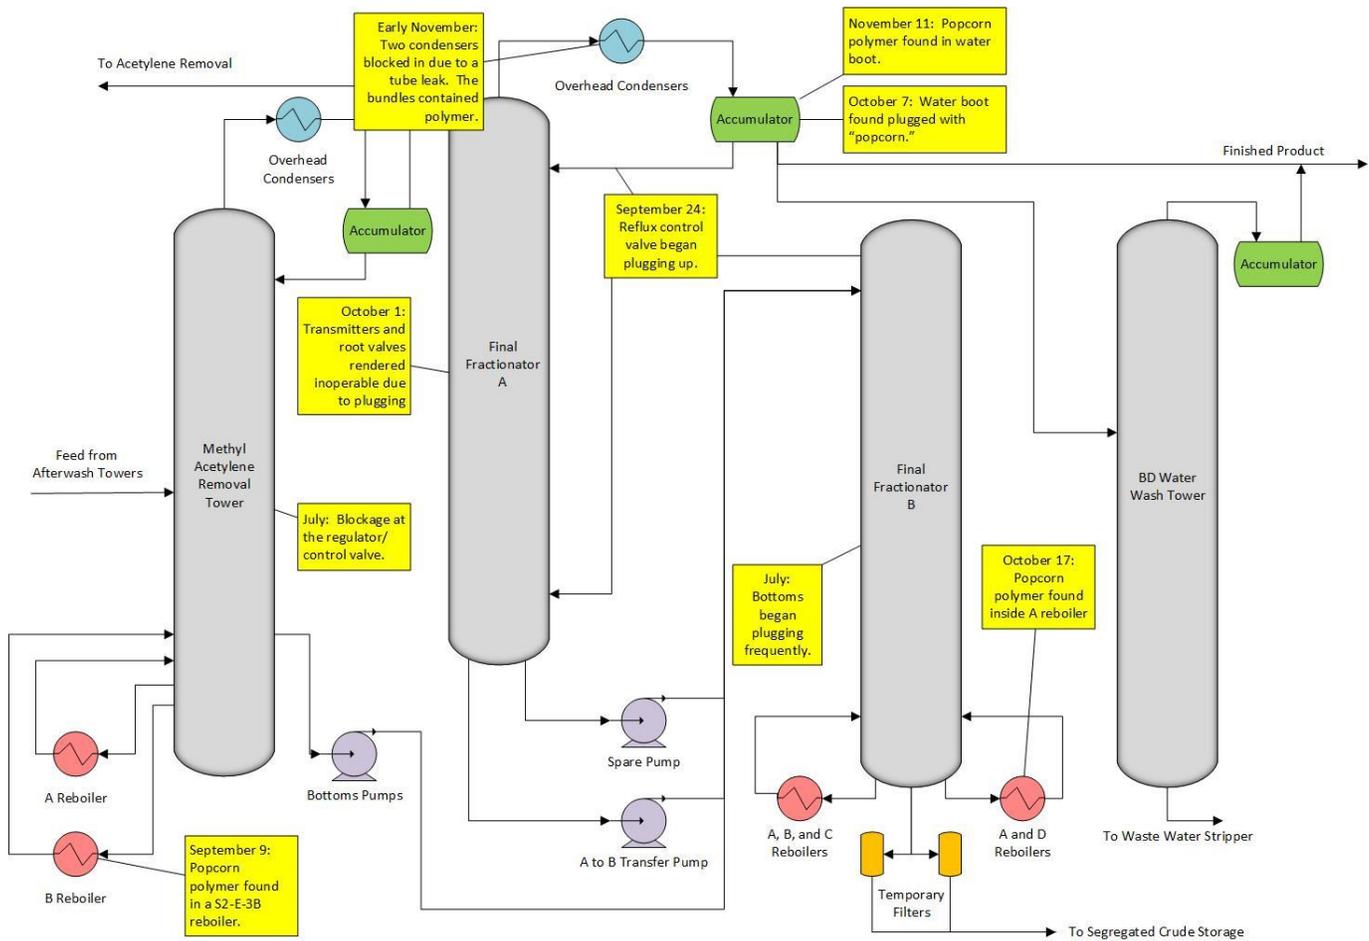
Figure 13. Simplified process diagram showing locations of recent polymer fouling (all dates shown are from 2019). (Credit: CSB)
