U.S. CHEMICAL SAFETY AND HAZARD INVESTIGATION BOARD

# INVESTIGATION REPORT

## E.I. DUPONT DE NEMOURS & CO., INC.

BELLE, WEST VIRGINIA

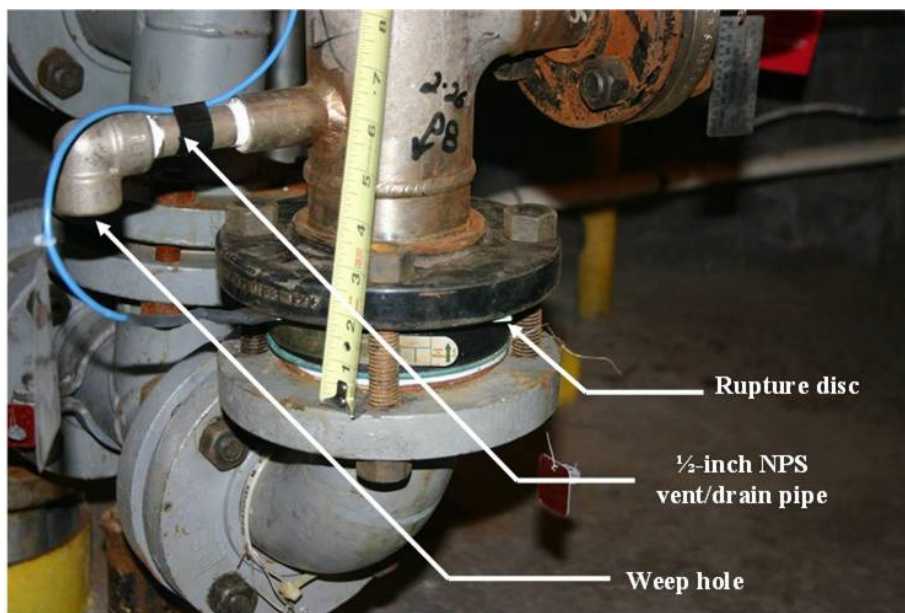
weep hole (Figure 3). This connection was associated with a thermal oxidizer “vent stack,” that vents to the atmosphere on the roof of the building during a process upset. Operators notified the board operator at 5:19 a.m. when they found the source of the release.

Figure 3. 0.5-inch NPS vent/drain pipe and rupture disc

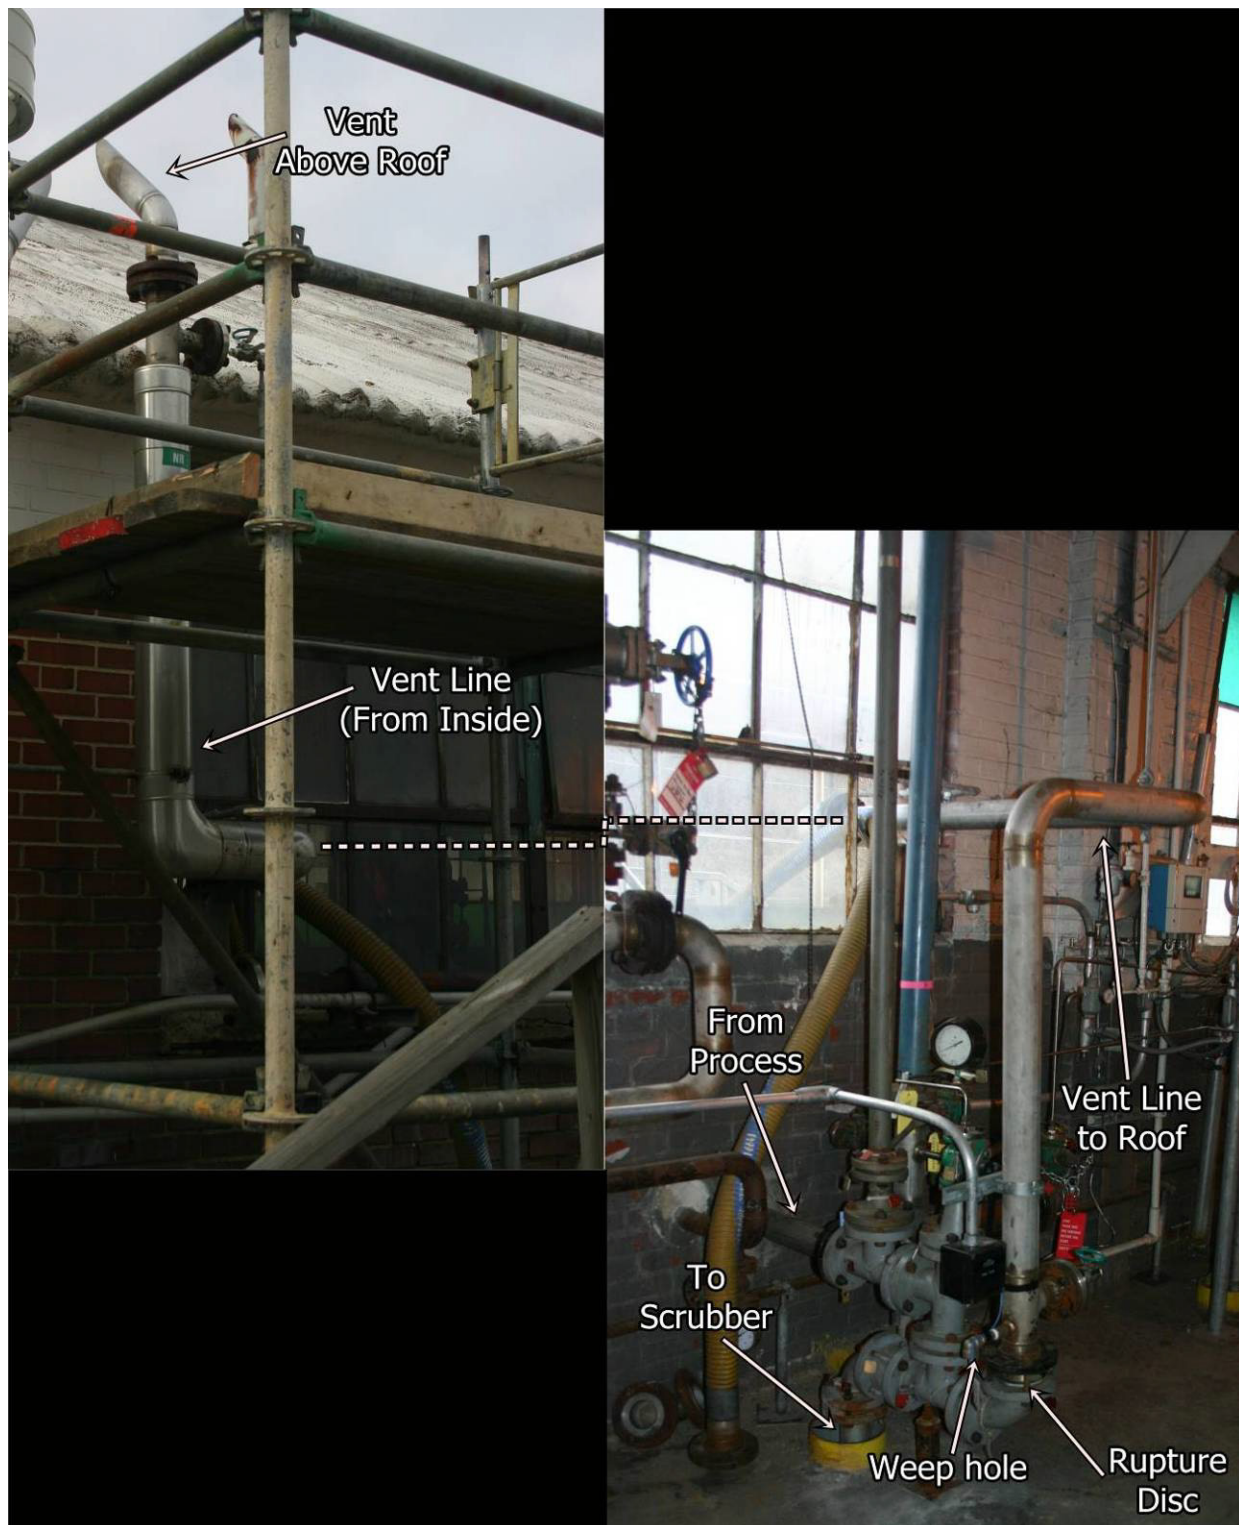
The rupture disc piping was routed to the atmosphere above the roof of the building, which would have provided an outlet path for the methyl chloride vapor where it would have dissipated and dispersed without notice.

Figure 4. Rupture disc piping and vent pipeline to atmosphere on roof

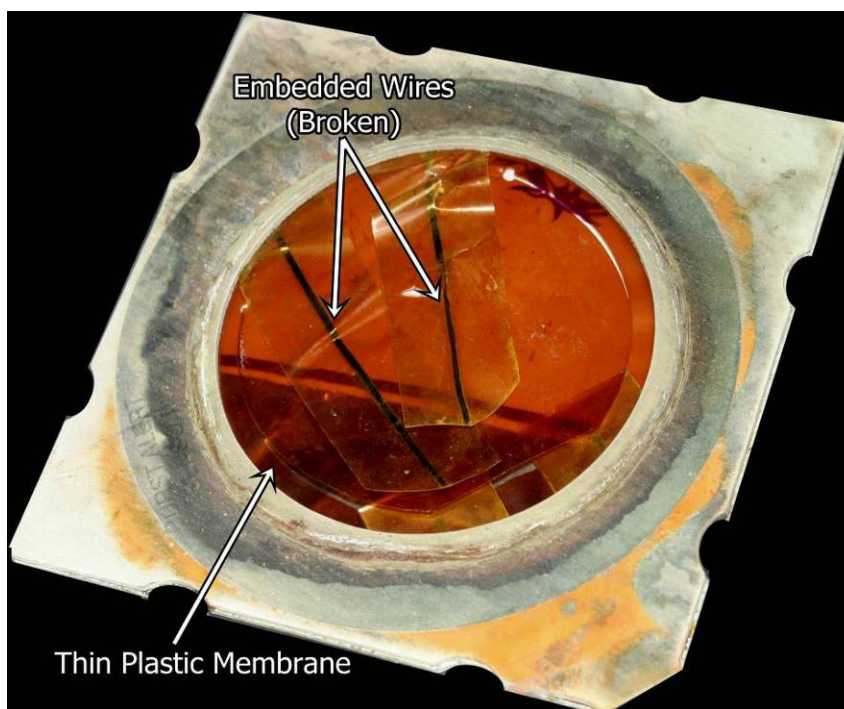
Figure 5. Rupture disc burst sensor post-incident

DuPont Belle used a “burst sensor” intended to notify the board operator that the rupture disk (Figure 5) activated. A burst sensor is a thin plastic membrane with embedded wires installed on top of the rupture disc. Small electrical current passes through the wires. When the rupture disc activates, the membrane and embedded wires break, triggering the alarm.

The CSB learned that the rupture discs and sensors associated with this system were historically problematic. The burst sensor involved in the January 22, 2010, incident had been replaced many times

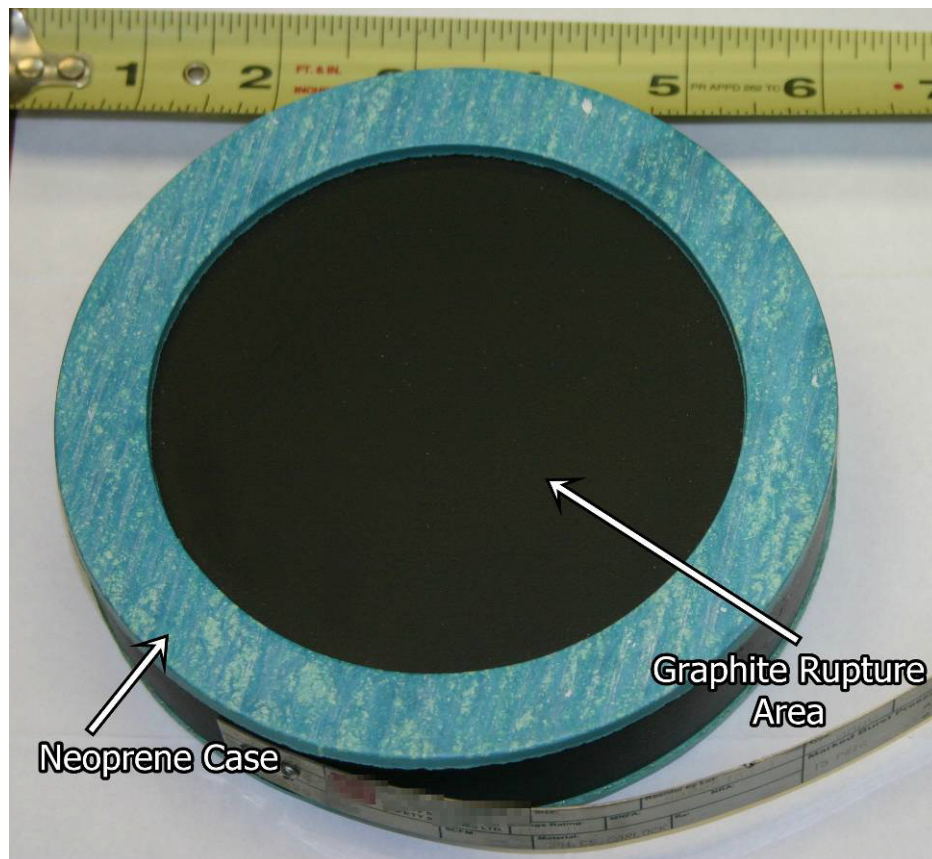
The rupture disc involved in the incident was a 4-inch diameter graphite rupture disc, designed to rupture at 15 psig, and mounted in neoprene casing (Figure 6). While the rupture disc is on a preventive maintenance (PM) schedule, the annual inspection was so infrequent that the disc is replaced only when it has activated or is removed for certain processes. Operators told the CSB investigators that once removed, the rupture discs, intact or compromised, are discarded and replaced with new ones. Even without a burst

Figure 6. New rupture disc

sensor, all overpressure protection devices, including rupture discs, should be routinely checked on an effective PM schedule as a layer of protection.<sup>16</sup>

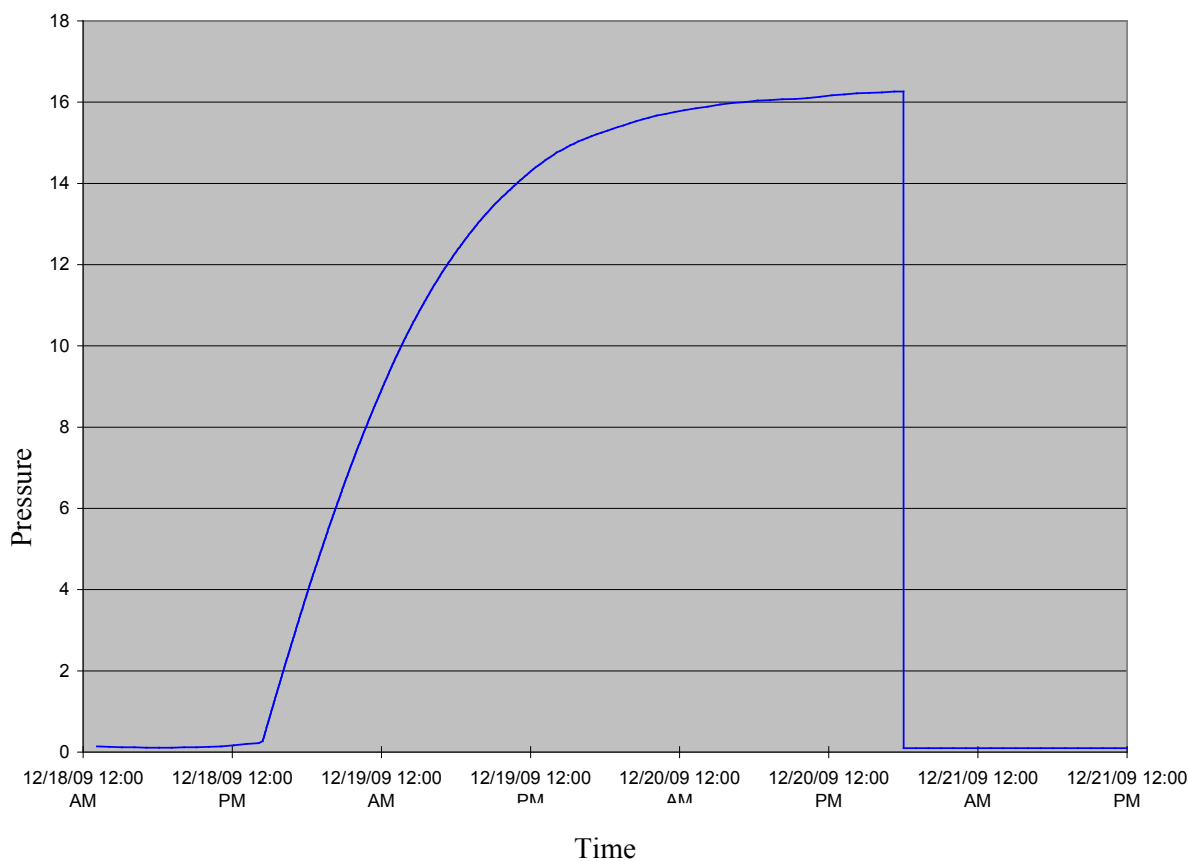
Figure 7. Process data showing sudden pressure decrease when rupture disc burst

The operators did not address the alarm when it triggered in December because they knew that work in the area was causing nuisance alarms; however, when the ECF alarm activated on January 22, 2010, operators responded. The board operator in the F3455 control room investigated and observed that the original alarm from December 21, 2009, was still displayed; the first item on the alarm screen had not been acknowledged because they had become accustomed to nuisance alarm conditions.<sup>21</sup>

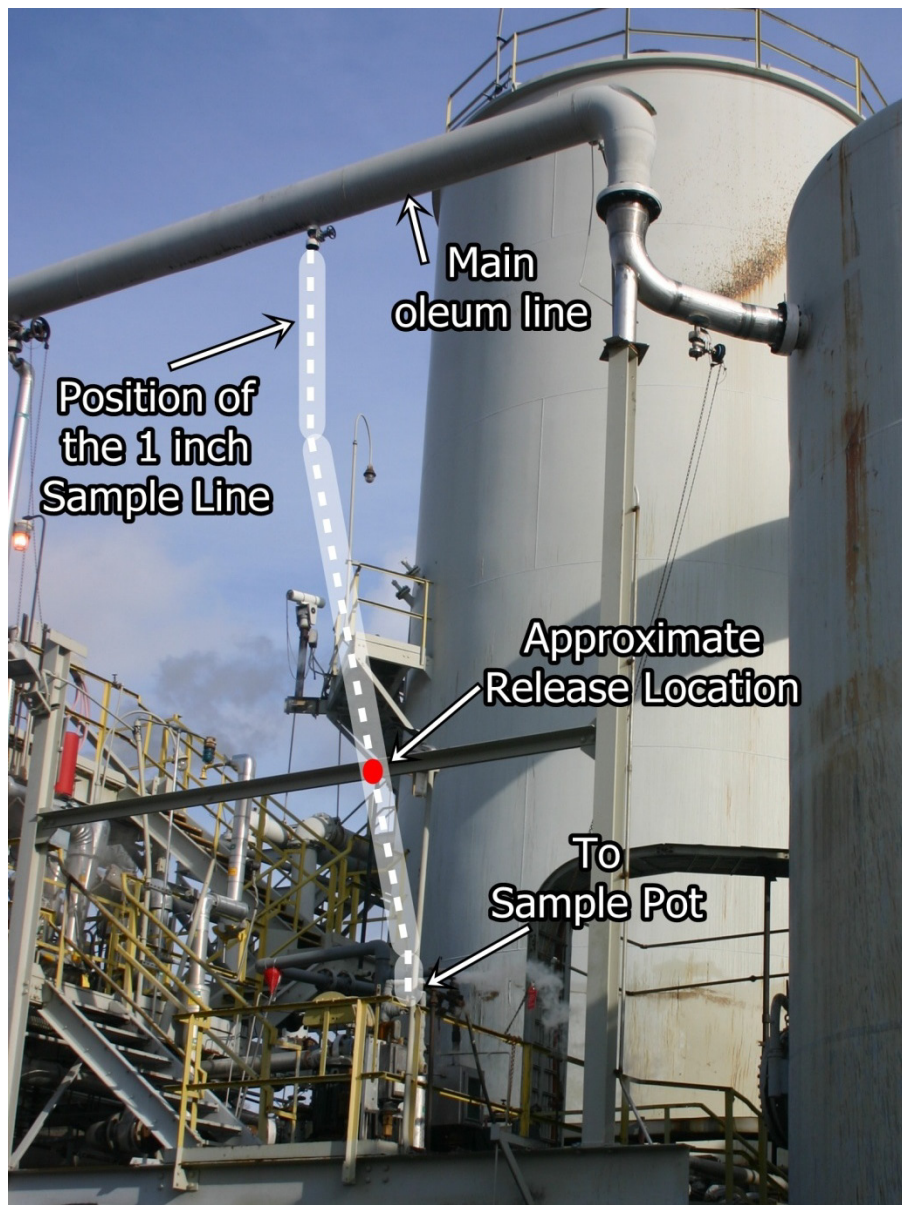
Figure 8. Photo of the position of the 1-inch sample line, which had not yet been replaced

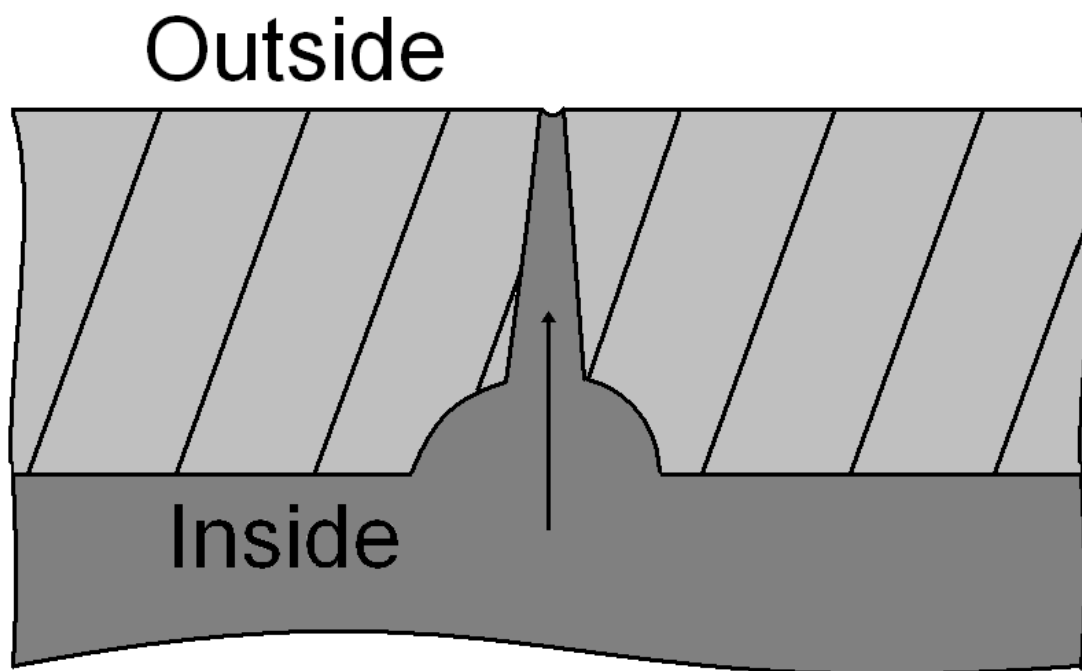
Caused by an unknown defect, oleum corroded through a small section of the pipe involved in the release on January 23, 2010. Starting as a pitting phenomena and finishing slightly larger than a pin hole, the corrosion penetrated the insulated stainless steel sample pipe (Figure 9).

Figure 9. The pitting phenomena in the small initial hole of the oleum sample line wall

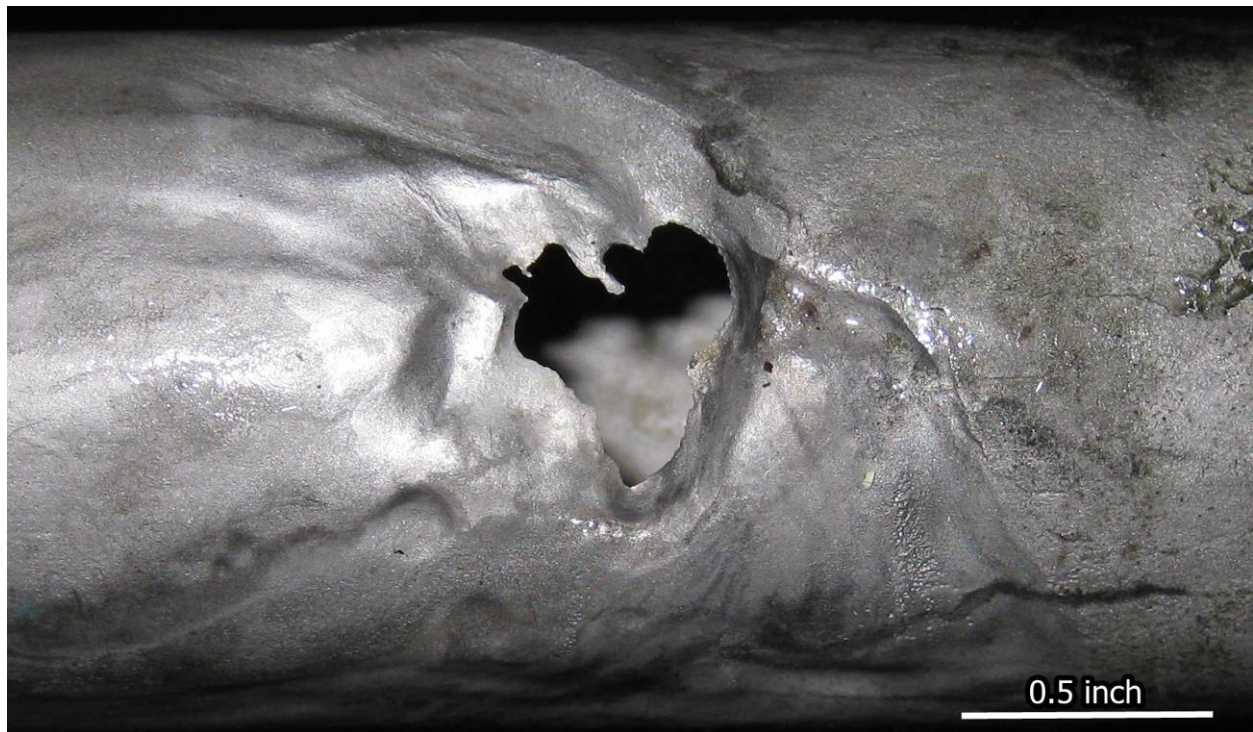
Once oleum was present on the exterior of the oleum pipe, it readily corroded the insulation and steam tracing line and then created a leak in the steam tracing, causing the steam and oleum to mix. This reaction created a strong solution of sulfuric acid that rapidly and effectively corroded the stainless steel sample line exterior, until a second larger hole developed at a location near the original small leak. The second hole clearly shows corrosion occurring from the outside-in (Figure 10).

Figure 10. The larger hole eroded from the outside-in on the oleum sample line<sup>26</sup>

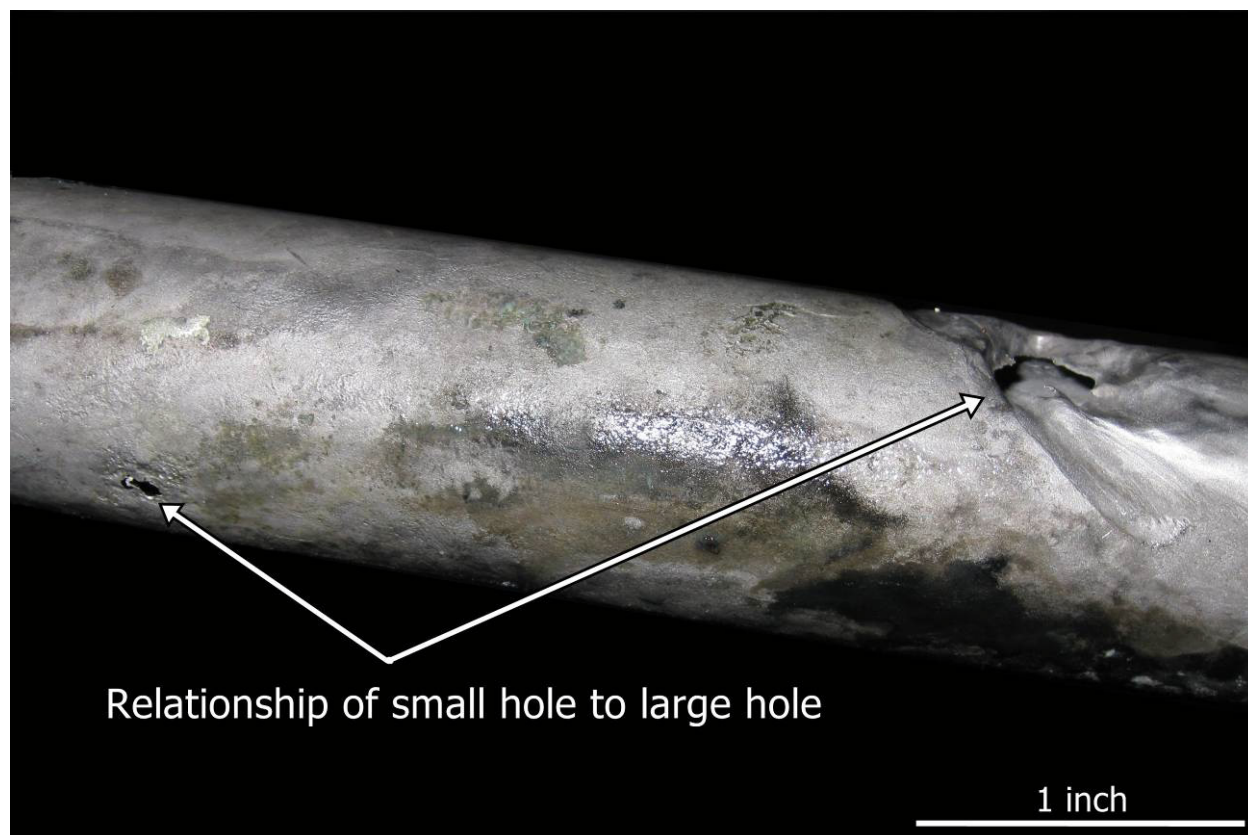
When DuPont removed the oleum-soaked insulation and cover, a larger hole was visible; the acid had also corroded a large amount of the steam tracing. When the sample line was properly cleaned, inspection revealed that the smaller hole was only a few inches away from the larger hole, and after thorough examination, metallurgists concluded that the small hole in the sample line initiated the oleum release (Figure 11).

Figure 11. Photo showing the orientation of the small hole to the main hole

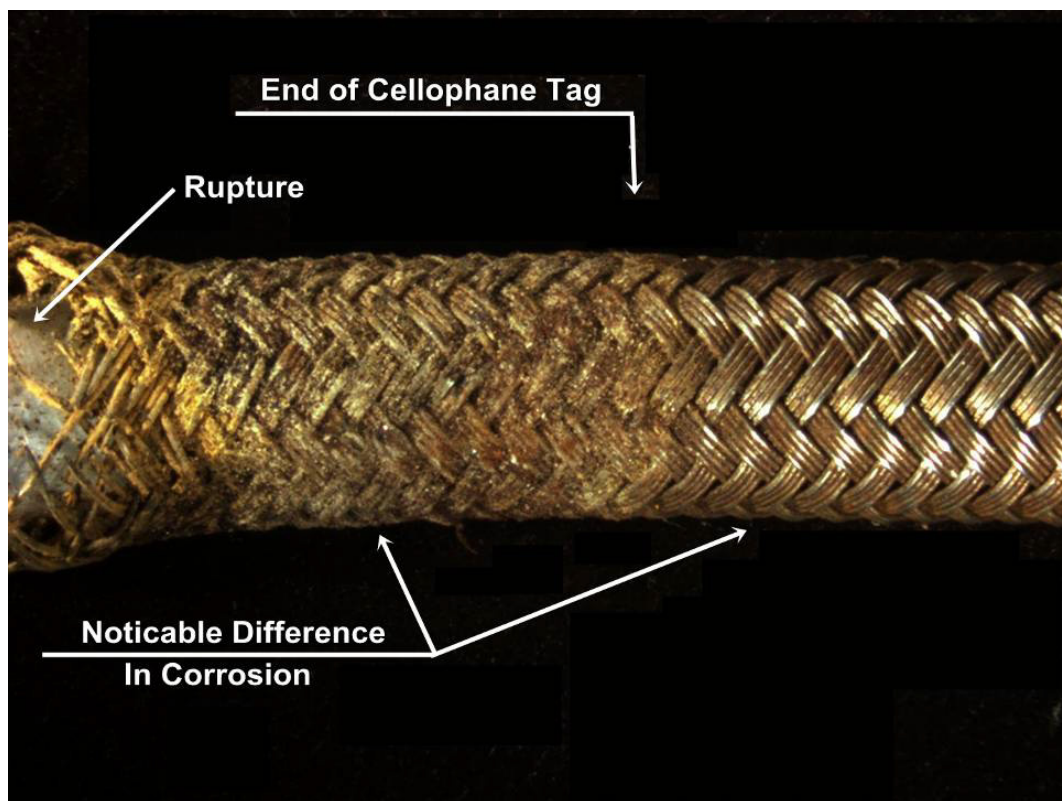
Figure 14. The distinct effect of the white plastic adhesive tag on the corrosion of the stainless steel overbraid

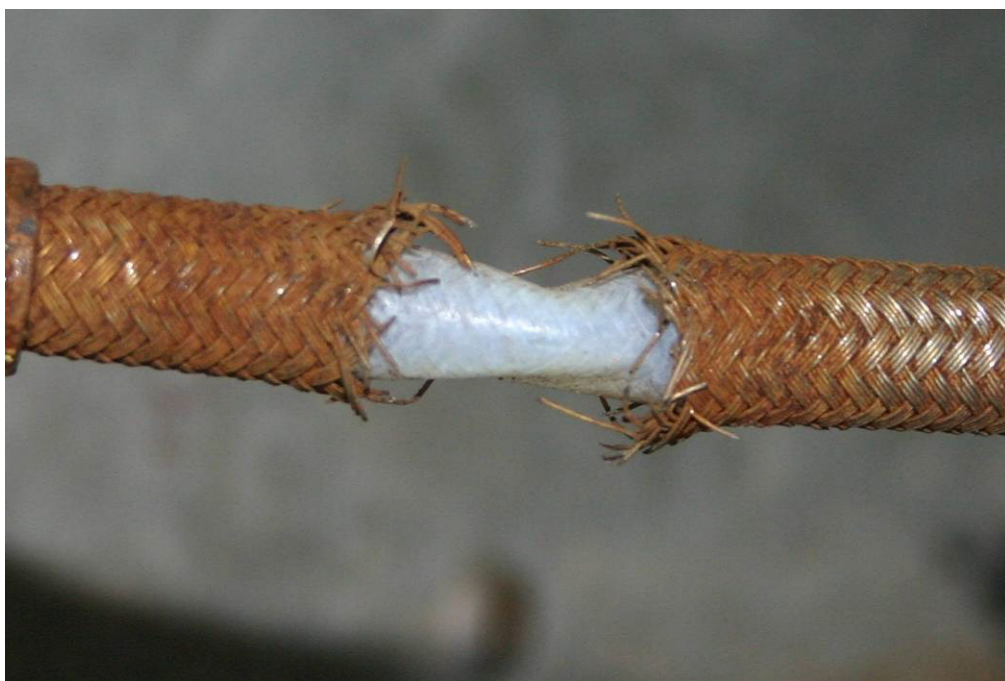
The hillside phosgene supply hose and valve assembly were removed and decontaminated in a water bath. When the hose was removed from the water, the white adhesive ID tag had fallen off, revealing a broken stainless steel braid and collapsed PTFE liner, a possible cause of the flow restriction (Figure 15).

Figure 15. Damaged hillside phosgene hose removed from phosgene cylinder. The plastic adhesive tag that covered the damaged section fell off during the hose decontamination procedure.

An operator stated during an interview that when he saw the physically defective section of the frayed hose, he told his coworkers, stressing that the hose was close to rupturing and that they were lucky to have found it and changed-out the hose in time. Unfortunately, this discovery was not captured as a near-miss, since supervisors were not made aware of the issue.

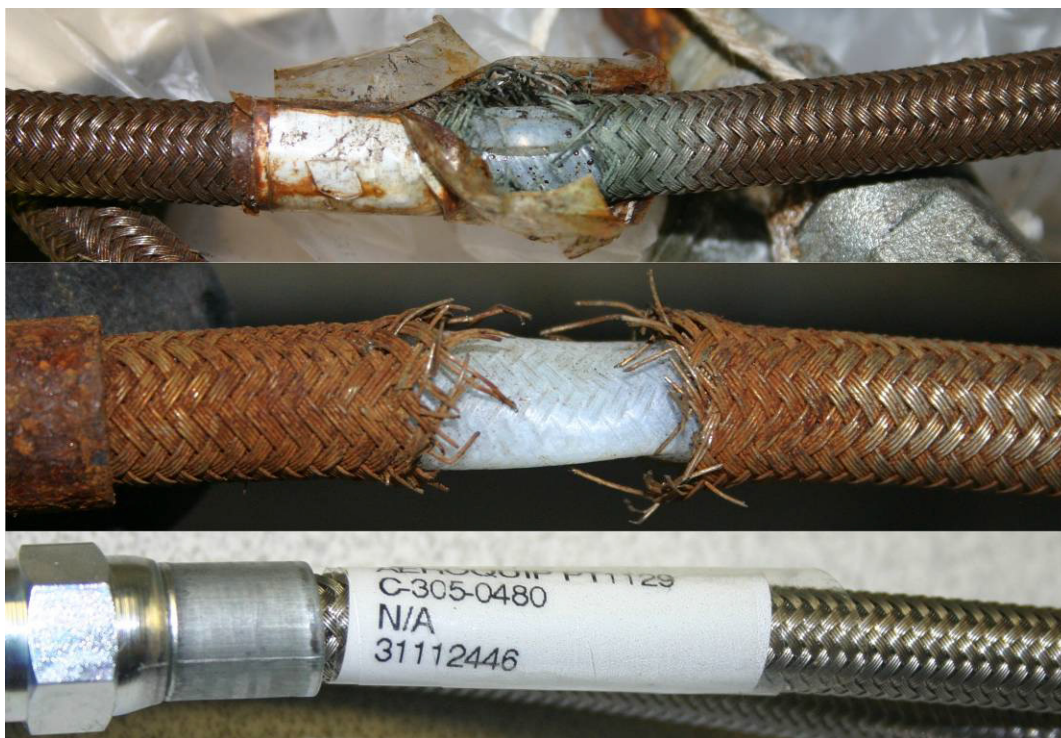
However, the PM schedule in SAP is actually set to a replacement frequency of 30 days. This procedure does not effectively communicate why the hoses must be replaced so frequently: if left on too long, the accepted corrosion condition poses a serious risk to the facility and the community.

Figure 16. Flex hose comparison photographs: (top to bottom) ruptured riverside hose, flow restricted hillside hose, a new hose with attached ID tag
