# Fire During Hot Work at Evergreen Packaging Paper Mill

Canton, NC | Incident Date: September 21, 2020 | No. 2020-07-I-NC

## Investigation Report

Published: September 24, 2021

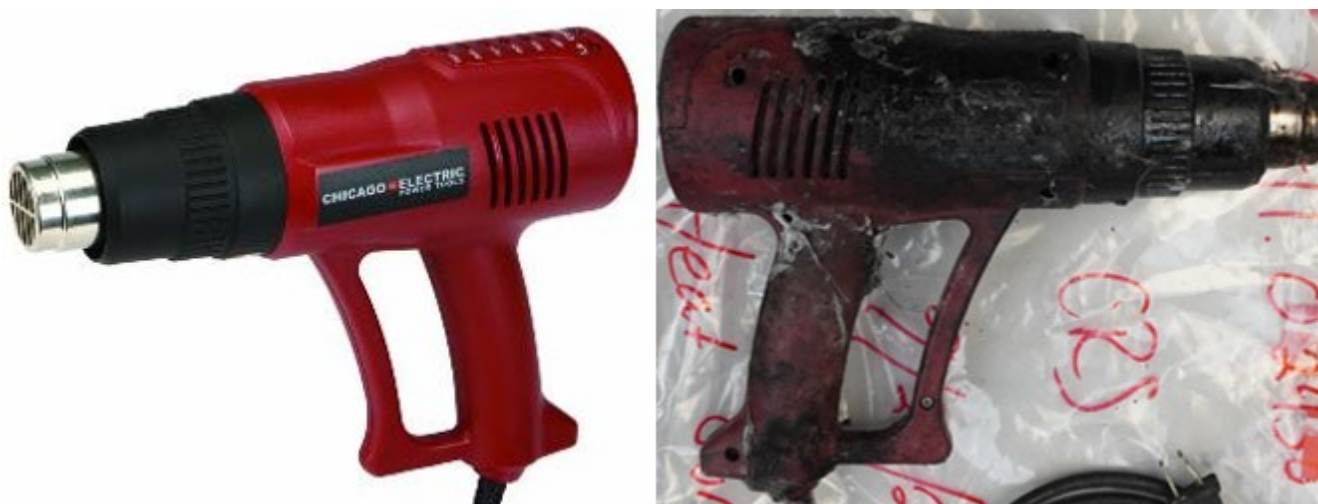
- **Hot Work Safety.** The electric heat gun used to warm the flammable resin could achieve temperatures in excess of the resin's flash point and auto-ignition temperatures. The electric heat gun came into direct physical contact with the flammable resin when it fell into the resin bucket. Blastco did not recognize the ignition hazard presented by the use of the heat gun, did not inform Evergreen or Rimcor of the heat gun's use, and did not take adequate action to prevent the introduction of ignition sources into a confined space containing flammable liquids. In addition, while Evergreen's internal policies defined hot work as "any activity that could serve as a source of ignition," Evergreen's contractor orientation materials limited the hot work definition to only "burning, cutting, brazing or welding." ([Section 3.1](#)).

The heat gun Blastco used to warm the resin was a Chicago Electric model heat gun [5]. According to the tool’s manual, it had six different heat settings, each with a low and high sub-setting, for a total of 12 temperature settings. These settings ranged from a minimum of 430°F to a maximum of 1,160°F. One of the Blastco workers who used the heat gun could not recall the exact setting used leading up to the fire but told the CSB that it was set on the third or fourth setting, which corresponds with a temperature of between 650°F (the low temperature of the third setting) and 790°F (the high temperature of the fourth setting).

**Figure 4.** Exemplar heat gun (left). Heat gun recovered from scene (right). (Credit: Harbor Freight [6], CSB.)

The CSB recommends to Blastco to update its hot work policy and employee training program to specifically identify the use of heat guns as hot work. The policy and programs should make clear that hot work encompasses any method of work that can ignite a fire and not just spark- or flame-producing work methods.

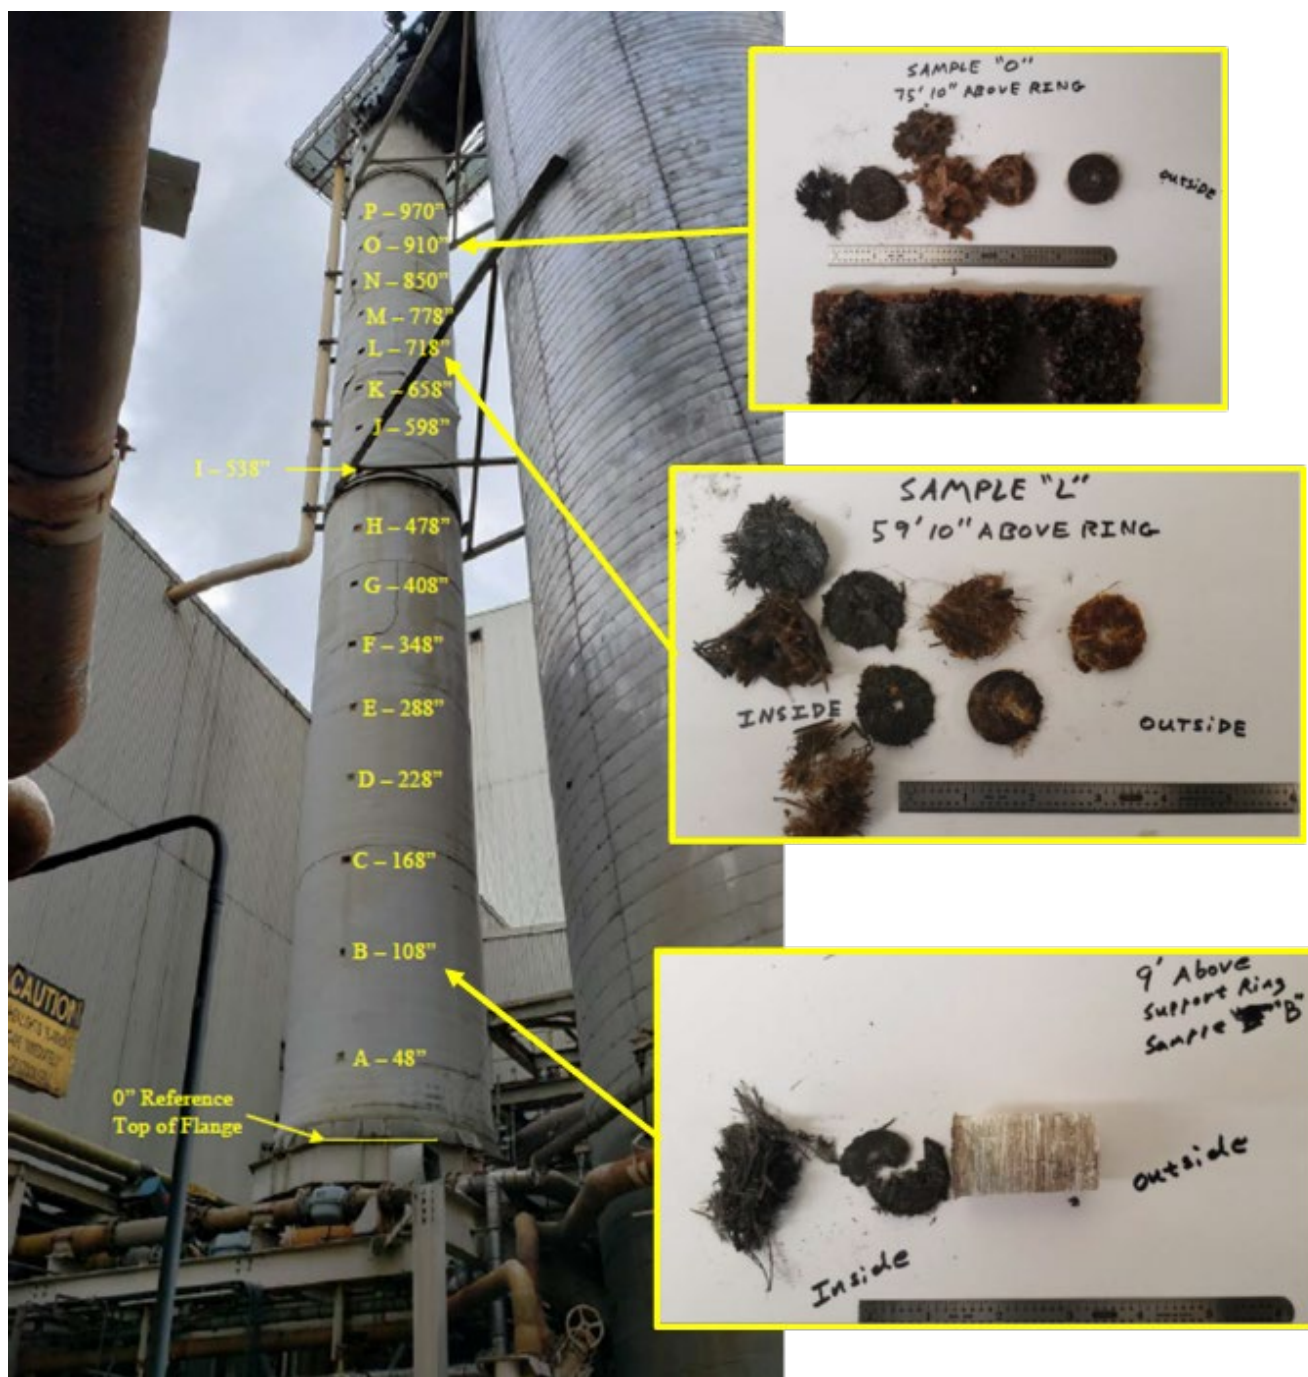
In order to determine the extent of the fire-induced damage sustained during the incident inside the upflow tower, 16 one- to two-inch circular core samples were removed from the side of the vessel (**Figure 10**). Blastco was working inside the tower from roughly the heights of sample "D" to sample "I." In the figure, the apostrophe symbol (') is used to notate feet and the quotation symbol (") is used to notate inches. During post-incident examination of the upflow tower, burn damage was found on the inside surface of the vessel's insulation near the top of the vessel.<sup>a</sup>

Figure 10. Internal fire damage in the upflow tower. (Credit: Evergreen. Edited by CSB.)
