U.S. Chemical Safety and Hazard Investigation Board

Fire During Hot Work at
Evergreen Packaging Paper Mill
Canton, North Carolina
September 21, 2020

Investigation Presentation

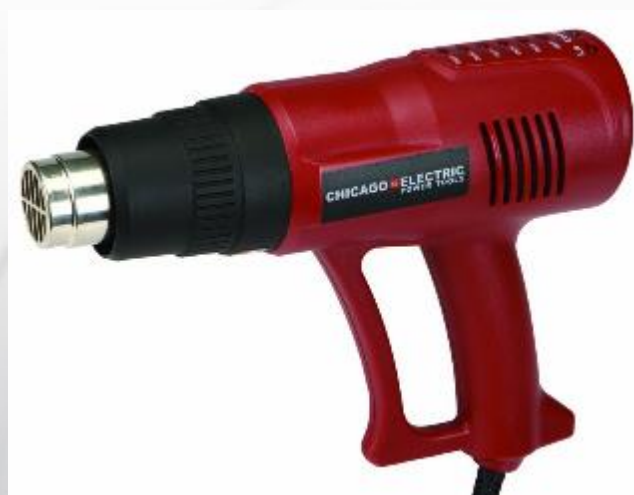
- Blastco workers attempted several methods of addressing the problem
- None were successful
- Two Blastco workers obtained an electric heat gun
- The workers used it inside the upflow tower to warm the resin
- This caused the resin to gel faster

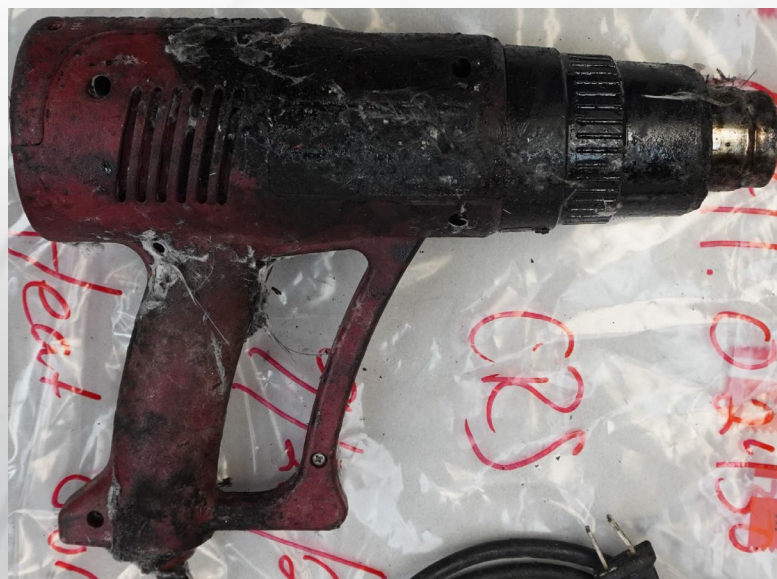
- Heat gun could produce temperatures in excess of resin flash point and autoignition temperatures
- Use of ignition sources in the presence of flammable liquids is a practice prohibited by OSHA
- Blastco did not warn Evergreen or Rimcor of its use of the heat gun in the presence of the resin

- Blastco did not recognize the ignition hazard presented by the heat gun
- Evergreen's internal policies and contractor orientation materials contained different definitions of hot work
- Staff proposes a recommendation each to Evergreen and Blastco

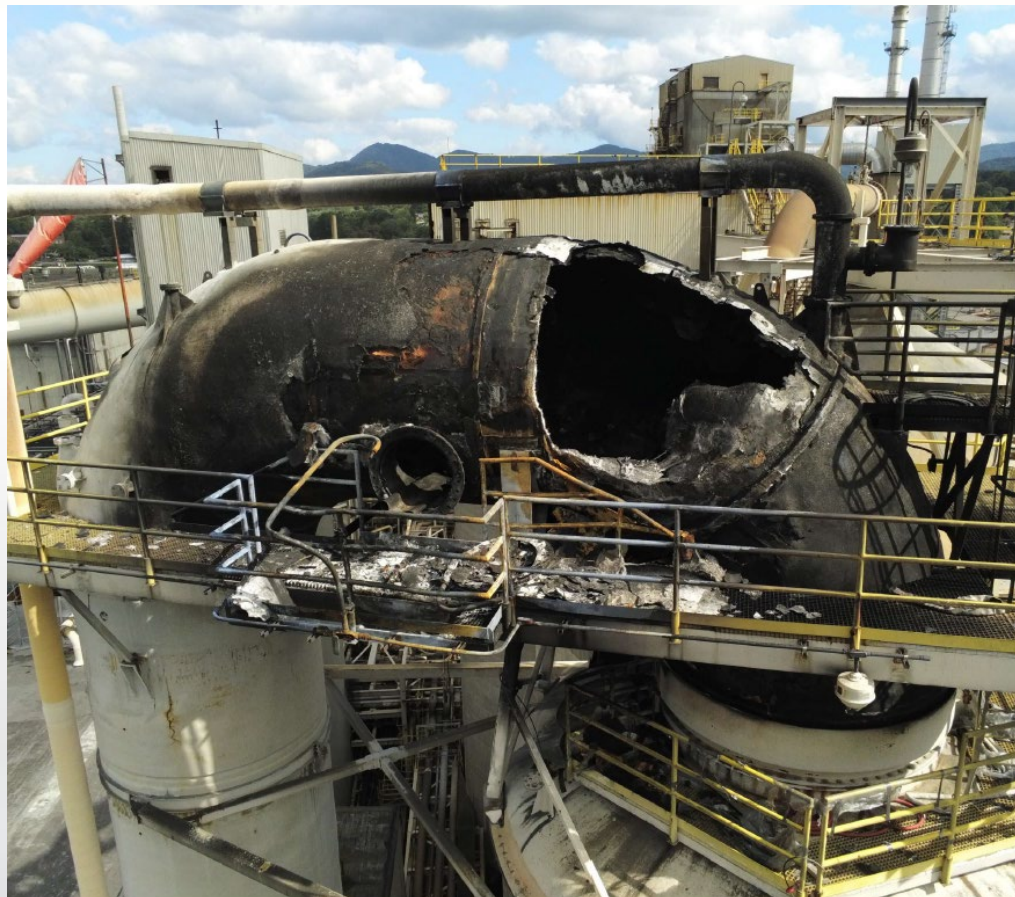
- FRP is combustible and will burn in the presence of a flame
- Upflow tower and crossover line constructed of FRP
- Evidence shows that inside surface of upflow tower burned
- This enabled the fire to rapidly spread to downflow tower
