Investigation Report

Published: October 11, 2022

SAFETY ISSUES:

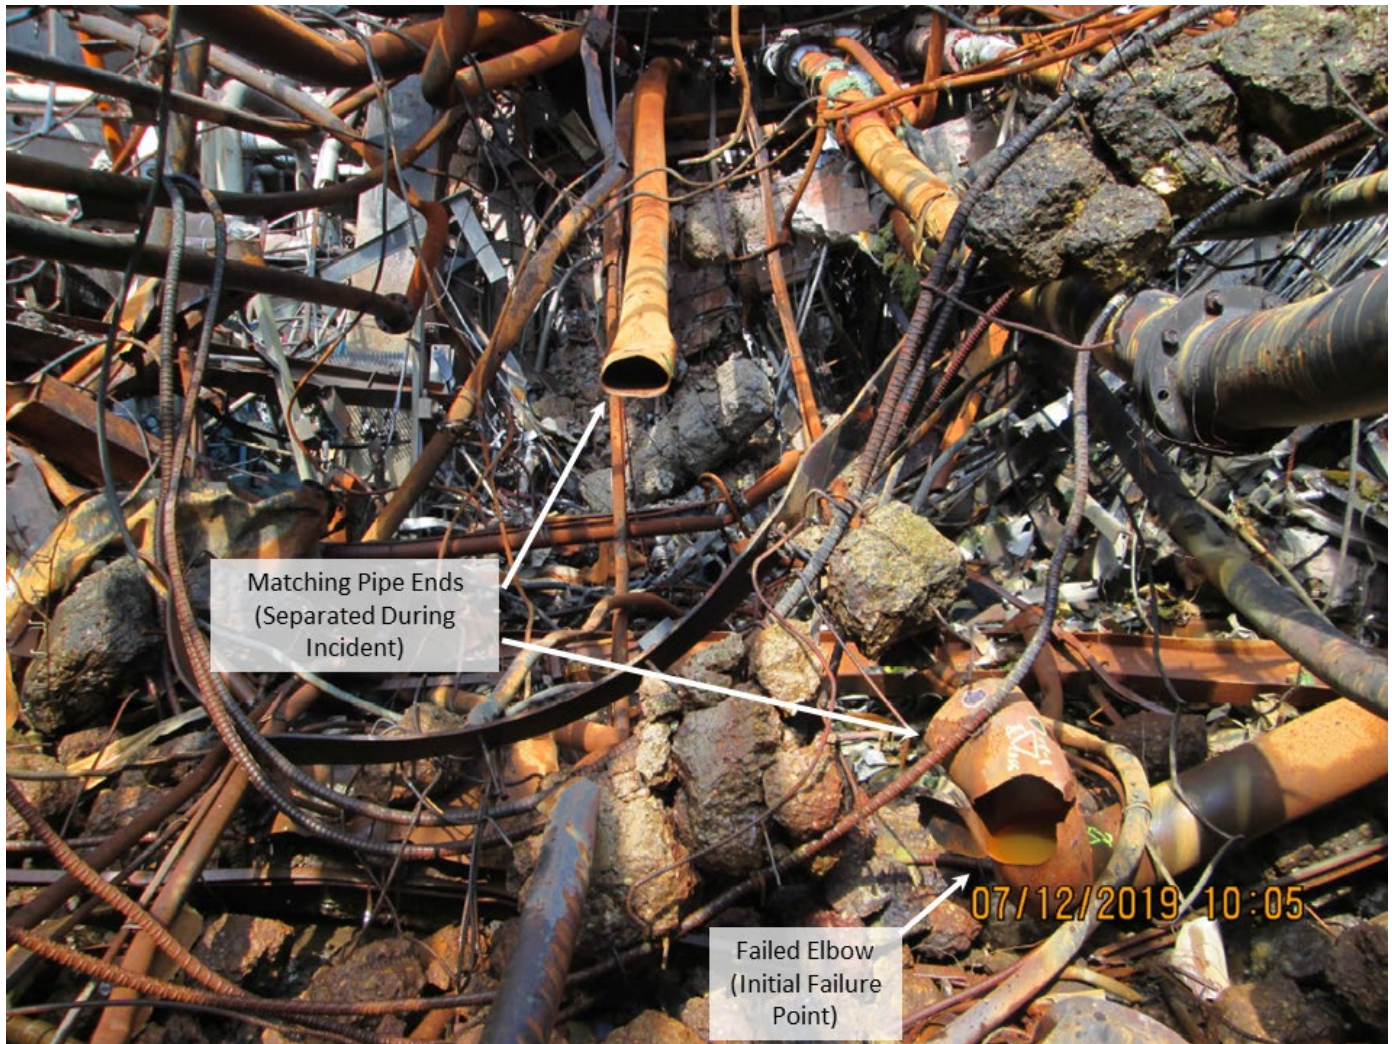
About three seconds after the operator increased the T-7 feed to 80 bph, at 4:00:16 a.m. an elbow on the discharge piping of pump P14-B ruptured (**Figure 7**). An incident timeline can be found in **Appendix A**, which includes the process data and operational events preceding and during the incident.

Figure 7. Photo of the ruptured pipe elbow found post-incident. (Credit: PES)

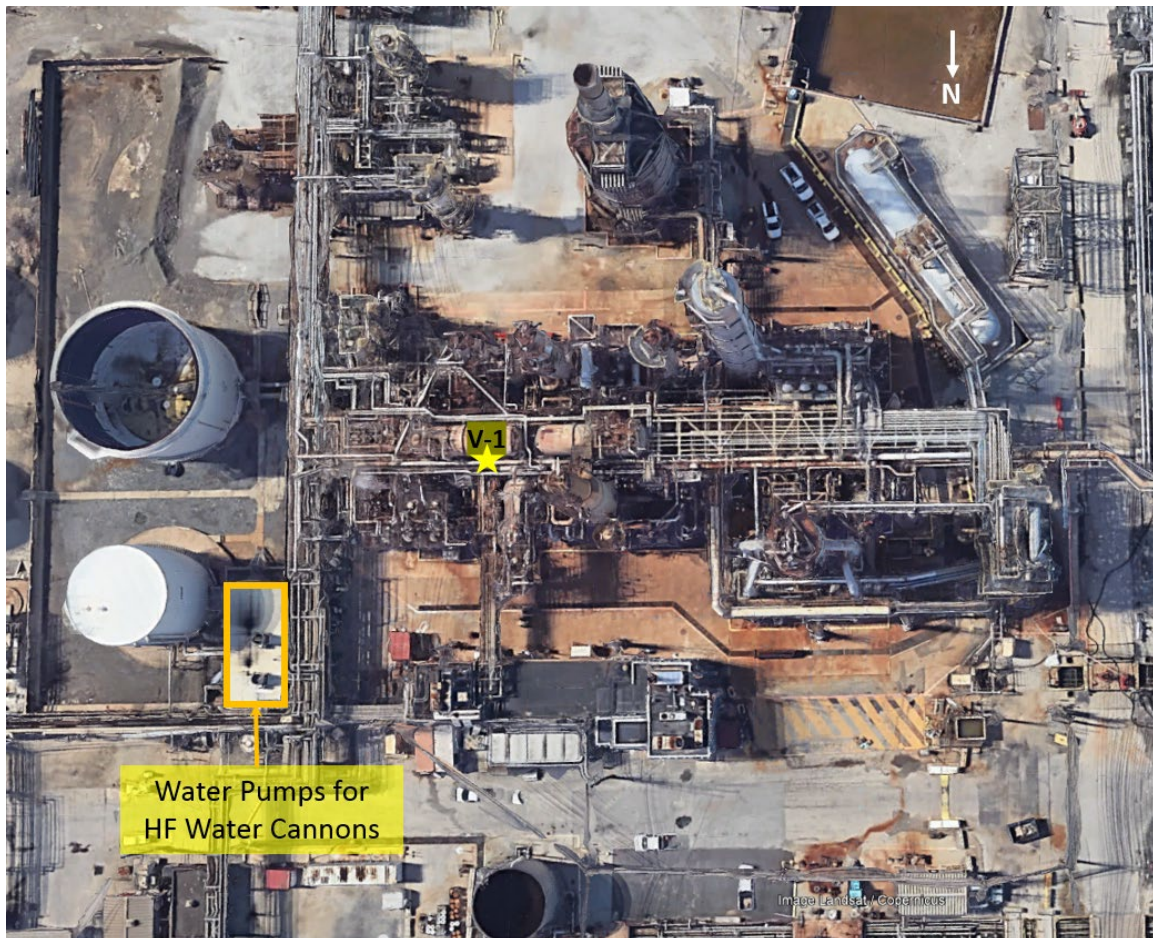
At 4:12 a.m., the control room operator tried to remotely turn on the water pumps that fed the elevated HF mitigation water cannons, which were designed to reduce airborne HF through vapor suppression,^{b,c} but the water pumps did not turn on. The control system communication to the water pumps had failed at 4:02:06 a.m. (time of ignition) and a backup power system in the unit—the uninterruptible power supply (UPS)—also failed nine seconds later at 4:02:15.^d Field operator 1 tried to walk to the water pumps to manually turn them on, but the operator could not get to the pumps because the fire made that area too hot to enter (**Figure 10**).

Figure 10. Location of (1) the water pumps that fed the hydrofluoric acid mitigation water cannons (yellow rectangle), and (2) the location of the ruptured elbow from which the process release originated (yellow star). (Credit: Google Earth with annotations by CSB)

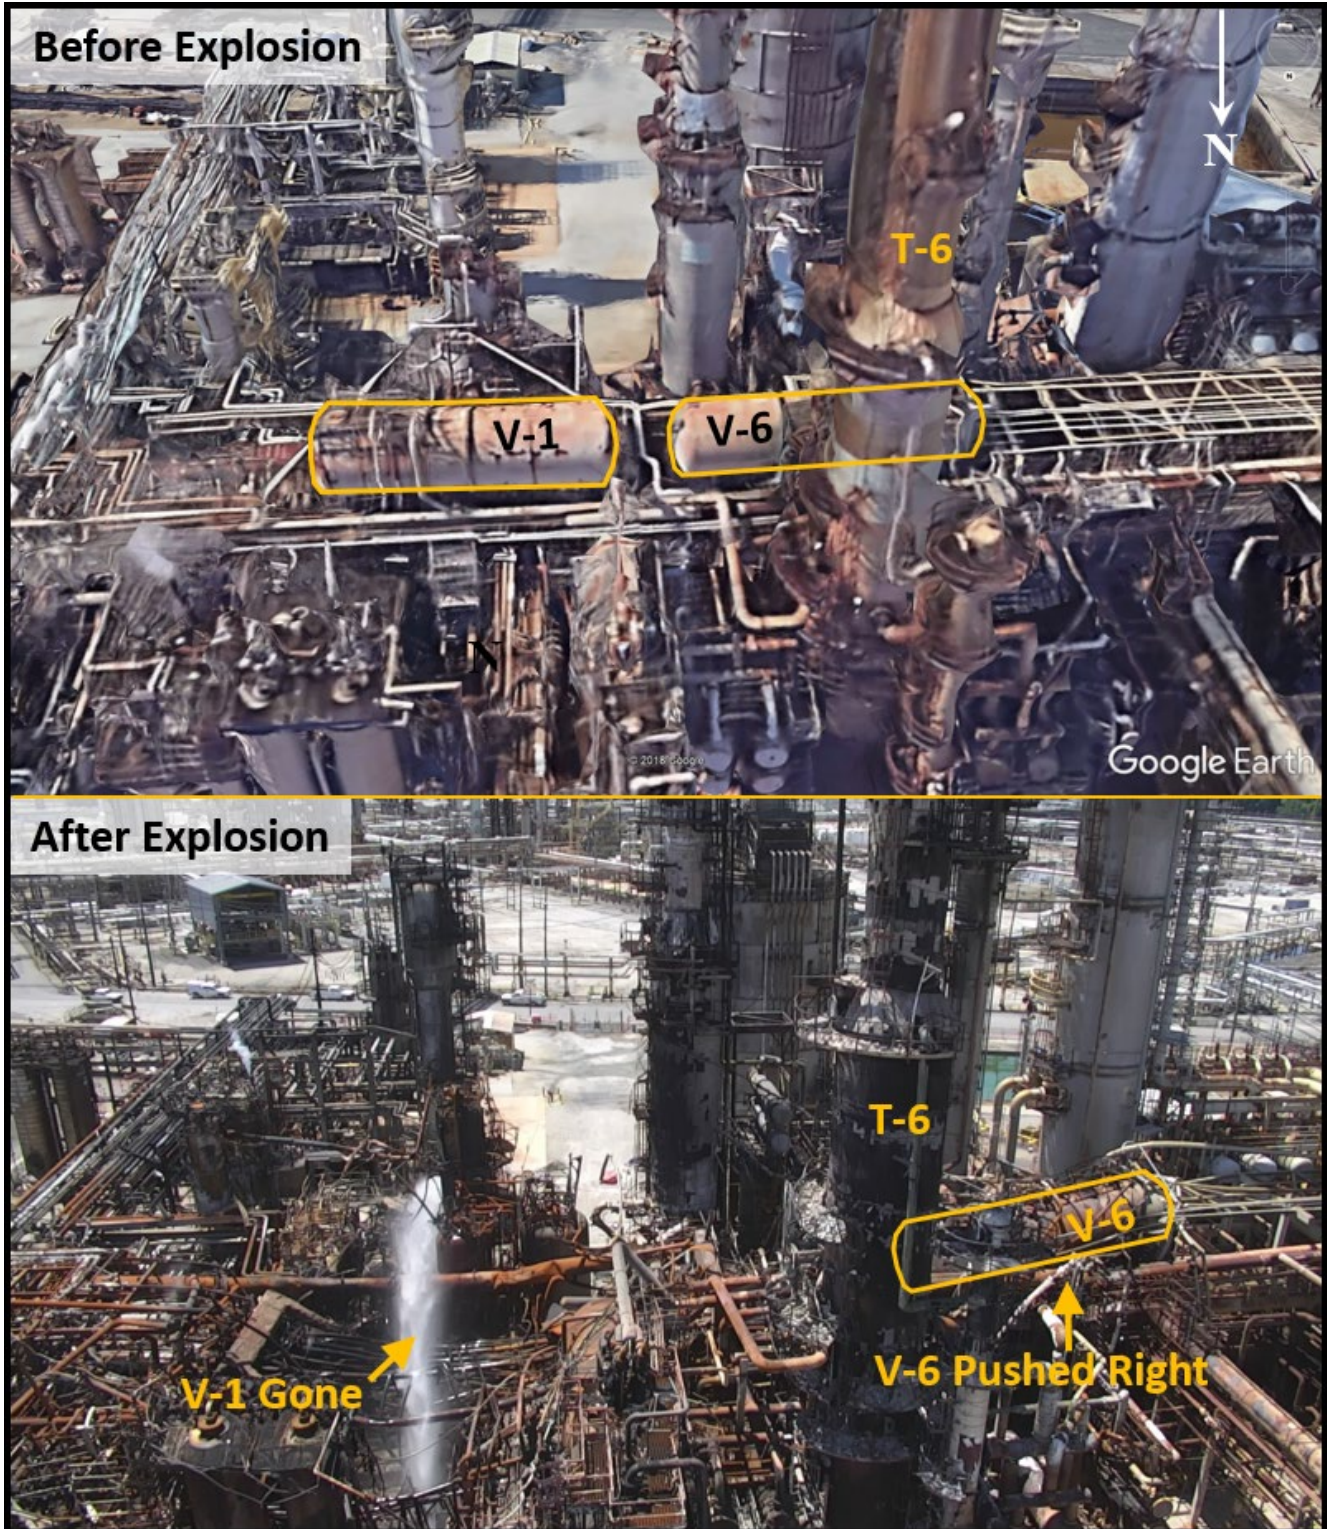
Figure 13. Comparison of the incident scene pre-incident and post-incident. (Top photo credit: Google Earth. Bottom photo credit: PES. annotations by CSB)

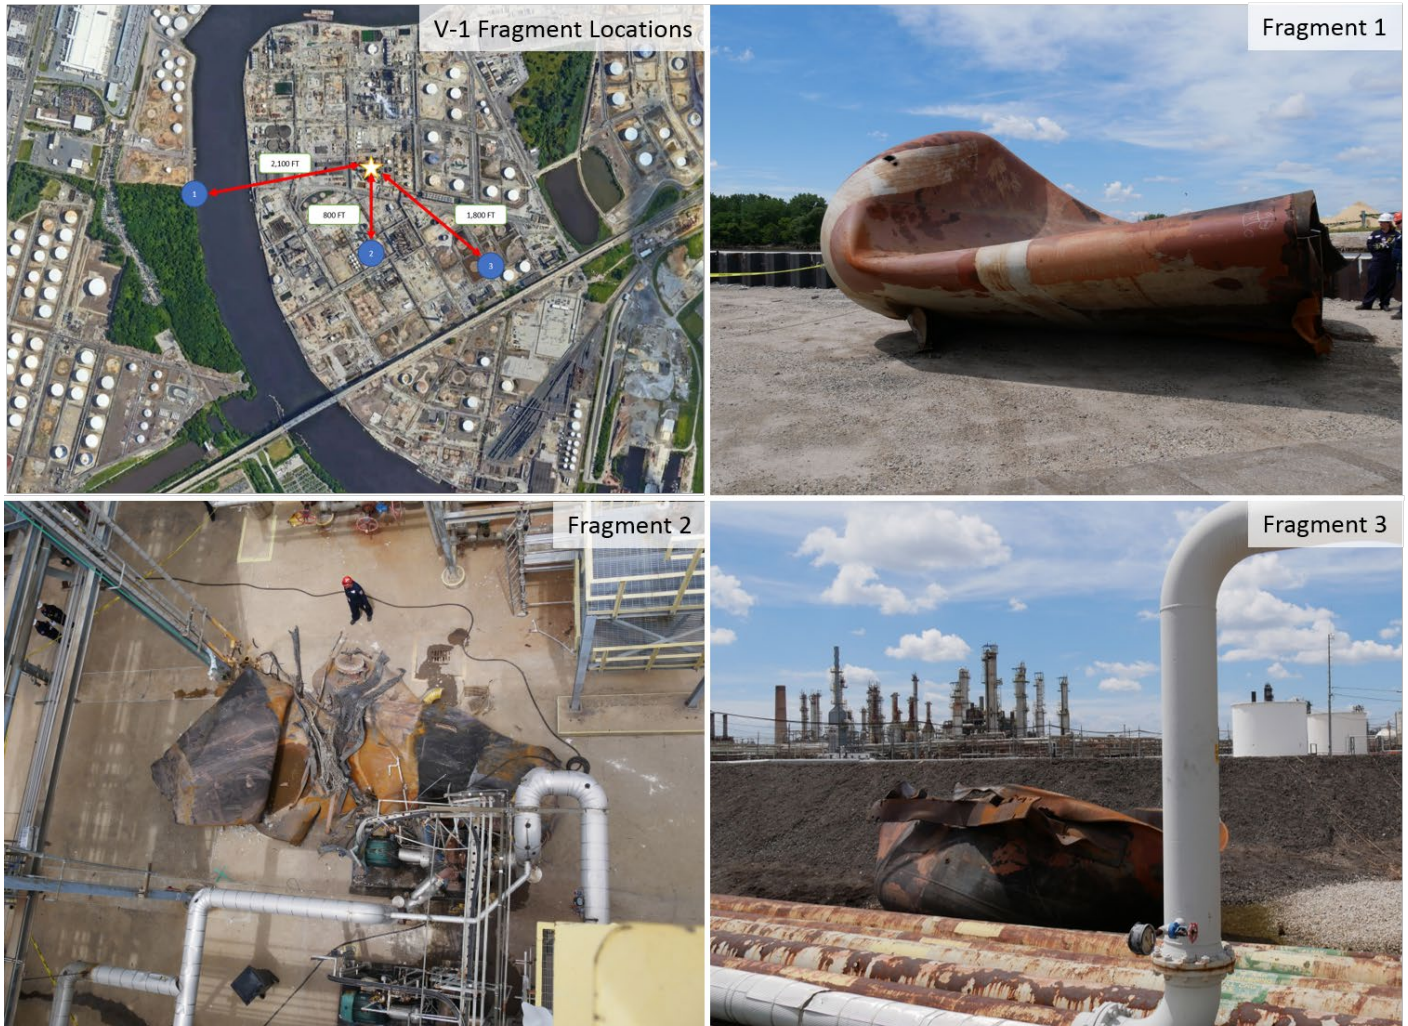
At 4:22 a.m., a third, and the largest, explosion occurred when the V-1 treater feed surge drum, containing primarily butylene, isobutane, and butane, violently ruptured (**Figure 12** and **Figure 13**). A fragment of the vessel weighing approximately 38,000 pounds flew across the Schuylkill River, and two other fragments, one weighing about 23,000 pounds and the other 15,500 pounds, landed in the PES refinery (**Figure 14**). This was also a secondary event caused by the fire. In **Figure 14**, the fragment 1 photo was taken after the fragment was recovered from the bank of the river and relocated to the PES refinery. The deformation of fragment 1 appears to be consistent with the deformation expected from its impact with the riverbank.

Figure 14. Locations and photos of the post-incident V-1 vessel fragments. (Top left photo credit: Google Earth with annotations by CSB. Credit for other photos: CSB)

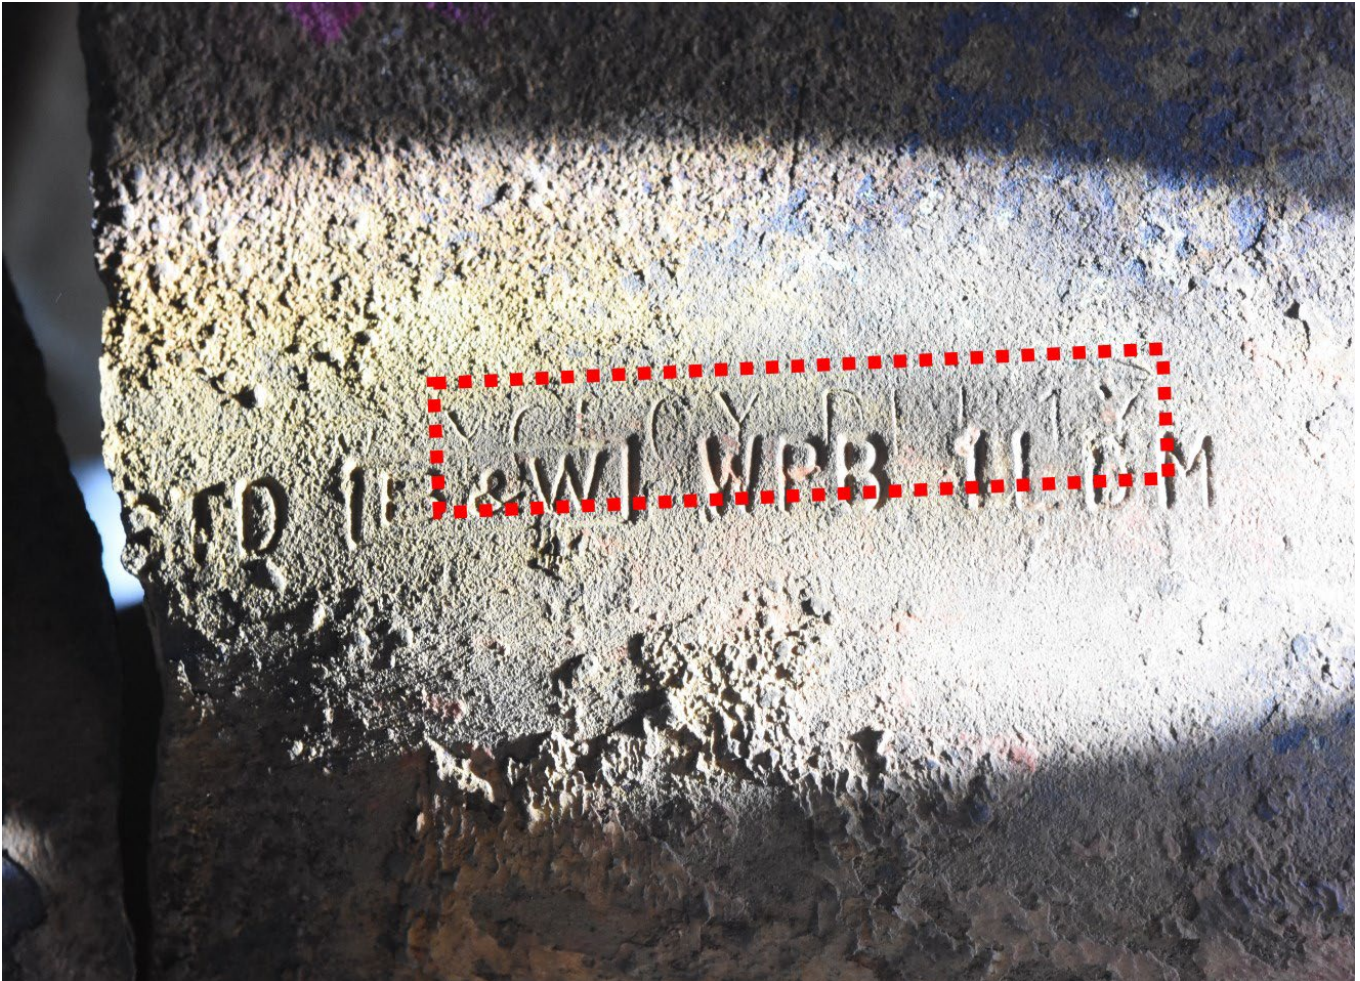
of steel from ASTM A234 WPB, and its composition matches the specification ASTM A234 WPR, which was established in 1980, after the elbow's installation [19, p. 7].^a

Figure 16. Photo of specification stamps on the failed elbow. “YOLOY,” highlighted with red, is faintly visible behind the “WPB” stamp.

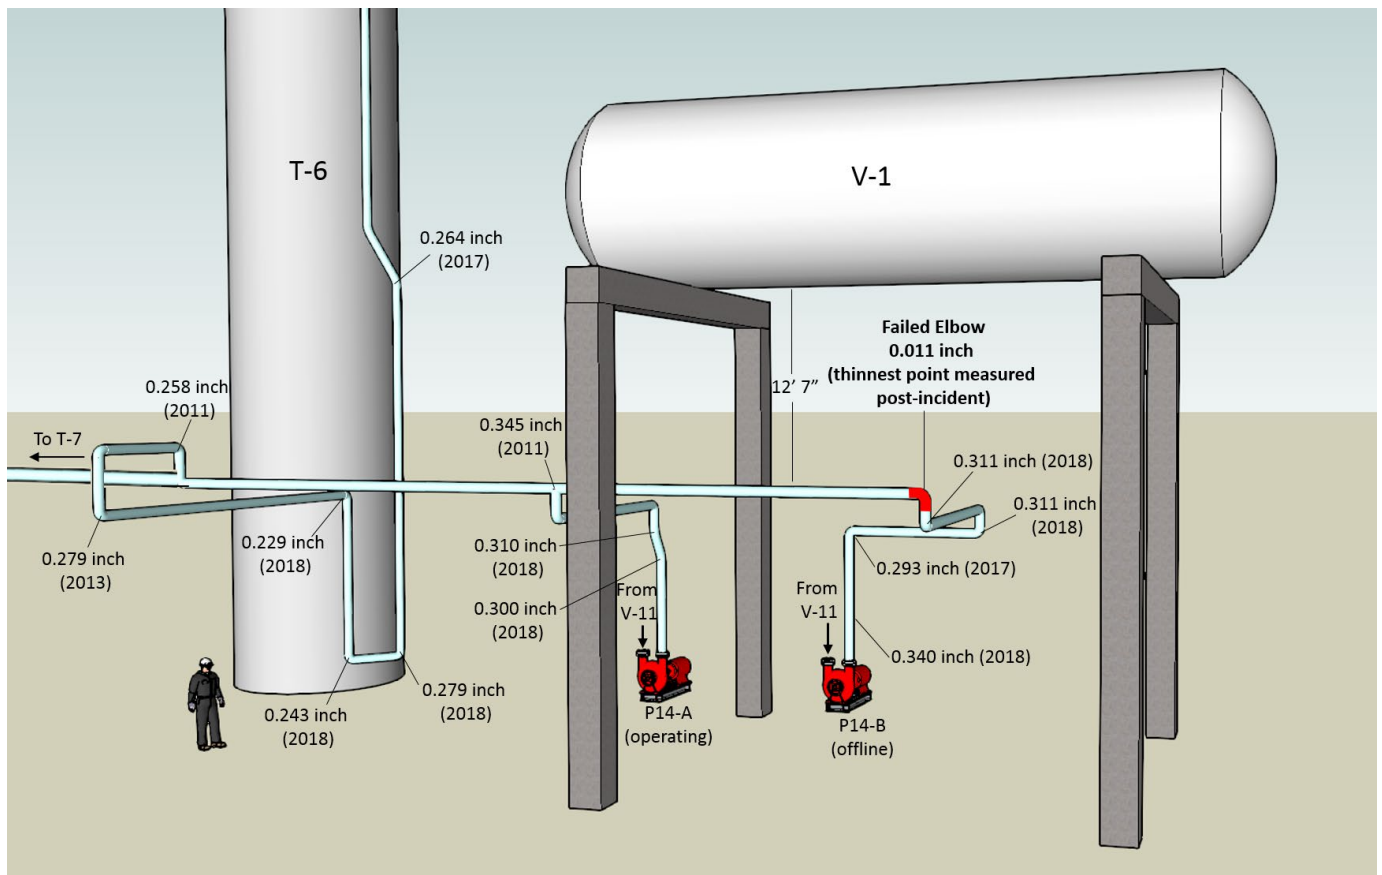
When CMLs were first specified for the PES refinery HF alkylation unit in 1973 (at that time, the refinery was owned by Gulf Oil), the inspection group based the inspection program on the piping being susceptible to a uniform corrosion mechanism and selected representative CMLs to monitor corrosion of the piping. Since 1973, the various refinery owners added additional CMLs. In 2002, the piping circuit containing the failed elbow contained 41 CMLs, and by 2019 the circuit contained 141 CMLs. **Figure 17** shows the portion of the piping circuit that contained the failed elbow, indicating CML locations and the most recent thickness measurements. There was not a CML on the elbow that failed.

Figure 17. Model of the piping circuit containing the ruptured elbow, showing the most recent thickness measurements at designated Condition Monitoring Locations (CMLs). (Credit: CSB)

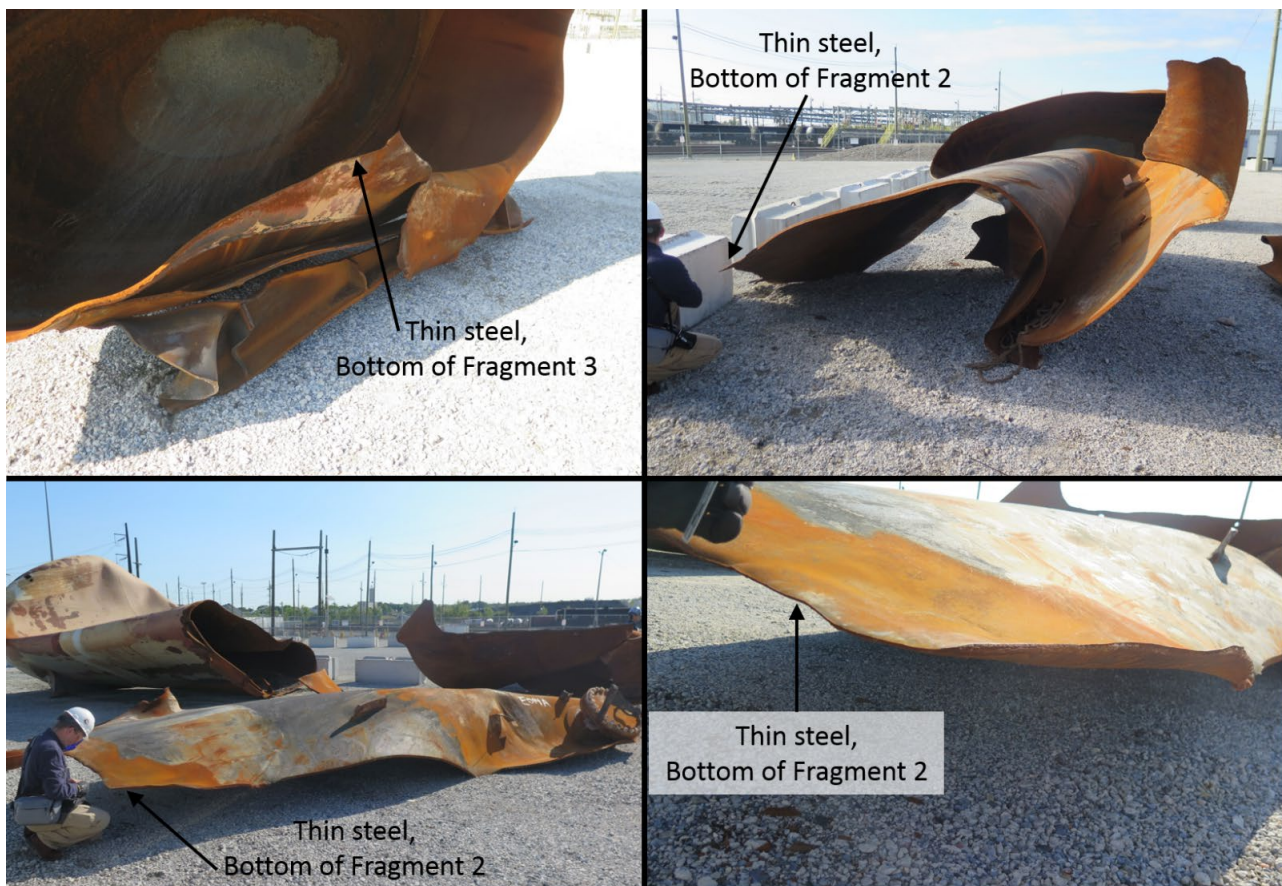
During the incident, at 4:22 a.m., the V-1 treater feed surge drum, containing primarily butylene, isobutane, and butane, violently ruptured. A fragment of the vessel weighing approximately 38,000 pounds flew across the Schuylkill River, and two other fragments, one weighing about 23,000 pounds and the other 15,500 pounds, landed in the PES refinery. After the incident, CSB investigators analyzed the V-1 fragments. The investigators observed thinning of the bottom portion of the V-1 fragments, as shown in **Figure 18**. Fragment 2 had been cut into two pieces before being relocated to the location shown in **Figure 18**. The observed thinning of the V-1 vessel is consistent with what would be expected from a jet flame impinging on the vessel from the ruptured elbow, as shown in **Figure 19**. A jet flame (or jet fire) is a “pressurized stream of combustible gas or atomized liquid ... that is burning. [...] A jet fire is usually [] localized, but very destructive to anything close to it [21, pp. 87-88].” The pipe that ruptured was at a pressure of about 380 psig, which supplied the pressurized gas fueling the jet flame that impinged on the V-1 vessel (**Figure 19**).

Figure 18. Photos of recovered fragments of V-1. (Credit: CSB)

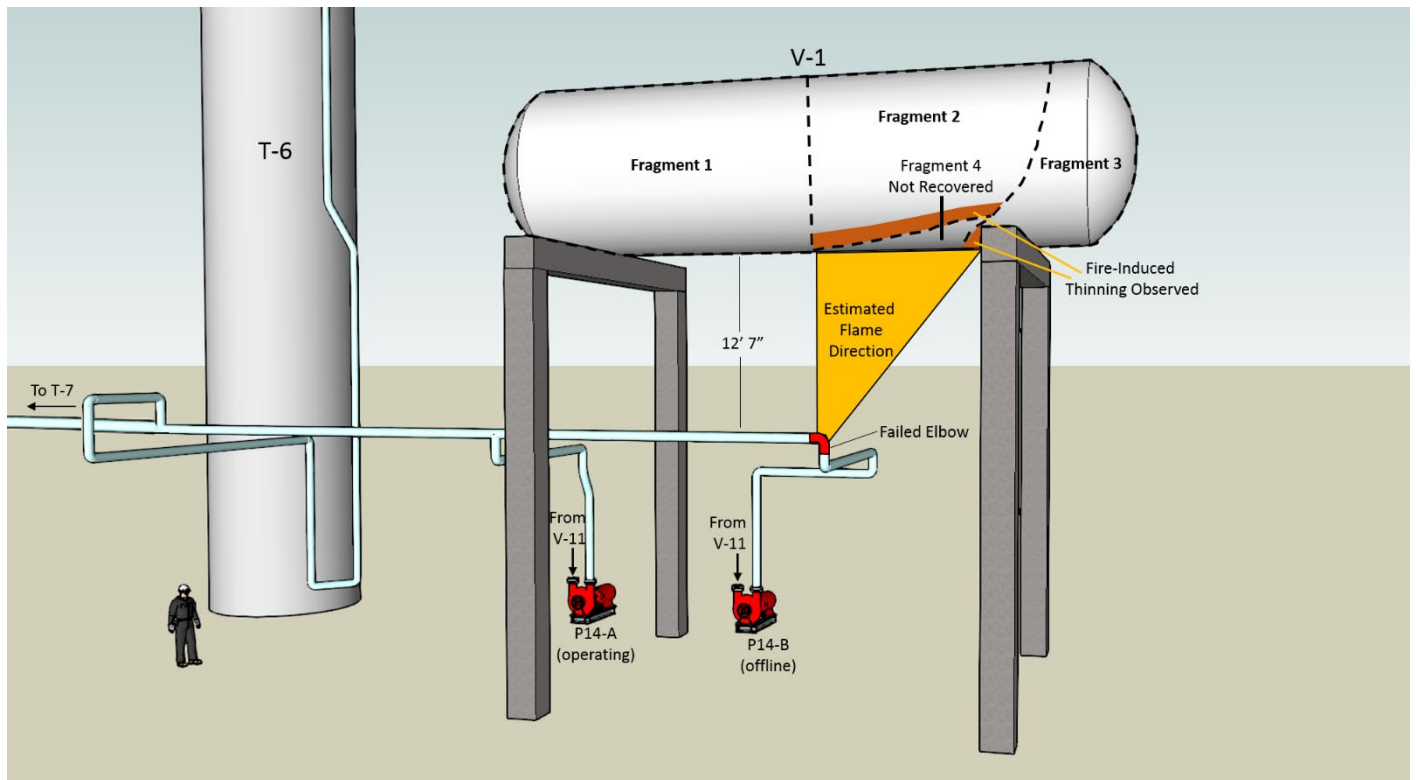
Figure 19. Locations of observed V-1 thinning, and depiction of the estimated flame size originating from the failed elbow, which impinged on the bottom of V-1. (Credit: CSB)

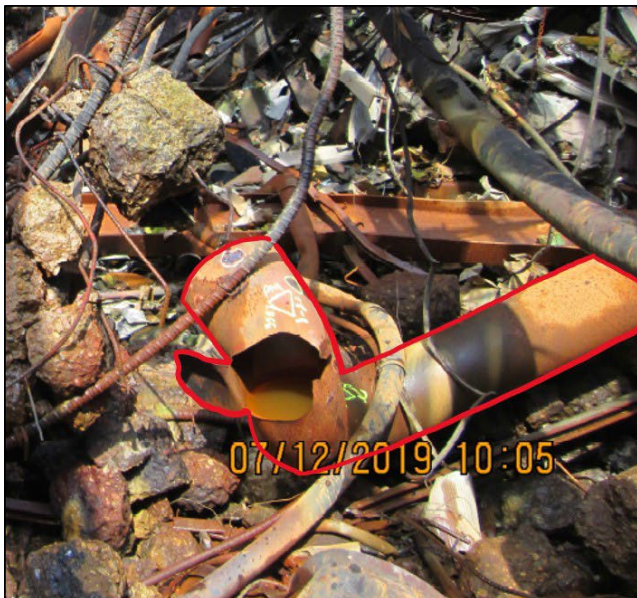
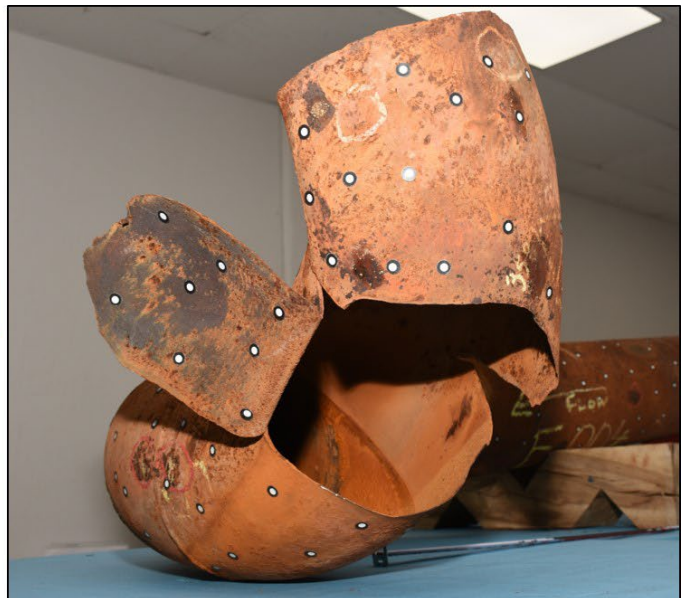
The original thickness of this piping was 0.322 inch when it was installed in 1973. Thickness measurements of the ruptured elbow show that the piping had a minimum wall thickness of 0.011 inch,^b which is less than 7% of the PES default retirement thickness of 0.180 inch—the thickness at which PES removes and replaces piping. The ruptured elbow operated at temperatures of around 100°F and HF acid concentrations of around 2.5 weight percent.

Figure 22. The ruptured elbow as found in the PES alkylation unit after the incident (left, outlined in red) and the same rupture during metallurgical testing (right).

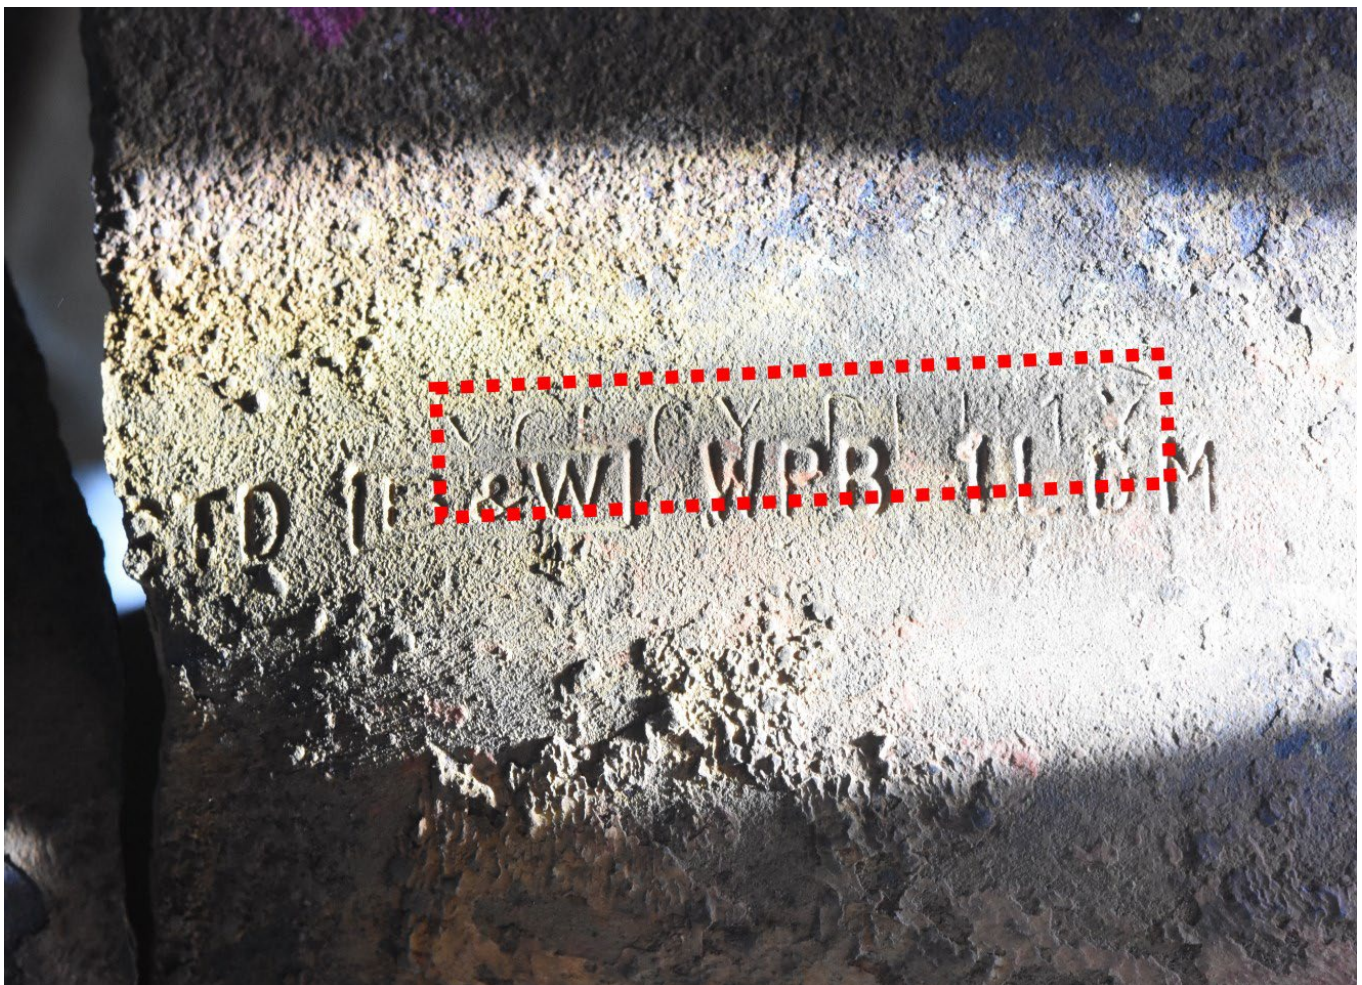
- After the elbow’s installation around 1973, language changes to ASTM A234 were made in 1980 and 1996 that make it clear that YOLOY steel cannot be labeled or restamped as ASTM A234 WPB steel. These language changes should prevent future instances of this improper material substitution.

Figure 24. Photo of specification stamps on the failed elbow. “YOLOY,” highlighted with red, is faintly visible behind the “WPB” stamp.

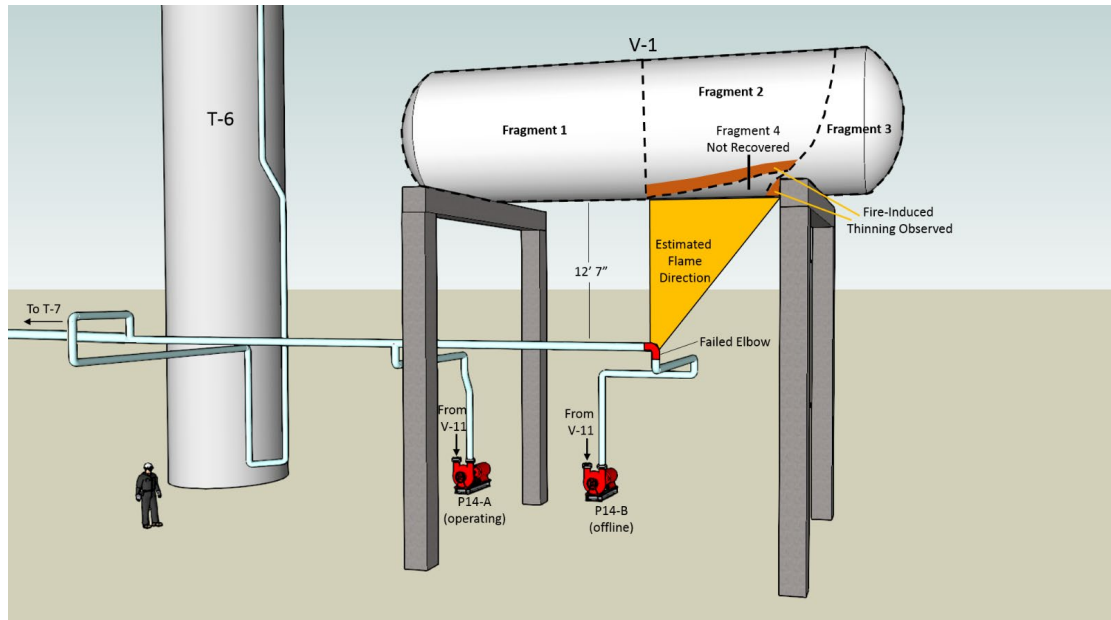
Figure 26. Locations of observed V-1 thinning, and depiction of the estimated flame size originating from the failed elbow, which impinged on the bottom of V-1. (Credit: CSB)

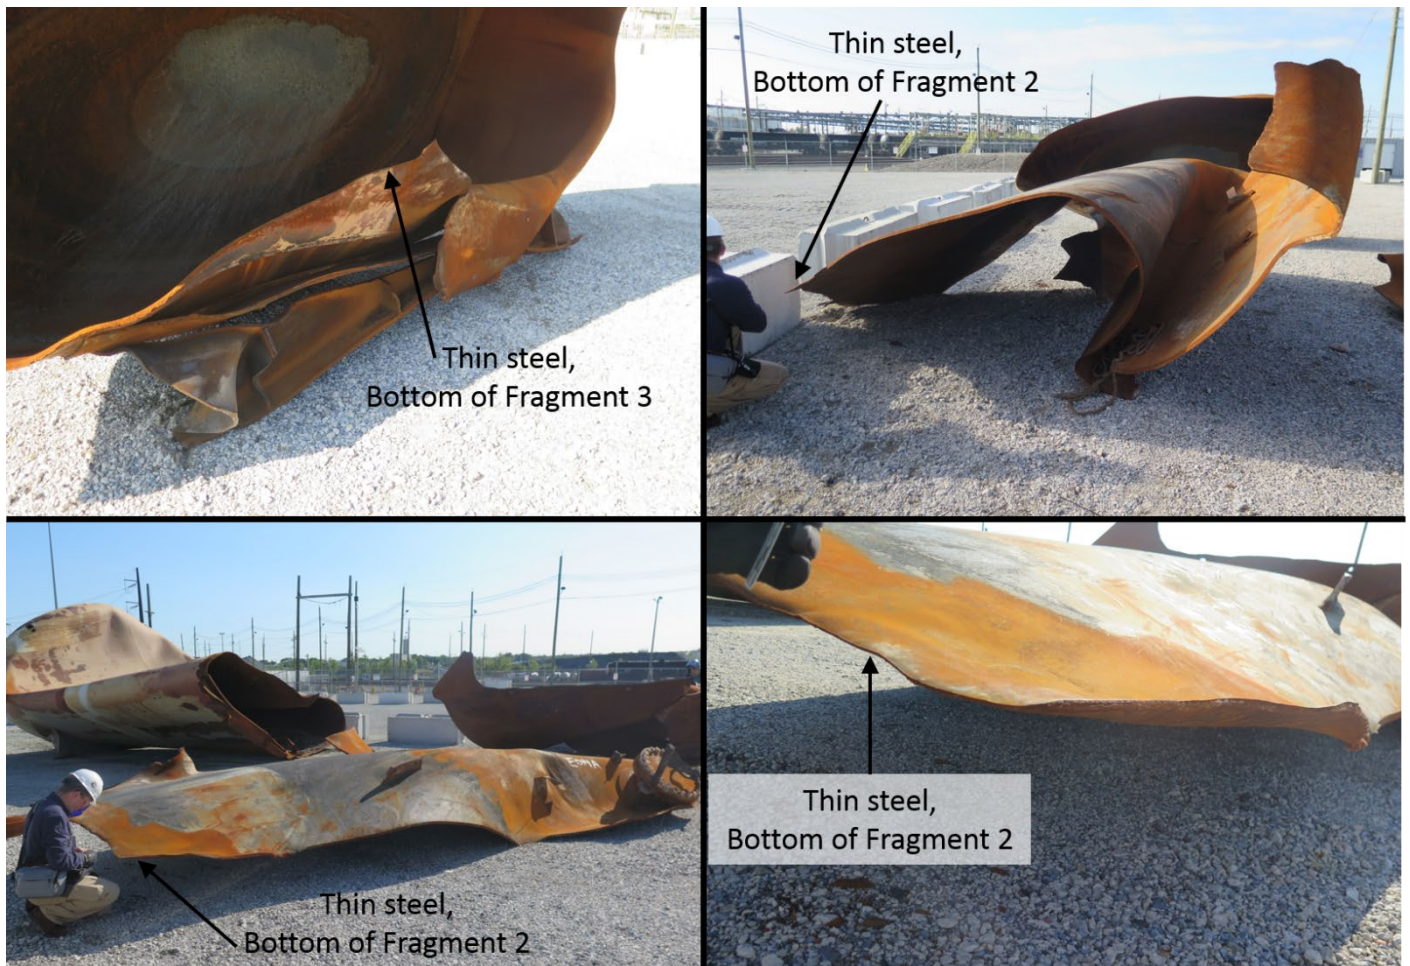
Figure 27. Photos of recovered fragments of V-1. (Credit: CSB)
