# Investigation Report

Published: October 11, 2022

## U.S. Chemical Safety and Hazard Investigation Board

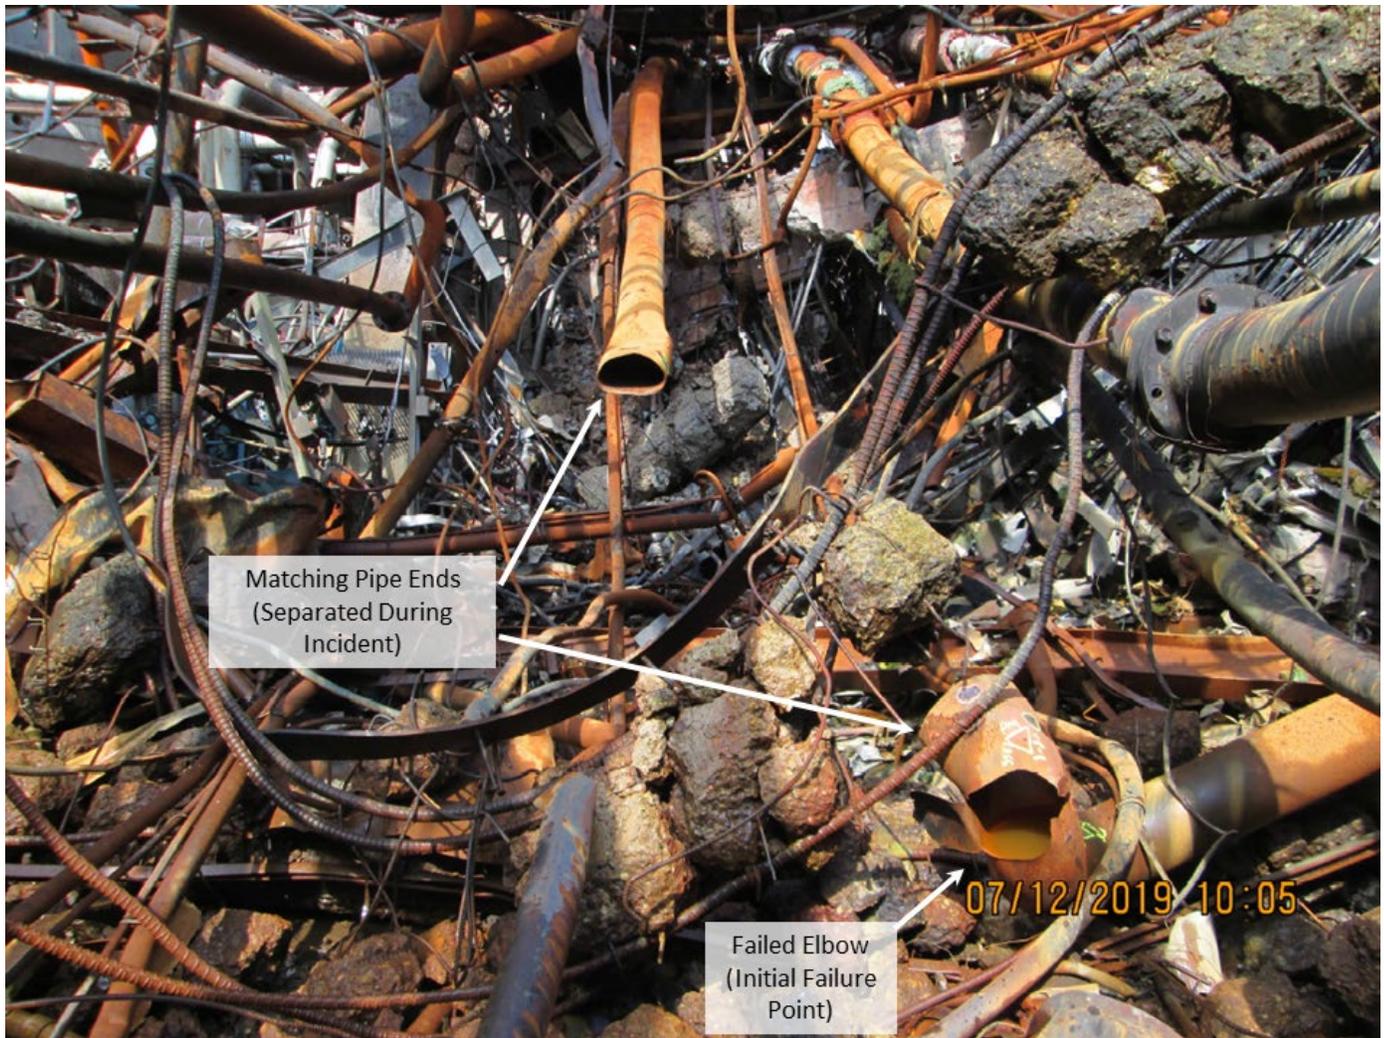
About three seconds after the operator increased the T-7 feed to 80 bph, at 4:00:16 a.m. an elbow on the discharge piping of pump P14-B ruptured (**Figure 7**). An incident timeline can be found in **Appendix A**, which includes the process data and operational events preceding and during the incident.

**Figure 7.** Photo of the ruptured pipe elbow found post-incident. (Credit: PES)

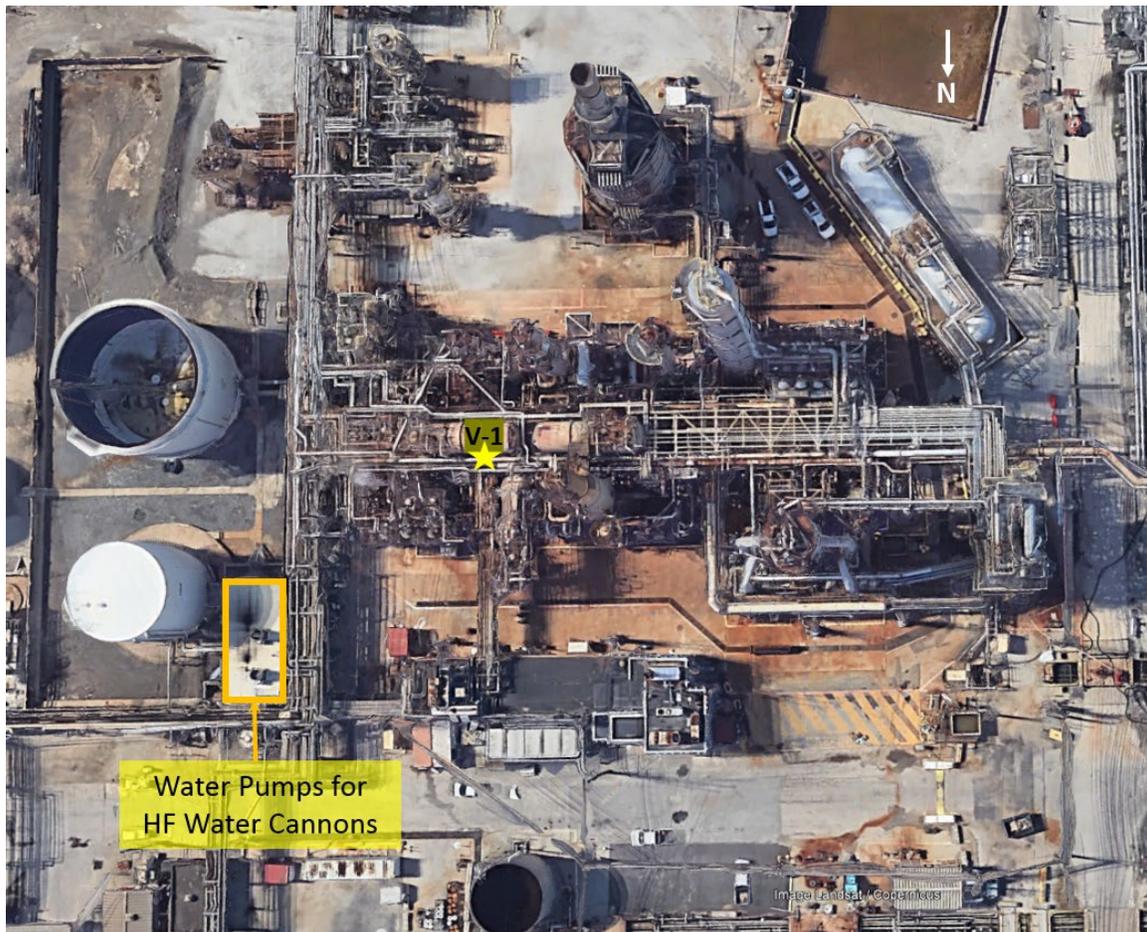
At 4:12 a.m., the control room operator tried to remotely turn on the water pumps that fed the elevated HF mitigation water cannons, which were designed to reduce airborne HF through vapor suppression,<sup>b,c</sup> but the water pumps did not turn on. The control system communication to the water pumps had failed at 4:02:06 a.m. (time of ignition) and a backup power system in the unit—the uninterruptible power supply (UPS)—also failed nine seconds later at 4:02:15.<sup>d</sup> Field operator 1 tried to walk to the water pumps to manually turn them on, but the operator could not get to the pumps because the fire made that area too hot to enter (**Figure 10**).

**Figure 10.** Location of (1) the water pumps that fed the hydrofluoric acid mitigation water cannons (yellow rectangle), and (2) the location of the ruptured elbow from which the process release originated (yellow star). (Credit: Google Earth with annotations by CSB)

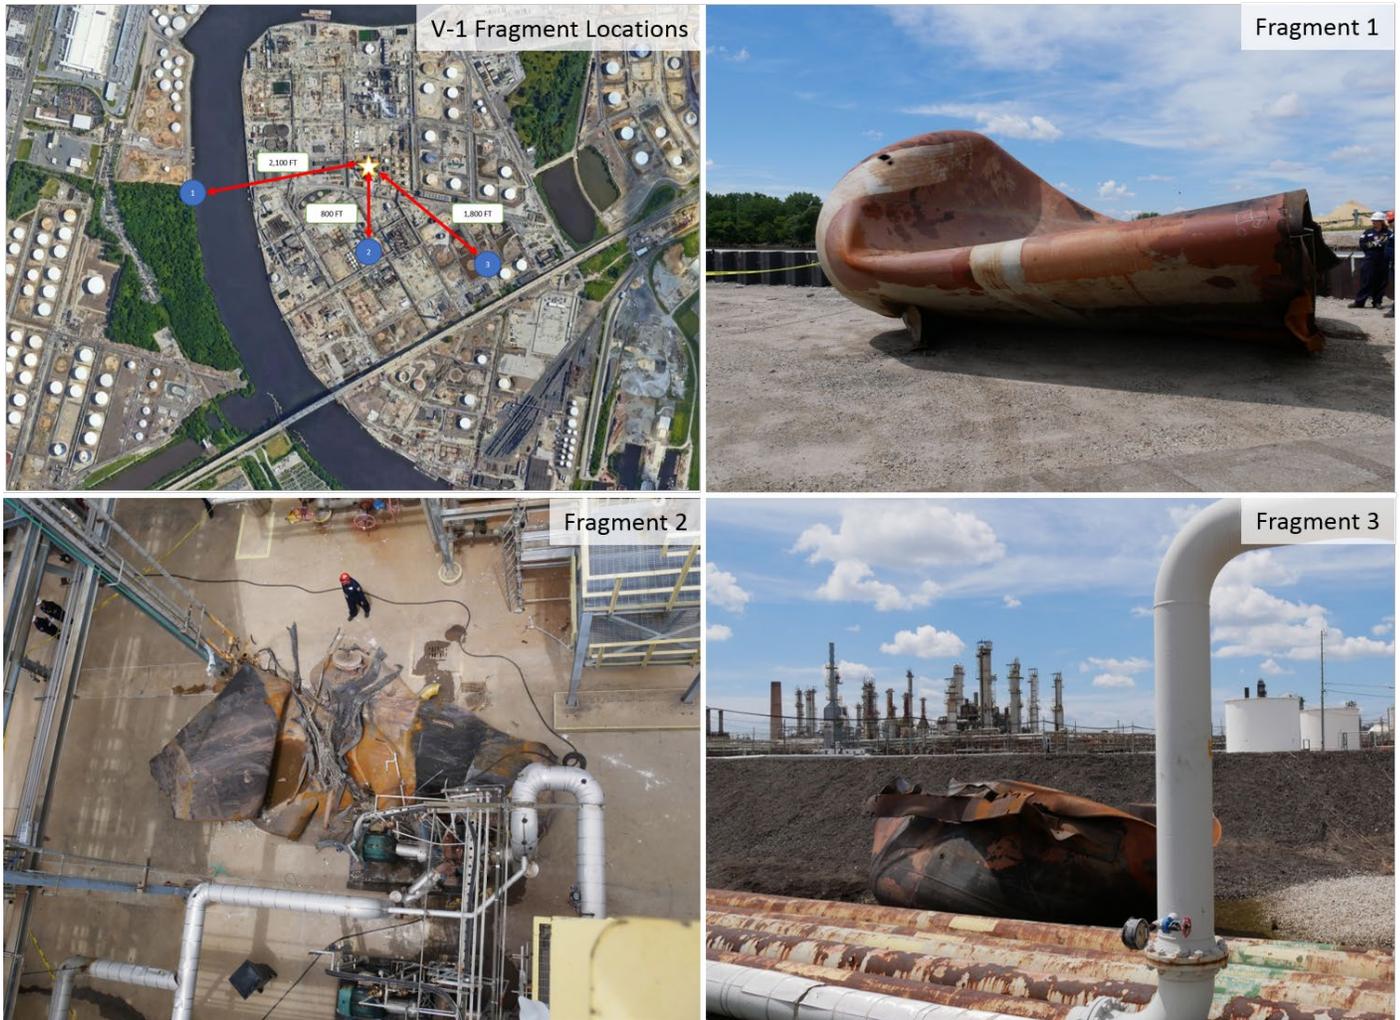
**Figure 14.** Locations and photos of the post-incident V-1 vessel fragments. (Top left photo credit: Google Earth with annotations by CSB. Credit for other photos: CSB)

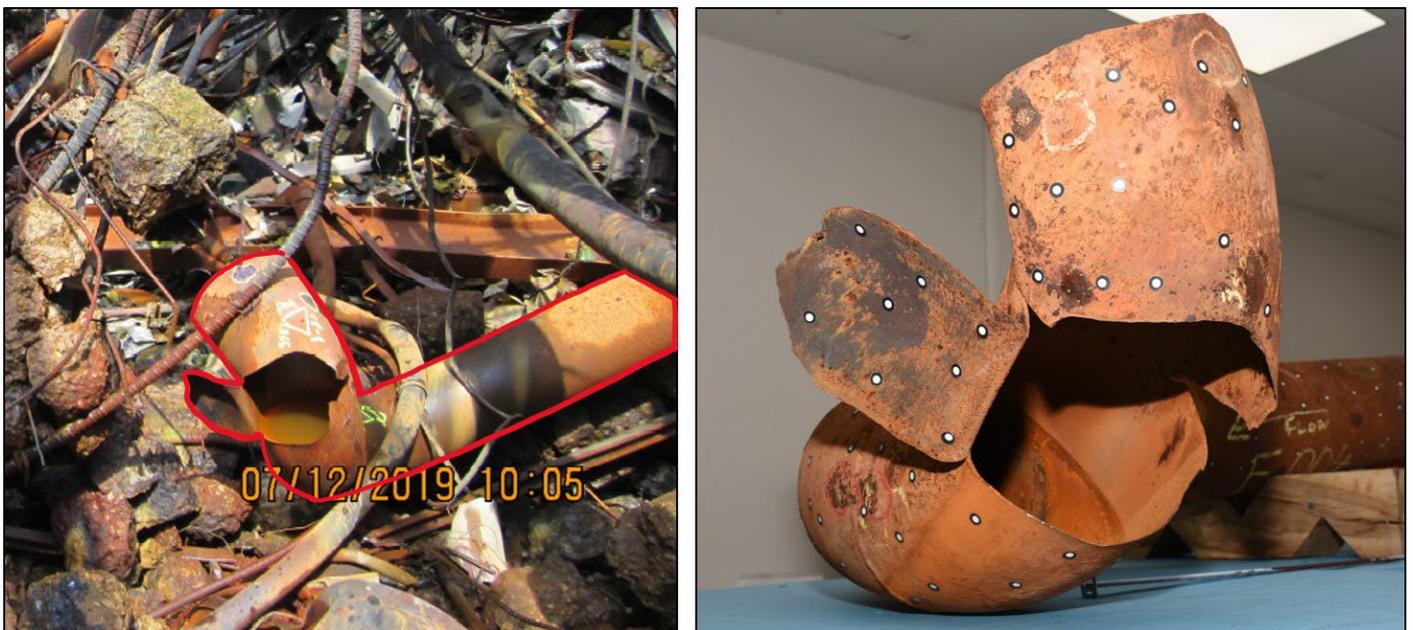
The original thickness of the elbow and adjacent piping was 0.322 inch when it was installed in 1973. Thickness measurements of the ruptured elbow show that the piping had a minimum wall thickness of 0.011 inch,<sup>a</sup> which is less than 7% of the PES default retirement thickness of 0.180 inch—the thickness at which PES removes and replaces piping. The ruptured elbow operated in a portion of the alkylation unit containing “trace acid” as defined by API Recommended Practice (RP) 751 *Safe Operation of Hydrofluoric Acid Alkylation Units* [17, p. 47], at temperatures of around 100°F and HF acid concentrations of around 2.5 weight percent.

**Figure 15.** The ruptured elbow as found in the PES alkylation unit after the incident (left, outlined in red) and the same rupture during metallurgical testing (right).

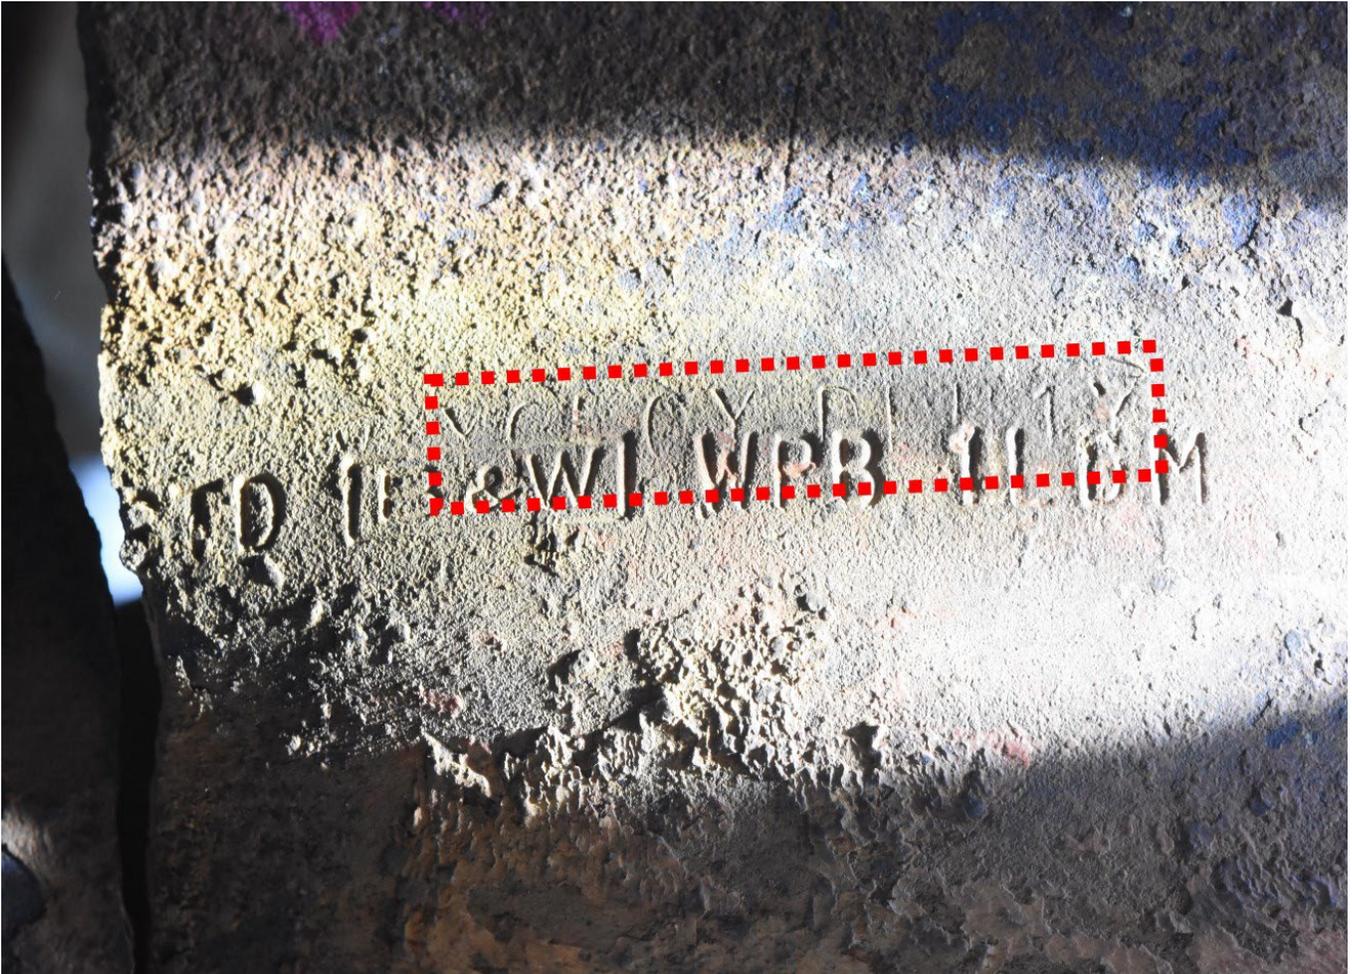
of steel from ASTM A234 WPB, and its composition matches the specification ASTM A234 WPR, which was established in 1980, after the elbow's installation [19, p. 7].<sup>a</sup>

**Figure 16.** Photo of specification stamps on the failed elbow. “YOLOY,” highlighted with red, is faintly visible behind the “WPB” stamp.

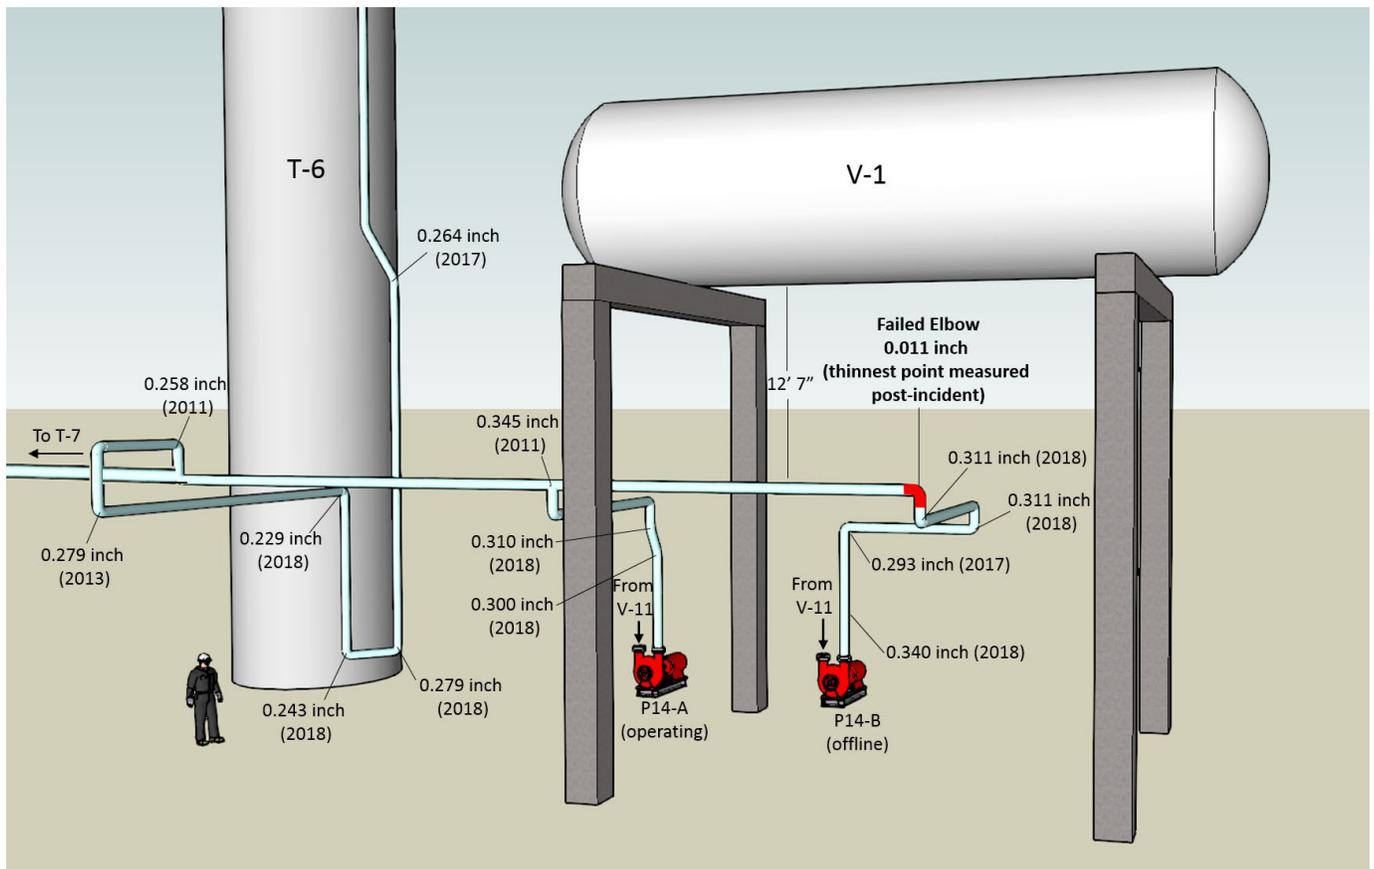
When CMLs were first specified for the PES refinery HF alkylation unit in 1973 (at that time, the refinery was owned by Gulf Oil), the inspection group based the inspection program on the piping being susceptible to a uniform corrosion mechanism and selected representative CMLs to monitor corrosion of the piping. Since 1973, the various refinery owners added additional CMLs. In 2002, the piping circuit containing the failed elbow contained 41 CMLs, and by 2019 the circuit contained 141 CMLs. **Figure 17** shows the portion of the piping circuit that contained the failed elbow, indicating CML locations and the most recent thickness measurements. There was not a CML on the elbow that failed.

**Figure 17.** Model of the piping circuit containing the ruptured elbow, showing the most recent thickness measurements at designated Condition Monitoring Locations (CMLs). (Credit: CSB)

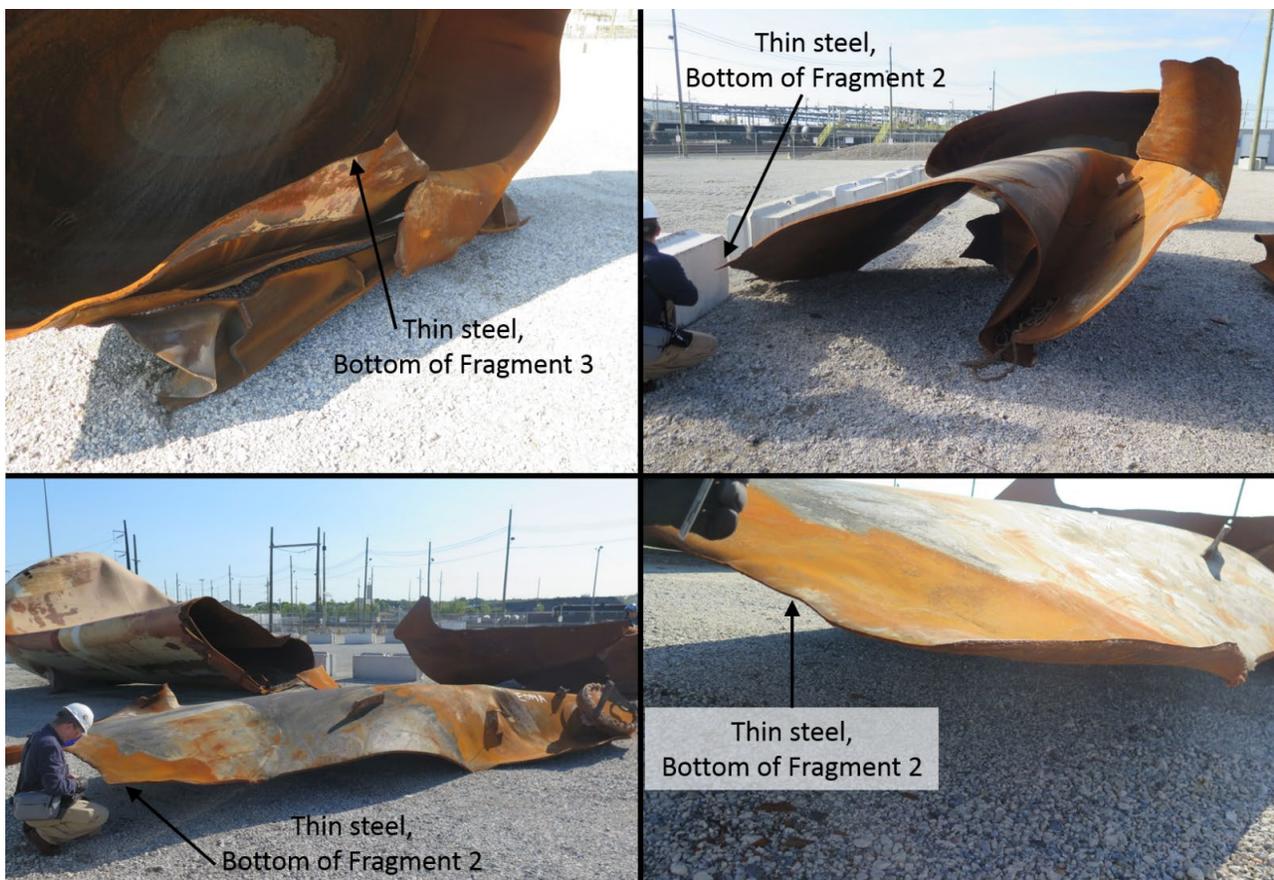
During the incident, at 4:22 a.m., the V-1 treater feed surge drum, containing primarily butylene, isobutane, and butane, violently ruptured. A fragment of the vessel weighing approximately 38,000 pounds flew across the Schuylkill River, and two other fragments, one weighing about 23,000 pounds and the other 15,500 pounds, landed in the PES refinery. After the incident, CSB investigators analyzed the V-1 fragments. The investigators observed thinning of the bottom portion of the V-1 fragments, as shown in **Figure 18**. Fragment 2 had been cut into two pieces before being relocated to the location shown in **Figure 18**. The observed thinning of the V-1 vessel is consistent with what would be expected from a jet flame impinging on the vessel from the ruptured elbow, as shown in **Figure 19**. A jet flame (or jet fire) is a “pressurized stream of combustible gas or atomized liquid ... that is burning. [...] A jet fire is usually [] localized, but very destructive to anything close to it [21, pp. 87-88].” The pipe that ruptured was at a pressure of about 380 psig, which supplied the pressurized gas fueling the jet flame that impinged on the V-1 vessel (**Figure 19**).

**Figure 18.** Photos of recovered fragments of V-1. (Credit: CSB)

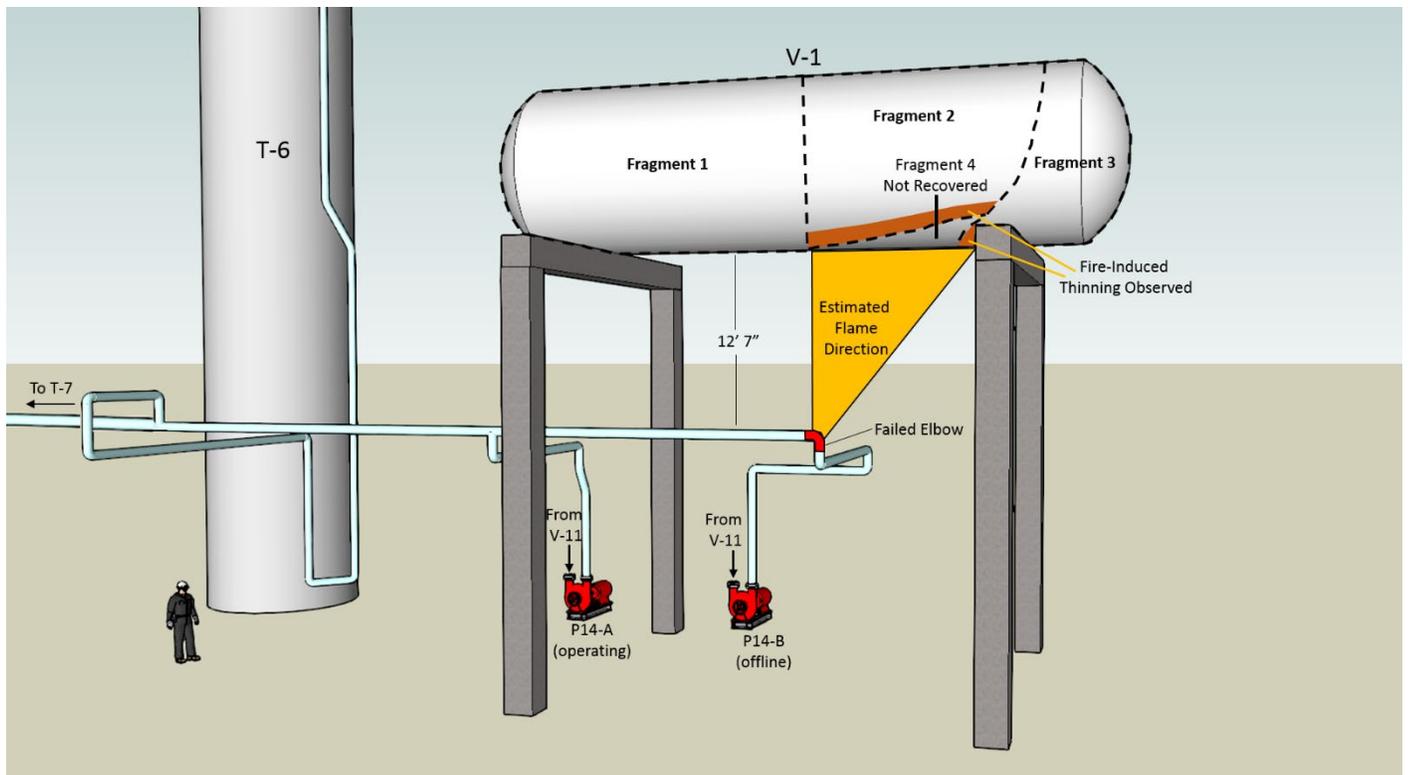
- **Remotely Operated Emergency Isolation Valves.** Based on the thinning of the V-1 vessel steel, the CSB concluded that a jet flame from the ruptured elbow impinged upon the bottom of the V-1 vessel, causing the steel to stretch and thin until the vessel ruptured. The large hydrocarbon sources downstream of the failed elbow could not be remotely or automatically isolated, and therefore PES was unable to stop the jet flame in a timely manner to prevent the V-1 vessel rupture. ([Section 2.3](#))

**Figure 19.** Locations of observed V-1 thinning, and depiction of the estimated flame size originating from the failed elbow, which impinged on the bottom of V-1. (Credit: CSB)

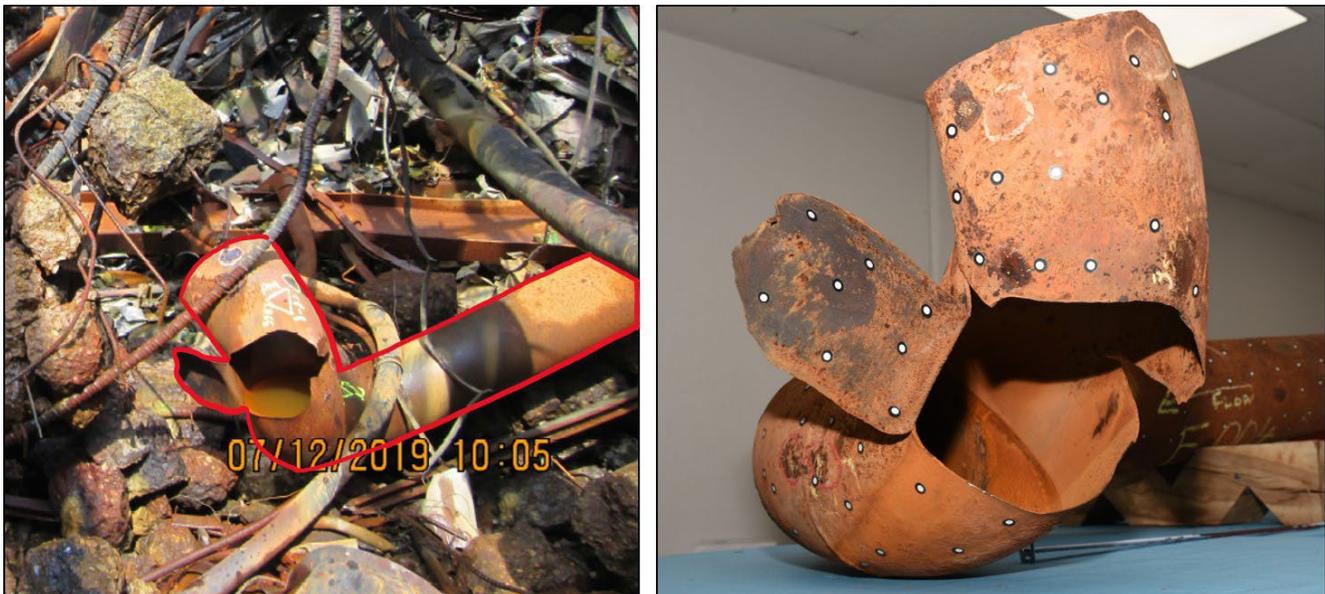
The original thickness of this piping was 0.322 inch when it was installed in 1973. Thickness measurements of the ruptured elbow show that the piping had a minimum wall thickness of 0.011 inch,<sup>b</sup> which is less than 7% of the PES default retirement thickness of 0.180 inch—the thickness at which PES removes and replaces piping. The ruptured elbow operated at temperatures of around 100°F and HF acid concentrations of around 2.5 weight percent.

**Figure 22.** The ruptured elbow as found in the PES alkylation unit after the incident (left, outlined in red) and the same rupture during metallurgical testing (right).

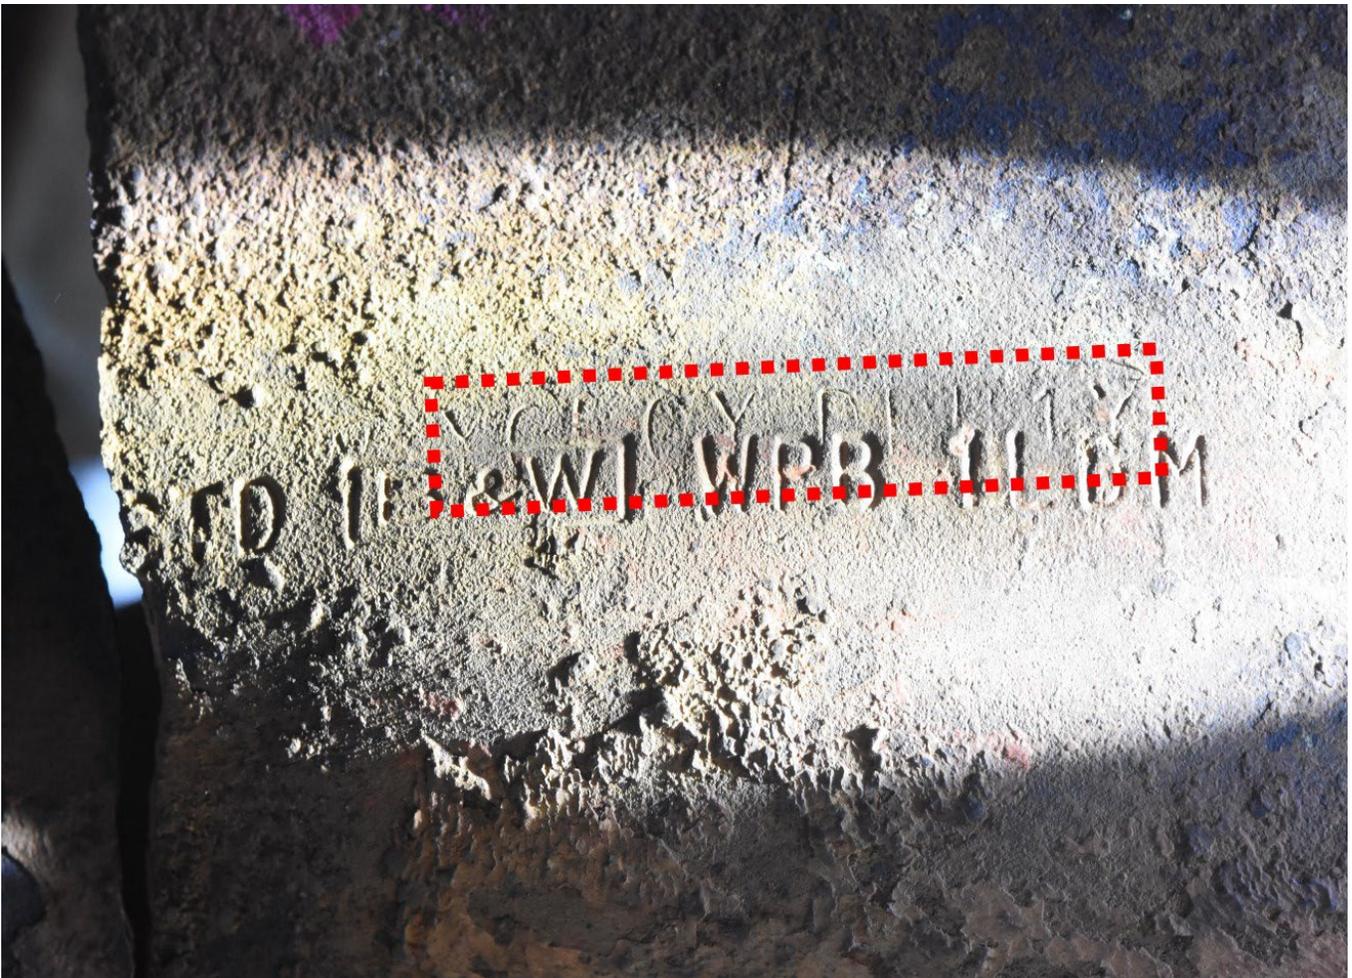
- After the elbow’s installation around 1973, language changes to ASTM A234 were made in 1980 and 1996 that make it clear that YOLOY steel cannot be labeled or restamped as ASTM A234 WPB steel. These language changes should prevent future instances of this improper material substitution.

**Figure 24.** Photo of specification stamps on the failed elbow. “YOLOY,” highlighted with red, is faintly visible behind the “WPB” stamp.

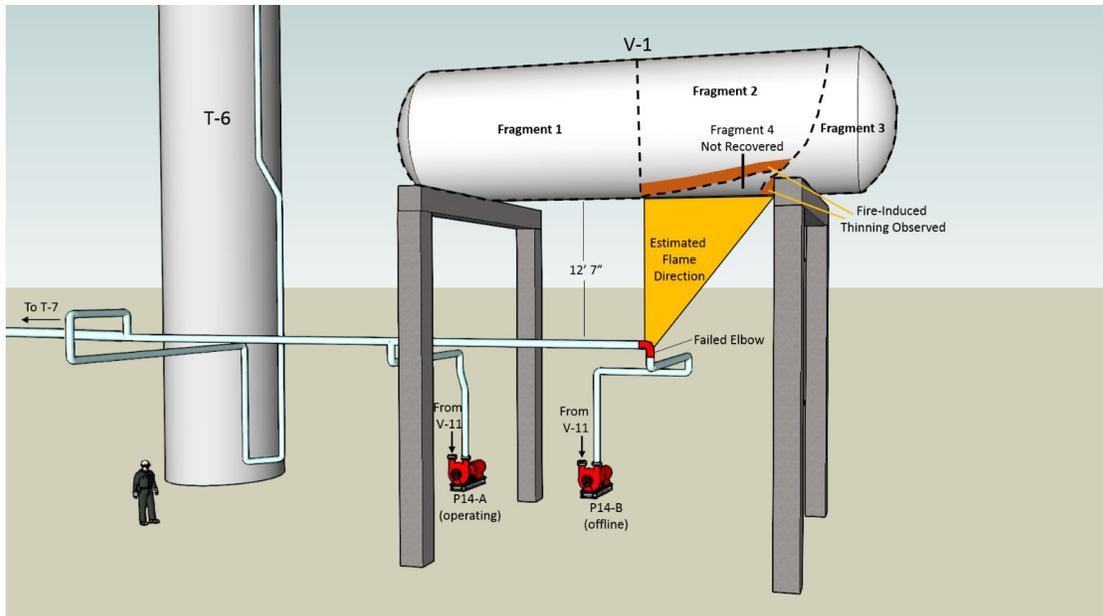
**Figure 26.** Locations of observed V-1 thinning, and depiction of the estimated flame size originating from the failed elbow, which impinged on the bottom of V-1. (Credit: CSB)

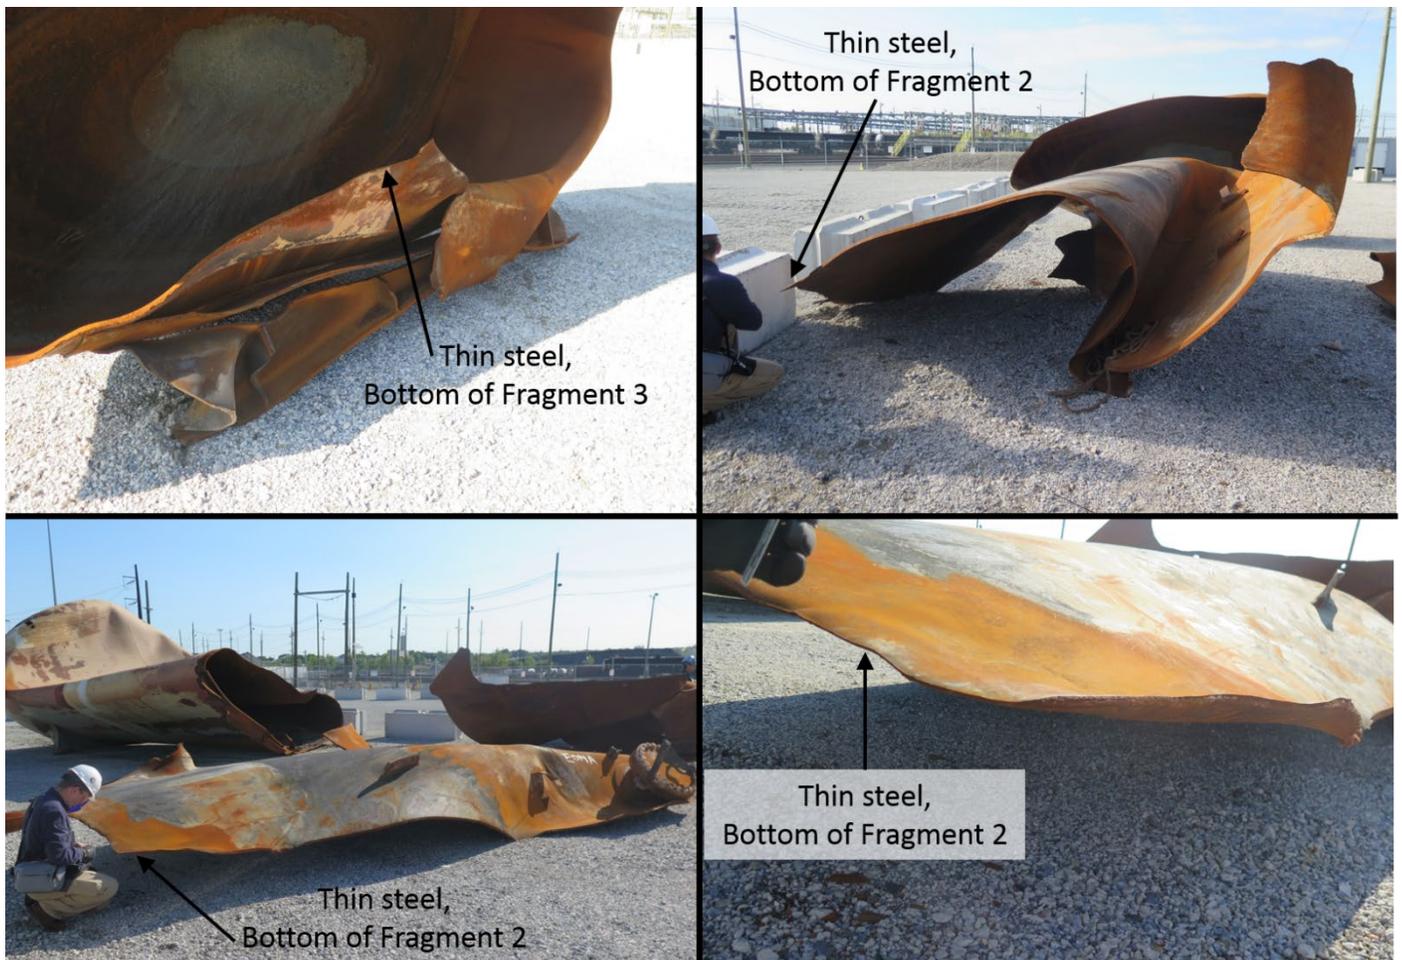
**Figure 27.** Photos of recovered fragments of V-1. (Credit: CSB)
