U.S. Chemical Safety and  
Hazard Investigation Board

# Ethylene Release and Fire at Kuraray America, Inc. EVAL Plant

Pasadena, Texas | Incident Date: May 19, 2018 | No. 2018-03-I-TX

## Investigation Report

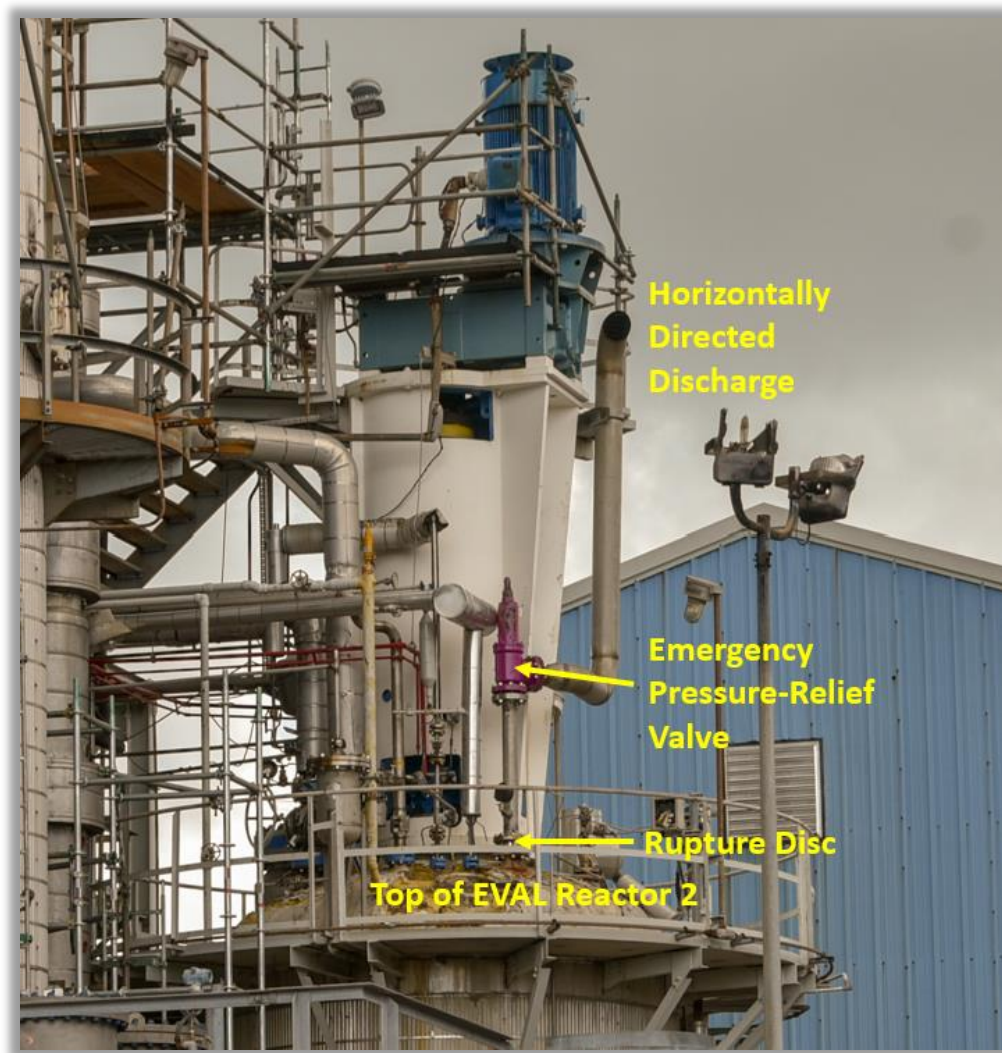
**Figure 7.** EVAL Reactor 2 Emergency Pressure-Relief System. (Credit: CSB)

The emergency pressure-relief system for EVAL Reactor 2 was designed to discharge reactor vapor to the ambient air (atmosphere) about 40 feet above the ground. Annotating the horizontal 90-degree angle on this piping (**Figure 6**, **Figure 7**, and **Figure 8**) illustrates that Kuraray did not install the outlet piping from the emergency pressure-relief system vertically upward (180-degree angle). As will be further discussed, this piping design detail directed flammable ethylene vapor through the horizontally aimed piping and toward an area where many workers were performing maintenance activities that included welding operations.

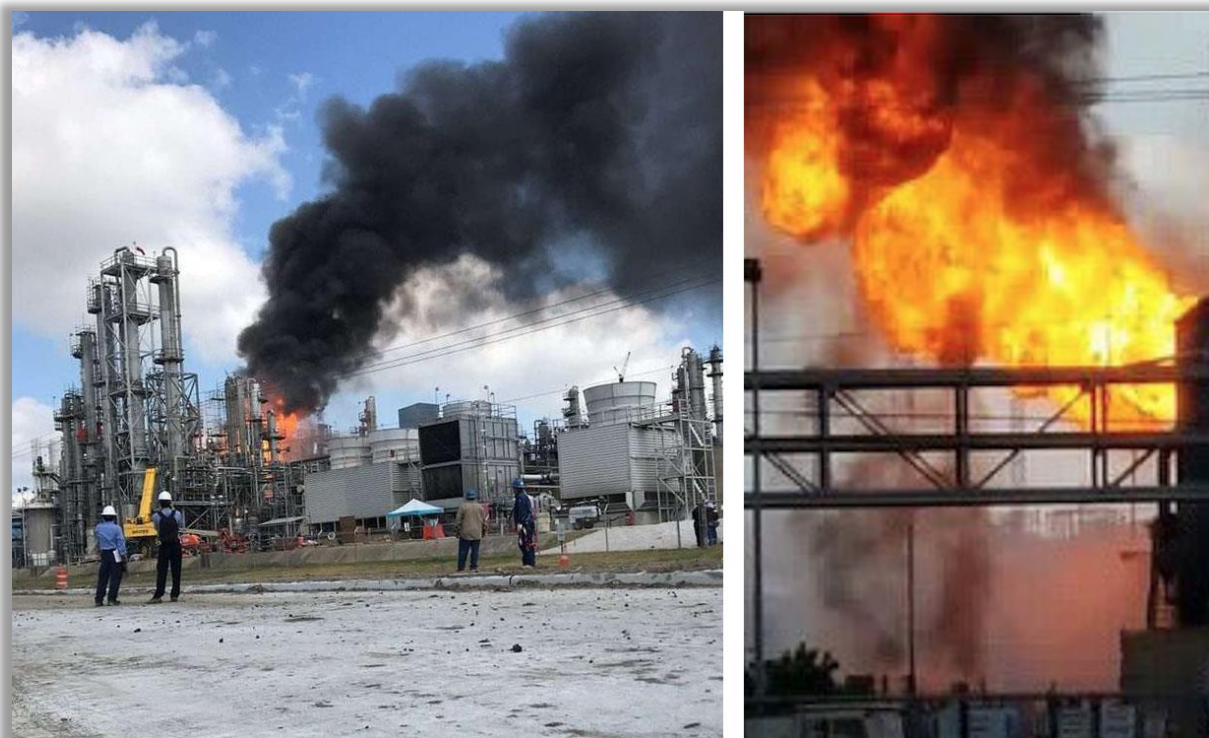
**Figure 14.** Ethylene Fire. (Credit: left image, Houston Chronicle; right image, Tiffany Craig, KHOU TV, courtesy of Edward Ross)

**Figure 14** shows images of the ethylene fire at Kuraray after the initial cloud of ethylene vapor was consumed. The left photo shows the developed fire from a local road, and the right image shows a screen capture from a [video](#) of the fire.

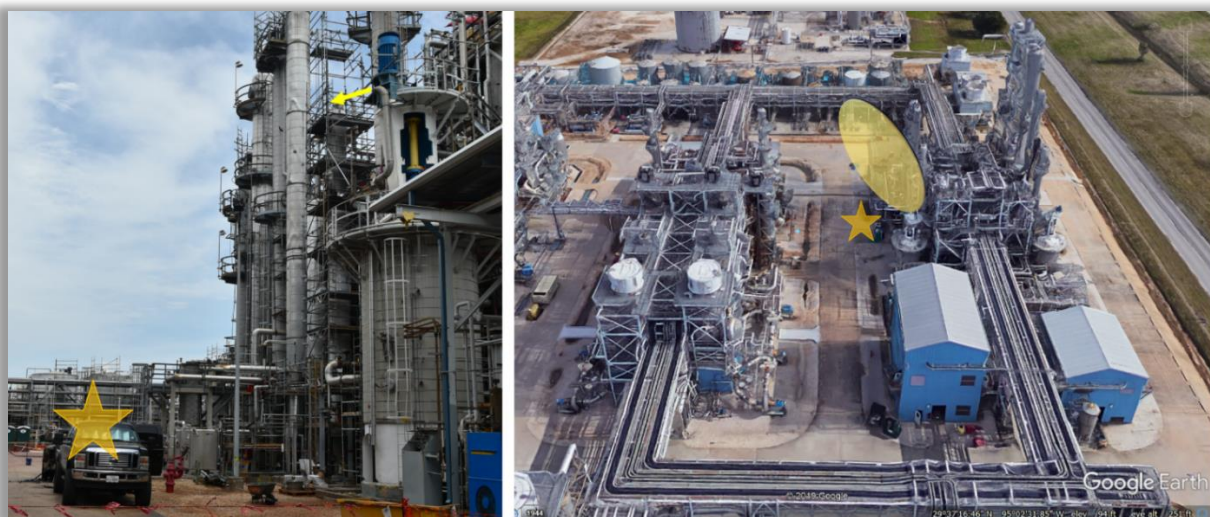
**Figure 15.** Ethylene Release.<sup>b</sup> (Credit: left image, CSB; right image, Google Earth annotated by CSB)

The images in **Figure 15** show the approximate area and direction of the ethylene release from the EVAL Reactor 2 emergency pressure-relief system (yellow oval in the right image). The gold star shows the likely location of the ignition source—an operating welding machine on the bed of a pickup truck.<sup>a</sup>

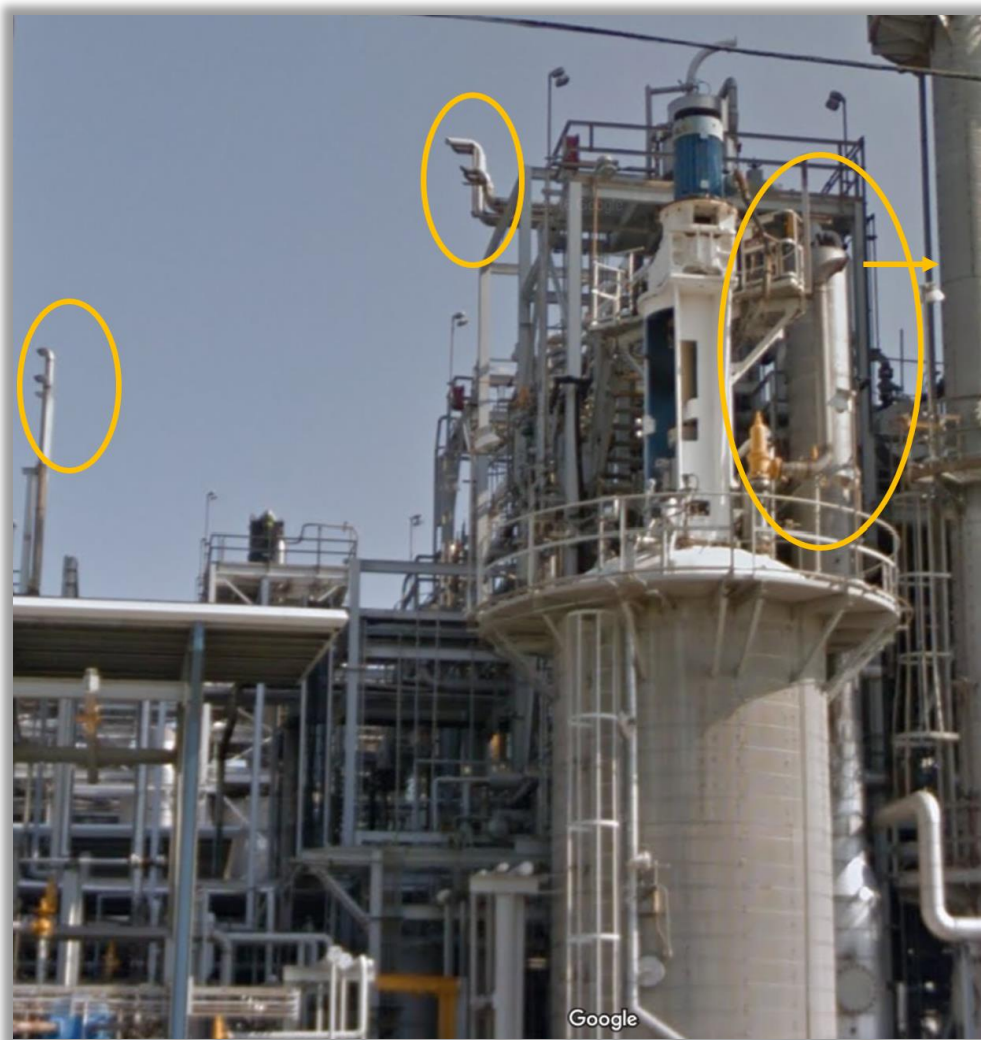
**Figure 19.** Horizontally Aimed Discharge Piping. (Credit: Google Maps annotated by CSB)

Although the CSB investigation focused on the EVAL Reactor 2 emergency pressure-relief system, publicly available images suggest that Kuraray also designed other emergency pressure-relief systems that discharged through horizontally aimed piping. The CSB obtained **Figure 19** using the Google Maps “Street View” feature. The image shows several piping systems designed to discharge into the air through horizontally aimed piping, including the emergency pressure-relief system for one of the other three EVAL Reactors (farthest right yellow oval with yellow arrow). The outlet piping from this EVAL Reactor appears designed to release reactor vapors containing flammable ethylene through horizontally aimed piping toward a public road.

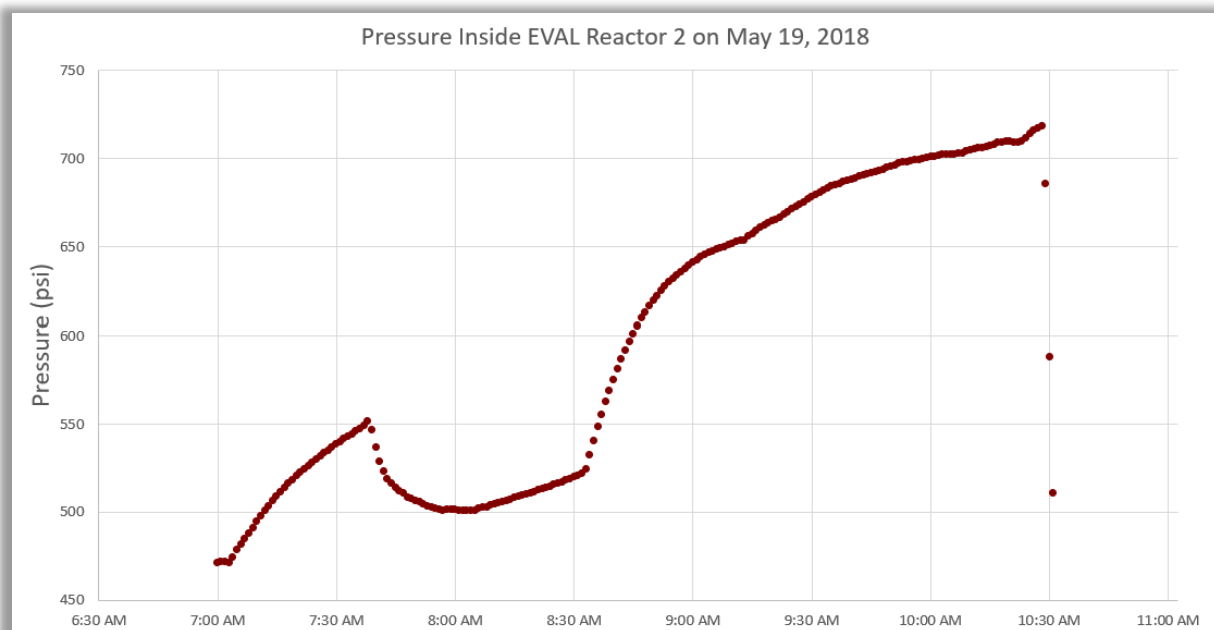
**Figure 24.** EVAL Reactor 2 Pressure.<sup>c</sup> (Credit: CSB)

**Figure 24** shows the pressure inside EVAL Reactor 2 in psi (psi) leading up to the incident on May 19, 2018. Kuraray operators stopped adding ethylene to the reactor at [8:46 a.m.](#) when the pressure inside EVAL Reactor 2 was 606 psi. At [9:01 a.m.](#), the High-High-Pressure alarm sounded when the pressure inside the reactor was 640 psi. Although actions taken by Kuraray's board operators slowed the rate at which the pressure inside the reactor was increasing, the pressure continued rising until the emergency pressure-relief system activated at [10:28 a.m.](#)

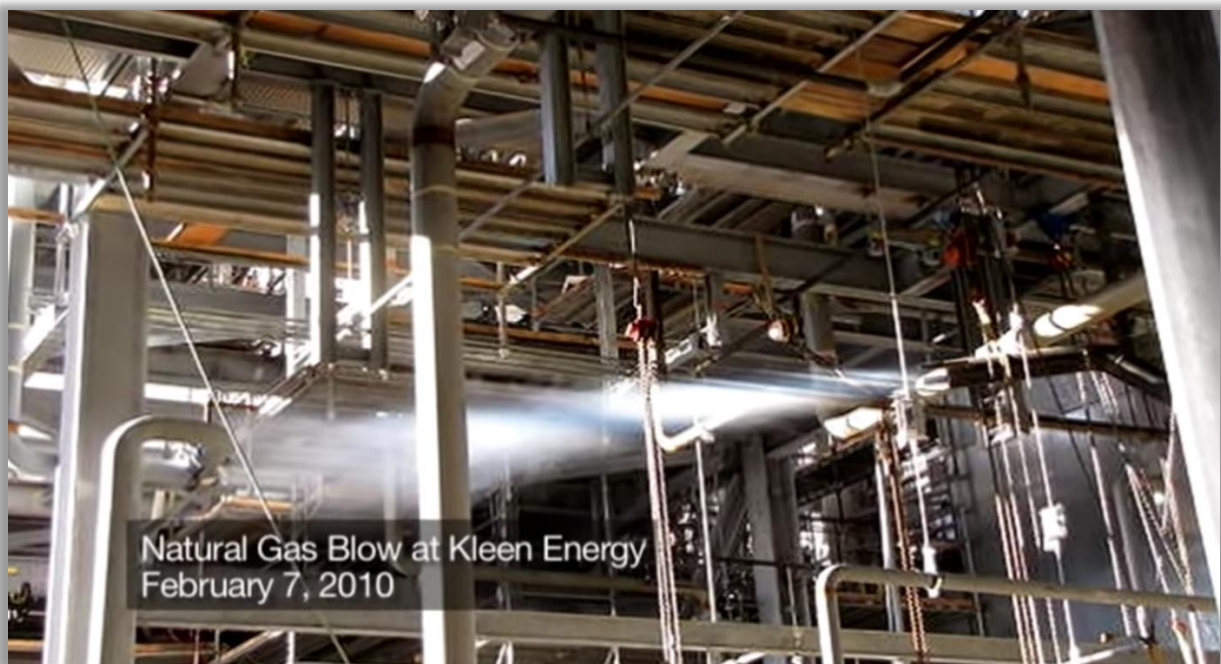
**Figure 28.** Horizontal Natural Gas Blow at Kleen Energy. (Credit: CSB [83])

The incident occurred during the planned cleaning of fuel gas piping, part of the commissioning and startup phase of the Kleen Energy project. At the time of the incident, workers were conducting a “gas blow,” whereby natural gas was forced through the piping at high pressure and volume to remove debris [82, pp. 2-3]. **Figure 28** shows the horizontally aimed discharge of natural gas during a gas blow at Kleen Energy. Like the outlet piping from the EVAL Reactor 2 emergency pressure-relief system, the gas blow piping did not discharge flammable gas to a safe location. At the exit of the horizontally aimed piping, the cleaning operation intentionally discharged the natural gas (and debris) into the air [82, p. 11].

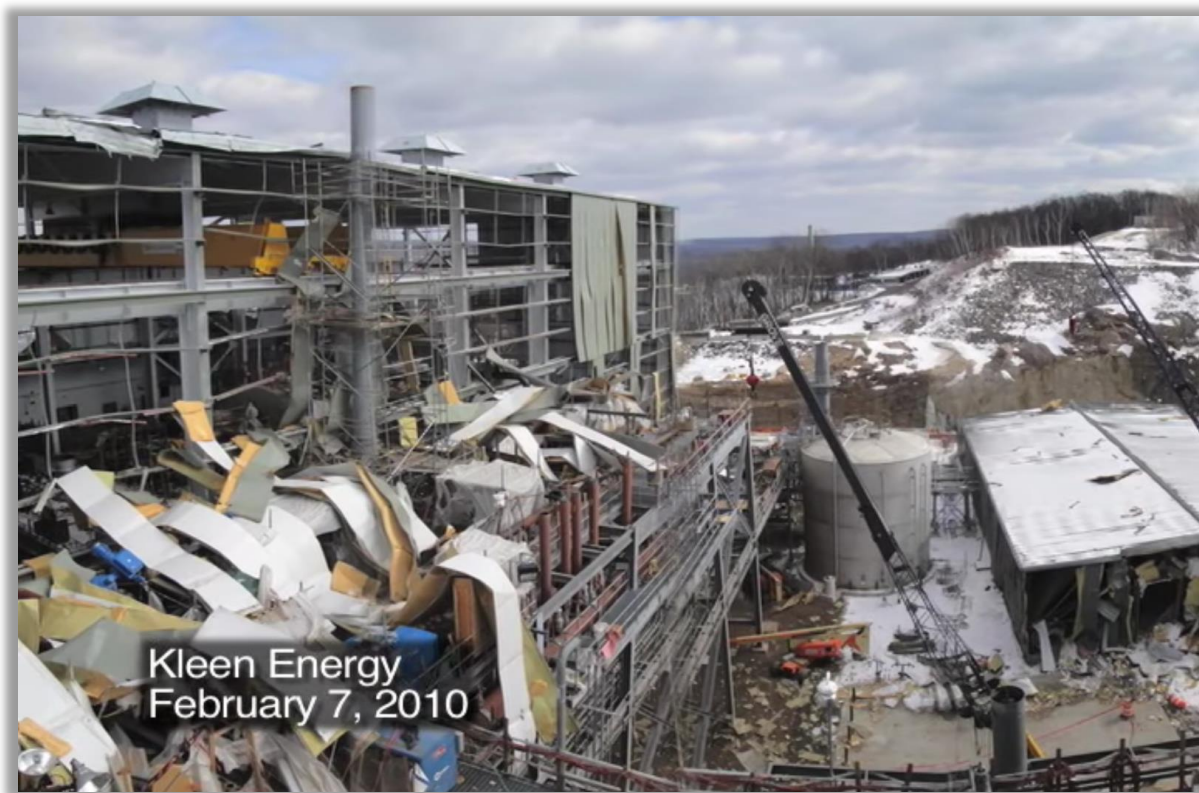
**Figure 29.** Explosion Damage at Kleen Energy. (Credit: CSB [84])

**Figure 29** shows a portion of the Kleen Energy facility that was heavily damaged when flammable gas (used to clean piping) was discharged into the air horizontally, ignited, and exploded. This release of natural gas into the air was similar to an atmospheric discharge from an emergency pressure-relief system.
