## Perspectives on Containment Wall Failure at ITC Deer Park, Texas

Fire at First & Second 80's Tank Farm at  
Intercontinental Terminals Company  
Event of March 17, 2019 at Deer Park, Texas

April 24, 2023

Atlas Engineering, Inc.  
551A Pylon Drive  
Raleigh, NC 27606  
Firm License #: C-1349

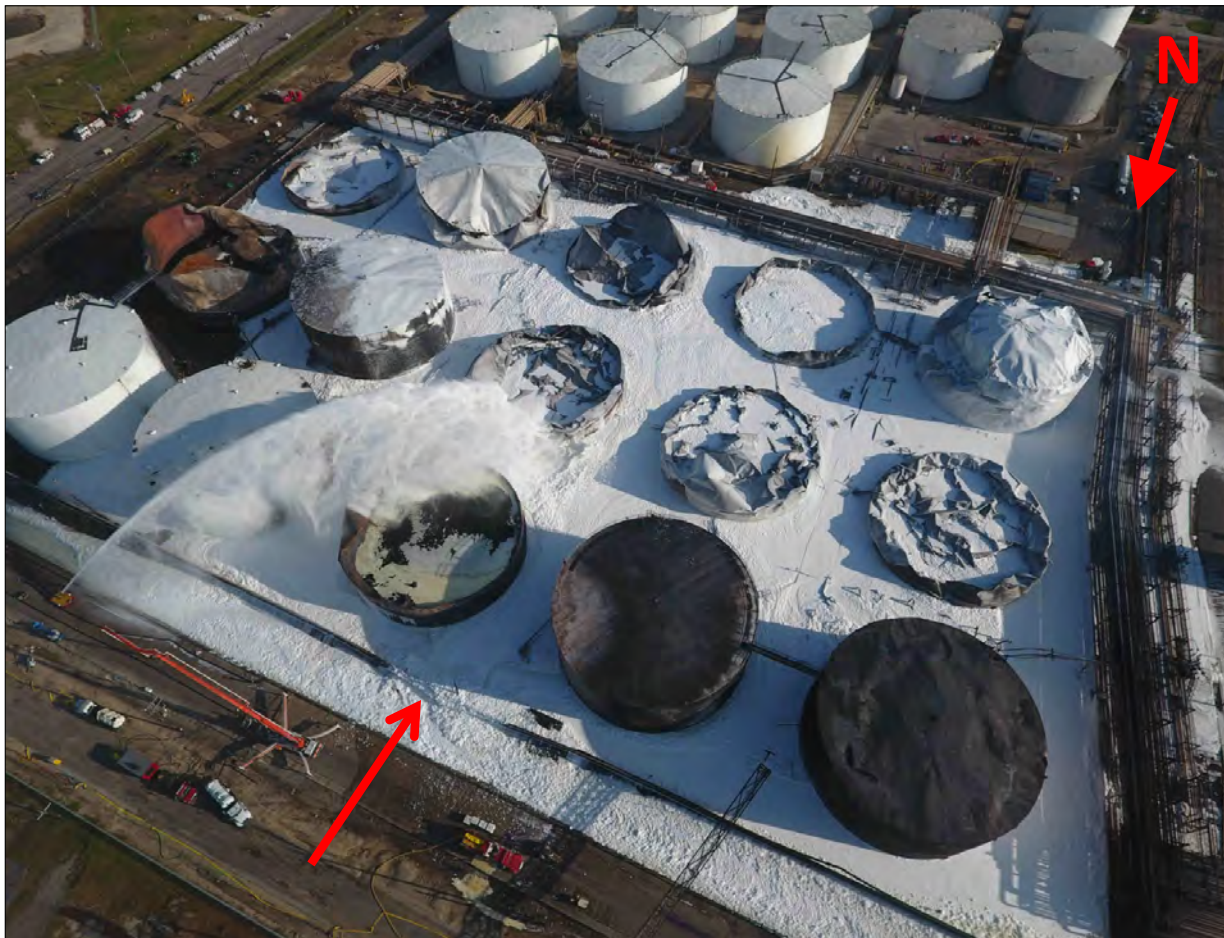
On March 22, the fire had been successfully suppressed and the firefighters were periodically re-applying additional firefighting foam to maintain a continuous blanket of foam across the site. UAS overflights were being conducted periodically to observe the status of the tank farm. Operations planned for that day included removal of product from vessel 80-7 by utilizing a concrete pump truck to reach damaged vessels from outside the containment wall. Drains and pumps throughout the site were also being used to lower the liquid level inside the containment area. But at approximately 12:00pm on March 22, a section of the containment wall on the north side of the tank farm, between tanks 80-4 and 80-7, failed, allowing the liquid mixture inside the tank farm to flow into the drainage ditch between the tank farm and Tidal Road (photo 4).

**Photo 4:** Containment wall failure (red arrow) during fire suppression efforts<sup>12</sup>

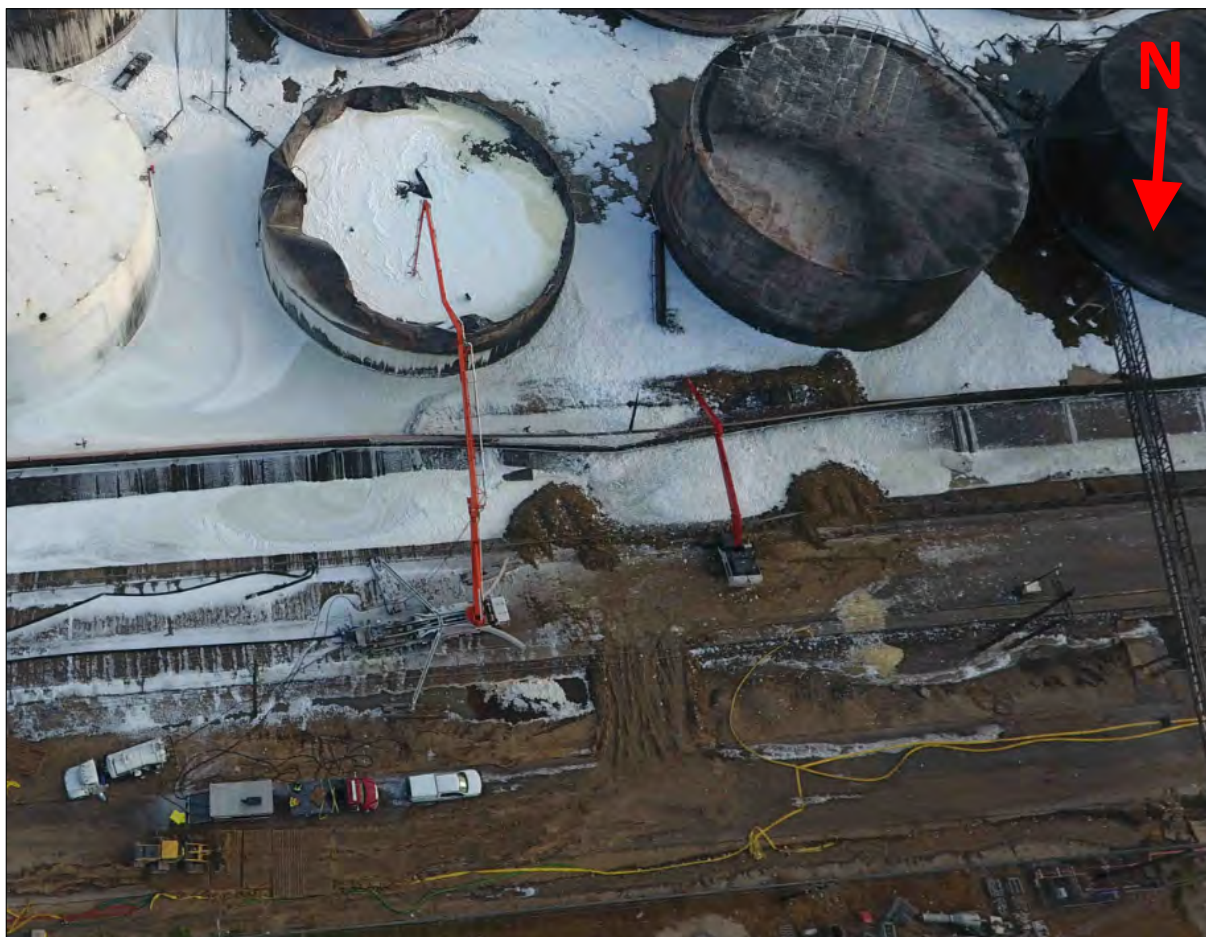
The response team had to retreat from immediately impacted areas. Flare-ups of fire in the drainage ditch and tank farm required re-application of firefighting foam. The team deployed additional booms in the waterways to contain product, and took measures to mitigate the leak from the tank farm. Initially, the incident response team utilized T-rail Jersey Barriers and sandbags inside the tank farm in an attempt to build a new containment structure to stop the breach and reestablish containment. This was augmented on March 23 by bringing in off-site soils to reinforce the immediate measures and construct a dike wall inside the breach (photo 5).

**Photo 5:** Responders constructing soil dike wall inside containment area to mitigate breach<sup>13</sup>

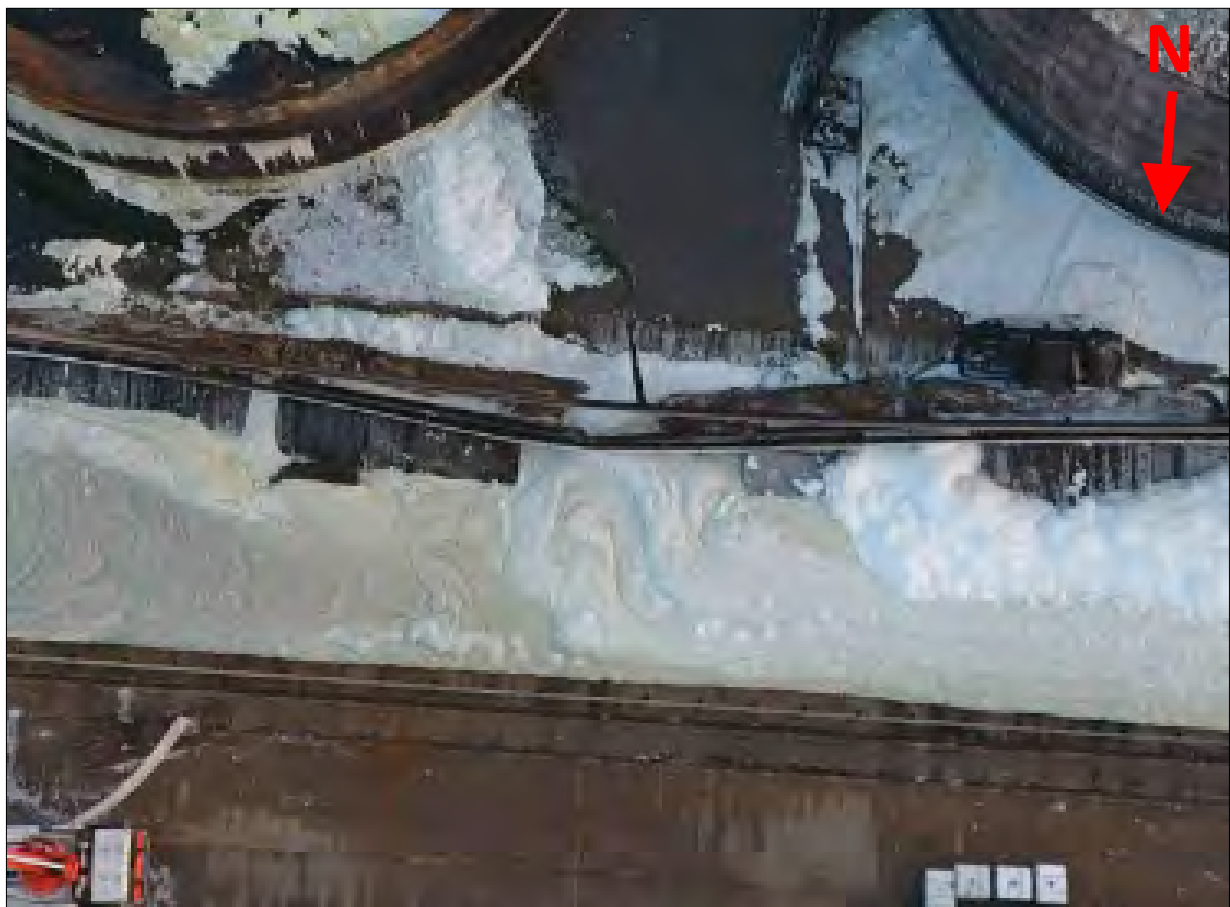
UAS overflight video footage was made available to Atlas by the CSB to aid in determining the condition of the wall during the event. Aerial footage showed that a section of the wall had shifted laterally to the north, tearing the waterstop at multiple construction joints and permitting fluid to flow into the drainage ditch north of the tank farm (photo 6). The wall remained straight and continuous between construction joints. A section of the soil immediately south of the containment wall shifted laterally as well, opening a crack in the ground surface that permitted large volumes of fluid to wash down into the soil. A steel pipe that was supported on top of the containment wall was separated from the wall as it displaced, but appears to have remained intact and was suspended above the area of the breach. The two pipes on the exterior of the containment wall, one black and the other white, were displaced by the wall.

Large volumes of firefighting foam flowed out of the containment area during this event, with foam traveling underneath the containment wall at the area of the breach. No foundation was visible in the photo, indicating that the wall may have separated from the foundation slab as it shifted. Much of the drainage ditch is obscured by foam, but there are indications that the sloped slabs lining the ditch, adjacent to the containment wall, have displaced.

**Photo 6:** Closeup from aerial view of containment wall failure<sup>14</sup>

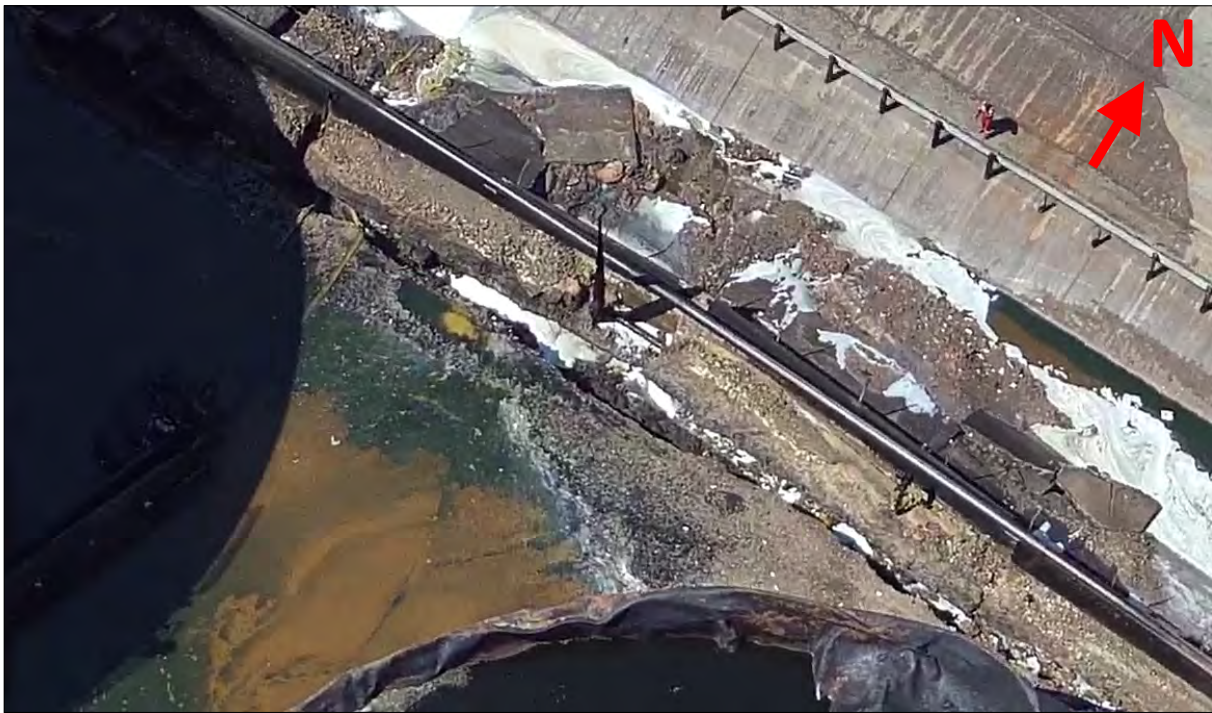
Photo 7 was taken after the bulk of the liquid had ceased to flow from the breach in the containment wall, but before emergency measures to build a temporary berm were taken. In this photo, a large erosion gully has been formed at the location of the primary breach, between 80-4 and 80-7, with smaller erosion gullies formed at adjacent construction joints in the wall where the waterstop was compromised as the wall shifted. The crack in the soil is visible parallel to the containment wall that resulted from the lateral shift of the wall and soil immediately behind the wall. The firefighting water distribution pipe running parallel to the containment wall can be seen exposed where the soil eroded away. It is not possible to determine if the foundation was displaced from its original position from this photo. The remains of a wood light pole that has been burned can be seen standing in this area. The remaining section of the light pole is still vertical. The sloped slabs on the south side of the drainage ditch have been displaced, with many buckling in the middle and some displaced entirely by the flow of liquid into the ditch. Eroded soil can be seen in the drainage ditch.

**Photo 7:** Aerial photo of containment wall failure after water flow stopped and before temporary dike wall was constructed<sup>15</sup>

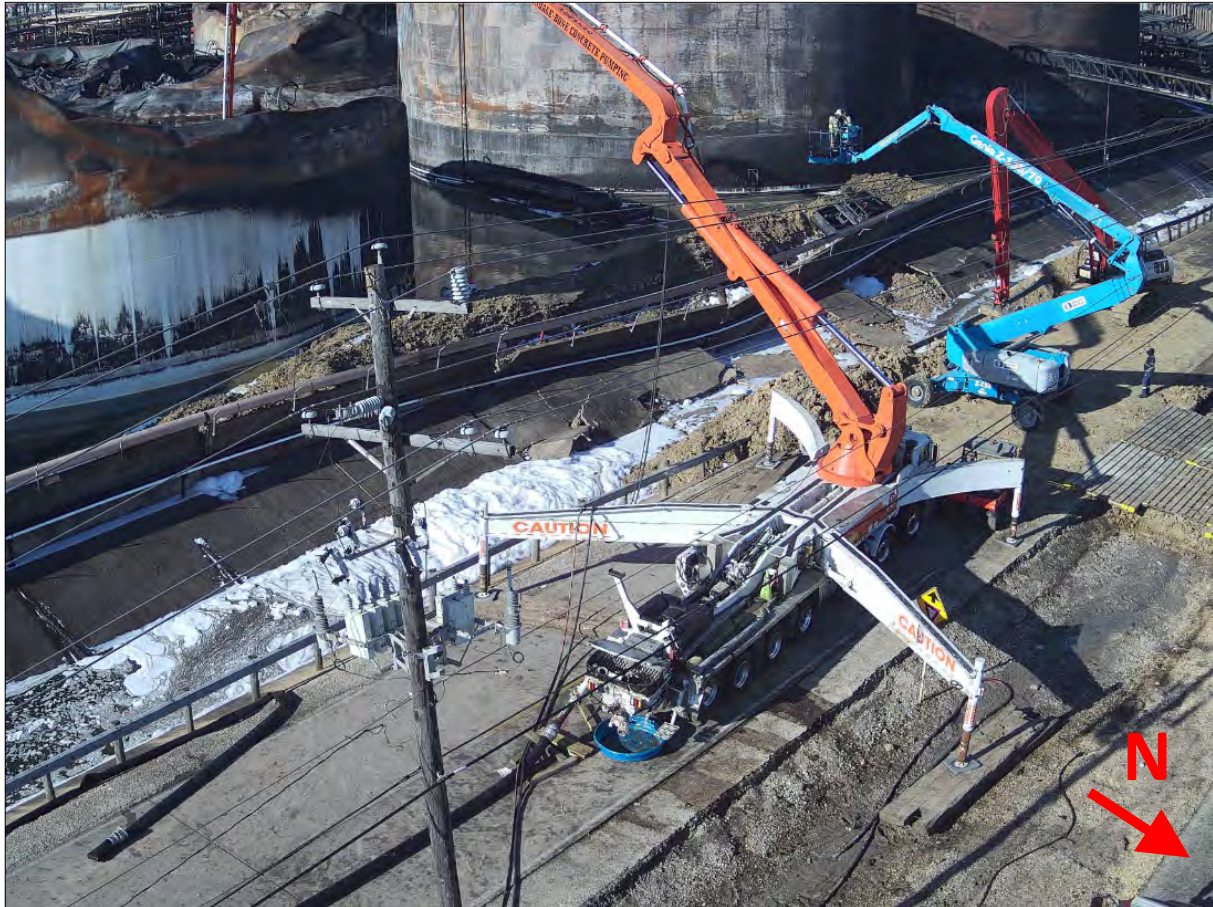
A photo of the breach after the response team had placed soil inside the tank farm to build a temporary berm can be seen in photo 8. The containment wall can be seen to have shifted laterally, with a slight outward rotation in this photo. The wall sections remained intact between construction joints, however the lateral displacement of the wall had resulted in gaps and torn waterstop at several construction joints. The sloped slabs on the south face of the drainage ditch can be seen buckled upward.

**Photo 8:** View of containment wall failure, after temporary dike wall was constructed<sup>16</sup>

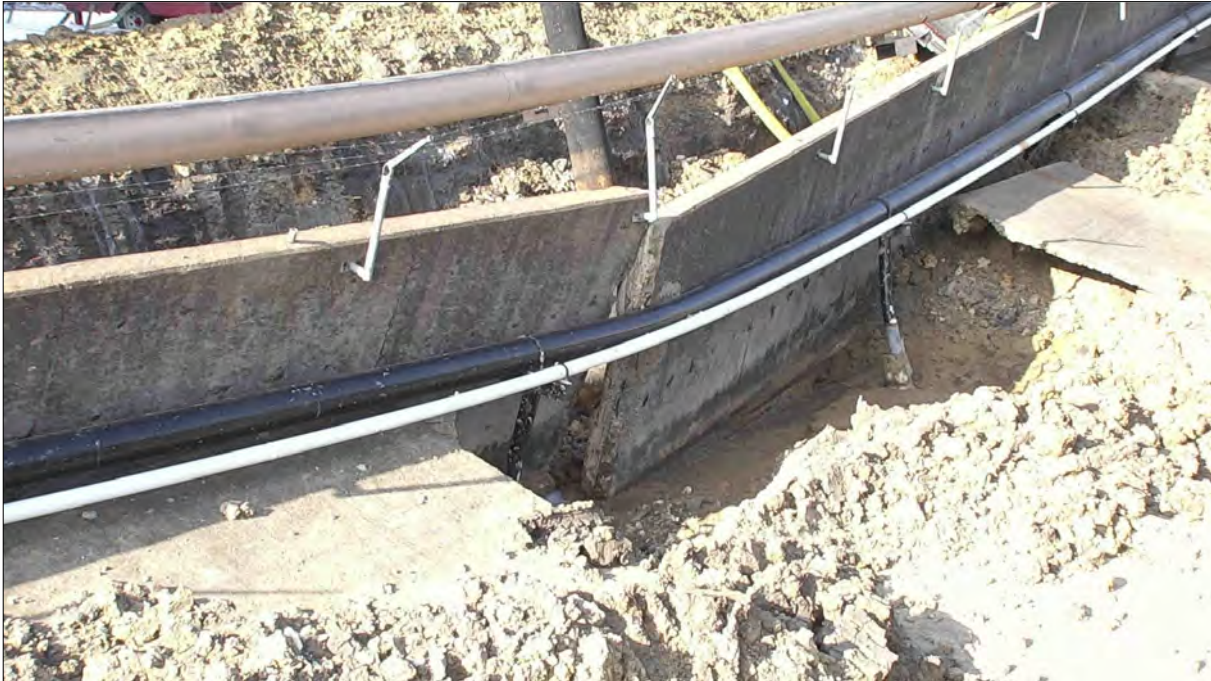
A close-up photo of the primary breach location can be seen in Photo 9. The soil had been eroded away from both sides of the containment wall at the breach. The wall had separated at a construction joint, and no dowels were visible spanning across the construction joint. The bottom of the wall was not visible in this photo, and it cannot be determined from this photo if the wall had a footing. The soil on the lower-right corner of the photo was soil placed after the breach to form the temporary dike wall. The temporary dike wall constructed by the responders inside the containment area can be seen in the upper left corner of the photo.

**Photo 9:** Close-up photo of containment wall breach provided by CSB<sup>17</sup>

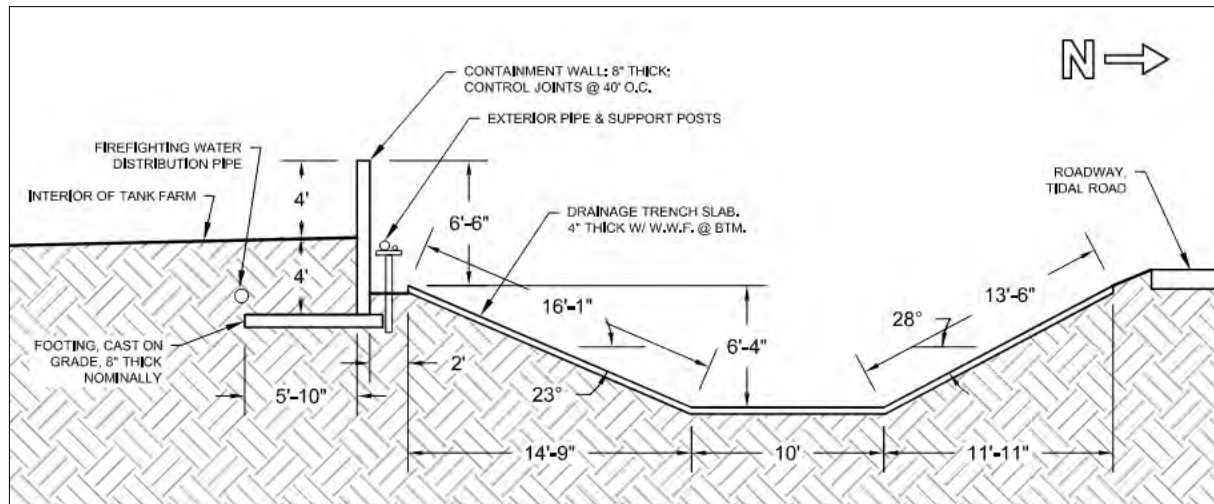
Measurements of the existing wall and drainage ditch were taken to construct a cross section sketch of the area (Figure 3). Measurements of reinforcement in the containment wall were made at locations where the containment wall had been broken by equipment during remediation efforts (Photo 11).

**Figure 3:** Cross section sketch of the containment wall

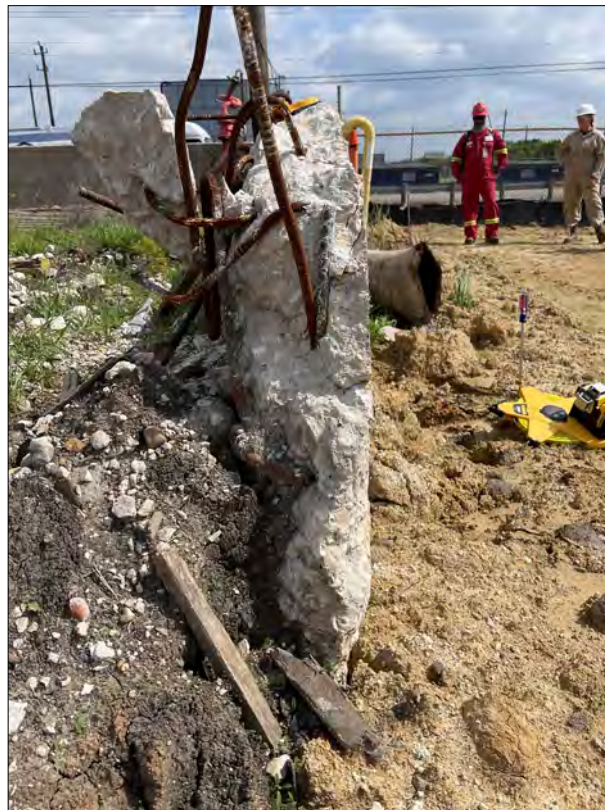
**Photo 11:** Exposed reinforcement at a section of the east containment wall where the wall was removed during remediation efforts

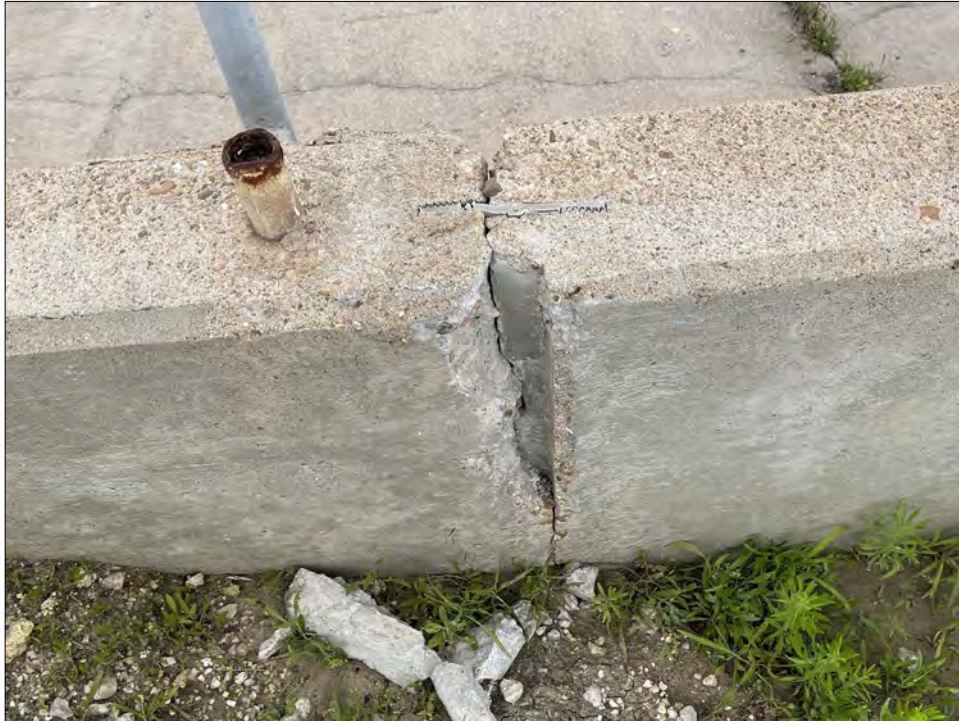
The containment wall was a cast-in-place concrete wall 8-inches thick and extending above the interior grade of the tank farm approximately 4 feet. The depth of the containment wall into the soil was not able to be determined at this visit. The wall had impressions from a panelized formwork system and through-wall break-off form ties, or snap-ties, spaced regularly in the horizontal and vertical direction, indicating it was constructed free-standing with a panelized formwork system on each face (photo 12). The wall was reinforced with two layers of deformed mild-steel reinforcing bars. The wall was cast in sections, with a construction joint every 40 feet. The joints were formed with a shear-key at the joint and a ribbed-wing centerbulb PVC waterstop incorporated into the construction joints to prevent liquids from leaking through the wall at the joints (photo 13 & 14).

**Photo 13:** Construction joint with cast-in concrete shear key and centerbulb waterstop

5. Incorporate water stop features to develop full continuity of systems. Pay special attention to terminations or transitions between systems, such as where footing-to-wall joints meet wall construction joints.

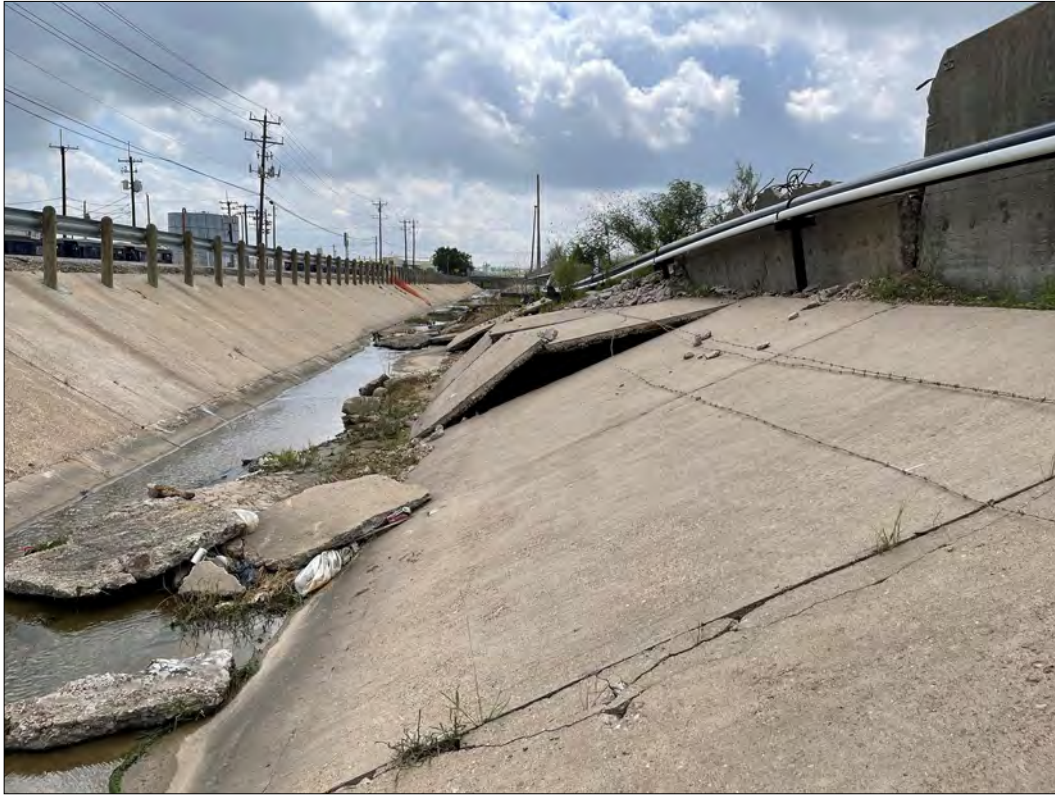
The drainage ditch between the containment wall and Tidal Road was a concrete-lined structure with a flat bottom and sloped side walls (photos 15 & 16). The concrete slab was approximately 4-inches thick, with welded-wire-reinforcement observed at broken sections of the concrete, typically located near the bottom of the slab. The concrete slabs were cast in sections, with construction joints between the slabs (photo 17). The welded-wire reinforcement did not span across the construction joints. Holes through the slab were observed along the bottom edge of the sloped side-wall slabs, appearing to have the purpose of providing drainage of groundwater from behind the side slab into the drainage ditch. In the areas adjacent to the breach that appeared un-disturbed, sections of the sloped sidewall concrete slab had buckled upward in the middle of the slab.

**Photo 16:** Damaged Section of Drainage Ditch, looking east

During the breach in the containment wall, the sloped slabs of the drainage ditch buckled upward, indicating either a large upward force from soil and hydrostatic water pressures or a large lateral force from lateral sliding of the containment wall. The sloped sidewalls of the ditch were not directly connected to the containment wall, with a gap between the top of the slab and the containment wall of at least 2-feet. Nor were the sloped slabs sized or reinforced in any way that indicates they were intended to brace the containment wall. Their construction appears to be designed to prevent erosion of the soil forming the drainage ditch only.

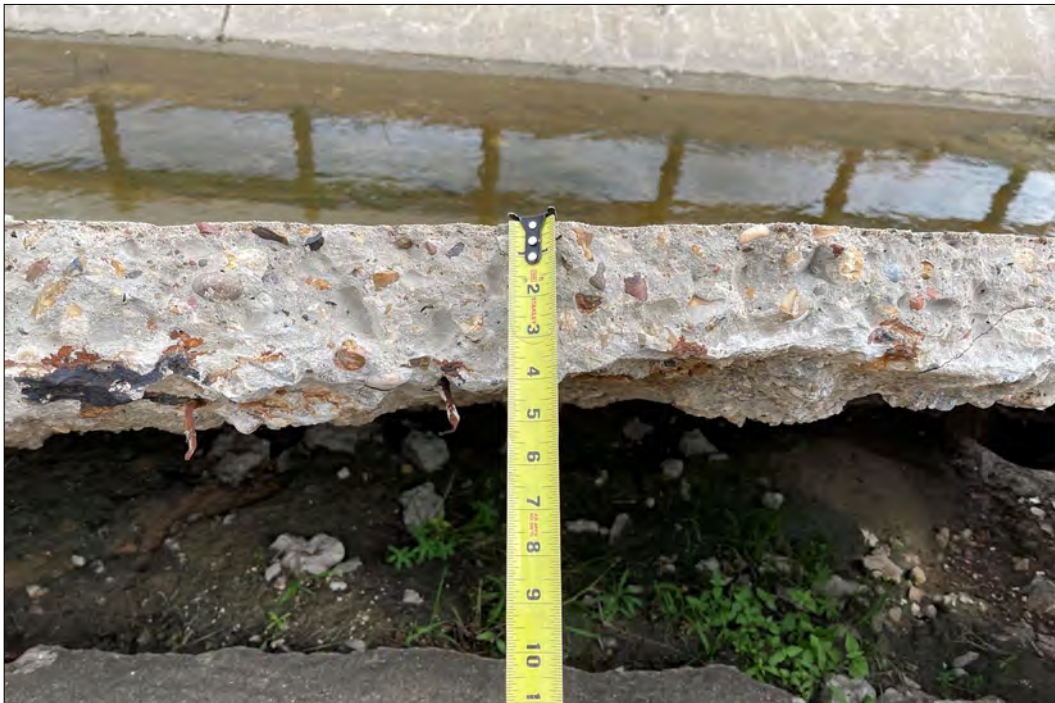
**Photo 17:** Displaced section of concrete slab that formed sloped sidewall of ditch

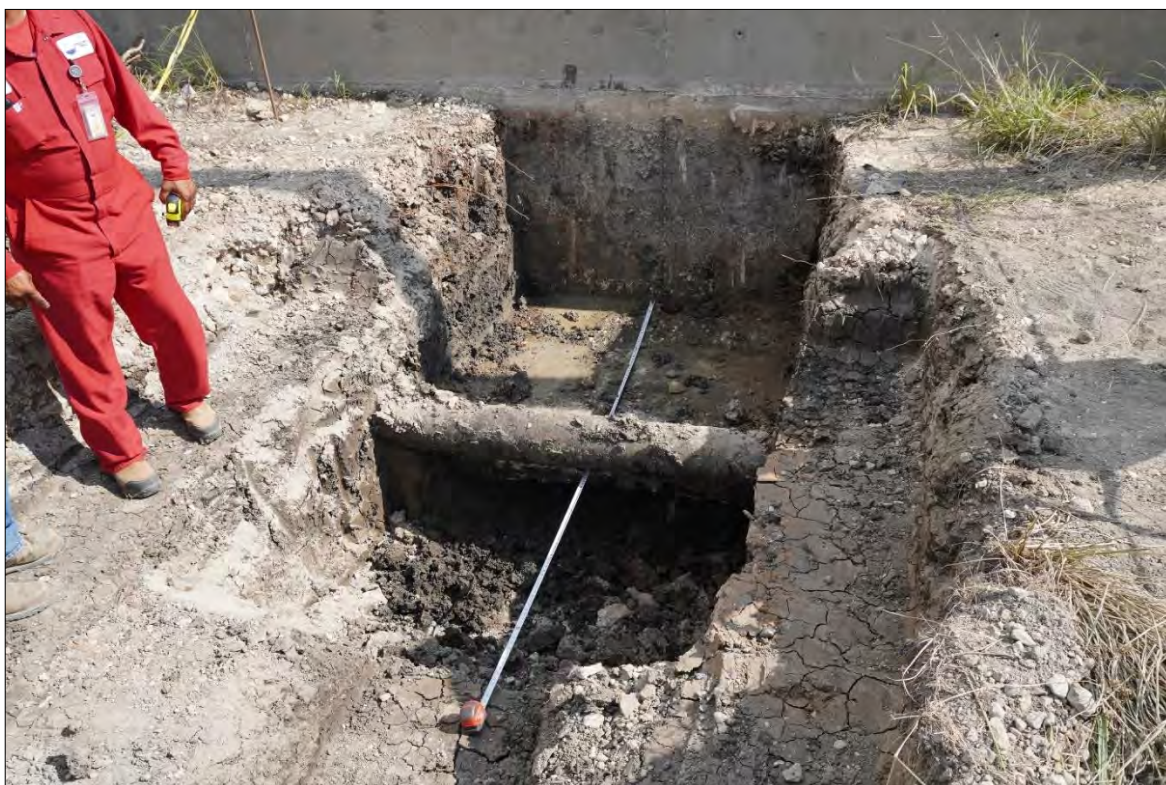
ITC excavated a section of the interior face of the containment wall on June 9, 2022. Atlas Engineering was unable to visit the site during the excavation, however CSB personnel were able to observe the condition of the wall after the excavation and take measurements (Photos 22 & 23). Measurements taken in the excavation area were used to refine the cross-section sketch through the containment wall shown above in Figure 3. The excavation revealed the containment wall extends down 4 feet below the grade level of the interior of the tank farm. There was a horizontal slab extending approximately 5 feet south from the interior face of the containment wall. This slab had a highly irregular edge and bottom surface, indicating it was cast against grade. No standing water was seen in the footing, indicating the natural groundwater level was below the base of the footing. The excavation also revealed the location of an underground firefighting water distribution pipe that supplied the fixed firefighting monitors located along the north wall inside the tank farm.

**Photo 22:** Containment wall footing excavation, south face of north wall, inside containment area

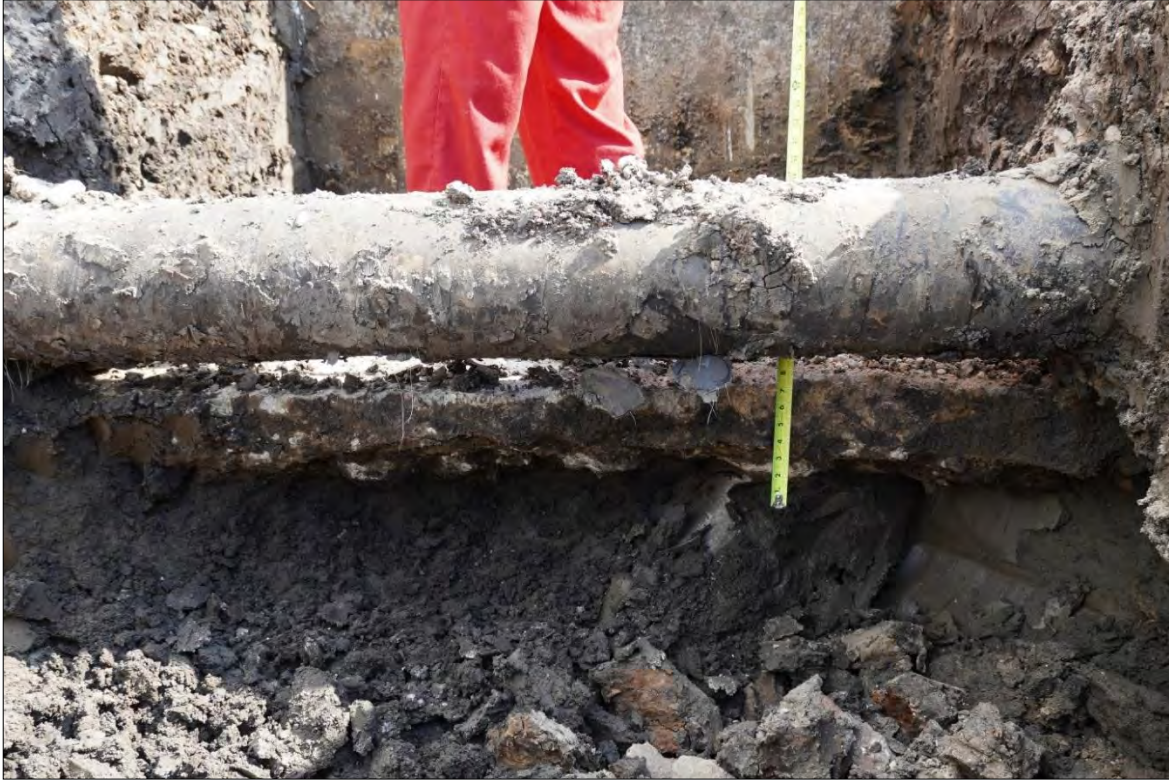
**Photo 23:** Containment wall footing and underside of footing

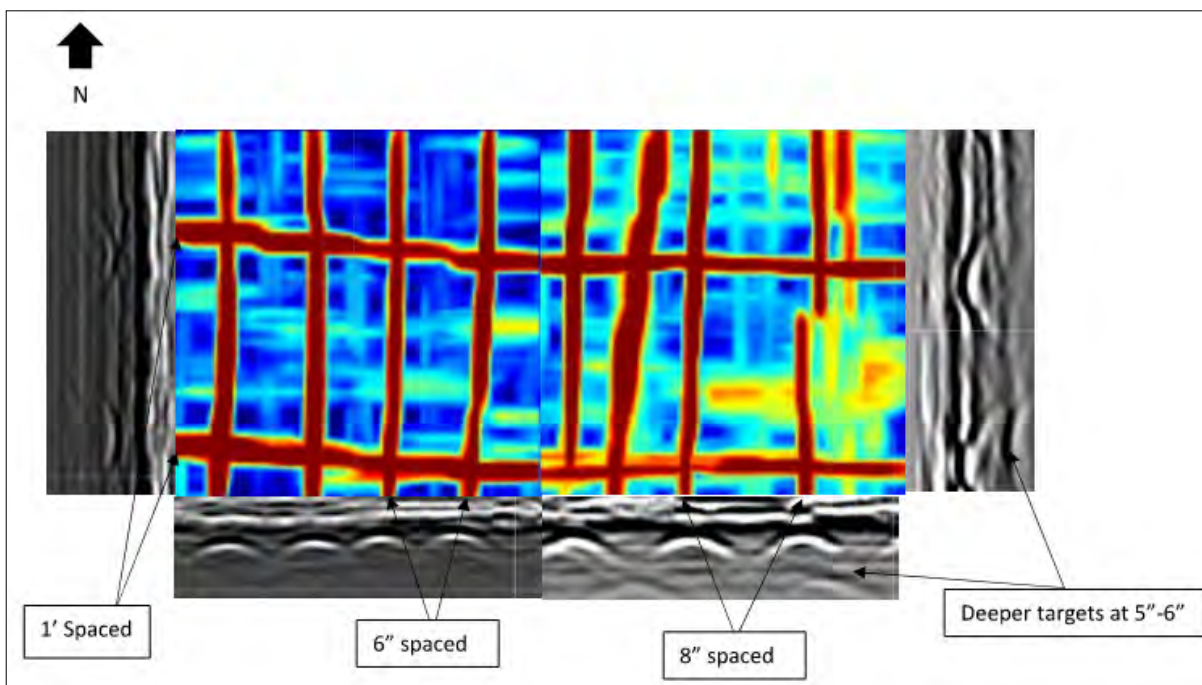
A contractor was utilized to perform a ground penetrating radar (GPR) scan of the foundation in an attempt to determine if reinforcement was present in the foundation and its general configuration. Due to the irregular surface of both the top and bottom of the concrete footing, the GPR instrument was limited in the information it could provide. The depth of the concrete could not be definitively identified due to the irregularities of the bottom surface of the concrete, a result of being cast against grade. GPR did indicate the presence of reinforcement in the concrete foundation, running both longitudinally and across the slab.<sup>18</sup> GPR was not able to identify if any dowels existed between the horizontal concrete slab serving as the footing and the vertical concrete wall forming the containment wall. Longitudinal reinforcement was detected approximately 12-inches on center, while transverse reinforcement was detected with spacings varying from 6 to 8-inches on center (Figure 4). The size of the reinforcement could not be determined from the GPR results. Excavation on the exterior side of the containment wall was not possible due to the presence of active pipelines in the area.

**Figure 4:** GPR scan results of retaining wall foundation slab from Holes Technology LP Report
