# Investigation Report

**Published: April 24, 2023**

On August 27, 2020, extreme winds from Category 4 Hurricane Laura caused severe damage to buildings storing chemical formulations comprised primarily of trichloroisocyanuric acid (TCCA) at the Bio-Lab, Inc. Lake Charles (Bio-Lab) facility in Westlake, Louisiana, located in the southwestern area of the state. TCCA-based formulations are chlorinating agents often used as a sanitizer to kill algae and bacteria in large volumes of water, predominantly swimming pools and hot tubs, and sold in tablet, stick, and granular forms. In large bodies of water, the TCCA formulation is soluble and breaks down slowly, releasing available chlorine in the water to sanitize contaminants. When a TCCA-based formulation instead comes in contact with or is wetted/moistened by a small amount of water and does not dissolve, it can experience a chemical reaction, generating heat and causing the decomposition of the chemical, which in turn produces toxic chlorine gas and can produce explosive nitrogen trichloride. After the buildings at the Bio-Lab facility were damaged by Hurricane Laura winds, rainwater contacted the TCCA-based formulation stored insid

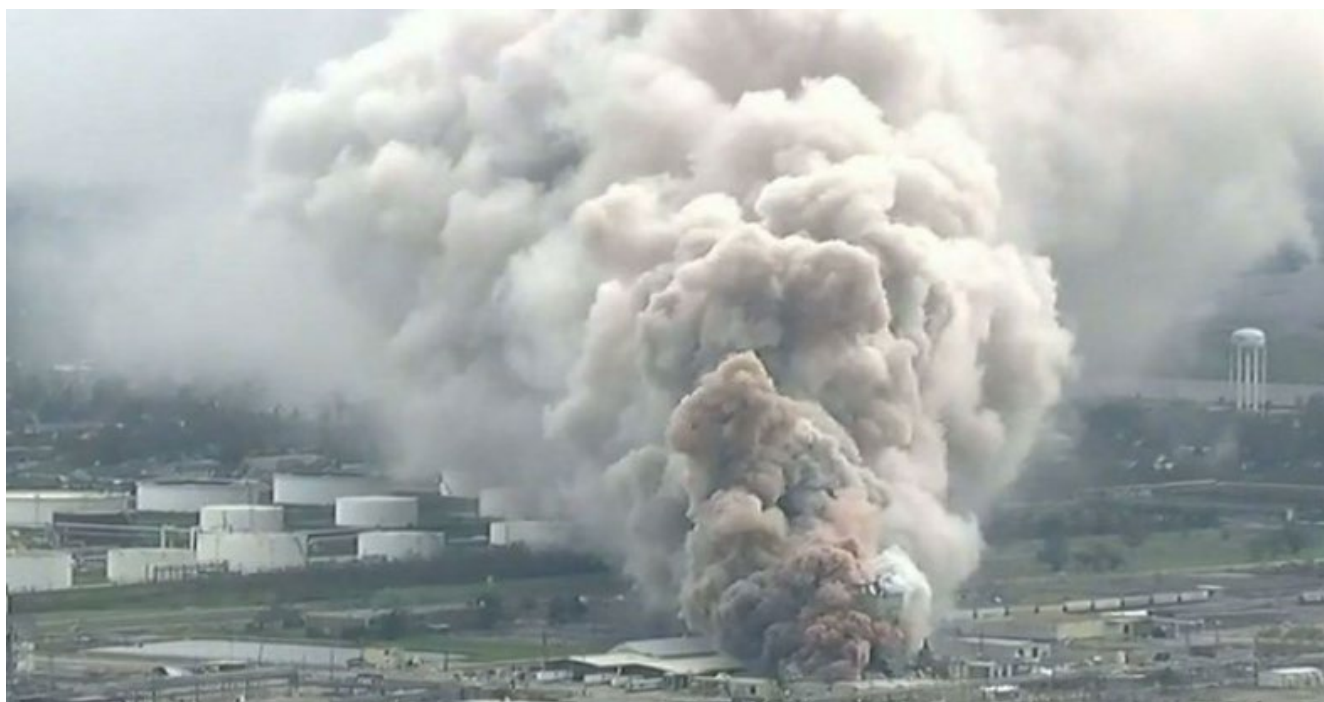
**Figure 7.** Photo of decomposition gases, including toxic chlorine, released from Bio-Lab Plant 4 after the building was severely damaged during Hurricane Laura and rainwater contacted the stored chemicals. (Credit: The Associated Press [22])

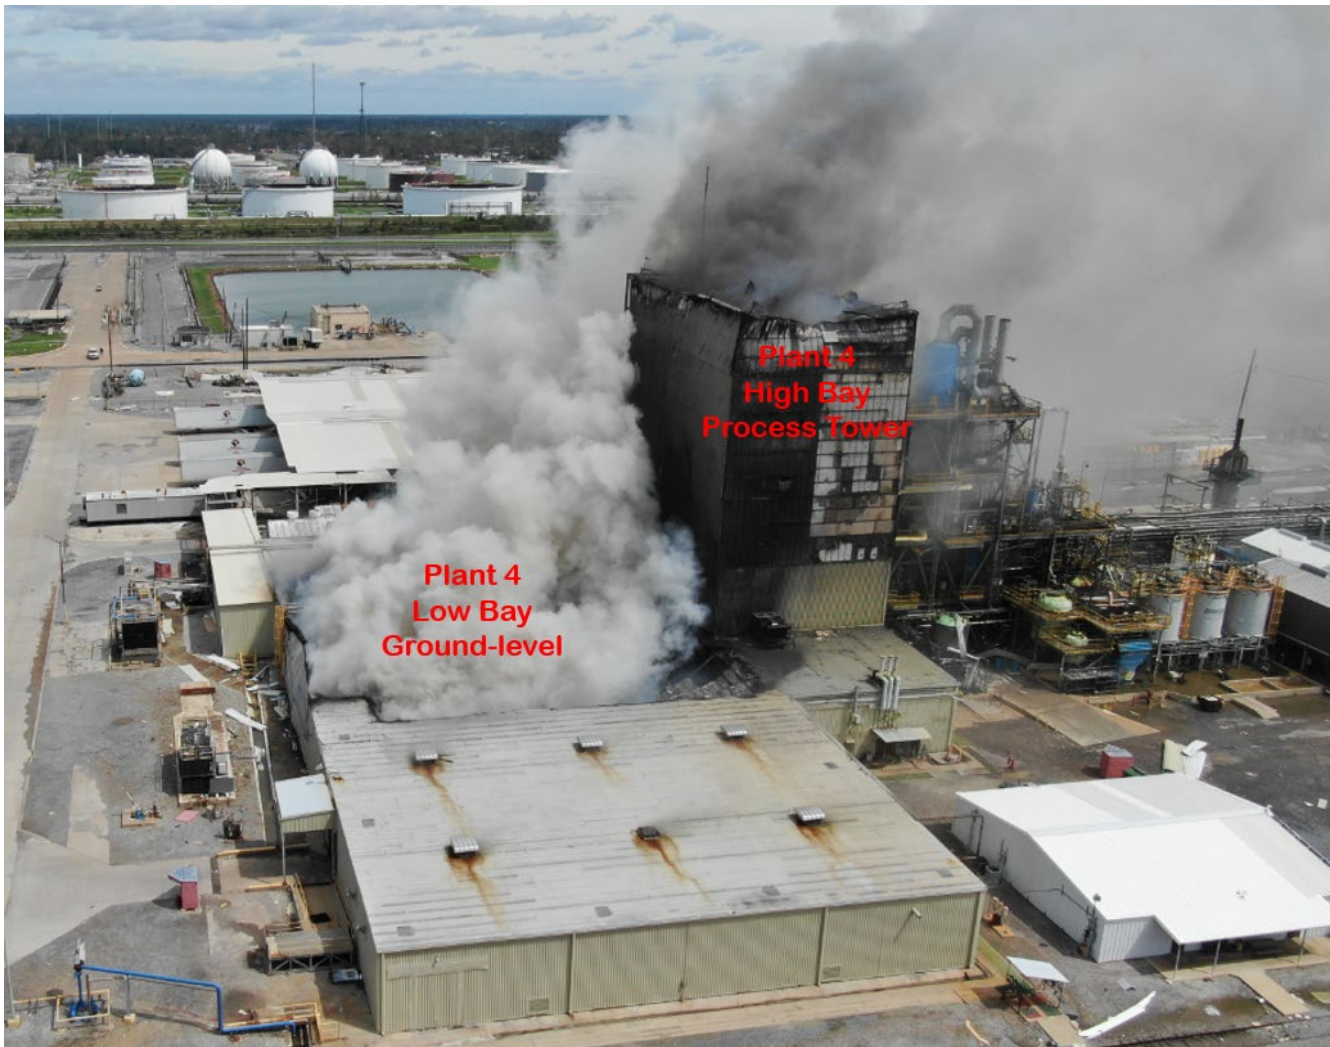
**Figure 9.** Decomposing chemicals in Plant 4 on August 27, 2020. (Credit: Louisiana State Police, annotations by CSB)

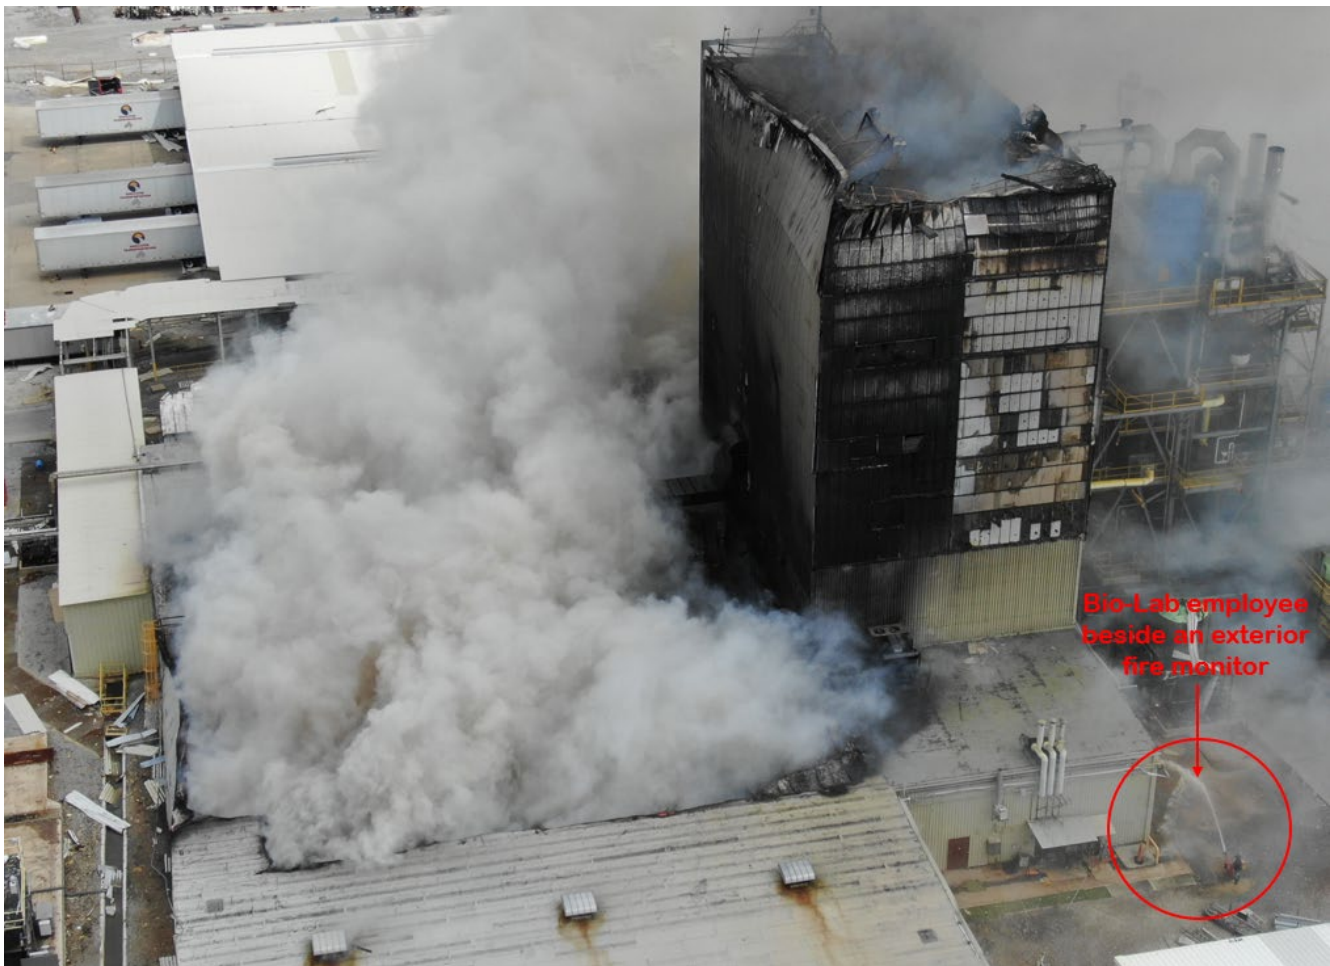
successful in manually starting one diesel fire water pump. By around 11:40 a.m., with the sole diesel fire water pump pressurizing the fire water system, the supervisor, two production operators, and the maintenance supervisor began turning on fire water monitors and attempted to spray water on the Plant 4 building or in the air to “knock down some of the smoke.” The supervisor quickly realized there was inadequate water pressure at the monitor. The Bio-Lab employees then examined the fire water system piping<sup>a</sup> and discovered a leak in the fire water system at the adjacent Lonza Arch Chemicals (Lonza) facility, to which Bio-Lab provides fire water.<sup>b</sup> The employees successfully stopped the water leak, turned off Lonza’s deluge system,<sup>c</sup> and isolated the area. These actions, however, did not significantly increase the water pressure within Bio-Lab’s fire water system (**Figure 11**). By this time, the fire had worsened and was beyond the capability of the Bio-Lab responding employees.

**Figure 11.** Available water pressure at an exterior fire monitor near Plant 4. (Credit: Louisiana State Police, annotations by CSB)

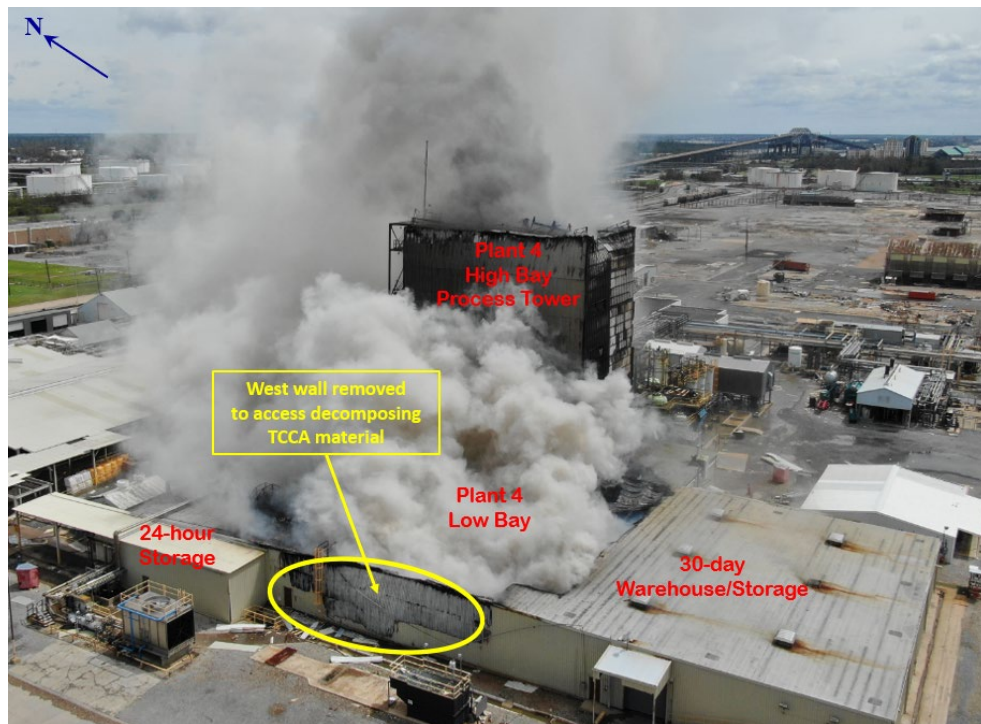
**Figure 12.** Decomposing chemicals stored in Plant 4. (Credit: Louisiana State Police, annotations by CSB)

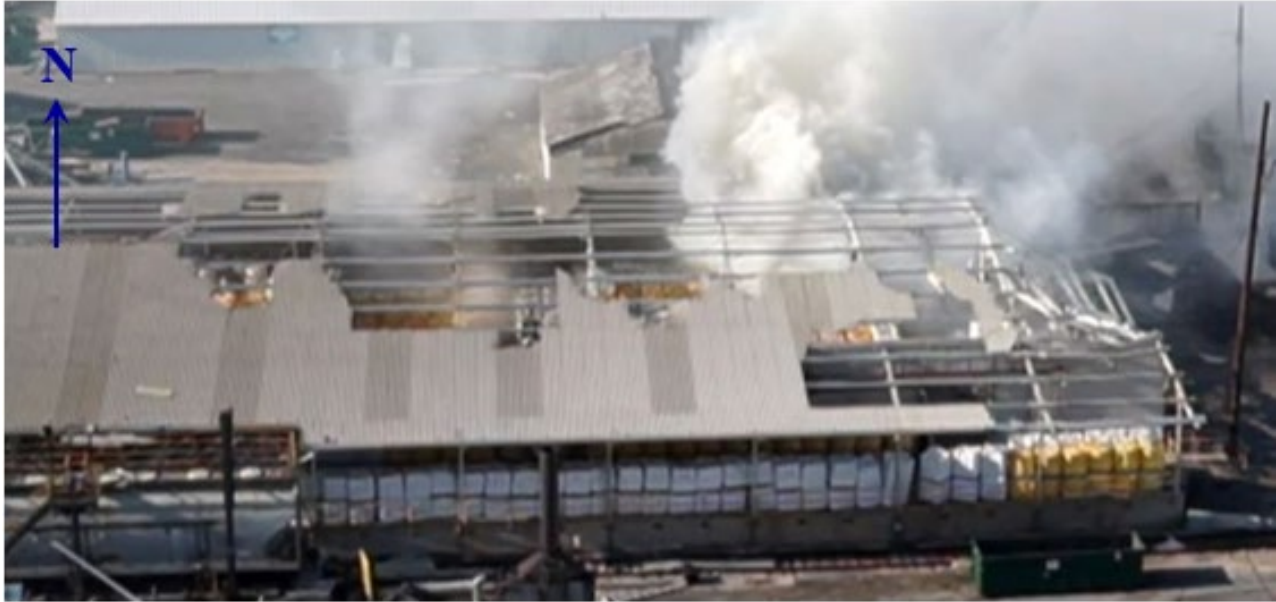
**Figure 13.** Damaged Finished Goods Warehouse roof emitting white fumes. (Credit: Bio-Lab)

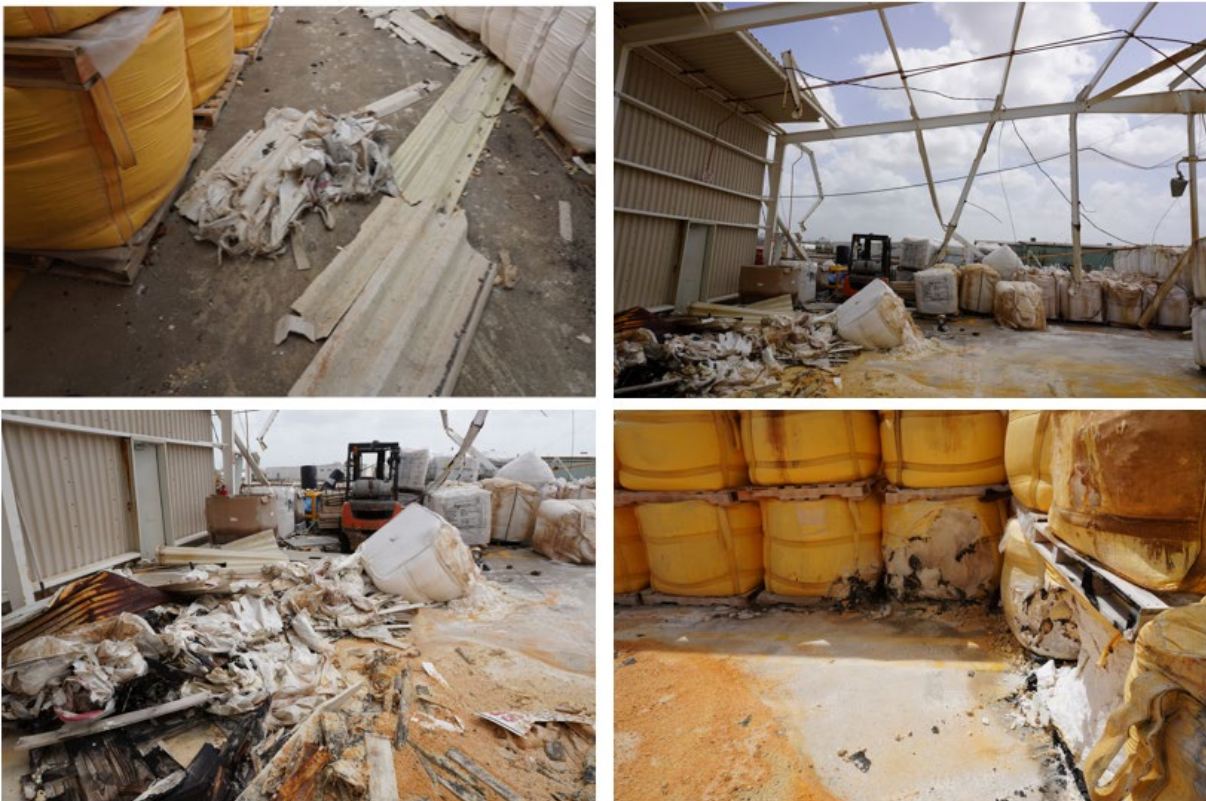
**Figure 14.** Inventory and storage areas inside the Finished Goods Warehouse following the second event. (Credit: CSB)

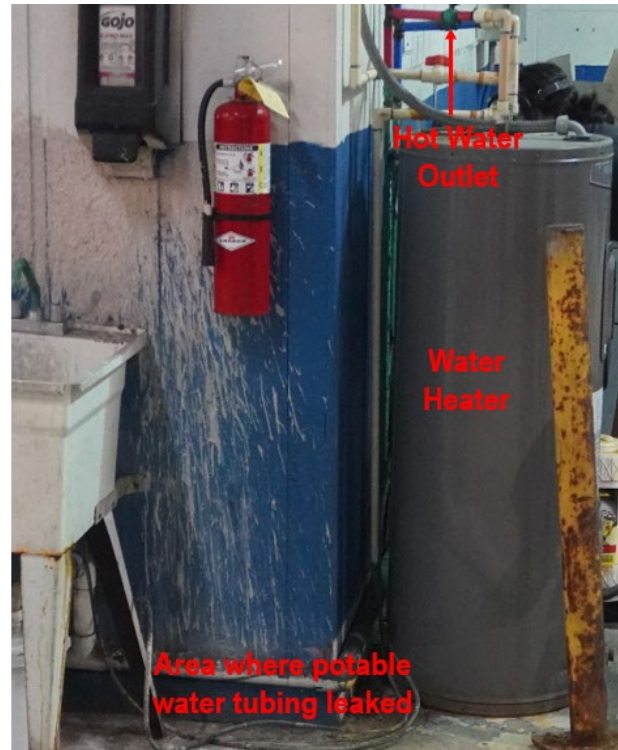
Between the close of business on Saturday, September 12, 2020, and the normal arrival of employees on Monday, September 14, 2020, a 3/8-inch polyethylene water line leaked in the Bio-Lab Conyers Plant 6, flooding a portion of the building. At approximately 4:50 a.m. on Monday, September 14, 2020, while Worker #1, a production lead, was in the building office preparing for the shift, Worker #2, a blending operator, entered the office and reported seeing water on the building floor. Worker #1 proceeded to the area to assess the situation and saw that water covered approximately 75% of the floor. Worker #1 estimated that the floodwater was about two or three inches deep in some areas but lower than the top of the wood pallets used to store TCCA-based formulation near the building's north wall (**Figure 23**).<sup>a</sup> He then walked near the employee restrooms (**Figure 23**) and saw water releasing from a polyethylene line connected to the water heater (**Figure 24**). Worker #1 immediately closed the water heater's hot water outlet valve, which stopped the water leak. After stopping the water leak, Worker #1 contacted the Maintenance Department to report the damaged line and notified management of the flooded warehouse.

**Figure 24.** Location of polyethylene line that leaked, causing an area in the Bio-Lab Conyers Plant 6 to flood. (Credit: CSB)

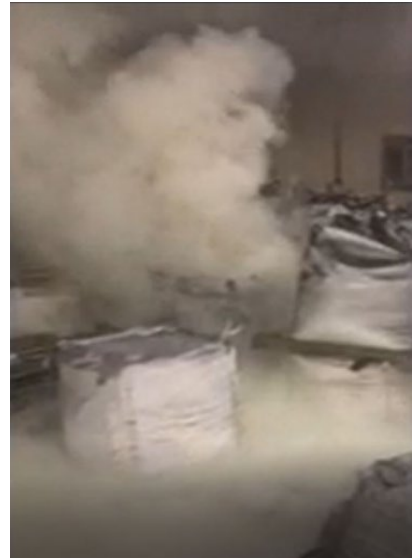
**Figure 25.** Decomposition on September 14. (Credit: Bio-Lab Conyers)

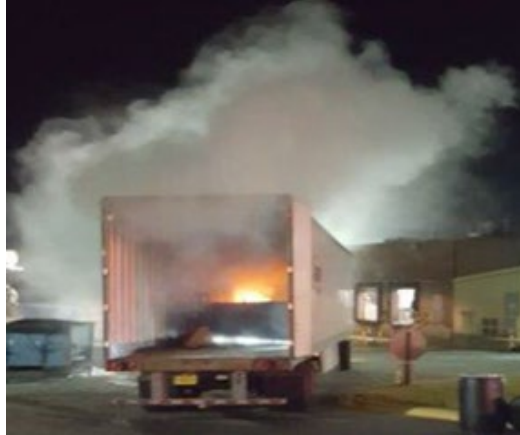
**Figure 28.** Decomposition on a rental trailer at Bio-Lab Conyers. (Credit: Bio-Lab Conyers)

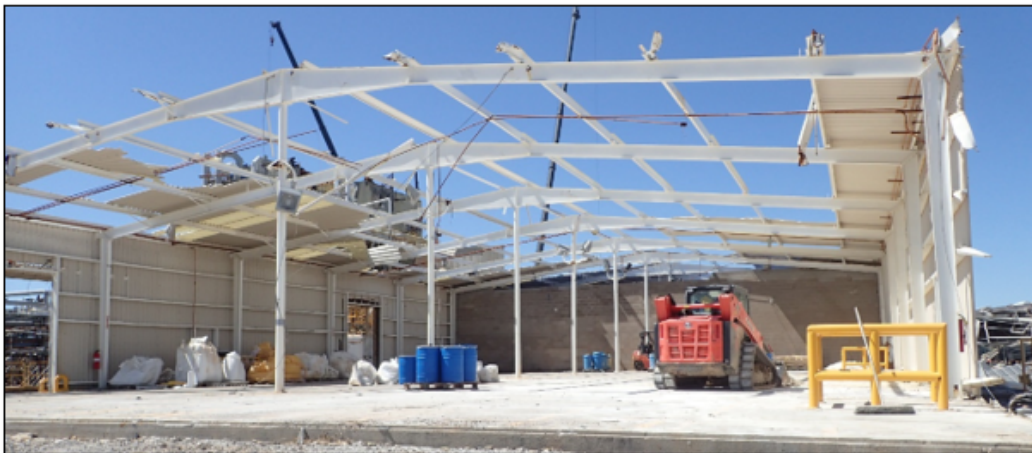
*Eastern bay of south FGW, looking SW. Wrecked framing has been removed (Atlas, 9/29/2020)*

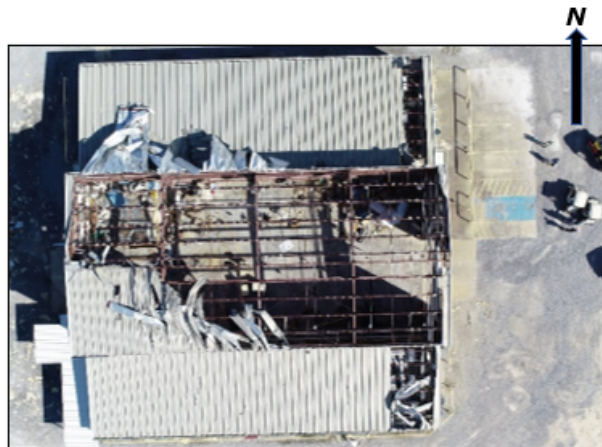
We observed debris from the roof and found that the metal roof panels tore free around the screw heads. At the roof areas that had been stripped, the purlins and structural frames appeared undamaged.

*A-Z Building (Atlas UAV, 9/30/2020)*

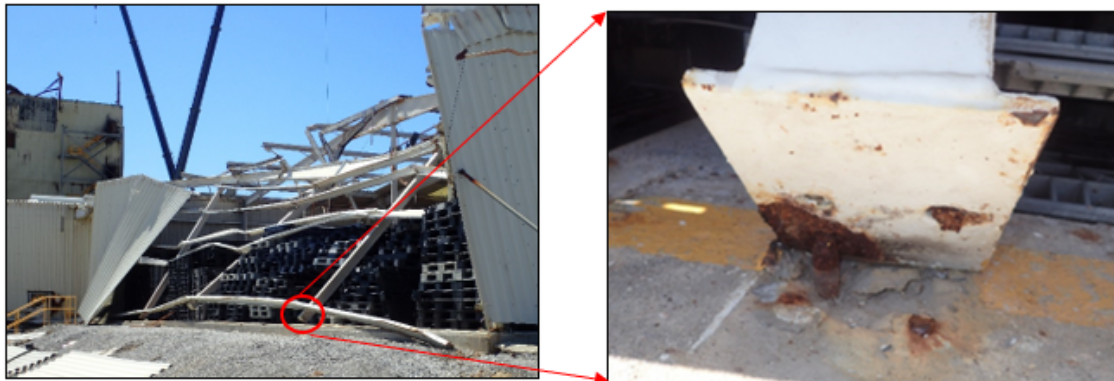
**Wind Damage** – At both FGW's, the columns at the eastern end-walls collapsed to the west, falling into the eastern building bay and buckling roof purlins and wall girts as they fell. We examined the column bases at these end-walls and found severe corrosion at the anchor bolts. Several anchor bolts had corroded in two, leaving the end-wall columns unattached to the slab, and less able to resist wind loads.

*Eastern bay of north FGW, looking SW, & close-up of column base and anchor bolts (Atlas 9/29/2020)*

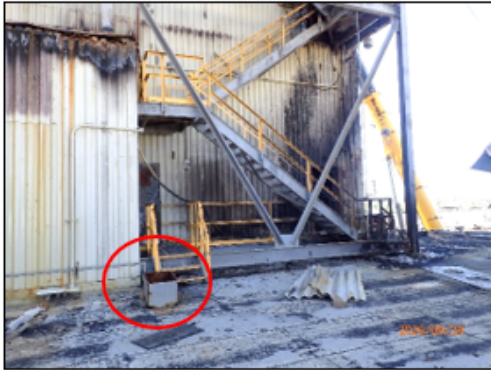
*Roof-top ductwork torn away, at two roof areas adjacent to Low Bay*

*Roof opening at broken duct, Low Bay roof north of High Bay tower (Atlas 9/29/2020)*

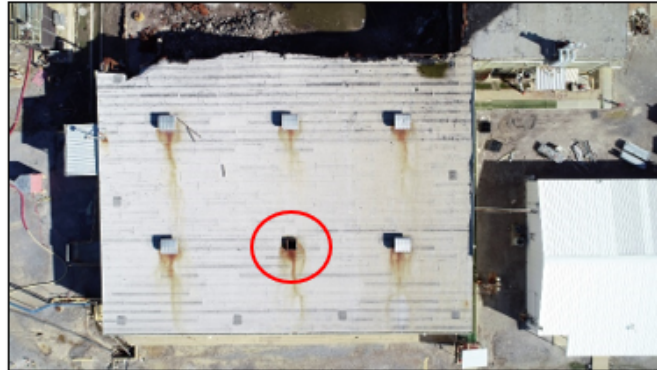
*Open roof duct at 30-day Warehouse, just south of Low Bay (Atlas UAV 9/30/2020)*

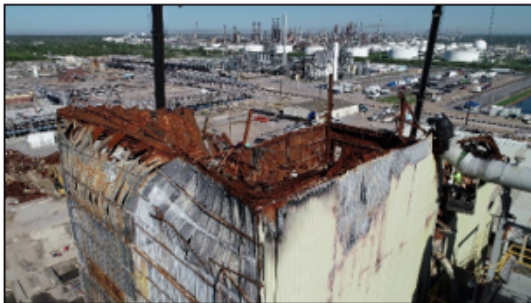
*Upper 35' of tower looking NW,  
after fire & demo work (Atlas UAV, 9/30/2020)*

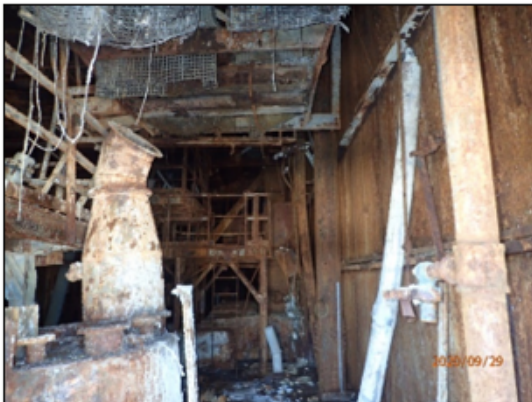
*3<sup>rd</sup> floor level from north stair, showing heat-  
deformed columns & bracing (Atlas, 9/29/2020)*

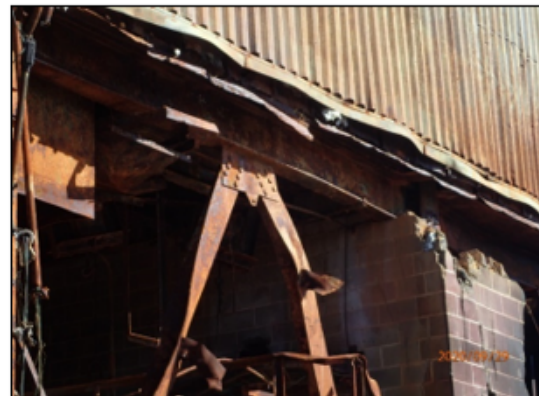
*Ground floor level looking east, showing heat-  
deformed brace & spandrel (Atlas, 9/29/2020)*
