# Chemical Decomposition, Fire, and Toxic Gas Release at Bio-Lab, Inc.

Conyers, Georgia | Incident Date: September 29, 2024 | No. 2024-04-I-GA

## Investigation Update

May 2025

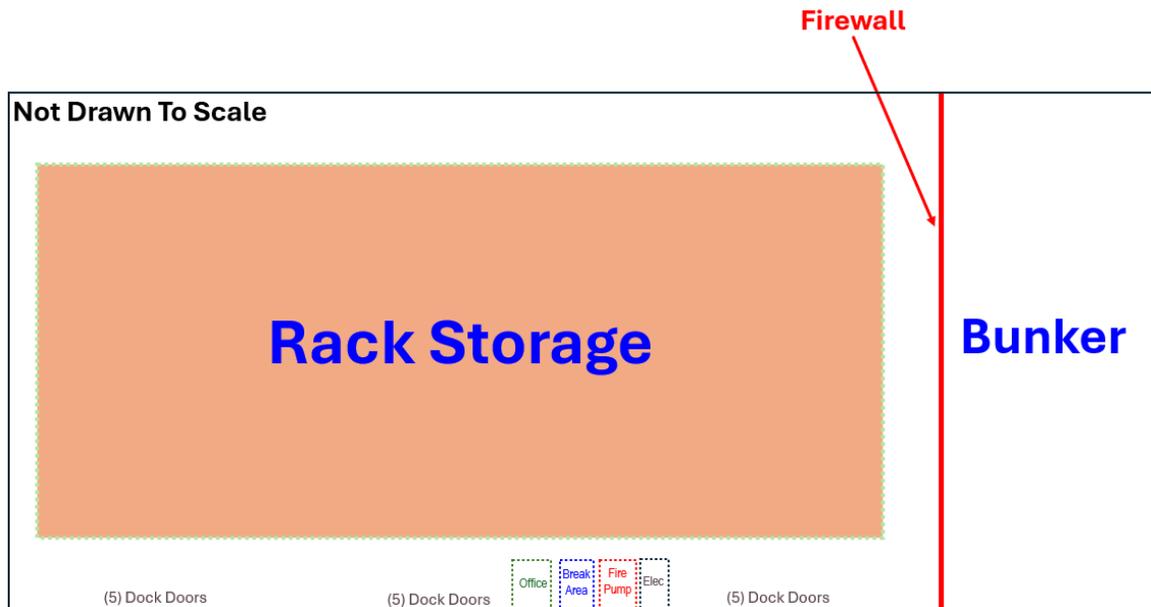
the firewall (Table 1),<sup>a</sup> which divided the warehouse into two storage areas (Figure 1) and was intended to prevent the spread of a fire. The area behind the firewall was referred to by Bio-Lab personnel as the “bunker.” The oxidizers stored outside the bunker were in multiple piles on racks and were packaged in very large individual flexible bulk bags called “super sacks” (Figure 2), each holding approximately 2,750 pounds of material.<sup>b</sup> The oxidizers were also stored alongside other dry chemicals within the rack storage system and were not segregated from the other dry chemicals.

**Figure 1:** Sketch of the Storage Warehouse floor plan showing the firewall, rack storage, and the bunker area. (Credit: CSB)

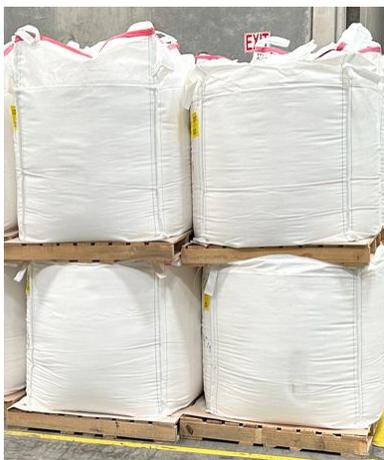
**Figure 2.** Depiction of super sacks stacked two high. (Credit: CSB)

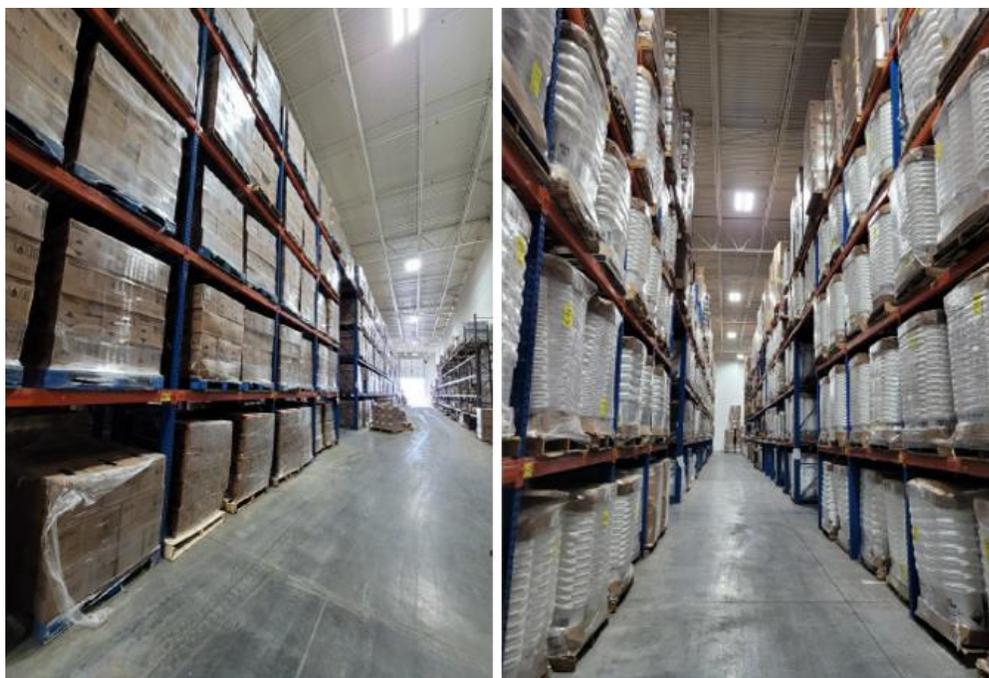
- Bio-Lab first began storing TCCA within the storage warehouse bunker on November 5, 2019. Although final construction activities inside the warehouse and on the building exterior continued through late December.
- In March or April 2021, Bio-Lab submitted drawings to Rockdale County to expand the scope of the storage warehouse by adding a new 49,000 square foot rack storage area outside the bunker. This area would be protected by an ESFR fire protection system designed to store various commodities, including pails, cardboard, and bottles, up to a height of 25 feet.<sup>a, b</sup> They also applied for the necessary permit for the rack storage, which the Rockdale County Fire Marshal's Office approved. **Figure 3** shows a section of the storage warehouse's rack storage.

**Figure 3:** Photos of Warehouse Storage Racks included in a report dated April 2022. (Credit: Bio-Lab)

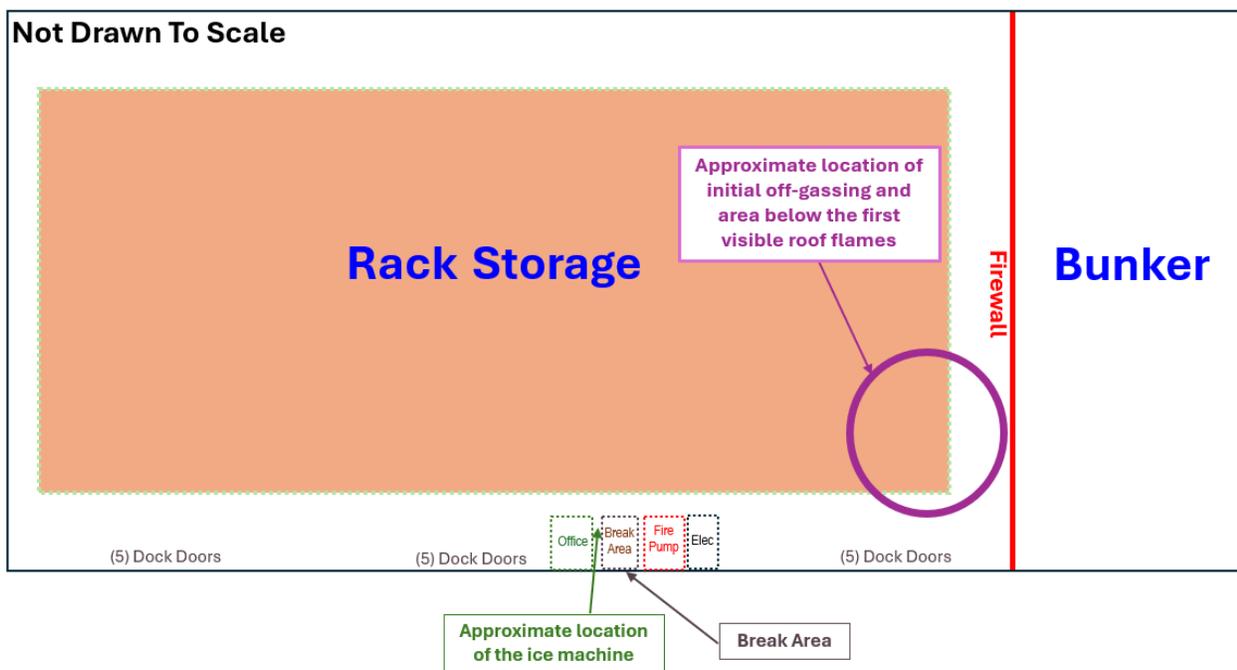
- One of the Bio-Lab employees assigned to fire watch in the storage warehouse explained to the CSB that the dropping of ice from the ice machine could be heard while sitting in the break area because of the ice machine’s location. On the morning of the incident, the employee reported hearing a “popping” sound as she stepped out of the break area (**Figure 4**) to begin the 5:00 a.m. round, which she initially believed was the ice machine. However, based on previous experience and training, the employee immediately concluded that the product was wet and called the only other Bio-Lab employee on site, who arrived shortly thereafter. Both TCCA and DCCA produce nitrogen trichloride when wet, which is an explosion hazard, and likely the popping sound heard by the employee. At that time, no flames were observed.

**Figure 4.** Depiction of the storage warehouse floor plan showing the ice machine’s approximate location, Break Area, and area where initial off-gassing was observed. (Credit: CSB)

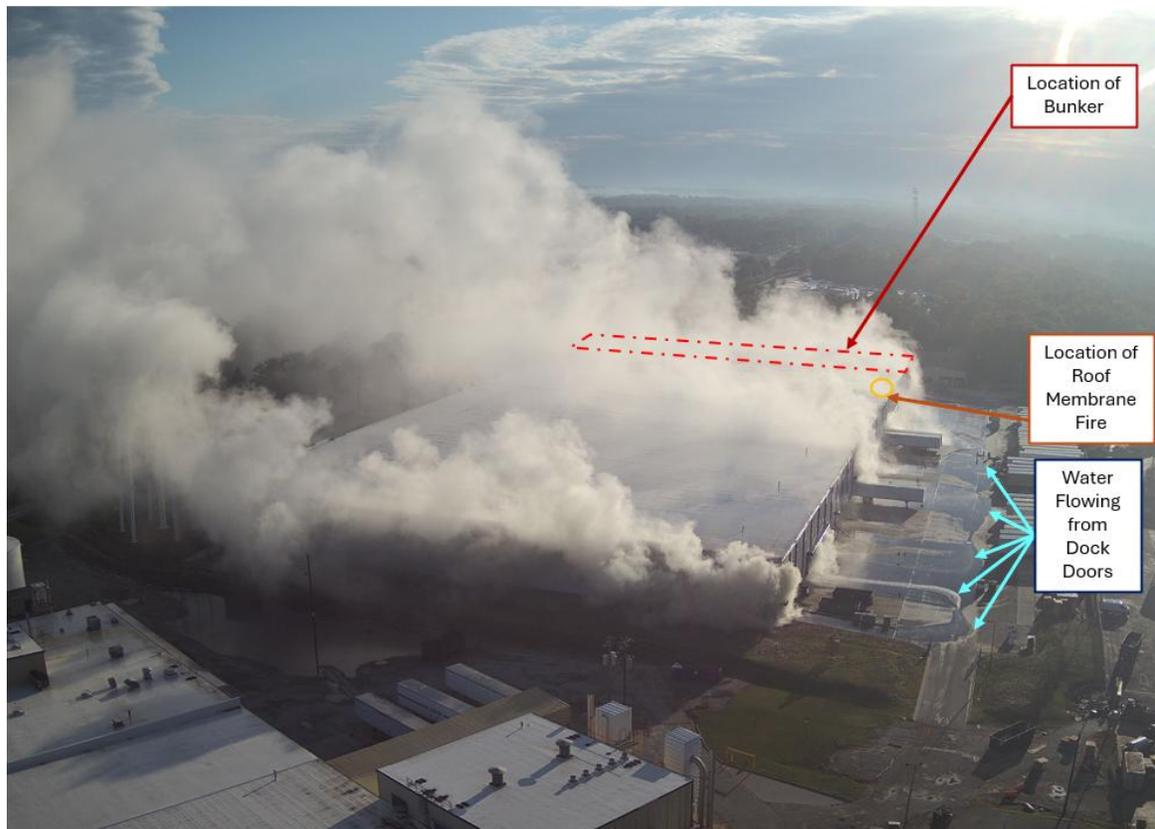
noted that a large volume of water was flowing out of the building through the dock doors. Both Bio-Lab and RCFR personnel also had observed large volumes of water running out of the dock doors even before the RCFR respondents flowed any water, suggesting the sprinkler system was activated. Once the sprinkler system was activated, it would continue to flow some water until either the system was completely drained or the water supply to the storage warehouse was completely stopped. **Figure 5** shows the large volume of water flowing out from the warehouse interior through all the dock doors along the full length of the building, except the bunker.

**Figure 5.** Water Flow from the storage warehouse’s interior through dock doors. (Credit: Rockdale County Fire Rescue, annotated by CSB)<sup>a</sup>

<sup>a</sup> Rockdale County Fire Rescue used their drone to take the picture at 8:41 a.m., showing water still flowing out from the dock doors 30 minutes after the morning fire on the roof was extinguished.

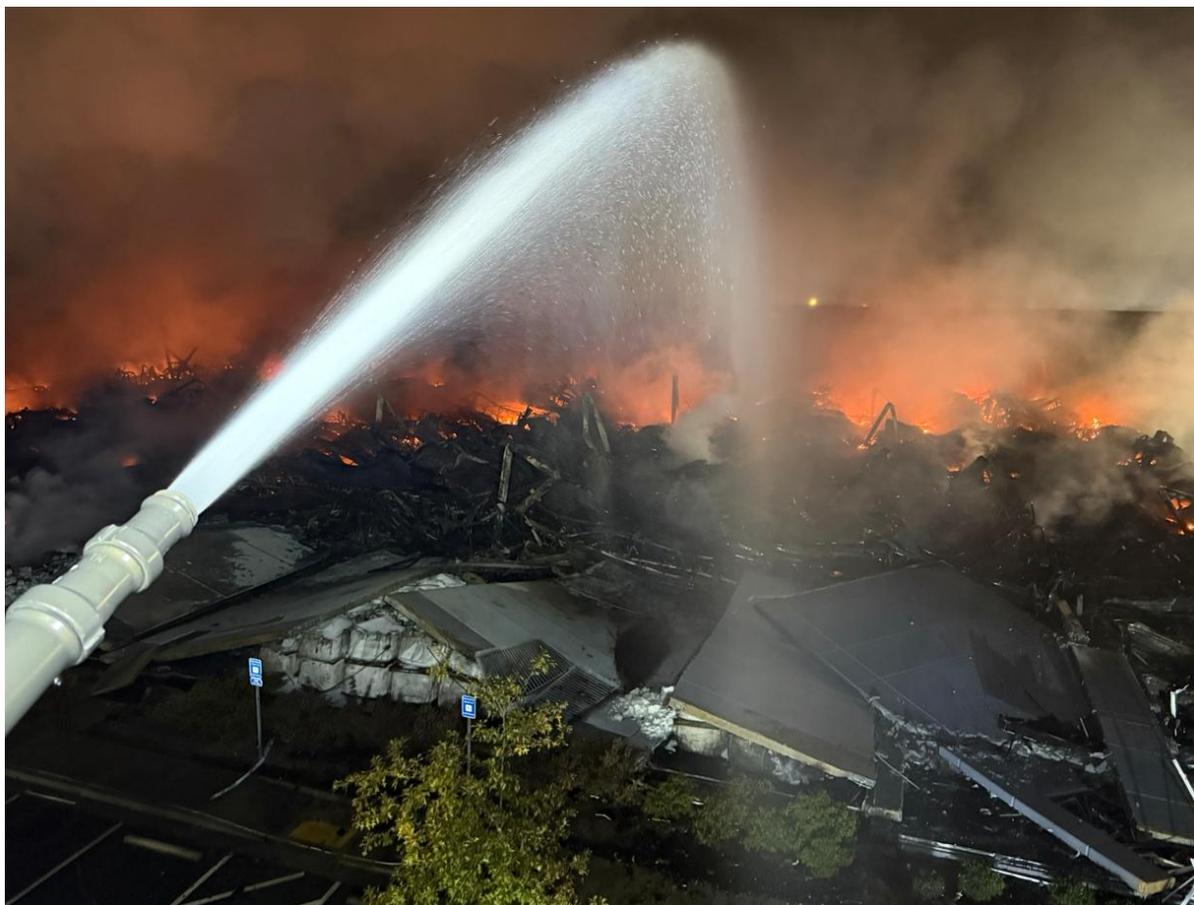
- The fire destroyed the storage warehouse. By approximately 8:00 p.m., the warehouse roof and most of the walls had collapsed, and firefighting efforts transitioned to extinguishing smaller fire hotspots within the building footprint. At this time, the number of active fire personnel was reduced, and additional excavation support was requested at the site.<sup>a</sup> As shown in **Figure 6**, the purpose of the additional excavation equipment was to allow workers to bring down the remaining damaged wall sections for safety reasons, and to move structural debris within the building footprint to allow emergency response personnel access to extinguish fire hotspots and reacting product within the building debris throughout the night. These activities were focused on controlling the impacts to the community from the ongoing release of fumes from within the building debris. **Figure 6** depicts the hotspots of fire and off-gassing from the super sacks and materials trapped under the building debris during the evening of September 29, 2024.

**Figure 6.** Hotspots of fire and off-gassing from super sacks and materials trapped under building debris, the evening of September 29, 2024. (Credit: Rockdale County Fire Rescue)

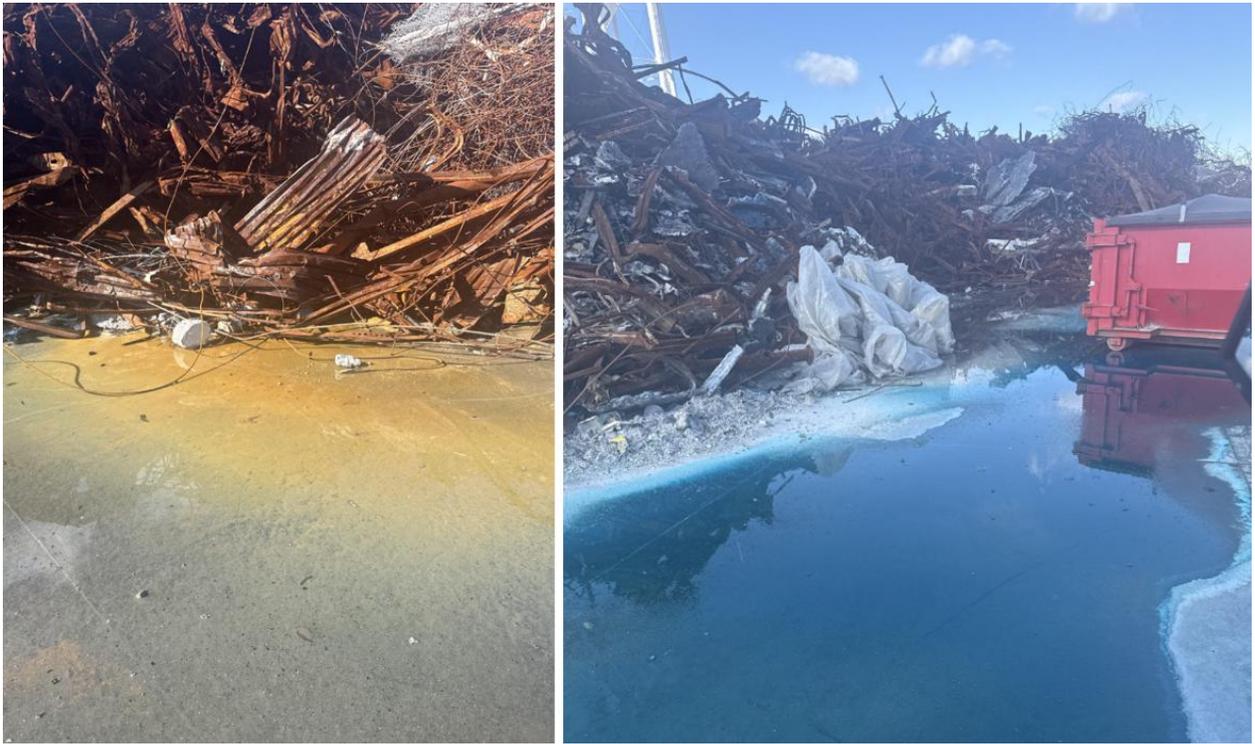
**Figure 7.** Surface water runoff of metals from rusting structural debris (left) and residual chemicals (right) on the former warehouse's concrete slab (Credit: Bio-Lab).

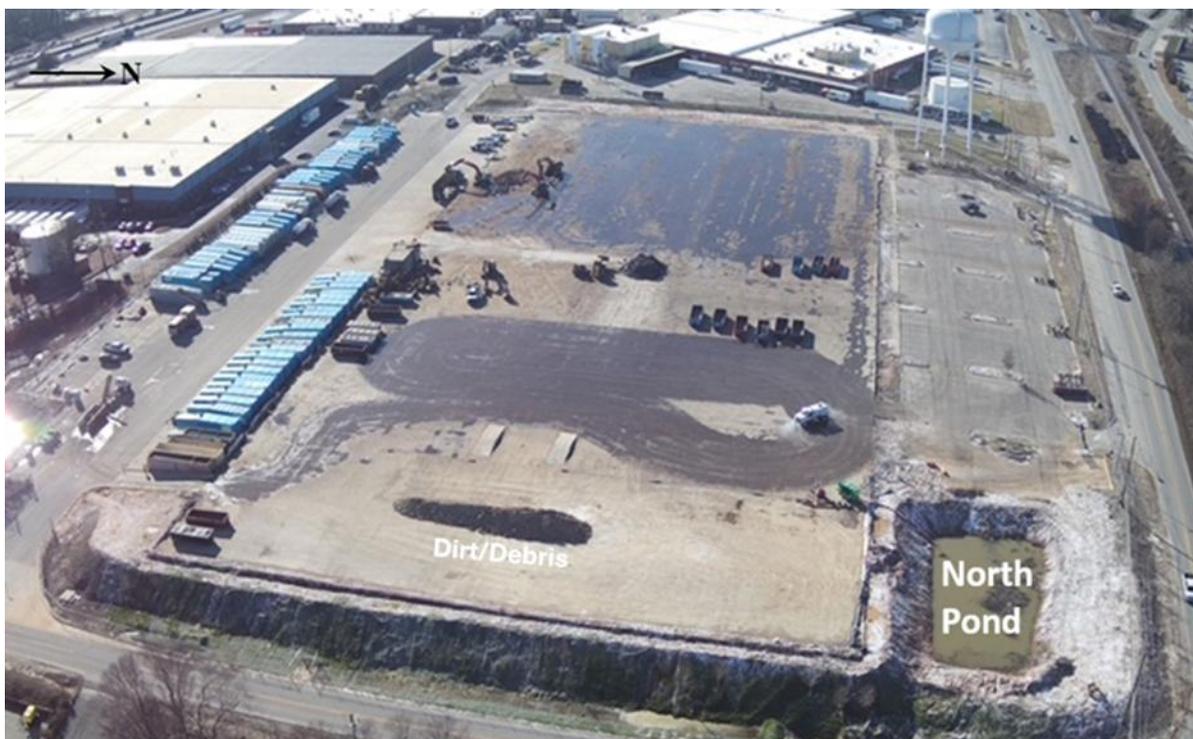
- After the immediate firefighting response phase of the incident, the emergency response transitioned to a phase of establishing and implementing a controlled demolition of the warehouse to remove the remaining chemicals and structural components for safety and environmental concerns under a Unified Command. This second emergency response phase ended on October 17, 2024.
- Bio-Lab and KIK continued to clean up and remediate the incident scene where the warehouse was located to eliminate off-site contamination and environmental risks from surface water runoff containing metals and other chemicals released from the debris (**Figure 7**), at the request of the Georgia Environmental Protection Division. The Bio-Lab warehouse involved in the September 2024 incident has been demolished (**Figure 8**).

**Figure 8.** Concrete slab where the warehouse was located before the 2024 Conyers incident. (Credit: Bio-Lab)
