Explosion, Molten Salt Eruption, and Fatal Injury at TS USA Liquid Nitriding Facility

Chattanooga, Tennessee | Incident Date: May 30, 2024 | No. 2024-01-I-TN

Investigation Report

Published: June 2025

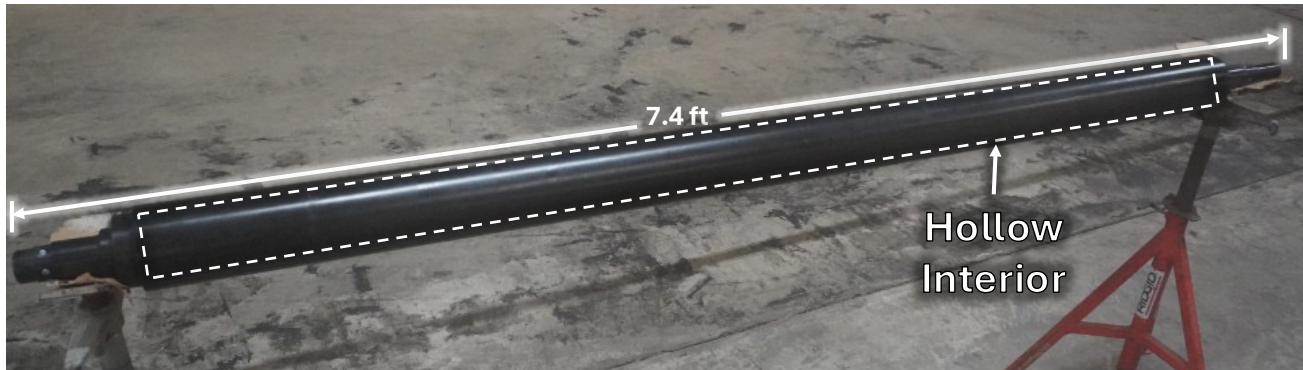
During the incident, TS USA was processing cylindrical metal parts, called rollers. The rollers were constructed of 316 stainless steel and were approximately 7.4 feet (2.3 meters) long. The rollers had an approximately 5-inch (120-millimeter) outer diameter and contained a 4-inch (100-millimeter) cavity through the largest diameter portion, as shown in **Figure 4**. The cavity was enclosed by press fit inserts at each end that contained five blind holes, which are holes that are not drilled entirely through the material [12, p. 95]. The press fit insert also had

Figure 4. Metal roller containing a cavity that TS USA processed during the incident. The annotated area is approximate. (Credit: CSB)

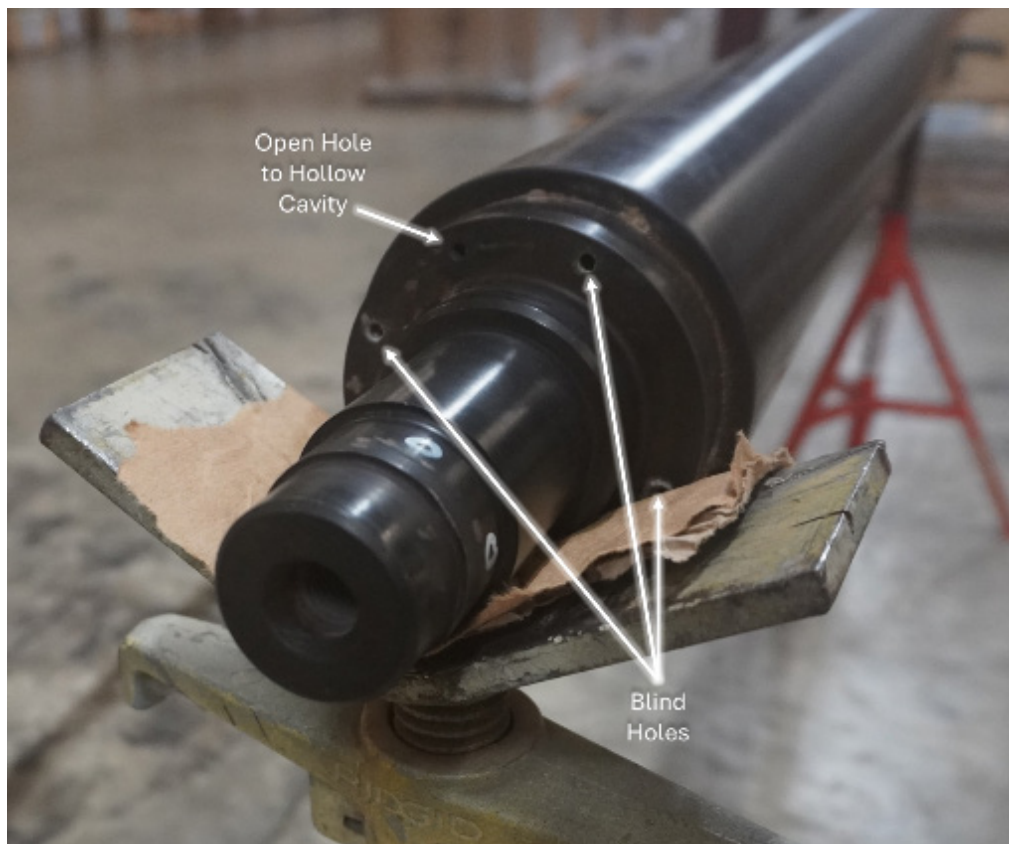
an approximately 0.2-inch (5-millimeter) diameter hole on either end of the roller that penetrated to the cavity interior, as shown in **Figure 5**. There were no other openings to the interior cavity.

Figure 5. Open hole to the interior cavity on rollers. (Credit: CSB)

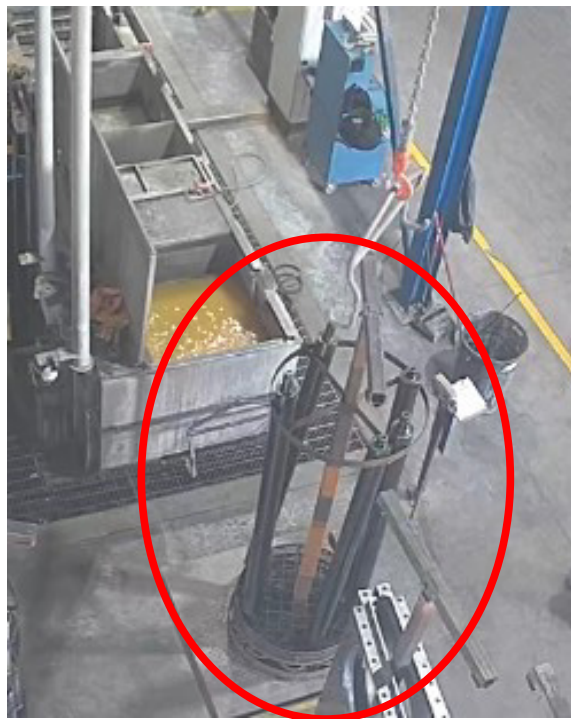
On May 24, 2024, at approximately 11:36 a.m., the remaining five rollers began the nitriding process. The rollers were placed in a metal cage, called a fixture, to secure the parts as they were moved and submerged in different steps of the nitriding process (**Figure 7**).

Figure 7. Five rollers are placed in the fixture.
(Credit: TS USA, annotated by CSB)

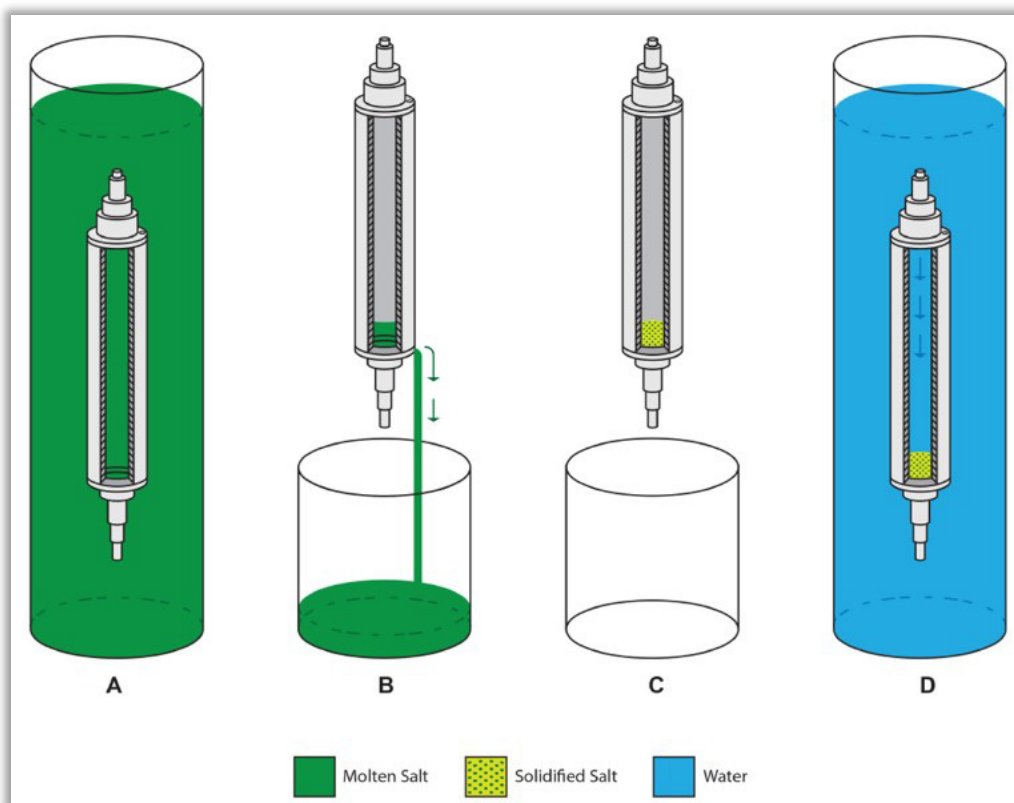
The rollers were then fully submerged in the hot water rinse tank to remove residual salt from the parts. The water from the hot water rinse tank entered the rollers' cavities through the five-millimeter drain holes on the top of the roller (**Figure 10.D**). The water was unable to freely flow through the one roller because of the solidified salt plug. The lack of flow significantly decreased the rate at which the salt dissolved, trapping the solidified salt and water inside the cavity of the roller.

Figure 10. Sequence of events: A) Molten salt enters the roller. B) Molten salt incompletely drains from the roller. C) Molten salt solidifies in the roller. D) Water enters the roller and cannot exit. (Credit: CSB)

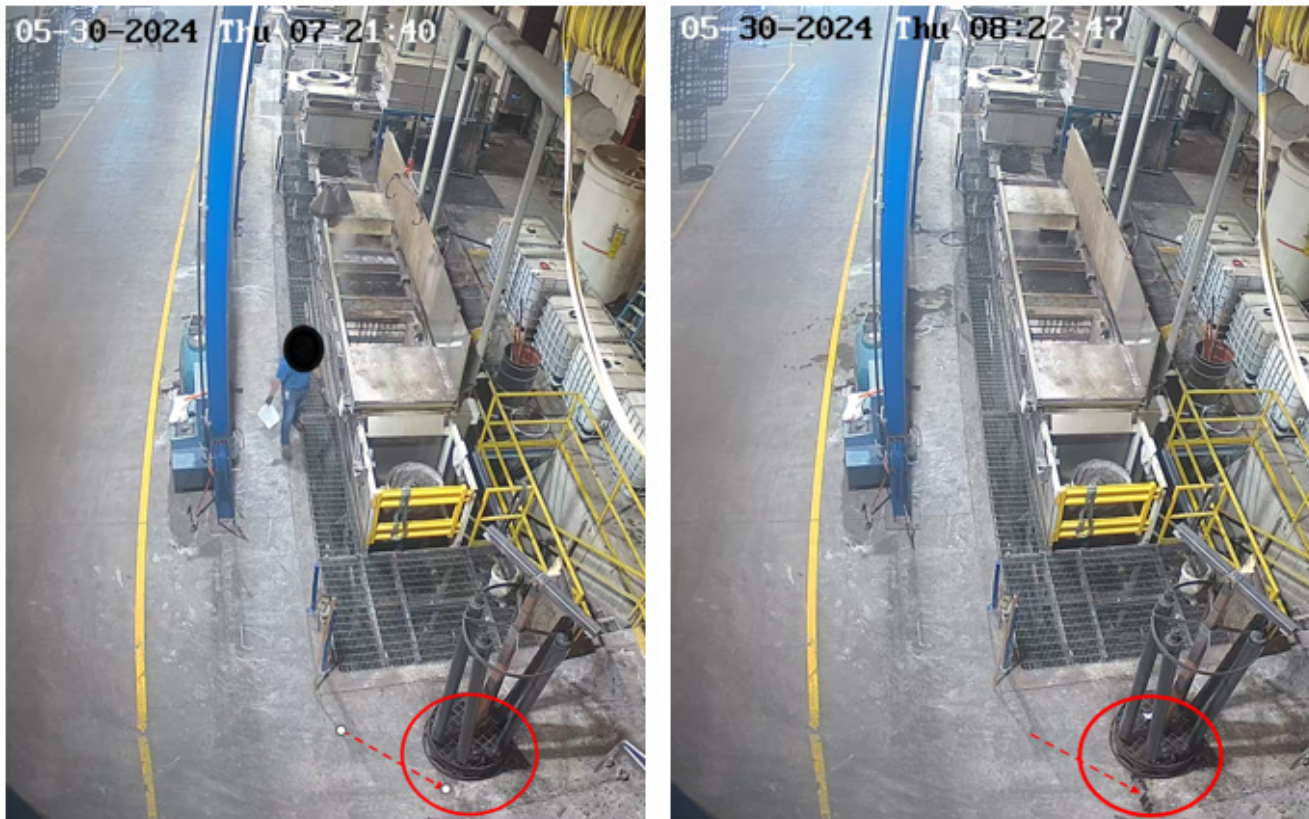
After the rollers had cooled for over an hour, the plant manager and supervisor observed that at least one roller was too hot to continuously touch. The one roller that was unable to drain likely remained hot due to the retention of water in its cavity. Since the manager and supervisor were unable to continuously touch the roller (**Section 2.2**), the surface temperature likely exceeded 140°F because metal surfaces greater than 140°F can cause immediate burns [13, pp. 4-5] [14].

Figure 11. Rollers at the end of the nitriding line. On the left, the rollers are sitting on a concrete floor at the end of the process line with no visible water draining. The photo on the right shows water that had drained from the roller an hour later. (Credit: TS USA, annotated by CSB)

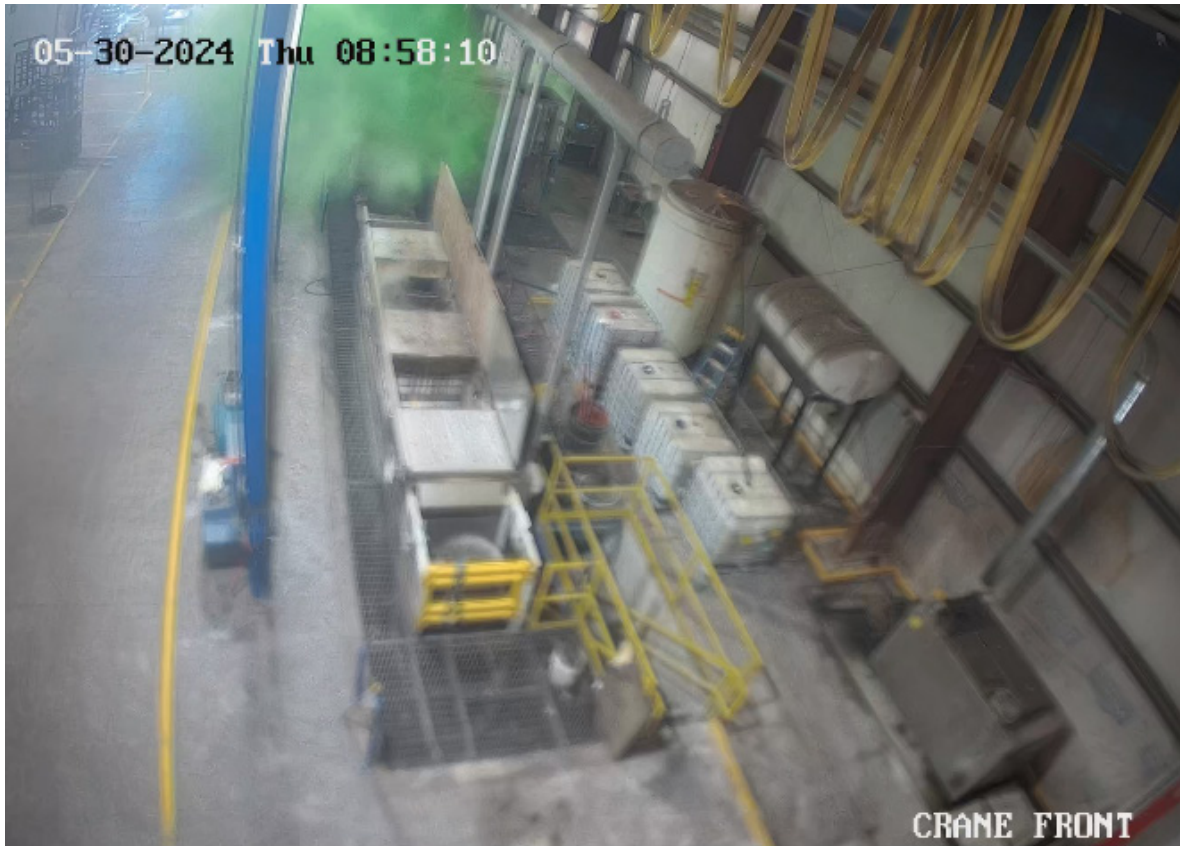
By 8:54 a.m., the rollers were submerged in the oxidizing tank. Approximately two minutes later, as the rollers began to heat up, steam began to vent from one of the submerged rollers and intensified as the line operator raised the rollers from the oxidizer bath. At 8:58 a.m., the chemical mixture inside the oxidizing tank erupted (**Figure 12**), releasing hot molten salt into the process area and engulfing the line operator, resulting in second- and third-degree chemical and thermal burns over 95 percent of his body. The line operator was treated on-site by Chattanooga Fire Department (CFD) personnel who were called to the facility and then was transported by

Figure 12. Molten oxidizing salt erupting from the oxidizing tank. (Credit: TS USA)

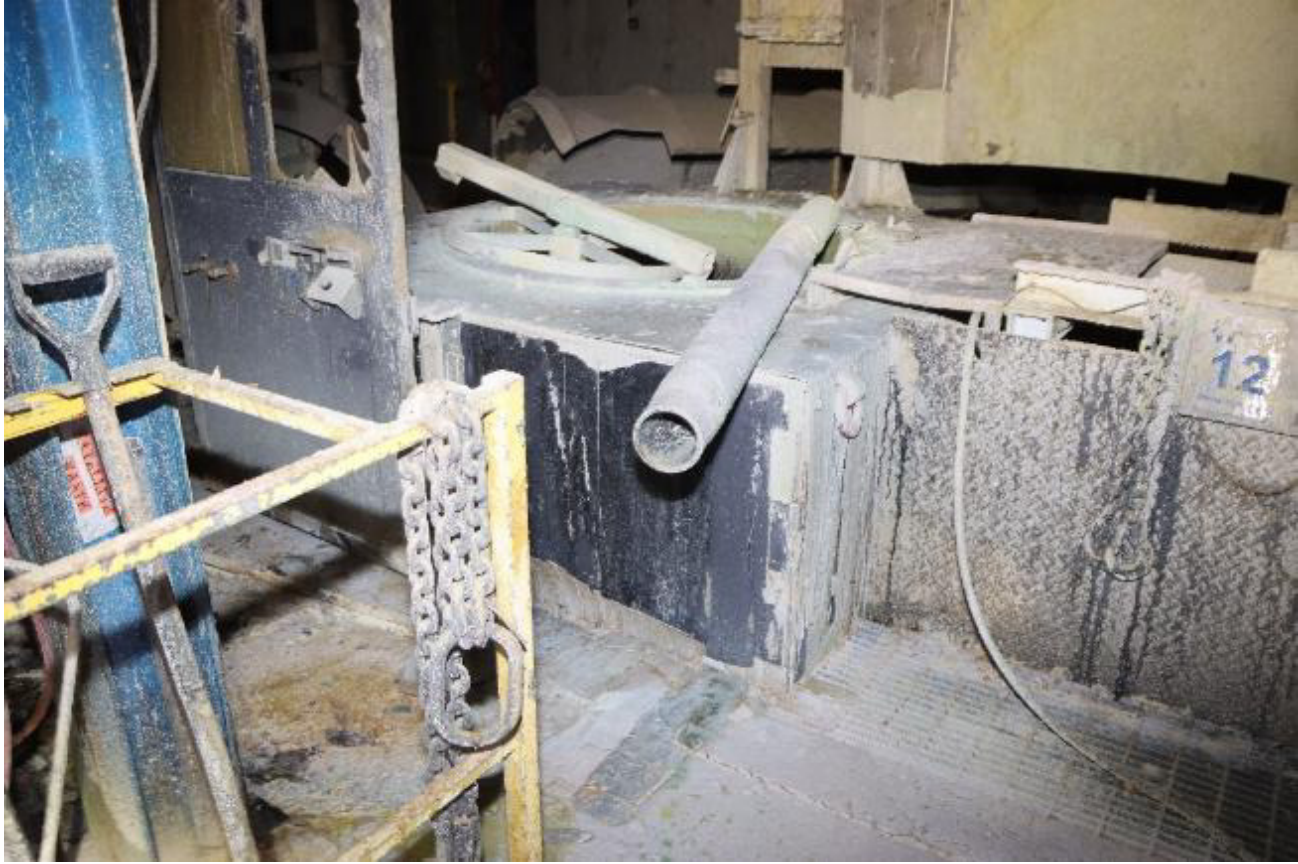
Following the incident, the plugged roller (**Figure 13**) was found outside of the oxidizer vessel, indicating that it was propelled from the vessel due to the release of the steam. Damage to the overhead crane indicated that the roller had contacted the equipment approximately 20 feet above.

Figure 13. Roller in its final resting state following the explosion, with a missing press fit end. (Credit: TS USA)

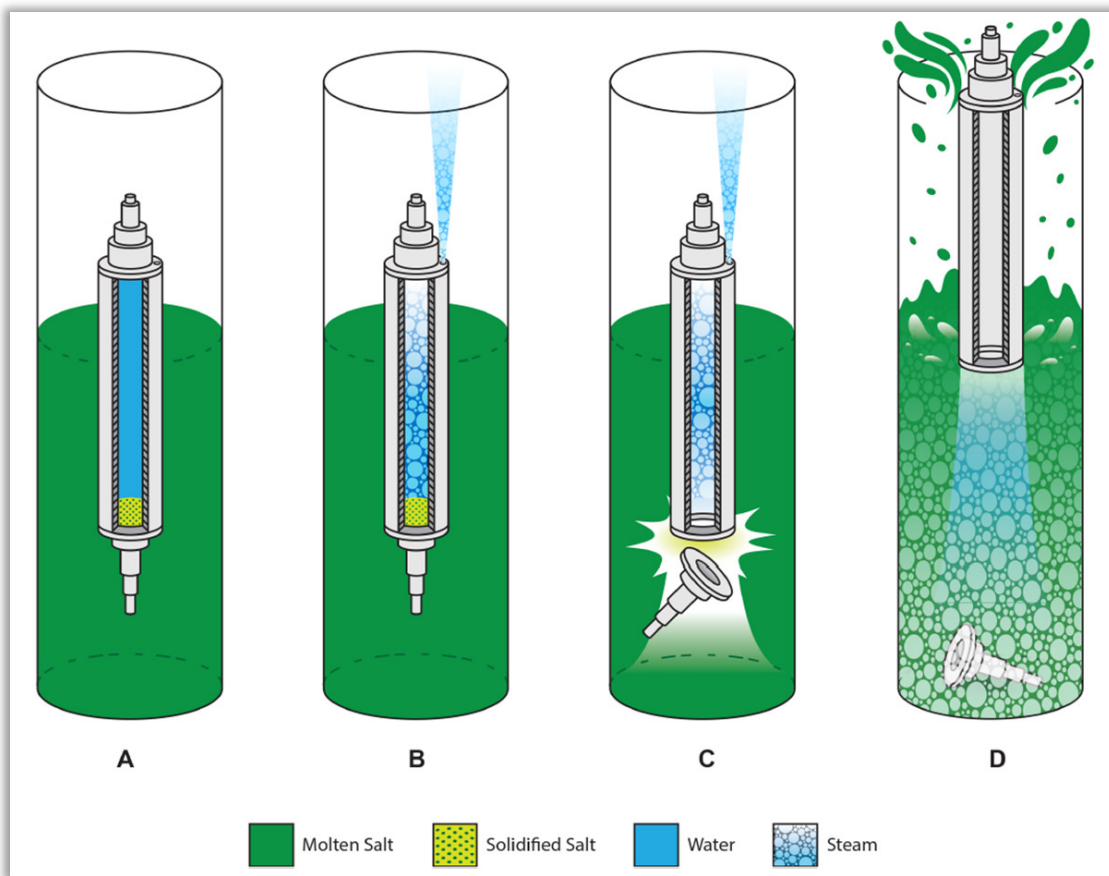
the rapid vaporization of water, also known as a vapor or steam explosion.^a The rapid expansion of the steam displaced the molten salt in the oxidizer bath, resulting in molten salt erupting from the vessel (**Figure 14.D**).

Figure 14. Sequence of events of the overpressure: A) The roller is placed in the molten salt bath. B) Water boiled and vented from the roller. C) Overpressure caused the press fit end to dislodge. D) Rapid expansion of steam and molten salt eruption. (Credit: CSB)

The CSB concludes that the retained water boiled inside the roller's cavity and rapidly expanded as steam. The increased pressure forcefully ejected the roller's press fit end, the salt plug, and the water into the molten salt bath. The water rapidly boiled, creating a violent steam explosion that drove an uncontrolled eruption of molten salt from the vessel.

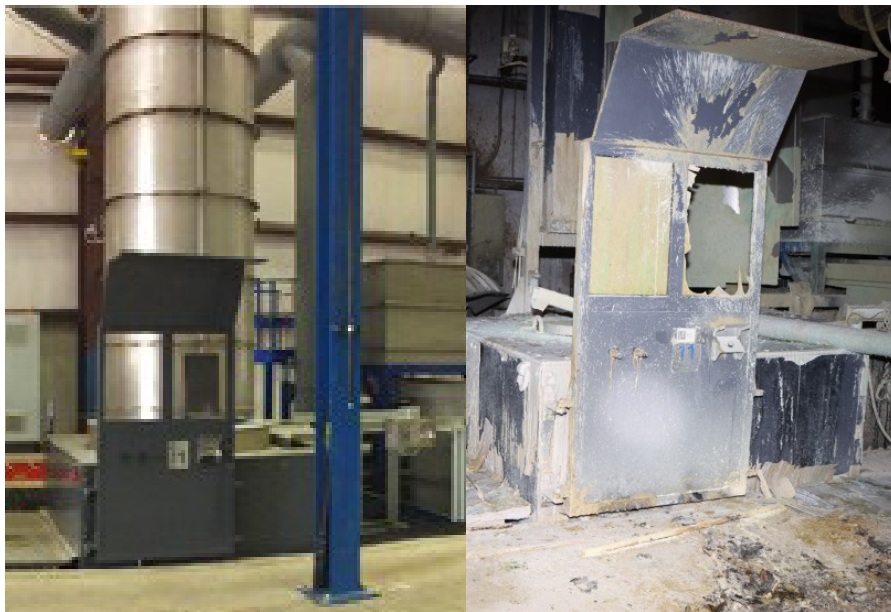
At the time of the incident, the line operator was behind the barrier when the molten salt eruption occurred. The line operator was engulfed in the molten salt as it erupted from the oxidizer bath. The barrier did not protect the line operator from the eruption. Furthermore, the viewing window melted due to exposure to the molten salts.

Figure 17. Protective barrier at the oxidizer bath, pre-incident (left) and post-incident (right). (Credit: TS USA)

The CSB concludes that the additional passive engineering controls in place at the Chattanooga facility were insufficient to protect the line operator due to the severity of the eruption of molten salt, which was more significant than the installed barrier was designed to withstand and protect against.

The CSB recommends that TS USA implement physical, protective barriers around the molten salt baths that isolate the employees from hazardous releases at all TS USA locations that perform liquid nitriding.

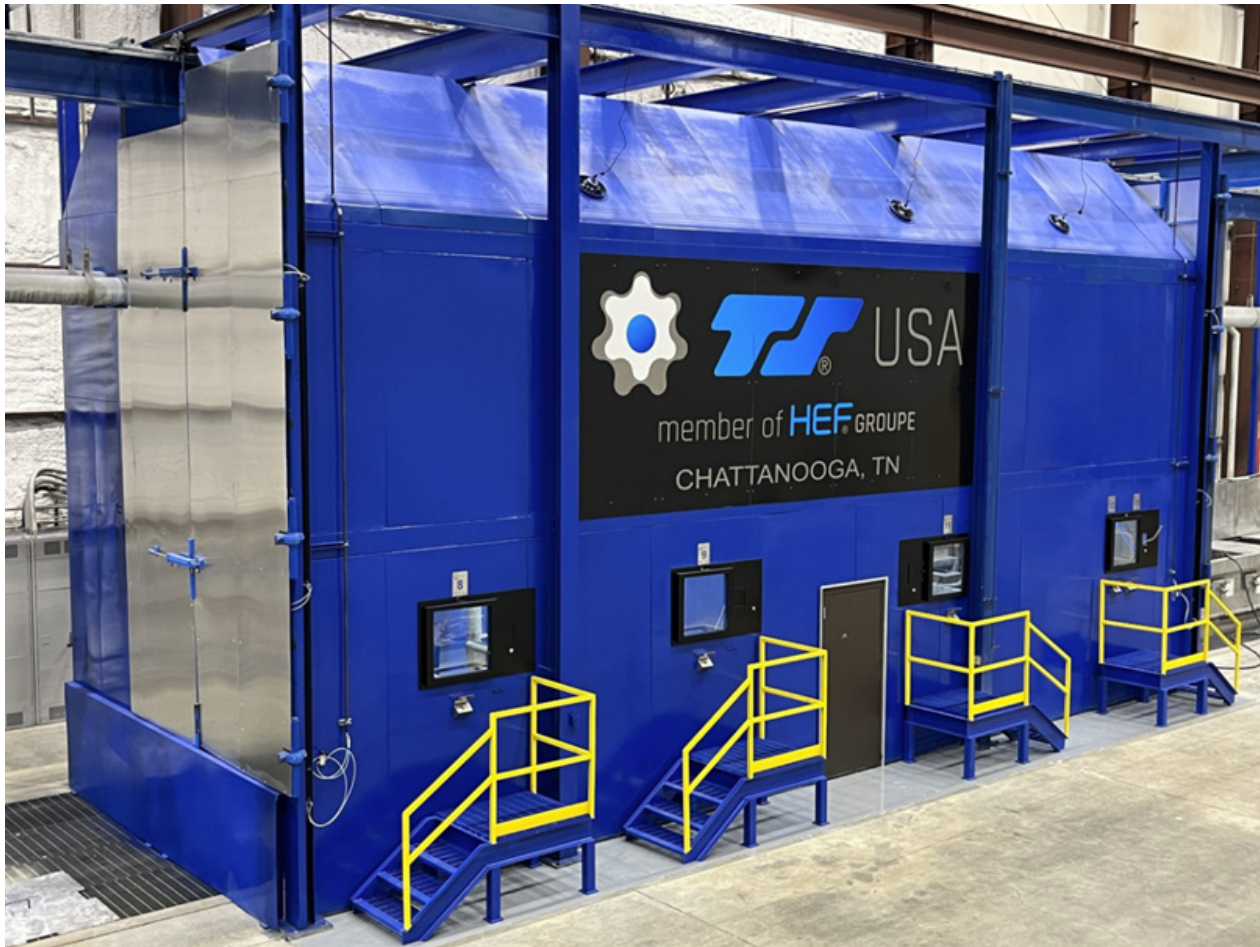
Following the incident at Chattanooga, TS USA constructed an enclosure (**Figure 18**) around the nitriding and oxidizer baths. This enclosure is intended to limit access to the molten salt baths and protect against loss of containment or an eruption of the molten salts. This enclosure, which has only been installed at the Chattanooga facility, provides a barrier from the molten salt while parts are in the nitriding and oxidizer baths. The enclosure is fully encapsulated and could prevent an eruption of molten salt from contacting any employees outside of the barrier.

Figure 18. Enclosure installed at the TS USA Chattanooga facility after the incident. (Credit: TS USA)

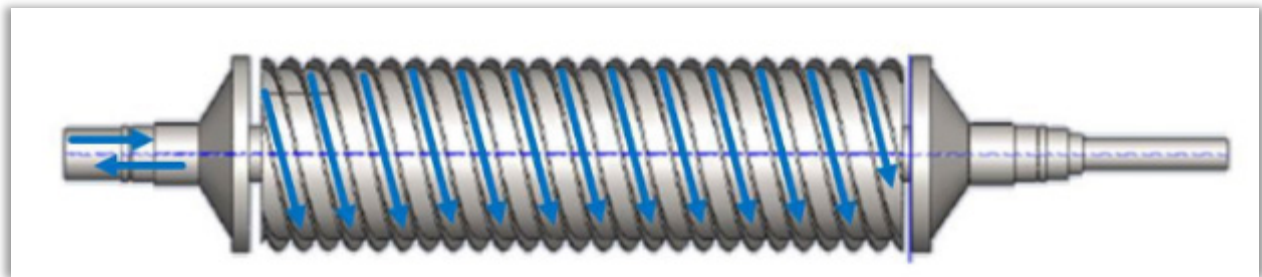
On January 25, 2018, an explosion occurred at a TS ETSA facility in Aguascalientes, Mexico, that injured three workers and caused serious damage at the facility. TS ETSA was hired to treat an 8-foot (2.3-meter) long cylindrical roller with an 18-inch (450-millimeter) outer diameter, and an internal coil that spiraled through the center (**Figure 20**). This roller was designed so that a fluid could cool the roller while it was operating.

Figure 20. A diagram of the roller involved in the Mexico explosion. (Credit: TS ETSA)

On the day of the incident, a cap was placed over the end where the fluid could enter and leave; however, TS ETSA's investigation found that the cap was not correctly placed over the opening. TS ETSA positioned the roller so that the capped end was facing downward when it was hooked up to the crane. The roller was then processed through the degreasing, cleaning, and rinse baths; water likely entered the roller during the rinsing step. The roller was then sent to the preheating step. TS ETSA measured that the roller reached a temperature of approximately 400°F during preheating.

The explosion ejected molten salt from the bath and launched the roller across the facility, where it impacted several areas, destroyed the nitriding salt bath's furnace, cracked a wall at the facility, deformed the crane's support structure, destroyed the crane's hoist, and tore a hole in the roof. In addition to the damages caused by the launched roller, the ejected salts damaged the electrical control boards at the facility and sprayed onto the building's roof and onto the roofs of neighboring buildings. The ejected salt contacted three employees, causing first- and second-degree burns and eye damage.

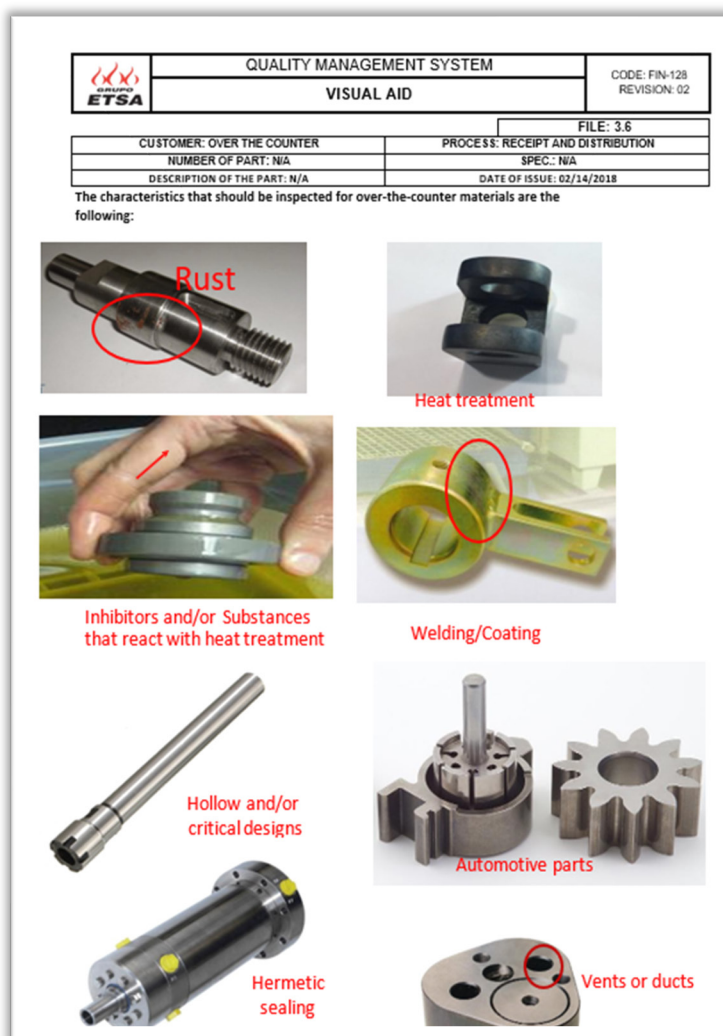
Figure 21. The visual aid created by TS ETSA for part inspections. (Credit: TS ETSA, translated by the CSB)

TS ETSA investigated the incident and developed a formal report detailing the incident, causal factors, and corrective actions. TS ETSA determined that the cause of the incident was that a part with an accumulation hazard was allowed to be processed in the liquid nitriding line. As part of TS ETSA's corrective actions, a pre-processing inspection is now required at the facility before parts are allowed to be processed, and a visual aid was created to help employees with the inspection (**Figure 21**). The visual aid showed operators specific items to look for during the inspection, such as hollow cavities, welds, or sealed parts.

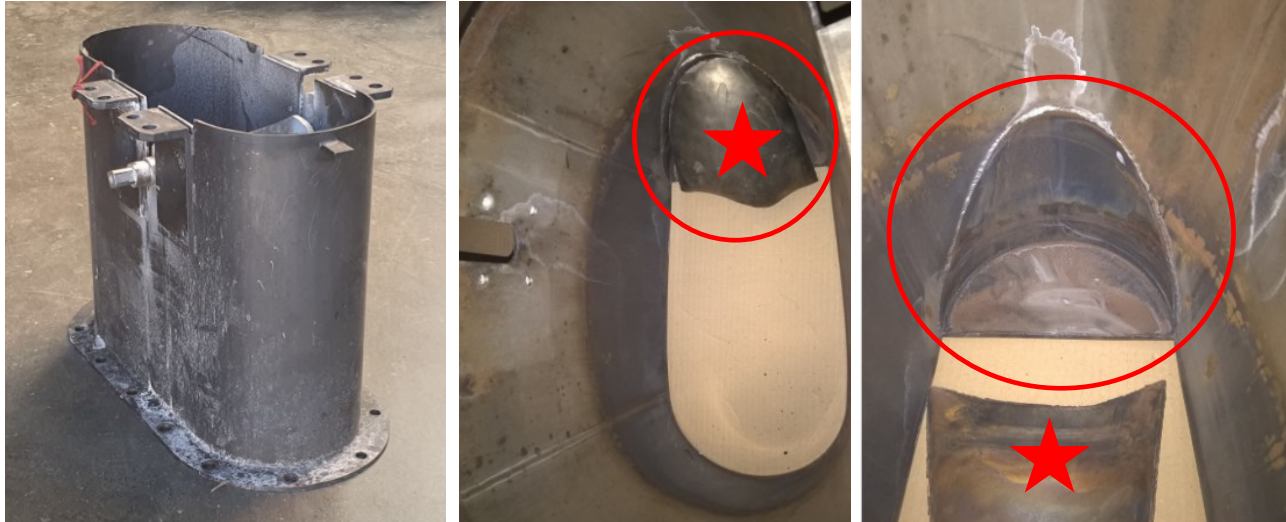
In May 2020, an incident in which molten salt was ejected from a nitriding bath occurred at the TS REW facility in Valentigney, France, although no injuries resulted from the incident. TS REW was treating a part. The part was approximately 14 inches (360 millimeters) tall, 22 inches (550 millimeters) long, and 9 inches (240 millimeters) wide. The part had a welded, sealed cavity that was filled with air (**Figure 22**).

Figure 22. The part with a sealed cavity in the part involved in the 2020 incident at the TS REW facility in France, staged to show the location of the void (circled) and how the explosion separated the cavity (star). (Credit: TS REW, annotated by CSB)

The part went through the preparatory steps and was introduced to the nitriding bath. As the part was entering the bath, the air trapped in the cavity began expanding due to the high temperature. As the trapped air expanded, the pressure increased until the weld failed, and the pressure was relieved in an overpressure explosion (**Section 3.2**). This increase in pressure happened rapidly as the part was only able to be submerged halfway before the explosion occurred. The incident resulted in salt being ejected from the nitriding bath. No one was injured during this incident.

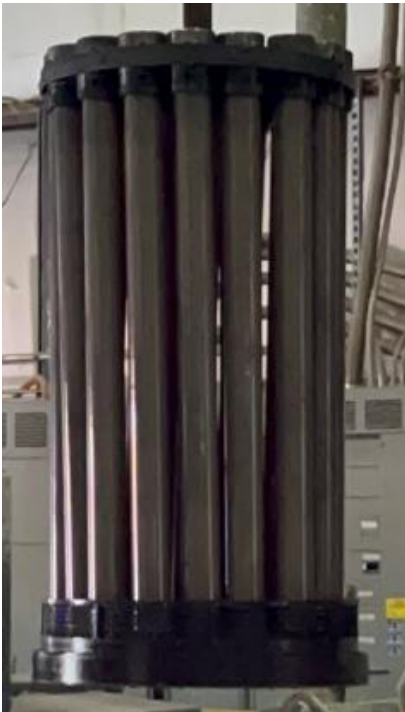
On the day of the incident, a cap was placed over the top of the cylinder. However, there were still holes in the bottom of the cylinder that allowed molten salt to enter the space. The cylinder was passed through the initial rinsing and degreasing steps in the liquid nitriding process. After the initial steps were completed, the cylinder was placed in the nitriding salt bath, which was approximately 1,100°F. The cylinder was then moved to the 800°F oxidizing salt bath. Shortly after, molten salts were ejected from the oxidizing salt bath. Some employees described it as an explosion event, while others stated that the salt just foamed and overflowed out of the oxidizing salt bath. No one was injured during this incident.

Figure 23. The hydraulic cylinders involved in the 2023 explosion in Chattanooga, Tennessee. (Credit: TS USA)
