## Investigation Update

March 2026

This document provides an update on the CSB's investigation of the October 10, 2025, incident at Accurate Energetic Systems, LLC.

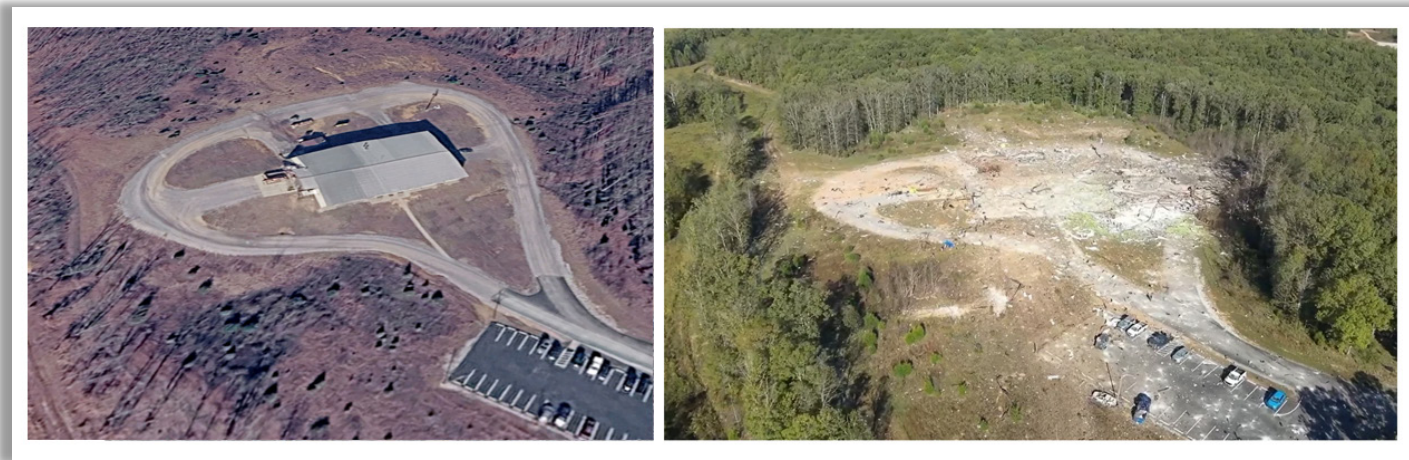
On October 10, 2025, at 7:47 a.m., multiple catastrophic explosions fatally injured 16 employees at the Accurate Energetic Systems, LLC ("AES") facility in McEwen, Tennessee (**Figure 1**). Another employee was seriously injured in the incident, and six additional employees reported injuries. The incident occurred in a building used to manufacture commercial explosive products. The explosions razed the building and launched debris up to 700 feet [1]. The blast reportedly was felt more than 20 miles away. At the time of the incident, approximately 24,600 pounds of explosives were in the building, approximately 23,000 pounds of which were consumed in multiple detonations. Roughly 1,000 pounds of unexploded energetic material that had been launched from the building were recovered on-site and subsequently disposed of by burning it on-site.

**Figure 1.** Incident building before (left) and after (right) the October 10, 2025, incident. (Credit: Google Earth (left); WZTV Nashville [2] (right))

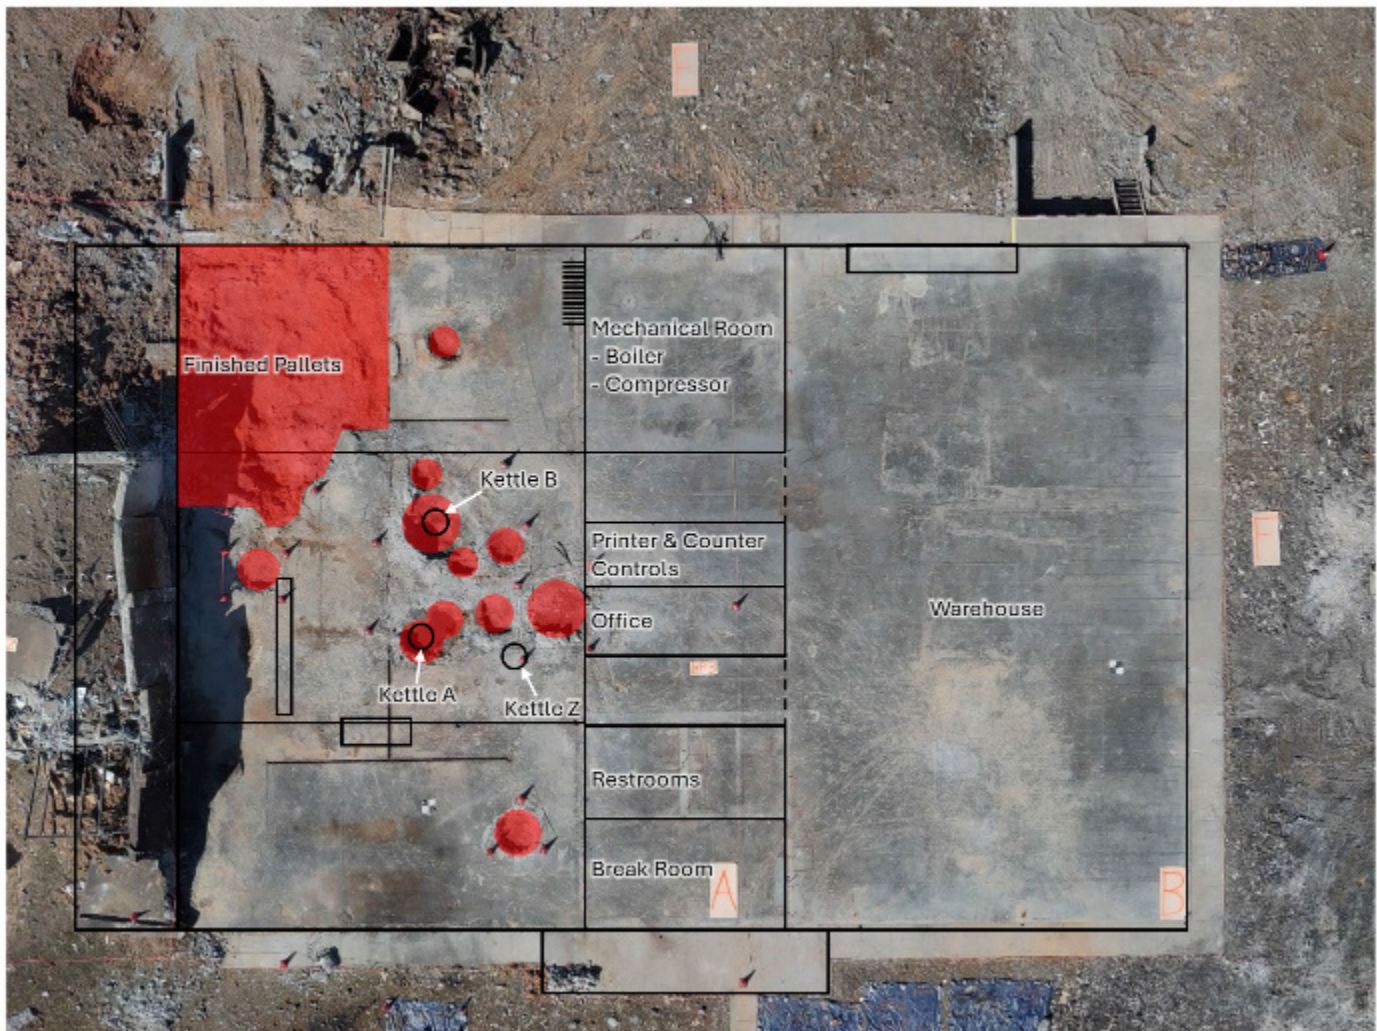
- Following the incident, Building 602's foundation was cleared to reveal damage and craters, indicating the locations where high explosives detonated in the building at the time of the incident (**Figure 9**).

**Figure 9.** Building 602's foundation after the incident with walls and equipment overlaid. Craters and foundation damage are indicated in red. (Credit: ATF via WKRN [17] with annotations by CSB)

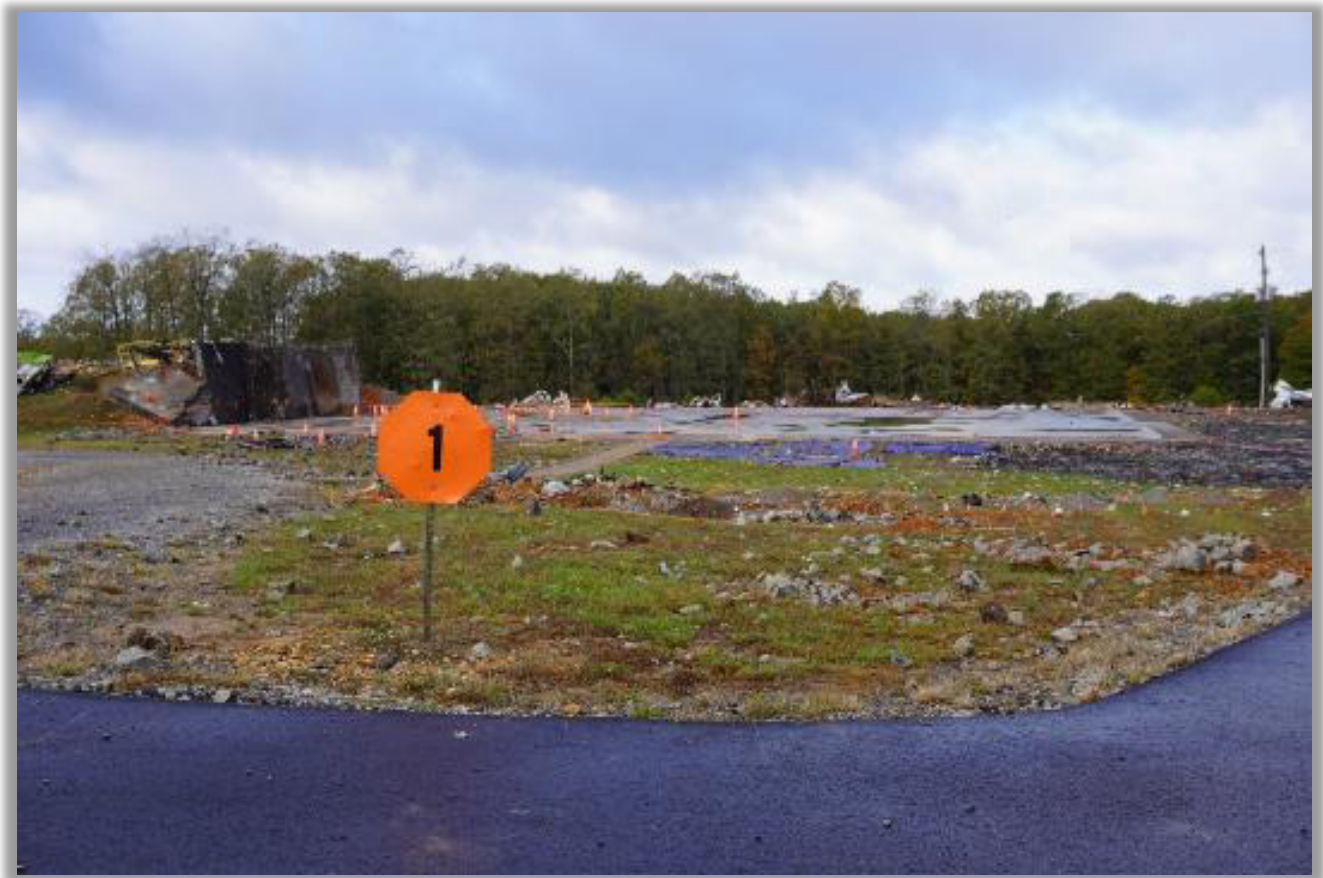
**Figure 10.** Post-incident photo of the Building 602 location after the foundation was cleared.<sup>a</sup> (Credit: CSB)

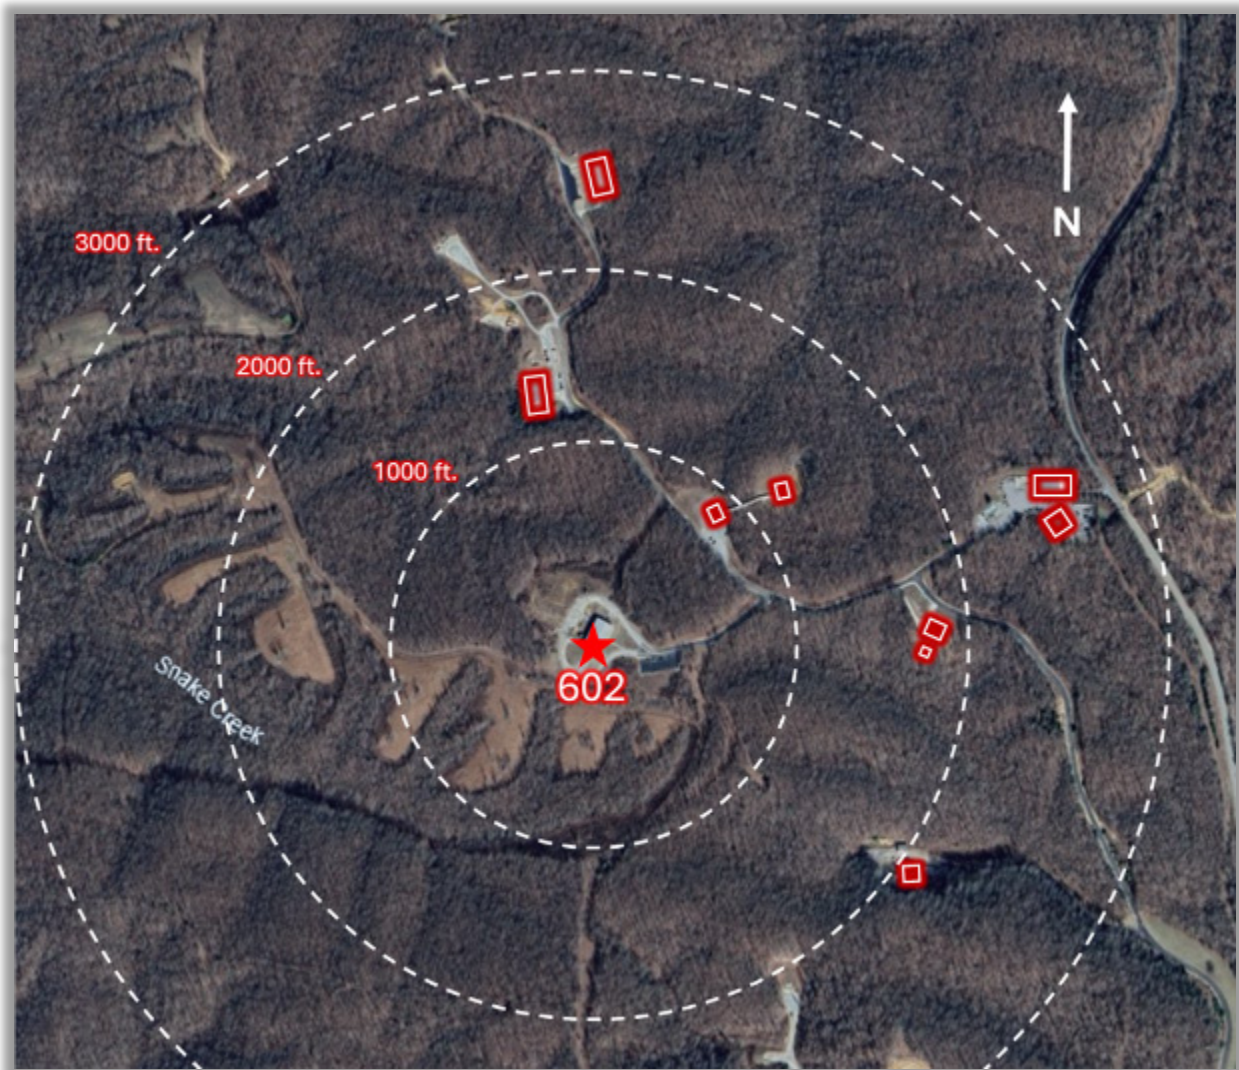
- The Bureau of Alcohol, Tobacco, Firearms, and Explosives (ATF), which responded initially to the incident, recovered approximately 1,000 pounds of unexploded energetic material that was launched from the building. This explosive material was disposed of by burning it on-site [1].
- AES reported to the CSB that the incident resulted in approximately \$4.3 million in property damage. Building 602 was completely destroyed as a result of the incident (**Figure 10**), and nine additional buildings within the AES complex were damaged (**Figure 11**).

**Figure 11.** Map of buildings damaged by the incident. (Credit: Google Earth with annotations by CSB)

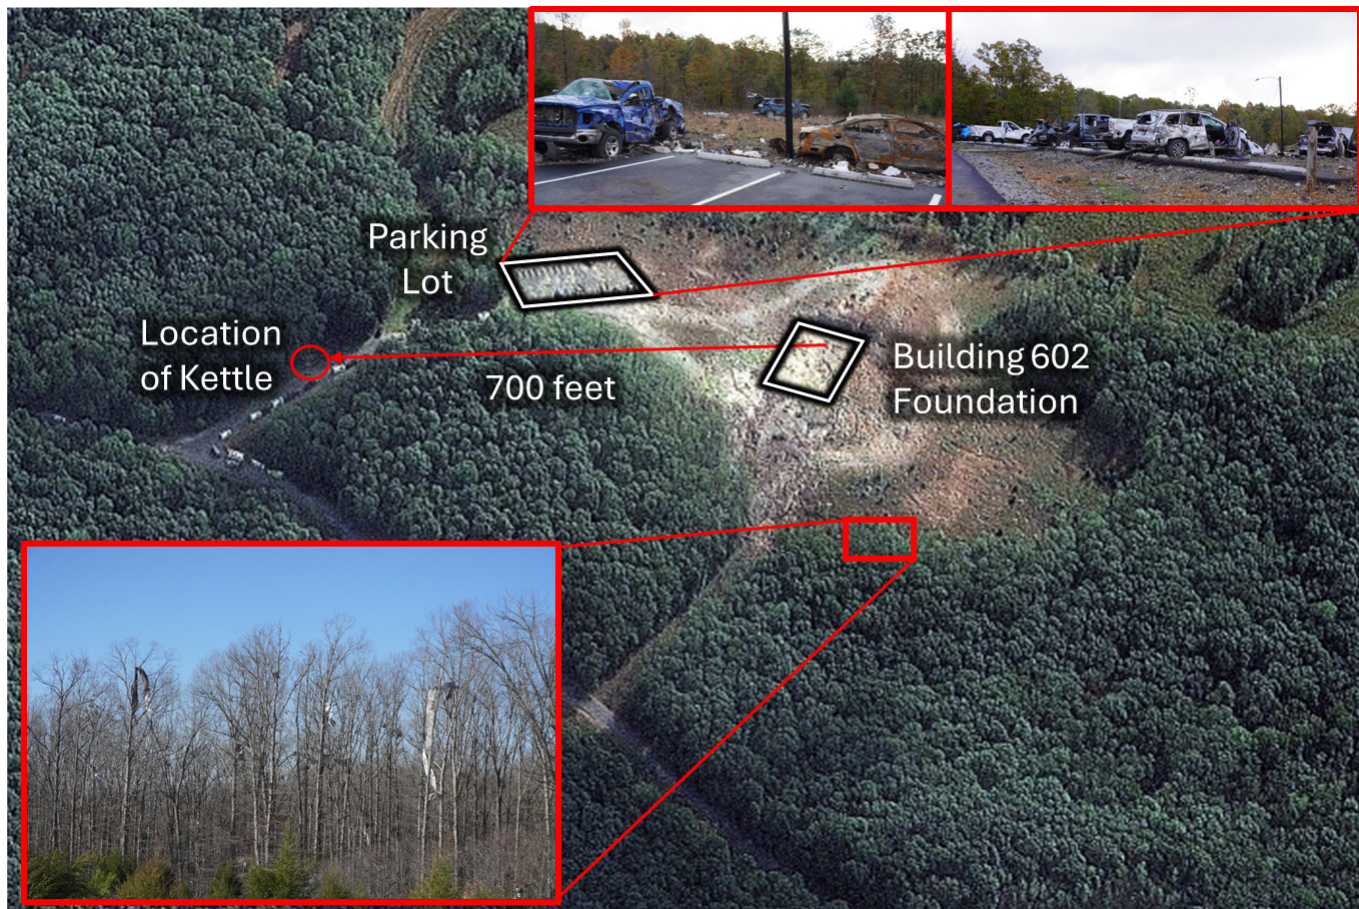
- Debris from the event was propelled over 700 feet from Building 602. At least six of the nine kettles were recovered after the incident. A kettle was found more than 700 feet from the initial location (**Figure 12**). Explosion debris was found scattered throughout the wooded area surrounding the building. The incident destroyed vehicles located in the parking lot, approximately 250 feet from the building (**Figure 12**).

**Figure 12.** Debris locations from the explosion (Credit: WSJ [18], annotations and inset by CSB)
