U.S. Chemical Safety and  
Hazard Investigation Board

# Chemical Decomposition, Fires, and Toxic Gas Release at KIK Consumer Products / Bio-Lab Conyers Facility

Conyers, Georgia | Incident Date: September 29, 2024 | No. 2024-04-I-GA

## Investigation Report

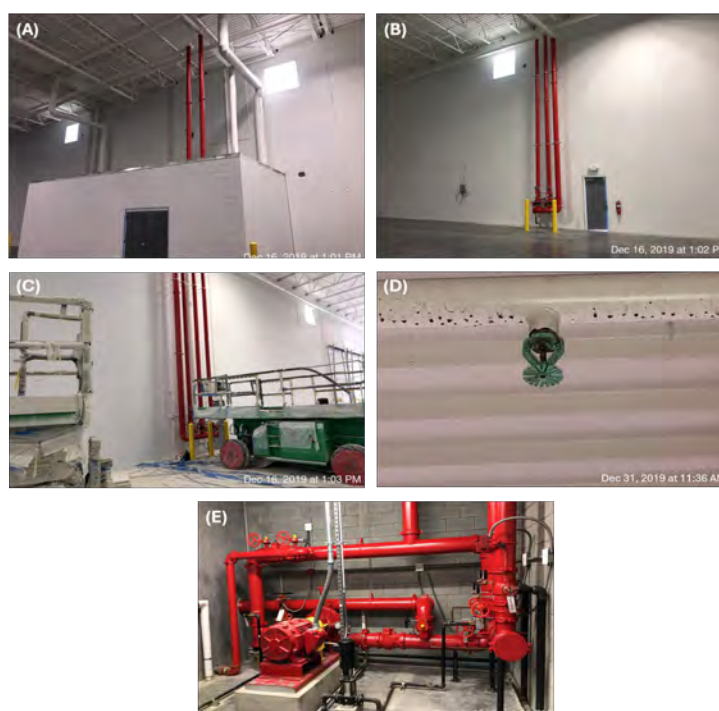
The Plant 12 Storage Warehouse was equipped with an automatic ESFR wet pipe sprinkler system with brass-finish sprinkler heads (**Figure 5D**),<sup>c,d</sup> during the construction of the building in 2019.<sup>e</sup> The system was designed to operate using the municipal water supply at a minimum water pressure of 52 pounds per square inch gauge (psig),<sup>f</sup> and included an additional electric booster fire pump (**Figure 5E**).<sup>g</sup>

**Figure 5.** ESFR sprinkler system installed in the Plant 12 Storage Warehouse, including (A-C) piping in different locations, (D) a corroded brass-sprinkler head, and (E) the fire pump. (Credit: ARCO, annotated by CSB)

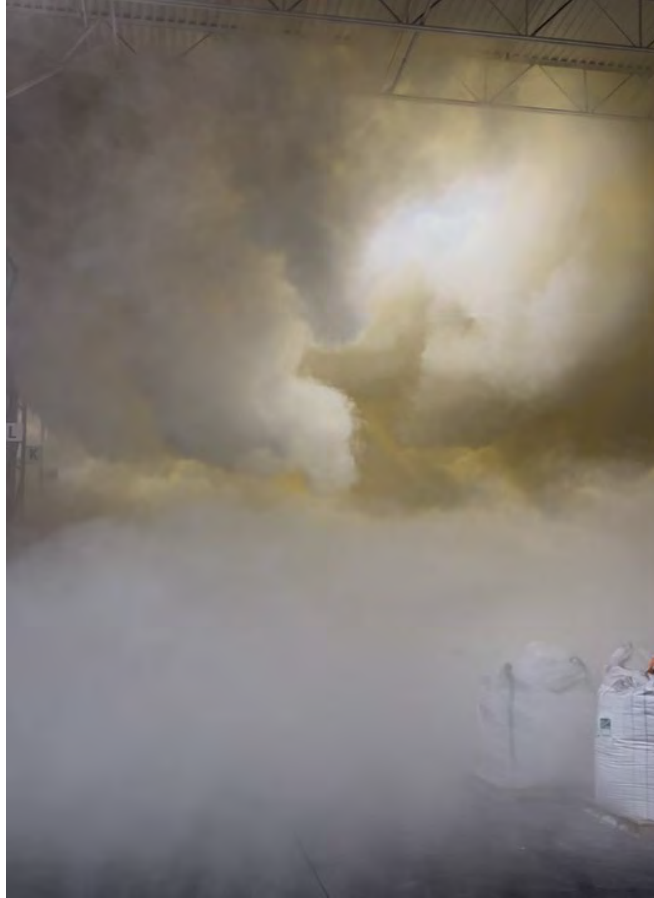
**Figure 17.** Initial off-gassing observed in the warehouse outside the bunker by a KIK employee assigned to fire watch. (Credit: KIK)<sup>a</sup>

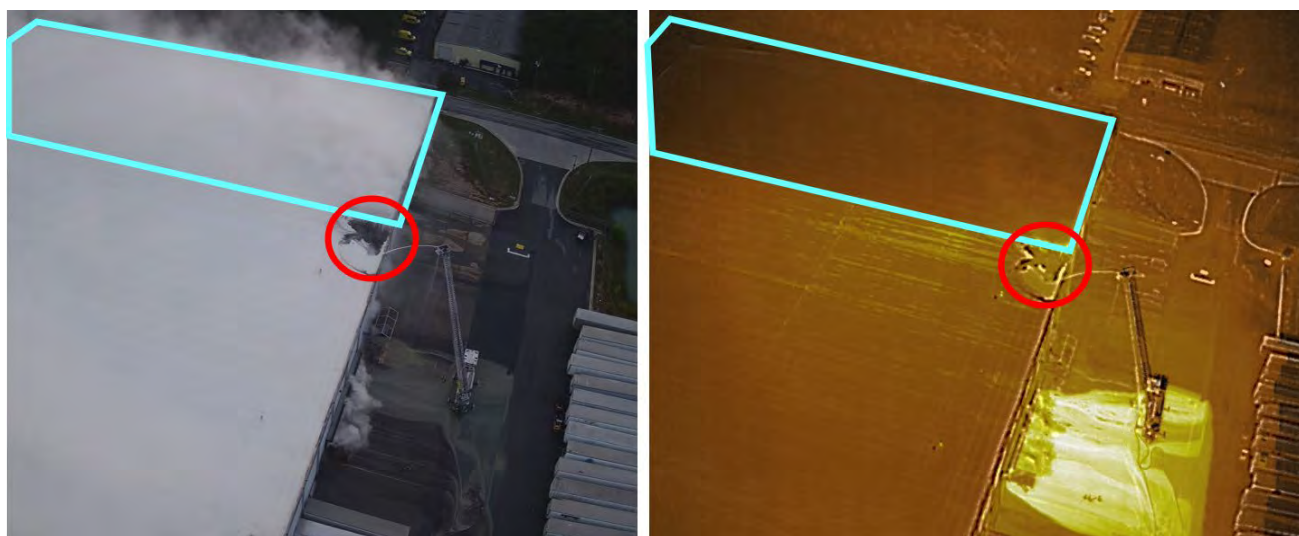
The heat from the fire inside the building was intense enough to initiate a fire on the roof of the building (**Figure 19**). RCFR informed the CSB that the fire on the roof was contained and limited to the roof membrane, which overlayed the metal roof decking. The fire charred and burned the roof membrane, but did not create a hole in the underlying metal roof decking. In **Figure 19**, the bunker is shown outlined in aqua, and the location of the roof fire is circled in red. In the drone thermal image at right, the bunker area is darker in coloration, indicating that the bunker is cooler in temperature than the main warehouse area. **Figure 20** shows the location of the 6:30 a.m. roof fire relative to the interior layout of the warehouse building.

**Figure 19.** Two images showing the roof membrane damage at 8:11 a.m. after the first was extinguished, with the bunker outlined in aqua and the roof damage circled in red. (Credit: RCFR, annotated by CSB)<sup>a</sup>

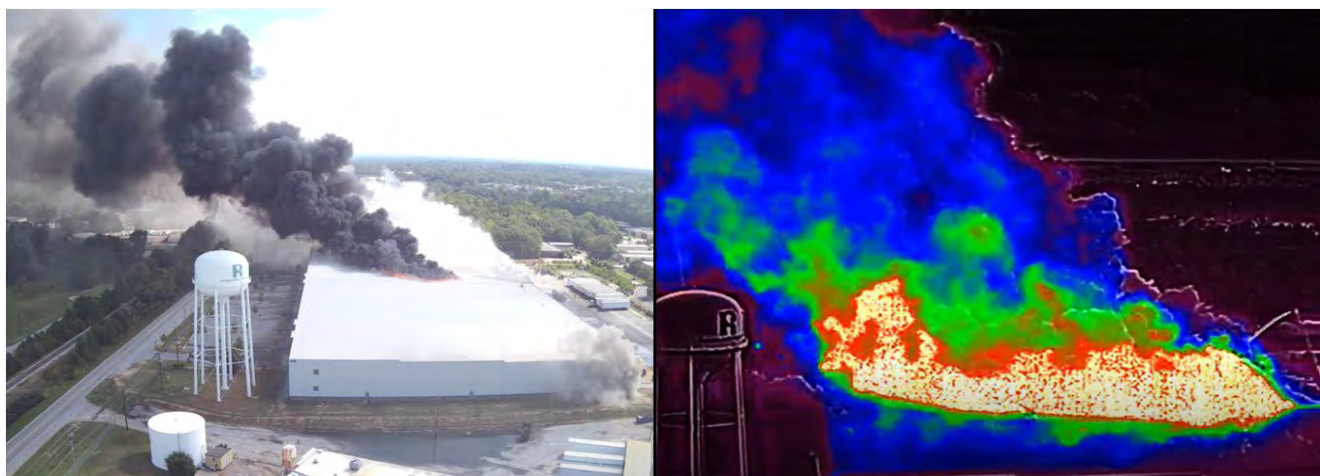
**Figure 21.** Black plume of smoke and fire venting through a large hole in the center of the building's roof (left) and thermal image of building (right) at 12:13 p.m. (Credit: RCFR)<sup>c</sup>

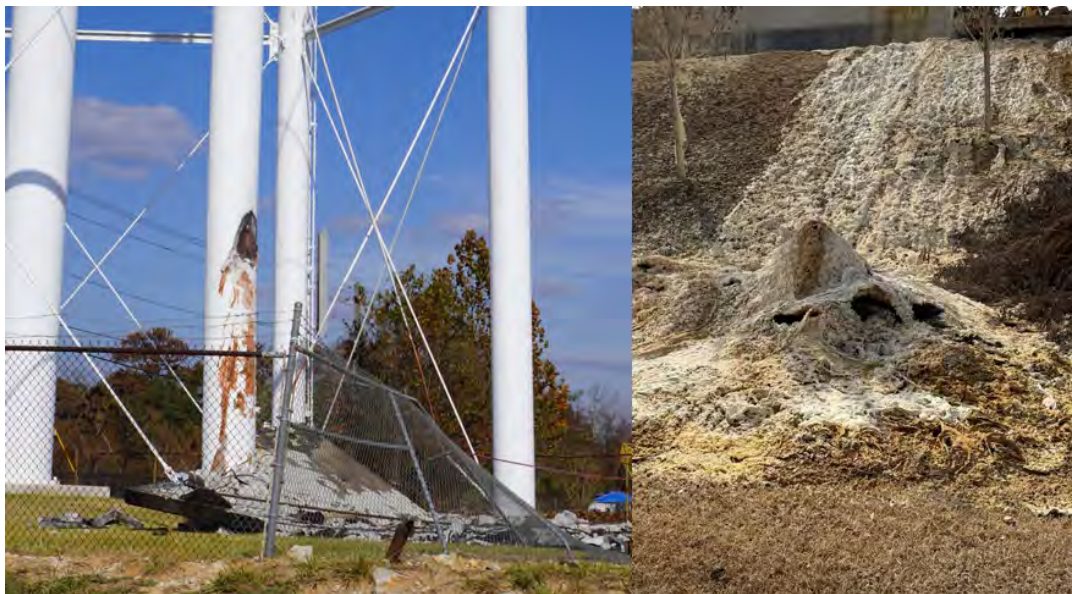
**Figure 24.** Damaged water tower supports struck by falling building walls (left) and reacting chemical material that spilled out after the bunker wall collapsed (right). (Credit: CSB [left], RCFR [right])

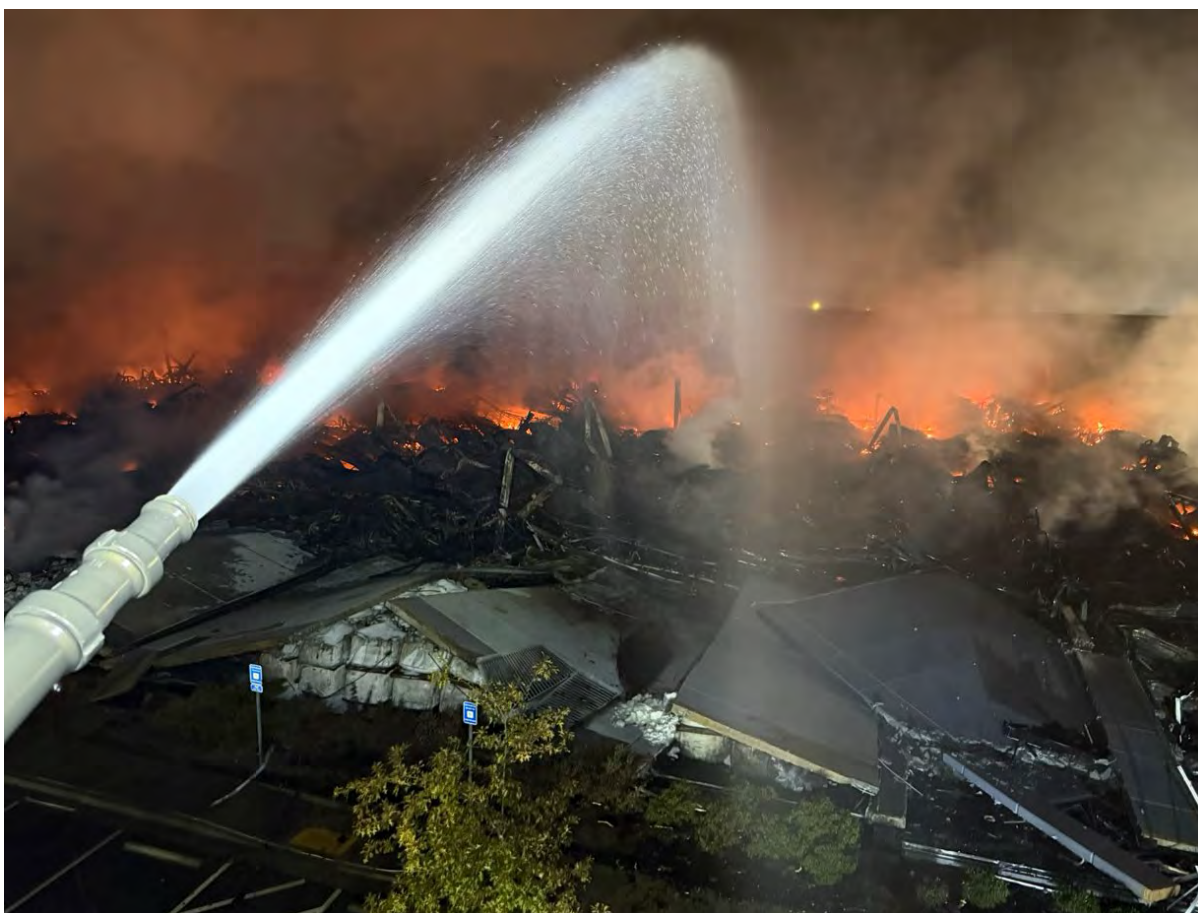
**Figure 25.** Hotspots of fire and off-gassing from super sacks and materials trapped under building debris on the evening of September 29, 2024. (Credit: RCFR)

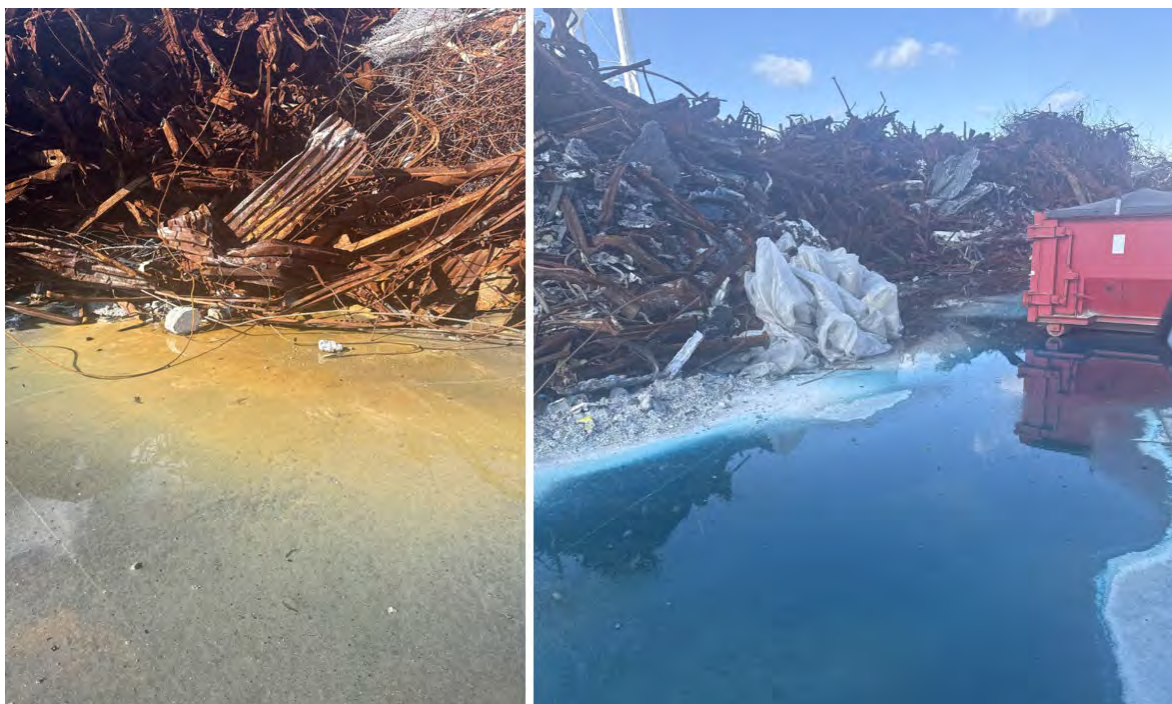
**Figure 28.** Surface water runoff of metals from rusting structural debris (left) and residual chemicals (right) on the former warehouse’s concrete slab. (Credit: KIK)<sup>b</sup>

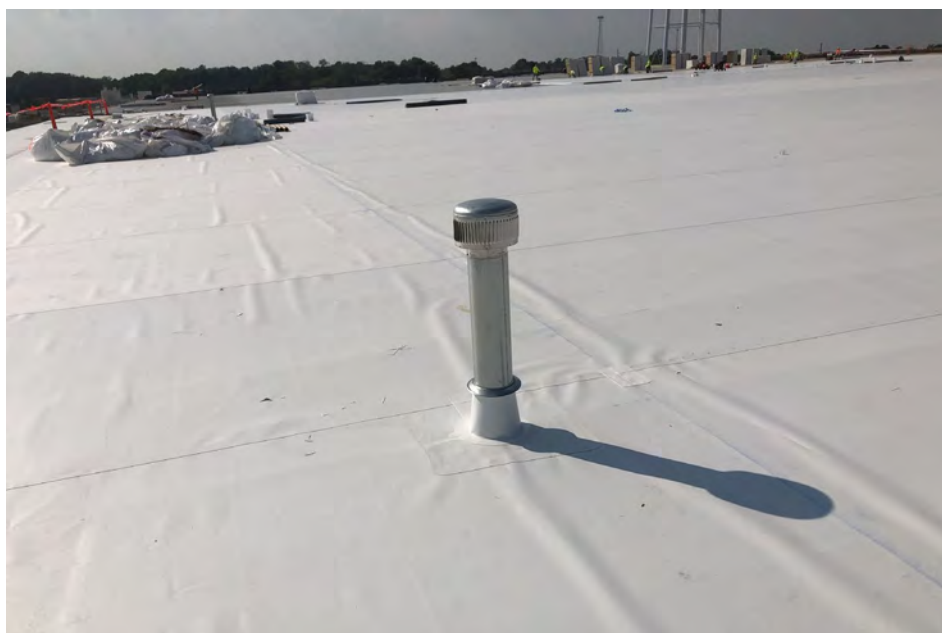
**Figure 30.** Roof penetration at the Plant 12 Storage Warehouse. (Credit: ARCO)

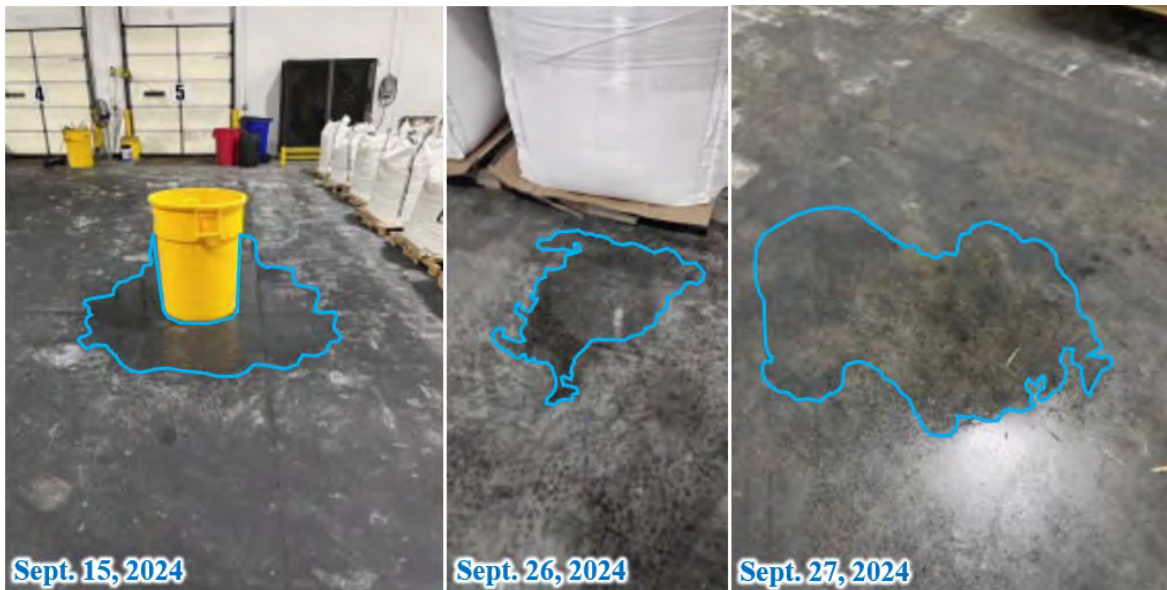
**Figure 32.** Roof leaks discovered in the Plant 12 Storage Warehouse on September 15, 26, and 27, 2024, with each puddle extent outlined in blue. (Credit: KIK, annotated by CSB)

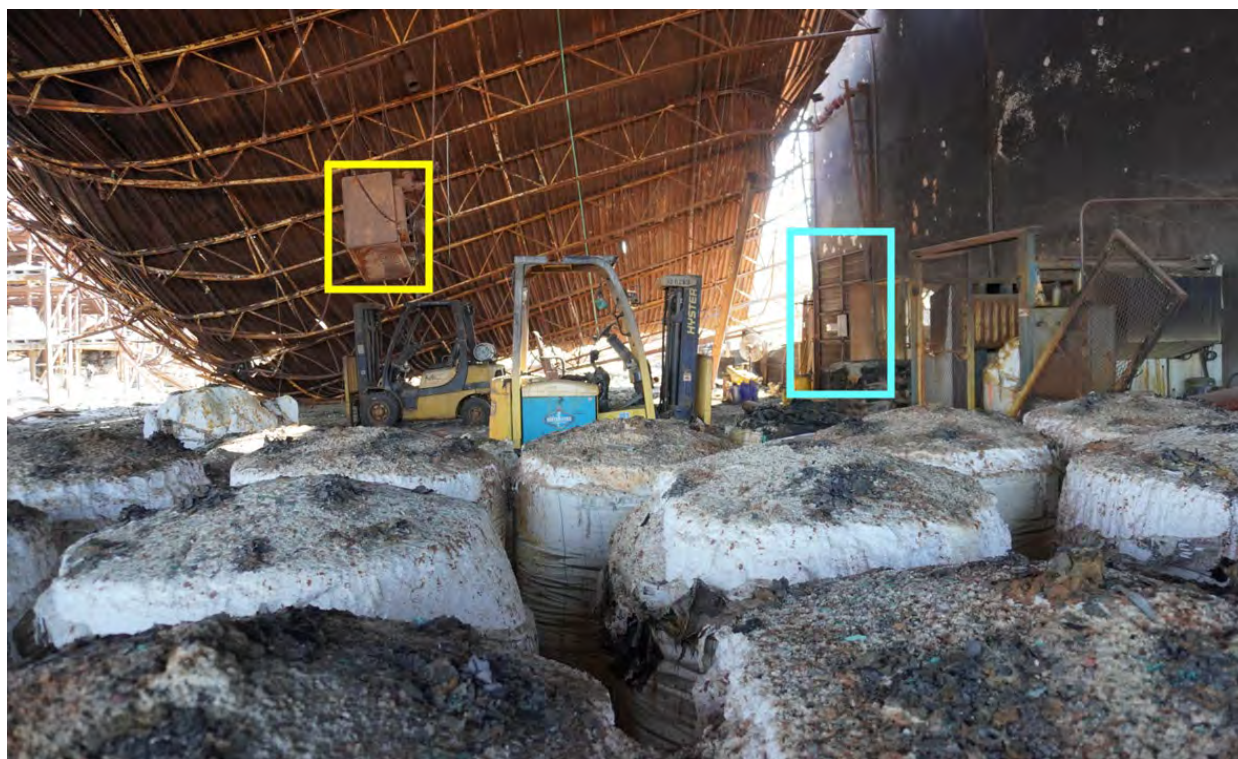
**Figure 33.** Super sacks located adjacent to the dock door (indicated by aqua box) and heater (indicated by yellow box) with the leaking vent penetration post-incident on October 14, 2024. (Credit: CSB)

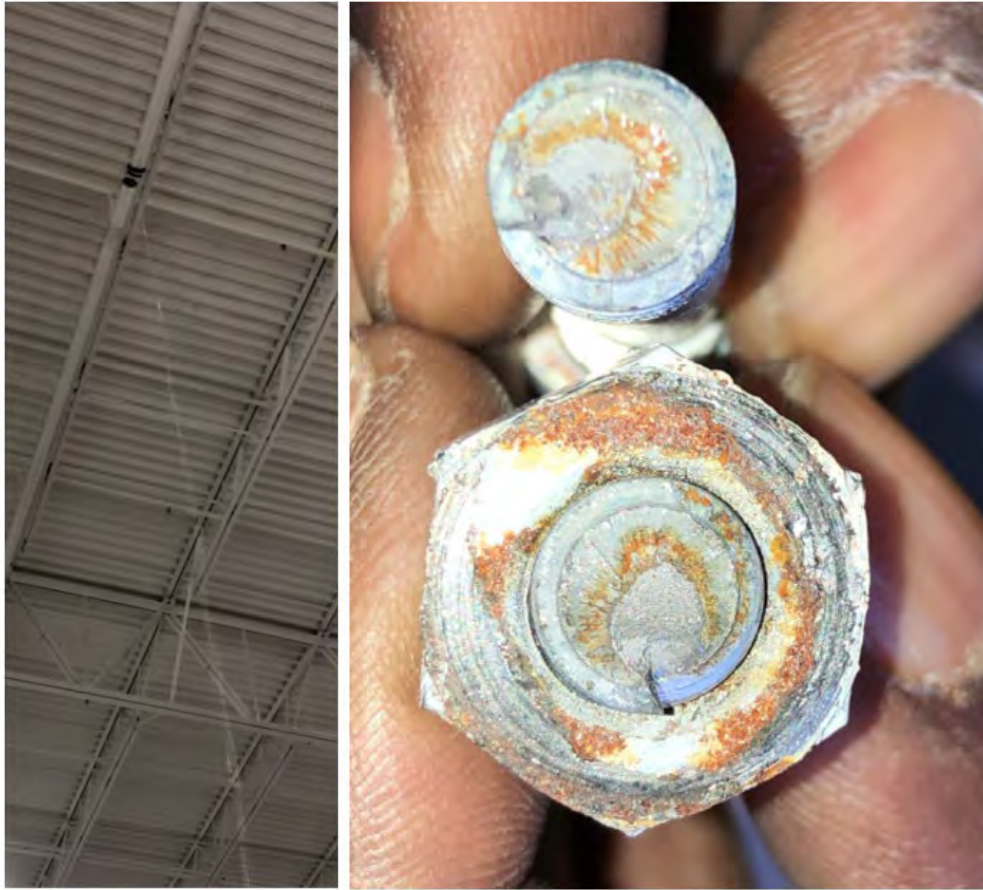
**Figure 34.** Failed fire protection piping coupling, pictured on December 30, 2019, due to bolt failure [left], and corroded cross-section of failed bolt [right]. (Credit: ARCO)
