Report No. 5005.7350

May 8, 2020

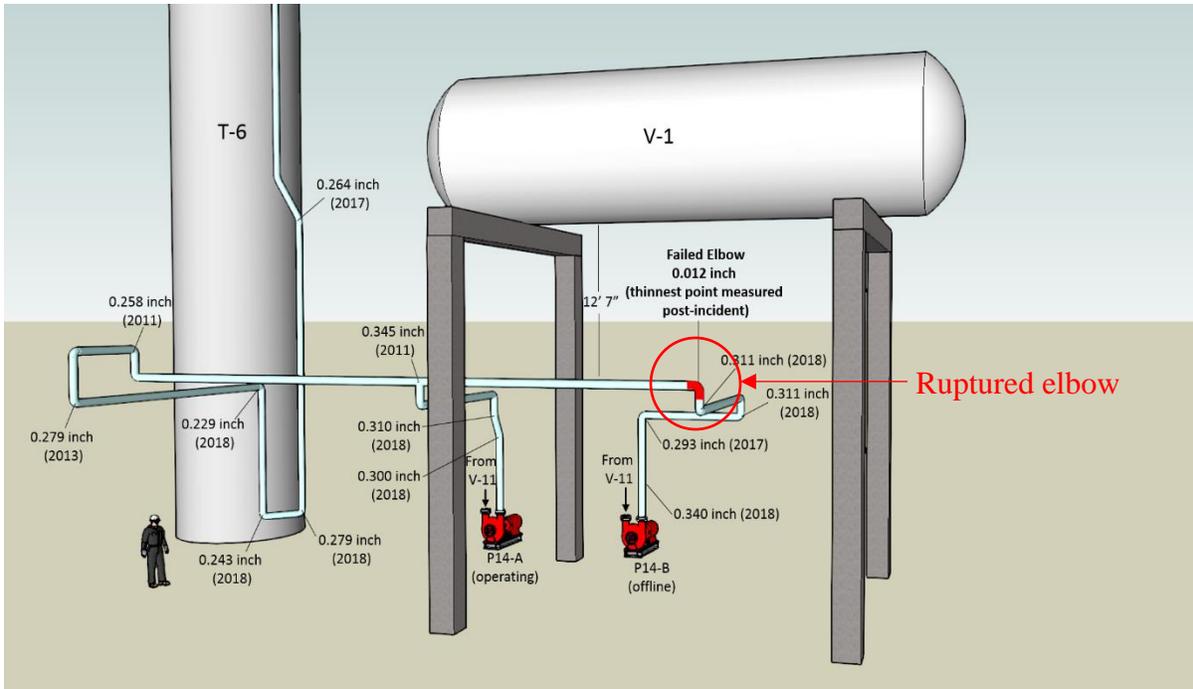
Specimen	Energy Absorbed (ft•lbs)	Lateral Expansion (mils)	Fracture Appearance Shear (%)r
1	19.2	43	55
2	19.5	40	57
3	20.6	42	60
Average	19.8	41.7	57.3

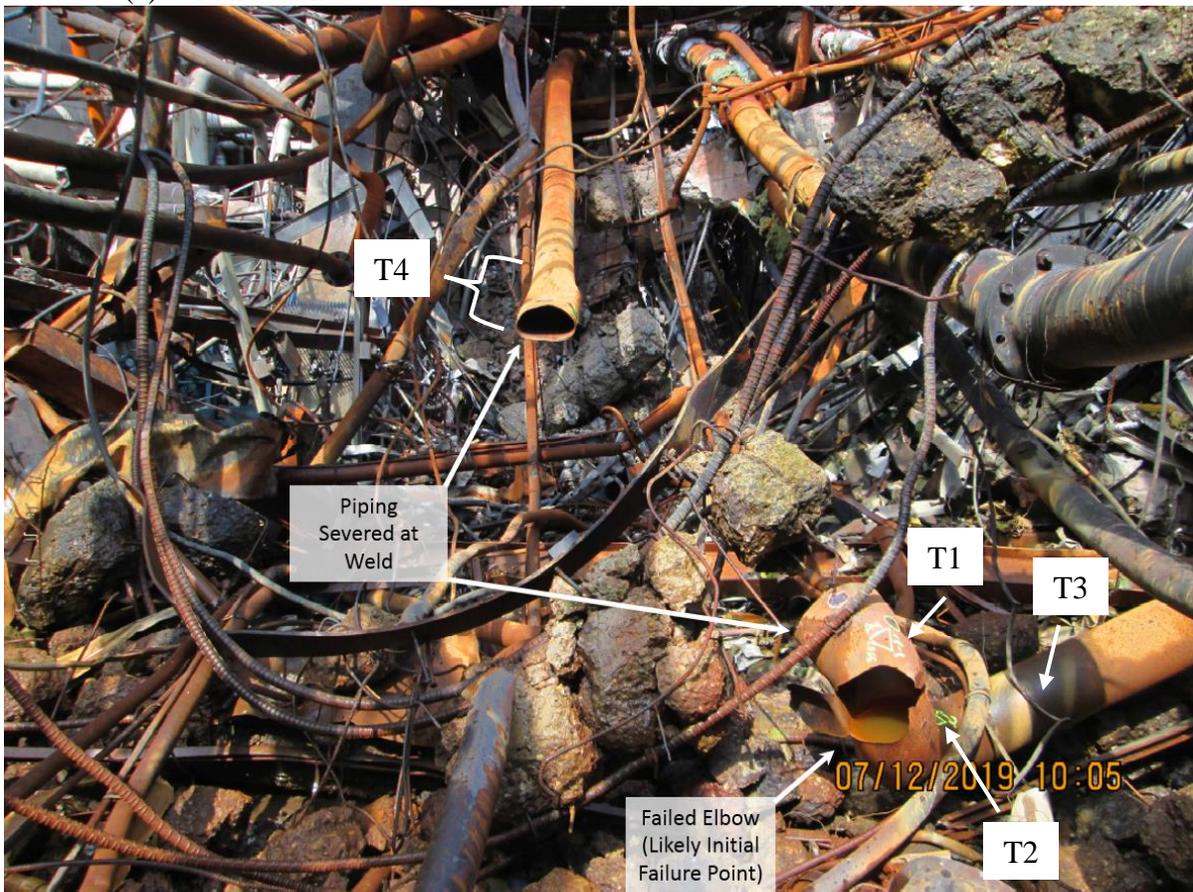
(b) Credit: CSB and PES

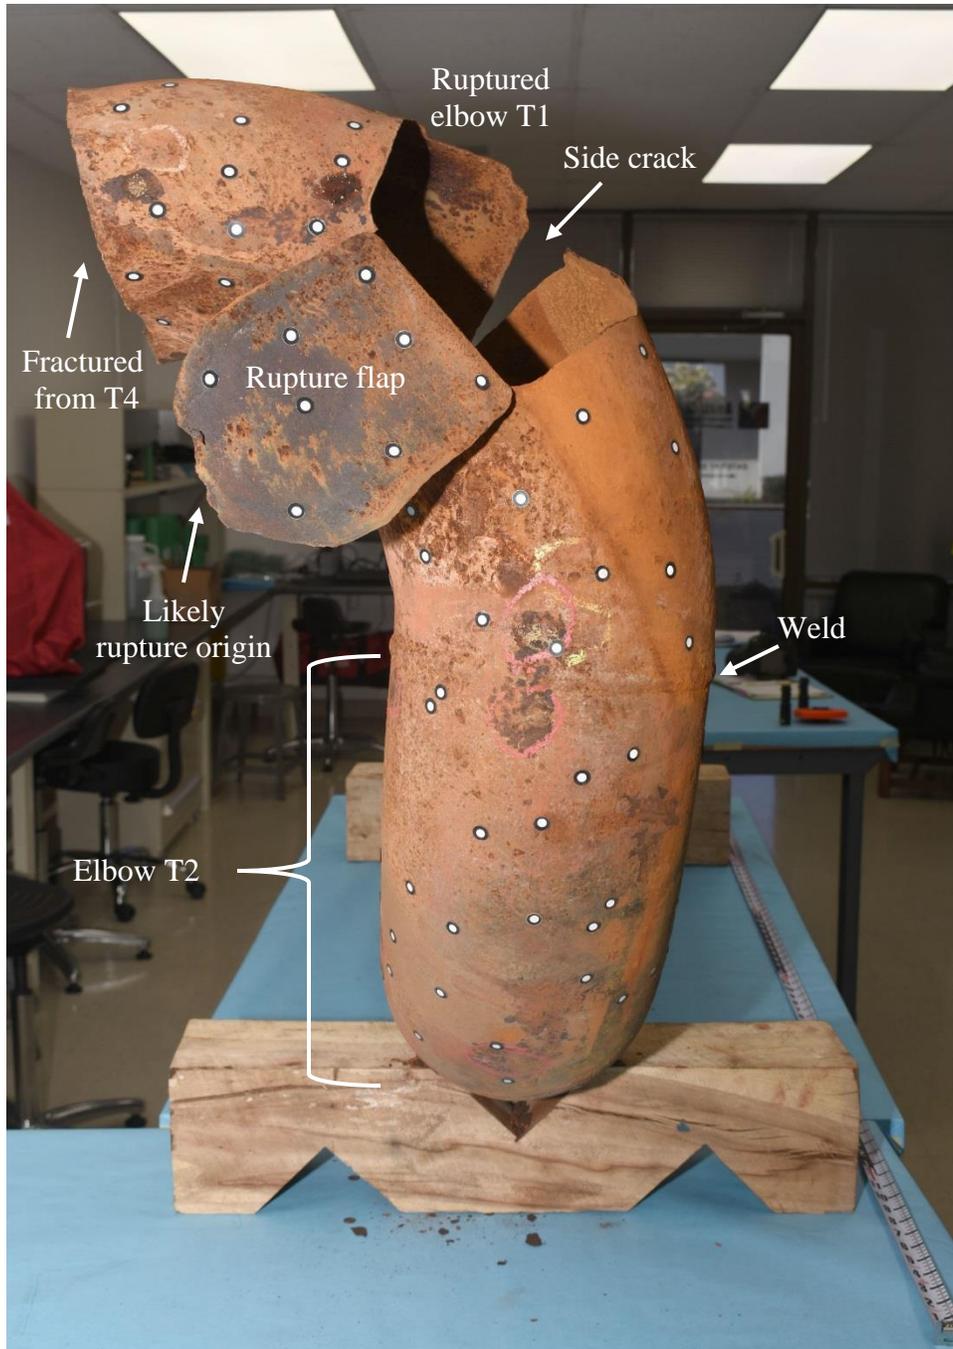
Figure 2 Photograph of E004, viewed from the ruptured end. Spots are reflectors that were applied to facilitate laser scanning.

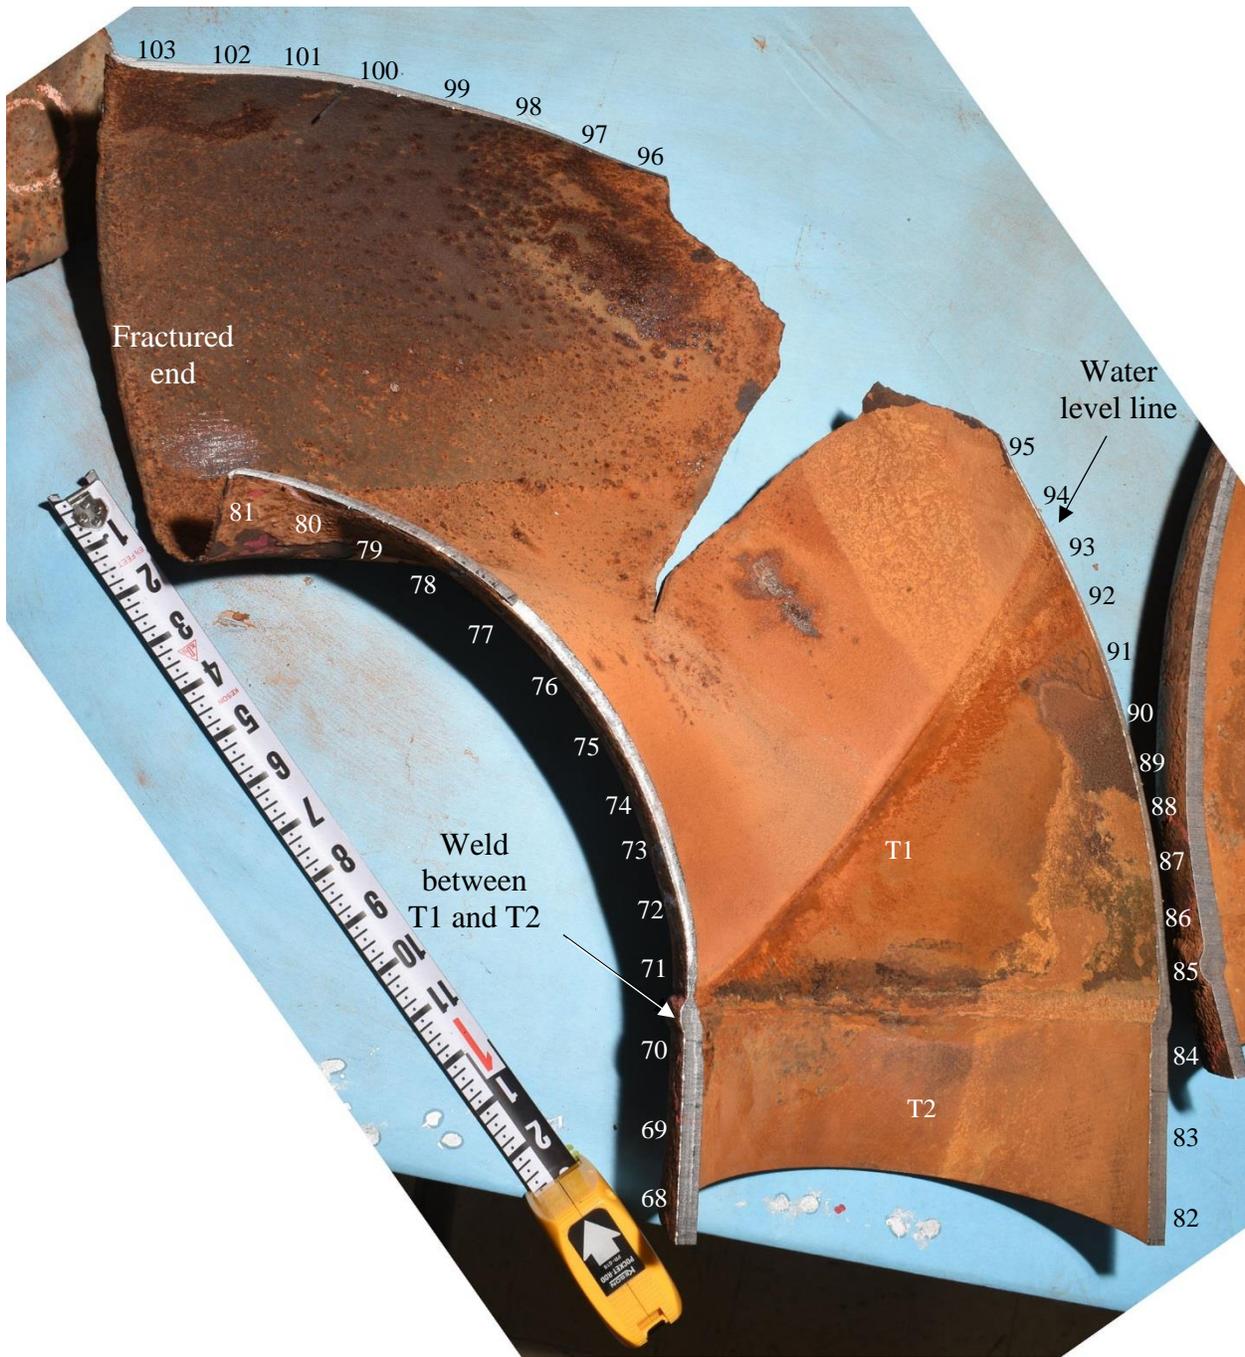
Figure 7 Longitudinal section of ruptured elbow T1. Numbers indicate thickness measurement locations listed in Table 5.

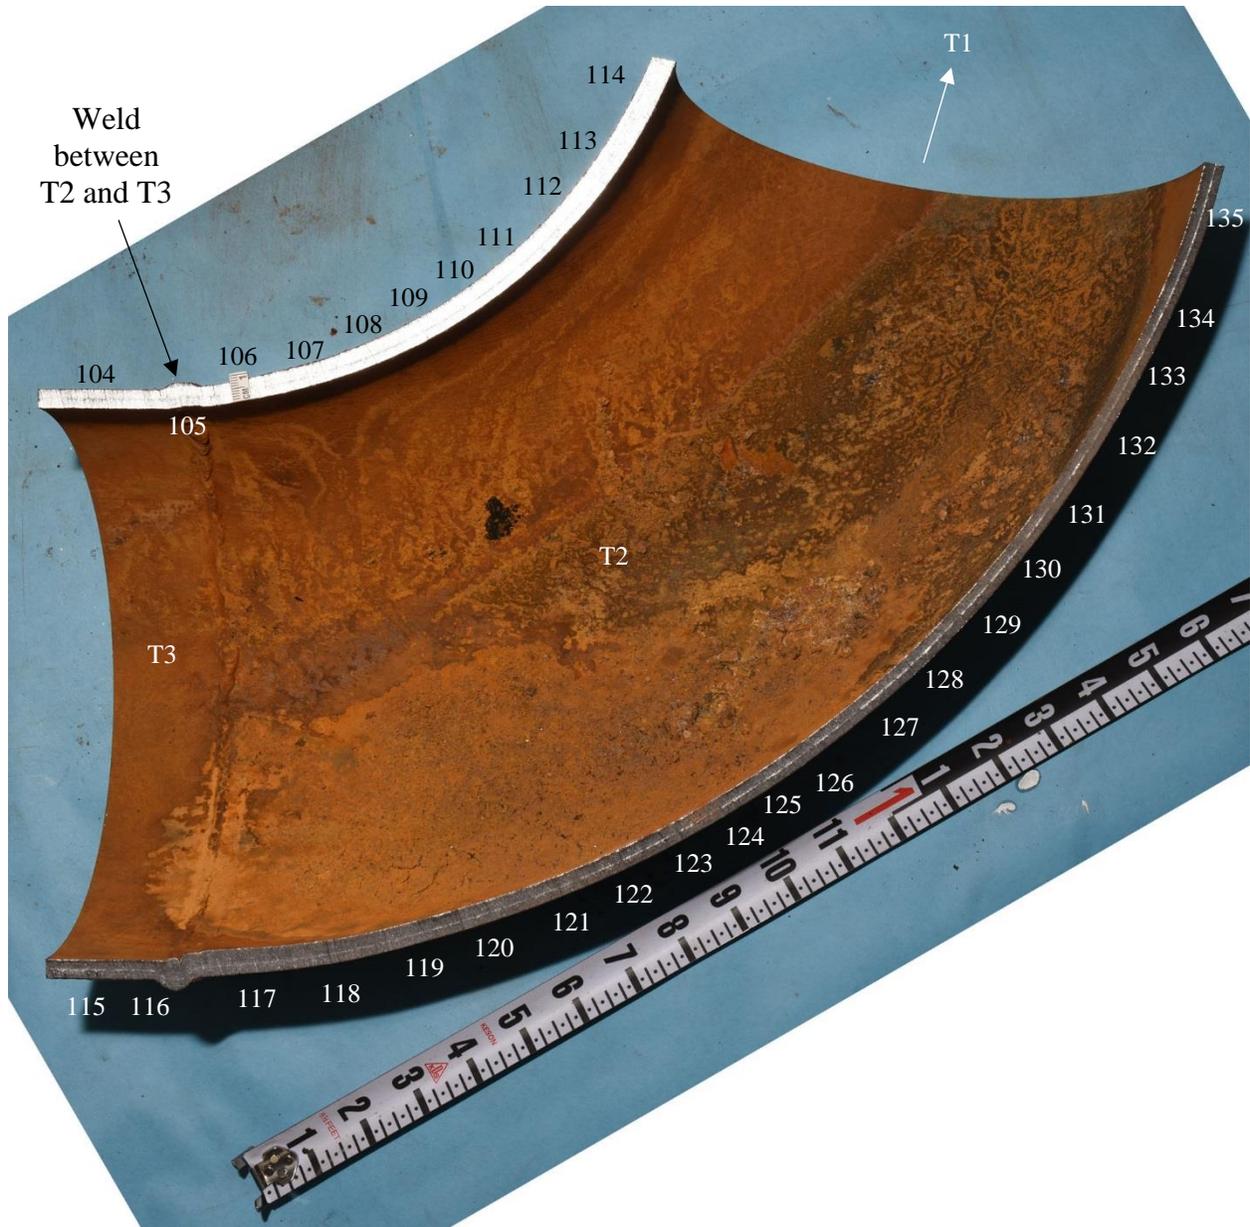
Figure 8 Longitudinal section through elbow T2.. Numbers indicate thickness measurement locations listed in Table 6.

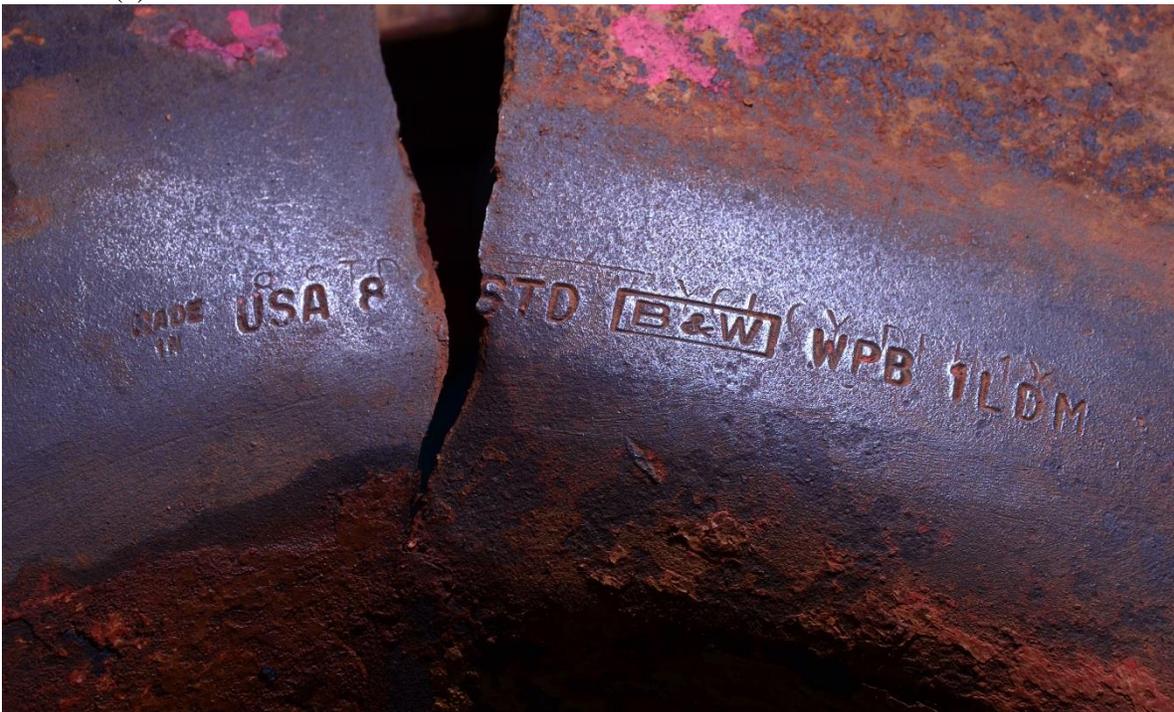
(b) Boxed region in (a)

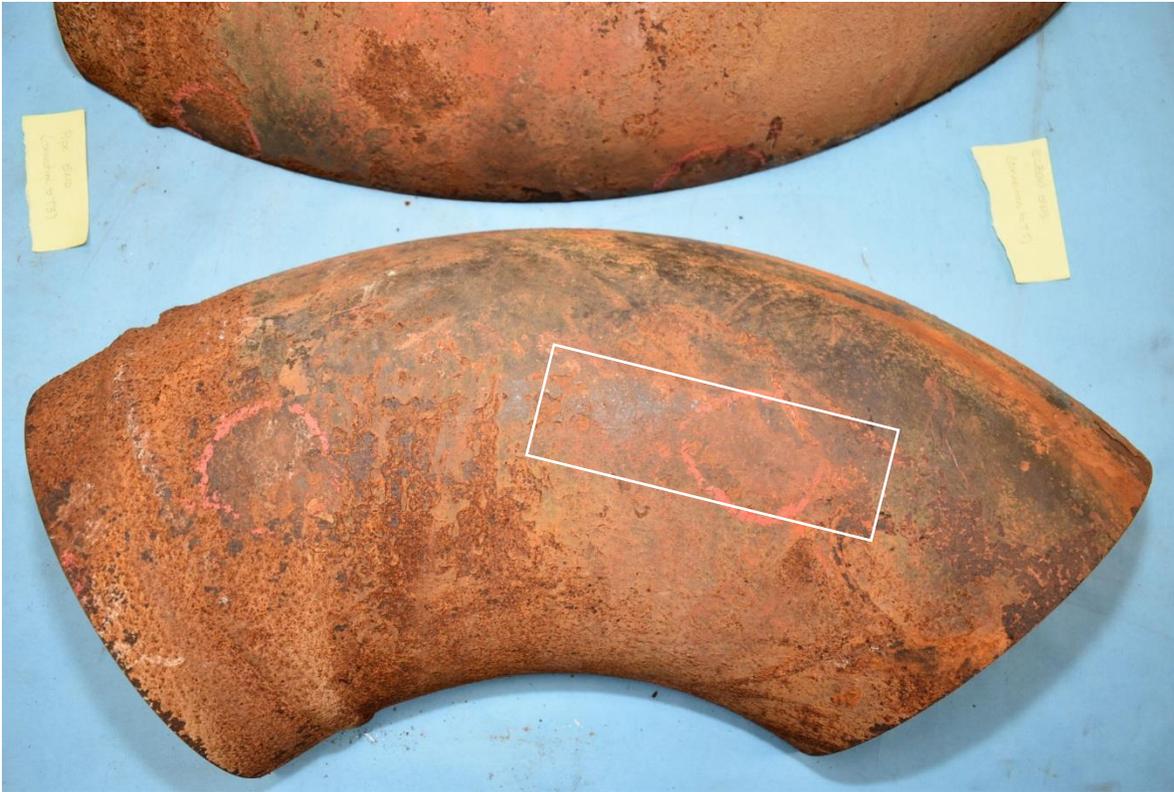
(a) Prior to cleaning

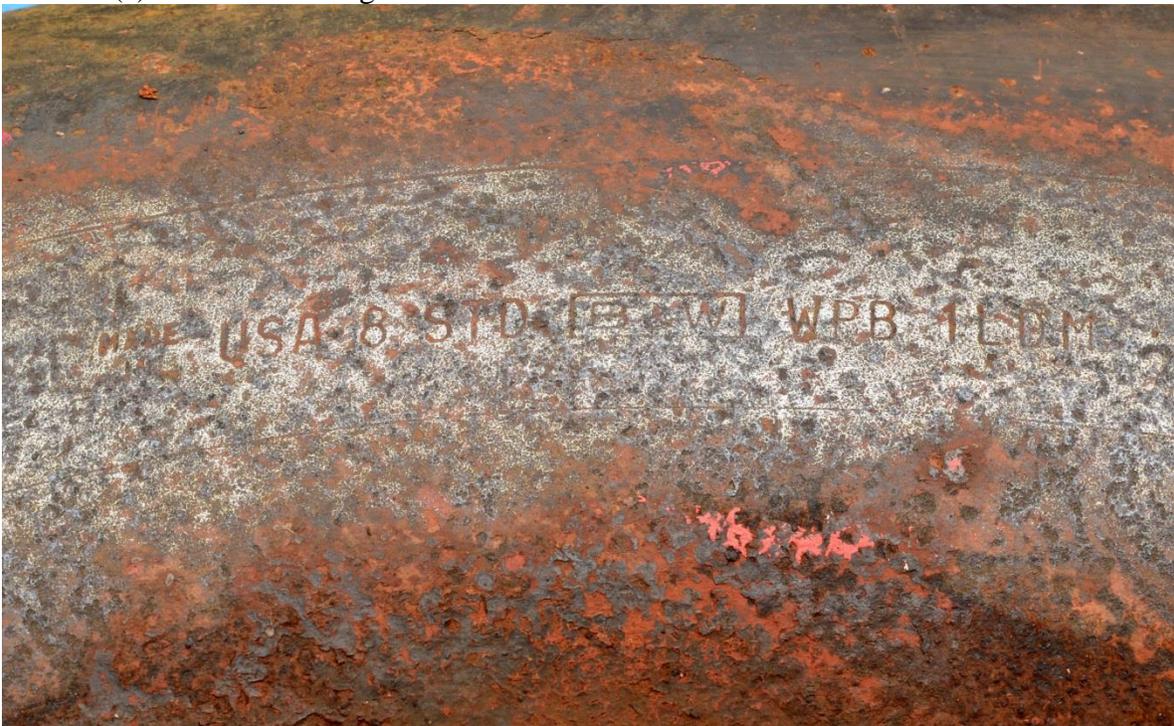
(b) After cleaning, boxed region in (a)

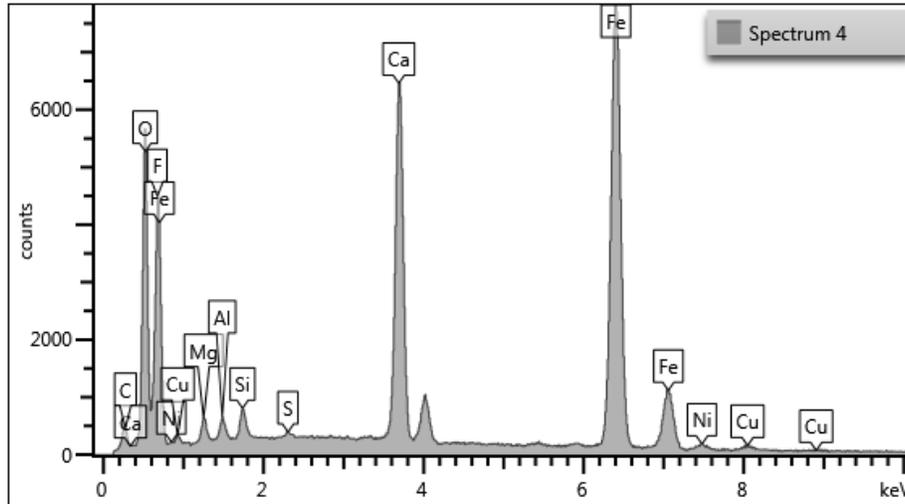
(a) Tenacious scale from inside T1 extrados

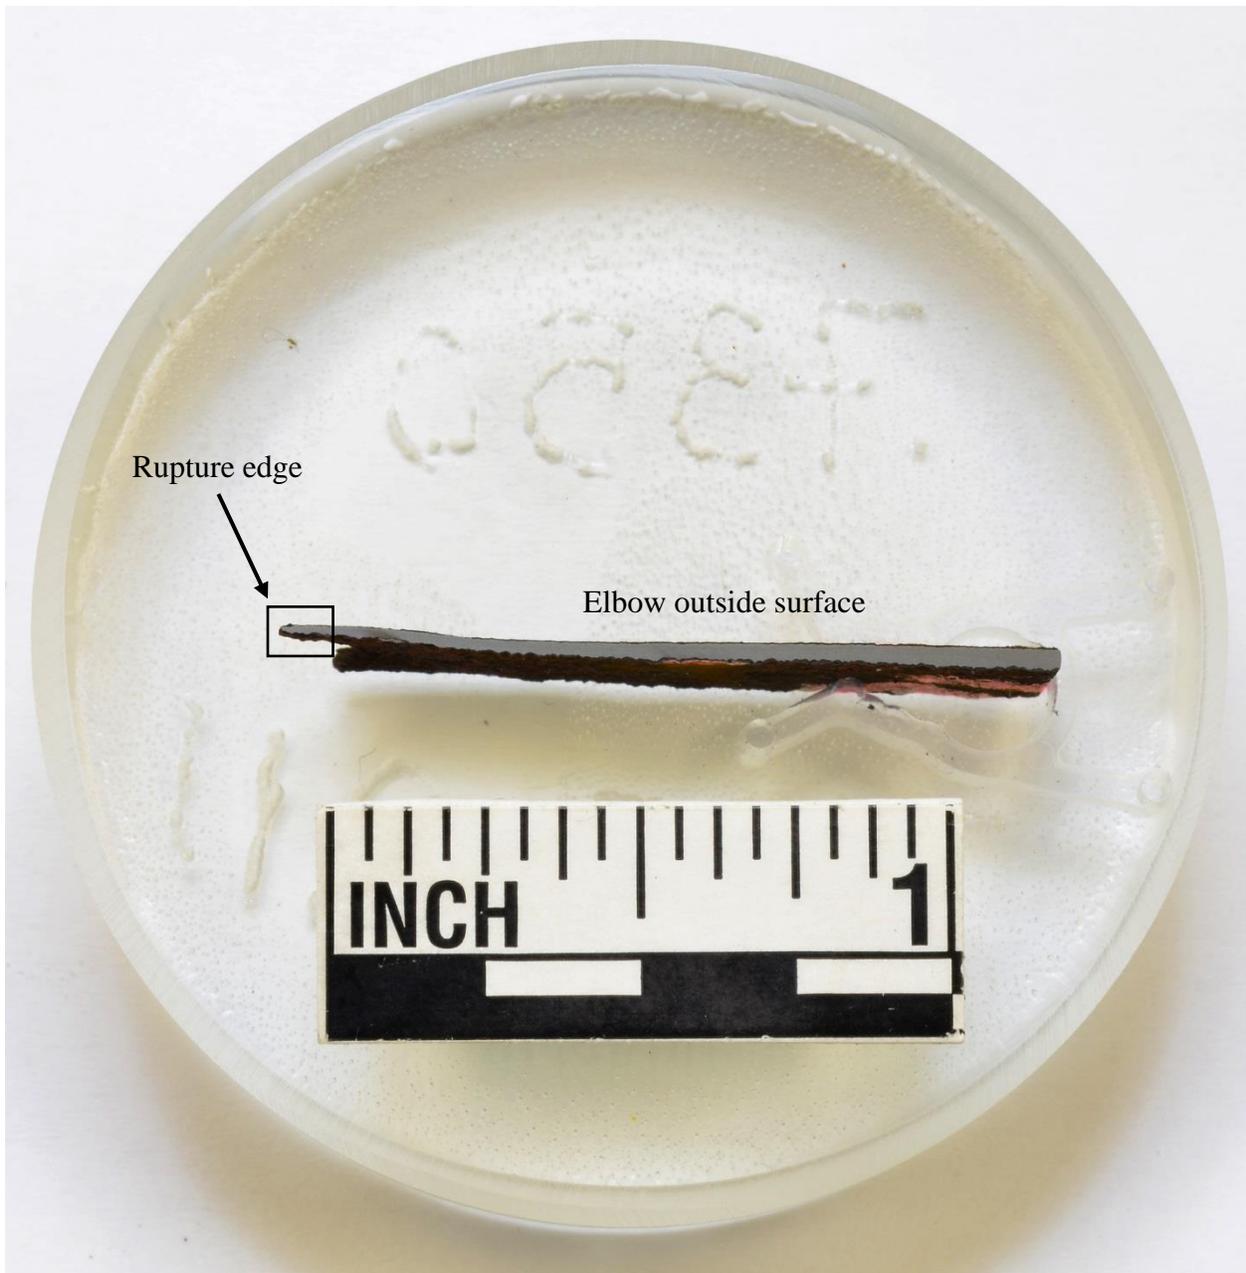
Figure 18 Photograph of the rupture flap section prepared for metallography.

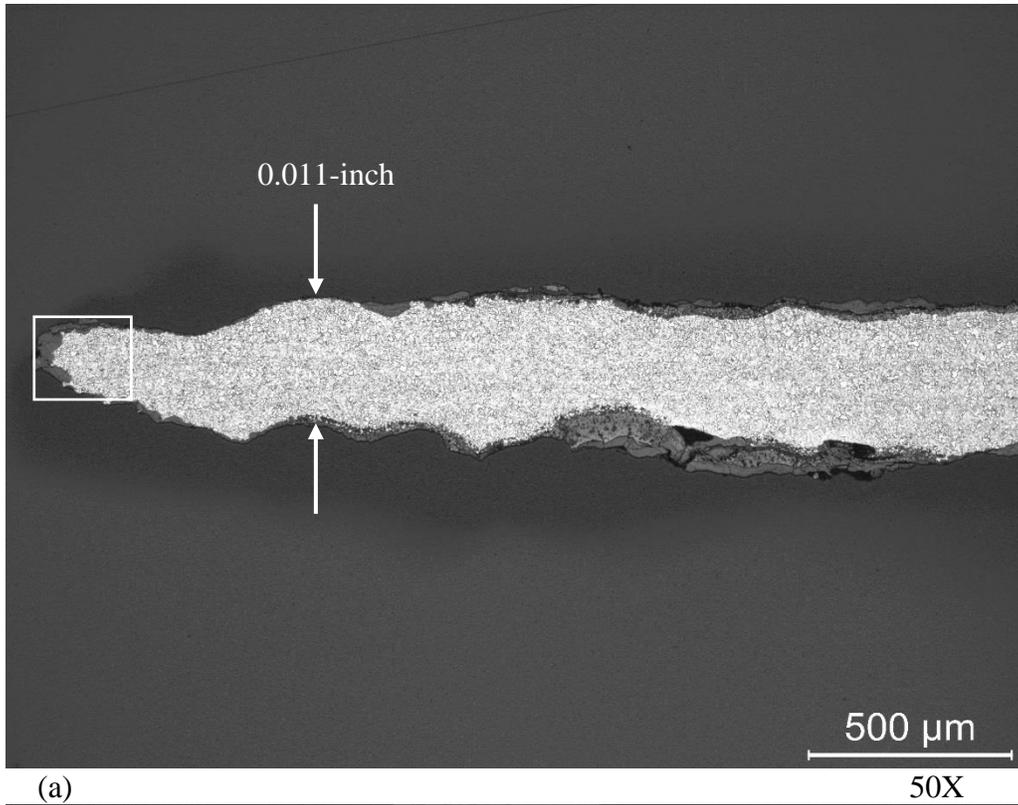
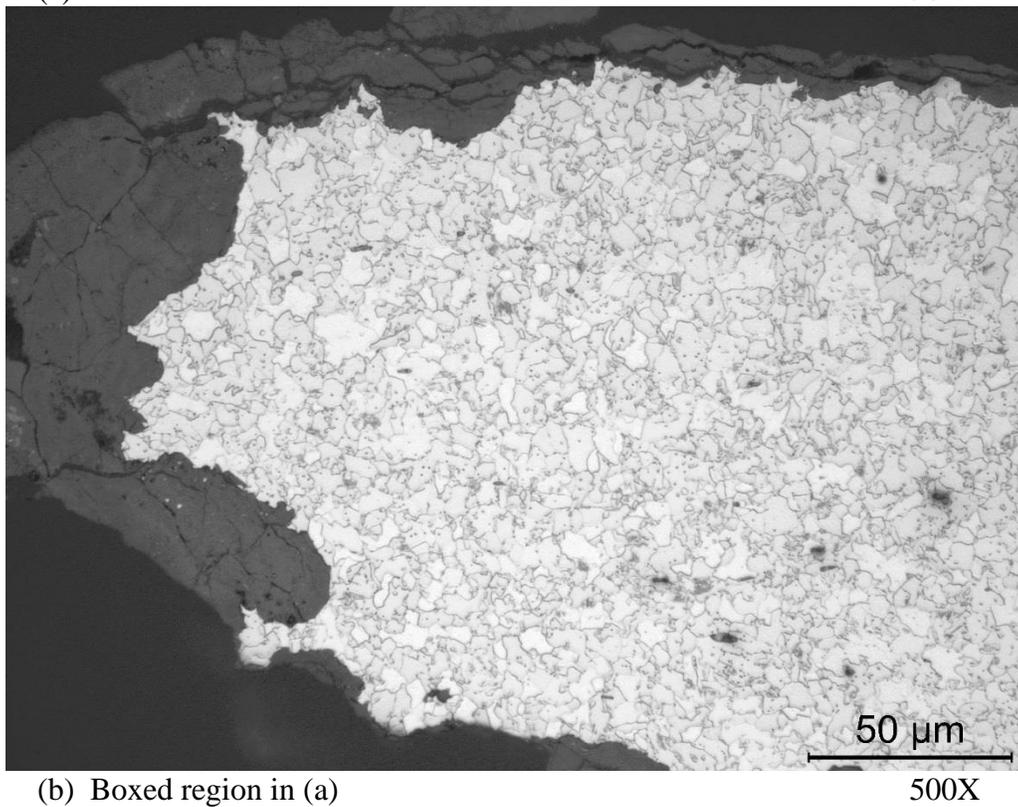
Figure 19 Micrographs of the rupture flap section prepared for metallography, from the boxed region in Figure 18.

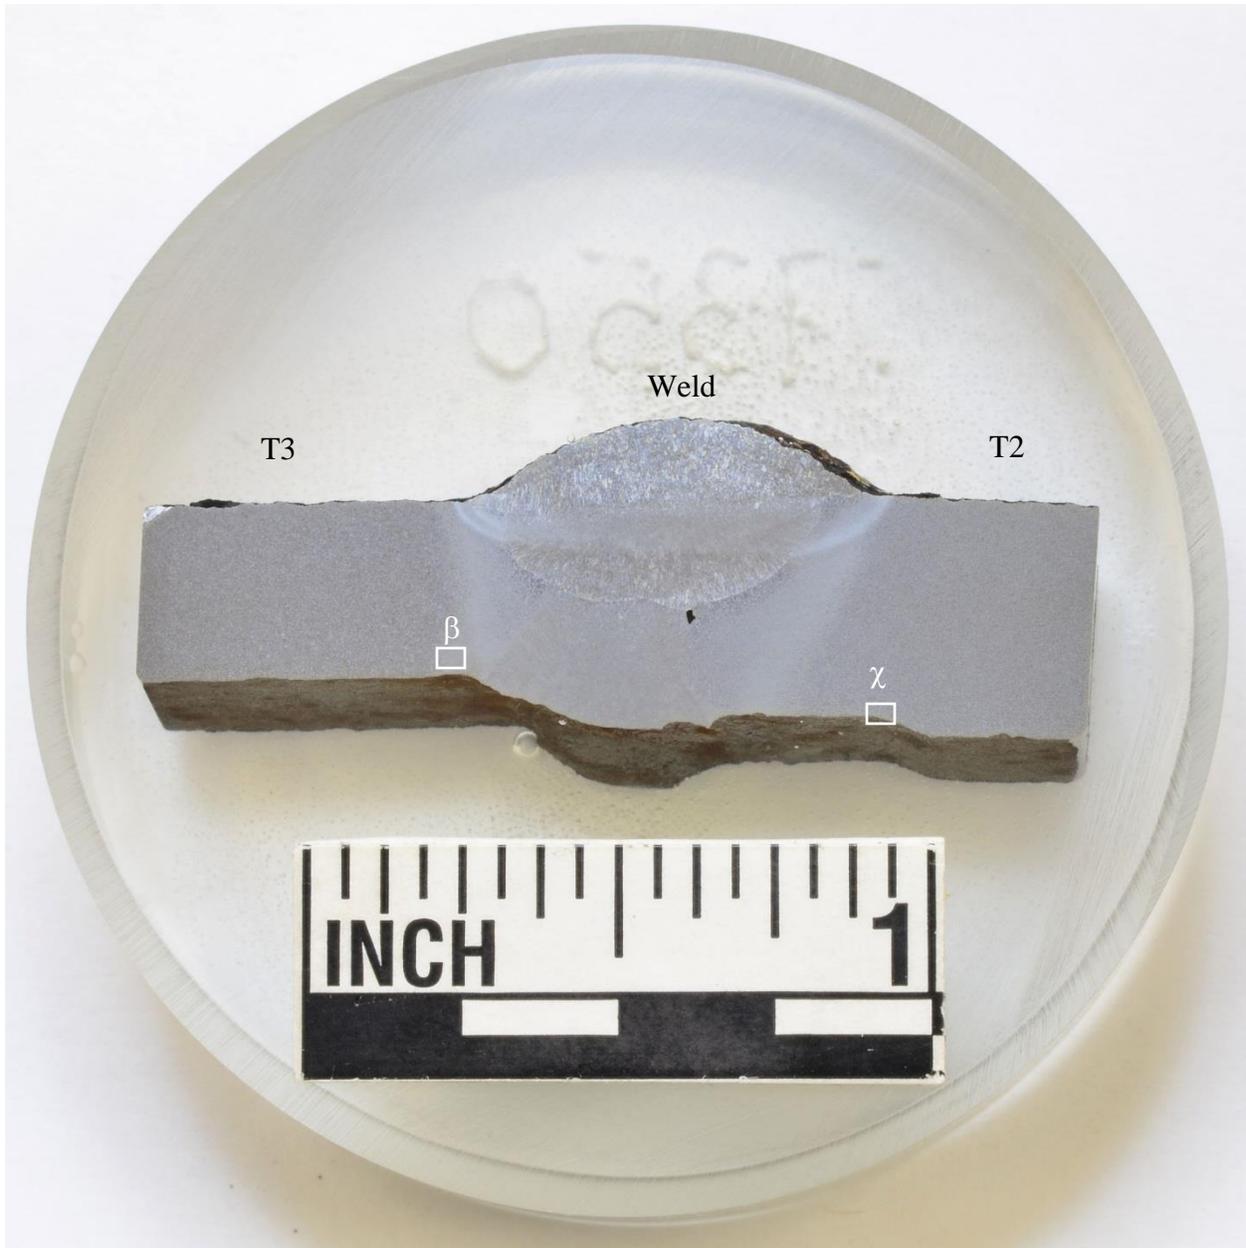
Figure 20 Photograph of the longitudinal section through the T2 to T3 weld prepared for metallography.
