NDK Crystal, Inc., Belvidere, IL High-Pressure Vessel Rupture

December 7, 2009

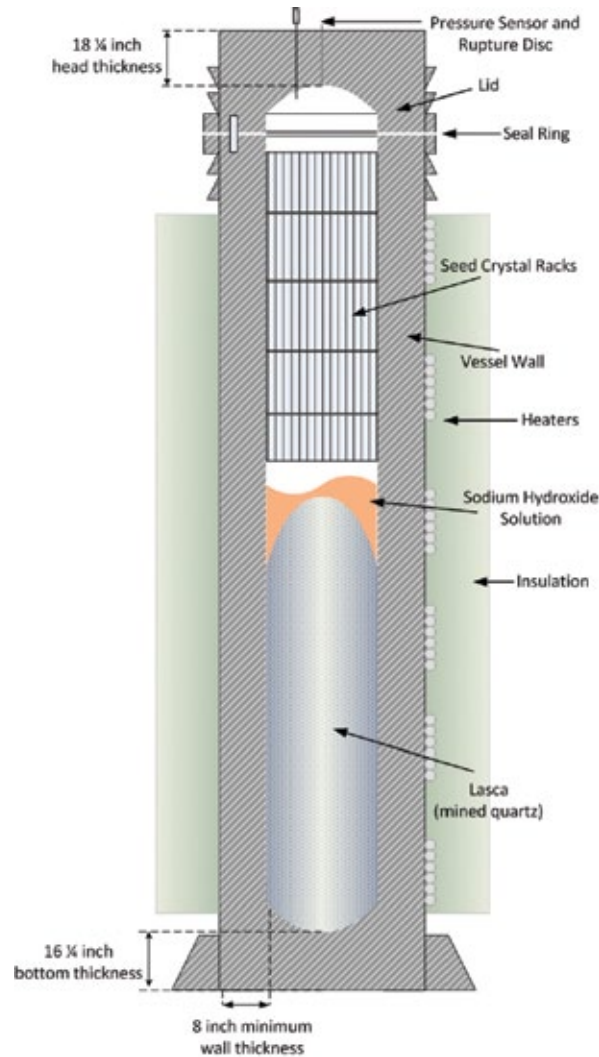
“seed crystals” at the top of the vessel. The seed crystals are wafer-thin pure quartz crystals with the desired grain structure on which the new crystals grow. Operators sealed the vessel with 10,000-pound lids clamped to the top. External electric heaters slowly increased vessel temperature to 700°F, which boiled the caustic liquid and increased the pressure inside the vessel to about 29,000 psig (Figure 3).

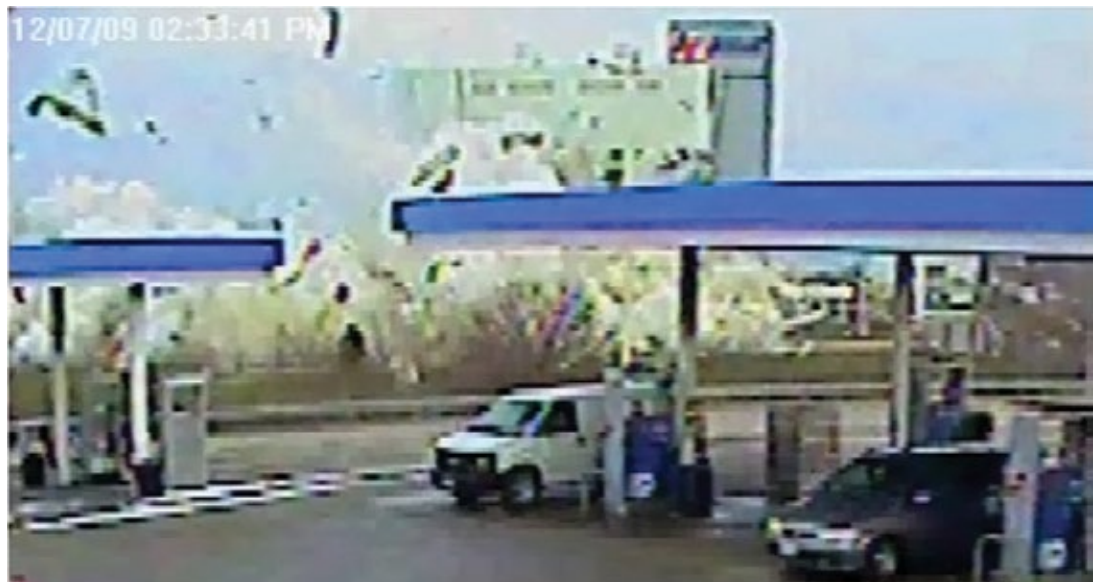
The sudden release of superheated liquid caused an eight-foot tall by four-foot wide vessel fragment, weighing approximately 8,600 pounds, to travel through two concrete walls and finally land about 435 feet from the NDK building (Figure 6). The fragment skipped across a neighboring facility parking lot and slammed into the wall of an adjacent business office (Figure 7). The force of the impact pushed the wall inward causing furniture to shift and ceiling tiles to fall. One person working near the wall was injured.

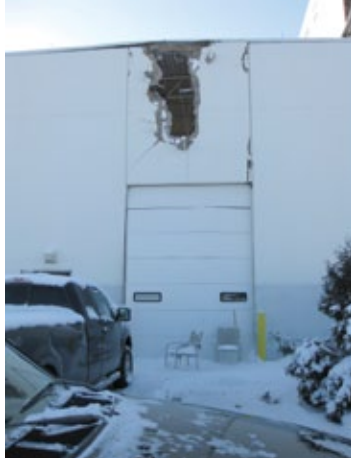
**FIGURE 7 (RIGHT)**

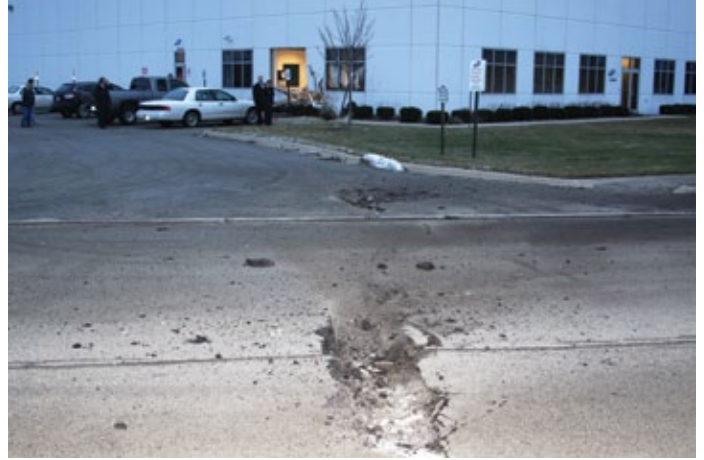
The thrust from the escaping liquid caused the base of the vessel to violently shear away from its foundation and blew pieces of structural steel out of the building into the parking lot of a nearby rest stop gas station, known as the Illinois Tollway (I-90) Oasis. One piece of structural steel struck and killed a truck driver at the rest stop. After shearing from its base and throwing shrapnel out of the facility, the vessel swung from the building and landed on the ground outside (Figure 8).

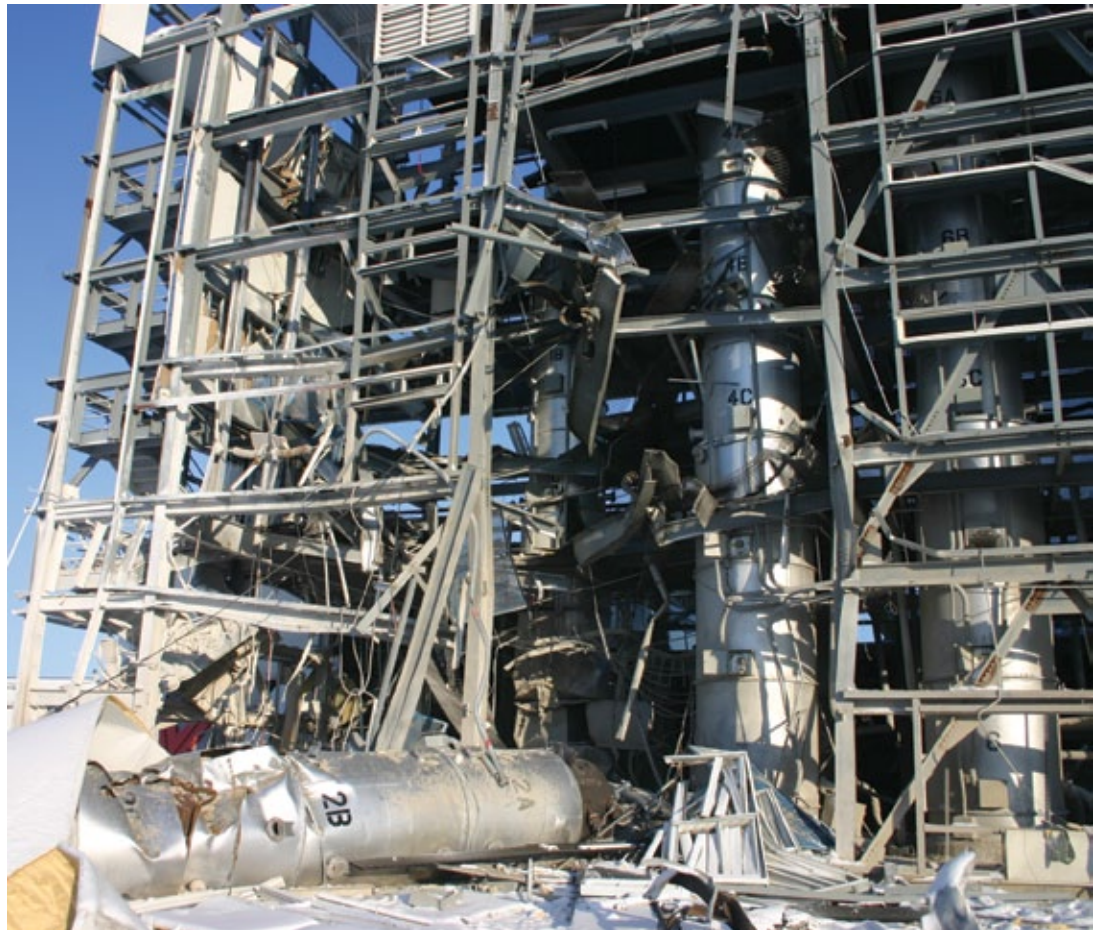
NDK Crystal damage after the incident; Vessel No. 2 rests on ground outside structure. The force of the explosion blew out most of the exterior wall panels.

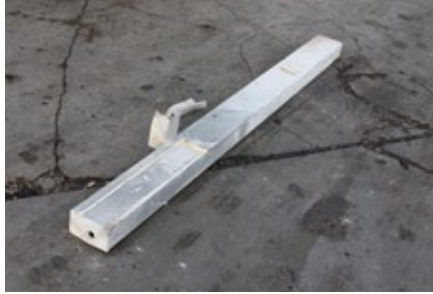
Structural steel fragment

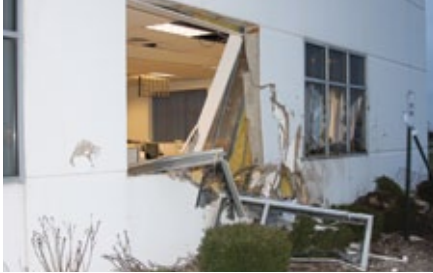
Grupo Antolin facility damage from vessel fragment.

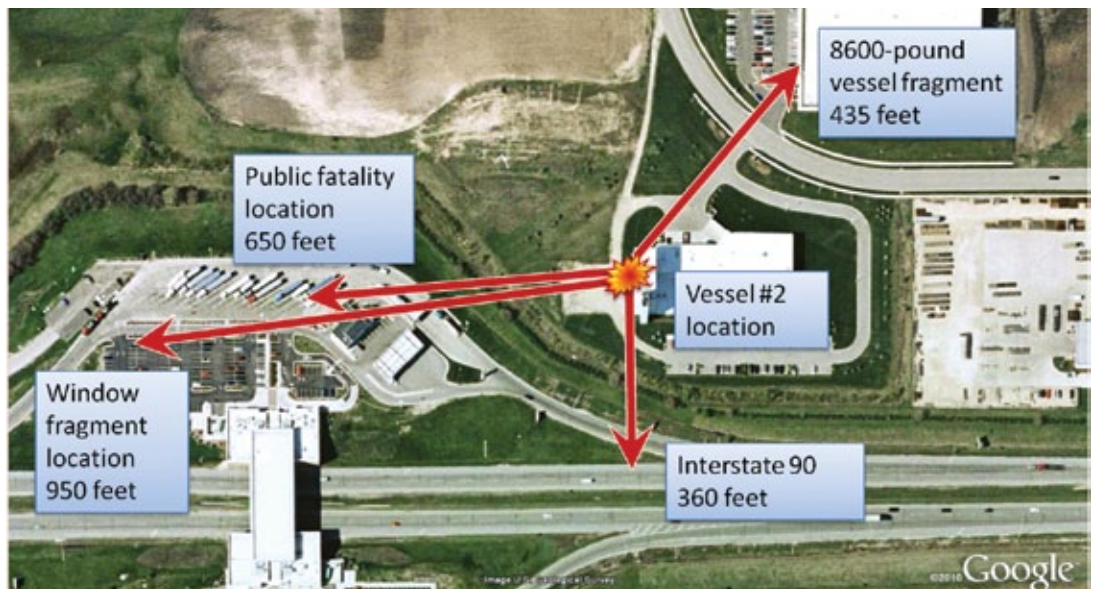
3.2 EMERGENCY RESPONSE

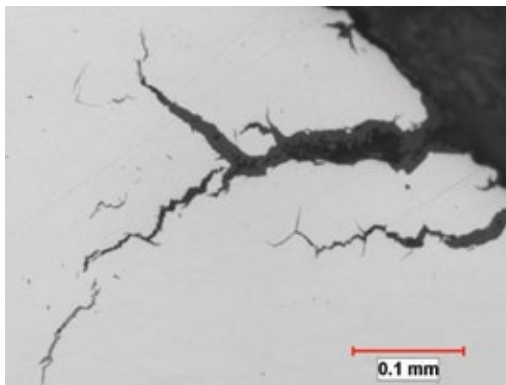
EPSI designed the vessels using the material NDK selected under the implied assumption that the acmite layer formation would prevent SCC in the vessel wall. The evidence of SCC in the fragment suggests that the acmite did not adequately protect the vessel, or that it was removed from this region of the vessel though some type of mechanical process, such as scratching or abrasion, during product removal or vessel cleaning between runs.

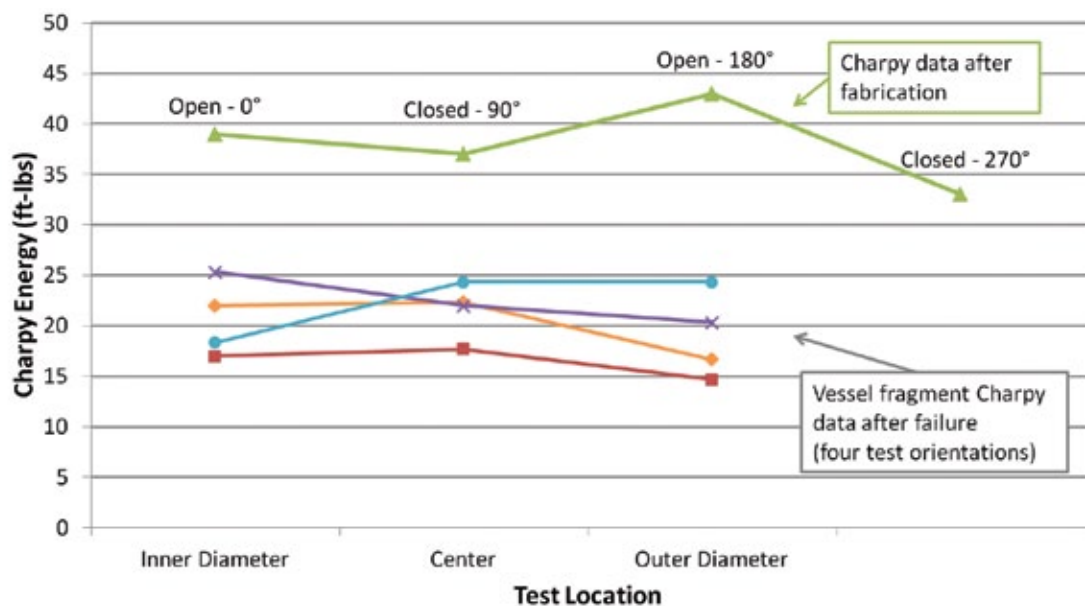
4.1.3 Forging Process and Heat Treatment

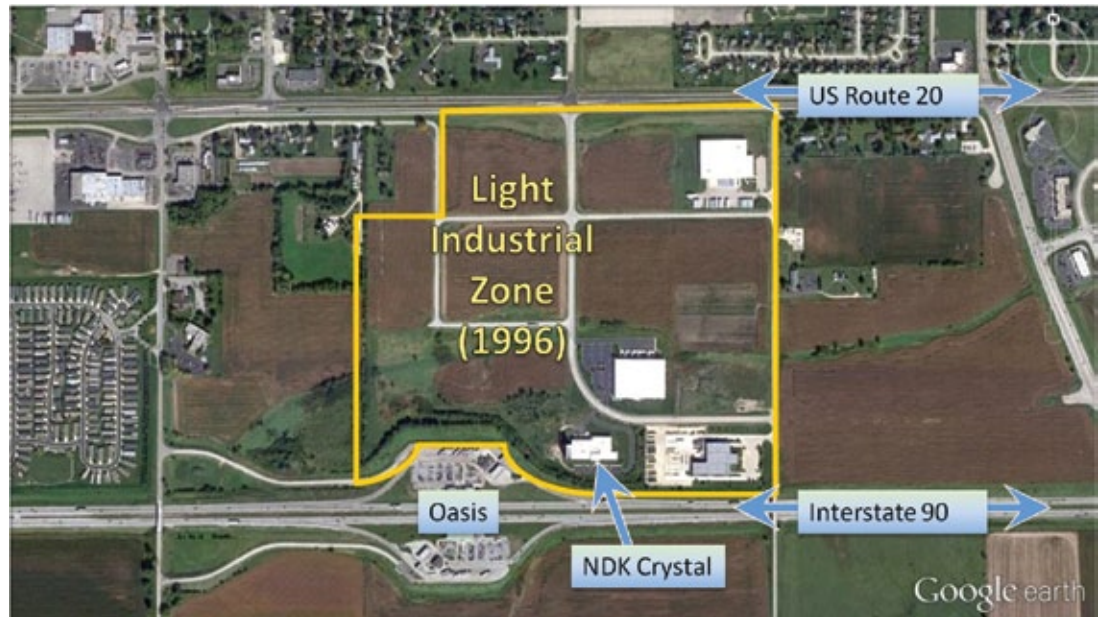
In 2001, NDK petitioned the City of Belvidere to permit the construction of its proposed office and manufacturing facility. After scheduled hearings with the Belvidere Planning and Zoning Commission, and Building Department, the City granted NDK a permit and zoned the proposed NDK location as “light industrial.” NDK purchased a lot in the light industrial district near the I-90 Tollway Oasis.
