U.S. CHEMICAL SAFETY AND HAZARD INVESTIGATION BOARD

# INVESTIGATION REPORT

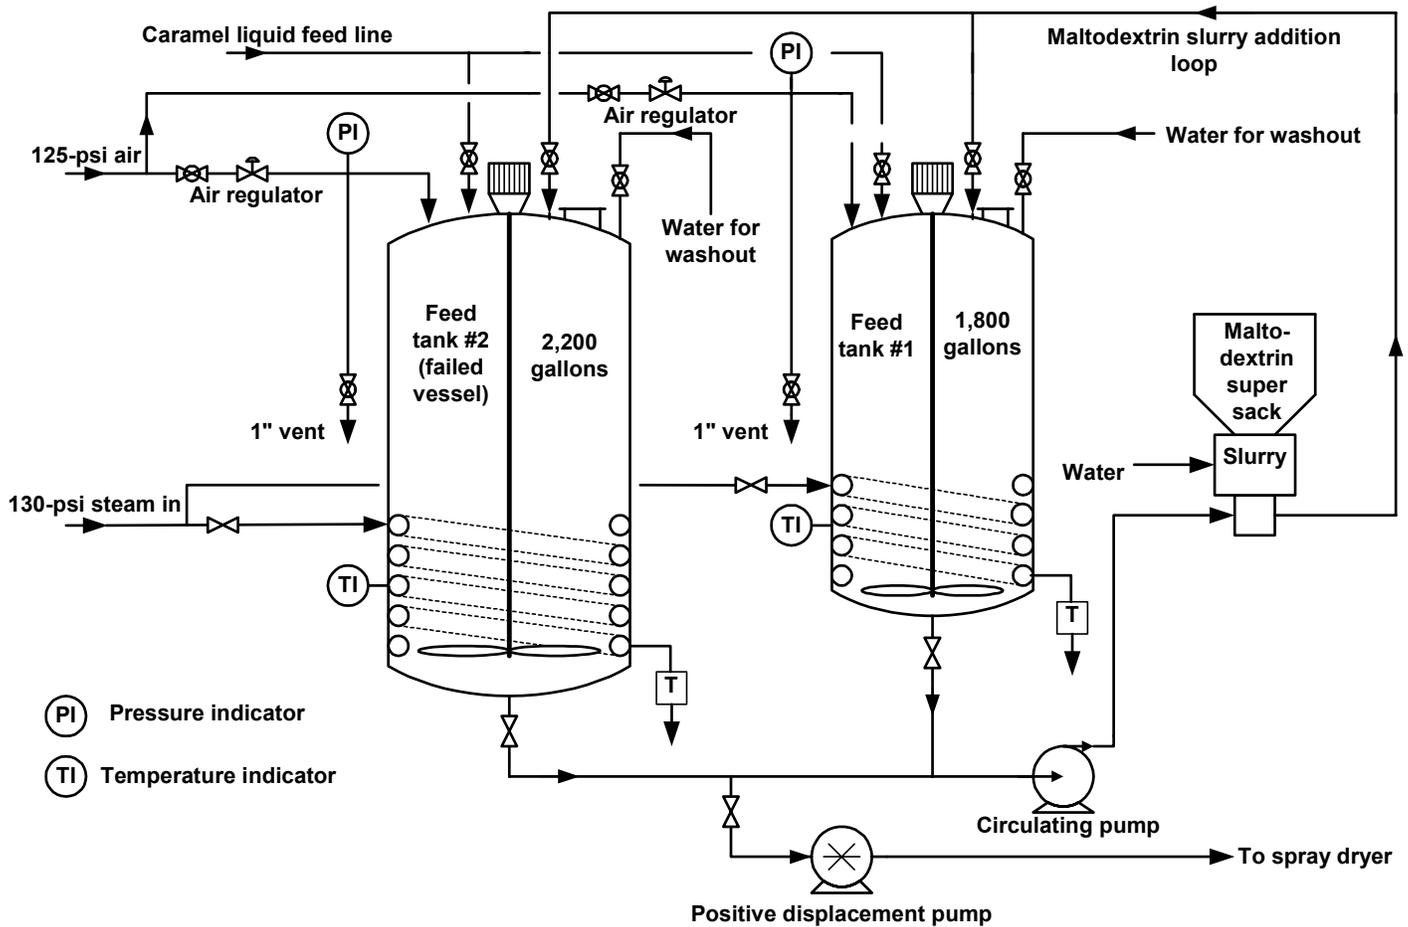
Figure 2. Feed tank flow schematic.

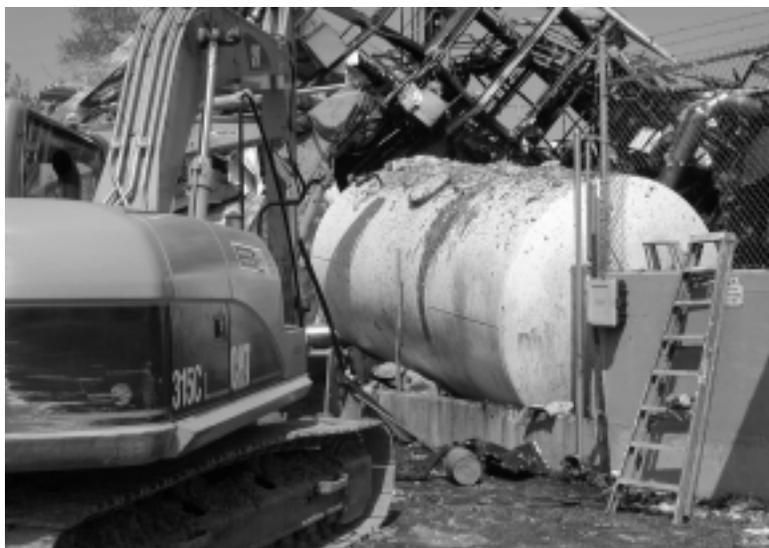
**Figure 3. Aqua ammonia storage tank prior to removal from diked area.**

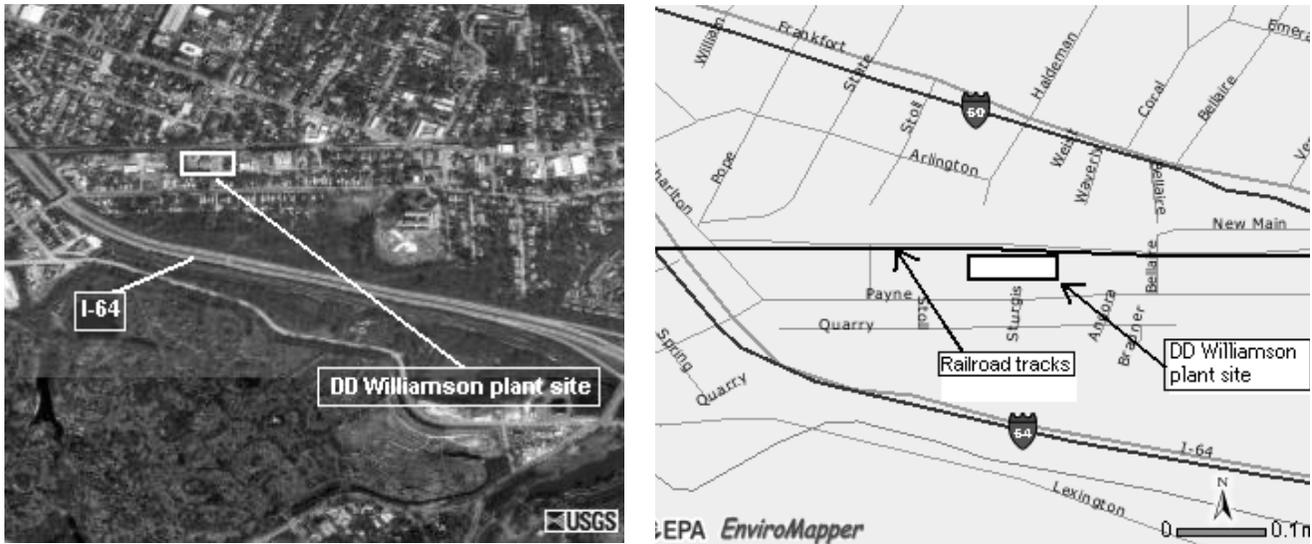
**Figure 4. DDW aerial photograph and location map.**

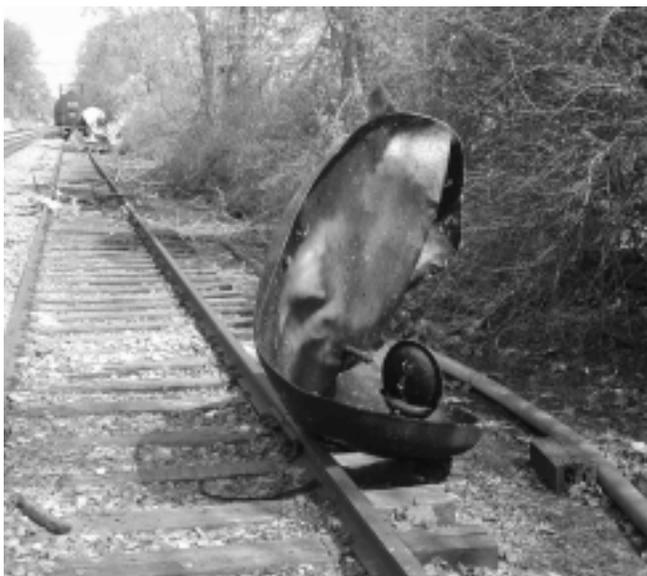
**Figure 5. Feed tank #2, top head.**

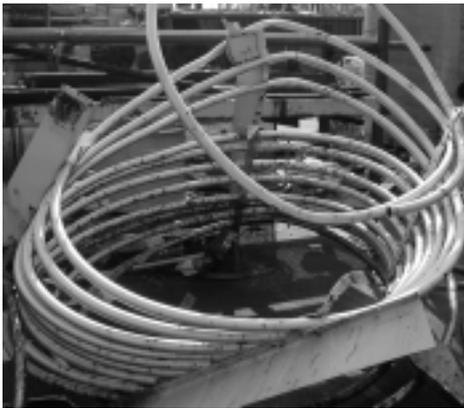
**Figure 7. Steam coil ejected from feed tank #2 (photographed in relocated position).**

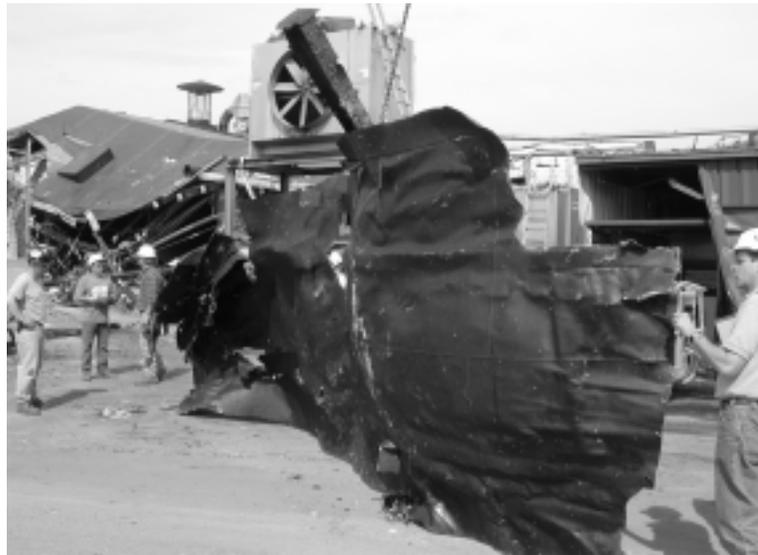
**Figure 6. Feed tank #2 shell, after recovery.**

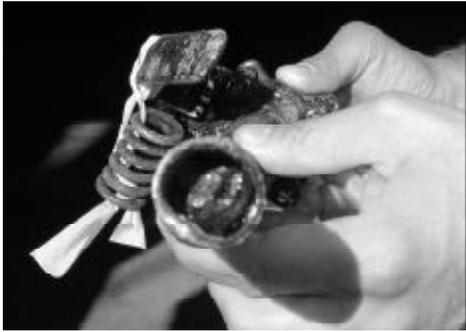
Figure 8. Plugged 1-inch vent pipe.

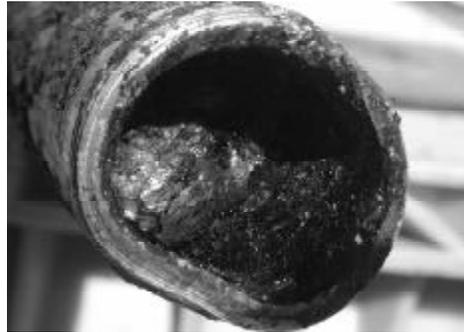
Figure 9. Closeup of vent pipe pluggage.

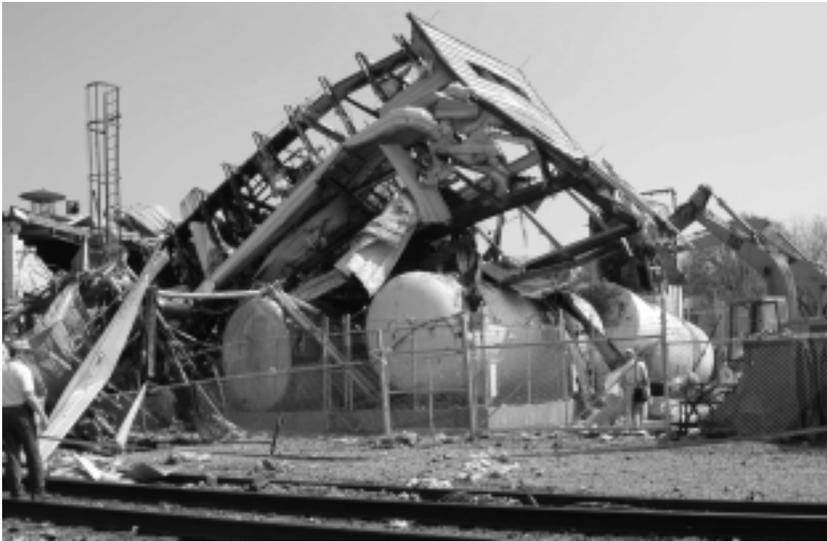
**Figure 11. Collapsed spray dryer structure.**
