VOLUME: 2 DATE: MARCH 12, 2025

INCIDENT REPORTS

EVENTS REPORTED TO THE CSB UNDER THE ACCIDENTAL RELEASE REPORTING RULE

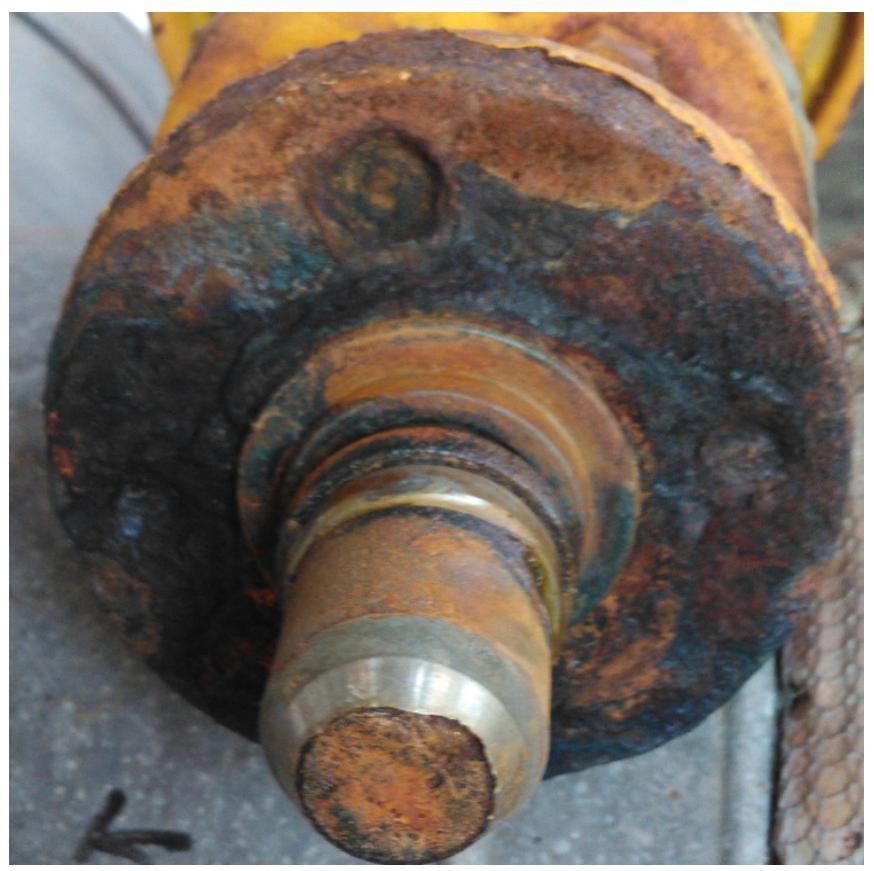
BASF's investigation found that the drain valve was severely corroded. Over time, chlorine being released from the drain valve had reacted with condensed water that had accumulated in the piping system's insulation blanket, creating hydrochloric acid that had corroded the valve and deteriorated the bolts in the valve's bonnet (**Figure 1**). After the incident, BASF discovered that three other valves were similarly corroded.

Figure 1. Corroded drain valve's bonnet and bolts. (Credit: BASF)

Based on BASF's investigation, the CSB determined that the probable cause of the incident was the catastrophic failure of corroded bolts in the drain valve's bonnet. The corrosion was caused by prolonged exposure to hydrochloric acid, created by the reaction between chlorine and condensed water.

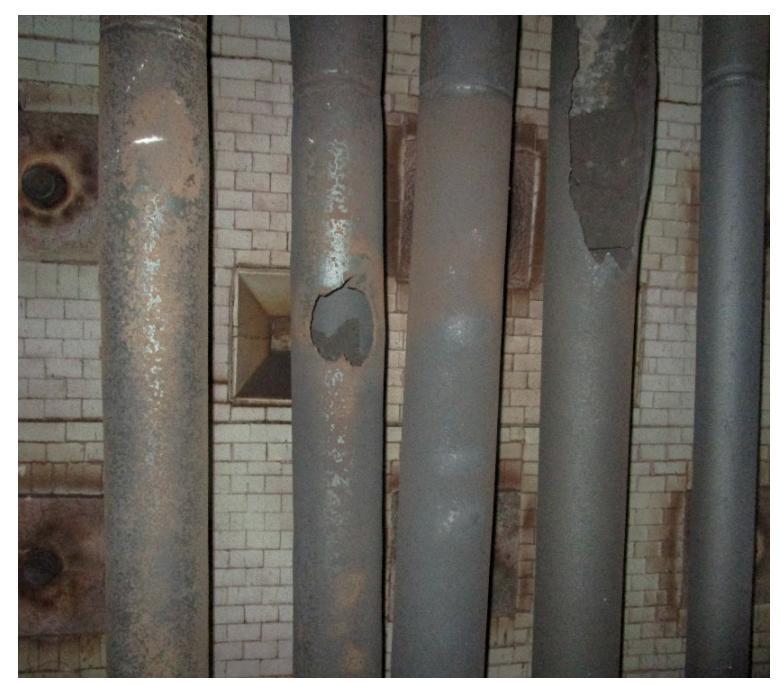
Figure 2. Failed fired heater tubes. (Credit: Chevron-Phillips)

Based on Chevron Phillips's investigation, the CSB determined that the probable cause of the incident was the rupture of fired heater tubes from short-term overheating. When the tubes were broken, a hydrogen and hydrocarbon gas mixture flowed from downstream equipment into the firebox. Flames from the burners ignited the flammable materials, resulting in the fire. Inadequate winterization of flow control equipment contributed to the incident.

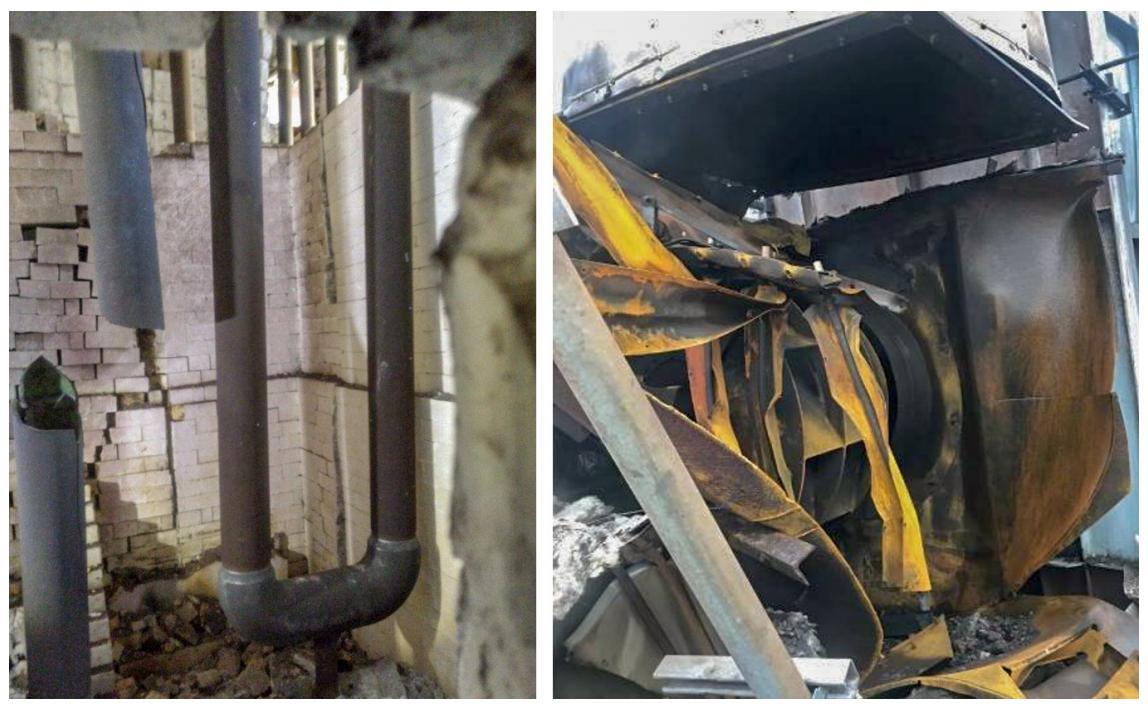
Figure 2. Fired heater explosion damage. The left image shows the broken tube and walls, and the right image shows a fan. (Credit: Chevron Phillips)

Chevron Phillips' investigation determined that the tube failure likely occurred because the fired heater tubes were shut down without decoking. Coke fouling can insulate the tube surface, resulting in local hotspots and increasing the risk of thermal shock and tube failure in fired heaters. These conditions stressed the tube's walls when the metal cooled faster than the internal coke, breaking the tube. Chevron Phillips' investigation concluded that hot insulation inside the firebox likely ignited the gas (autoignition).

Based on Chevron Phillips's investigation, the CSB determined that the probable cause of the incident was a fired heater tube failure from thermal stress due to the rapid shutdown. When the tube broke, a hydrogen and hydrocarbon gas mixture from downstream equipment flowed into the firebox. Hot insulation within the firebox likely ignited the flammable gas, resulting in an explosion. Inadequate winterization of multiple valves, instruments, and control systems contributed to the incident.

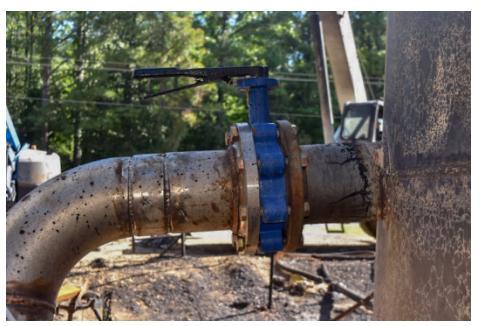
Red Hancock's investigation found that although most of the liquid was removed from the two tanks that were not replaced, some salt water, residual hydrocarbon material, and air remained inside these tanks. At the time of the incident, seven Red Hancock employees were completing the tank replacement work, which included installing an elevated walkway between the tanks and finishing piping and structural connections. While welding piping between the two middle tanks, one of the employees opened a valve (**Figure 2**) to the older tank that contained residual crude condensate material, likely releasing some hydrocarbon vapors into the new piping being welded. The flammable vapor ignited, and flames traveled back into the

Figure 2. Open valve between new piping (left) and an old tank (right). (Credit: Red Hancock)

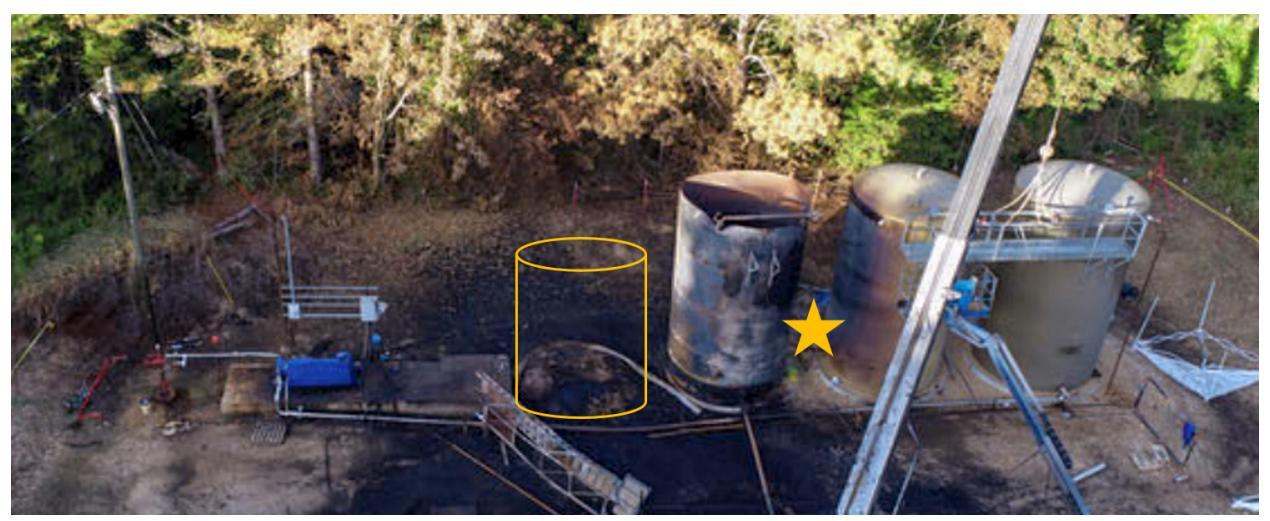
tank, resulting in an explosion and fire that ejected the top of the tank. In addition, the blast launched and forcefully propelled an adjacent tank approximately 80 feet into the woods (**Figure 3**).

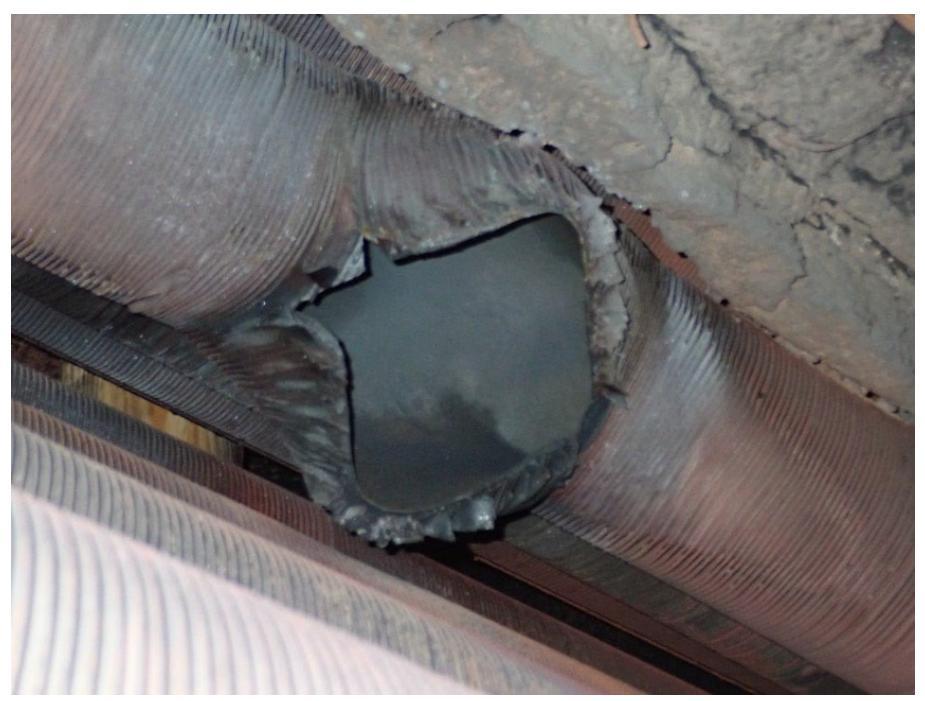
Less than an hour later, a convection section tube in the fourth pass ruptured due to short-term overheating (**Figure 2**), releasing a flammable mixture of hydrogen and hydrocarbons into the firebox. Flames from the gas-fired burners ignited the mixture, resulting in a large fire.

Figure 2. Ruptured fired heater tubing. (Credit: Valero)

Based on Valero's investigation, the CSB determined that the probable cause of the incident was a ruptured fired heater tube from short-term overheating. Flames from the fired heater's gas-fired burners ignited these flammable chemicals, resulting in the fire. The lack of automated safeguards that did not prevent the burners from being ignited before the minimum flow was established through each of the four tube passes contributed to the incident. Had Valero had such automated safeguards in place, this incident likely could have been prevented.

Additionally, Valero found that the fired heater lacked engineered safeguards to prevent the burners from being lit before establishing flow in each of the four passes. In response to the incident, Valero modified its automated burner controls to help ensure that the flow rate through every pass exceeds a predetermined minimum flow rate before operators can ignite a burner.

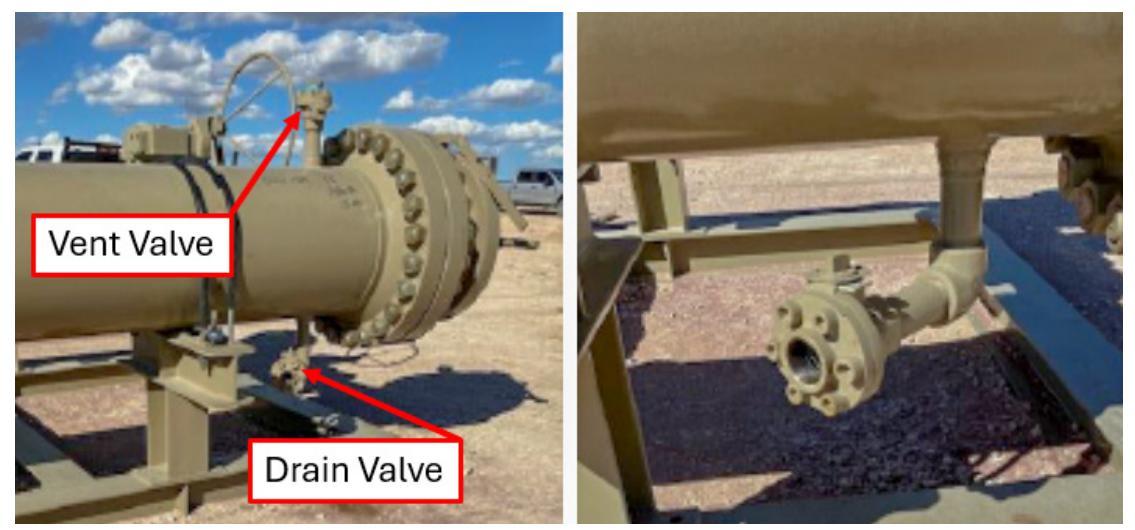
When the two workers went to remove the pig from the receiver, the pressure in the receiver was above 1,150 pounds per square inch ("psi"). To safely remove the pig, the pressure needed to be reduced by relieving it through a vent valve located at the top of the receiver. The contractor initially tried to remove the plug from the vent valve to relieve the pressure but found that the plug could not be removed with hand tools. This indicated that there could be pressure between the valve and the plug, forcing the threads tightly against each other. The contractor concluded that the vent valve might be leaking and decided to relieve the pressure inside the receiver using the drain valve instead, which was located at the bottom of the receiver (**Figure 1**).

Figure 1. Orientation of the vent valve and drain valve (left) and post-incident position of the drain piping after opening the valve (right). (Credit: XTO, edited by the CSB)

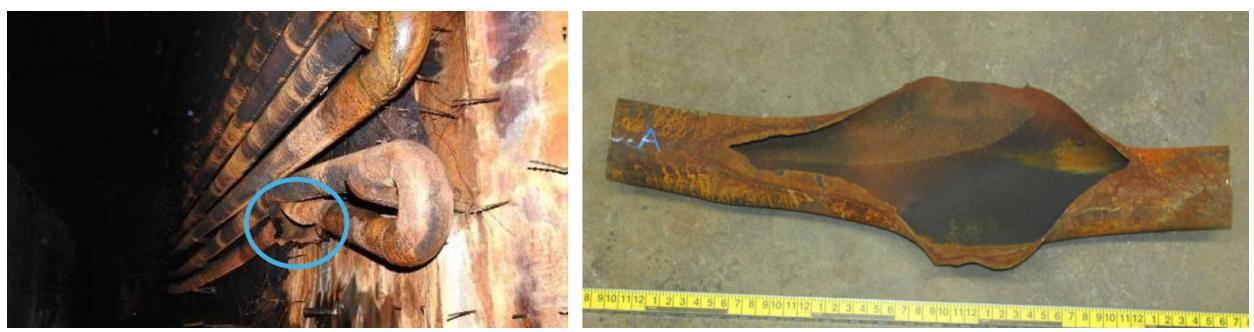
Delek's investigation identified that ambient temperatures at the facility dropped to 12 degrees Fahrenheit by 11:00 p.m. on the night of the incident. This cold weather caused operational issues with some instruments and controls, leading to low hydrocarbon flow through the tubes of a fired heater. The decreased flow resulted in reduced heat transfer, which likely caused the metal temperatures in the tubes to rise significantly. This high-temperature condition ultimately caused a tube to rupture (**Figure 2**), releasing flammable hydrocarbons into the firebox, where the existing burner flame ignited them. Delek commissioned a metallurgical examination and found that the tube ruptured due to creep damage (which results from prolonged exposure to stress at elevated temperatures) and short-term overheating.

Figure 2. The ruptured tube within the fired heater (left) and after removal (right). (Credit: Delek)

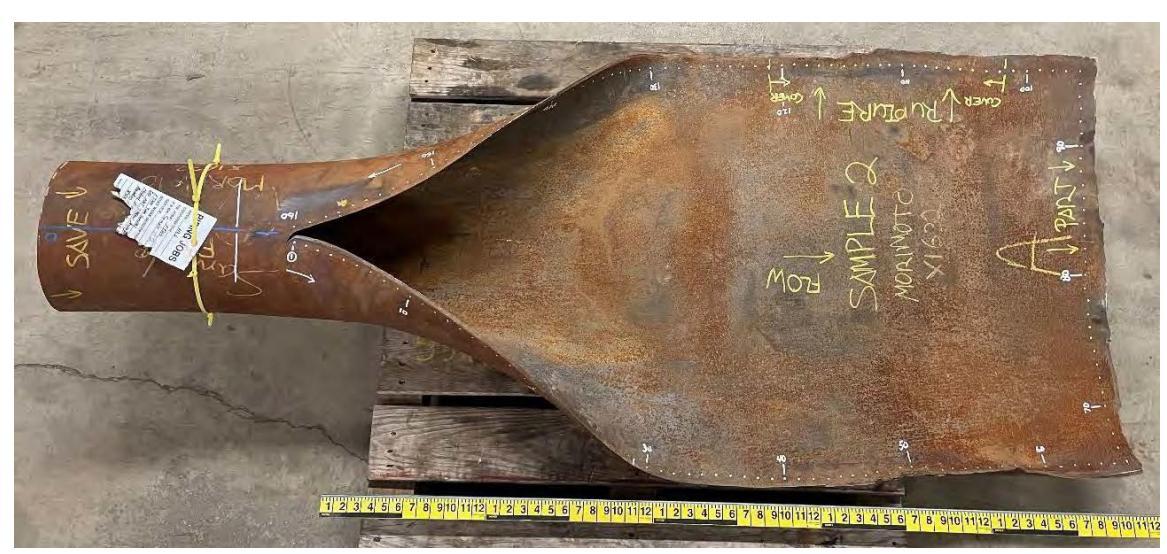
the tube failure was likely the result of a combination of localized creep damage (which results from prolonged exposure to stress at elevated temperatures) and short-term overheating.

Figure 2. Ruptured tube. (Credit: PBF Energy)

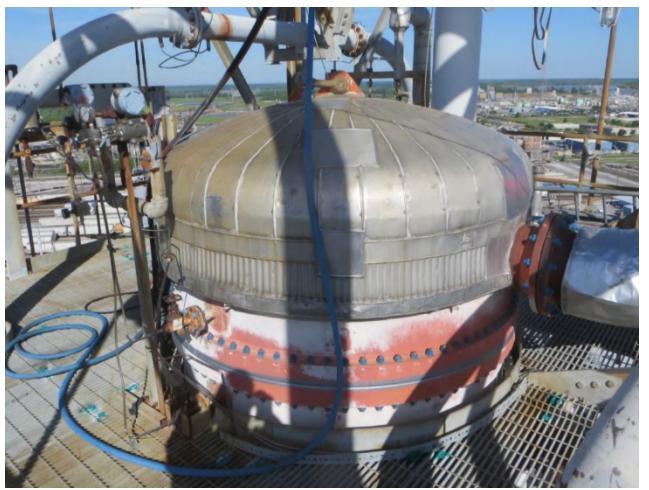
Figure 2. Top head of incident vessel. (Credit: Dow)

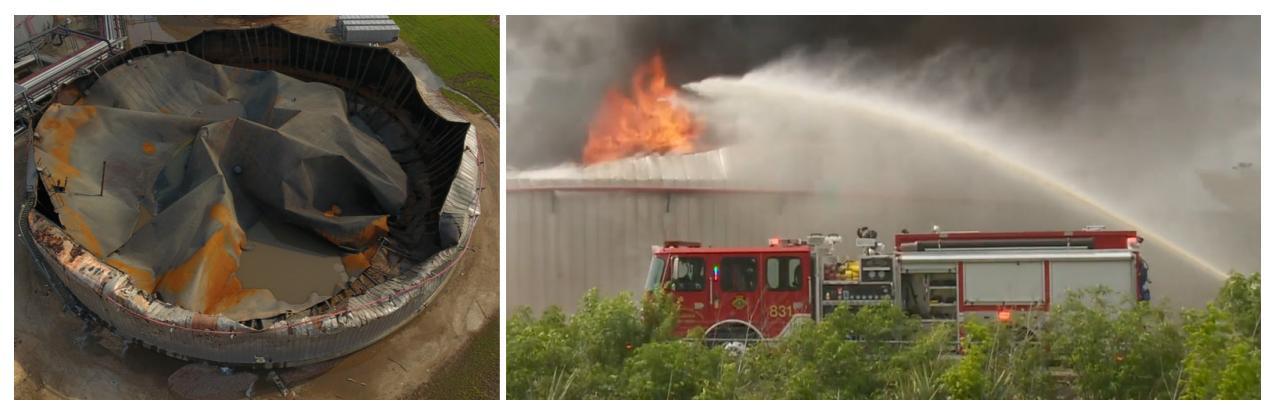
(Figure 2). Flammable hydrocarbon liquid burned in the tank for about nine hours before emergency responders extinguished the fire.

Figure 2. Post-incident photo of the damaged tank (left, Credit: IMTT) and the emergency response to the tank fire (right, Credit: WWL-TV).

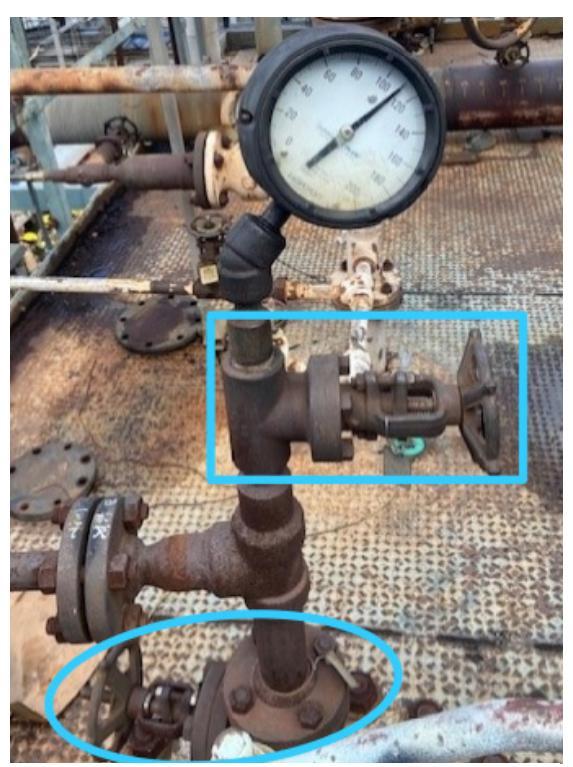
Figure 1. Photo of the pressure gauge and valves involved in the incident. (Credit: Marathon, annotations by CSB)

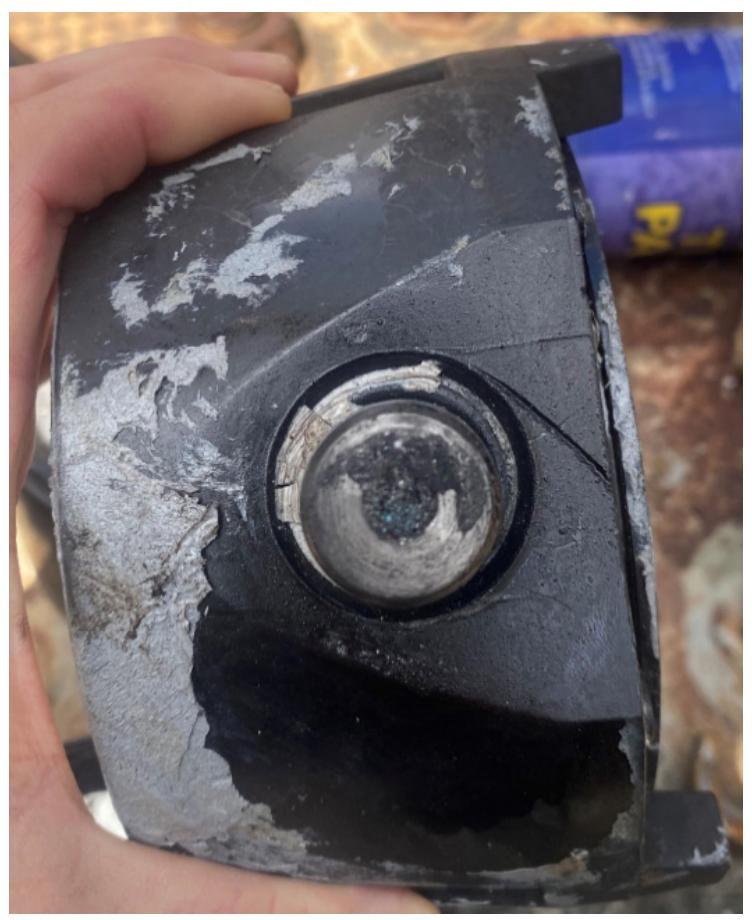
With the valve isolating the pressure gauge appearing to be closed, one of the operators began unscrewing the pressure gauge to relieve any residual pressure. The operator did not identify a potential leak as there was no indication of residual pressure while unscrewing the last threads of the pressure gauge. After the gauge was removed, however, the process pressure likely dislodged debris in the piping, causing the process stream to discharge into the atmosphere. This released flammable hydrocarbons containing hydrogen sulfide, exposing all four operators to the toxic hydrogen sulfide. Post-incident, Marathon found that the pressure gauge was plugged (**Figure 2**).

Figure 2. Pressure gauge involved in the incident. (Credit: Marathon)

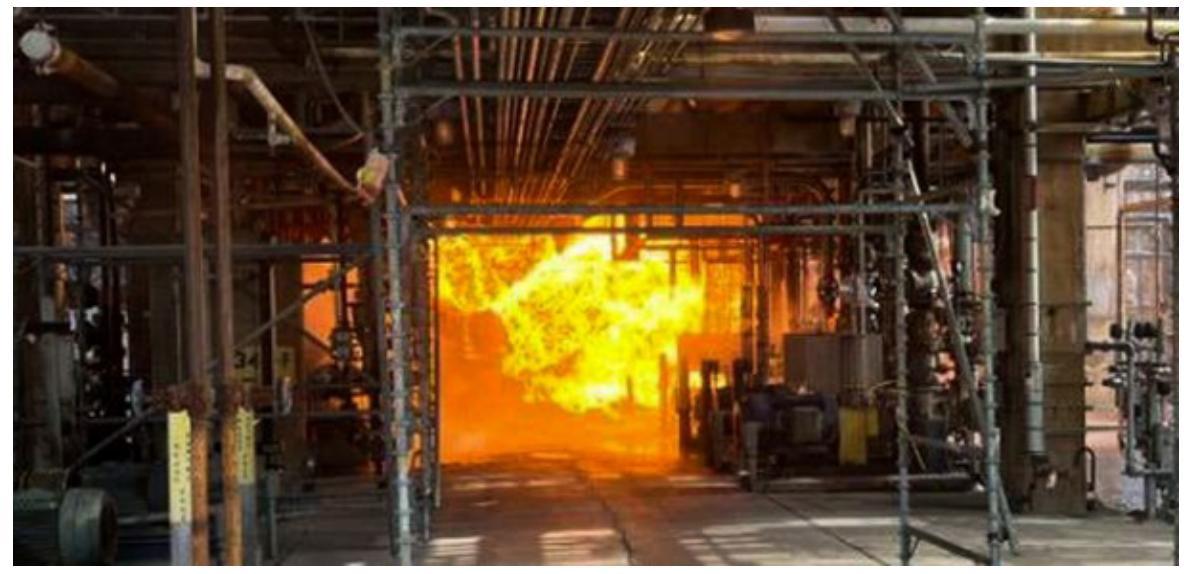
On the morning of the incident, two Marathon employees were completing an equipment oil change on an elevated platform above a pump that was supplying naphtha to downstream equipment. The pump's coupling failed, reducing outlet flow and creating high vibration that broke a small bore (³/₄-inch) piping section, releasing flammable naphtha. Employee 1 was on the platform cleaning up the work area while Employee 2 was carrying a bucket of oil down the stairs from the platform. Employee 2 smelled the released hydrocarbon and saw what looked like a steam cloud. Within minutes of the release, the flammable vapor ignited (**Figure 1**).

Figure 1. Fire from breached piping. (Credit: Marathon)

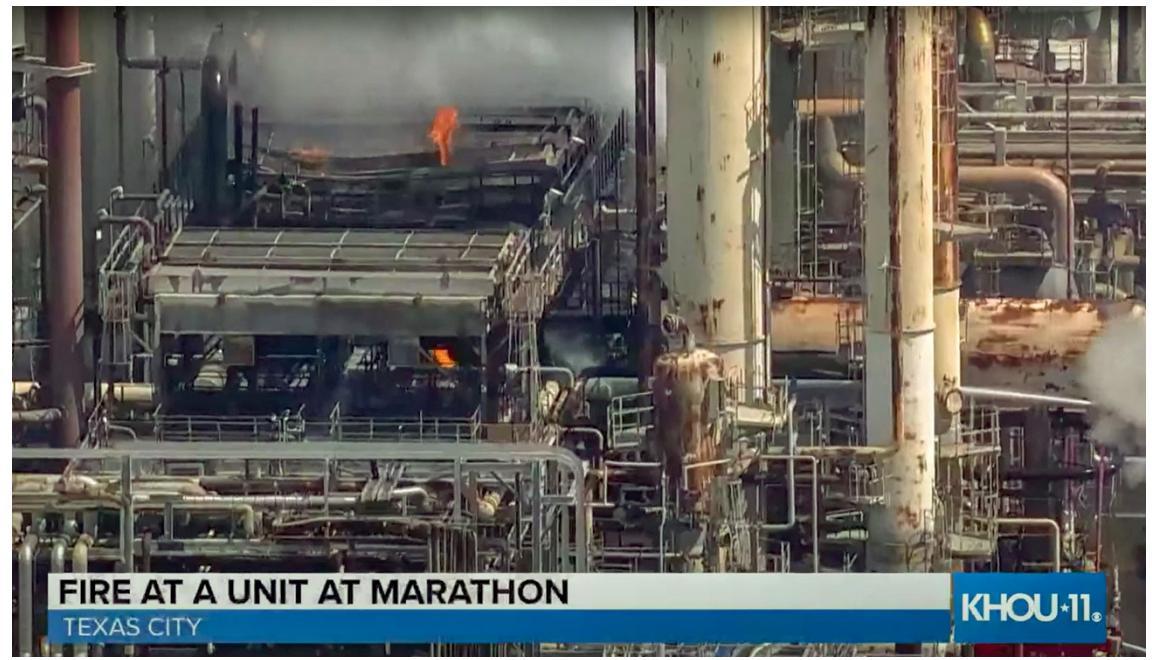
Figure 2. Fire impacting elevated platforms. (Credit: KHOU 11 News)

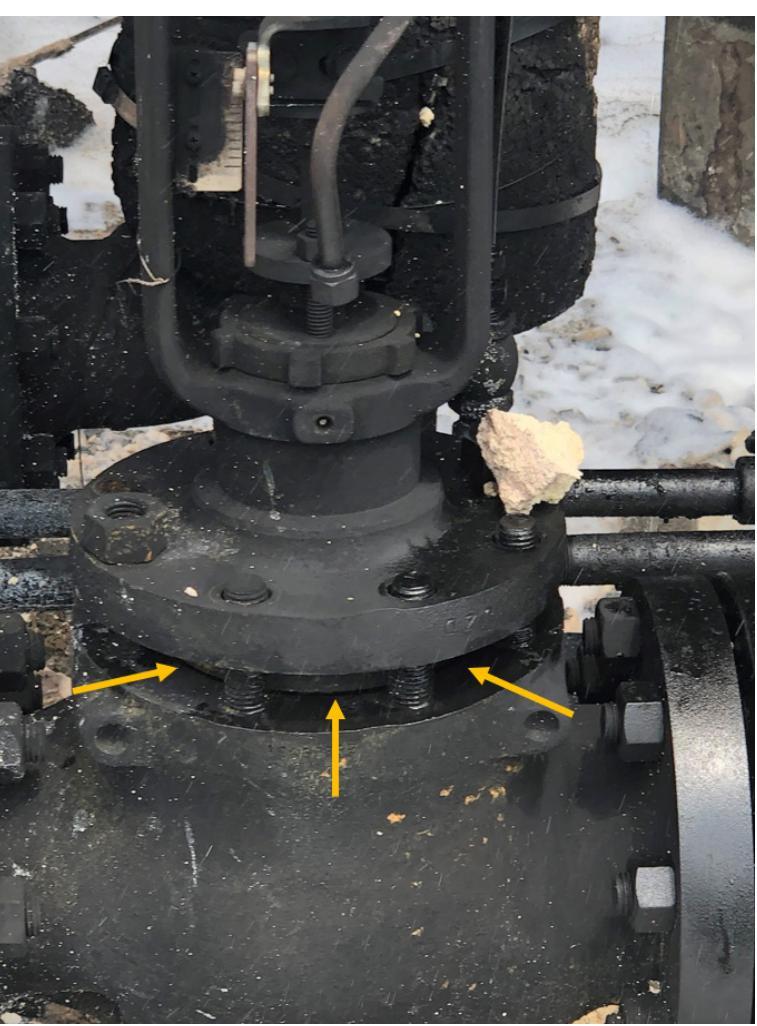
The investigation revealed that six of the eight nuts had been removed from the control valve's bonnet flange, which was the typical practice at the refinery when preparing to access the internal components. The control valve's bonnet flange had been partially disassembled while its downstream isolation valve was open, and it contained naphtha at 250 pounds per square inch gauge pressure and 425 degrees Fahrenheit. It is unknown whether the maintenance employees thought the system was safe to disassemble the control valve or did not recognize the hazard of disassembling the pressureretaining components.

Figure 2. Naphtha release point (gold arrows). (Credit: CVR Energy with annotations by CSB)

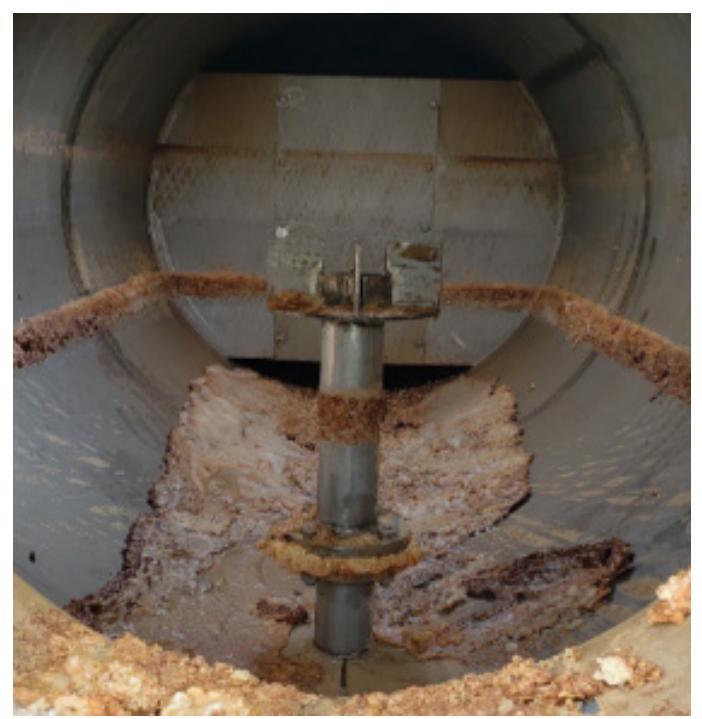
Figure 1. Tank Containing Solids at SABIC. (Credit: SABIC)

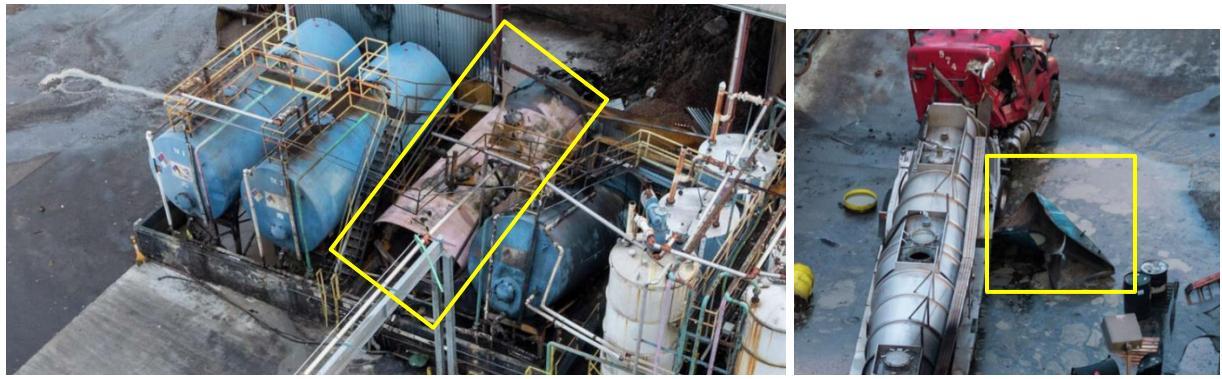
Figure 1. The tank that exploded (left). A portion of the tank after the explosion (right) (Credit: Tradebe, annotated by the CSB).

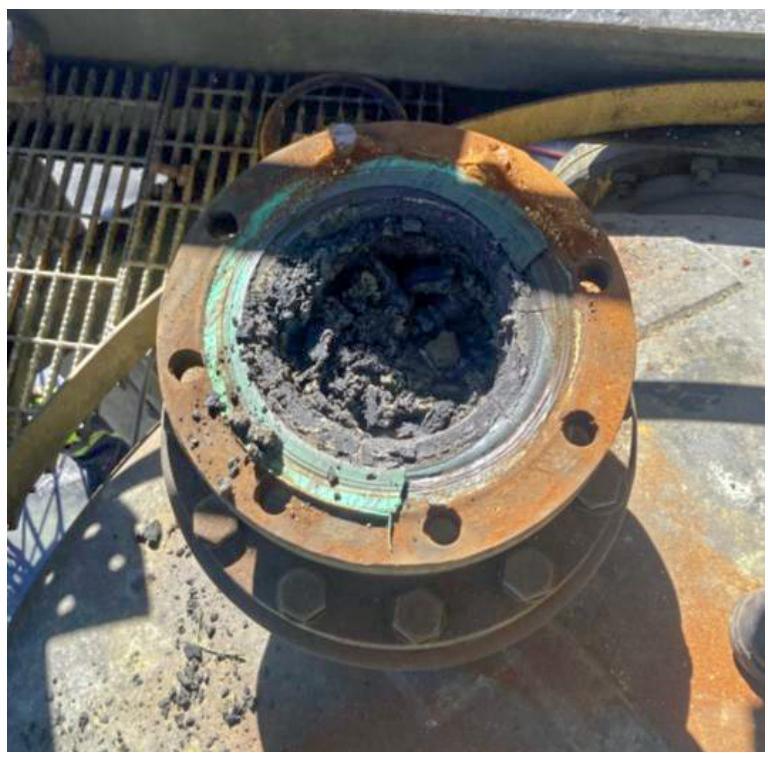
Figure 2. Solids in the rupture disc inlet piping. (Credit: Tronox)

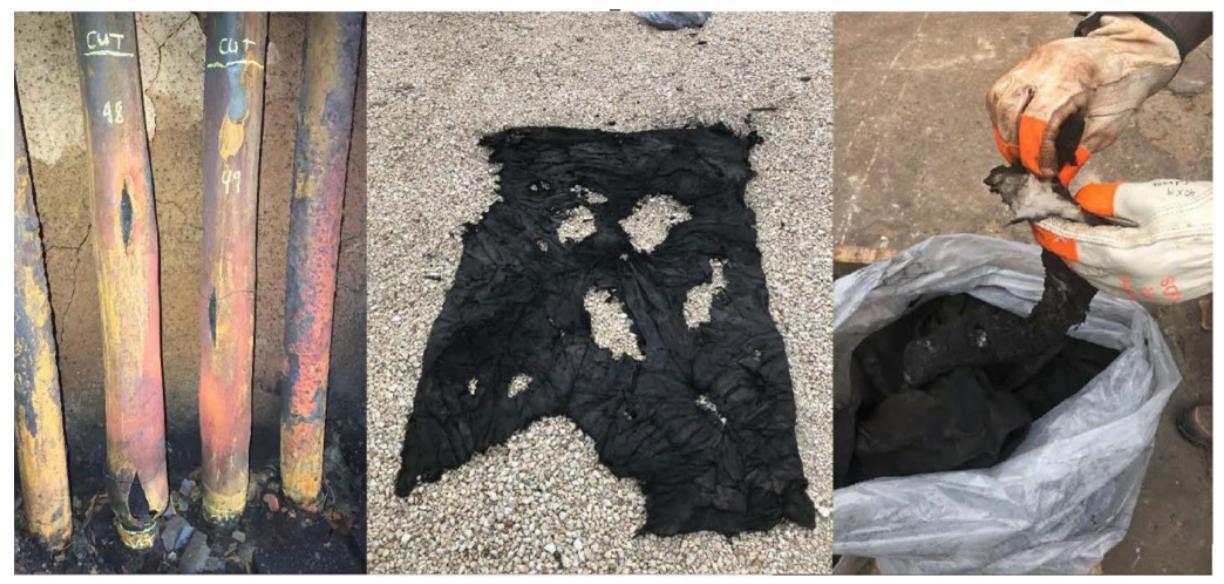
tubes ruptured because of a combination of creep damage (which results from prolonged exposure to stress at elevated temperatures) and short-term overheating.

Figure 2. Failed fired heater tubes (left) and debris removed post-incident (center and right). (Credit: ExxonMobil)

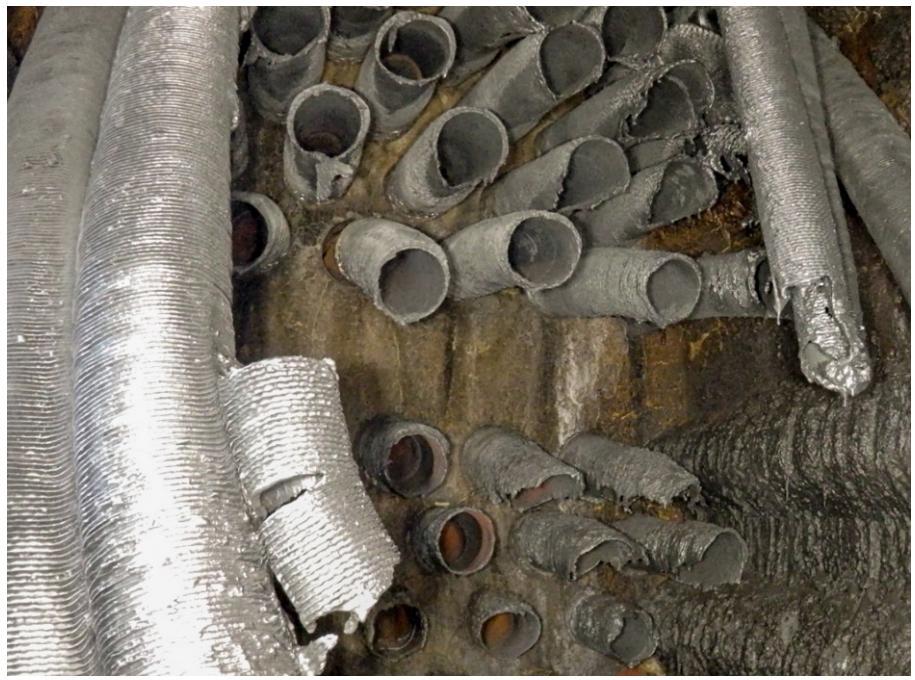
Figure 2. Broken fired heater tubes. (Credit: LyondellBasell)

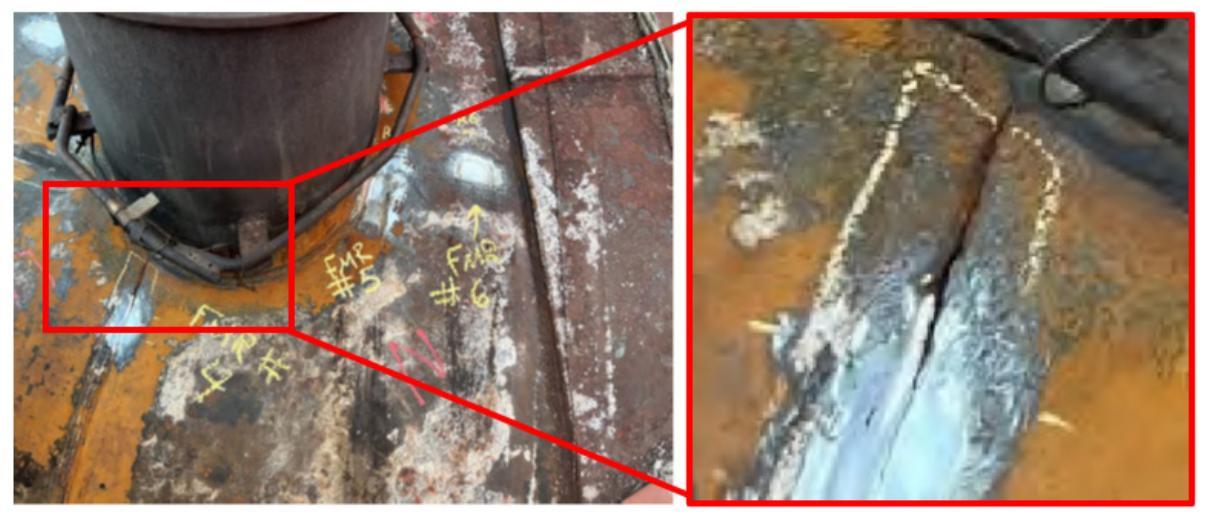
cracks in the reactor that were up to 67 percent of the wall thickness. The cracks were created by a damage mechanism known as corrosion fatigue. Corrosion fatigue is caused by cyclically applied stress under corrosive conditions. Internal cracks formed at the top of the reactor, an area that was consistently exposed to sulfur-containing chemicals commonly found in petroleum refining. This sulfidation corrosion was coupled with temperature swings over 200°F, which applied stress to the vessel through expansion and contractions of the metal with the temperature changes. LyondellBasell found that there had been more than 50 temperature cycles since 2011. Additionally, platform supports were added to the reactor head in 2001, contributing to the cracking by increasing the stress exerted on the vessel. Stress-assisted preferential sulfur penetration is the specific type of corrosion fatigue responsible for the 8-inch crack.

Figure 2. One of the cracks in the reactor's head. (Credit: LyondellBasell, edited by the CSB)
