U.S. CHEMICAL SAFETY AND HAZARD INVESTIGATION BOARD

# INVESTIGATION REPORT

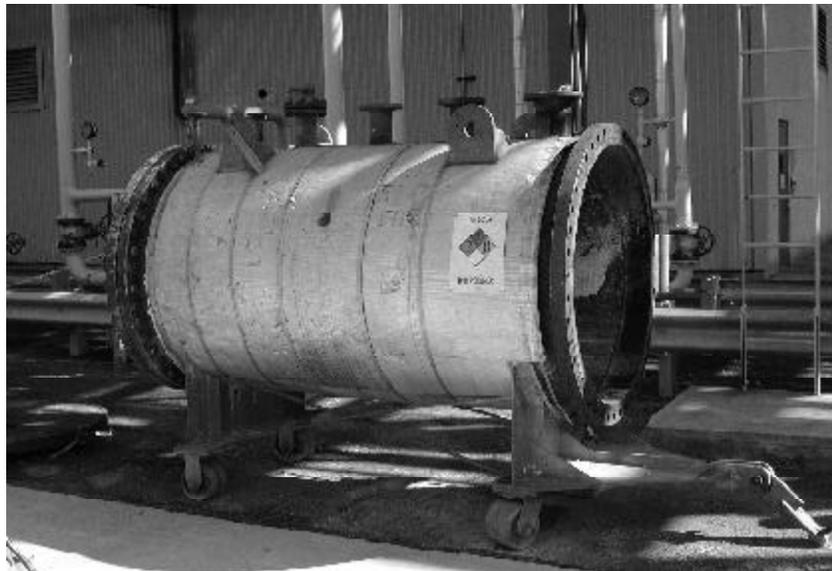
Figure 3. KD-502 polymer catch tank (actual vessel with one cover removed).

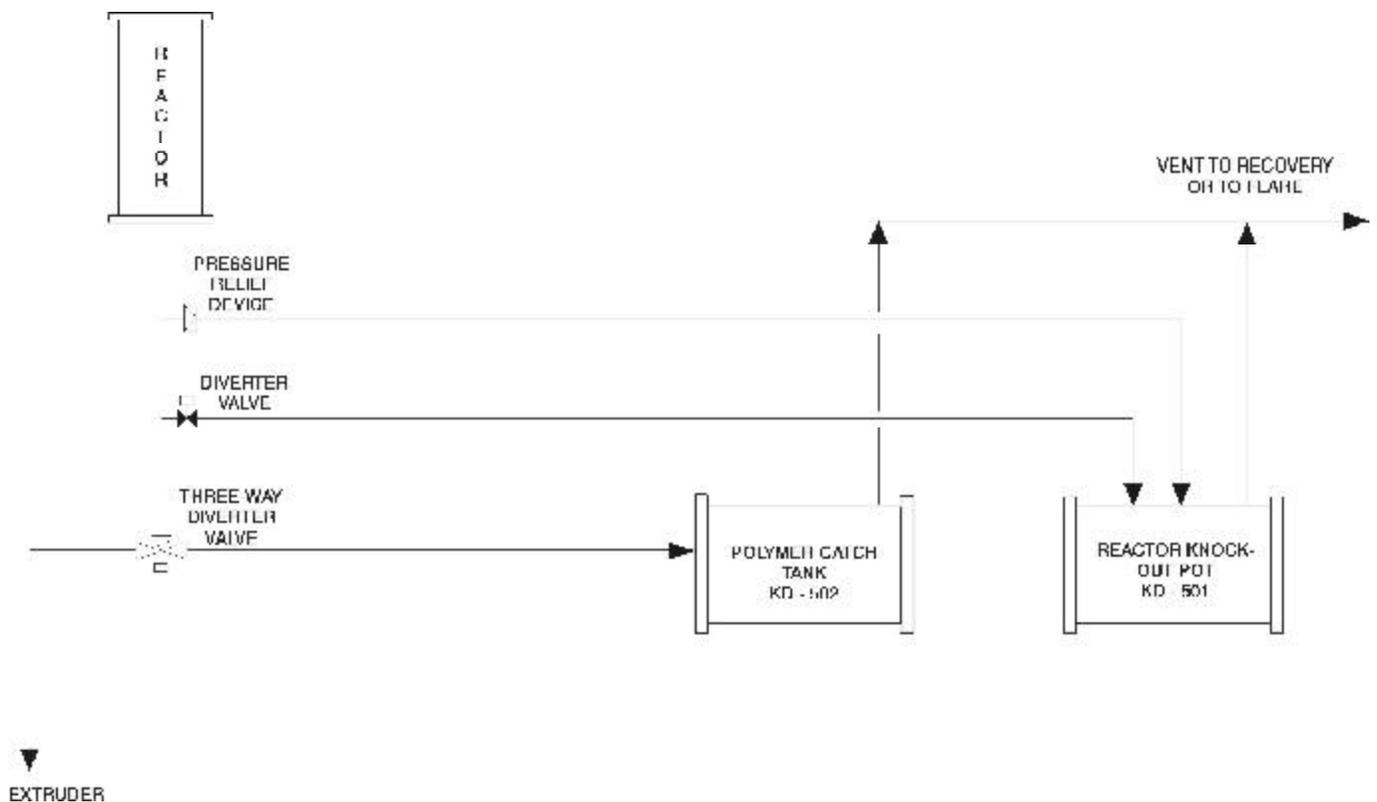
Figure 4. Simplified process diagram showing polymer catch tank and reactor knockout pot.

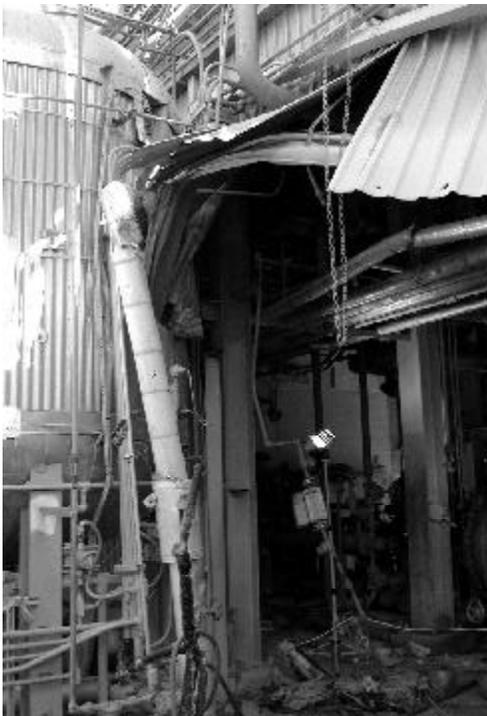
Figure 5. Damaged girder.

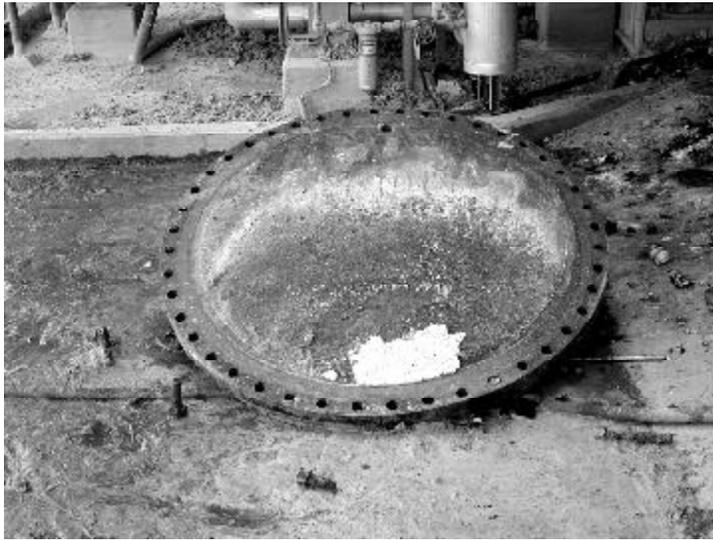
Figure 6. Polymer catch tank cover.

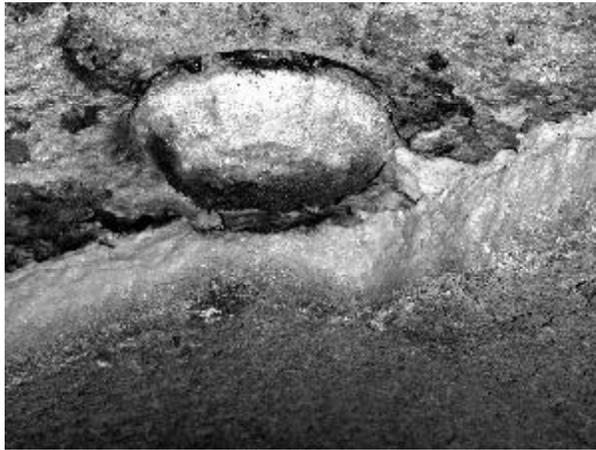
Figure 7. Polymer plugging the polymer catch tank vent nozzle.

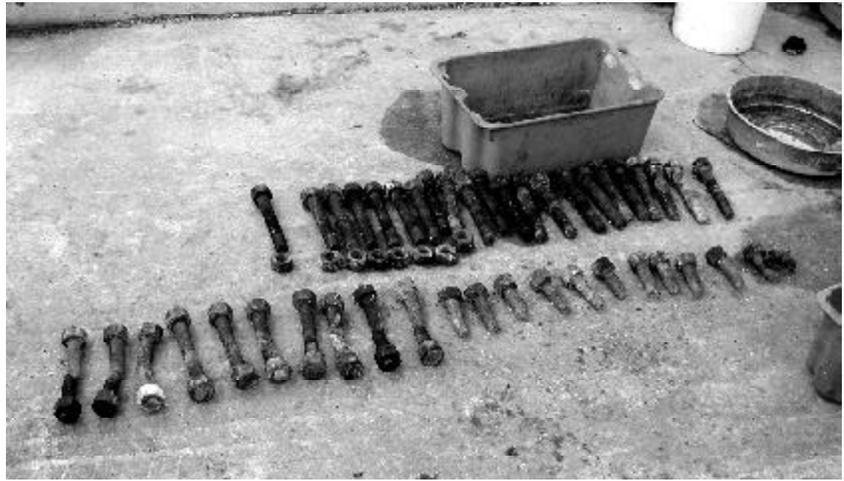
Figure A-2. Failed bolts from polymer catch tank cover.

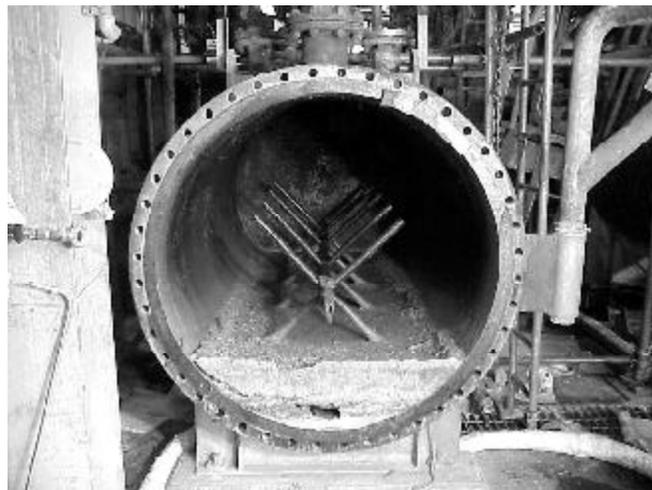
Figure A-3. Reactor knockout pot with internal frame visible.

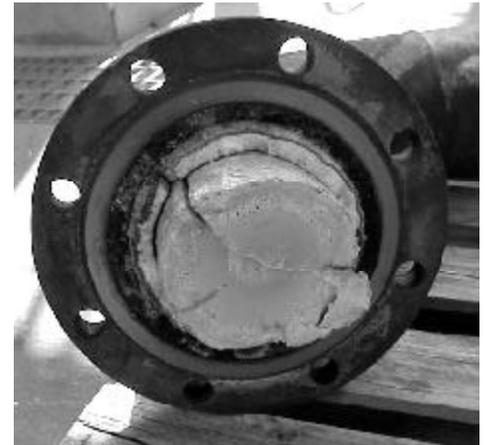
Figure A-4. Vent line obstructed by polymer layers.

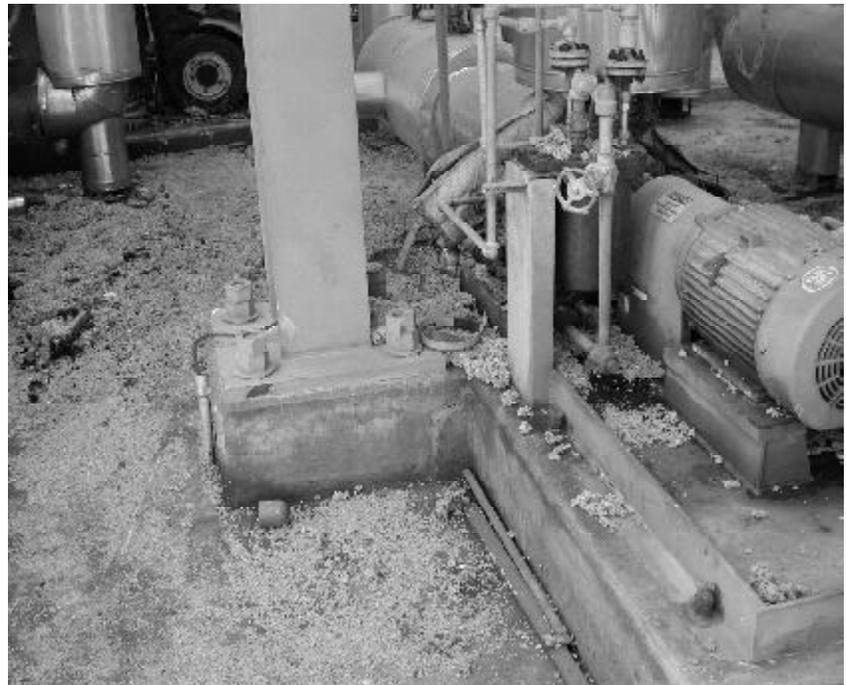
Figure A-5. Polymer scattered throughout work area.

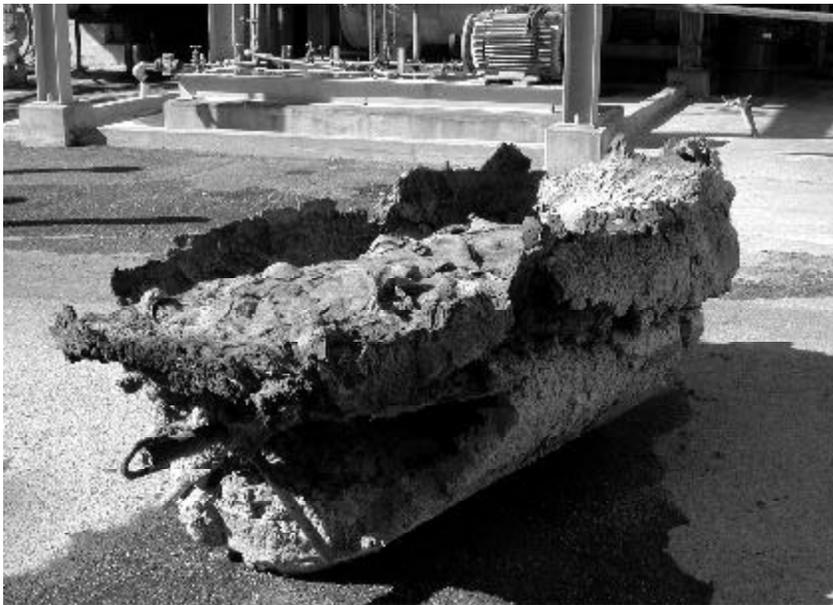
Figure A-6. Material extracted from polymer catch tank on March 11, prior to incident.

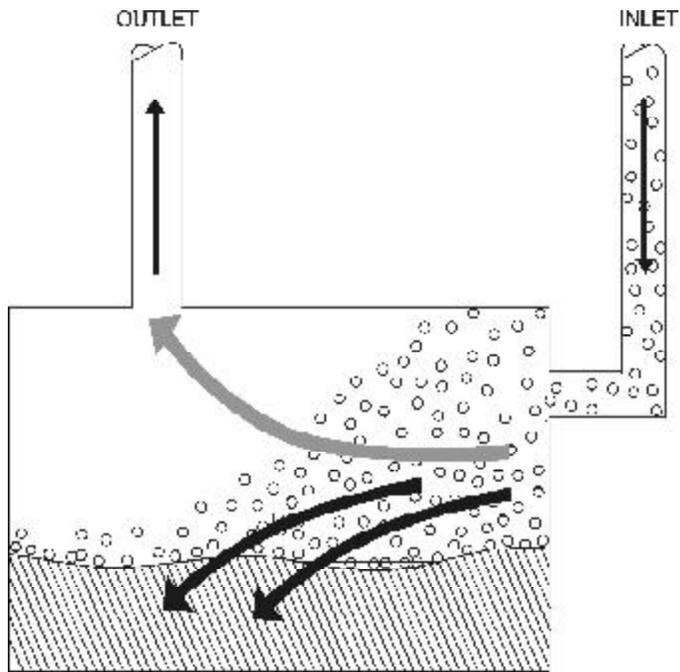
Figure A-7. Normal operation—settlement of particles.

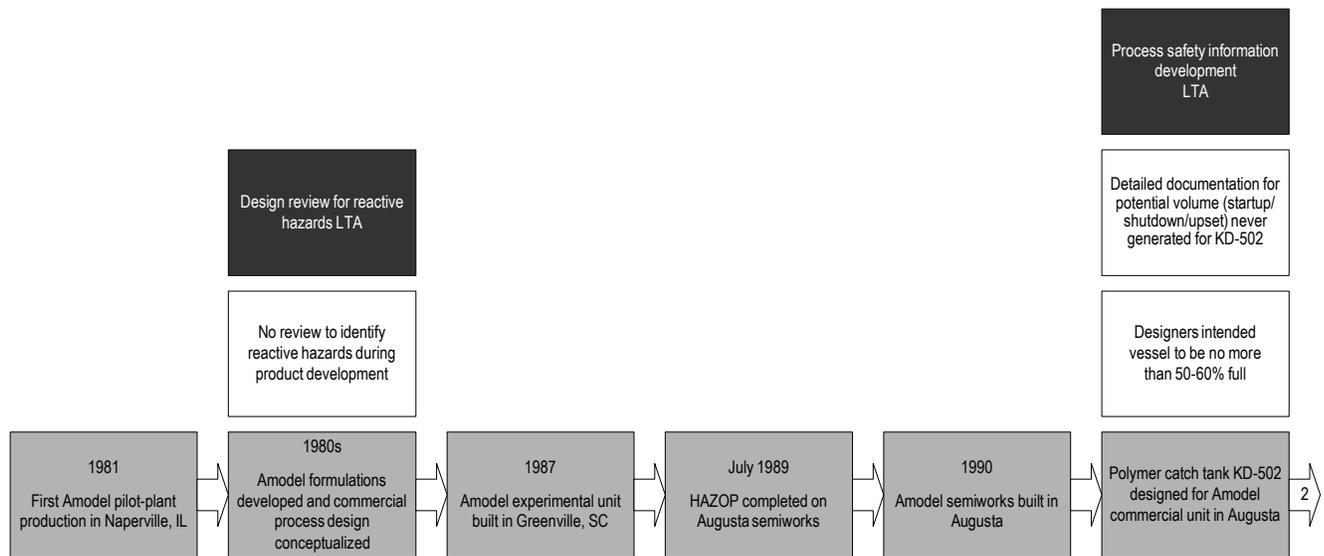
KD-501 = reactor knockout pot  
 KD-502 = polymer catch tank  
 LTA = less than adequate  
 MOC = management of change  
 PHA = process hazard analysis
