BETA LAB NO.M10198- LS2-CS3 TEE INDICATIONS	TESORO REFINING AND MARKETING COMPANY ANACORTES REFINERY 10200 W. MARCH POINT ROAD T91WA4428 ANACORTES, WA 98221	CUSTOMER P.O. NO.: 4501667904
PART: 6600-E HEAT EXCHANGER LS2-CS3 TEE INDICATIONS PART 16-1		DATE: AUGUST 13, 2010
PAGE 1 OF 45

**LABORATORY REPORT- LS2-CS3 TEE INDICATIONS FINDINGS**

**SAMPLE DESCRIPTION:** A heat exchanger failed and a test protocol was developed for the failure analysis of the component. This test protocol and its addendum, as of this date and contained in Attachment 1, were developed and signed by Tesoro Companies, Division of Occupational Safety and Health and U.S. Chemical Safety Board. FirstEnergy BETA Laboratory was selected as the referee test laboratory to perform the testing requirements of test protocol. The test protocol was not specific as to the test samples to be removed from the heat exchanger or the test locations/test parameters for each specific test within the test sample. Therefore it was agreed

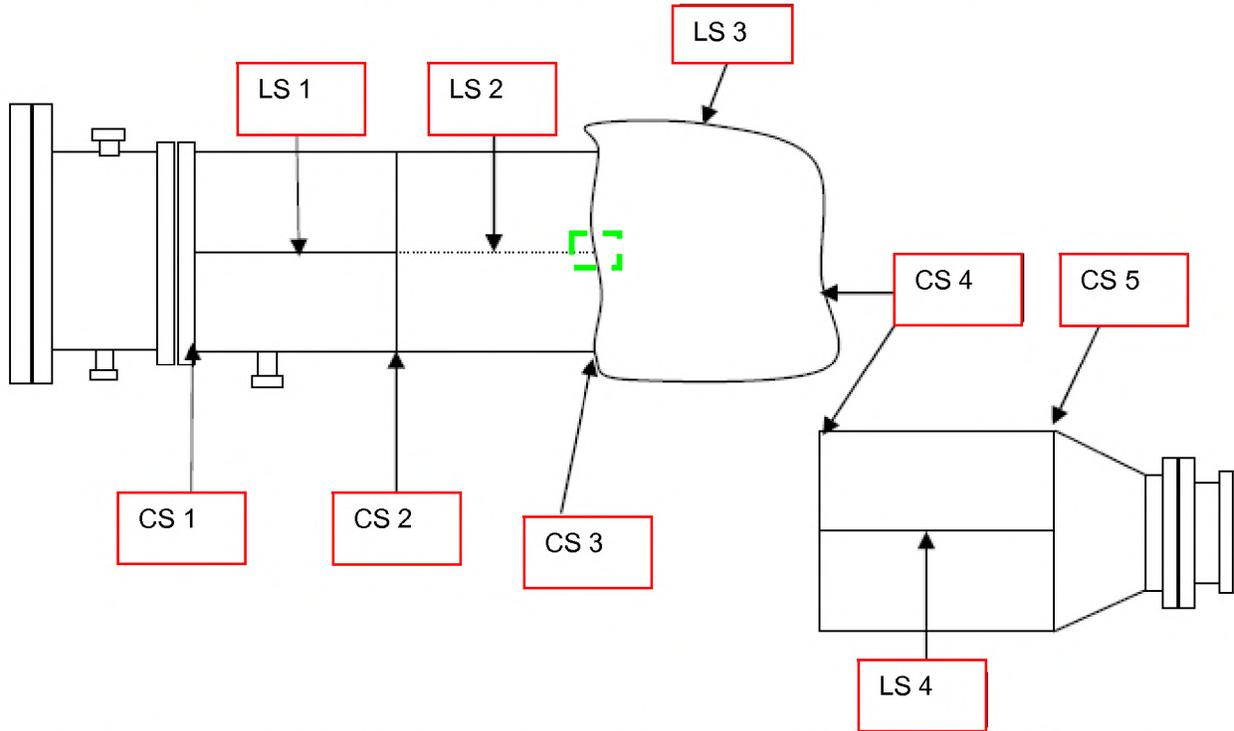
Sketch of main heat exchanger Cans 1-3 and separated back head Can 4- green dotted line is item for this report which is on the opposite side of the exchanger from the leak

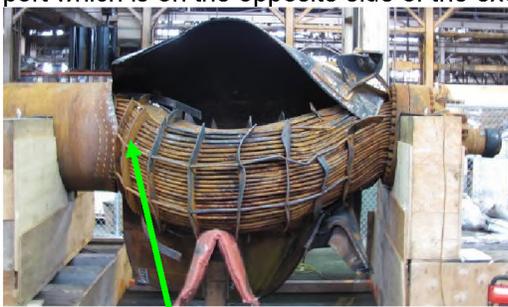
Leak side of the heat exchanger with areas of interest for this report on the backside

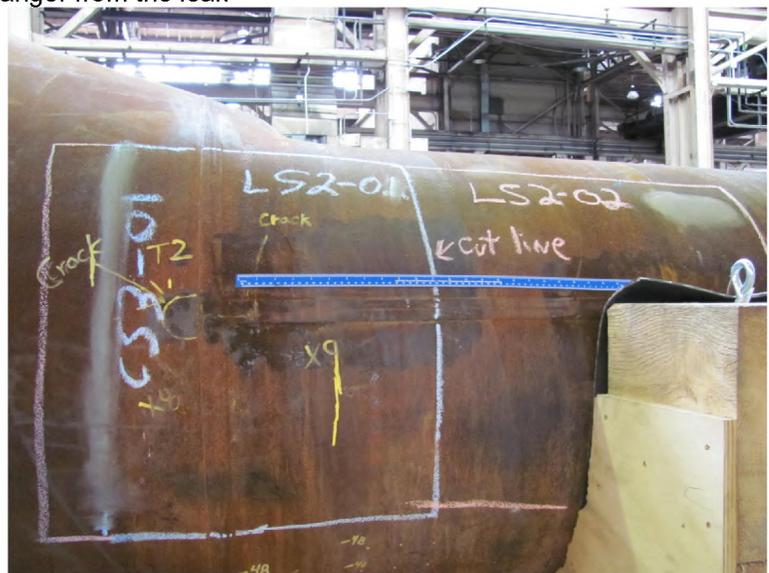
**FIGURE 1 Un-packaged 6600E heat exchanger with area marking for removal in two pieces**

**TEST RESULTS:** The heat exchanger weld seams had been previous labeled as shown in Figure 1 and the same labeling was used for this report. The pieces labeled part 16-1 and 16-2 (LS2-01/CS3-01) containing the field UT indication T2 shown in Figure 1 and 2, was received at BETA Lab for testing. These were given two part numbers because Halvorsen was requested to cut the piece in half for ease of handling and cutting. The ID surface of part 16-1 and 2 were magnetic particle inspected (by others, see attachment 3) and no reportable indications were found.

Note T-2 UT indication at CS3 and LS2 TEE

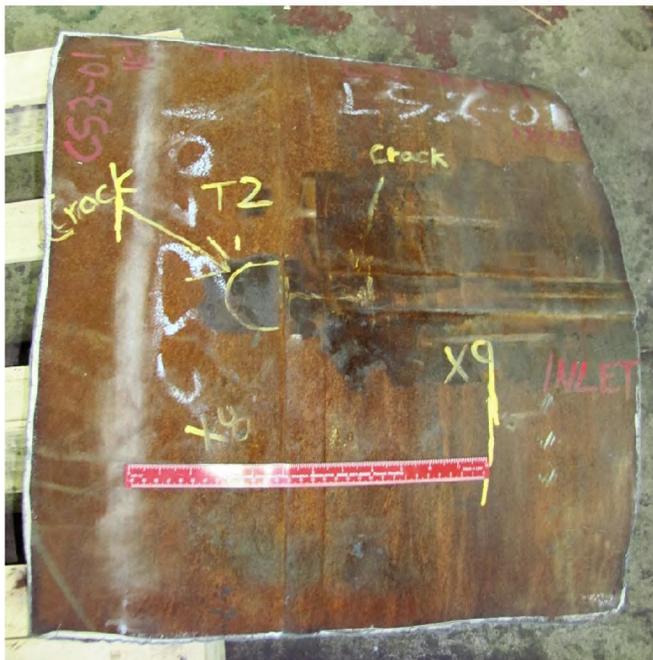
Part 16-1 cut out ready for shipment

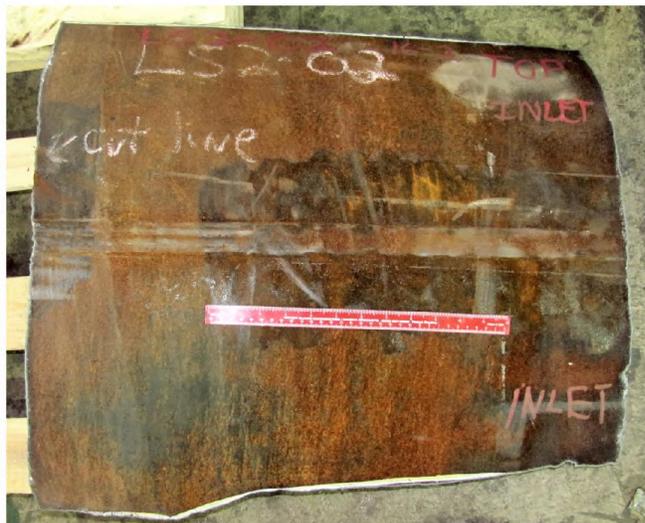
Part 16-2 cut out ready for shipment

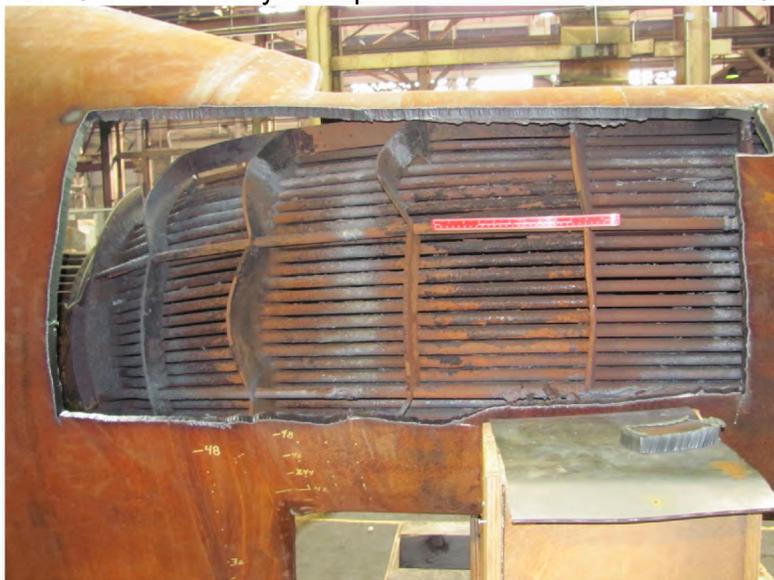
**FIGURE 2 Samples cut out at Halvorsen**

Area in shell wall where the samples above were removed

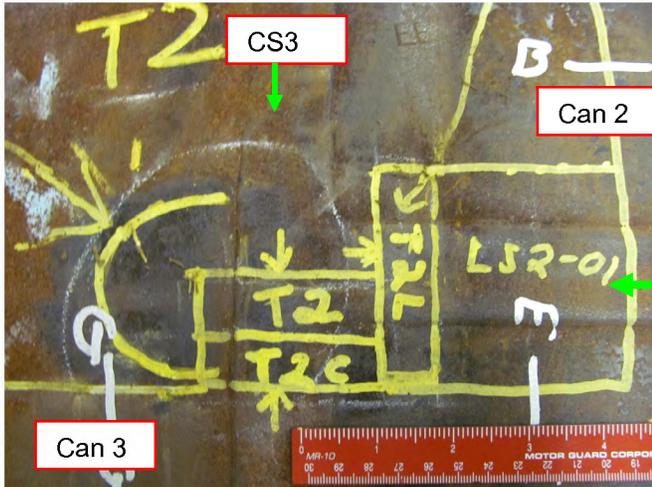
Three locations were selected, by others, for metallurgical mounting. The locations for the samples removal and the photos of the etched mounts are shown in Figure 3. The mounts were examined in the un-etched and etched conditions and photomicrographs were taken as selected by others. The photomicrographs are shown in Figures 4-23.

Part 16-1 with locations for three mounts at welds looking in the direction of the arrows

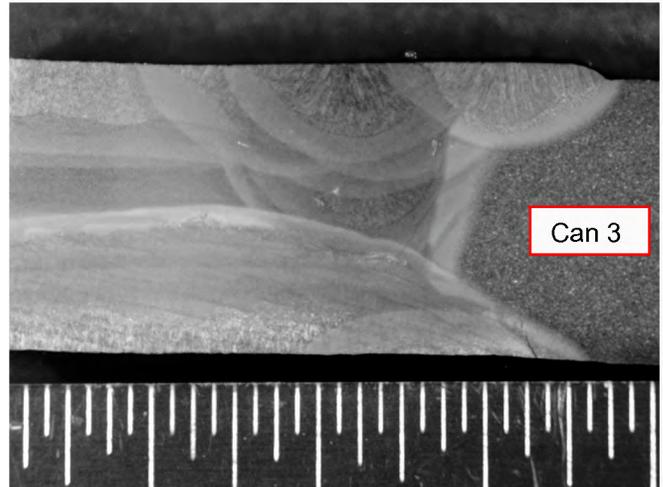
Photomicrograph of T2 looking in direction of the arrow ID on bottom, scale mark is 1/16 inch

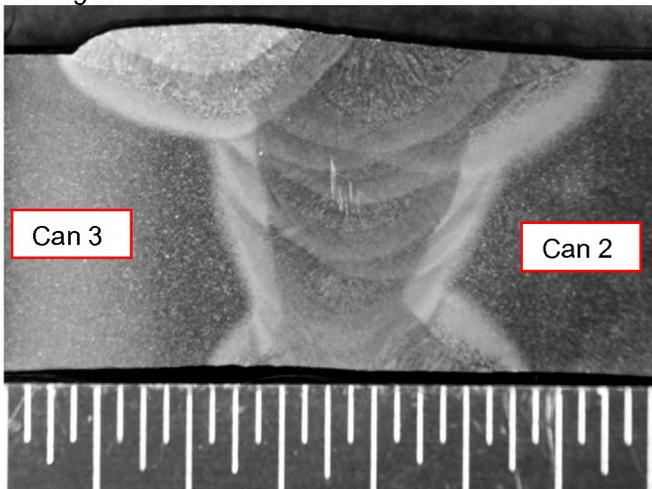
Photomicrograph of T2C looking in direction of the arrow-ID on bottom, scale mark is 1/16 inch, artifact in center of weld

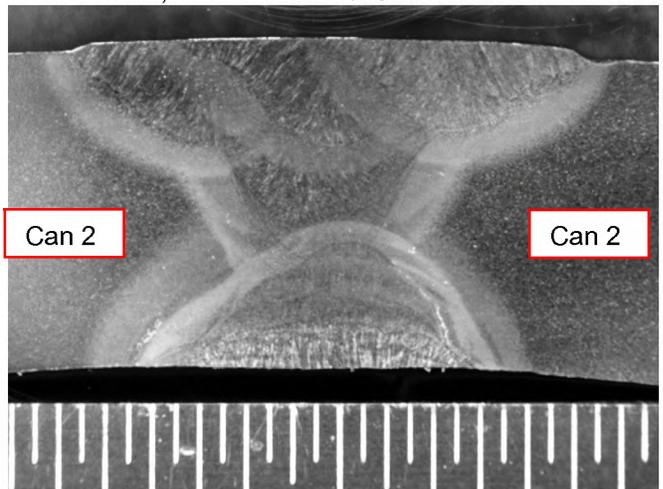
**FIGURE 3 Photomicrographs of the mounts for T-2, T2C and T-2L looking at the UT indications for T2 and T2L – ID on the bottom of each mount**

Photomicrograph of T2L looking in direction of the arrow-ID on bottom, scale mark is 1/16 inch

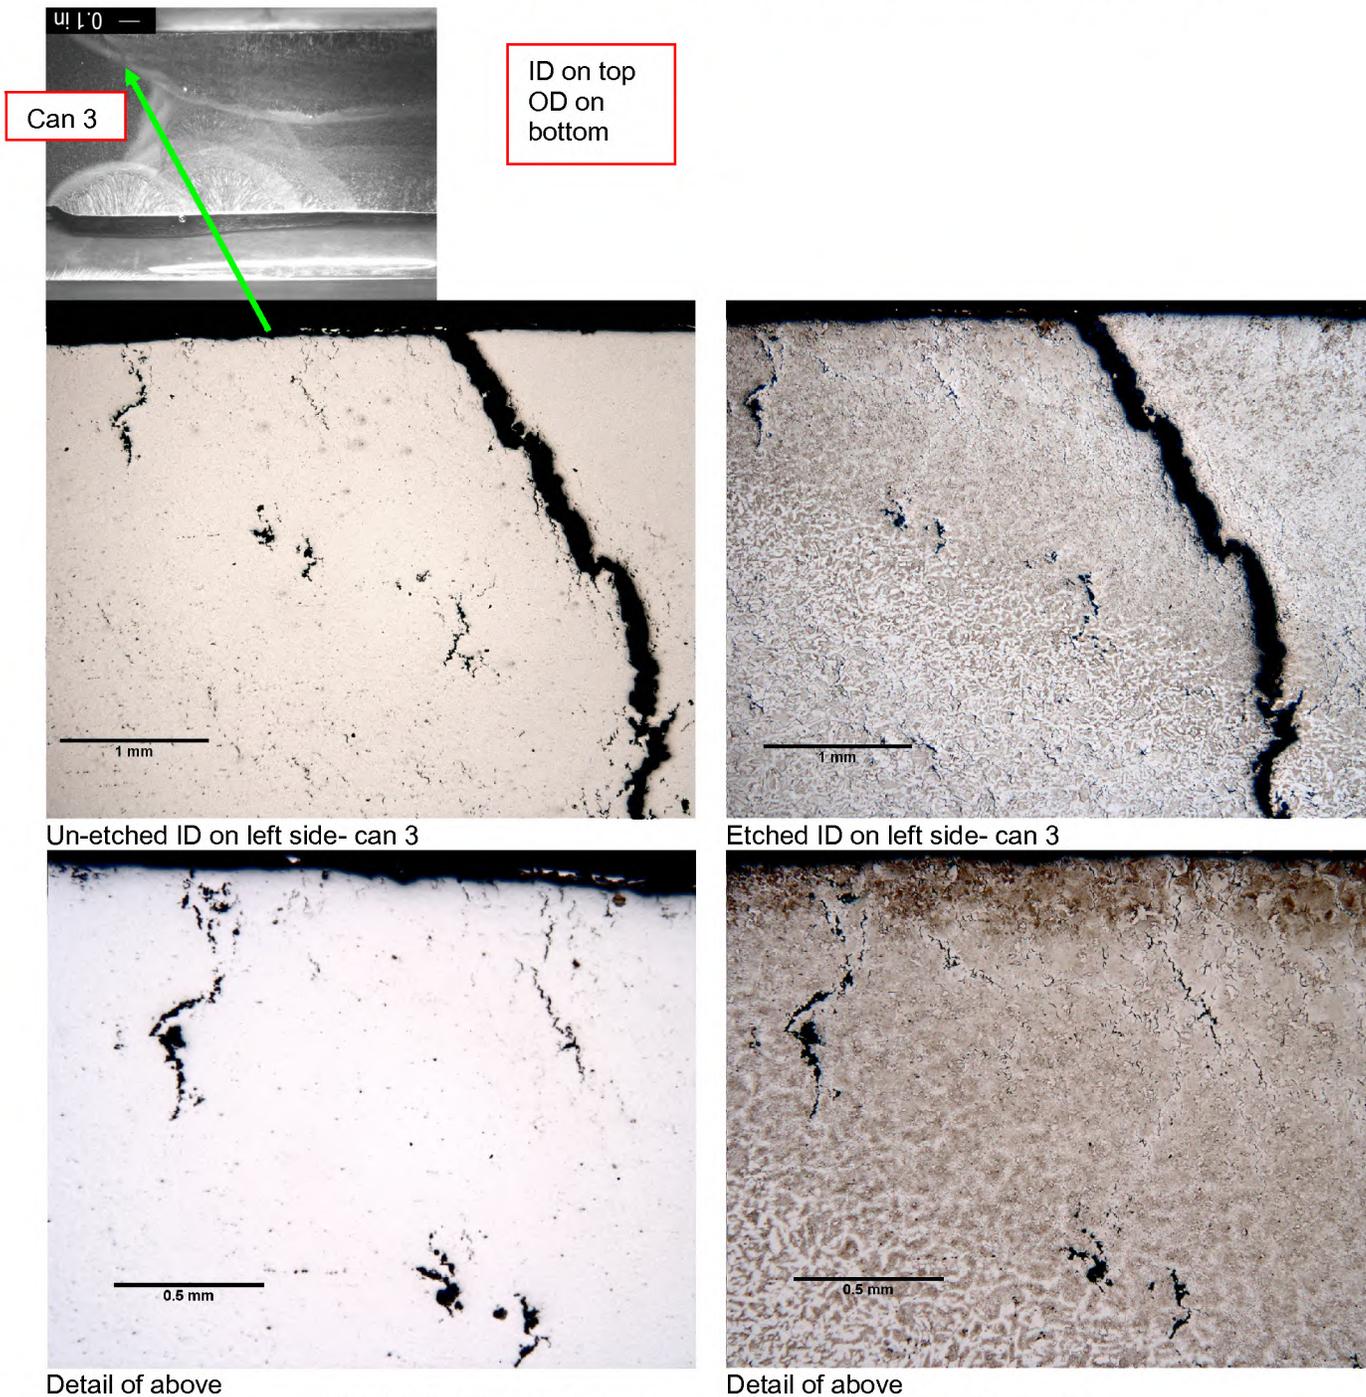
**FIGURE 4 Photomicrographs of Mount T2 at ID on Can 3 side**

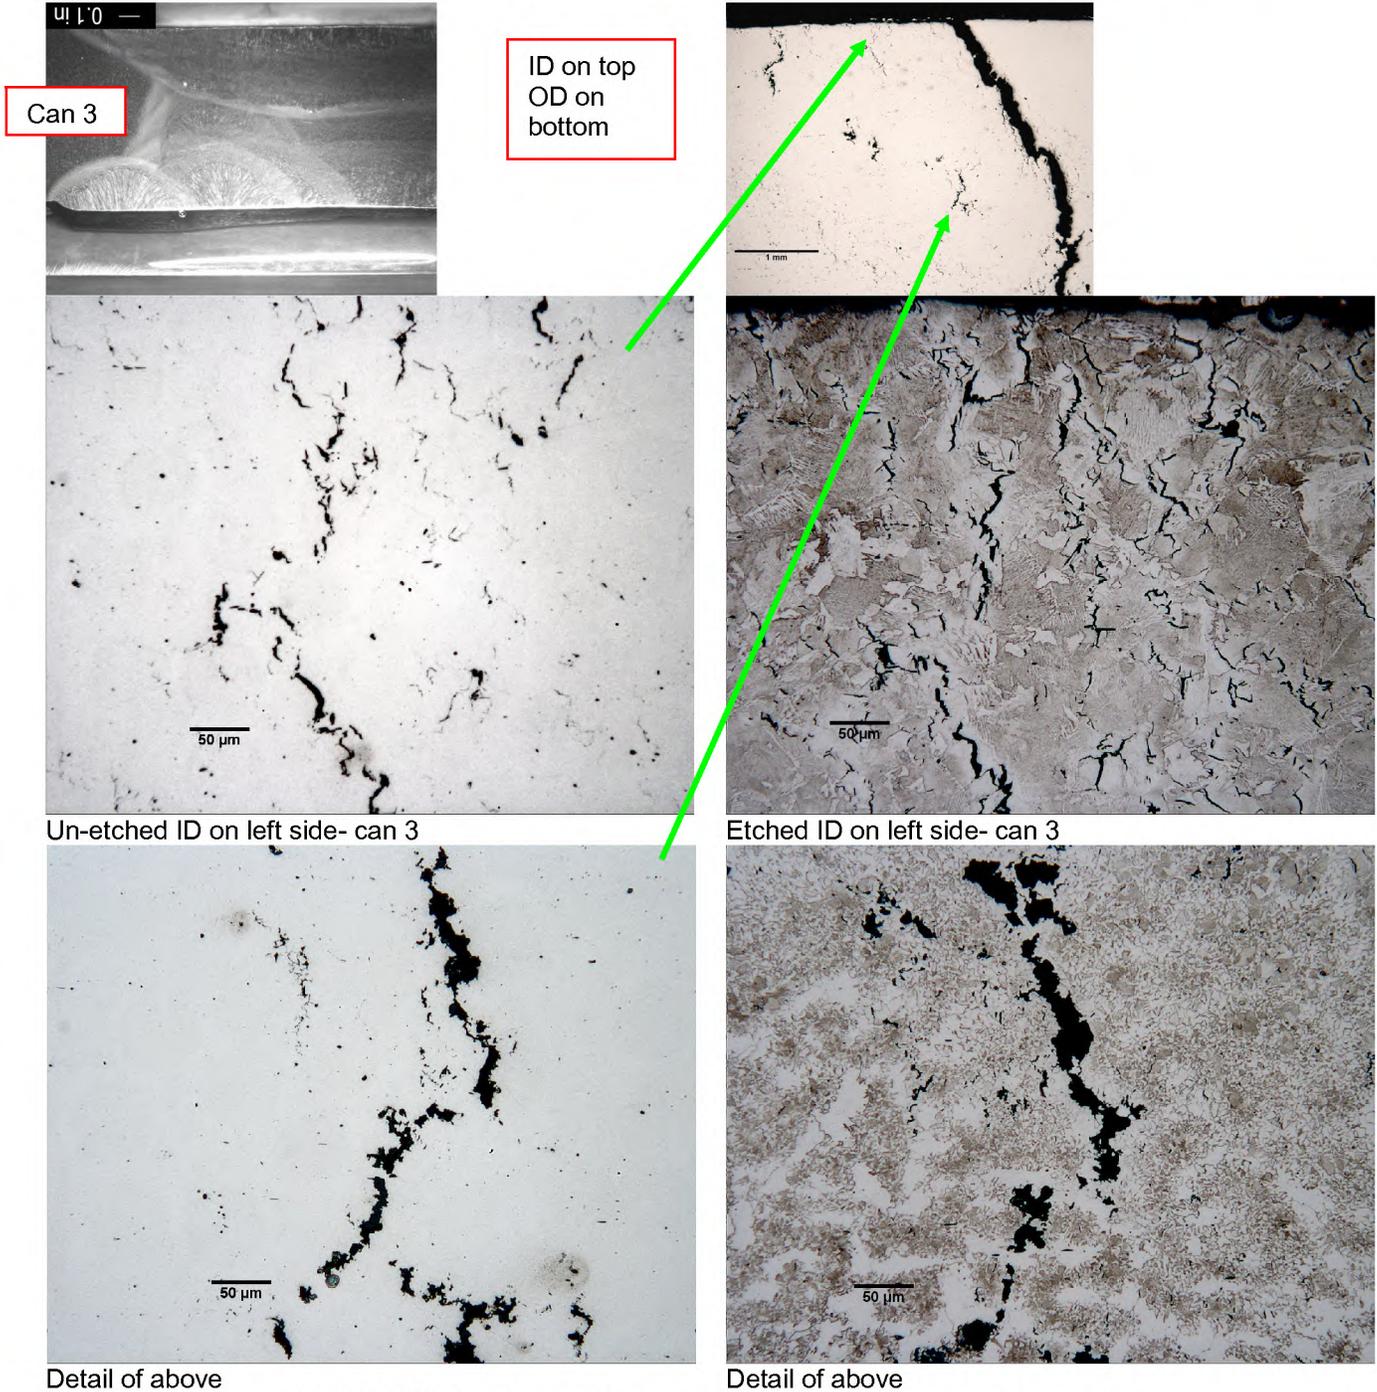
**FIGURE 5 Photomicrographs of Mount T2 at or near ID on Can 3 side**
