Confined Space Entry - Worker and Would-be Rescuer Asphyxiated

No. 2006-02-I-DE

Valero Energy Corporation Refinery

Delaware City, DE

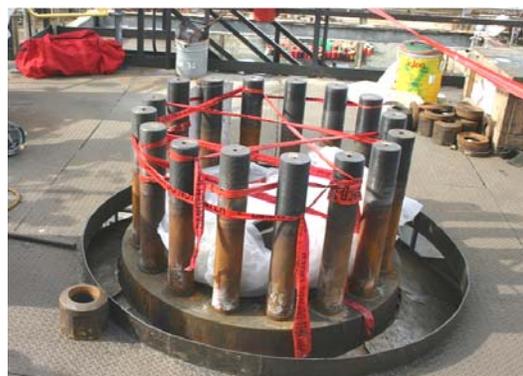
Figure 1. Plastic sheet and plywood disk on R1 manway. Red "danger" tape on the studs alerted workers of the unsecured confined space access opening.

top manway (Figure 1), the only open discharge point on the reactor.

Two days before the incident, workers employed by Catalyst Handling Services Corporation (CHSC), the catalyst contractor, finished loading the reactor with the new catalyst and placed a temporary plastic tarp and wooden cover over the open manway to prevent moisture and debris from falling into the reactor. They also attached a confined space warning sign to the studs surrounding the opening. About five hours before the incident, a CHSC foreman wrapped red "danger" tape around the studs.

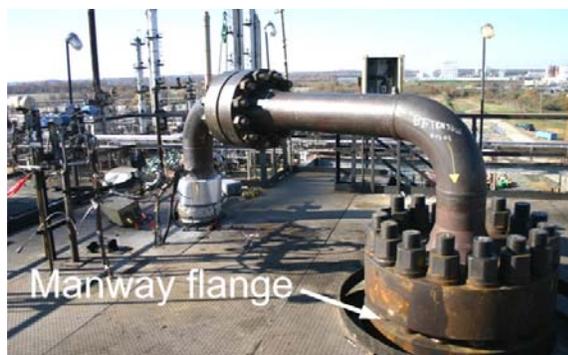
Figure 2. Pipe assembly connects 12-inch diameter process pipe to the reactor top manway (photo taken after the incident).

At about 11 p.m., two Matrix boilermakers removed the wooden cover and plastic tarp and cleaned the manway flange surface, a prerequisite to reinstalling the pipe assembly (Figure 2).

⁵ The top elbow assembly included the 12-inch diameter process pipe mating flange; 12-inch diameter pipe and elbow; and 24-inch manway mating flange (See Figure 2).

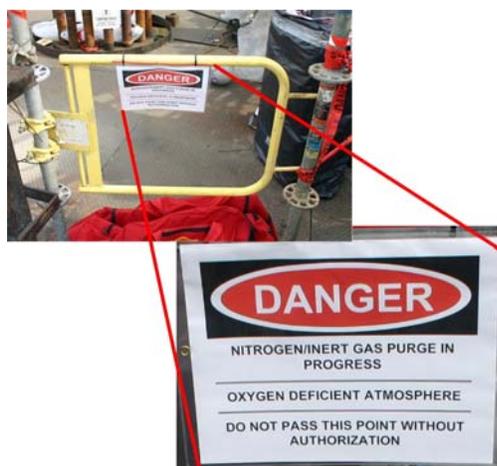
Figure 8. Nitrogen-purge controlled area barricade and warning installed on the R1 platform after the incident.

The Valero refinery has safe work procedures for using nitrogen, but they were inadequately implemented the night of the incident. The procedures required operators to install a barricade and post warning signs at all equipment access points (Figure 8) before the nitrogen purge was started, and to list all personnel working inside the barricaded area using a controlled area entry log. The barricade and control log were not used at the R1 manway the night of the incident, even though the reactor was on a nitrogen purge that vented directly onto the work platform area.

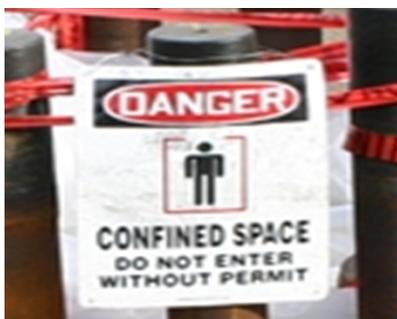
Figure 10. Typical sign used to identify unsecured confined space access opening.

The Valero site procedure for permit-required confined space entry required all open, permit-required confined space access points to be clearly identified with a warning sign (Figure 10).²³

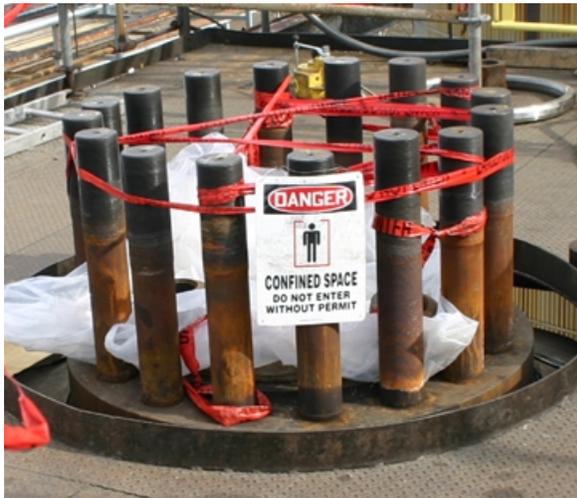
Figure 11. Confined space warning sign on the unsecured reactor manway after the incident.

The employer is also required to post danger signs (Figure 11) or other equally effective means to identify the hazard [§146(c)(2)]. In this incident, the red tape was the only warning on the manway—no warning sign was in place at the time of the incident.
