U. S. Chemical Safety Board

SONAT INVESTIGATION

Presentation Of Findings to the Board

Public Board Meeting September 15, 2000

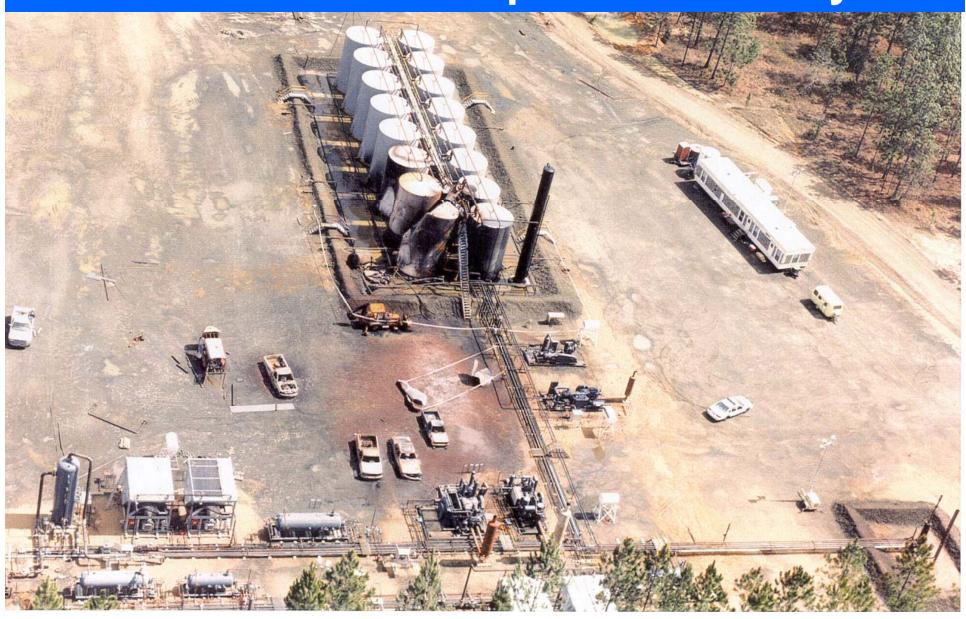
Aerial View of Sonat's Temple 22-1 Common Point Separation Facility

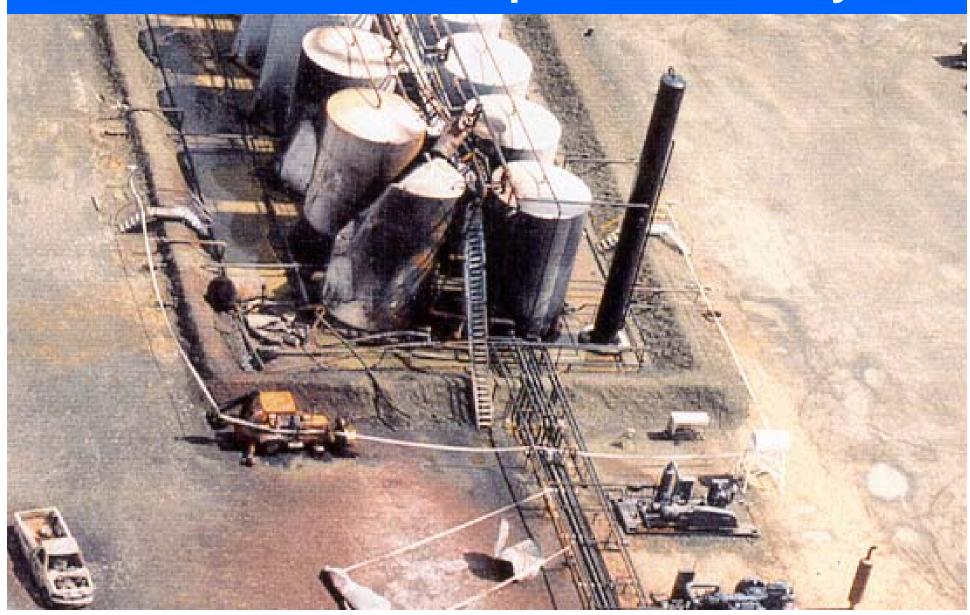
Aerial View of Sonat's Temple 22-1 Common Point Separation Facility

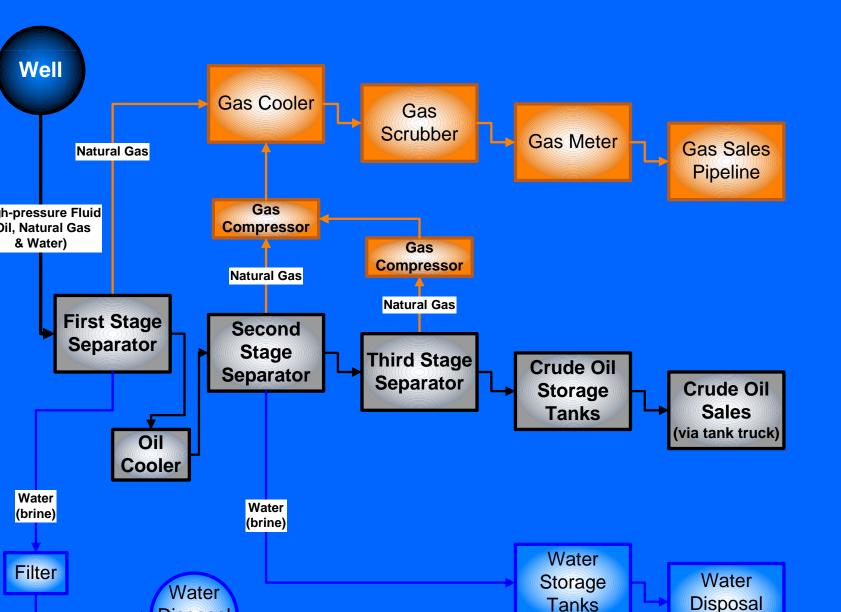
lock Flow Diagram of the Separation Process

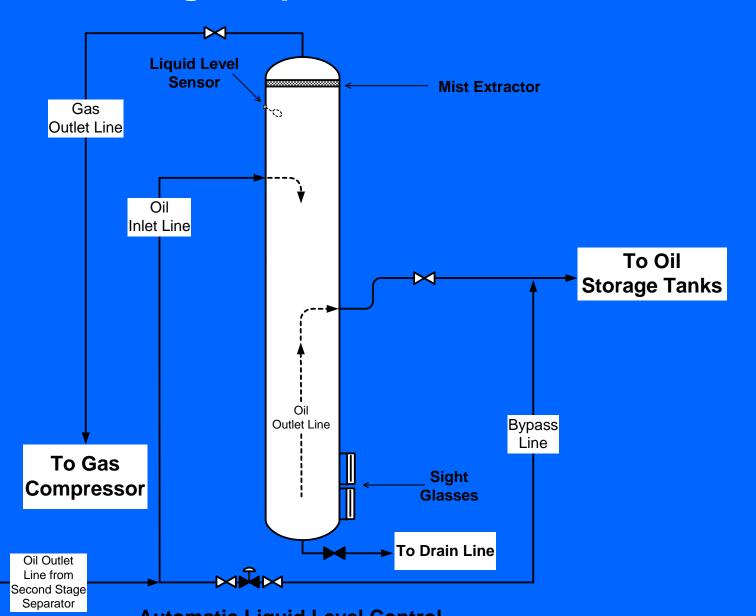
Third Stage Separator Schematic

The third stage separator that failed could not be isolated from an adjacent bypass line, because there was no inlet valve. Two valves on the bypass line and all other outlet valves were closed allowing high-pressure purge gases to overpressurize and rupture

The third-stage separator was only rated for atmospheric pressure service (0 psig). The purge gas stream to which the separator was exposed to had a pressure potentially as high as 800 psig.

The third stage separator was not equipped with any pressure-relief devices as specified by API Specification 12J which states "all separators, regardless of size or pressure, shall be provided with pressure protective devices". The vessel that failed falls within the scope of this specification

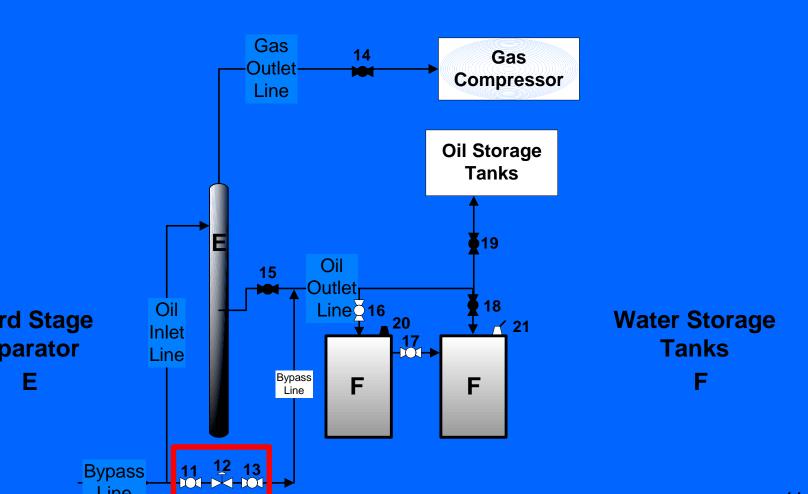
Valves realigned to purge pipeline, through a bypass line and two water storage tanks, out a tank roof hatch to the atmosphere

ended Valve Positions after the Final Alignment

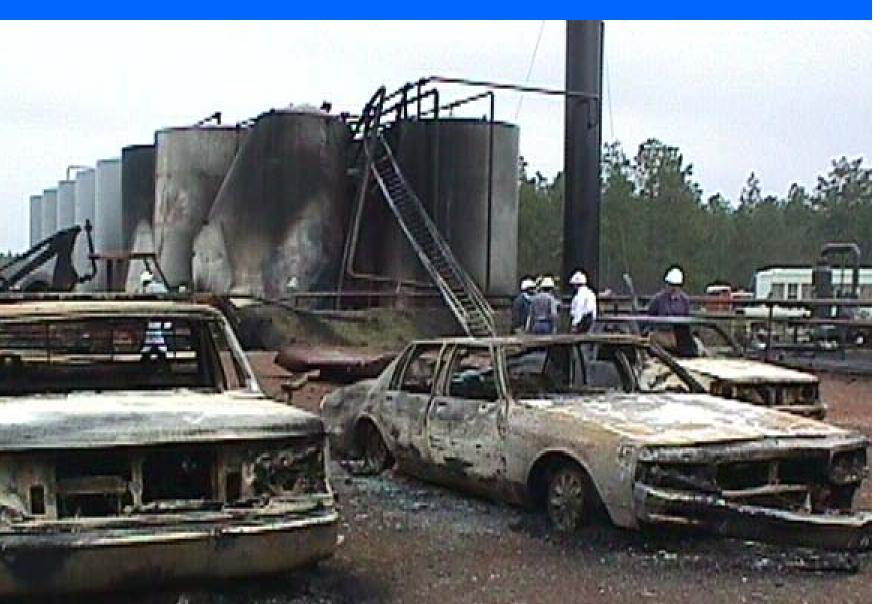
- 15 PM Bulk Train third stage separator failed, natural gas released and ignited producing large fireball
 - Four operators killed instantly
 - Damaged tanks and piping leak oil and gas which ignites

Damaged Vehicles and Storage Tanks

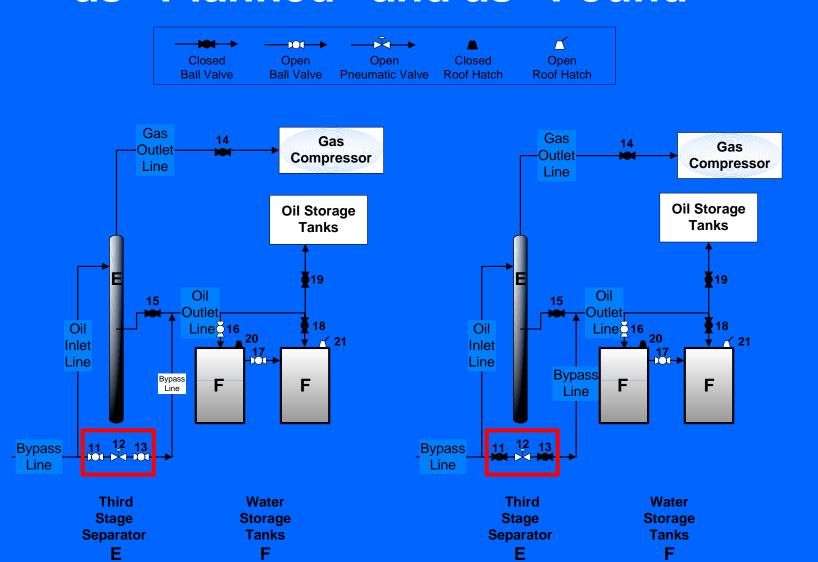
Police investigated incident site and discovered two bypass valves for the failed third stage separator in the closed position, which should have been open

Comparison of Valve Alignments as "Planned" and as "Found"

Why the bypass valves were closed or when they were closed could not be conclusively established
