BETA LAB No.M10329-B, TESORO EXCHANGER E6600-B EXAMINATION DATA	TESORO REFINING AND MARKETING COMPANY ANACORTES REFINERY 10200 W. MARCH POINT ROAD T91WA4428 ANACORTES, WA 98221	CUSTOMER P.O. No.: 4501667904, CHANGE ORDER #1
PARTS: E6600B HEAT EXCHANGER, PARTS 1B, 4B, AND 5B		DATE: MARCH 8, 2011
		PAGE 1 OF 52

LABORATORY REPORT

SAMPLE DESCRIPTION: A heat exchanger E6600-"B" was removed from operation at the Tesoro after undisclosed duration in service. The Exchanger B Shell Examination Protocol (Protocol) and Addendum 1 were developed and signed by Tesoro Companies, Division of Occupational Safety and Health, and U.S. Chemical Safety Board. The mentioned above Protocol and Addendum 1 are located in the Appendix 1 at the end of this Report. FirstEnergy BETA Laboratory was selected as the data collecting laboratory to perform the testing required by the Protocol. The BETA Laboratory, as a data collecting (referee) laboratory, acts under the same rules as in the previous job on the exchanger E6600E, which are as follows:

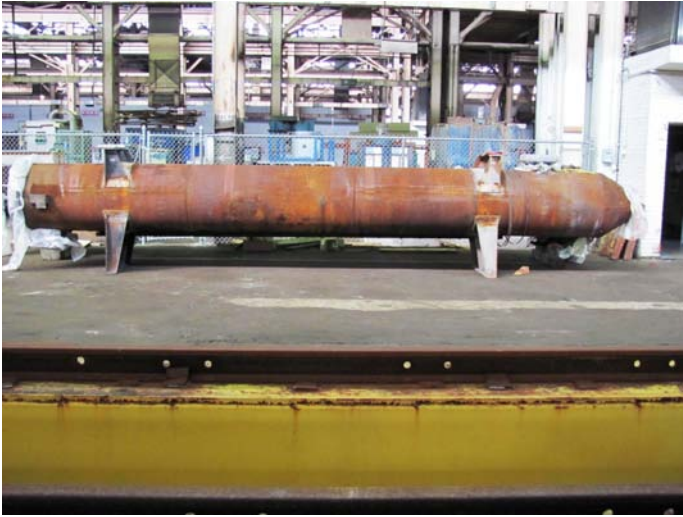
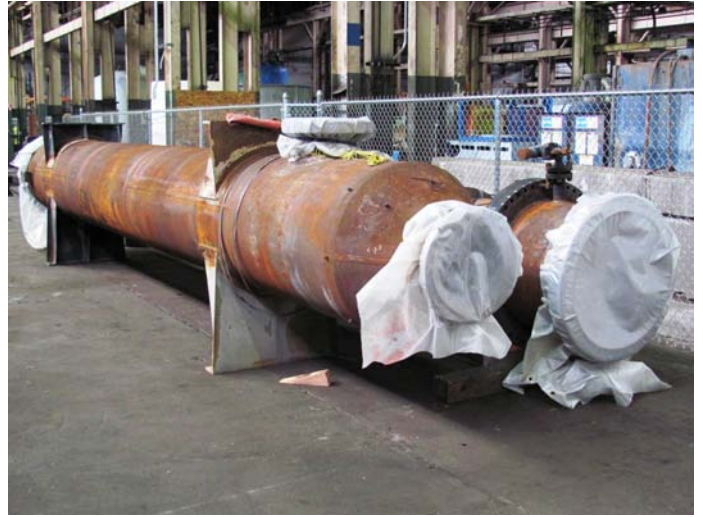
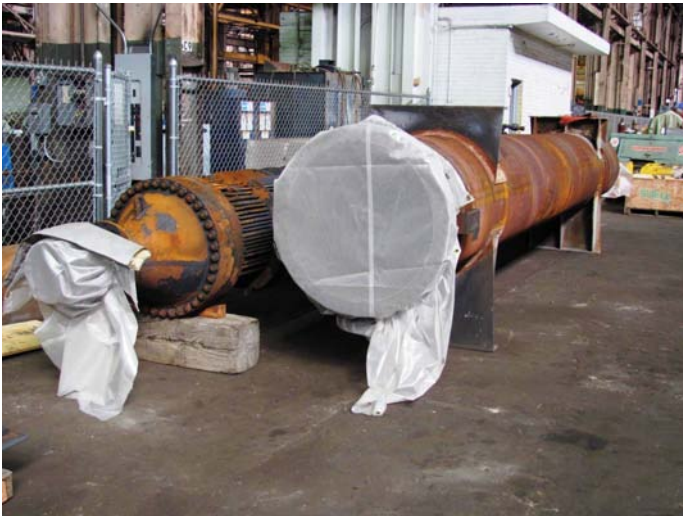
Figure 3
E6600-B Exchanger on the warehouse floor

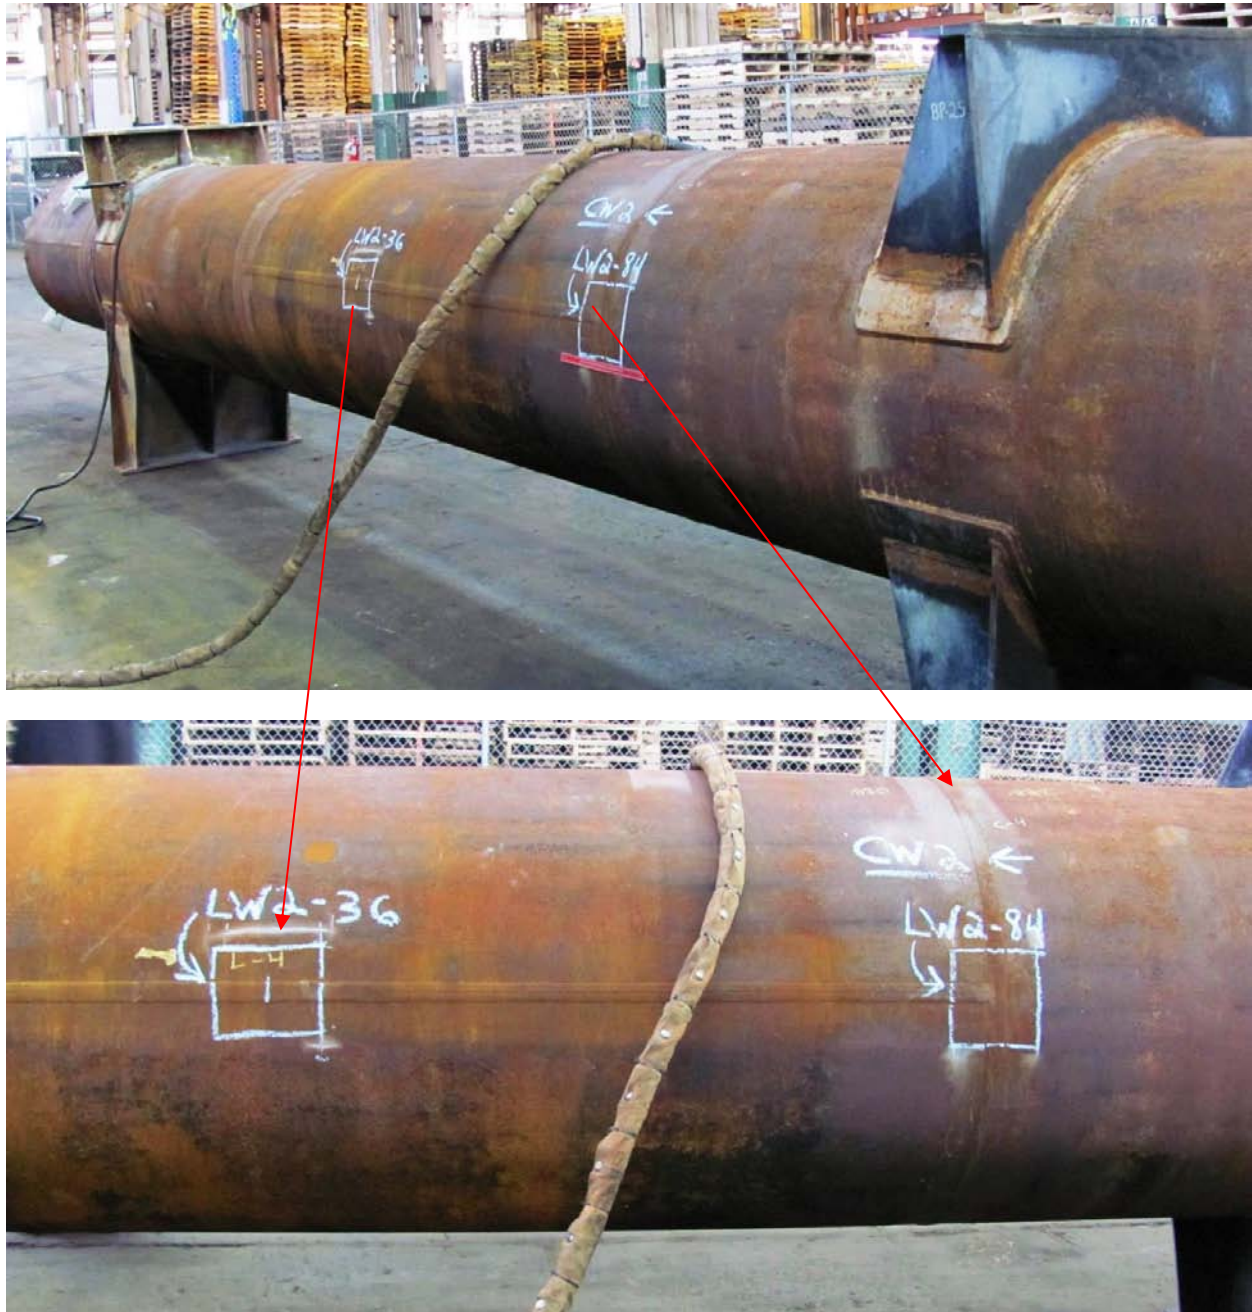
Figure 5.Shell

TESORO Exchanger E6600B as received at Halvorsen with the Parts 4 and 5 marked for cutting

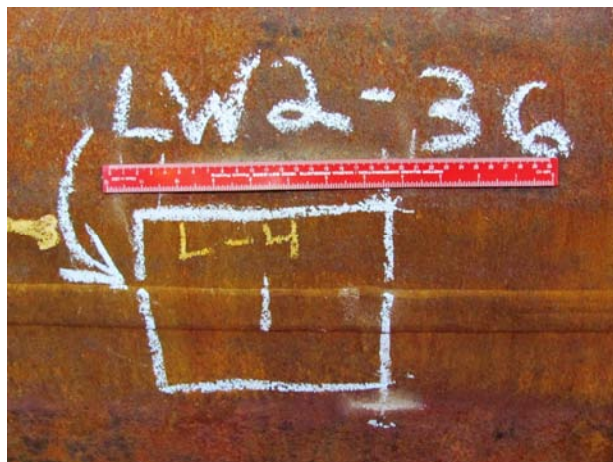
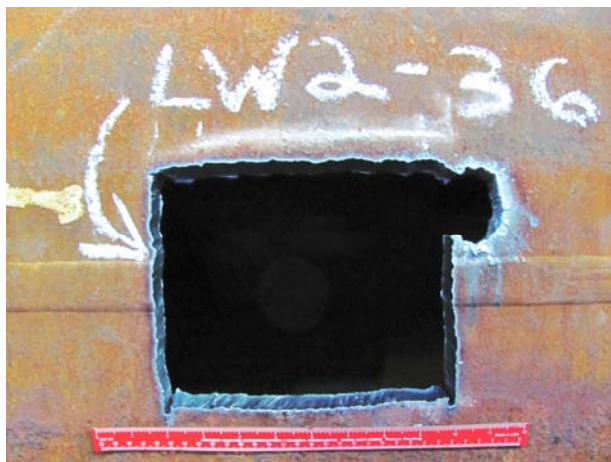
Figure 6.

Part 4B, approximate location on the weld LW2, 36" from the weld CW3

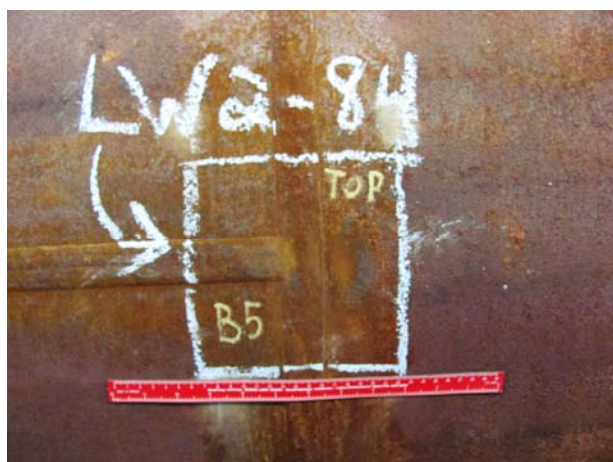
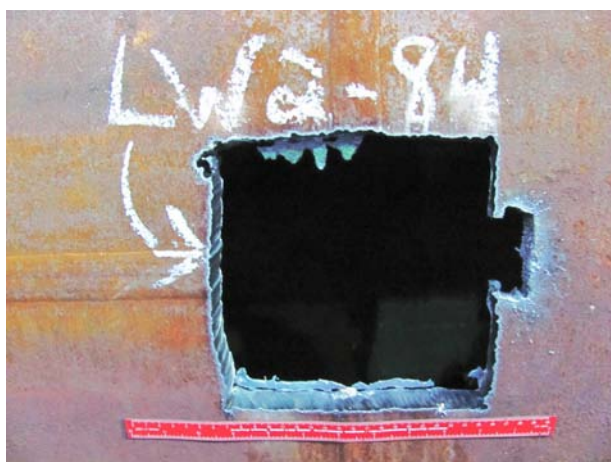
Part 5B, located on the LW2/CW2 Tee approximately 84" from the weld CW3

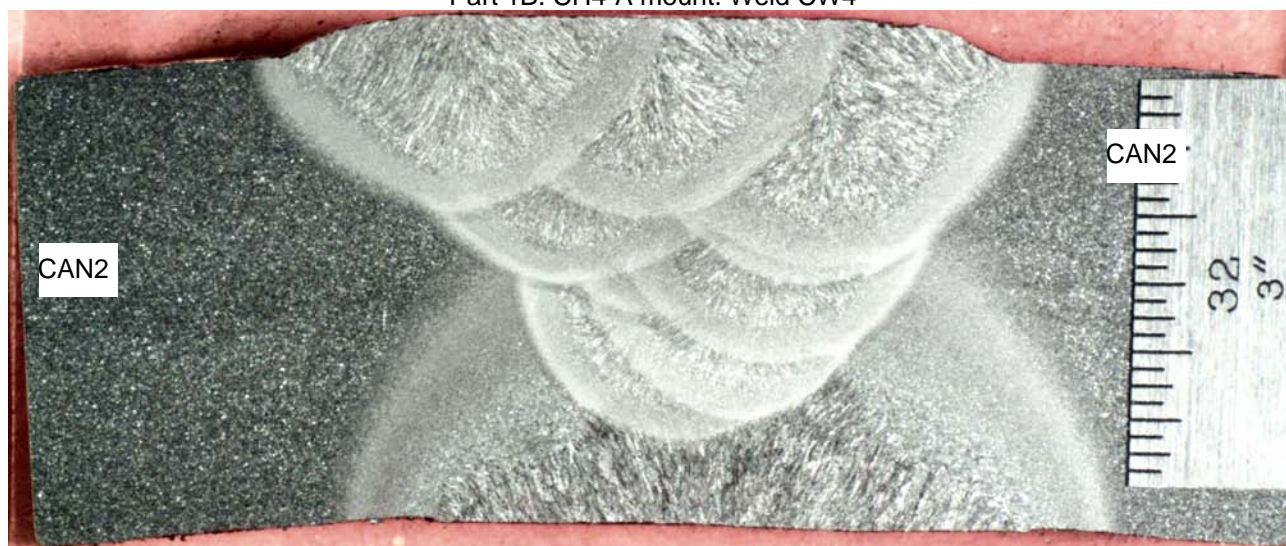
Figure 10. O.D. is on the top.

Part 1B. CH4-A mount. Weld CW4

Part 4B. LH2 mount. Weld LW2 located approximately 36" from weld CW3

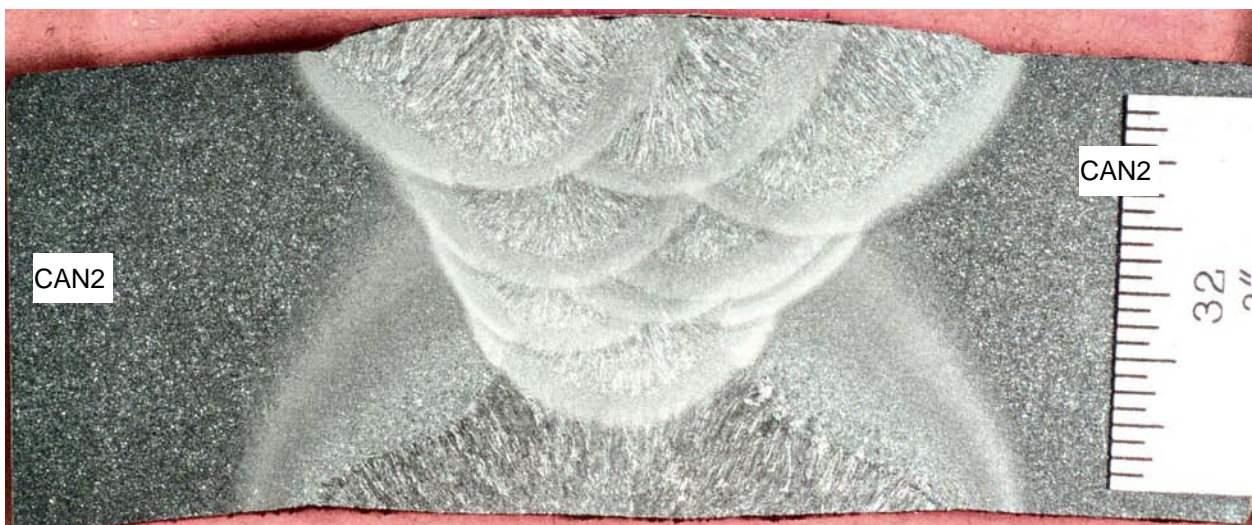
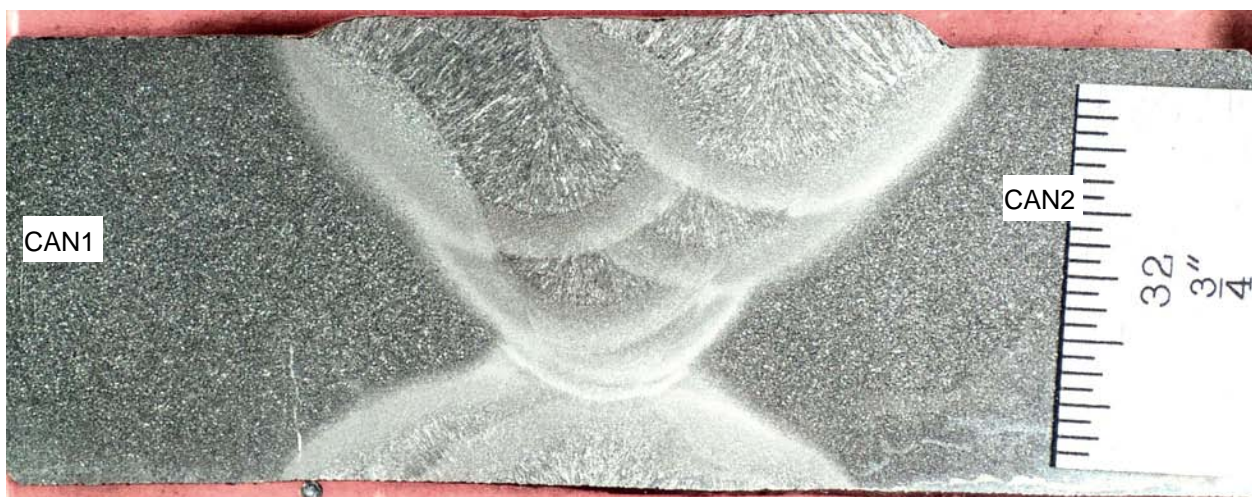
LM2-T mount. Weld LW2 at Tee with weld CW2.

CH2 mount. Weld CW2 at Tee with weld LW2

Figure 11. Macrophotographs of two mounts from part 5B located approximately 84" from weld CW3.
O.D. is on the top.
