Report No. 5004.7920 C Rev. 2

**METALLURGICAL EVALUATION OF PIPE SAMPLES FROM
THE CHEVRON USA INC., EL SEGUNDO REFINERY
#4 CRUDE UNIT 8-INCH DIAMETER 4-SIDECUT**

Customer Authorization: Contract CSB-12-C-002

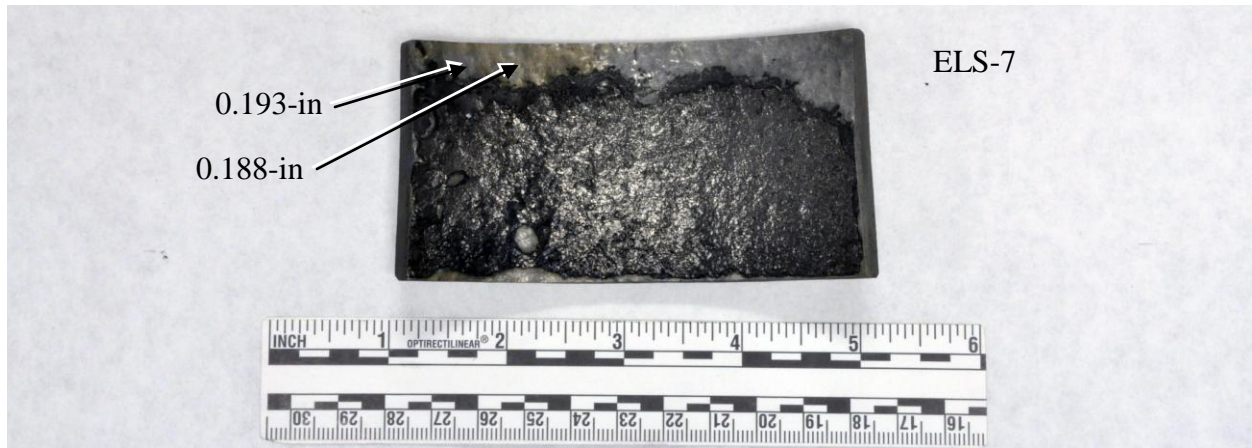
Figure 7 Photograph of the inside surface of a specimen from sample ELS-7 after cleaning. The specimen was sectioned from a location next to the specimen for chemical analysis.

Uneven or wavy wall loss, similar to that observed in the Richmond 4-sidecut samples, was investigated by cleaning specimens from the El Segundo 8-inch 4-sidecut by immersion in a 25% solution of Oakite® 33 and water. Alternating cycles of immersion in the solution and wire brushing the inside and outside surface scale removed the majority of the scales present. Photographs of the inside surfaces after cleaning are shown in Figure 5 through Figure 7. Uneven or wavy wall loss was present on all specimens examined except ELS-4-2, ELS-6 and ELS-7. Thickness measurements indicated in the figures were performed using a pointed anvil micrometer at locations selected to demonstrate the range of thickness associated with uneven wall loss on the cleaned specimens. The thinnest wall thickness measured was 0.128-inch on the cleaned specimen from ELS-1.

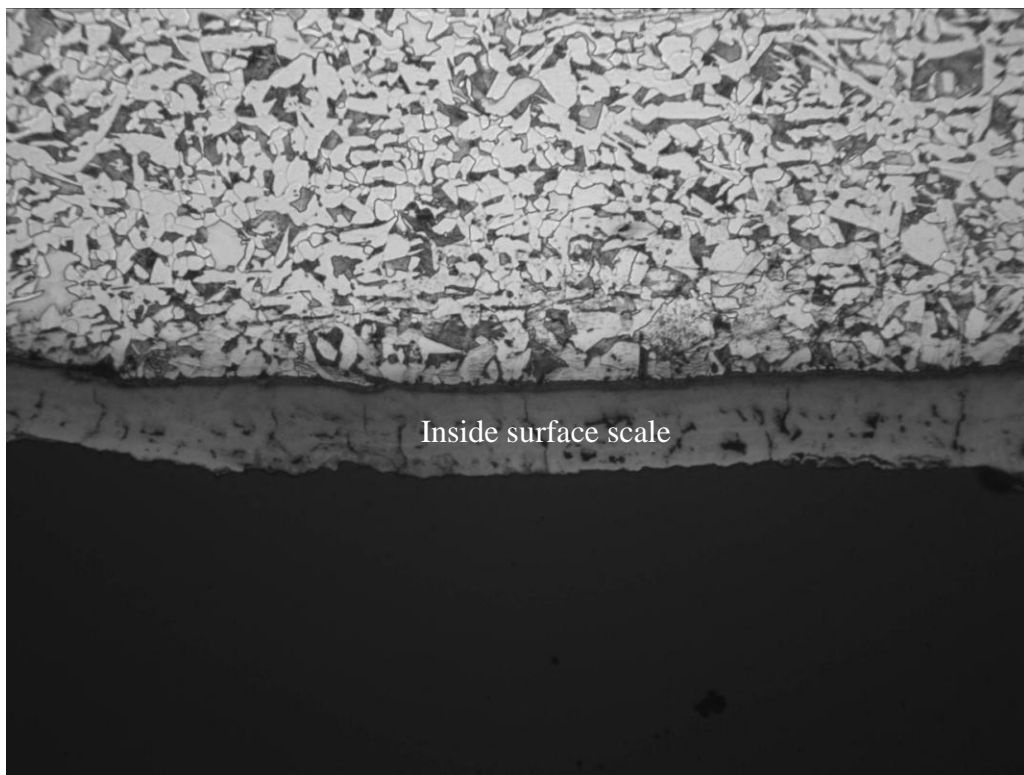
Figure 8 Optical micrograph of a specimen prepared from sample ELS-1. The section location is indicated in Figure 1a.

Metallography was performed on longitudinal specimens prepared from each sample. The locations of the sections in each sample are indicated in Figure 1 through Figure 4, and representative micrographs of the interface between the inside surface and the inside scale are shown in Figure 8 through Figure 14. In each specimen, the light gray scale was consistent with iron sulfide formed by sulfidation corrosion of carbon steel.
