U.S. CHEMICAL SAFETY AND HAZARD INVESTIGATION BOARD

INVESTIGATION REPORT

CHEMICAL SPILL CONTAMINATES PUBLIC WATER SUPPLY IN CHARLESTON, WEST VIRGINIA

REPORT NO. 2014-01-I-WV
SEPTEMBER 2016

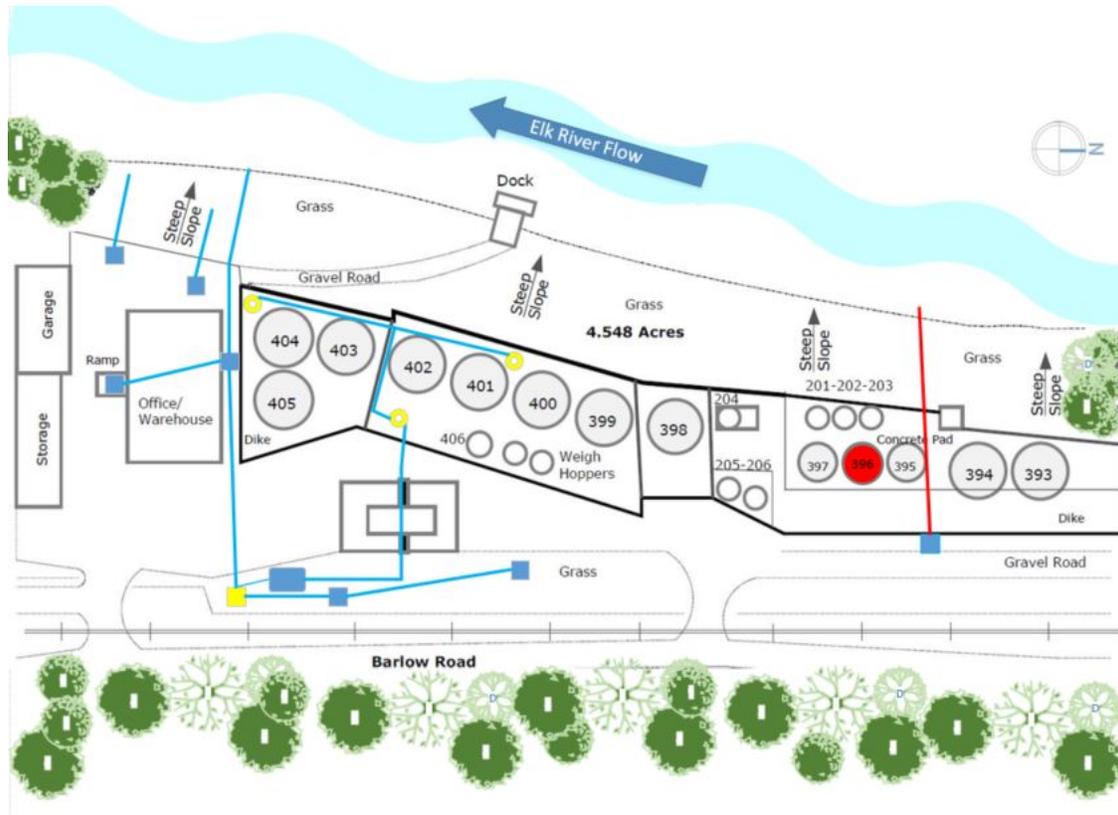
Figure 3. 2010 Etowah River Terminal site plot plan. (Source: Etowah River Terminal [adapted])

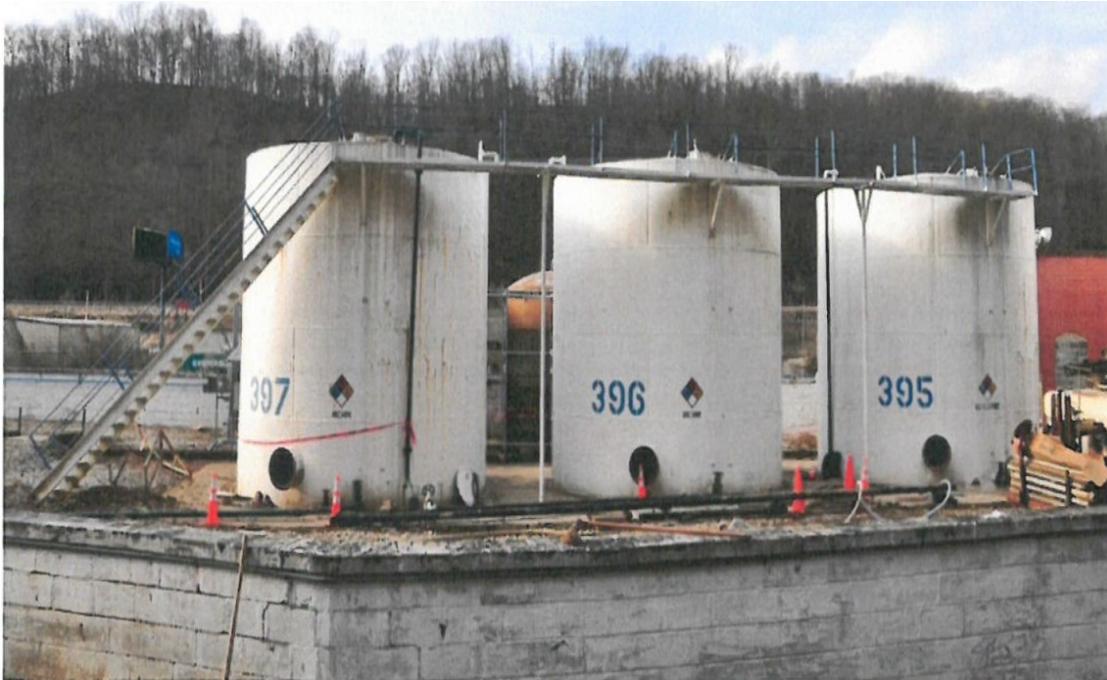
Figure 4. MCHM- and PPH, stripped-containing tanks at Freedom post-incident. (Source: CSB)

Tanks 395, 396 and 397 were 20 feet in diameter by 20 feet tall. The tanks had a lap-riveted⁴⁴ shell, cone roof and a 1/4-inch lap-welded⁴⁵ bottom. Tank 397 was a blend tank that was used to mix MCHM and PPH, stripped to produce a product known as ShurFlot 944.⁴⁶ The final product was stored in tanks 396 and 397 as well as in totes for sale (Figure 5).

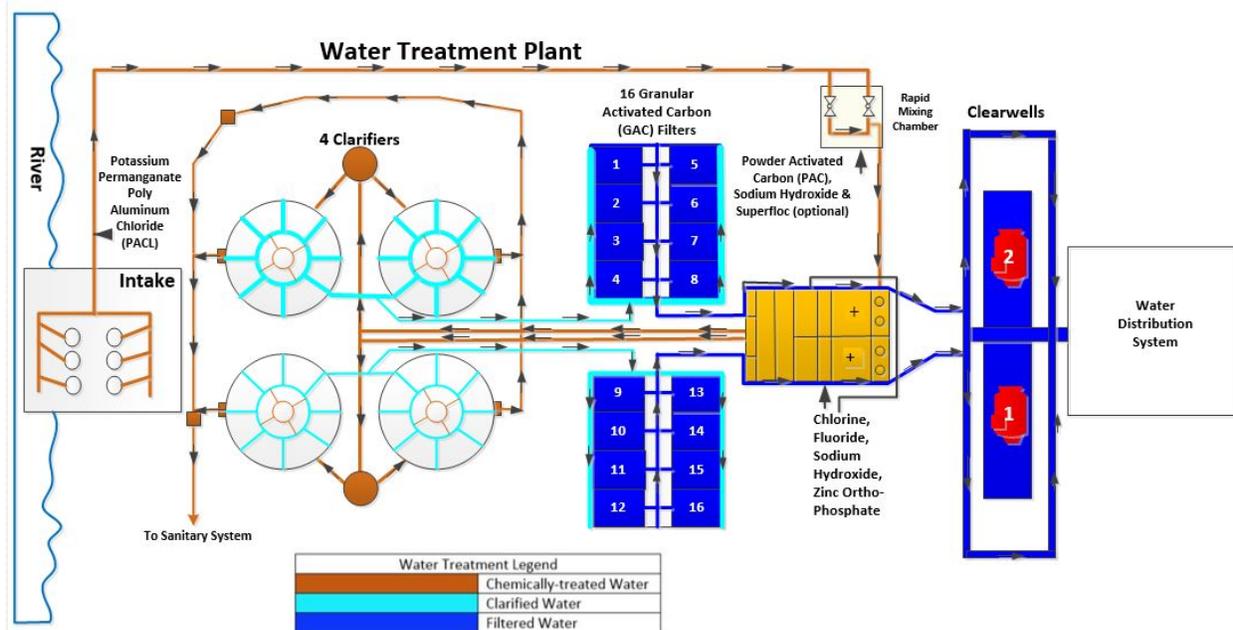
Figure 12. A simplified process diagram of a water treatment plant. (Source: CSB)

to prevent dental cavities.⁸⁰ Finally, this water moves to the clearwell,⁸¹ where the chlorine is given retention time to disinfect the water and then it is distributed into the system. See Figure 12.

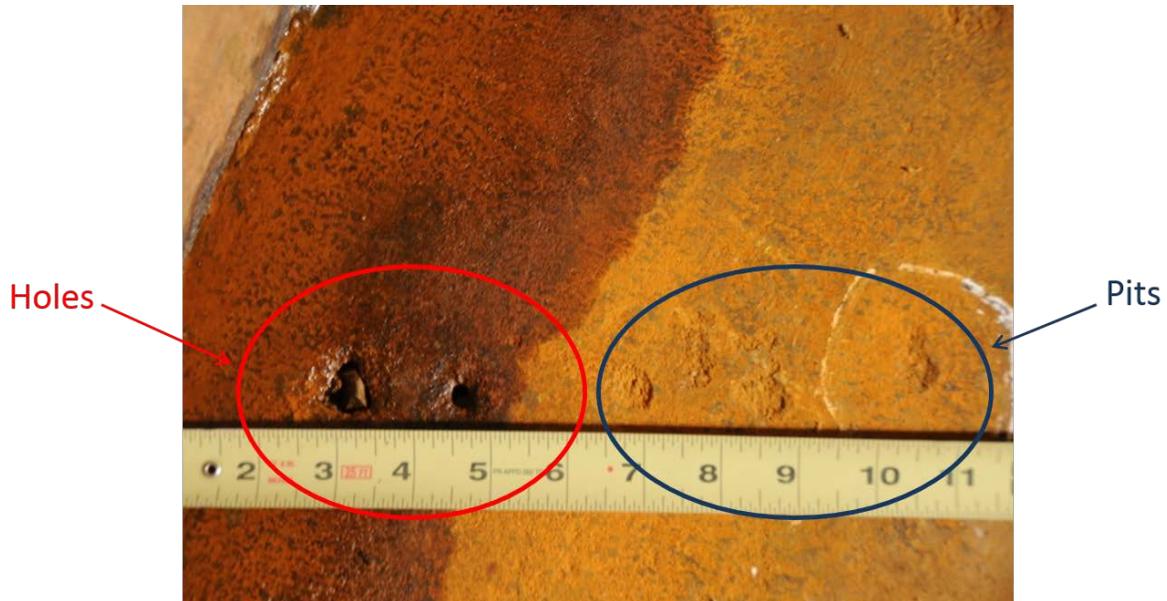
Figure 13. The bottom of tank 396 with holes and pits identified. (Source: CSB)

During a visual inspection of the bottom interior of tank 396, inspectors identified deep, isolated pits or crevices near the shell (side) of the tank in addition to two holes on the tank floor (Figure 13). CSB determined that the two holes, approximately 0.75 inches and 0.4 inches in diameter, were the source of the MCHM leak (Figure 14).

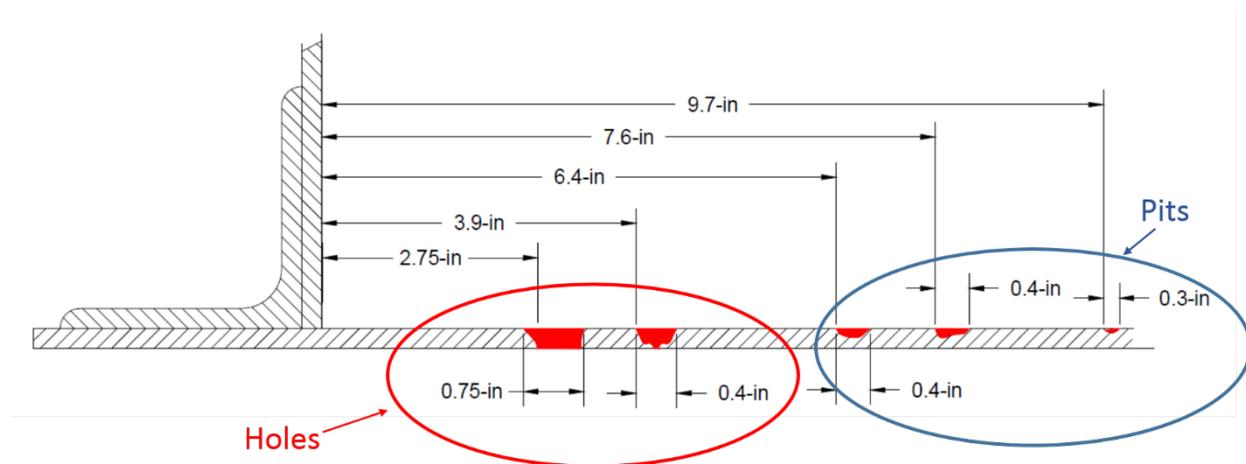
Figure 14. The bottom and shell wall of tank 396 with holes and pits identified through floor thickness. (Source: Powers)

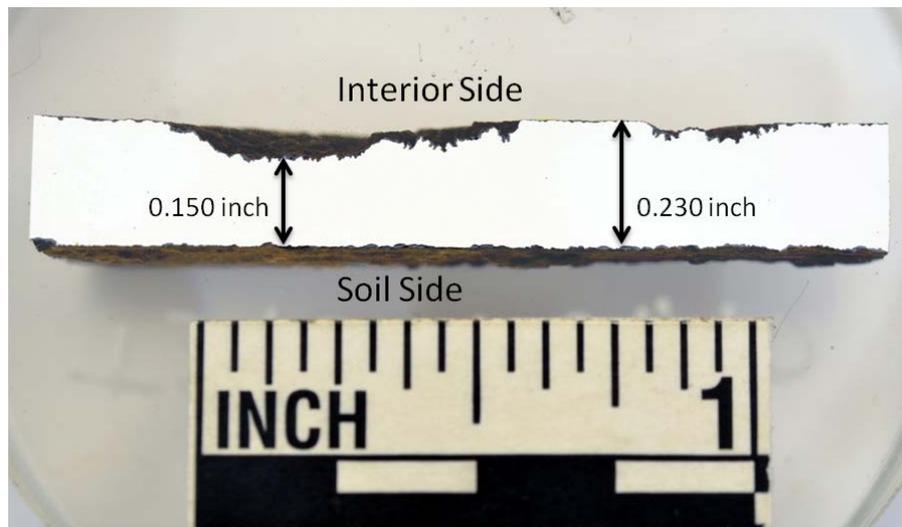
Figure 15. Cross-section of tank floor showing thickness variations from corrosion. (Source: CSB)

One feature of pitting corrosion is that pits usually initiate on the upper surface of a horizontally placed metal and grow in the direction of gravity.⁹⁰ The internal surface of the tank 396 floor had isolated pitting that degraded into its thickness (Figure 15). In comparison, the corrosion on the soil side of tank 396 was characteristic of uniform or general corrosion that would be expected on carbon steel of that age, with shallow pits and patches of iron oxides. The rate of pitting corrosion in a localized area is many times greater than the uniform rate of corrosion over an entire surface of a metal.⁹¹

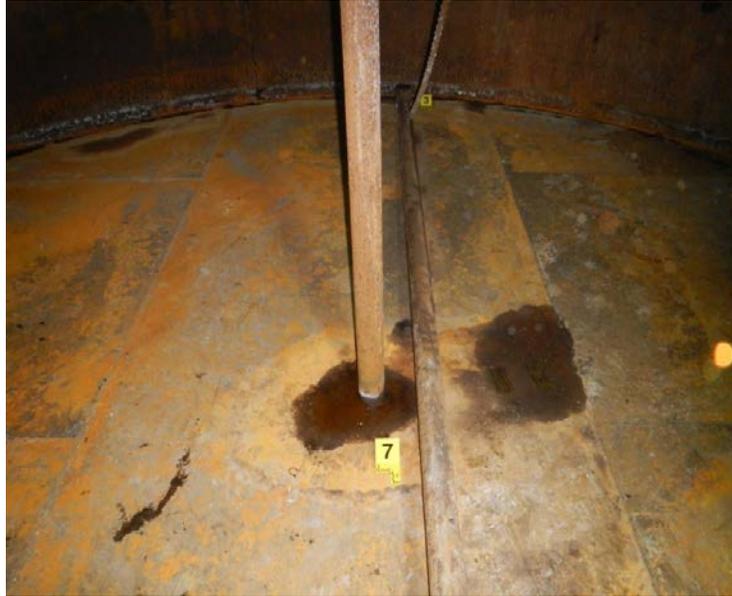
Figure 16. Retrofitted welded bottom of tank 396 (inside of tank). (Source: CSB)

Without original tank drawings or documentation, tank experts assumed the original tank 396 bottom lasted 25 years from its construction in 1938, and estimated its replacement took place sometime after 1963, while the site was under the ownership of the Elk Refining Company or PQS. Tank inspectors estimated, based on the post-incident condition of the tank floor, that the second bottom was at least 25 years old. At some point after the installation of the second bottom, polyvinyl acetate (PVA),⁹⁸ discussed in Section 3.1.4, was also likely added to the bottom of the tank to patch existing holes or prevent future corrosion (see the timeline in Figure 17).

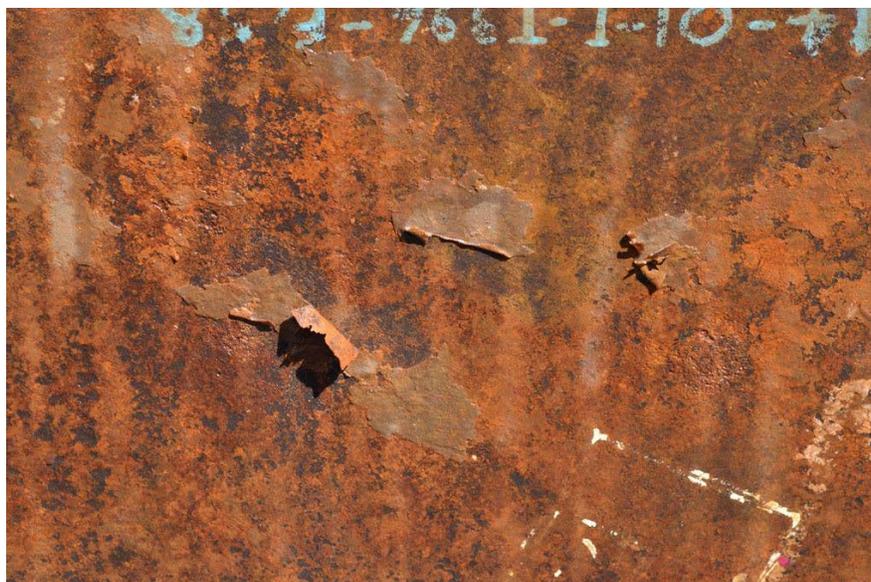
Figure 18. Remnants of coating on interior tank floor. (Source: CSB)

During the initial examinations prior to dismantling tank 396, inspectors noticed remnants of what could have been a flexible organic liner or patch, adhered to the interior surface of the tank floor, likely applied sometime before the leak occurred (Figure 18). Analytical testing determined that the chemical composition of the material was PVA.

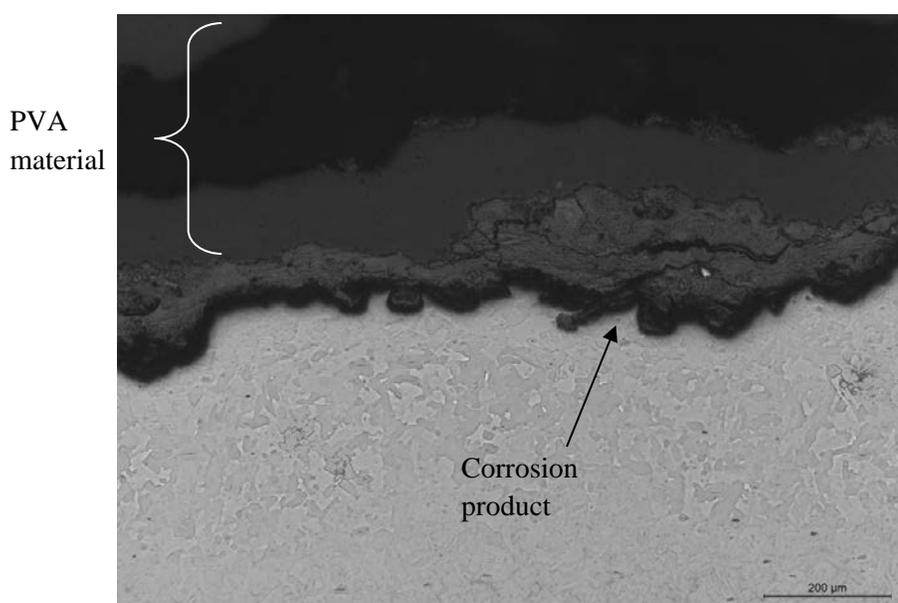
Figure 19. Corrosion product beneath PVA. (Source: CSB)

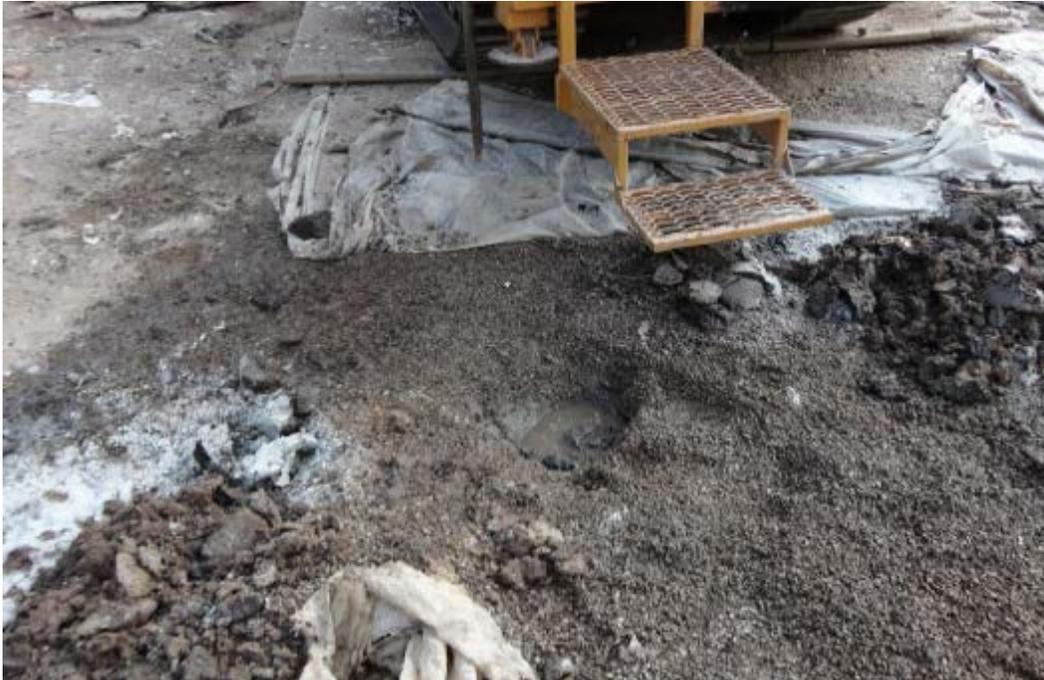
Figure 20. Gravel base under tank 396 and other MCHM tanks. (Source: Terracon)

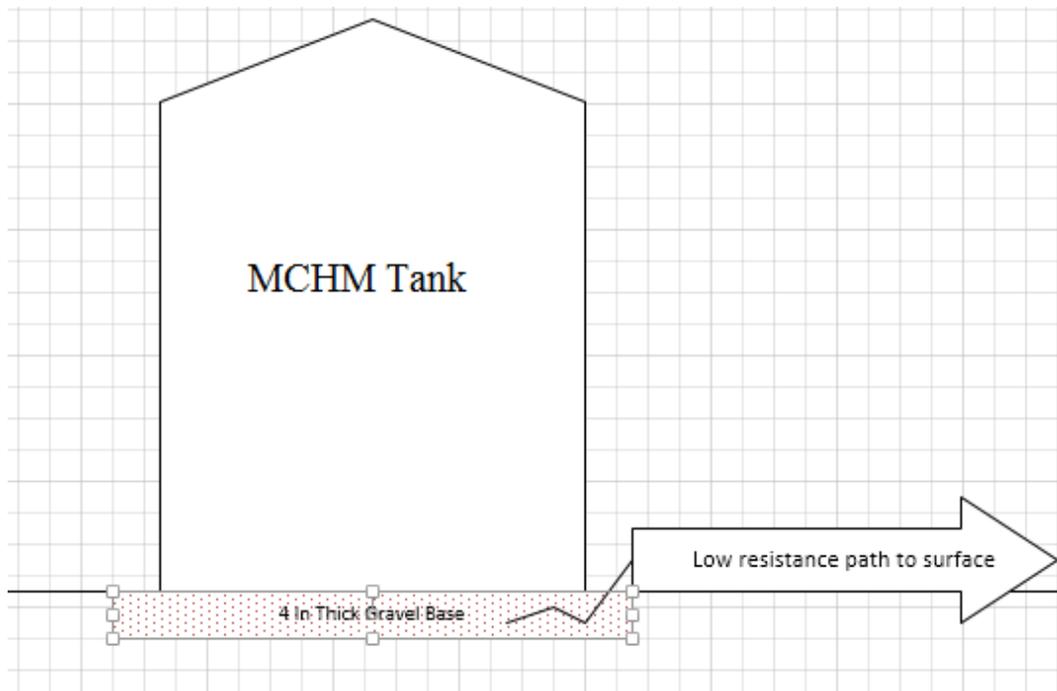
Figure 22. Low resistance flow path provided by gravel base. (Source: CSB)

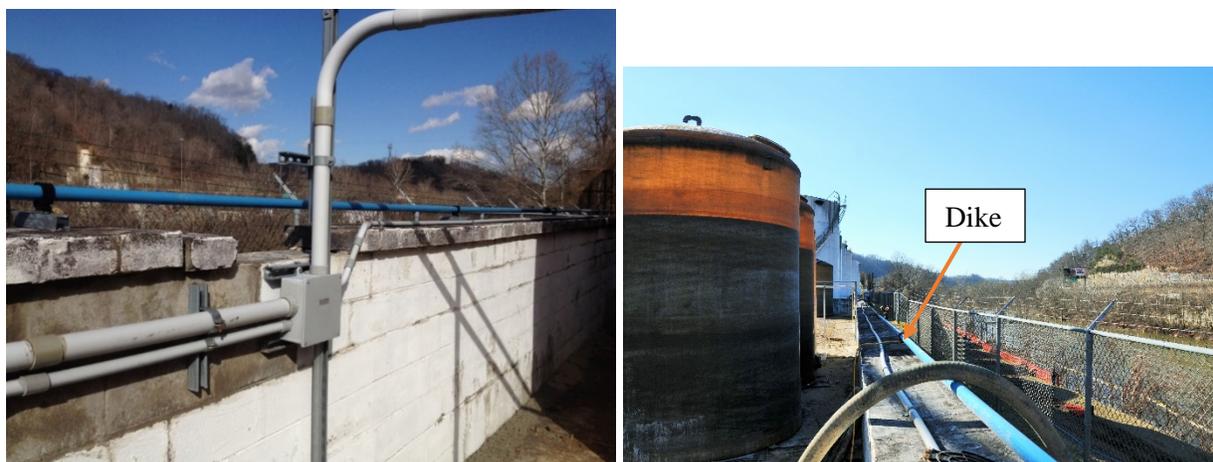
Figure 23. View from inside the dike wall facing the Elk River of the concrete block walls with no reinforcement (Left); dike wall along the tank farm parallel to the Elk River (Right). (Source: CSB)

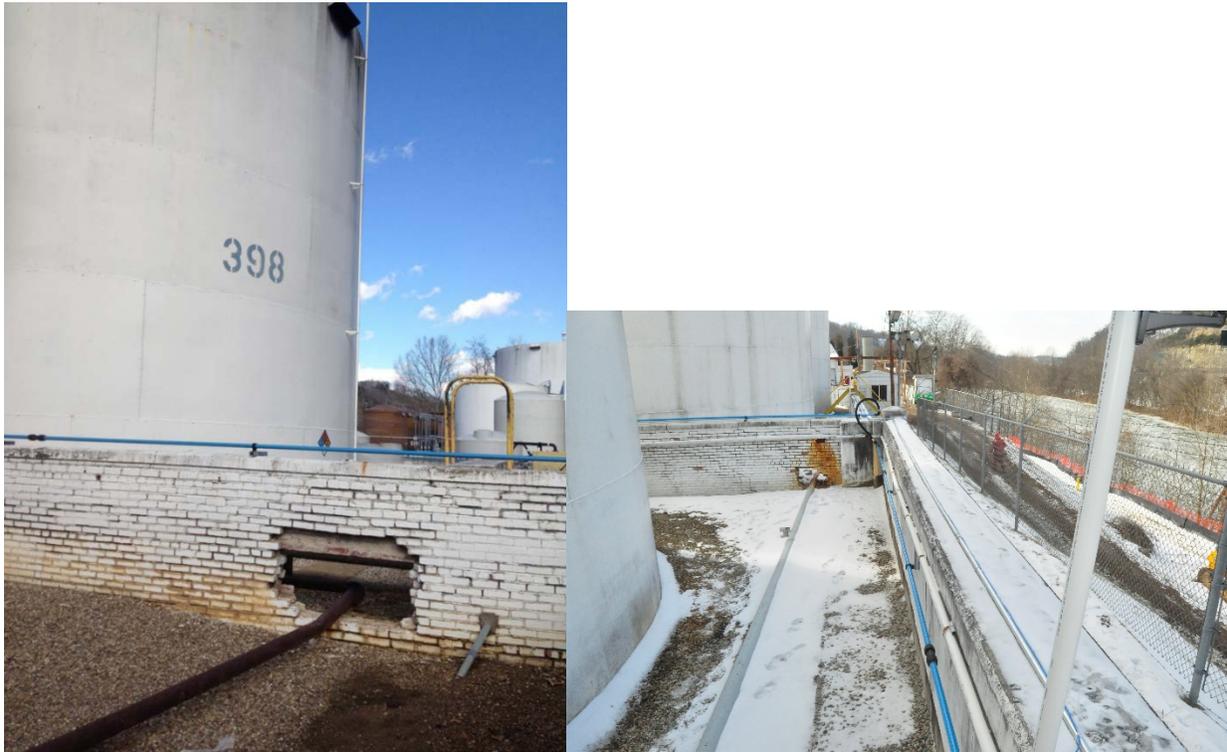
addition, although concrete caps were used around the top of the dike walls, many of these caps were missing or had deteriorated, which allowed for rainwater or other elements to infiltrate the walls.

Figure 24. The dike walls that surrounded the tank farms were in poor condition. (Source: CSB)

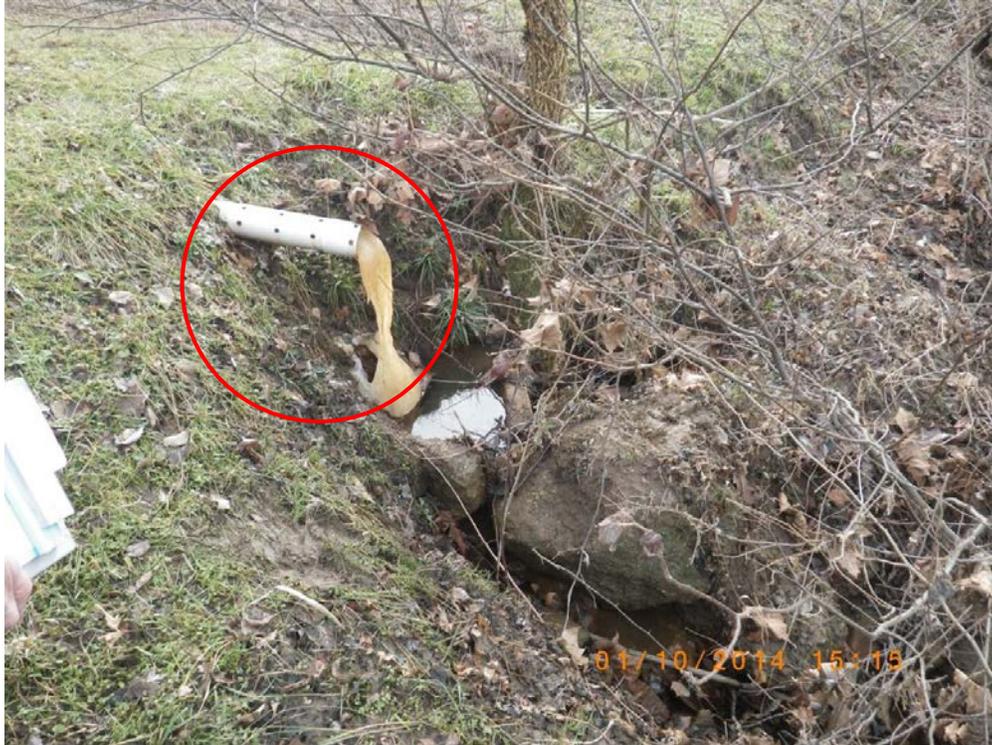
Figure 25. Ice-filled oil/water separator discharge pipe into the Elk River. (Source: WVDEP)

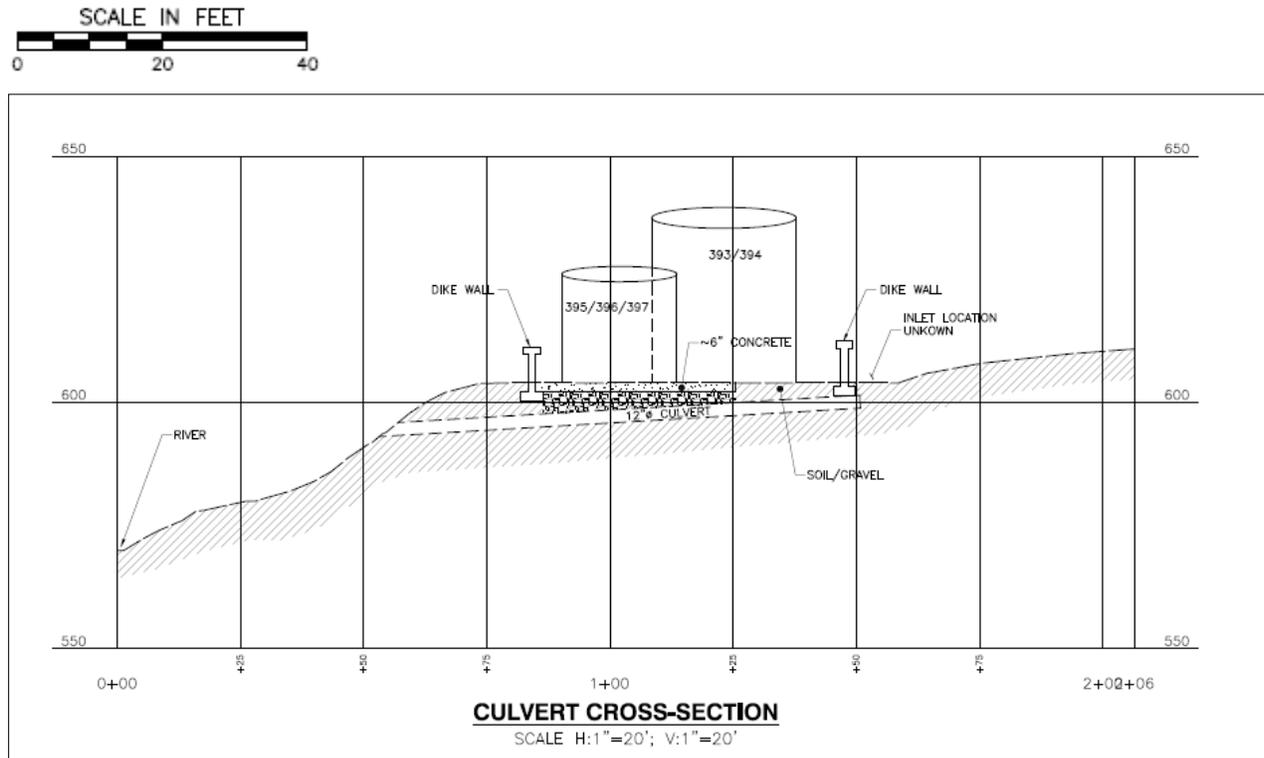
Figure 26. Cross-section of culvert beneath the Freedom site between tanks 394 and 395. (Source: Civil & Environmental Consultants, Inc. January 20, 2014)

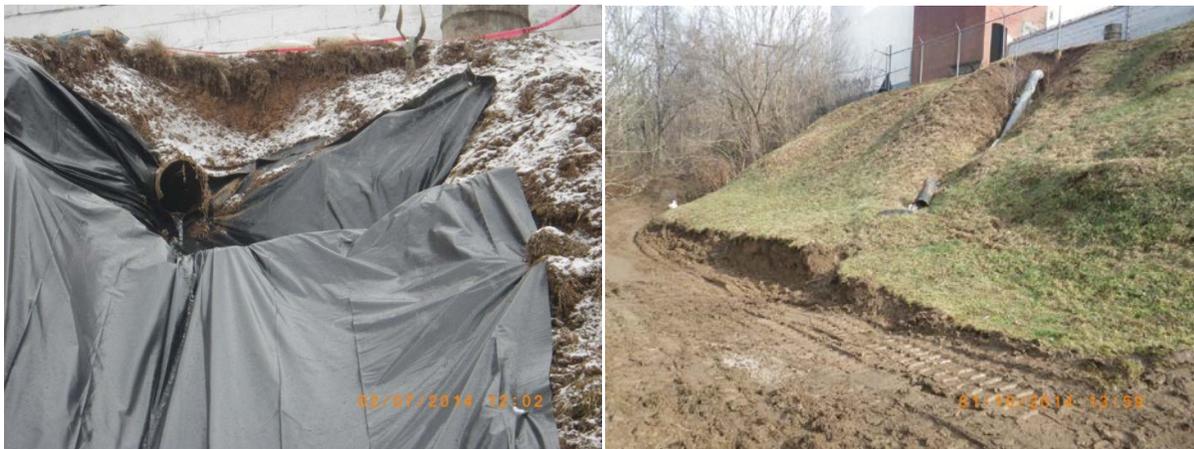
Figure 27. Water flowing through a corrugated steel culvert extending from the hillside (Left); stormwater pipe above interceptor trench (Right). (Source: WVDEP)

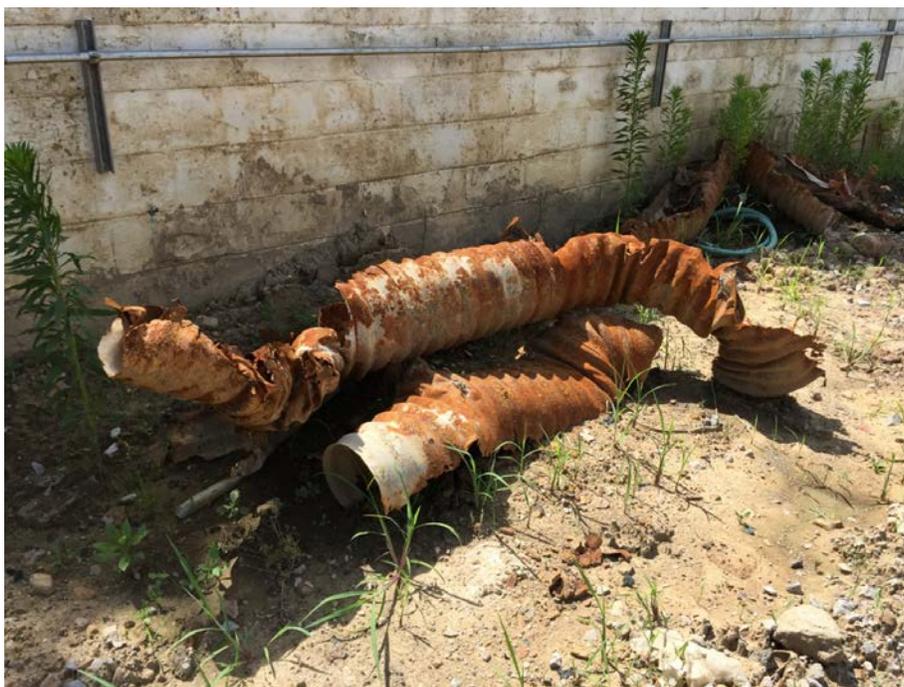
Figure 28. Photo taken on June 15, 2015, of remnants of the culvert that ran between tanks 394 and 395 beneath the site. (Source: CSB)

Parameter	Sample 1 (Culvert Inlet)	Sample 2 (Culvert Outlet)	Sample 3 (Culvert Containment Area)
MCHM, mg/l ¹³⁹	0.036	0.074	0.180

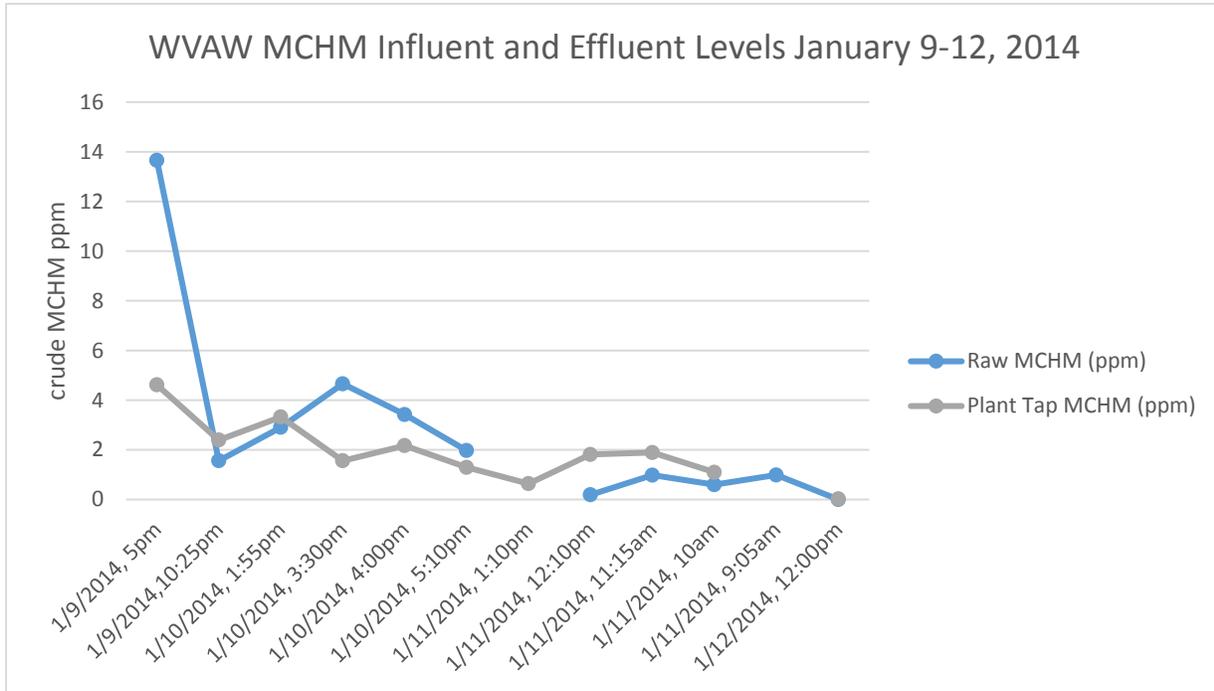
Figure 30. MCHM levels in influent (river water) and finished water (final product) at WVAW KVTP on January 9-12, 2014.

on January 9, water entering WVAW contained levels of MCHM measuring 13.7 ppm in the raw influent (river water) and 4.6 ppm after treatment at the plant tap (final product). On January 10, at 12:30 AM, water testing showed MCHM in the raw water at WVAW measuring 1.04 ppm and 3.35 ppm, but in the outgoing water at 1.02 and 1.56 ppm, respectively (Figure 30).
