U.S. Chemical Safety and Hazard Investigation Board

Seven Key Lessons to Prevent Worker Deaths During Hot Work In and Around Tanks

Effective Hazard Assessment and Use of Combustible Gas Monitoring Will Save Lives

No. 2009-01-SB

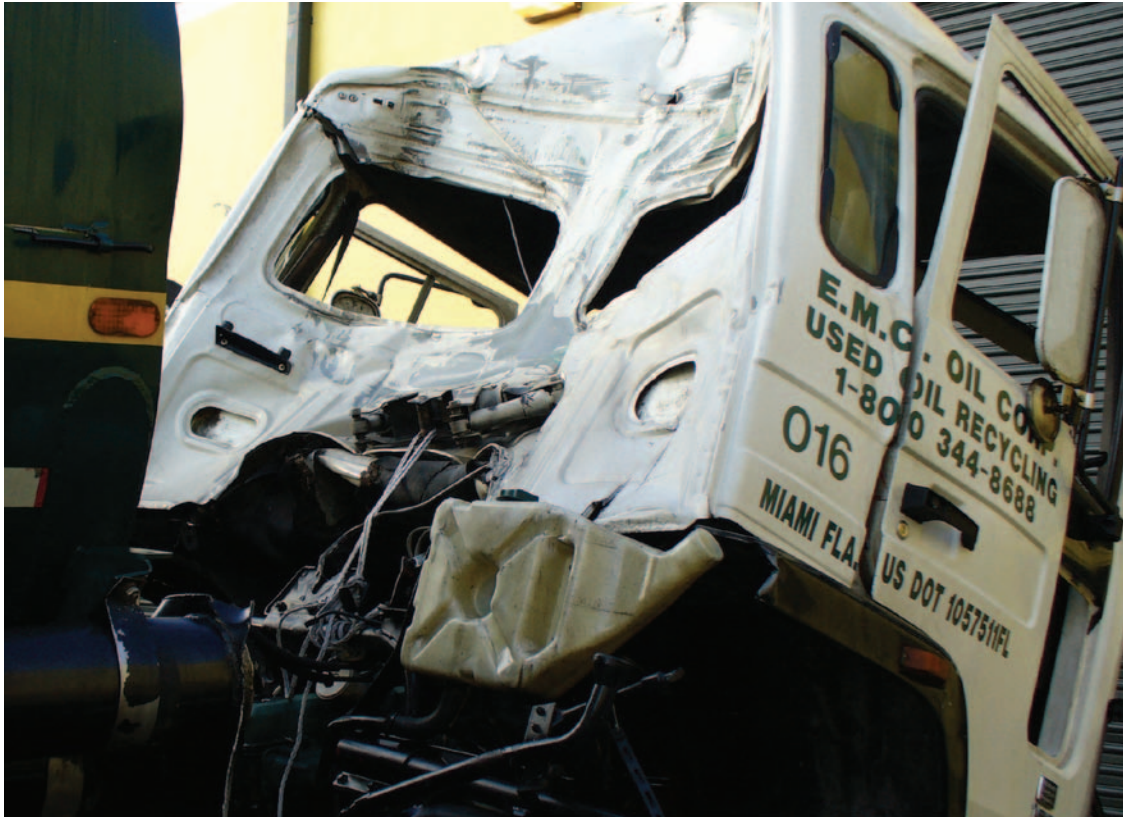
Damage to an oil tanker sustained from the December 2, 2008, explosion at EMC Used Oil Corporation.

An explosion killed a contract welder who was repairing a two-compartment oil tanker and injured another worker at the EMC Used Oil facility. The welder was in the process of welding transfer piping onto the tanker when residual hydrocarbon vapor from the 2,500-gallon rear compartment ignited, causing a powerful explosion.

The surviving worker stated that the contractors did not perform combustible gas monitoring and relied upon the host company to assure that tanks were safe for hot work. However, EMC indicated that it relied on contractors to monitor for gas; although the company owned a multiple gas detector, it was used only for confined space entry. EMC did not have a formal hot work permitting or authorization system.

Use Alternatives, Analyze the Hazards, Monitor the Atmosphere, Test the Area, Use Written Permits, Supervise Contractors

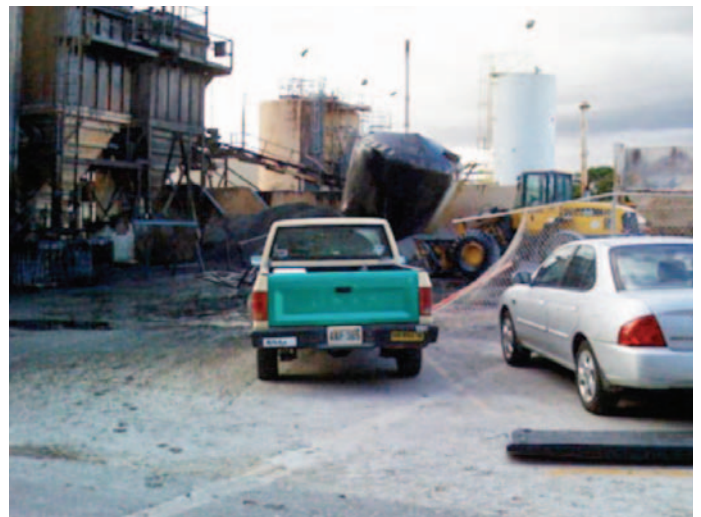
A contract welder was killed while welding on a catwalk located over a 9,300-gallon waste oil storage tank at the Philip Services Corporation (PSC). Following an investigation, the Honolulu Fire Department (HFD) concluded that, during the welding, sparks dropped in and around the vent area of the tank. The contents of the tank ignited, resulting in an explosion and fire. The force of the explosion hurled the contract welder about 120 feet, fatally injuring him. Three others were injured, and the tank was thrown about 30 feet.

According to the HFD investigation, a PSC official asserted that the contractors were not authorized to weld within the dike area surrounding the tank, a hot work permit had not been issued for the welding, and combustible gas monitoring was not conducted. Conversely, the contracting company's personnel asserted that they believed that the work was authorized and that PSC had conducted combustible gas monitoring prior to the welding activity.

View of Philip Services Corporation following a October 7, 2008, waste oil storage tank explosion.

Use Alternatives, Analyze the Hazards, Monitor the Atmosphere, Test the Area, Use Written Permits, Supervise Contractors

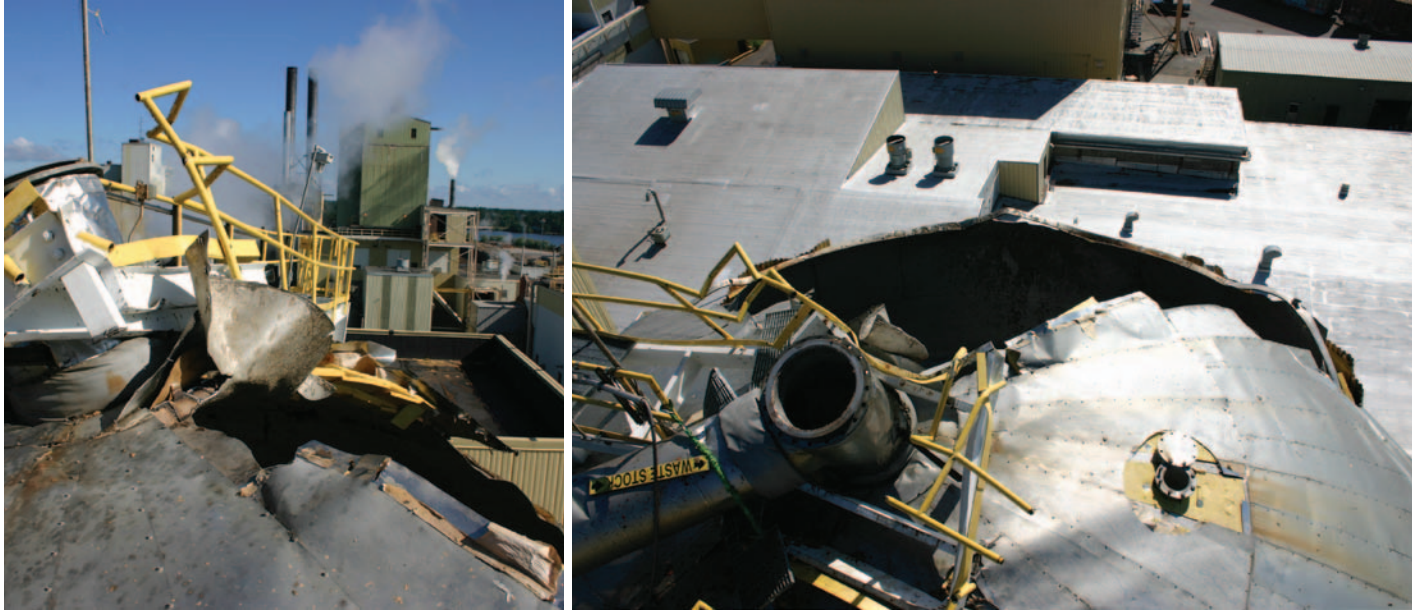
Views of the storage tank involved in the 2008 explosion at Packaging Corporation of America.

Three workers were killed in an explosion at the Packaging Corporation of America (PCA) fiberboard manufacturing facility while they were welding on a temporary metal clamp to stabilize a damaged flange connection. The flange was located on top of an 80-foot tall storage tank that contained recycled water and fiber waste.

Facility personnel were unaware of the potential presence of flammable gas from the decomposition of the organic material in the tank, and combustible gas monitoring was not typically required or performed prior to starting work. At the time of the accident, three workers were on a catwalk above the tank; one began welding the flange into place when sparks from the welding ignited flammable vapors inside the tank. The resulting explosion ripped open the tank lid, knocking two of the workers to the ground 80 feet below. All three workers died of traumatic injuries. A fourth worker, who had been observing the work from a distance, survived with minor injuries.

The CSB analysis of the tank contents determined that anaerobic bacteria had multiplied inside the tank and water recycle system over time, feeding on organic waste material. The bacteria likely produced hydrogen, a highly flammable gas, which ignited during the welding work. The CSB found that at the time of the incident, PCA supervisors and workers were unaware of the risks of flammable gas production from anaerobic bacteria growth. PCA did not perform a hazard analysis or recognize fiber waste tanks as potentially hazardous. Combustible gas monitoring was not required for the work.

Analyze the Hazards, Monitor the Atmosphere,
Test the Area

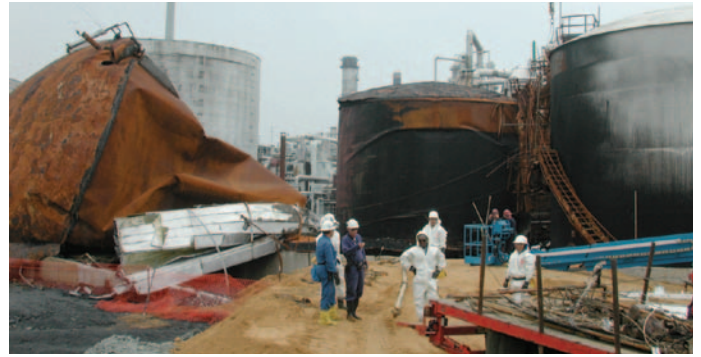
A massive explosion destroyed a large storage tank containing a mixture of sulfuric acid and flammable hydrocarbons at the Motiva Enterprises Delaware City Refinery. One contract worker was killed, eight others were injured, and sulfuric acid from collapsed and damaged tanks polluted the Delaware River. The explosion occurred during welding operations to repair a catwalk above the sulfuric acid tank, when flammable hydrocarbon vapor was ignited by welding sparks. This resulted in a powerful explosion inside the tank, which had holes in its roof and shell and a deficient inerting system.

On the day of the accident, combustible gas testing was performed only at the start of the hot work, but monitoring was not conducted for the duration of the hot work activities. Throughout the five hours between the last gas test and the explosion, the ambient temperature warmed by 14 degrees. This warming increased the evaporation of hydrocarbons inside the tank, and the resulting flammable vapor leaked out the tank's holes into the work area.

Motiva had a hot work program that included written permits, but the program was inadequate. Hot work was allowed near tanks that contained flammables including

A view of the flammable storage tank involved in the accident at the Motiva Refinery.

those that had known holes due to corrosion. Continuous atmospheric monitoring and the control of welding sparks were not required.

Use Alternatives, Analyze the Hazards, Monitor the Atmosphere, Test the Area, Supervise Contractors
