## Combustible Dust Explosion

- > **Incident Date: January 29, 2003**
- > **Kinston, North Carolina**
- > **6 Killed, 38 Injured**
- > [Full Report on CSB Website](#)

# SAFETY DIGEST

U.S. Chemical Safety and Hazard Investigation Board

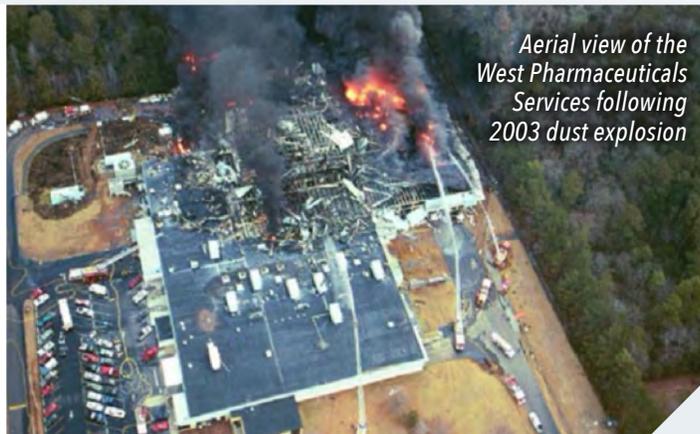
*Aerial view of the  
West Pharmaceuticals  
Services following  
2003 dust explosion*

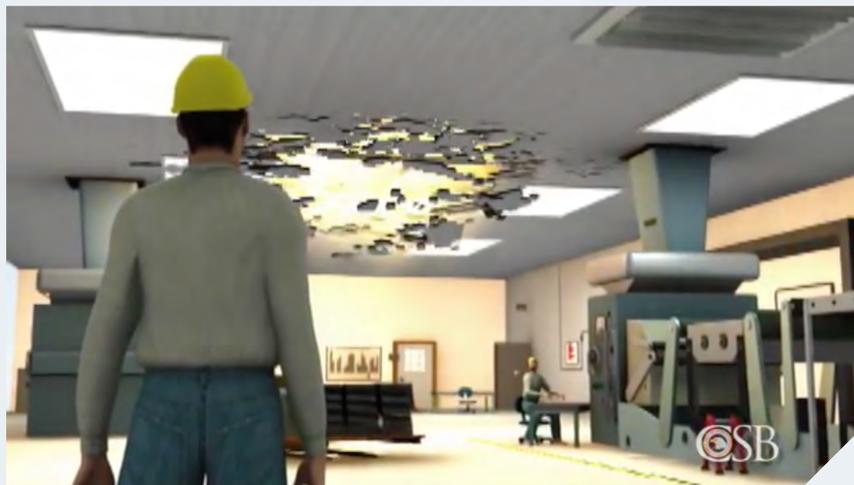
Animation still from the CSB's Safety Video *Combustible Dust: An Insidious Hazard*

rubber dispersed dust throughout the work area. The unsealed acoustic tile ceiling allowed large amounts of dust to accumulate in concealed areas that were difficult to clean. The electrical fixtures and wiring in the production area were general-purpose and not rated for use around combustible dust.

to prevent dust explosions. The standard states that dust accumulations of just 1/32 of an inch thick create conditions for a dangerous explosion and must be removed. Specific NFPA provisions that would likely have prevented the tragedy include: segregating dust-producing operations; sealing off walls, ceilings, and partitions to prevent intrusion and accumulation of dust; installing electric equipment suitable for explosive atmospheres; and regularly training employees on combustible dust hazards.
