BETA LAB NO. M10329, TESORO EXCHANGER E6600B EXAMINATION DATA	TESORO REFINING AND MARKETING COMPANY ANACORTES REFINERY 10200 W. MARCH POINT ROAD T91WA4428 ANACORTES, WA 98221	CUSTOMER P.O. NO.: 4501667904, CHANGE ORDER #1
PARTS: 6600B HEAT EXCHANGER, PARTS 1B, 2B, AND 3B		DATE: DECEMBER 27, 2010
PAGE 1 OF 91

LABORATORY REPORT

SAMPLE DESCRIPTION: A heat exchanger 6600B (Beta Exchanger) was removed from operation at the Tesoro after undisclosed duration in service. The Exchanger B Shall Examination Protocol (Protocol) and Addendum 1 were developed and signed by Tesoro Companies, Division of Occupational Safety and Health, and U.S. Chemical Safety Board. The mentioned above Protocol and Addendum 1 are located in the Appendix 1 at the end of this Report. FirstEnergy BETA Laboratory was selected as the data collecting laboratory to perform the testing required by the Protocol.

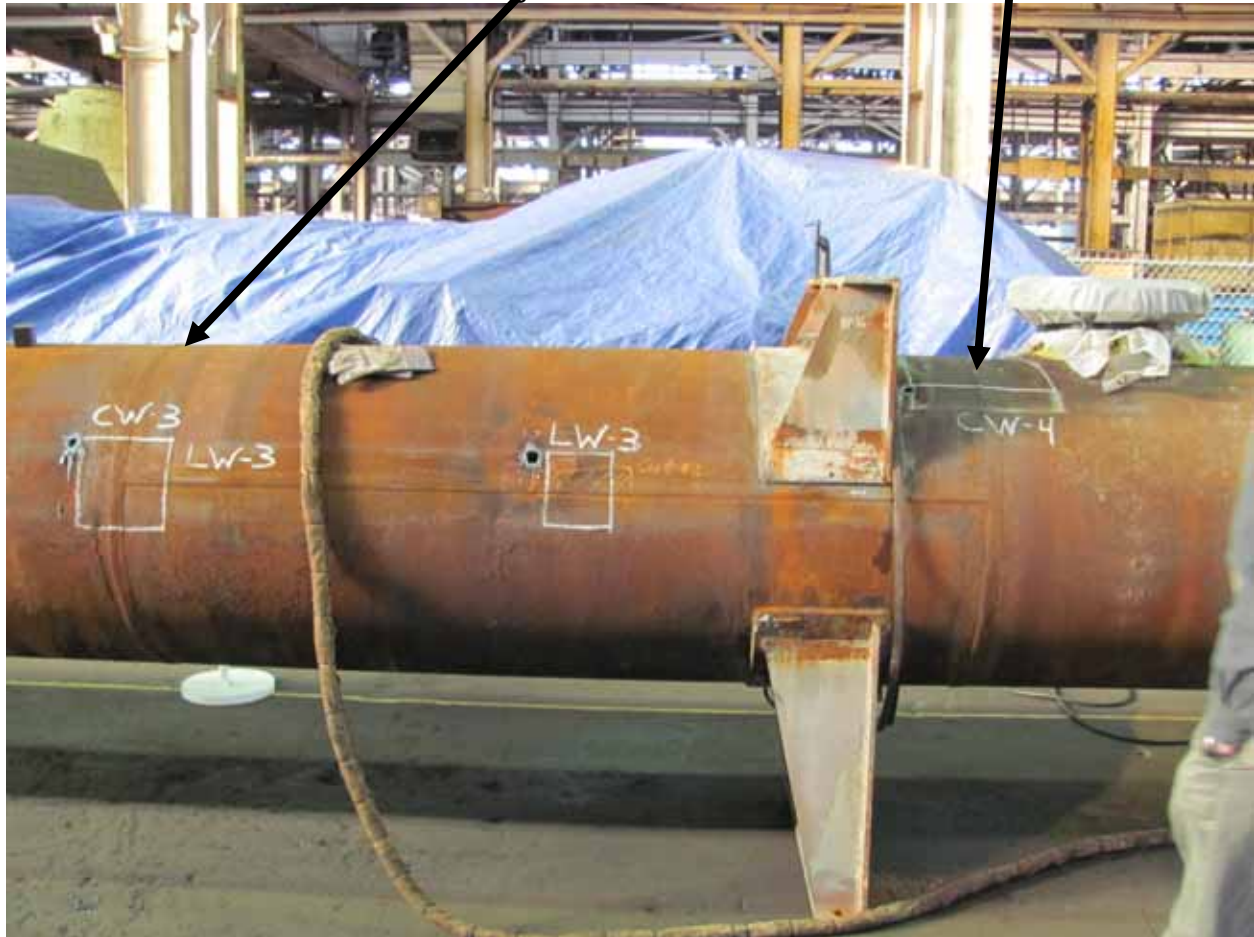
Figure 11.Shell

The areas of the interest marked by others and are ready to be cut out

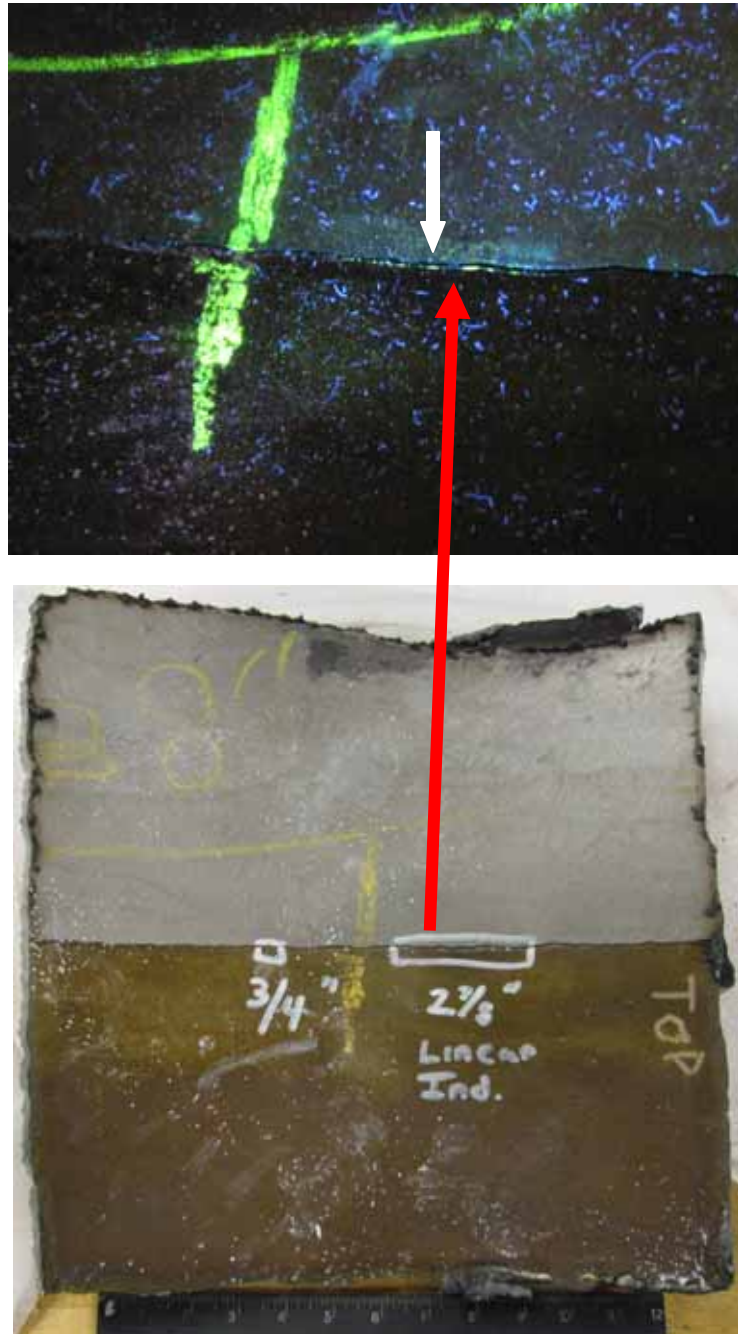
Figure 15. PT results of Part 1B. You are looking at ID. The s.s. clad is at the top portion of the sample on this picture.

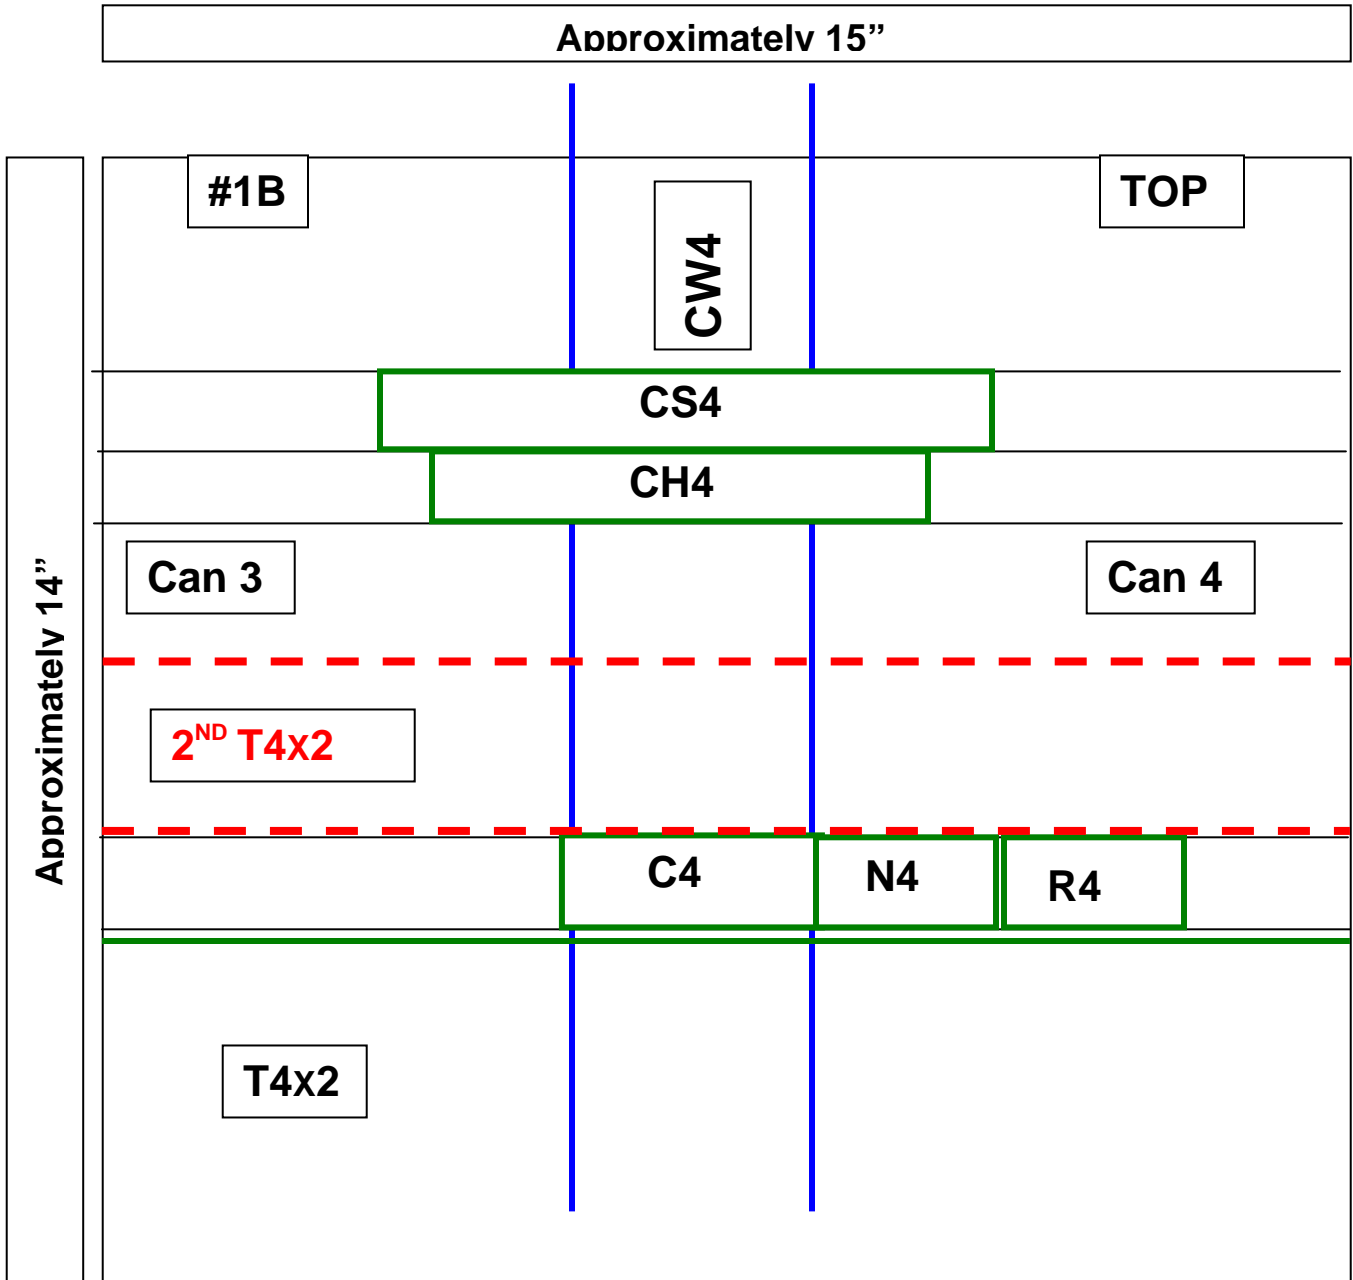
Figure 16b. 1B CW4 samples layout sketch. For labels explanation see Table on Figure 16a above.
You are looking at O.D.

There are two coupons for the tensile test T4 because the first one was not tested properly.

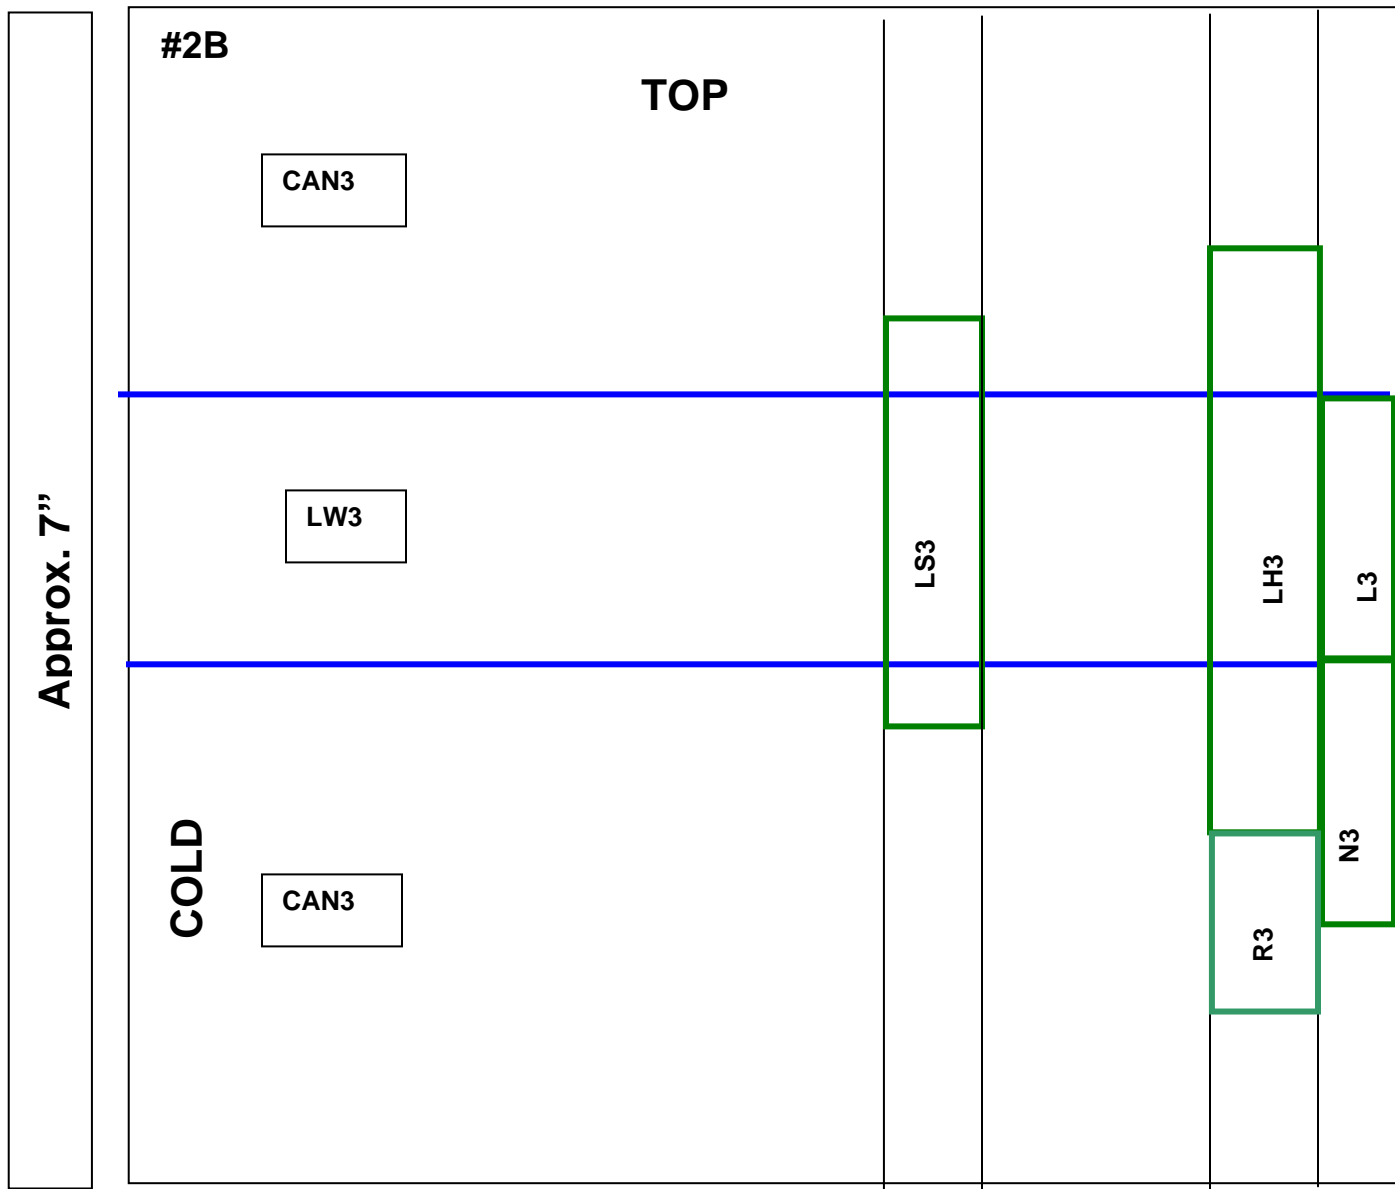
Figure 17b. 2B LW3 samples layout sketch. For labels explanation see Table on Figure 17a above.
You are looking at O.D.

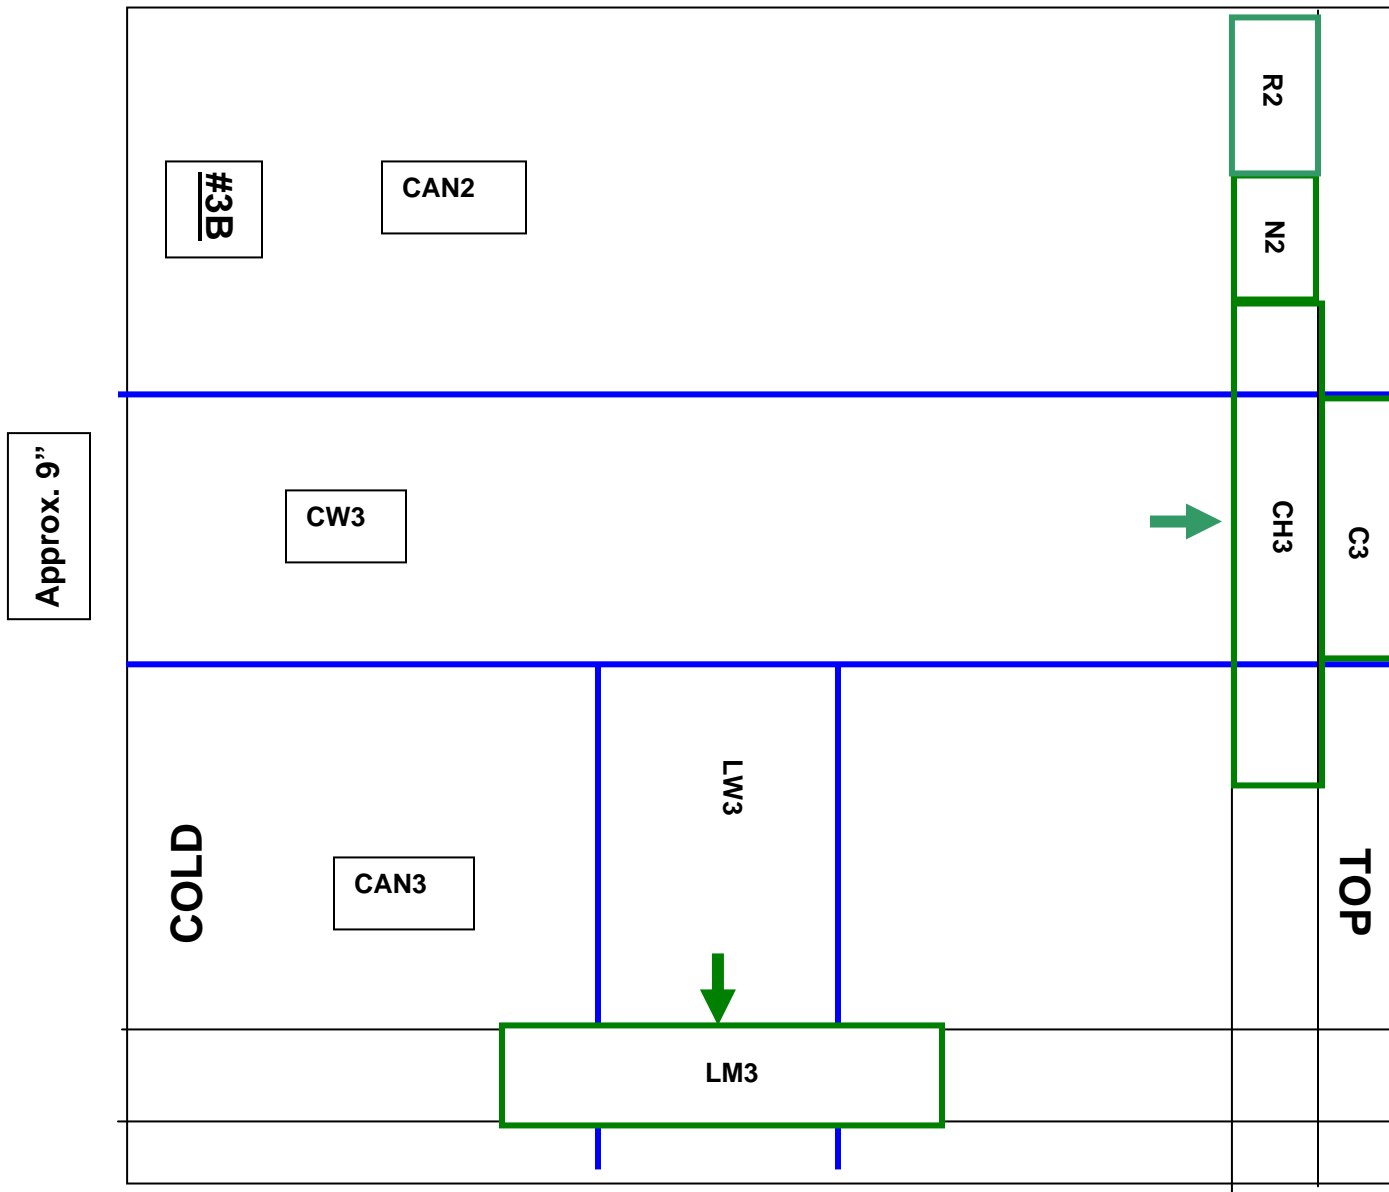
Figure 18b. 3B LW3-CW3 samples layout sketch. For labels explanation see Table on Figure 18a above. You are looking at O.D.

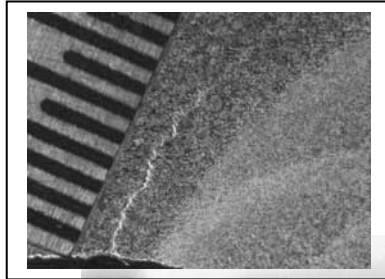
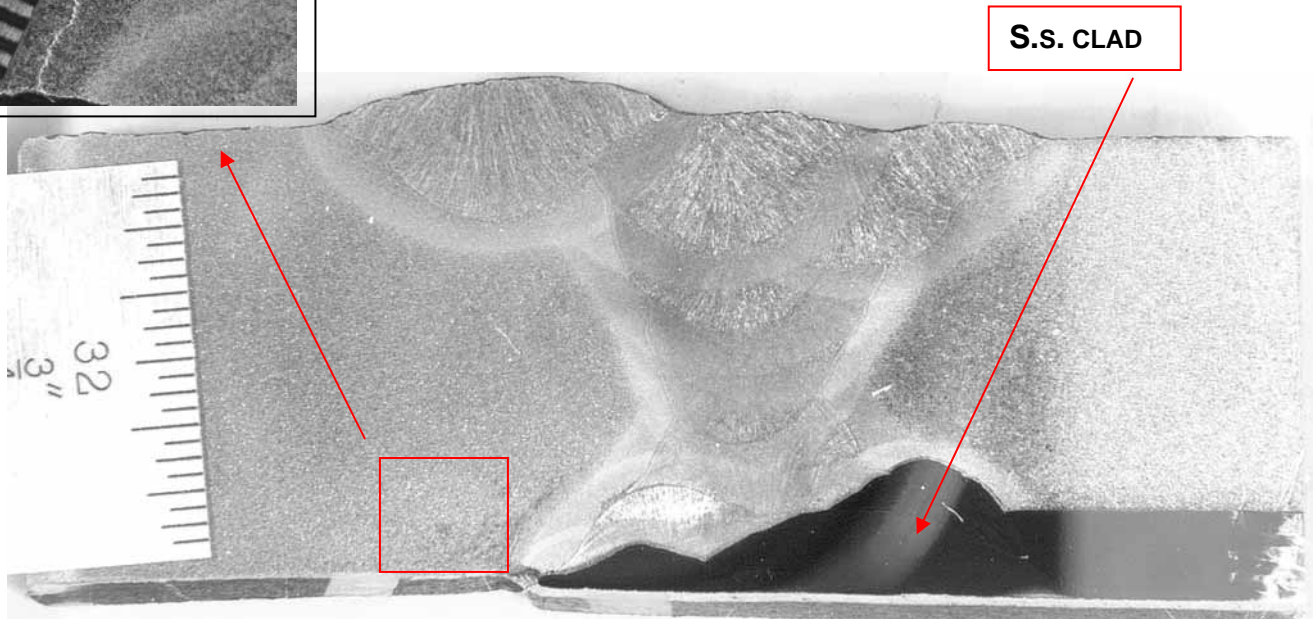
A

Part 1B. CH4 mount. Inset shows the crack at higher magnification. The ruler increment in inset is 1/64 inch.

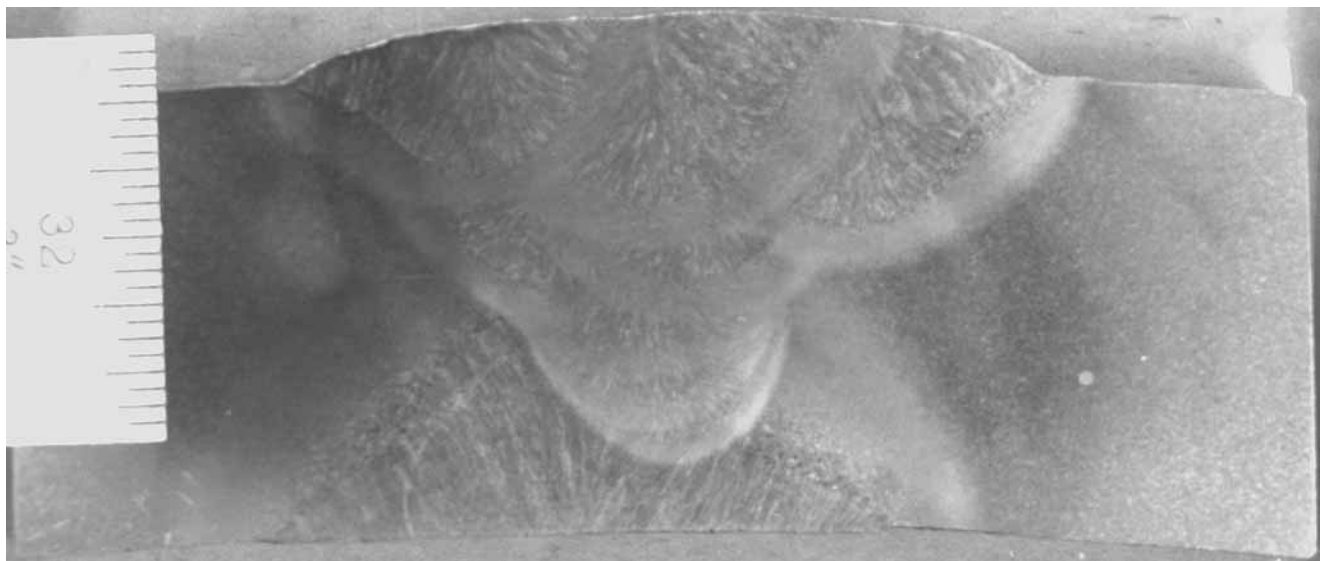
B

Part 2B. LH3 mount.

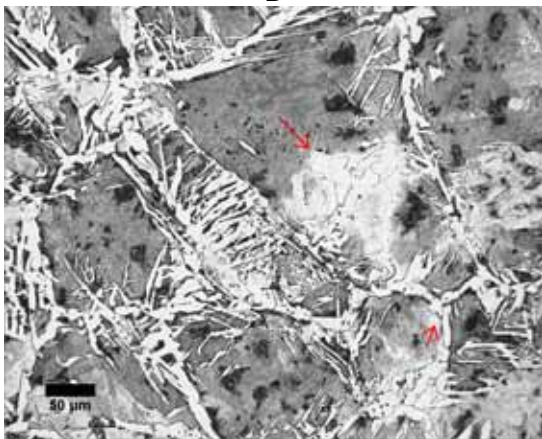
Figure 22. Definitions of the damage locations (devised by others) used in Table 11 and in the text

When the observed damage is located at the fusion line (FL) or at the 1st or 2nd grain of the CG HAZ (Coarse Grain of the Heat Affected Zone, CG everywhere in this report), it is marked as **“FL”**

It is typical to find damage beyond the FL and the 2nd grain of the CG, as it shown on the micrographs at left. The arrows at the microphotograph [B] show a decarburized spot indicative of the damage well deep in the CG, away from the FL. On microphotograph [C] the damage is in the 21st – 22nd grain inside the CG.

If this is observed, the location of the damage is defined as **“CG”**.

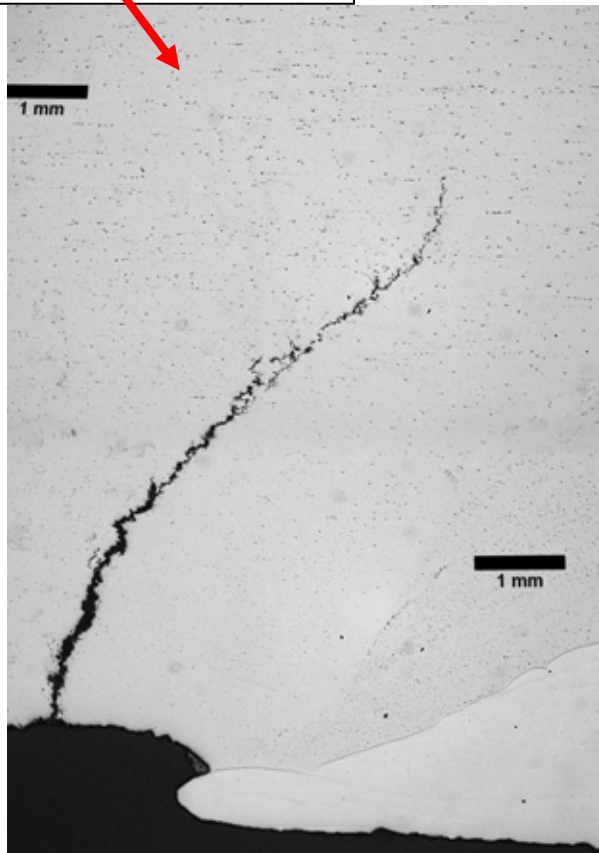
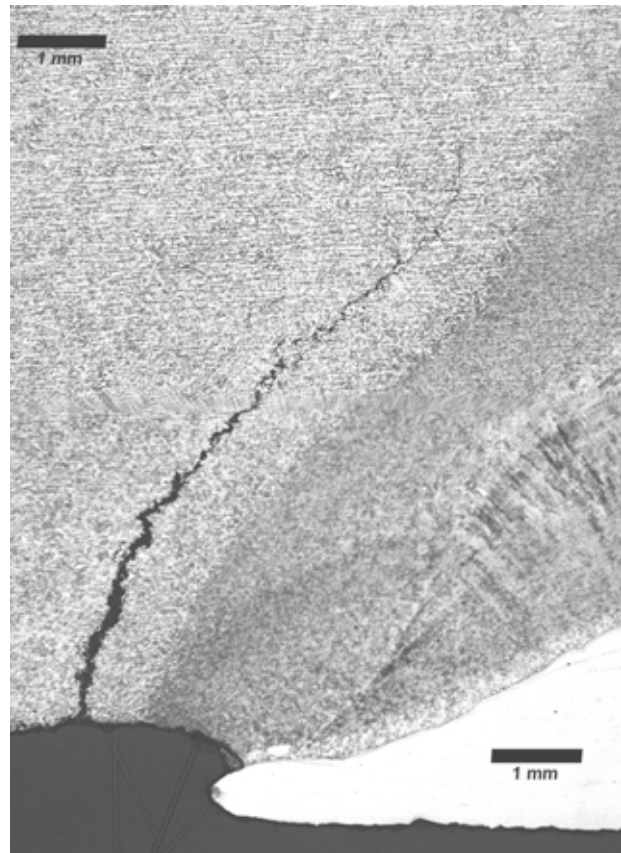
Figure 23.

Crack in the Base Metal. Un-etched

Same as at left. Etched

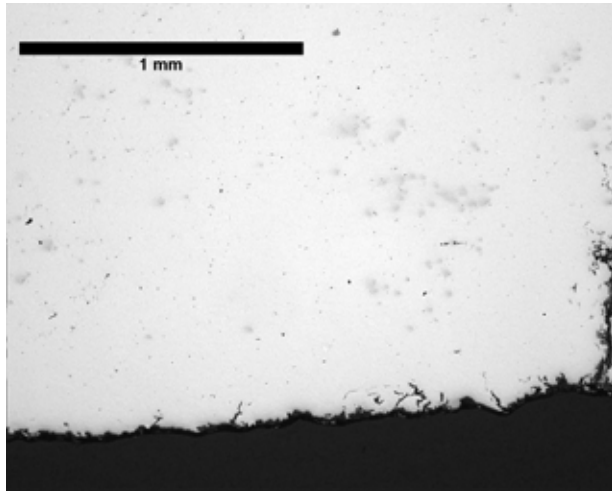
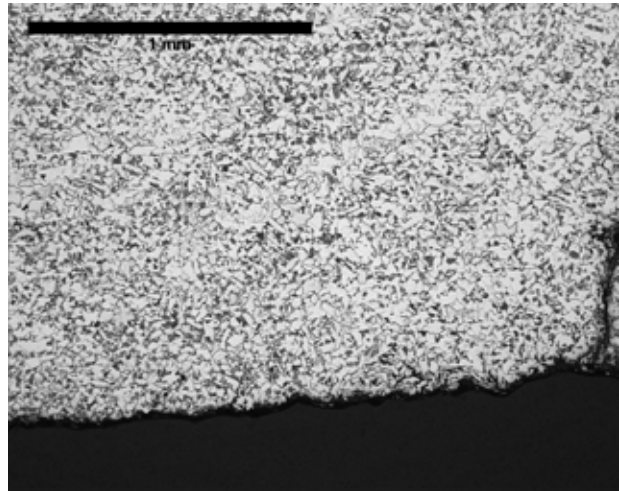
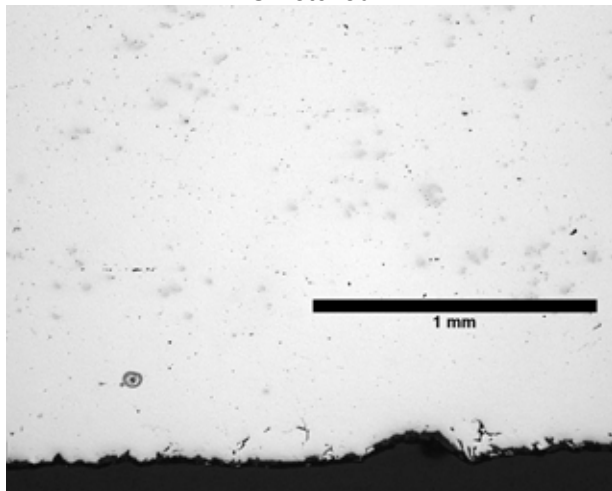
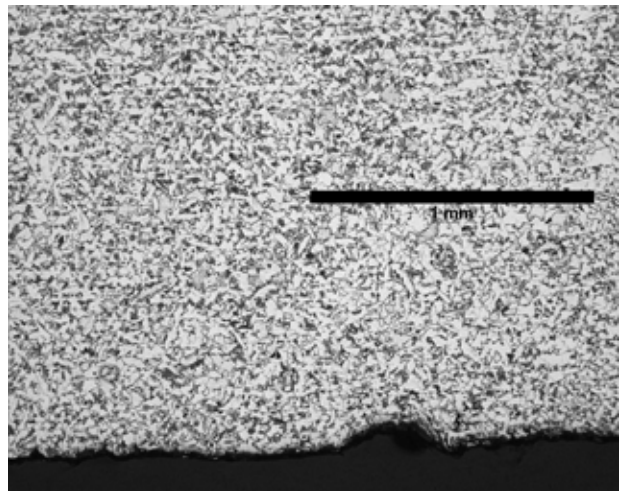
Figure 24

Area approximately 2 mm to the left from the crack.
Un-etched

Same as at left. Etched

Area approximately 4 mm to the left from the crack.
Un-etched

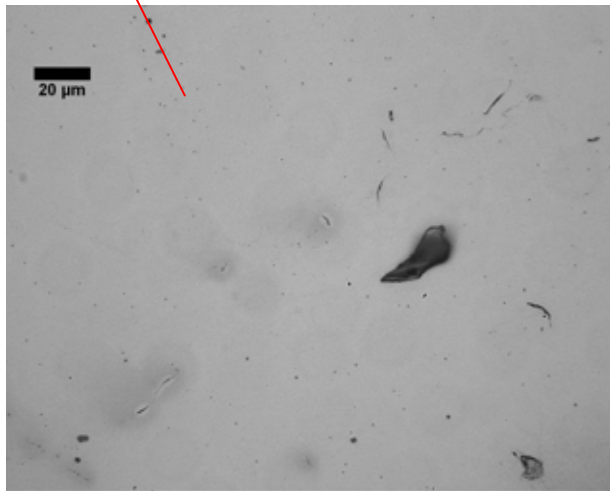
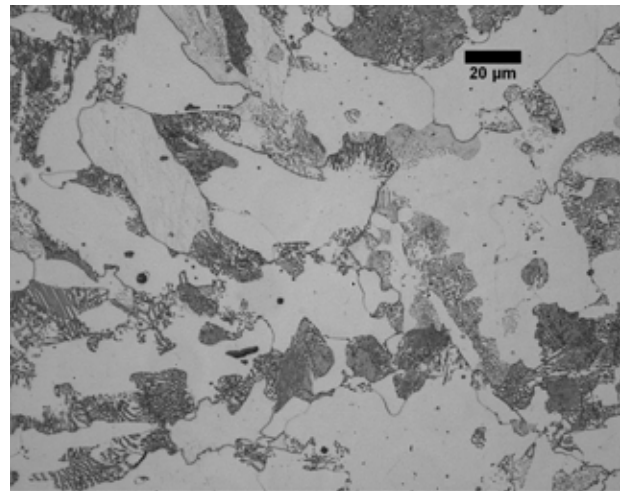
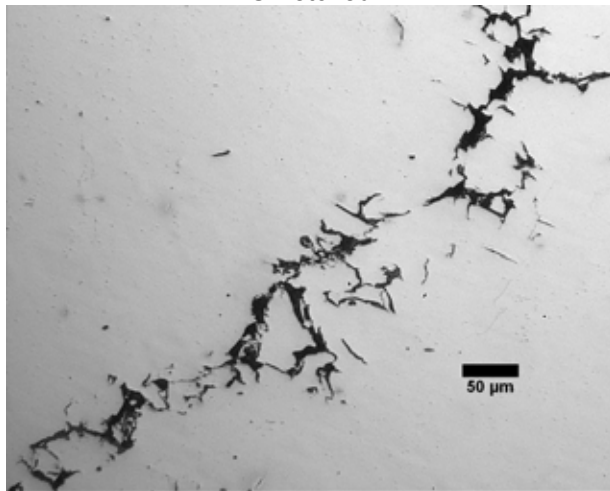
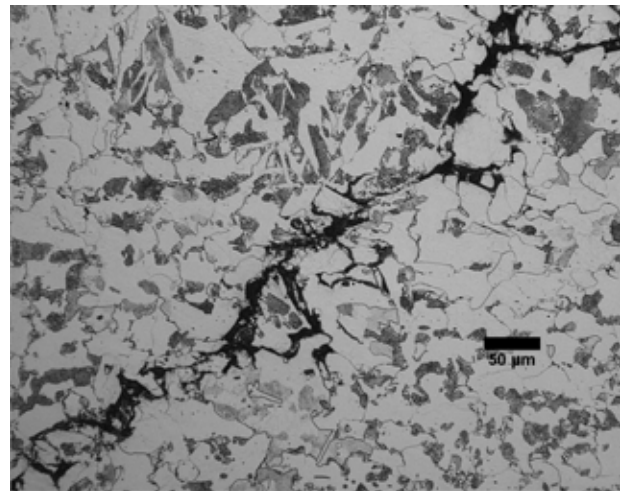
Figure 25

Area 4 mm from the crack to the left of the crack.
Un-etched

Same as at left. Etched

Area near the tip of the crack. Un-etched

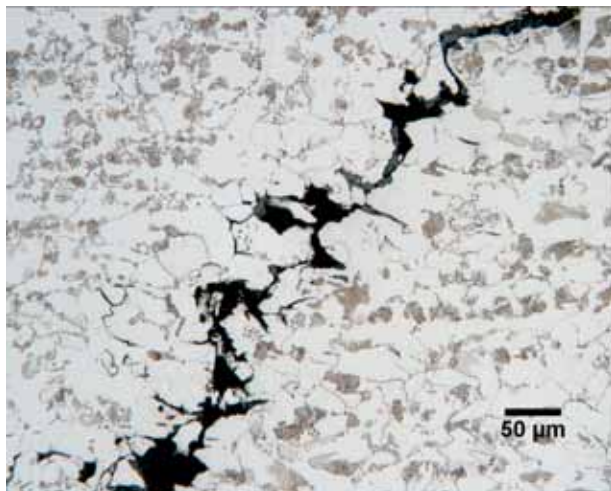
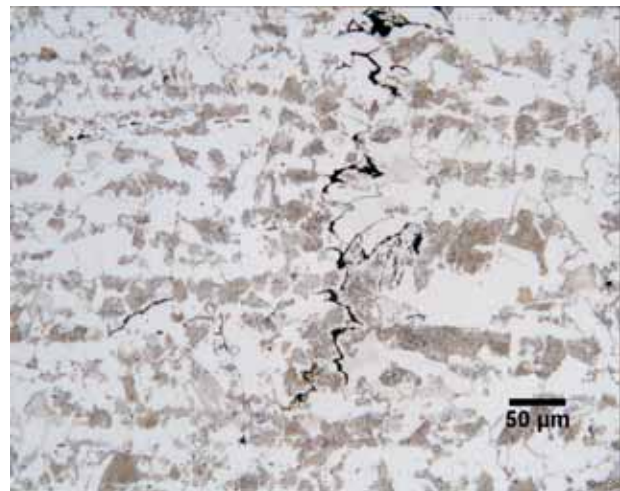
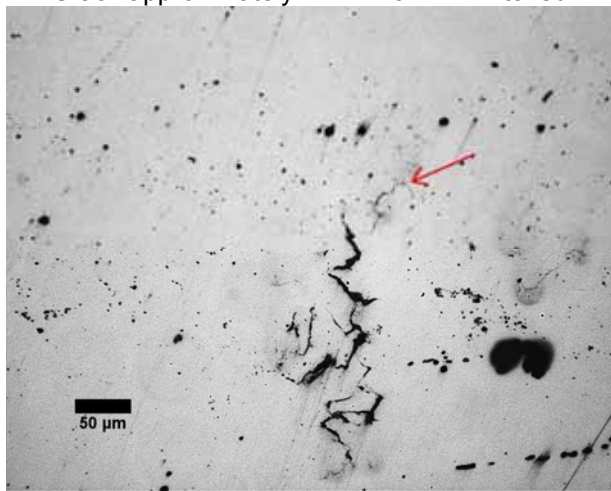
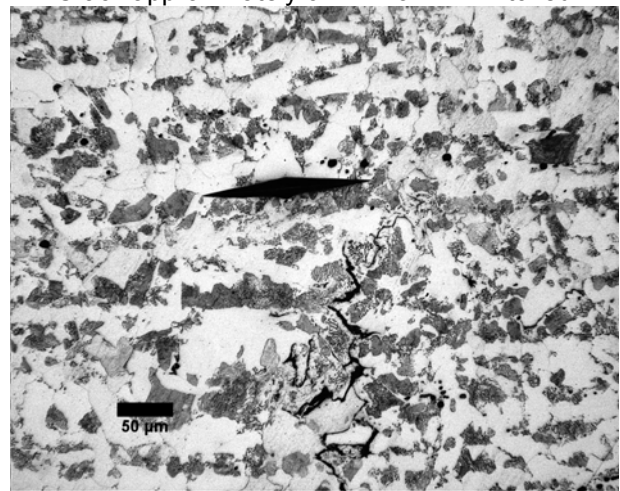
Figure 26

Crack approximately 4 mm from I.D. Etched

Crack approximately 6 mm from I.D. Etched

Tip of the crack and the last (deepest) damage observed. Un-etched.

Same as at left. The diamond is an identification of the deepest damage location. The measurements are in Table 12. Etched

It was requested to measure the following parameters in the microstructure of the welded joints: the depth of the damaged material, the location of the damage in the HAZ, and the widths of the coarse grain HAZ (CG HAZ) and fine grain of the HAZ (FG HAZ) at the deepest damage location. The results are in Table 12.

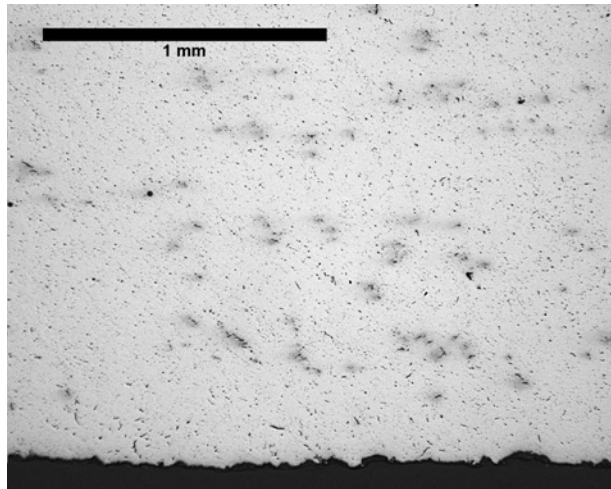
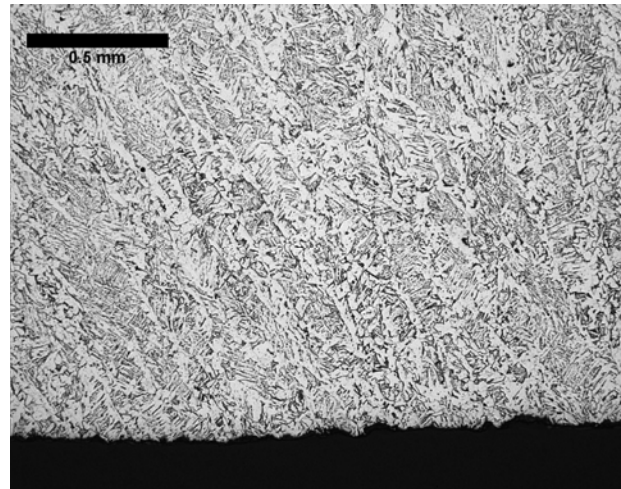
Figure 27.

Typical damage in the weld at I.D. Un-etched

Same as at left. Etched

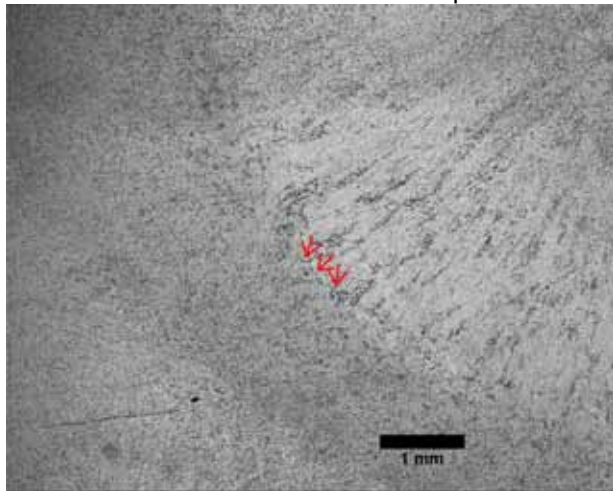
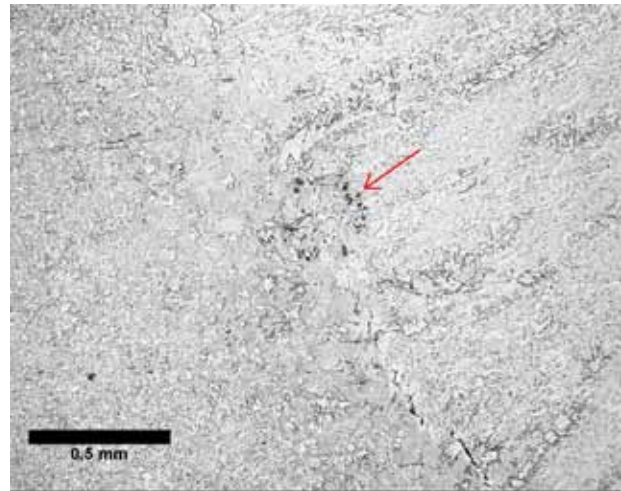
Figure 29

The deepest damage at the left side of the weld.
Etched

Same area as at left, enlarged. Etched

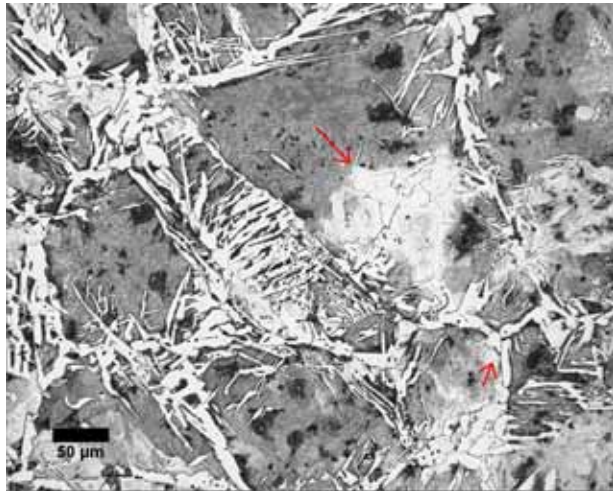
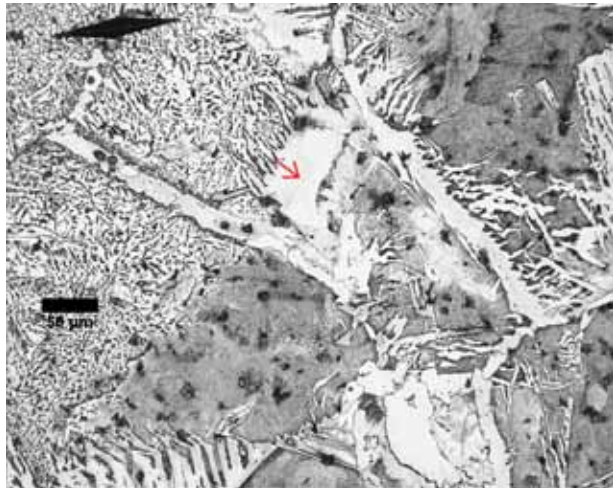
Figure 31

Right side of the weld. Damage of the 21st – 22nd grain in the coarse grain area of the heat affected zone.

The deepest observed damage at the right side of the weld. See Table 12 for measurements.

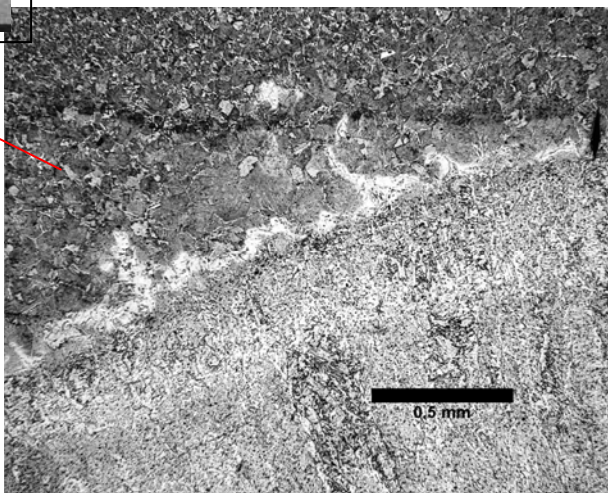
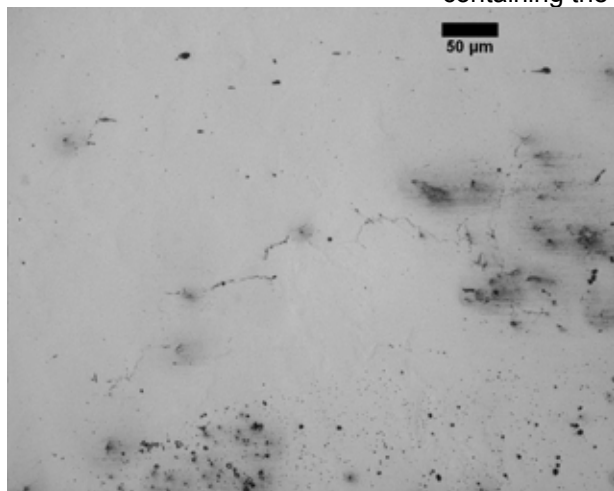
Left side of the weld at I.D. Decarburized area containing the damage. Etched

Left of the weld. Area at the toe at I.D. Un-etched

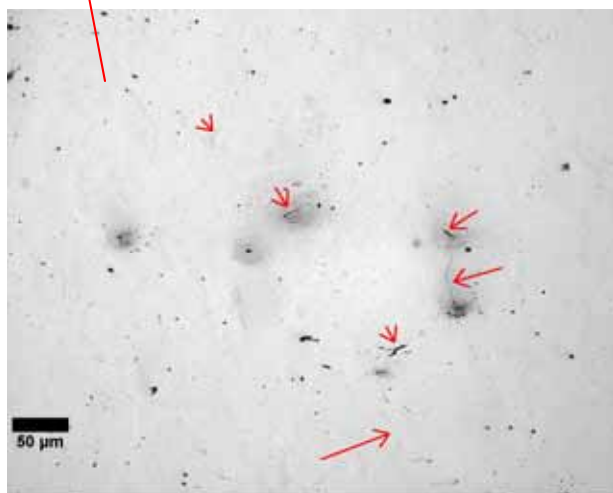
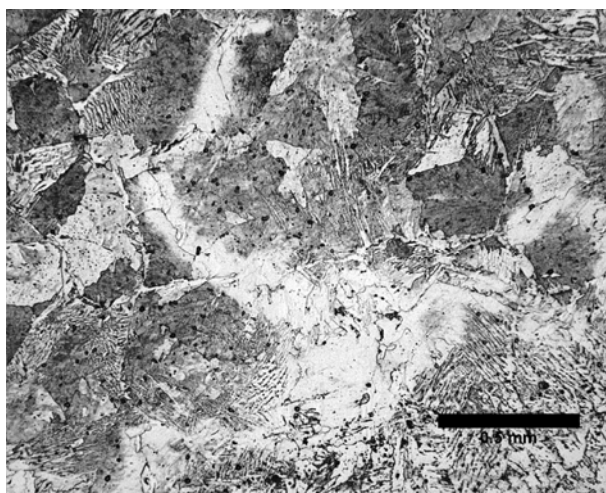
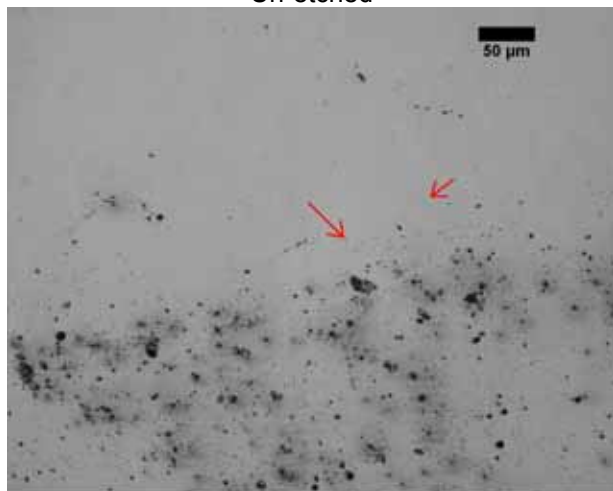
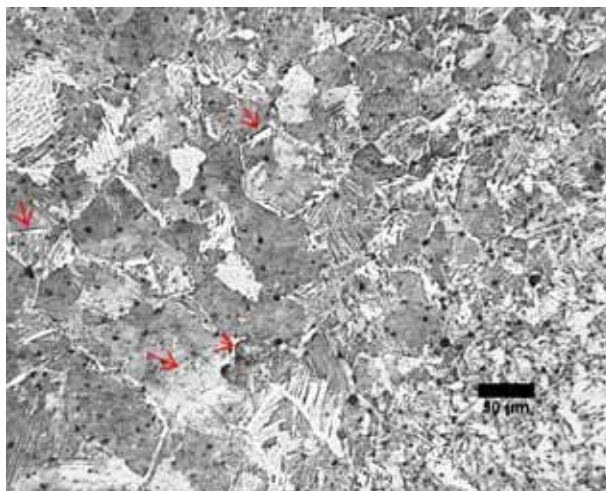
Figure 33.

Left side of the weld. Damage in the CG HAZ.
Un-etched

Same area as at left. Etched

Left of the weld. Area close to the end of the
damaged HAZ. Un-etched

Same as at left. Etched

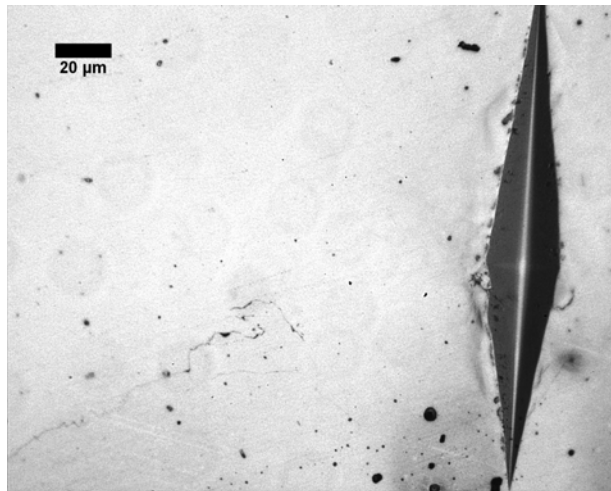
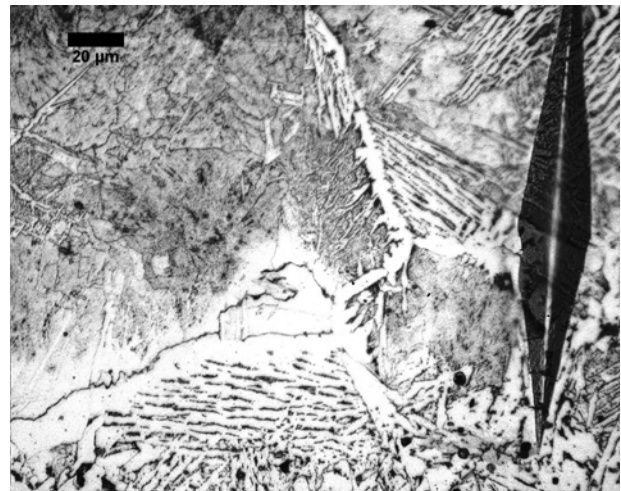
Figure 34

Left side of the weld. The deepest damage observed marked by a diamond indentation. Un-etched.

Same as at left. Etched. The measurements are in the Table 12.

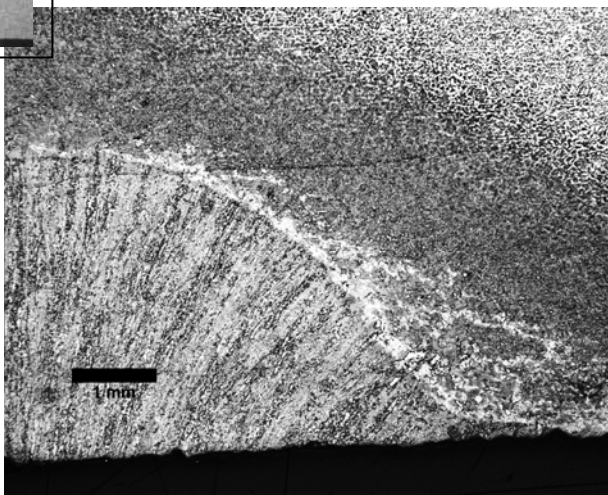
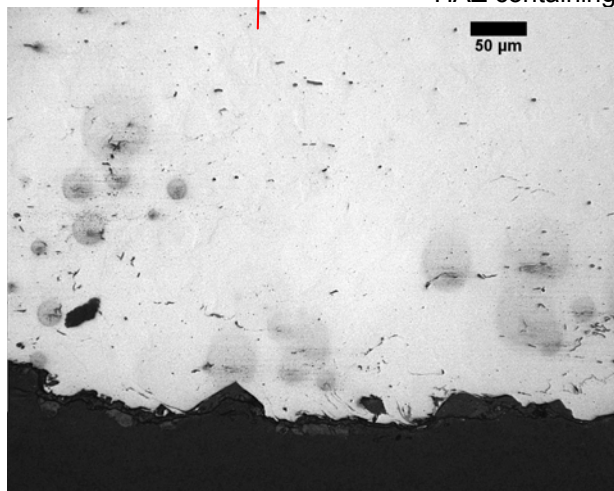
Right side of the weld. Decarburized layer in CG HAZ containing damage. Etched

Right side of the weld. Area near the toe of the weld. Un-etched

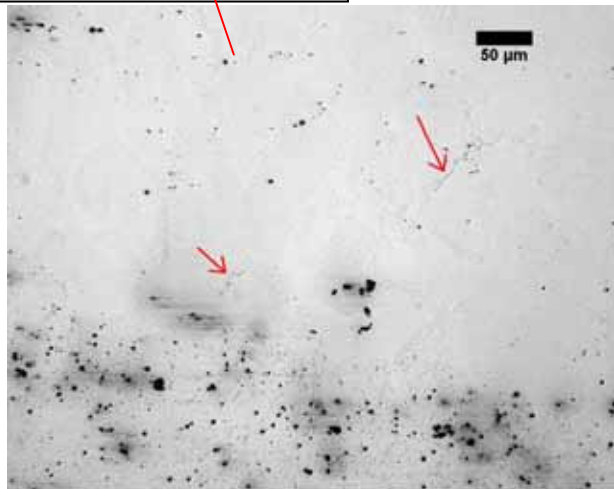
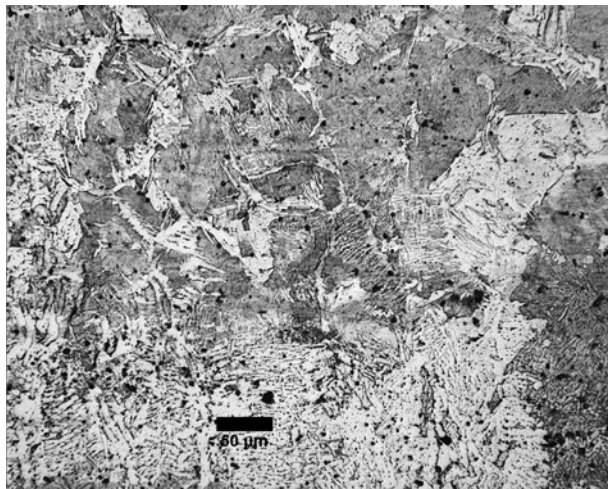
Right of the weld. Area of the deepest damage observed. Un-etched.

Same as at left. Etched.

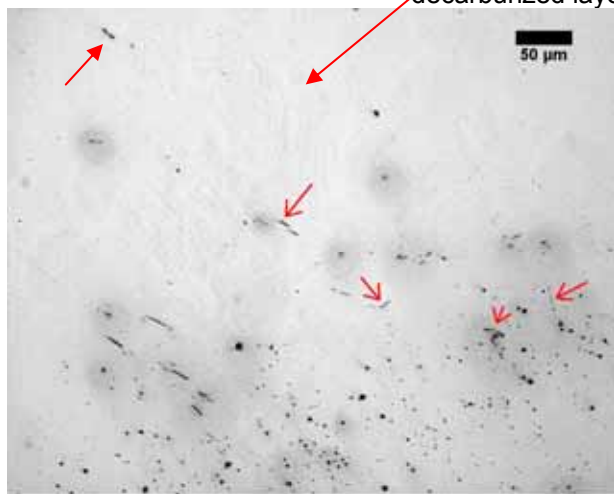
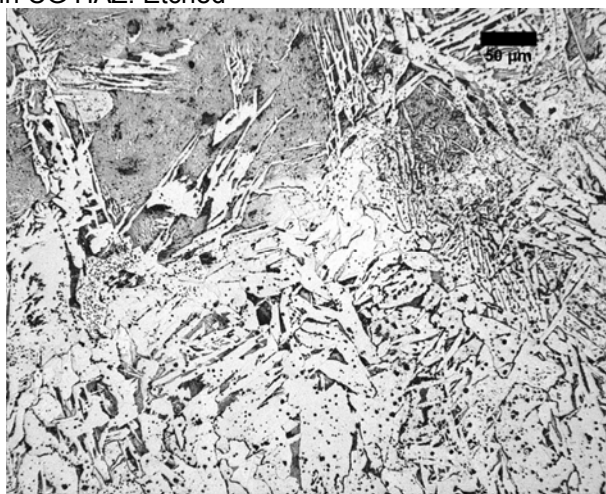
Figure 38

Left side of the weld at the toe. General view at decarburized layer in CG HAZ. Etched

Left side of the weld. Area near the end of the damaged zone. Un-etched

Same as at left. Etched

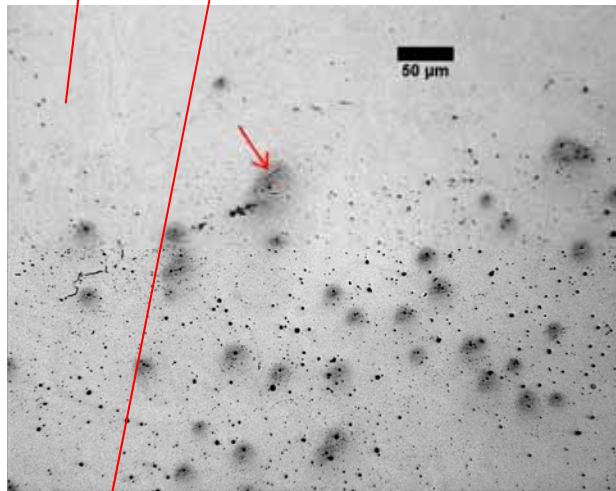
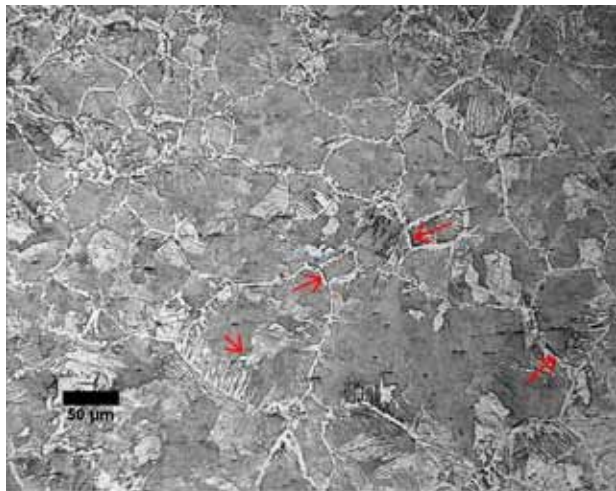
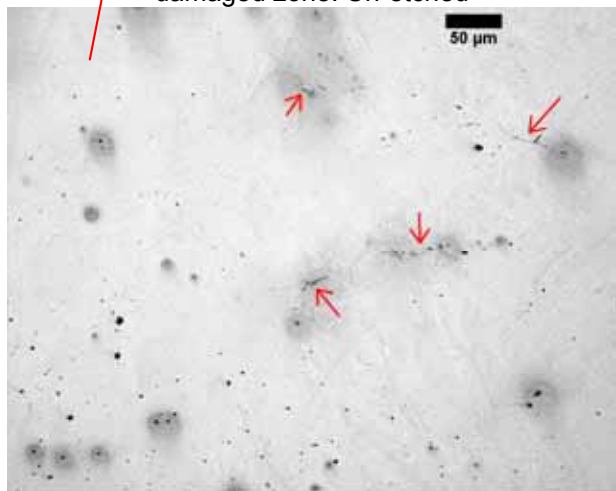
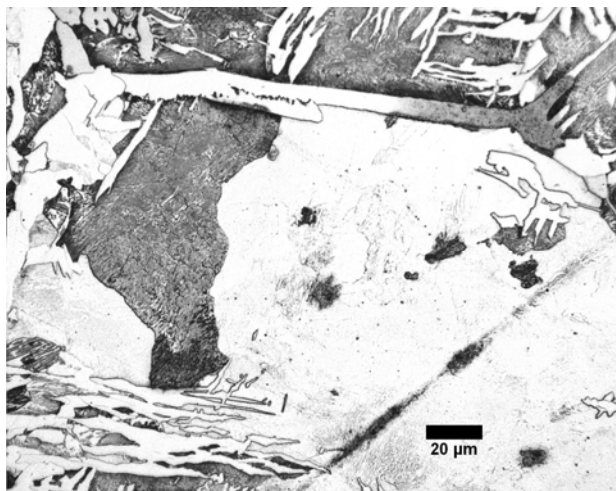
Figure 39

Left side of the weld. Area near the end of the damaged zone. Un-etched

Same area as at left. Etched

Right side of the weld. Area near the end of the damaged zone. Un-etched

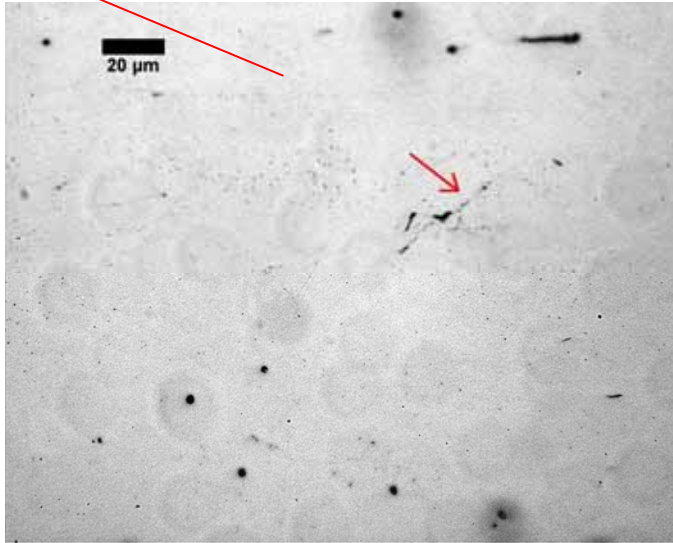
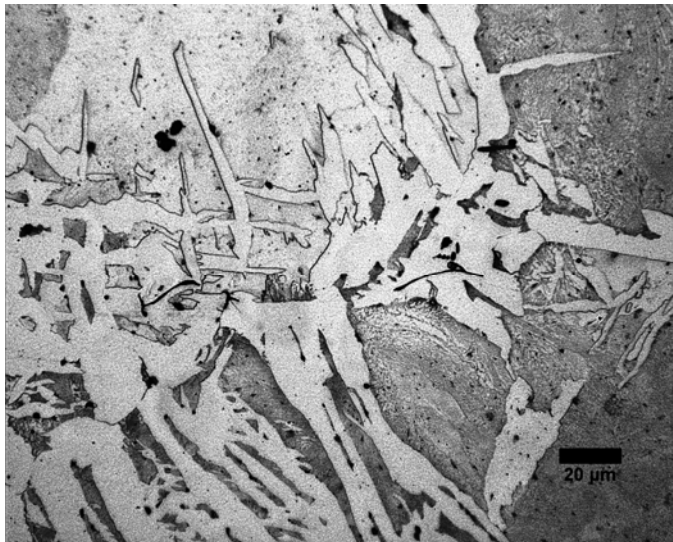
Figure 40

Right side of the weld. Area near the deepest damage.
Un-etched

Same area as above. Etched
