BETA LAB NO. M10329, TESORO EXCHANGER E6600B EXAMINATION DATA	TESORO REFINING AND MARKETING COMPANY ANACORTES REFINERY 10200 W. MARCH POINT ROAD T91WA4428 ANACORTES, WA 98221	CUSTOMER P.O. NO.: 4501667904, CHANGE ORDER #1
PARTS: 6600B HEAT EXCHANGER, PARTS 1B, 2B, AND 3B		DATE: DECEMBER 27, 2010
PAGE 1 OF 91

LABORATORY REPORT

SAMPLE DESCRIPTION: A heat exchanger 6600B (Beta Exchanger) was removed from operation at the Tesoro after undisclosed duration in service. The Exchanger B Shall Examination Protocol (Protocol) and Addendum 1 were developed and signed by Tesoro Companies, Division of Occupational Safety and Health, and U.S. Chemical Safety Board. The mentioned above Protocol and Addendum 1 are located in the Appendix 1 at the end of this Report. FirstEnergy BETA Laboratory was selected as the data collecting laboratory to perform the testing required by the Protocol.

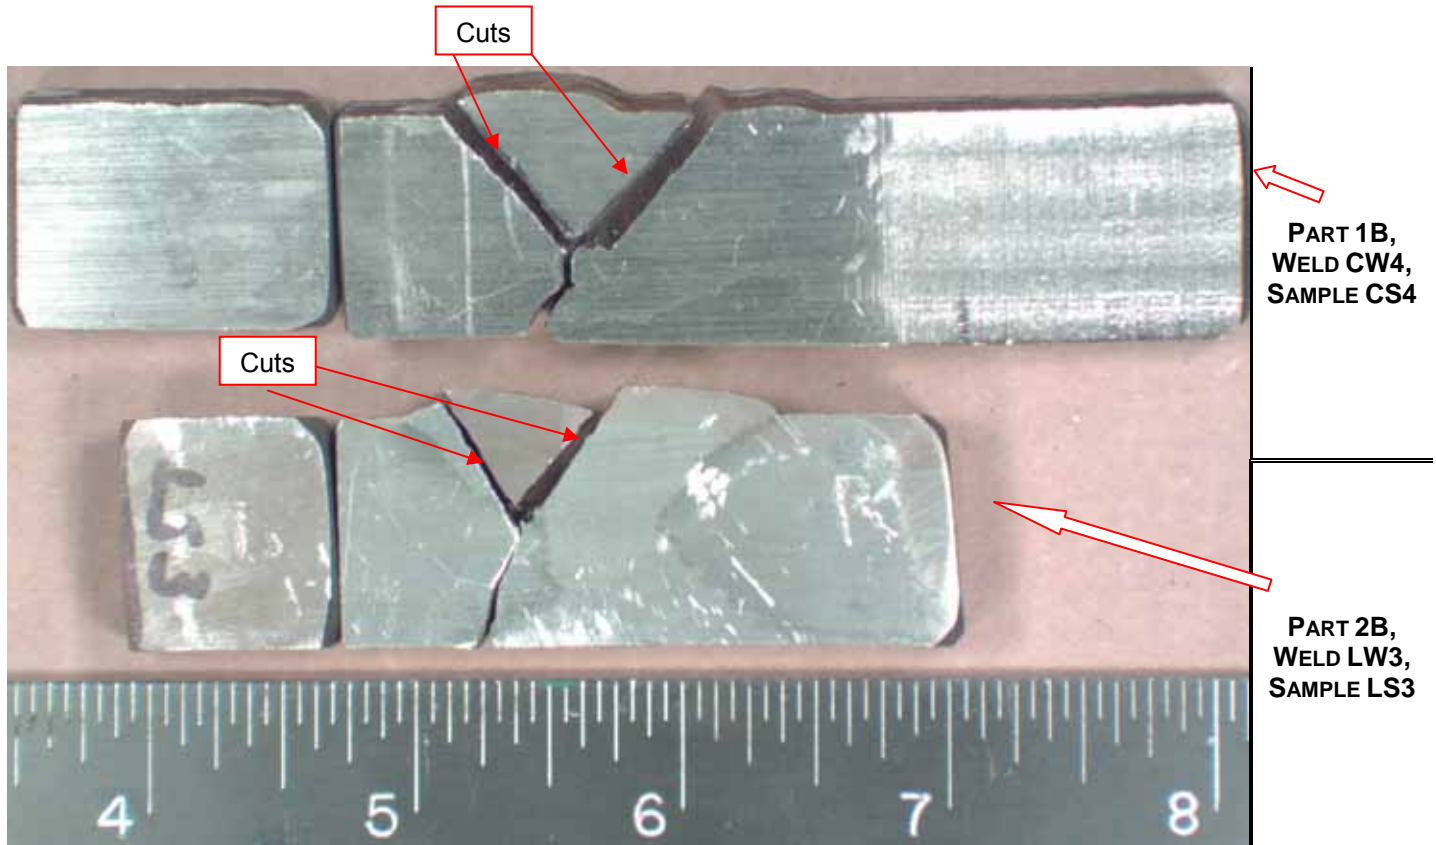
Figure 41. Two samples failed in the Lab for Fractography in Scanning Electron Microscope (SEM)
I.D. is on the bottom

Two locations were selected for Fractography in SEM. The two samples (sample CS4 with weld CW4 from Part 1B, and sample LS3 with weld LW3 from Part 2B) were V-shape cut from the O.D. to decrease the cross section but leaving untouched the damaged area, submerged in the liquid nitrogen for over half an hour and then impact failed to expose fracture surface (see Figure 41). The fracture surfaces than were examined in Scanning Electron Microscope and the results introduced on Figures 42 through 45.

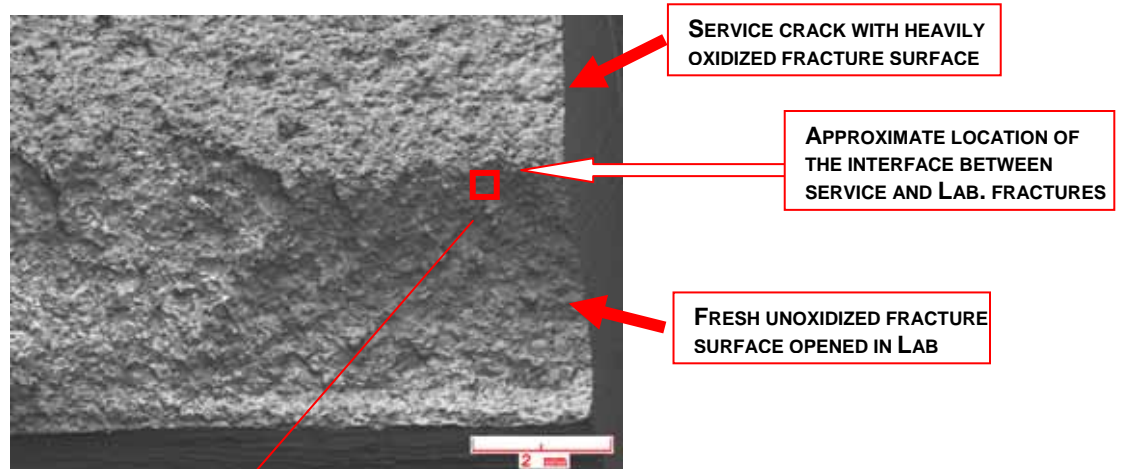
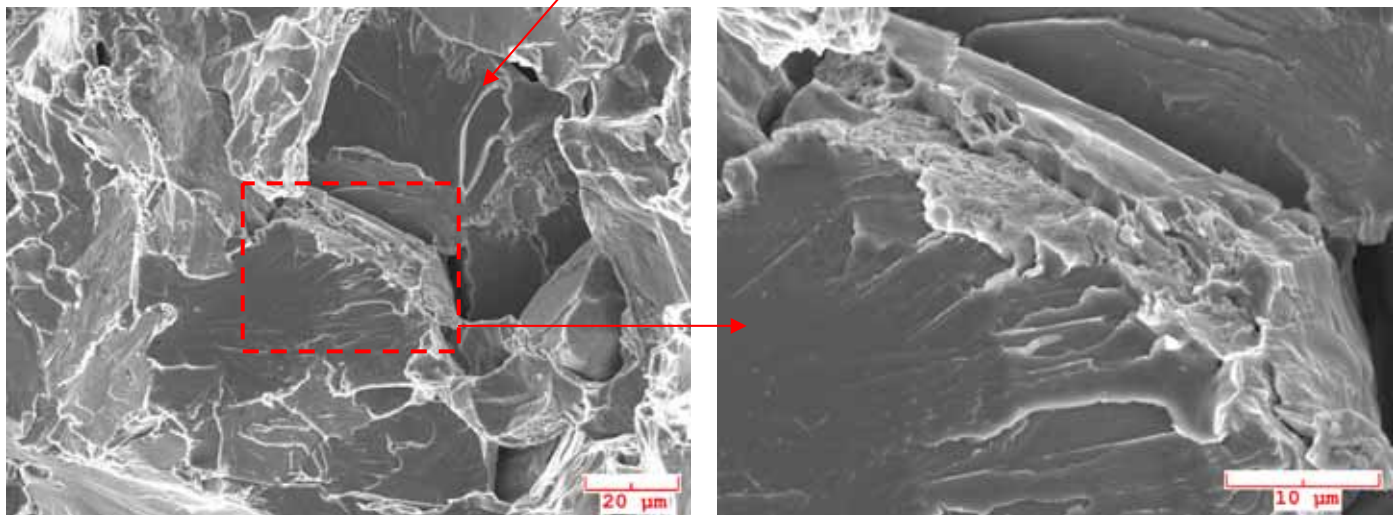
Figure 42. Fracture features of an area in the fresh fracture but near the tip of the service crack. The I.D. is at the top of the pictures.

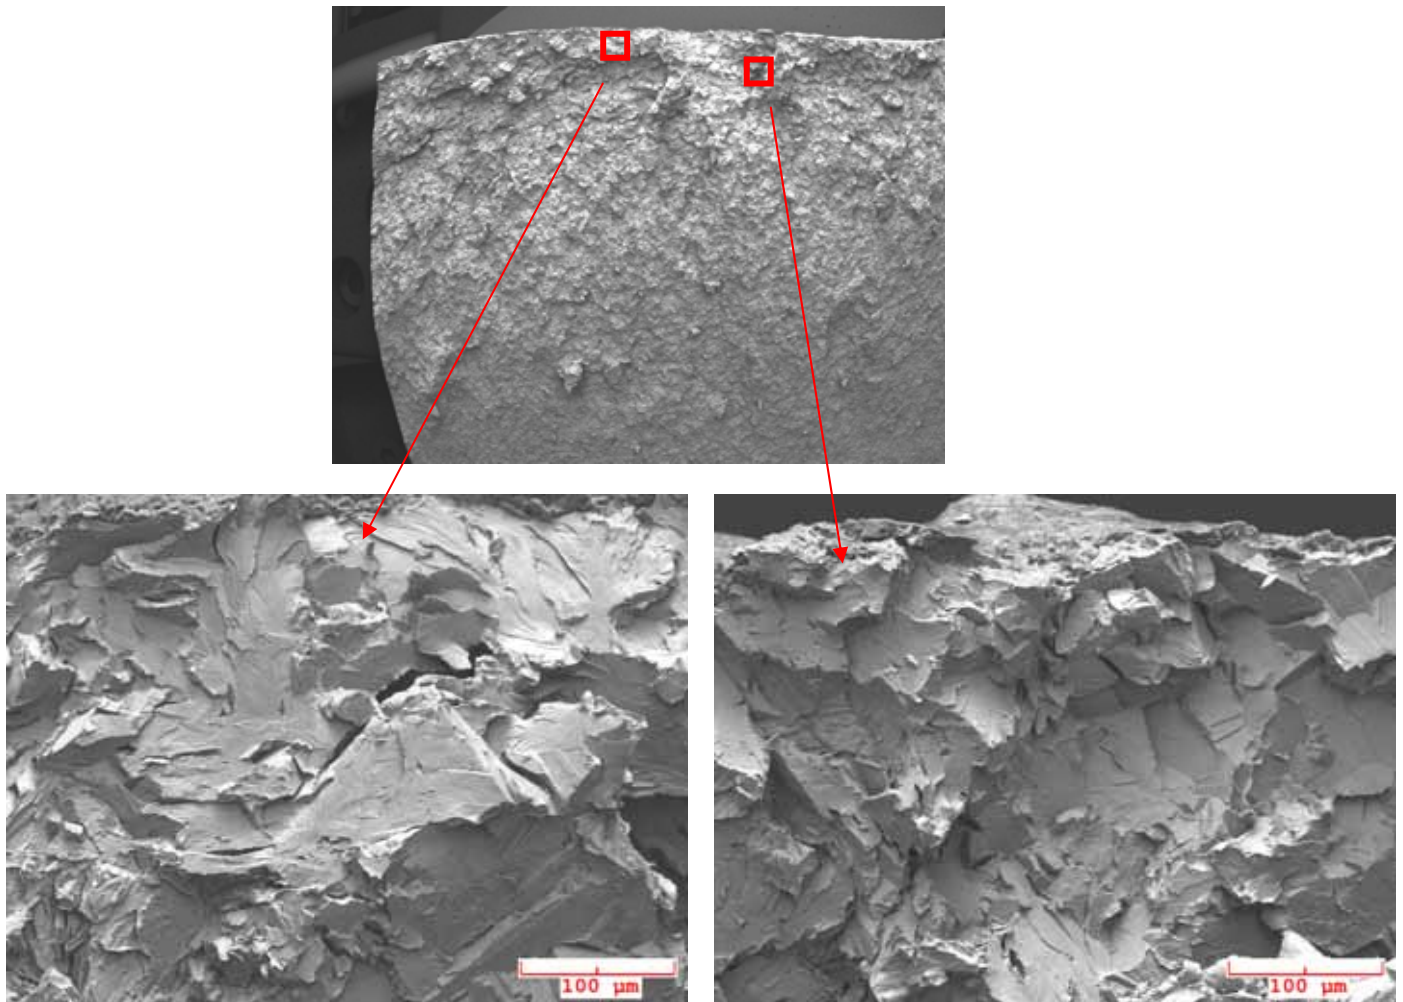
Figure 44. Fracture surface features at the I.D. The squares indicate the approximate location of the fractures shown. I.D. is at the top of the pictures.

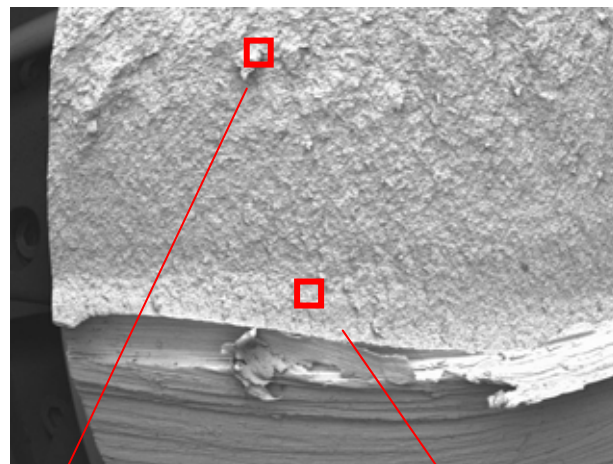
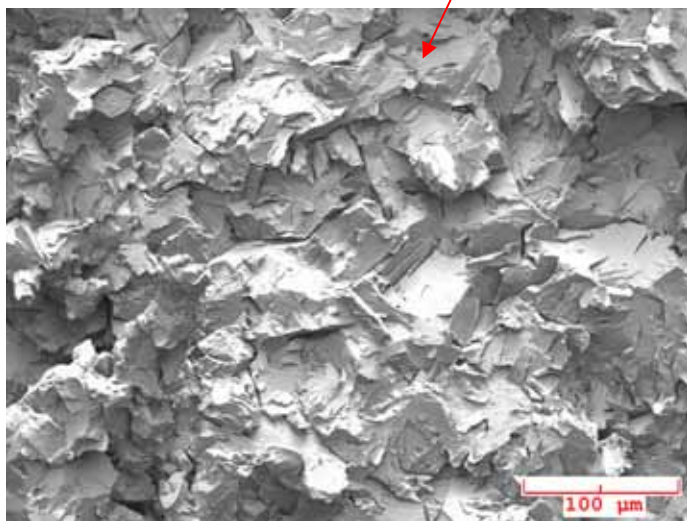
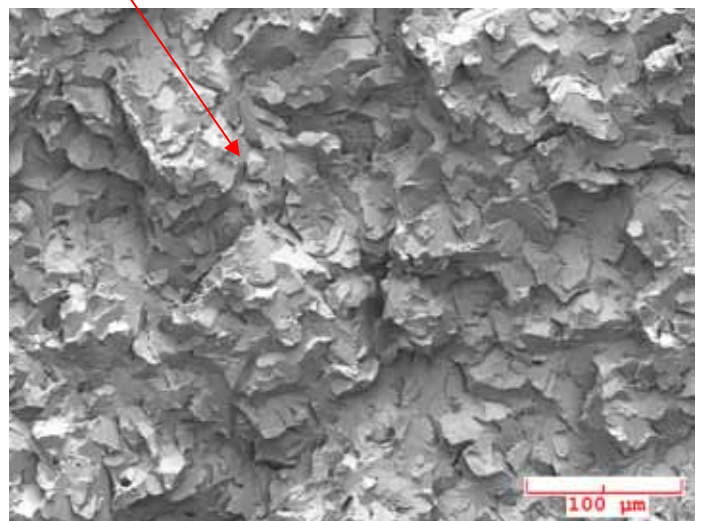
Figure 45. The squares indicate the approximate location of the fractures shown.
The I.D. is at the top of the photographs.

Fracture features near the middle of the fracture surface

Fracture features near the bottom of the V-cut

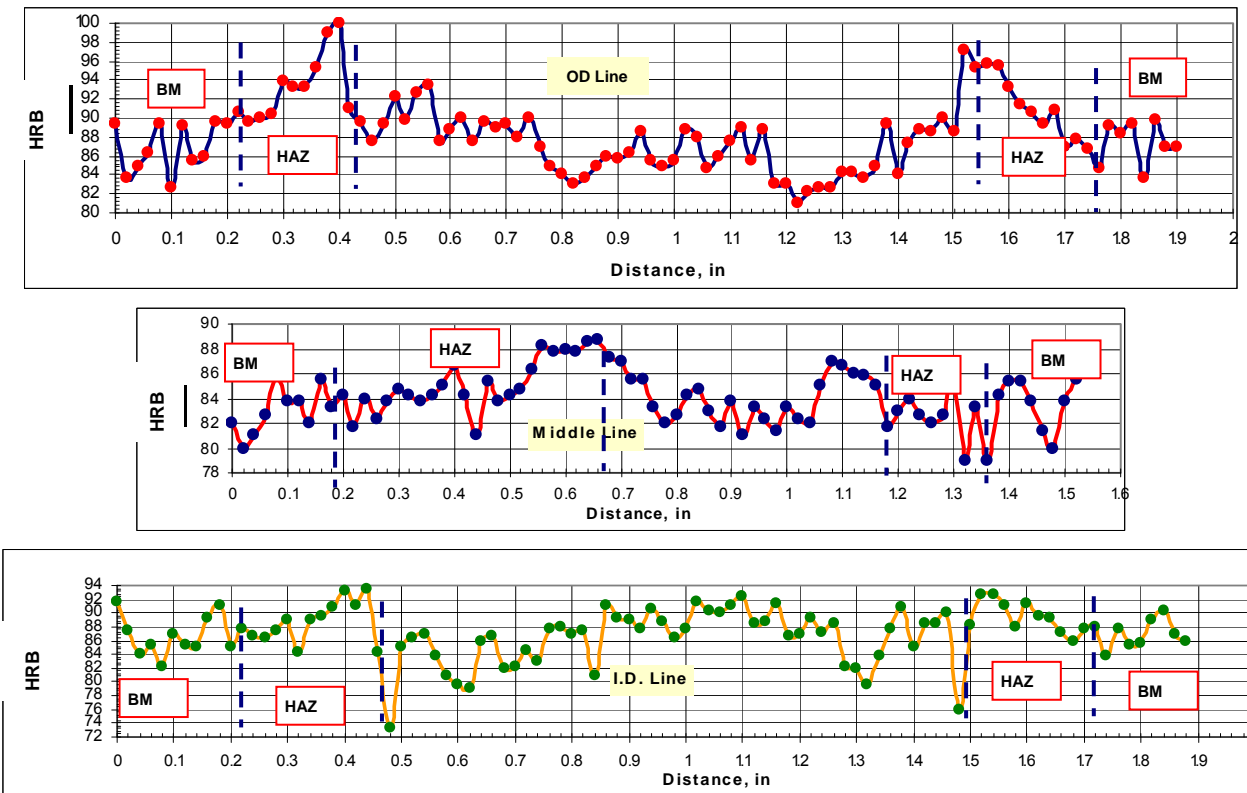
Figure 47

LABORATORY REPORT
PART 2B, WELD LW3, SAMPLE LH3.
HARDNESS TRAVERSES

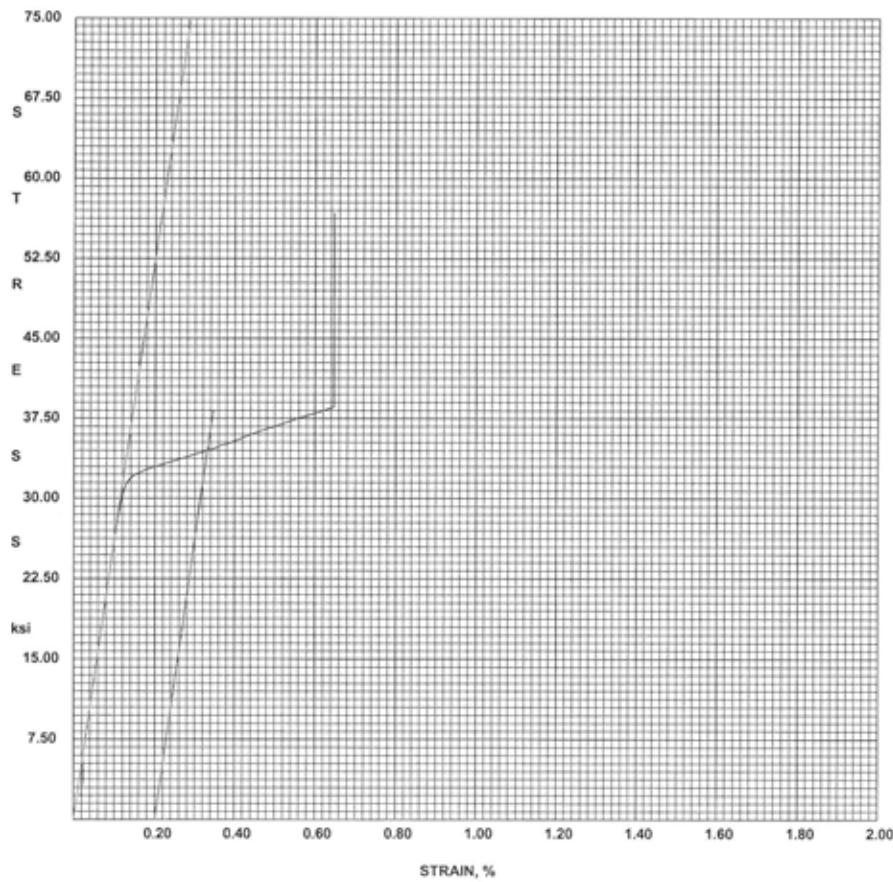
PART 1B, WELD CW4, SAMPLE T4-2, 2ND TEST

Customer	FIRST ENERGY
Contact	
PO	55102614
Order Ref	NA
Order Ref	M10329 T4
TTML Job#	JB0294-007
Test Date	11/10/2010
Operator	42
Test Setting	290M-TeFI-Weld TYE
Instrumentation	TO213762-4%-2.0"
Item Reference:	M10329 RP
...:	T4
...:	
Sample:	2
Width, in:	0.738
Thickness, in:	0.286
Ult Load, lbf:	11980
Tensile, psi:	56500
OS @ .2, psi:	34500
Elong, %:	9.5
Failure Type:	Ductile
Failure Location:	Base
