BETA LAB NO.M10329-B, TESORO EXCHANGER E6600-B EXAMINATION DATA	TESORO REFINING AND MARKETING COMPANY ANACORTES REFINERY 10200 W. MARCH POINT ROAD T91WA4428 ANACORTES, WA 98221	CUSTOMER P.O. NO.: 4501667904, CHANGE ORDER #1
PARTS: E6600B HEAT EXCHANGER, PARTS 1B, 4B, AND 5B		DATE: MARCH 8, 2011
PAGE 1 OF 52

LABORATORY REPORT

SAMPLE DESCRIPTION: A heat exchanger E6600-“B” was removed from operation at the Tesoro after undisclosed duration in service. The Exchanger B Shell Examination Protocol (Protocol) and Addendum 1 were developed and signed by Tesoro Companies, Division of Occupational Safety and Health, and U.S. Chemical Safety Board. The mentioned above Protocol and Addendum 1 are located in the Appendix 1 at the end of this Report. FirstEnergy BETA Laboratory was selected as the data collecting laboratory to perform the testing required by the Protocol. The BETA Laboratory, as a data collecting (referee) laboratory, acts under the same rules as in the previous job on the exchanger E6600E, which are as follows:

This report contains the results of evaluation of the samples contained in the Parts 1B, 4B, and 5B as labeled in Tables 2 and 3, and Figures 7 through 9.

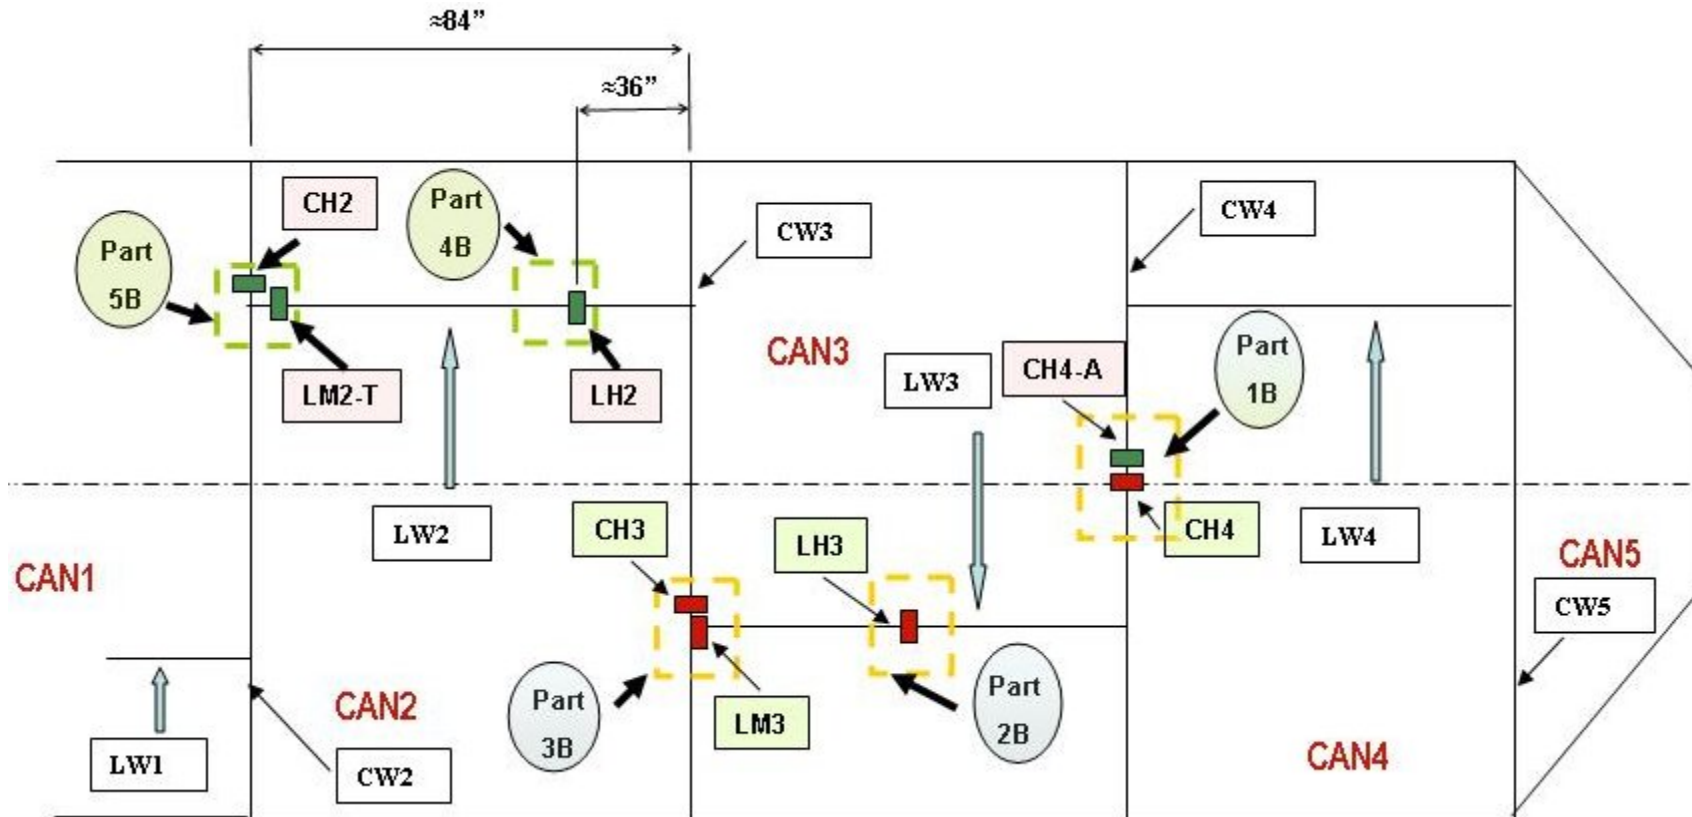
Figure 1. Layout of the samples evaluated in two reports -10329-A of 12/27/2010 (fill color red) and this report M10329-B (fill color green). You are looking at the OD of the shell. Not to scale.

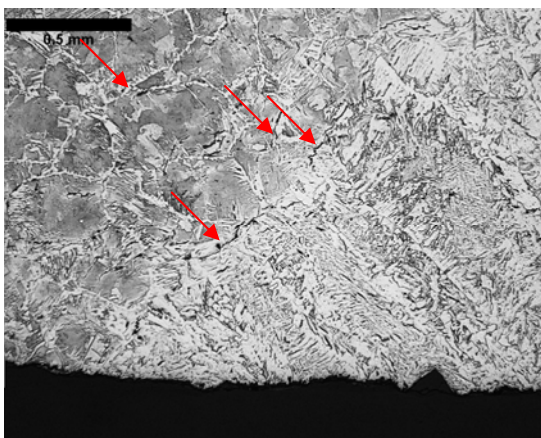
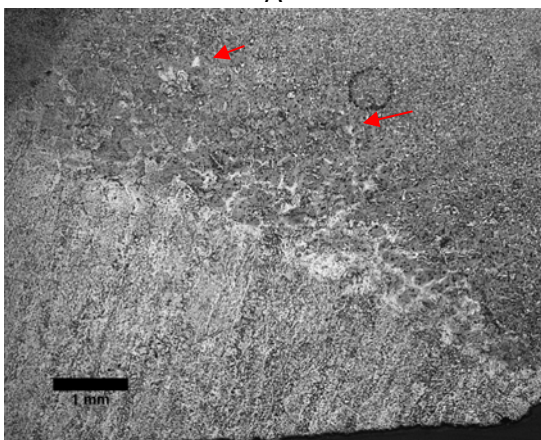
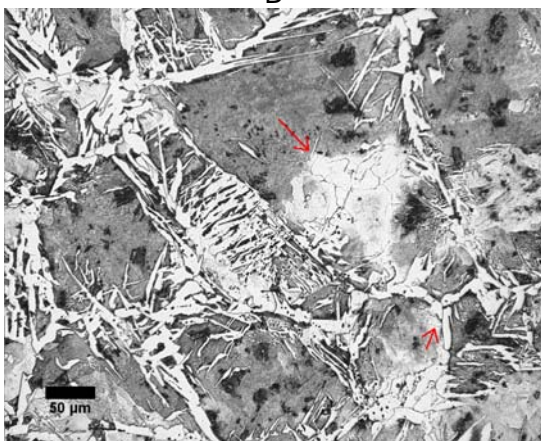
When the observed damage is located at the fusion line (FL) or at the 1st or 2nd grain of the CG HAZ (Coarse Grain of the Heat Affected Zone, CG everywhere in this report), it is marked as **“FL”**

It is typical to find damage beyond the FL and the 2nd grain of the CG, as it shown on the micrographs at left. The arrows at the microphotograph [B] show a decarburized spot indicative of the damage well deep in the CG, away from the FL. On microphotograph [C] the damage is in the 21st – 22nd grain inside the CG.

If this is observed, the location of the damage is defined as **“CG”**.

Figure 2. Definitions of the damage locations (devised by others) used in Table 9 and in the text

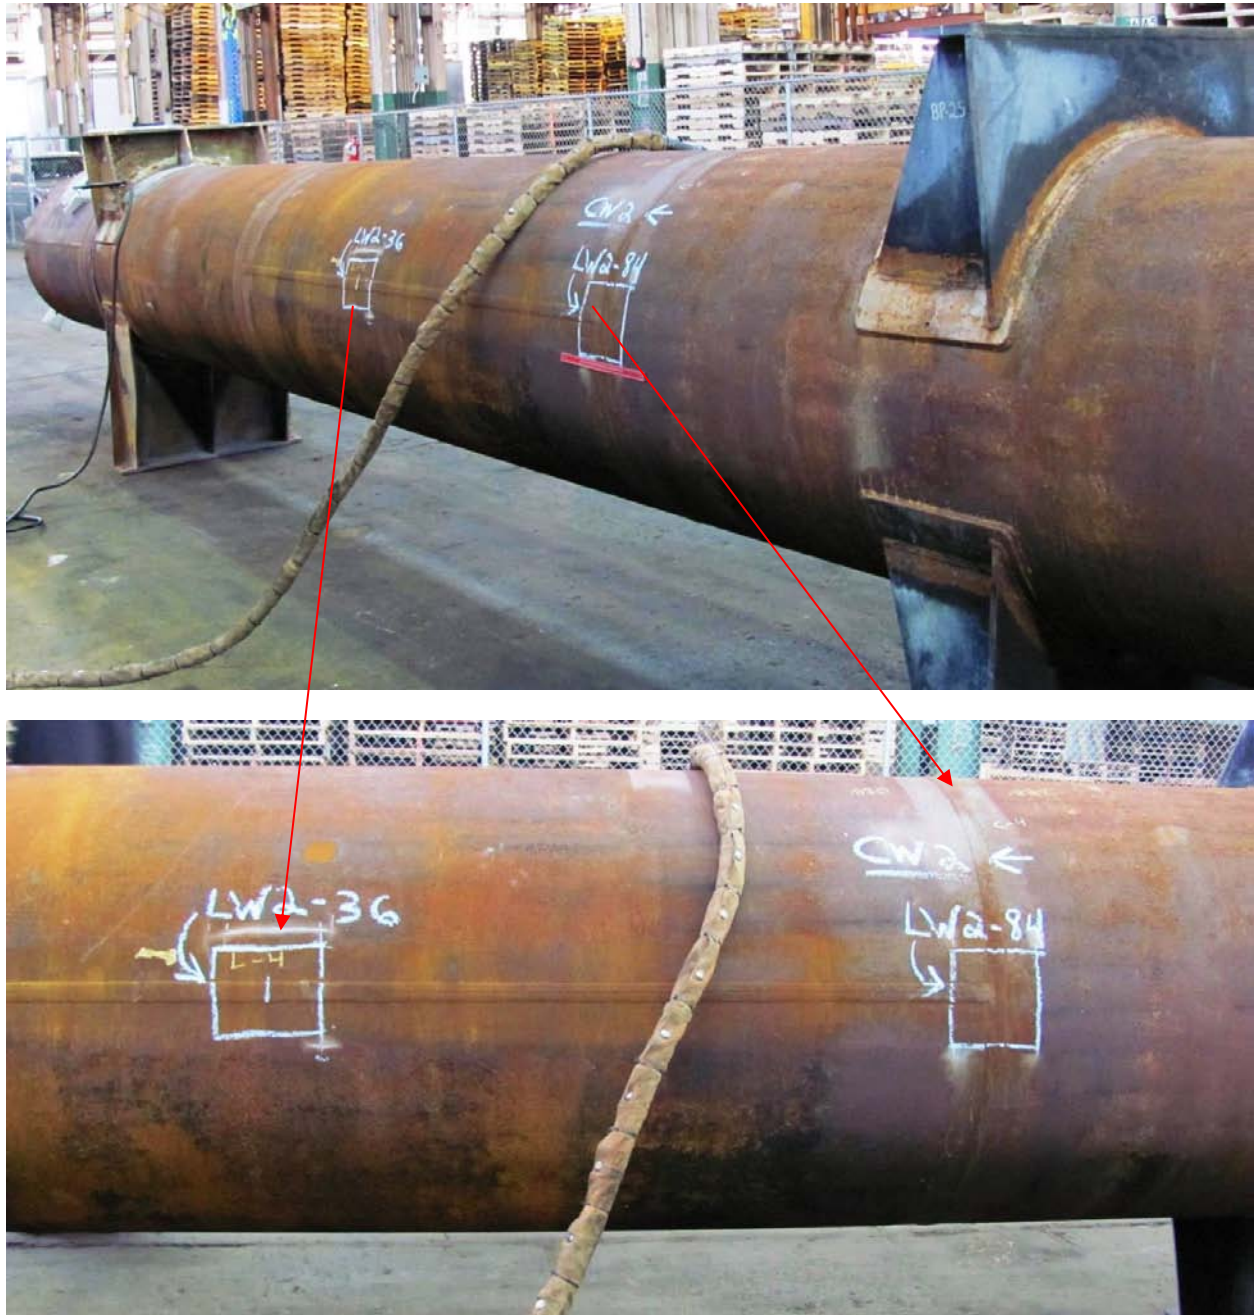
Figure 5.Shell

TESORO Exchanger E6600B as received at Halvorsen with the Parts 4 and 5 marked for cutting

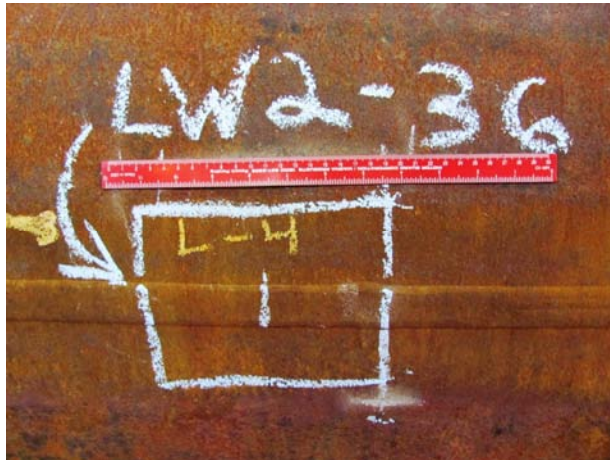
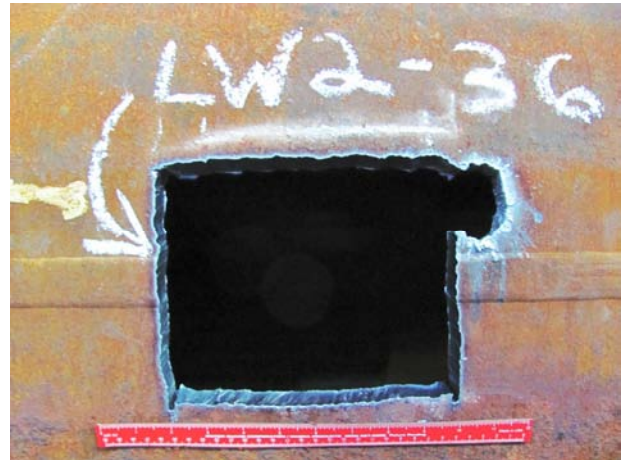
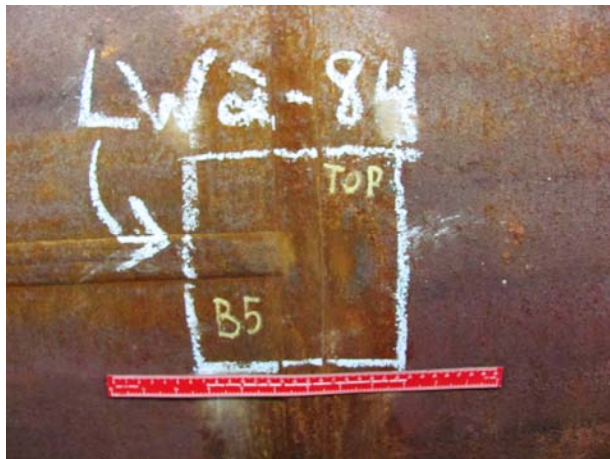
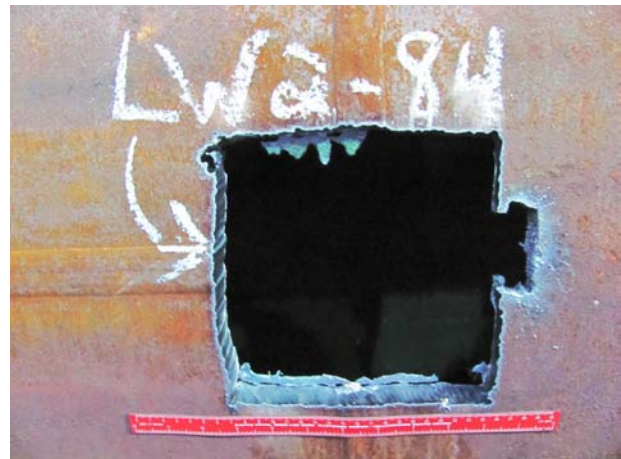
Figure 6.

Part 4B, approximate location on the weld LW2, 36" from the weld CW3

Part 5B, located on the LW2/CW2 Tee approximately 84" from the weld CW3

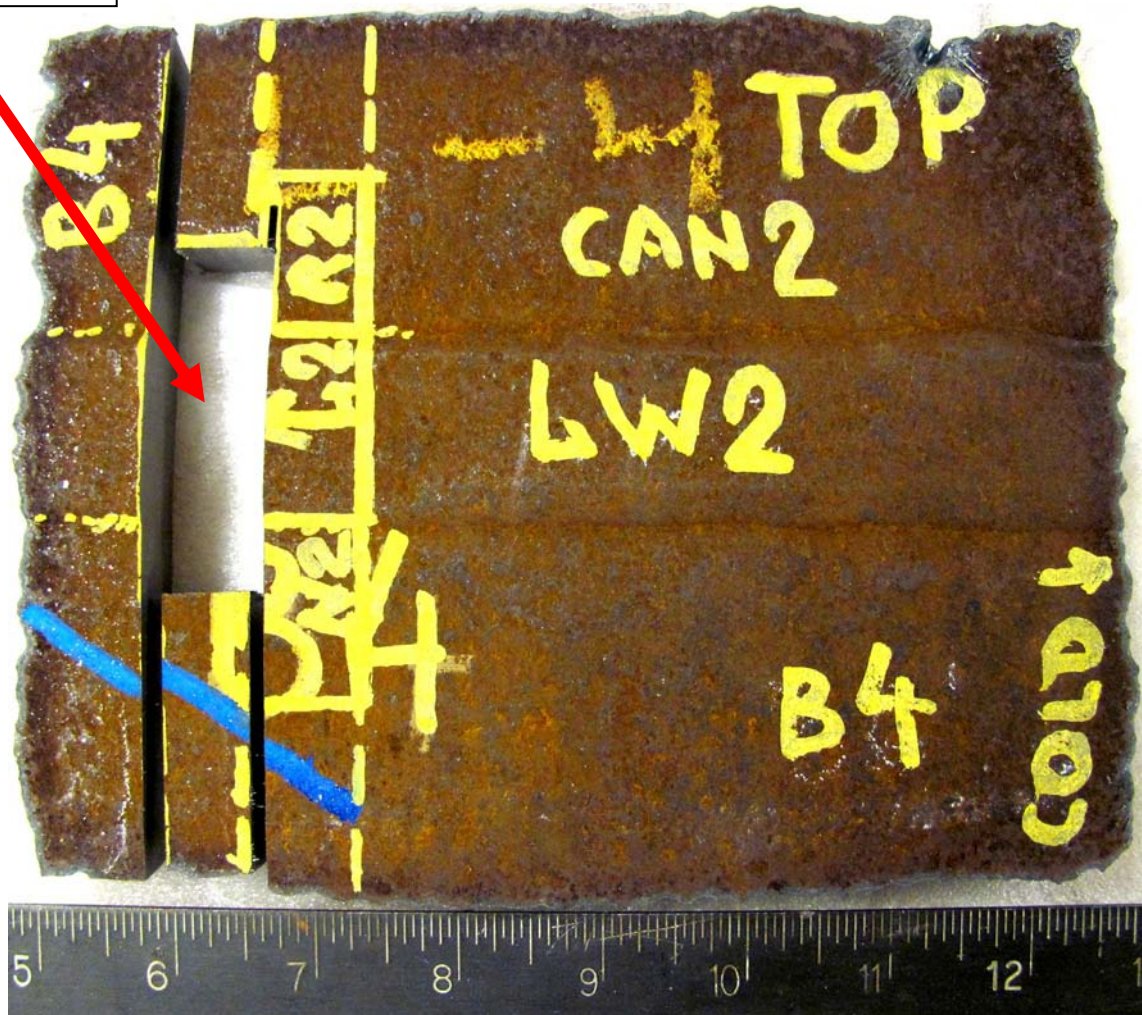
SAMPLE IDENTIFICATION	TEST
N2	CHEMISTRY OF BM CAN 2
L2	CHEMISTRY OF WM LW2
LH2	METALLOGRAPHY AND TRAVERSE HARDNESS OF LW2 (ARROW POINTS AT POLISHED FACE)
R2	ROCKWELL HARDNESS OF BM CAN 3

Figure 8a. Specimens layout and labeling. You are looking at O.D.

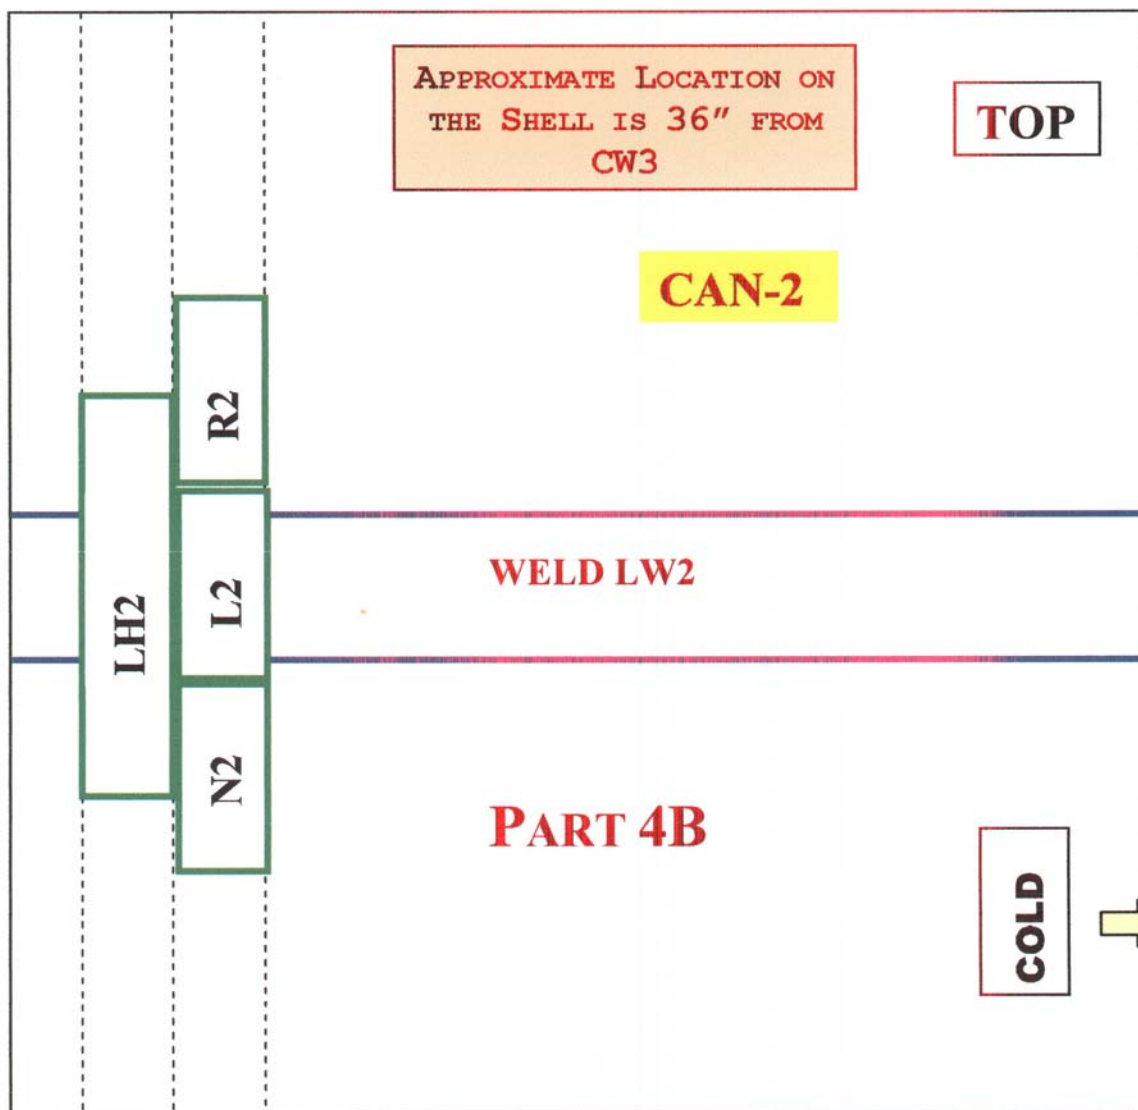
Figure 8b. Sketch of the specimens' layout and labeling. The photograph of the samples labeled and the table with the test to be performed are on Figure 8a above. You are looking at O.D.

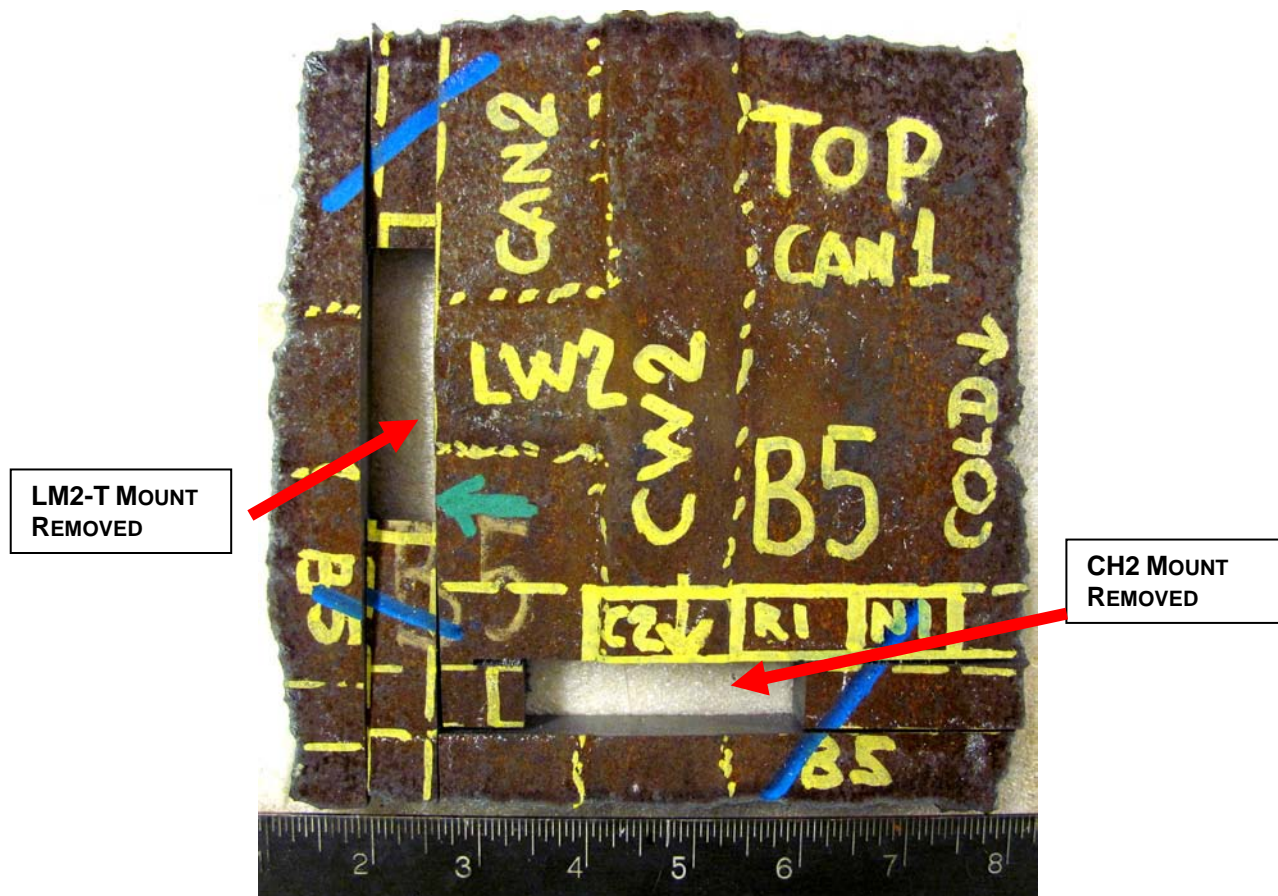
#5B – CW2-LW2

SAMPLE IDENTIFICATION	TEST
N1	CHEMISTRY OF BM CAN 1
C2	CHEMISTRY OF WELD METAL CW2
CH2	METALLOGRAPHY AND TRAVERSE HARDNESS OF CW2 (ARROW POINTS AT POLISHED FACE)
LM2-T	METALLOGRAPHY OF LW2 (ARROW POINTS AT POLISHED FACE)
R1	ROCKWELL HARDNESS OF CAN 2

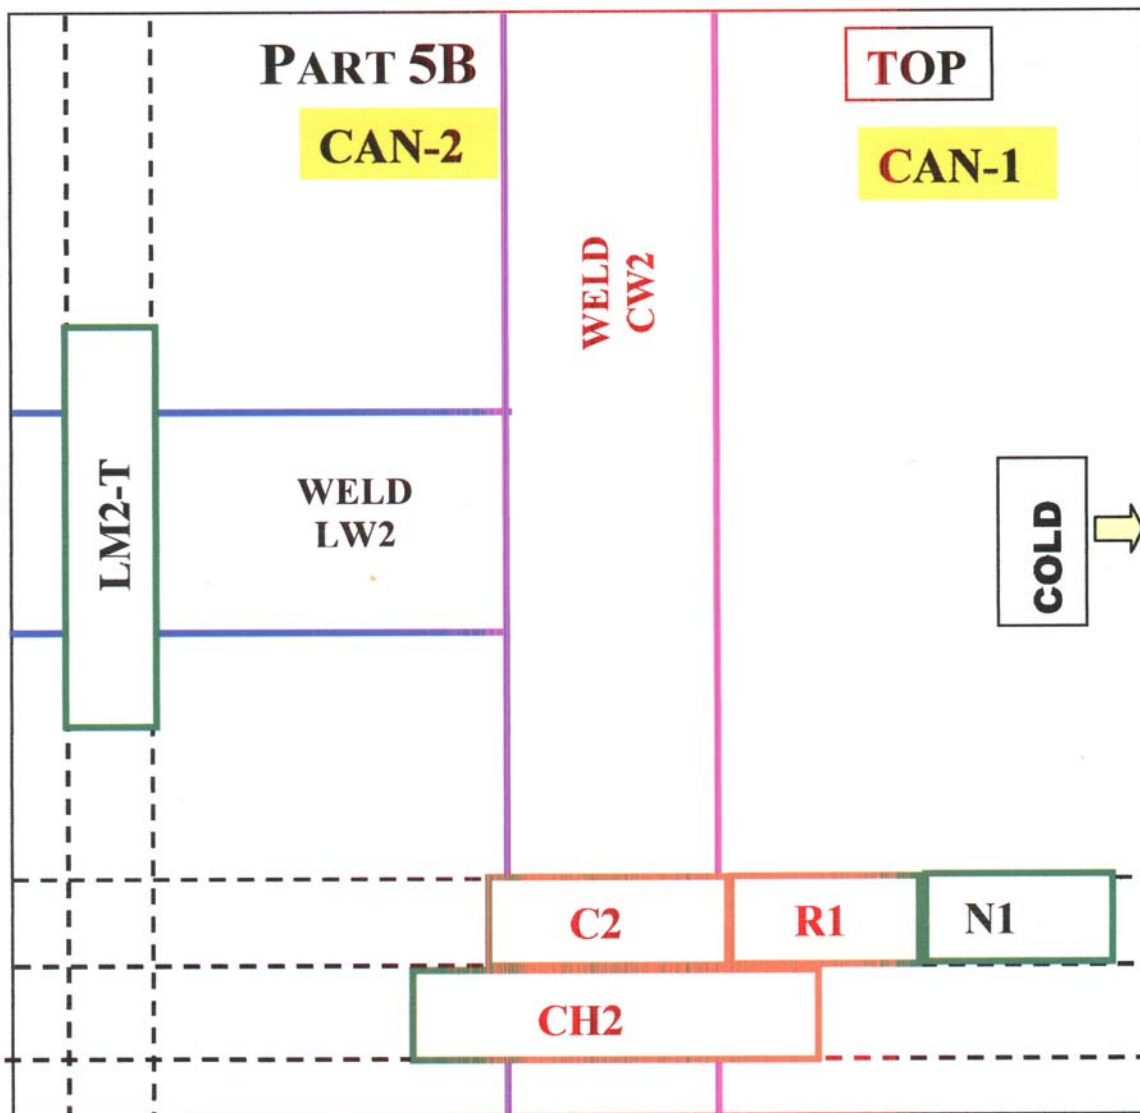
Figure 9b. Sketch of the specimens' layout and labeling. The photograph of the samples labeled and the table with the test to be performed are on Figure 9a above. You are looking at O.D.

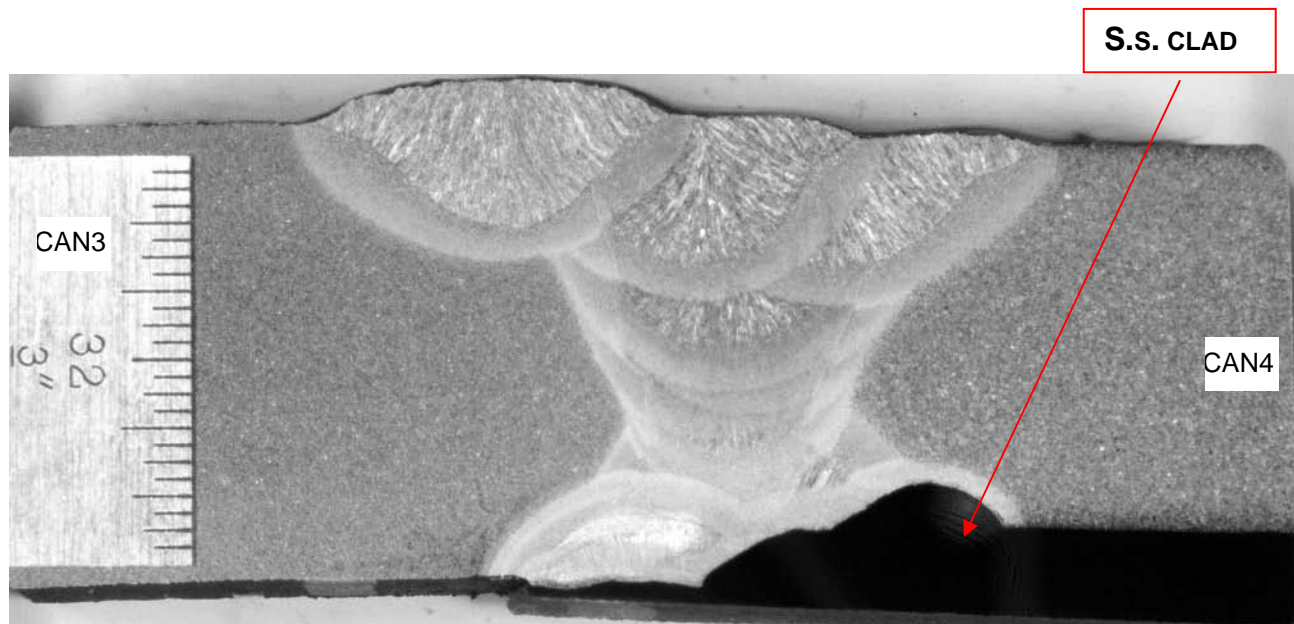
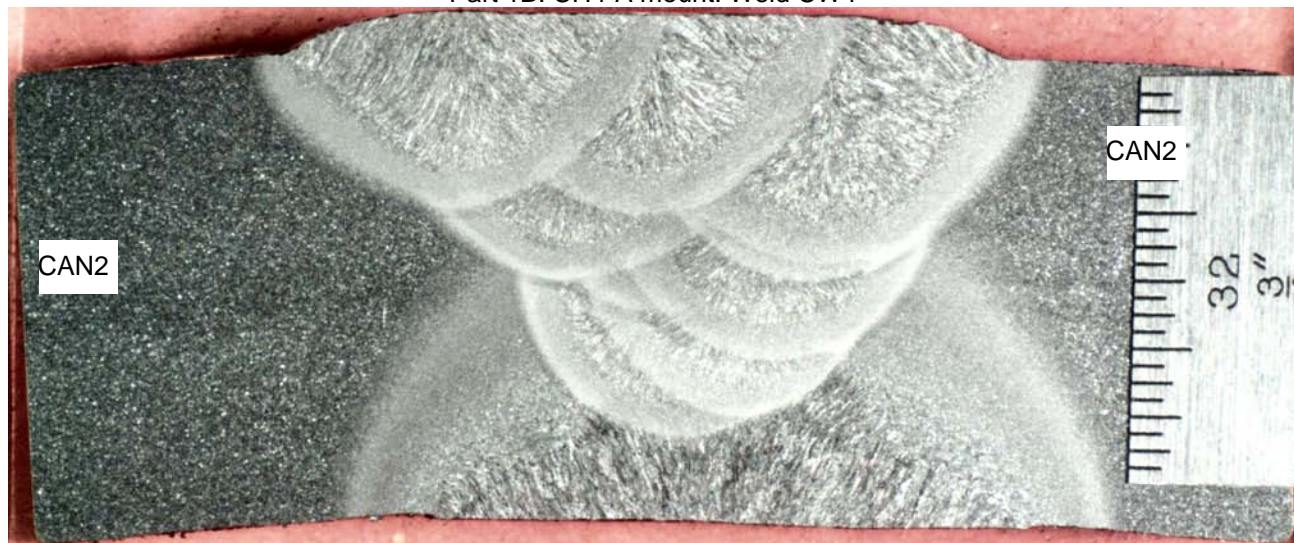
Figure 10. O.D. is on the top.

Part 1B. CH4-A mount. Weld CW4

Part 4B. LH2 mount. Weld LW2 located approximately 36" from weld CW3

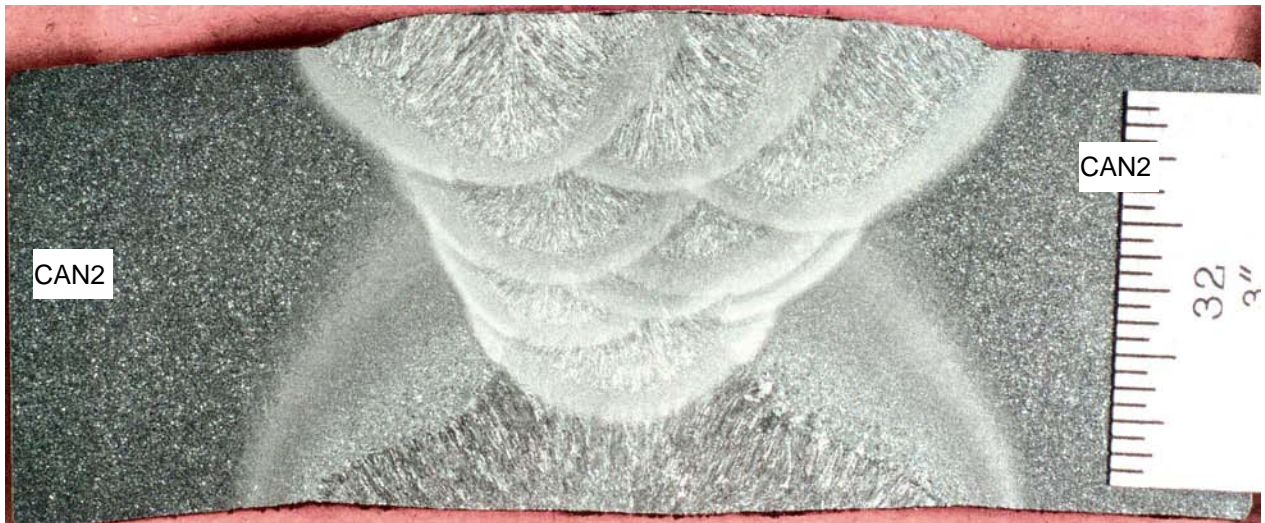
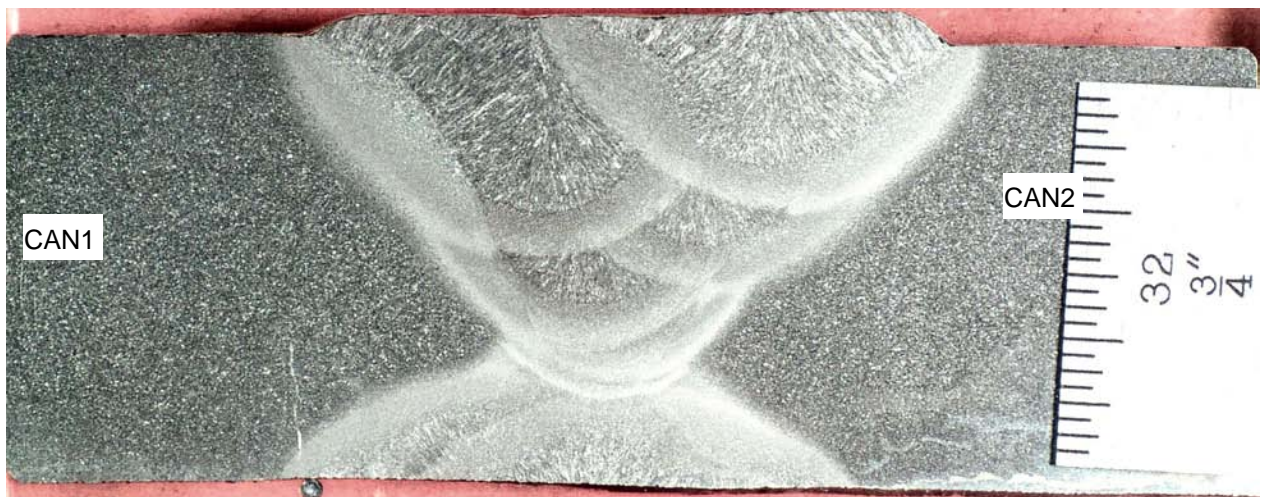
LM2-T mount. Weld LW2 at Tee with weld CW2.

CH2 mount. Weld CW2 at Tee with weld LW2

Figure 11. Macro photographs of two mounts from part 5B located approximately 84" from weld CW3.
O.D. is on the top.

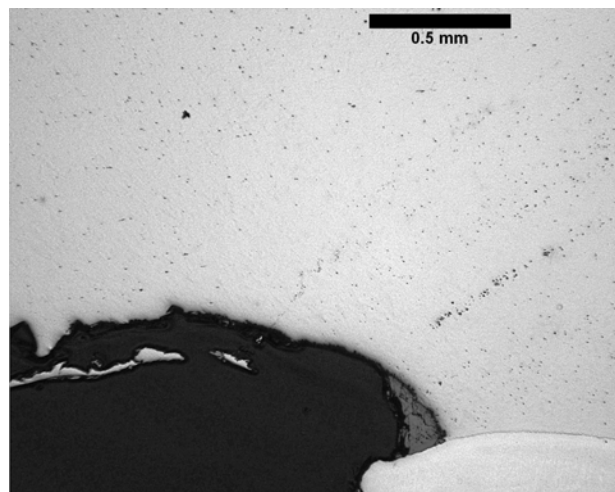
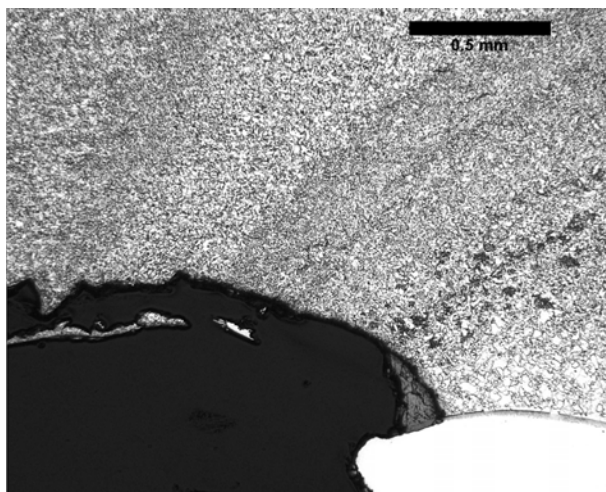
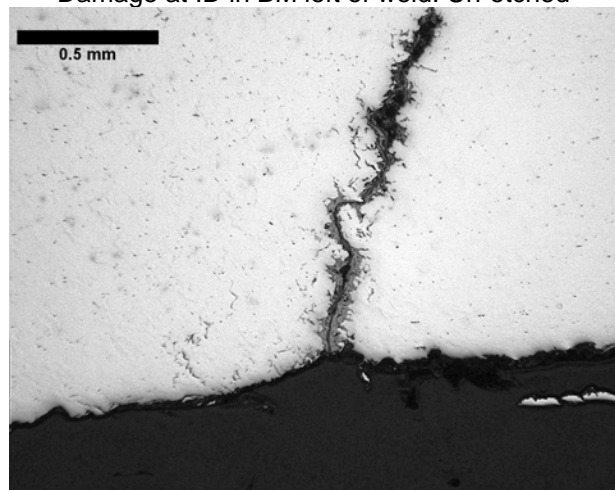
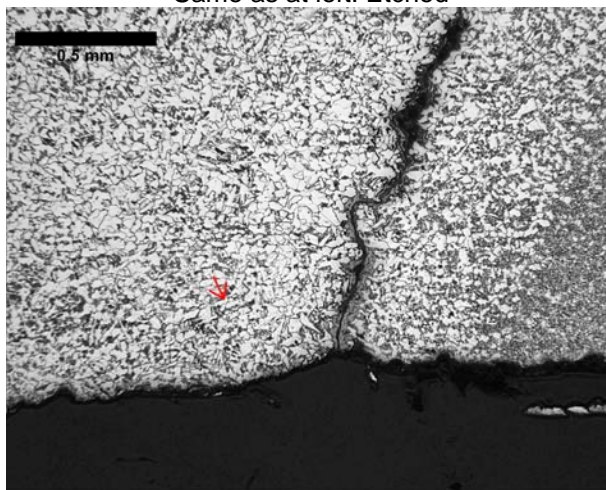
Figure 12

Damage at ID in BM left of weld. Un-etched

Same as at left. Etched

Beginning of the crack left of the weld in BM.
Un-etched

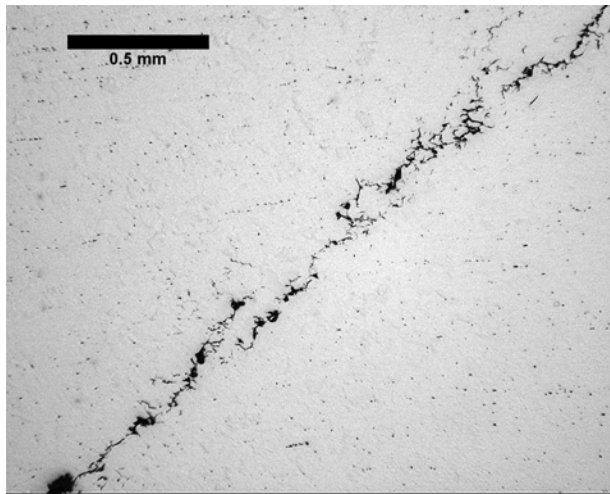
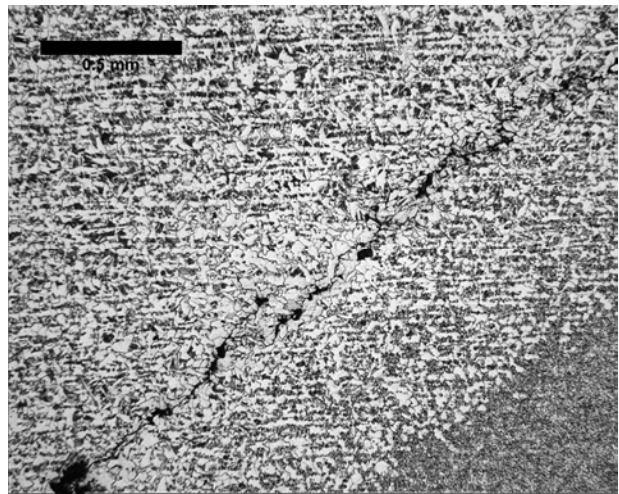
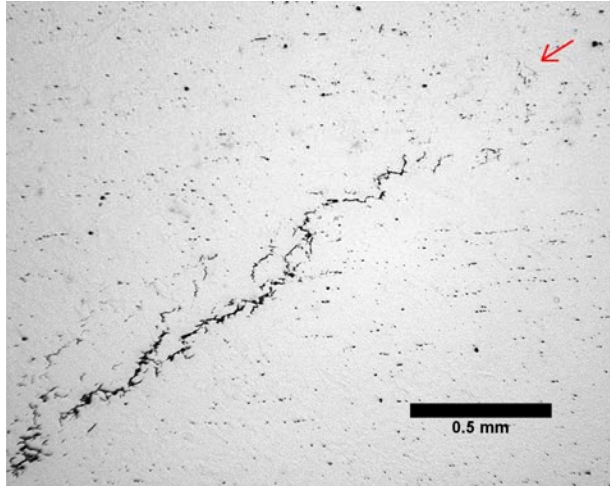
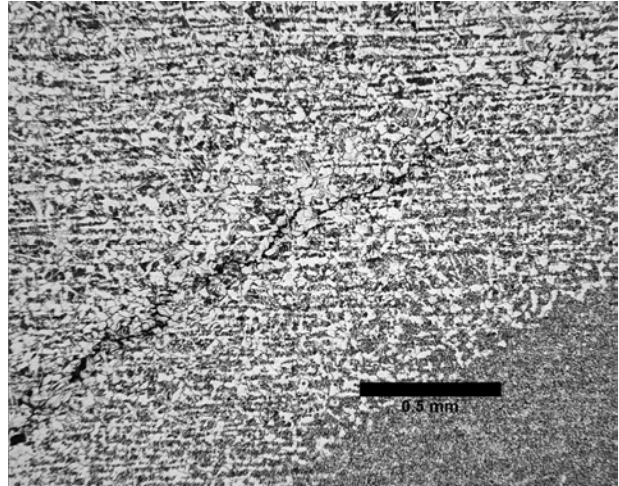
Figure 13

Left of the weld. BM. Middle of the crack.
Un-etched

Same as at left. Etched

Left of the weld. BM. Tip of the crack.
Un-etched

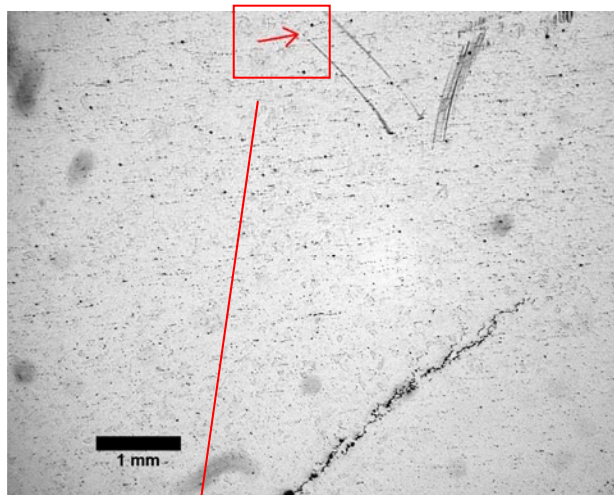
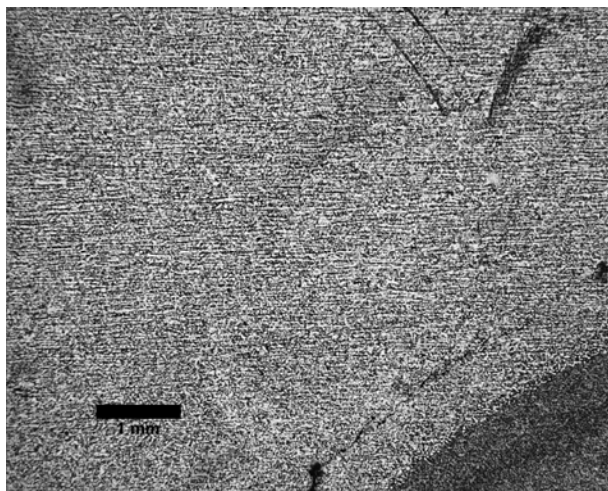
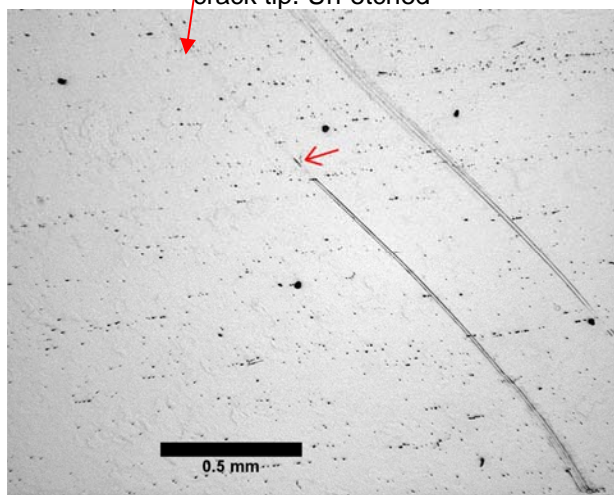
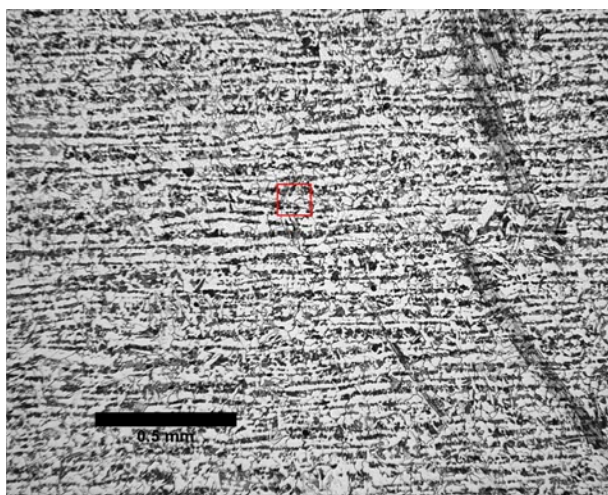
Left of the weld. Deepest damage in BM above the crack tip. Un-etched

Same as at left. Etched

Area from above at higher magnification. Un-etched

Damage Depth, mm	
Left of the Weld	Right of the Weld
7.97	0 (Clad)

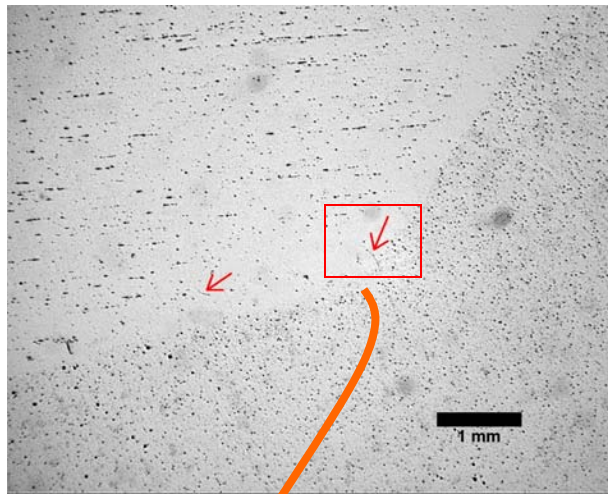
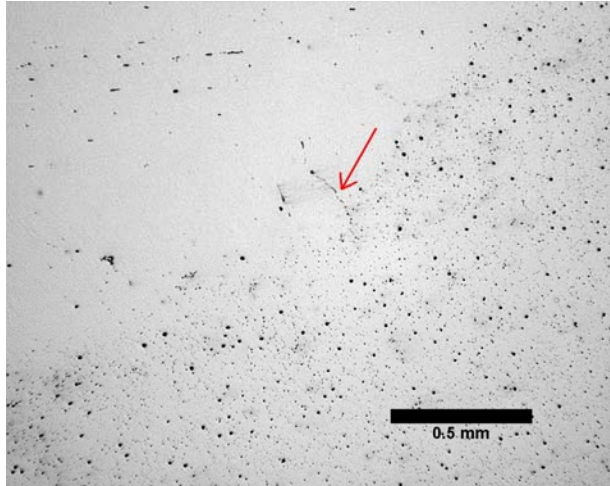
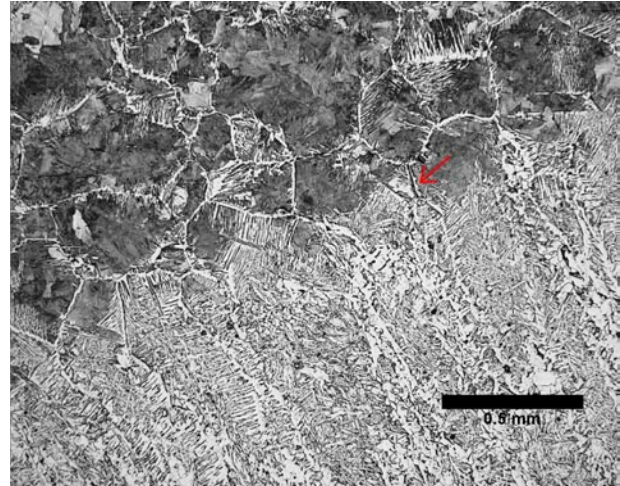
Left of the weld. Un-etched

Same as above at higher magnification. Un-etched

Same as at left. Etched

Damage Depth, mm	
Left of the Weld	Right of the Weld
3.58	3.06

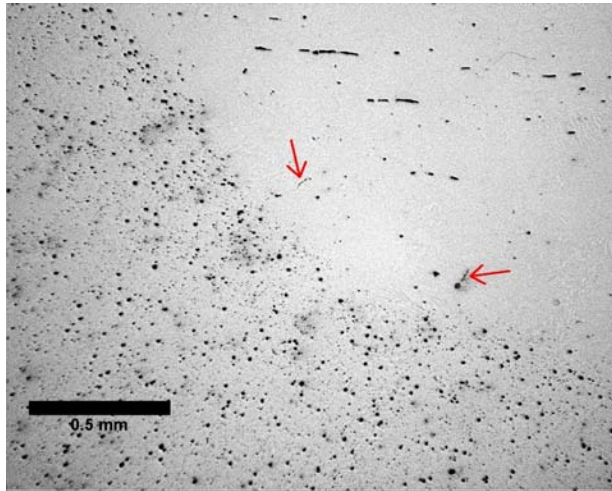
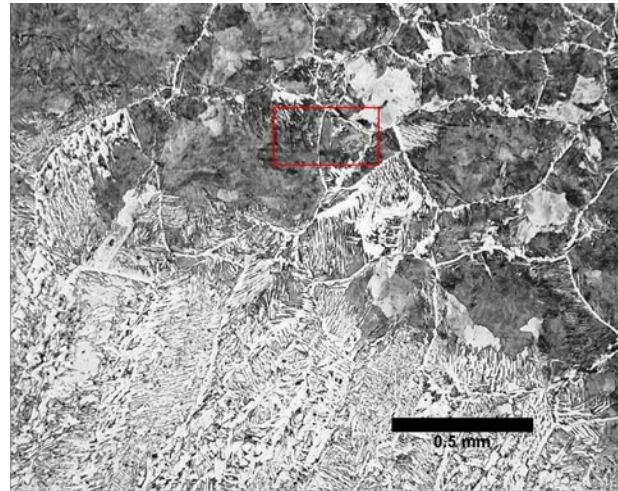
Right of the weld. Un-etched

Same as at left. Etched

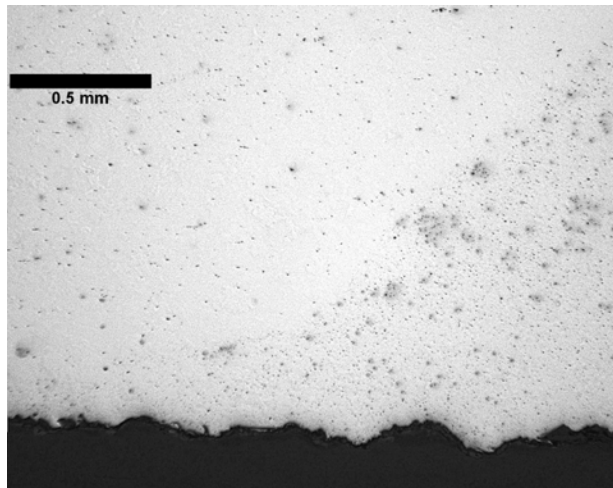
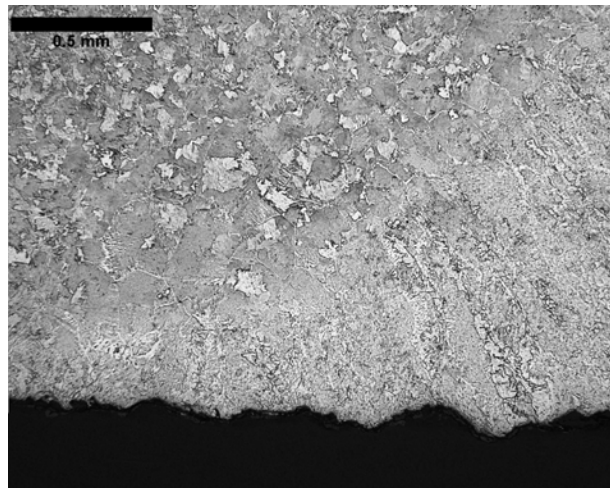
Left of the weld at ID. Un-etched

Same as at left. Etched

Damage Depth, mm	
Left of the Weld	Right of the Weld
0	0

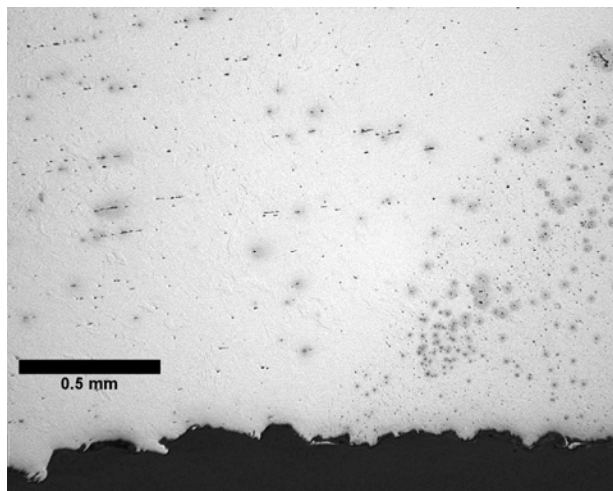
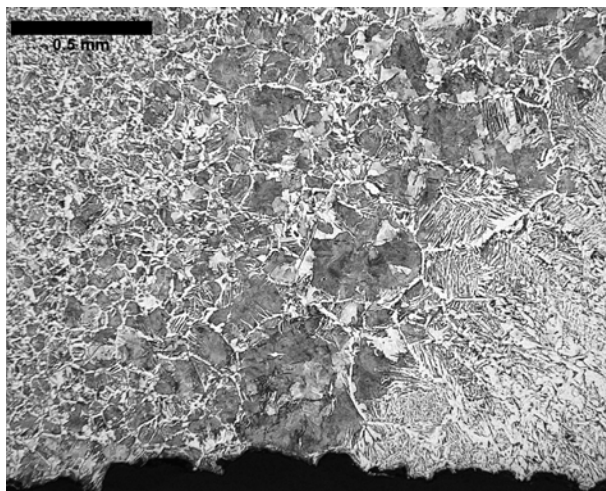
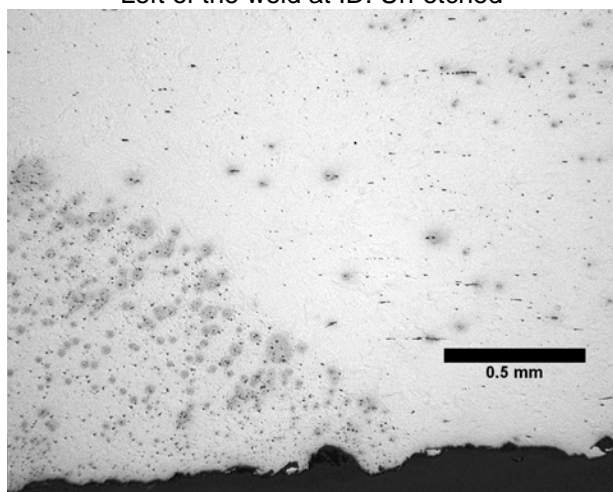
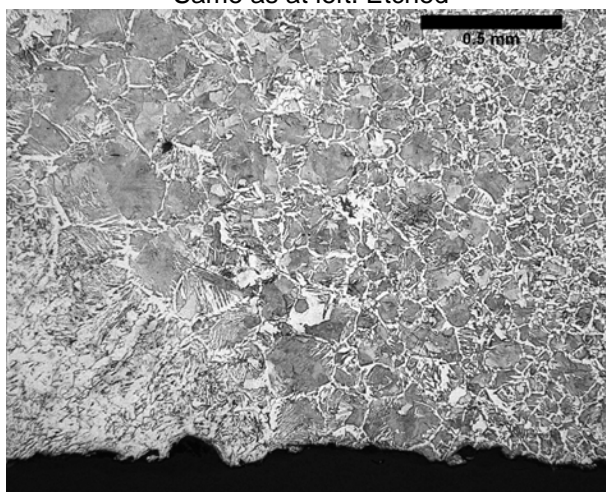
Left of the weld at ID. Un-etched

Same as at left. Etched

Right of the weld at ID. Un-etched

Damage Depth, mm	
Left of the Weld	Right of the Weld
0	0

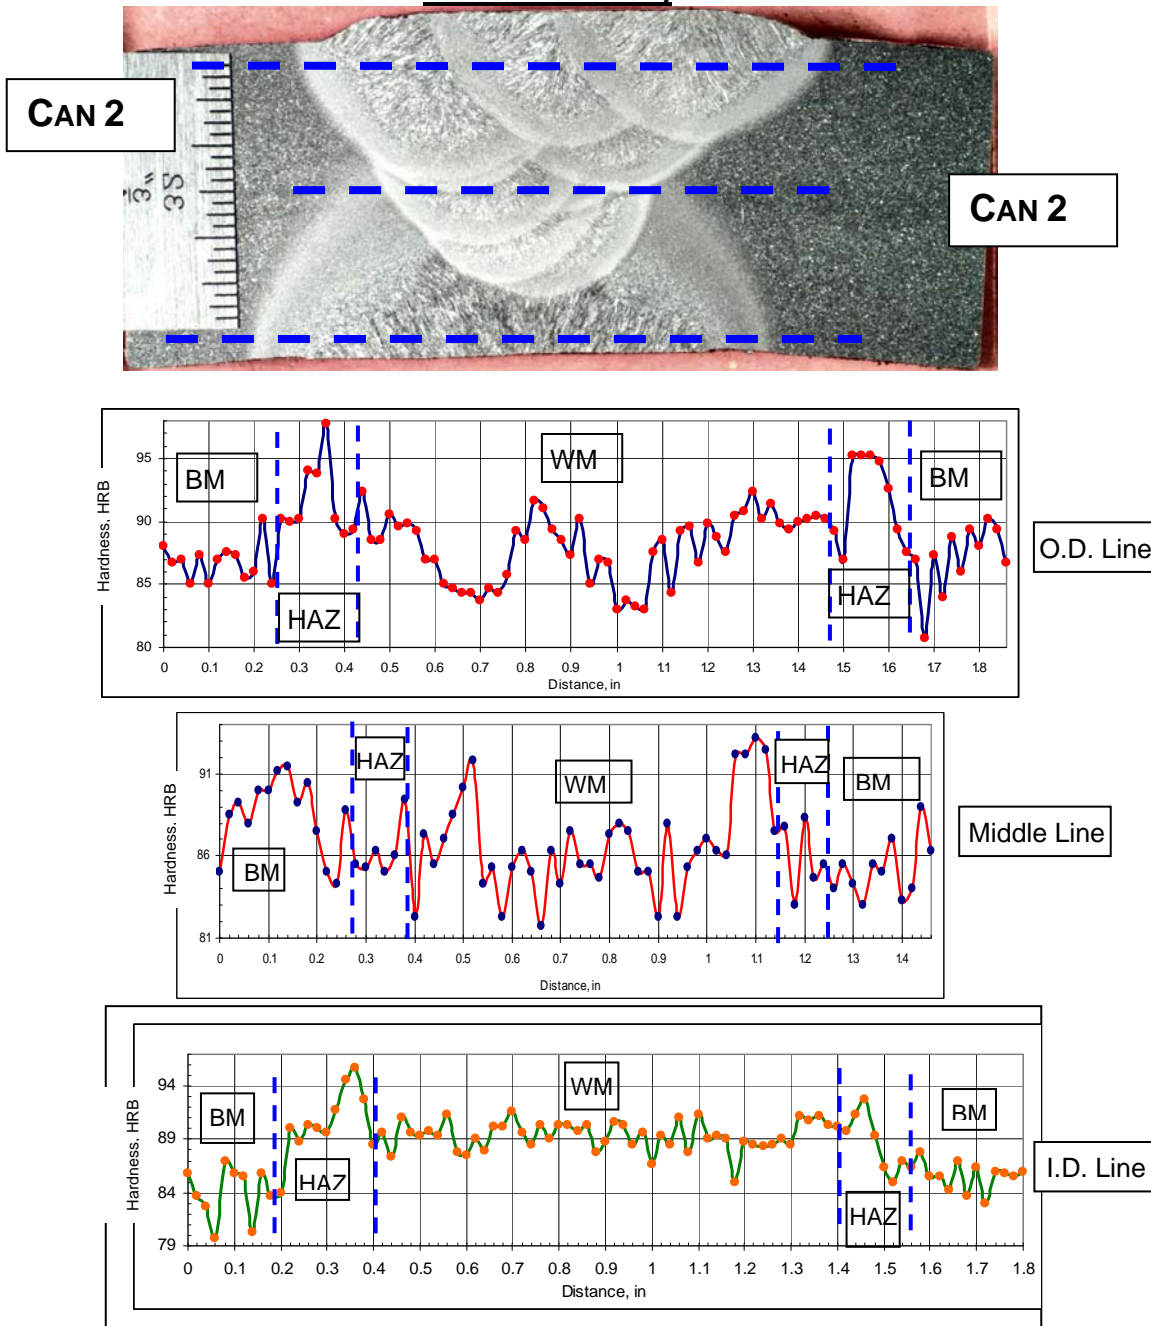
PART 4 B, WELD LW2, SAMPLE LH2. MACRO REVERSED VS TABLE 9 (LEFT AND RIGHT SIDES CHANGED PLACES)

Figure 19. Hardness distribution across LW2 weld at three levels. The macro at the top of the page is flipped to coincide with the hardness data

Semi-micro Vickers hardness under 500 g load were performed, as directed by others, across the welds. The Vickers hardness numbers were converted to Rockwell Scale B hardness numbers. The results are plotted on Figures 19 and 20 and in Tables 5 through 7.
