BETA LAB NO.M10329-B, TESORO EXCHANGER E6600-B EXAMINATION DATA	TESORO REFINING AND MARKETING COMPANY ANACORTES REFINERY 10200 W. MARCH POINT ROAD T91WA4428 ANACORTES, WA 98221	CUSTOMER P.O. NO.: 4501667904, CHANGE ORDER #1
PARTS: E6600B HEAT EXCHANGER, PARTS 1B, 4B, AND 5B		DATE: MARCH 8, 2011
PAGE 1 OF 52

LABORATORY REPORT

SAMPLE DESCRIPTION: A heat exchanger E6600-“B” was removed from operation at the Tesoro after undisclosed duration in service. The Exchanger B Shell Examination Protocol (Protocol) and Addendum 1 were developed and signed by Tesoro Companies, Division of Occupational Safety and Health, and U.S. Chemical Safety Board. The mentioned above Protocol and Addendum 1 are located in the Appendix 1 at the end of this Report. FirstEnergy BETA Laboratory was selected as the data collecting laboratory to perform the testing required by the Protocol. The BETA Laboratory, as a data collecting (referee) laboratory, acts under the same rules as in the previous job on the exchanger E6600E, which are as follows:

This report contains the results of evaluation of the samples contained in the Parts 1B, 4B, and 5B as labeled in Tables 2 and 3, and Figures 7 through 9.

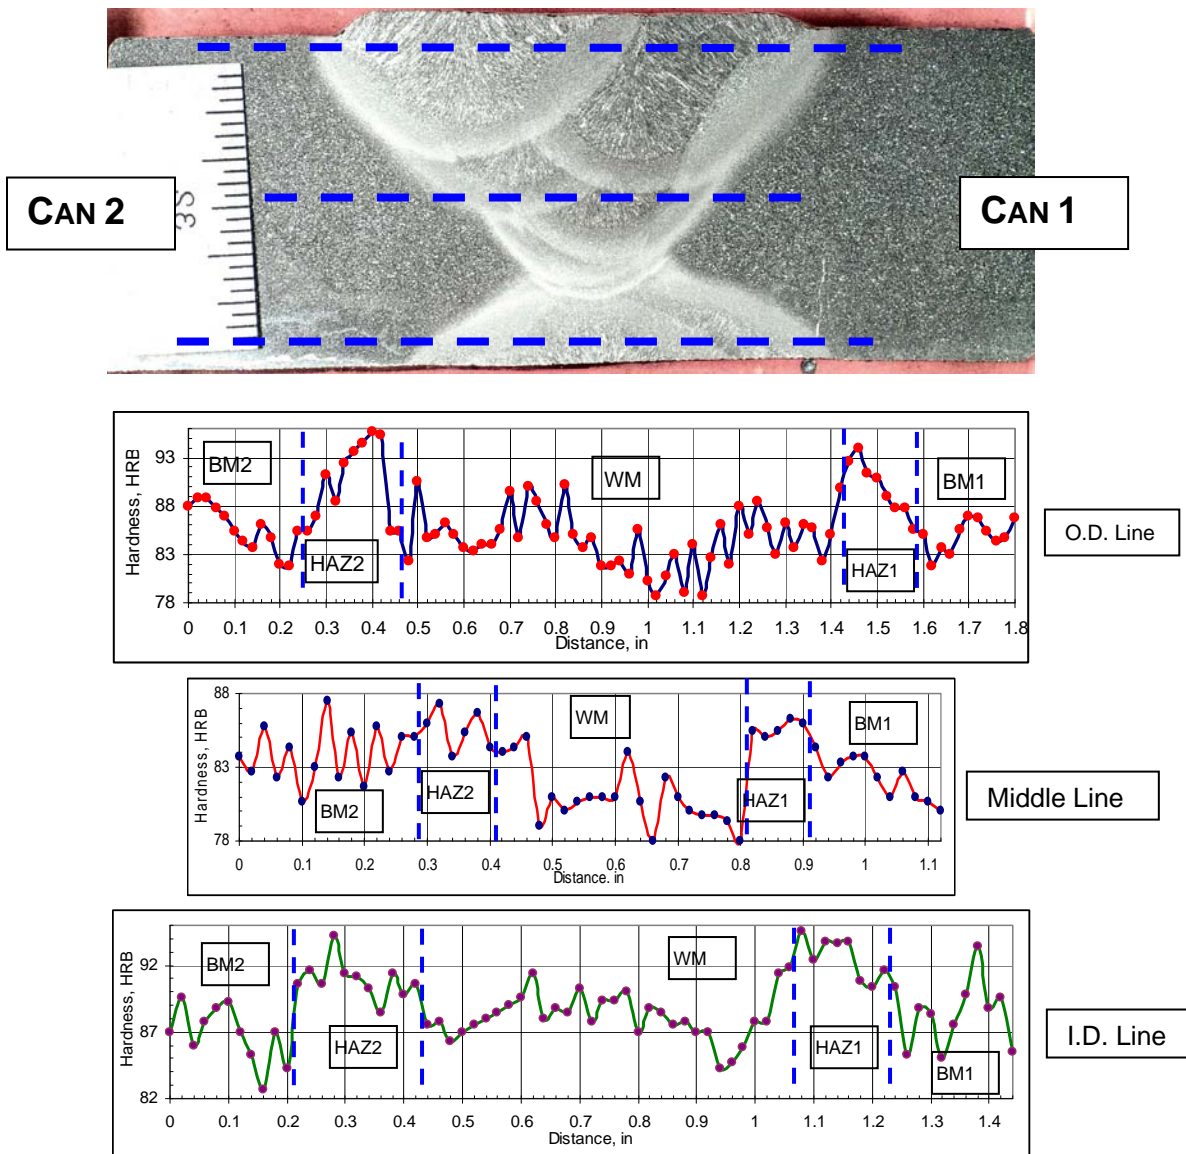
PART 5B, WELD CW2 AT TEE WITH LW2, SAMPLE CH2. MACRO REVERSED VS TABLE 9 (LEFT AND RIGHT SIDES CHANGED PLACES)

Figure 20. Hardness distribution across CW2 weld at three levels. The macro at the top of the page is flipped to coincide with the hardness data.

Semi-micro Vickers hardness under 500 g load were performed, as directed by others, across the welds. The Vickers hardness numbers were converted to Rockwell Scale B hardness numbers. The results are plotted on Figures 19 and 20 and in Tables 5 through 7.

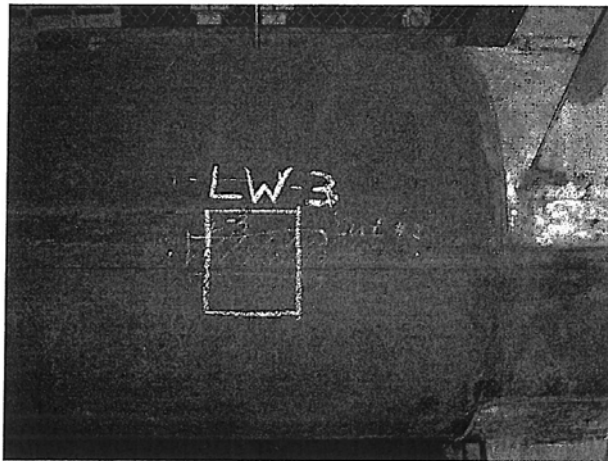
Figure 2: Long Seam Sample, LW-3

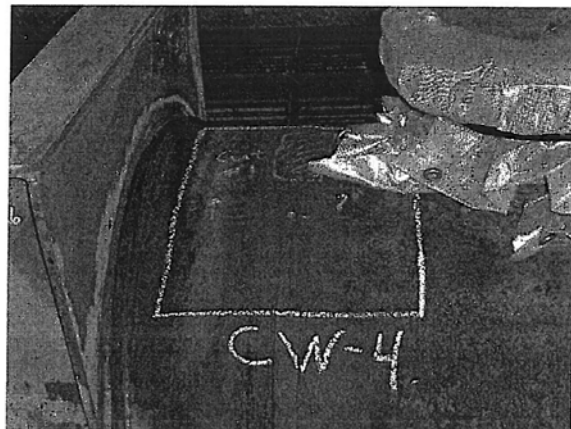
Figure 3: Girth Weld Sample, CW-4

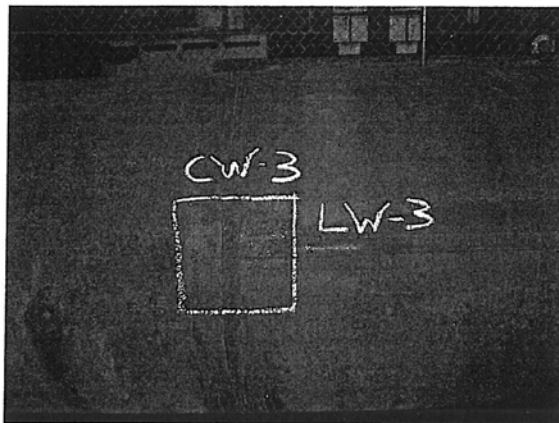
Figure 4: "T" Joint Weld Junction, CW-3/LW-3
