U.S. CHEMICAL SAFETY AND HAZARD INVESTIGATION BOARD

INVESTIGATION REPORT

CHEMICAL SPILL CONTAMINATES PUBLIC WATER SUPPLY IN CHARLESTON, WEST VIRGINIA

REPORT No. 2014-01-I-WV
FEBRUARY 2017

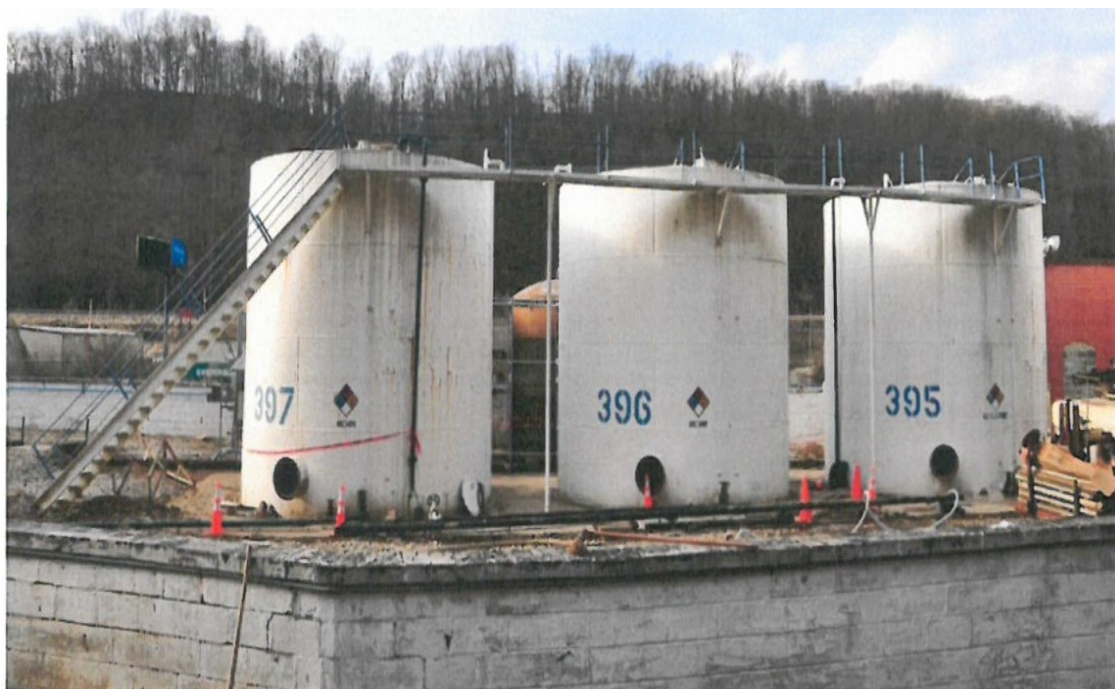
Figure 4. MCHM- and PPH, stripped-containing tanks at Freedom post-incident. (Source: CSB)

Tanks 395, 396 and 397 were 20 feet in diameter by 20 feet tall. The tanks had a lap-riveted⁴⁶ shell, cone roof and a 0.25-inch lap-welded⁴⁷ bottom. Tank 397 was a blend tank that was used to mix Crude MCHM and PPH, stripped to produce ShurFlot 944.⁴⁸ The final product was stored in tanks 396 and 397 as well as in totes for sale (Figure 5).

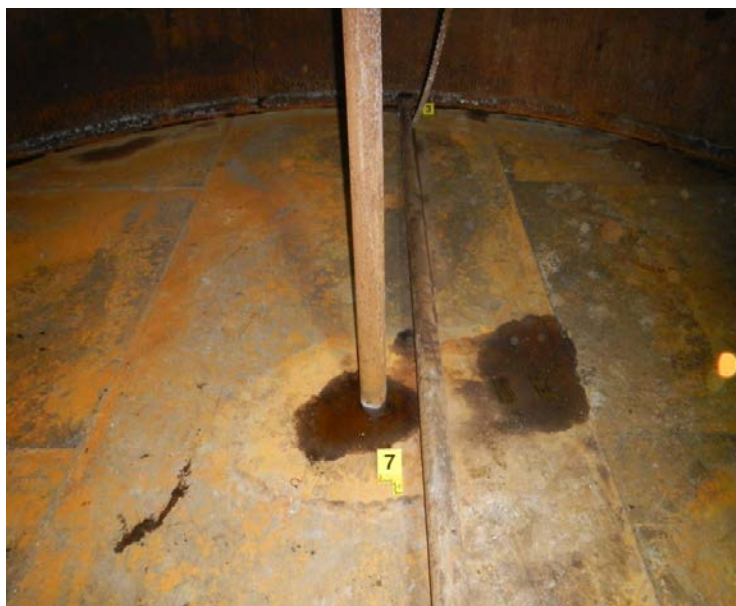
Figure 16. Retrofitted welded bottom of tank 396 (inside of tank). (Source: CSB)

An evaluation of the tank bottom in comparison to the tank shell indicated that tank 396 had two tank bottoms during its service life: the original riveted tank bottom and then a 250-mil (0.25-inch-thick) (6.35-mm) welded steel bottom that was retrofitted into the tank sometime after the original riveted bottom was replaced. The original riveted bottom was likely used until it failed and then the tank was retrofitted with a new welded steel bottom in order to continue its liquid storage function. The replacement bottom of tank 396 was a welded construction using lap-welded bottom plates, which suggests the bottom was retrofitted sometime after 1945 (Figure 16).¹¹⁸

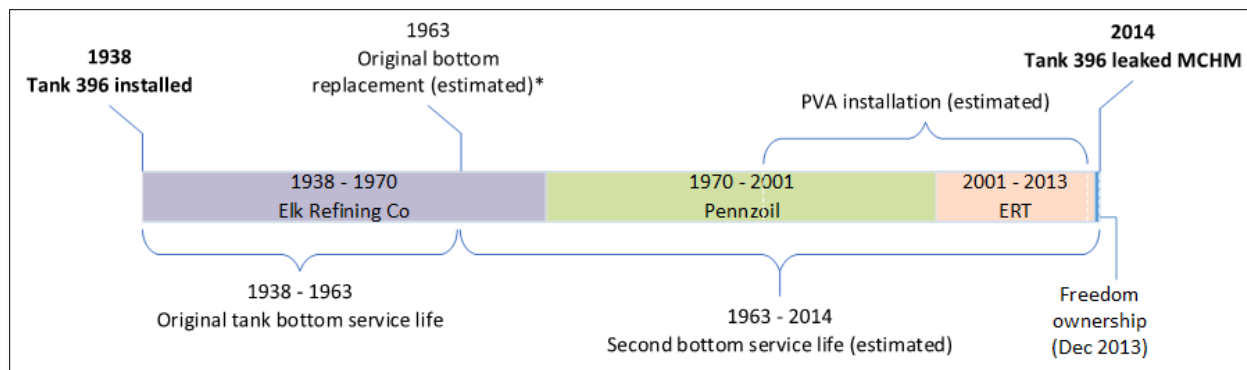
Figure 17. Tank 396 timeline. Original bottom replacement date based on 25-year service life. (Source: CSB).

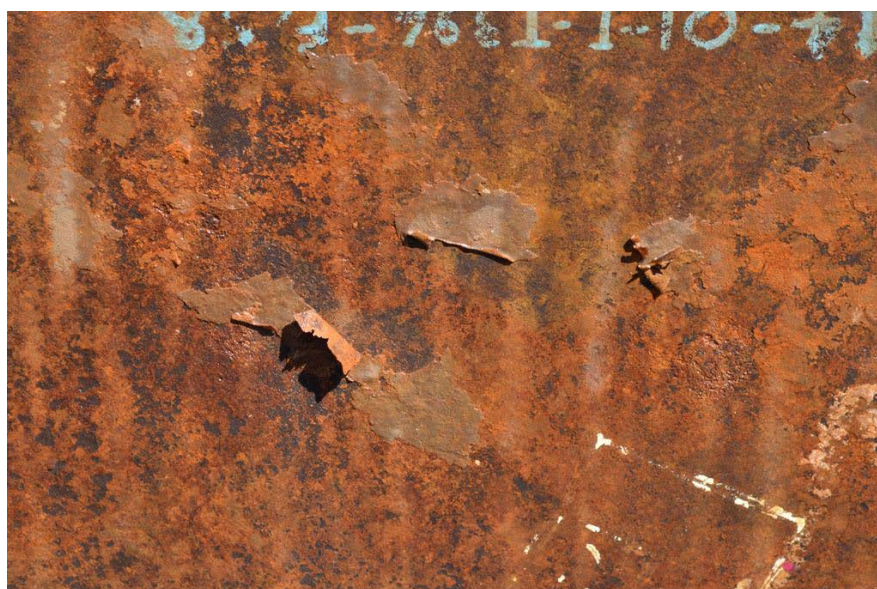
Figure 18. Remnants of coating on interior tank floor. (Source: Anamet¹²²)

During the initial examinations prior to dismantling tank 396, inspectors noticed remnants of what could have been a flexible organic liner or patch, adhered to the interior surface of the tank floor, likely applied sometime before the leak occurred (Figure 18).¹²⁰ Analytical testing determined that the chemical composition of the material was PVA.¹²¹

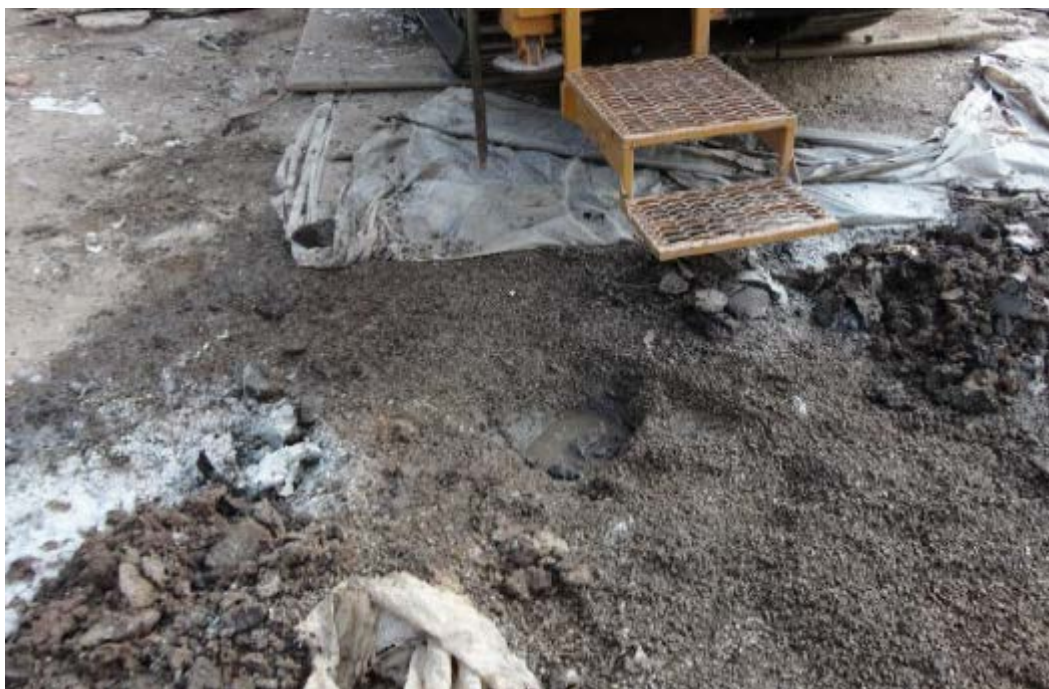
Figure 20. Gravel base under tank 396 and other tanks containing mixtures with Crude MCHM and PPH, Stripped.
(Source: Terracon)

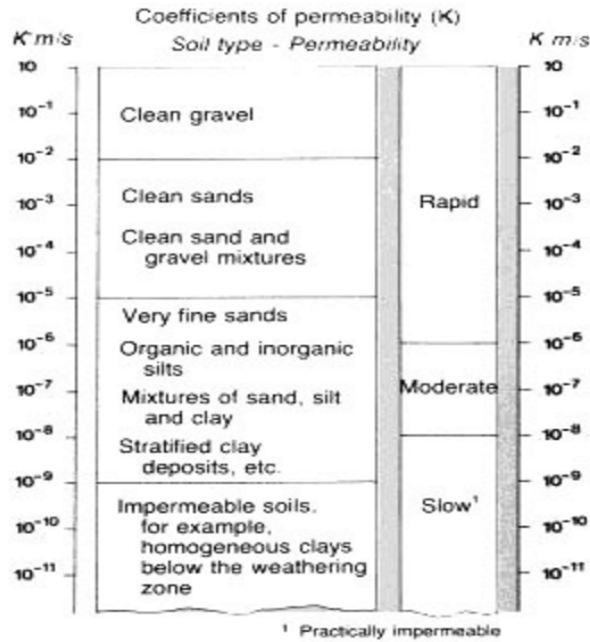
Figure 21. Permeability coefficients for different types of soils. (Source: Food and Agriculture Association)

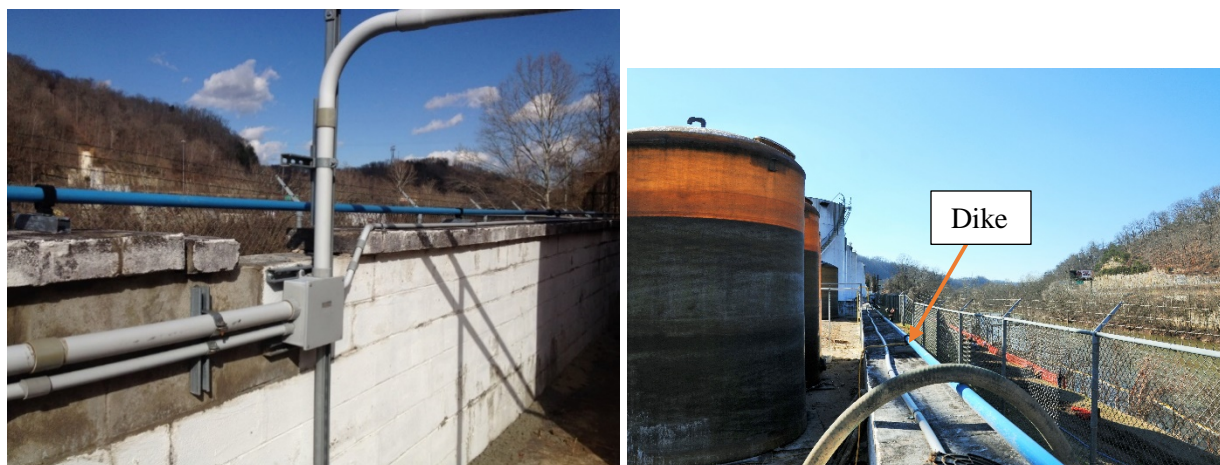
Figure 23. View from inside the dike wall facing the Elk River of the concrete block walls with no reinforcement (Left); dike wall along the tank farm parallel to the Elk River (Right). (Source: CSB)

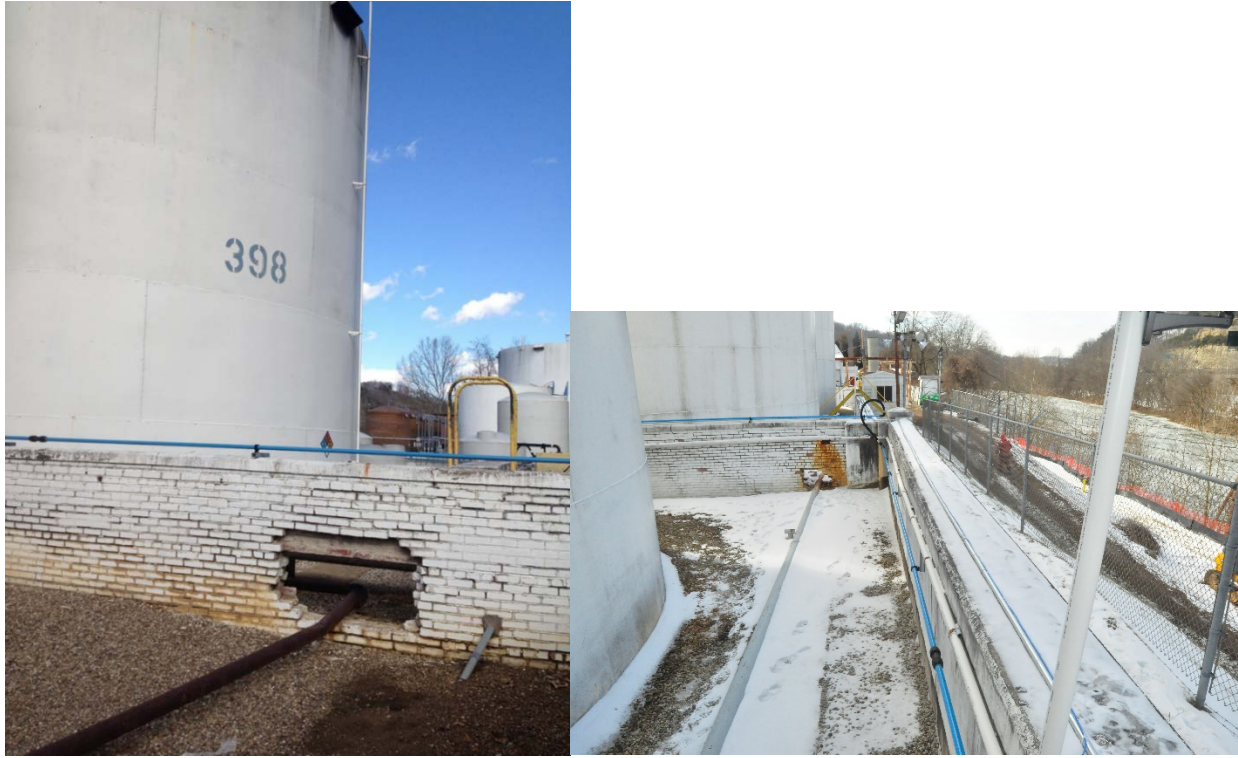
addition, although concrete caps were used around the top of the dike walls, many of these caps were missing or had deteriorated, which allowed for rainwater or other elements to infiltrate the walls.

Figure 24. The dike walls that surrounded the tank farms were in poor condition. (Source: CSB)

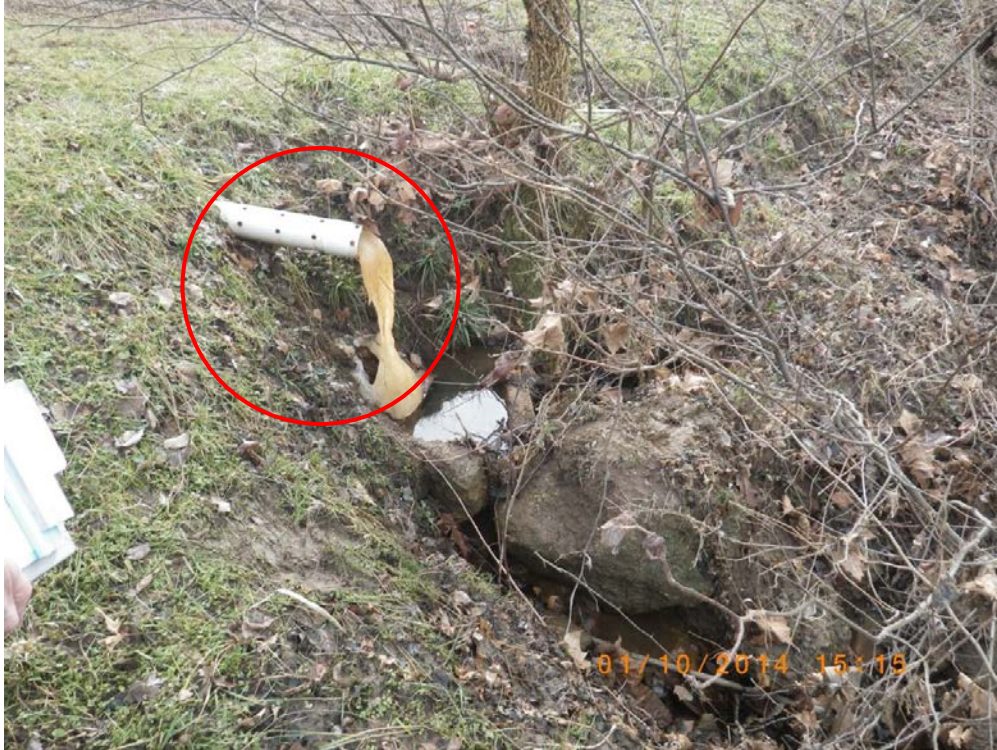
Figure 25. Ice-filled oil/water separator discharge pipe into the Elk River. (Source: WVDEP)

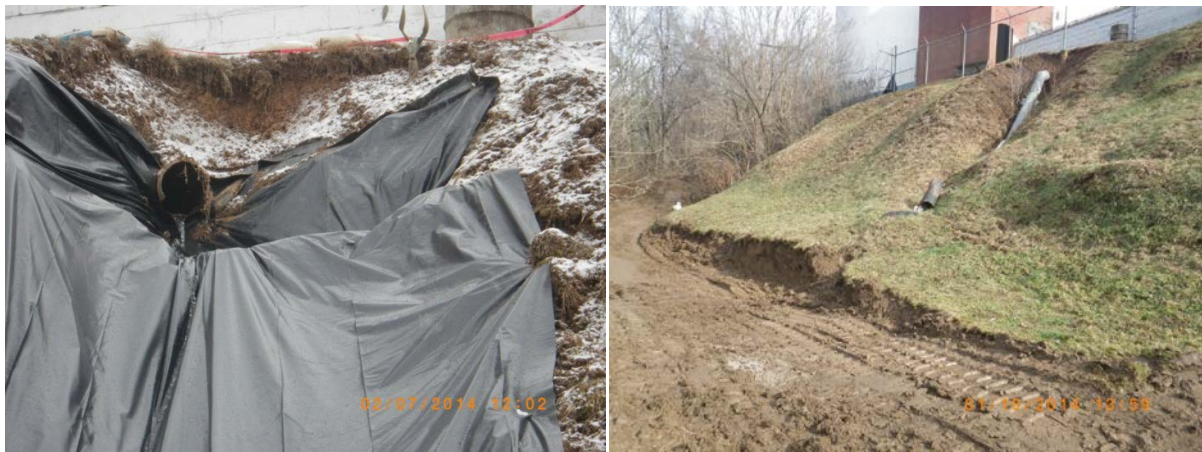
Figure 27. Water flowing through a corrugated steel culvert extending from the hillside (Left); stormwater pipe above interceptor trench (Right). (Source: WVDEP)

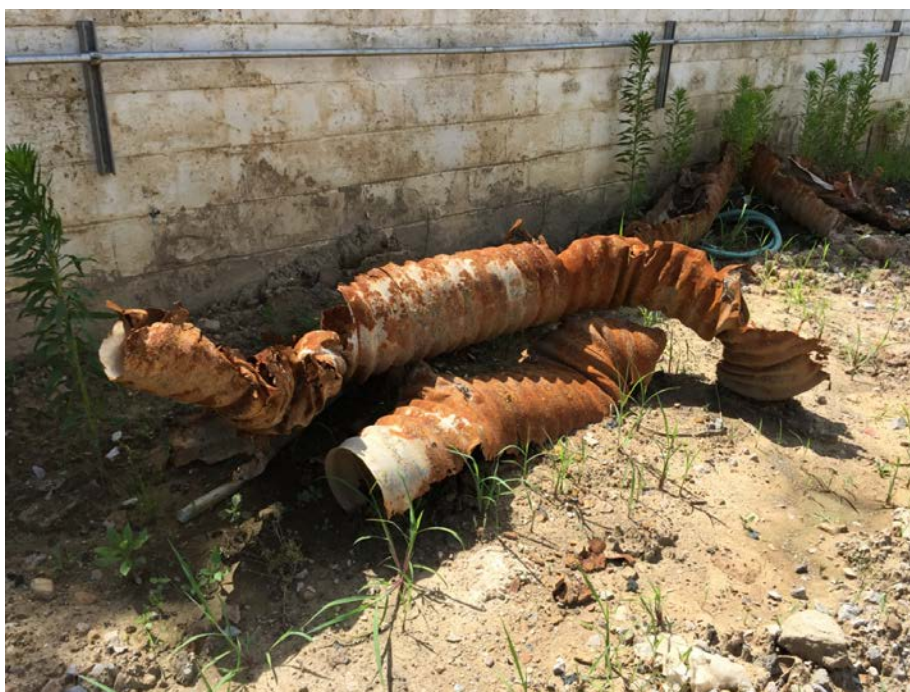
Figure 28. Photo taken on June 15, 2015, of remnants of the culvert that ran between tanks 394 and 395 beneath the site. (Source: CSB)

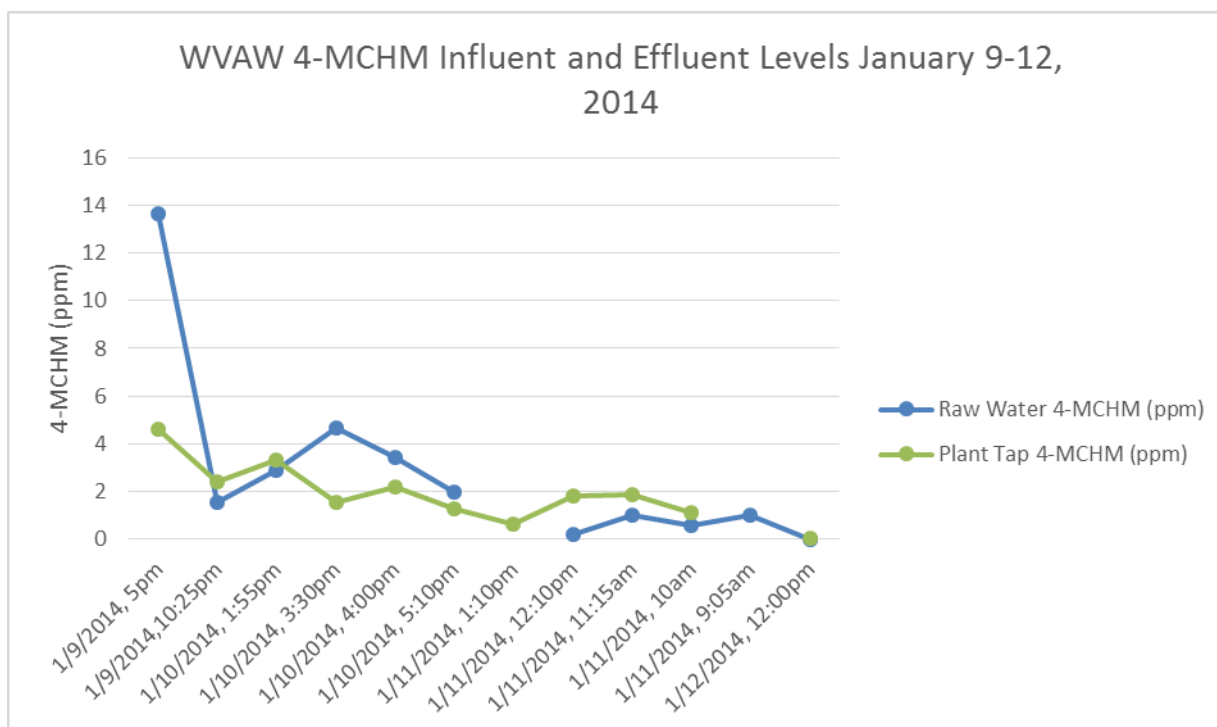
Figure 30. 4-MCHM levels in influent (river water) and finished water (final product) at WVAW KVTP on January 9-12, 2014. (Source: WVAW)
