U.S. CHEMICAL SAFETY AND HAZARD INVESTIGATION BOARD

INVESTIGATION REPORT

CHEMICAL WASTE-MIXING INCIDENT

KALTECH INDUSTRIES GROUP, INC.

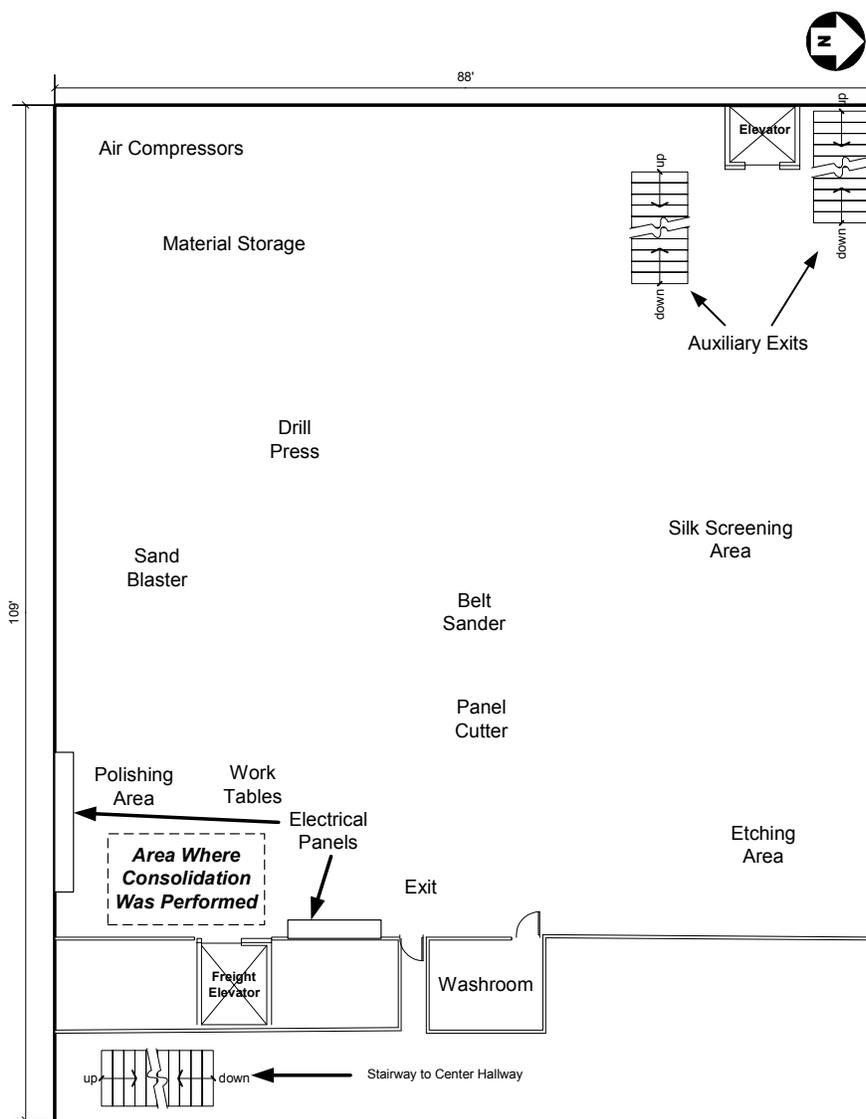
Figure 1. Basement plan, 123 West 19th Street.

surface by a chemical etching process, which involved dissolving metal with an aqueous solution of ferric chloride and hydrochloric acid to create the desired surface pattern. Finally, the signs were polished and coated with paints, lacquers, and inks. Most of the manufacturing operations were conducted in the basement of the building (Figure 1); painting and coating were performed on the mezzanine level.

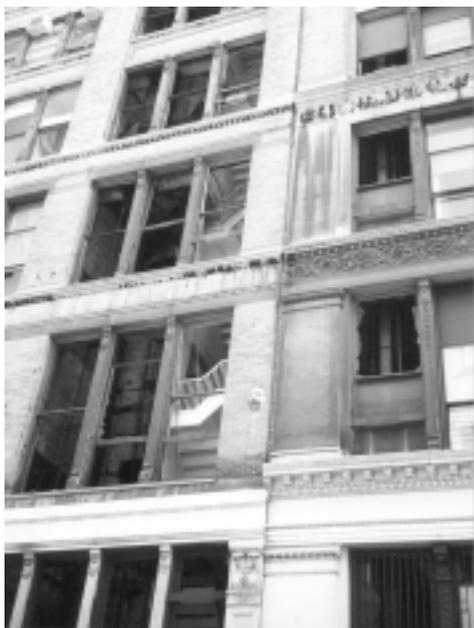
Figure 2. Front of building, windows blown out up to fifth story.

The highly confined environment of the basement offered limited pathways for the explosion pressure to vent. The blast was partially relieved via the building's center hall stairway. However, the associated shock caused the stairwell to collapse, injuring two painting contractors—one working on the second floor and the other on the fourth floor. The collapse of the stairwell further restricted egress from the basement and impeded rescue efforts. A stairway from the northwest part of the basement leading to the mezzanine⁷ was the only other exit pathway, but it was damaged and obstructed by large pieces of ceiling masonry.

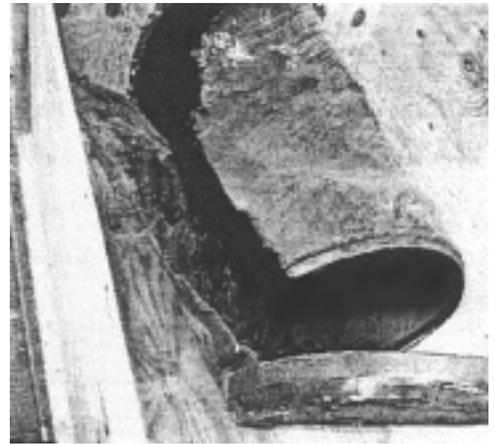
CSB investigators found two 55-gallon drums in the blast area that showed signs of being pressurized; one was metal and the other plastic. The plastic drum ruptured; the full length of the sidewall was torn open, and the bottom had blown out (Figure 3). The vendor label indicated that the drum originally contained ferric chloride solution.

Both of the workers who performed the consolidation stated that they pumped the waste from the smaller containers into a 55-gallon plastic drum. CSB investigators believe that the ruptured plastic drum was likely the receiving container.

Figure 3. Ruptured 55-gallon plastic drum.

CSB investigators believe that the ruptured plastic drum was likely the receiving container.

After the wastes were mixed in the drum, a chemical reaction most likely occurred, which rapidly generated gas or vapor.

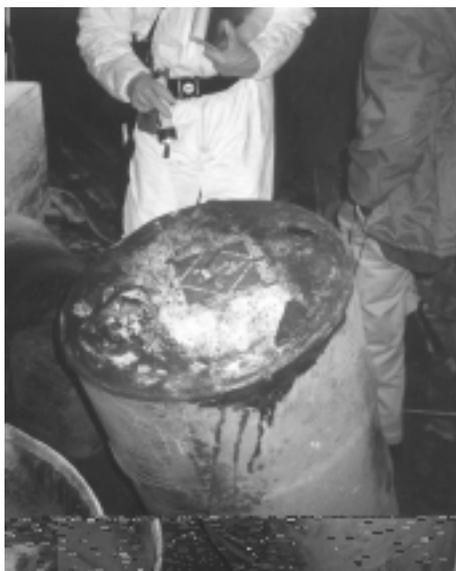
Figure 4. Bulged metal drum

The other container that displayed indications of overpressure was a 55-gallon metal drum. Although the drum did not rupture, the top was bulged upward and the bottom was rounded (Figure 4)—a clear indication that it had been pressurized. The paint on the drum was not scorched, and the top and side labels were still intact and quite readable. The vendor label described the original contents to be Inksolv solvent (Figure 5; i.e., ethyl alcohol to which propyl alcohol and propyl acetate are added as denaturants).⁸ OSHA analyzed a liquid residue found in the bulged drum after the incident. Its composition was found to be consistent with the solvent described on the label.

CSB investigators believe that the blast knocked the metal drum over, spilling some of its flammable contents. The alcohol likely ignited and served as the source of fuel for the fire, which probably flashed back into the drum, causing an internal deflagration severe enough to distort the container. The ignition source may have been one of the many electrical devices in the general area of the consolidation.

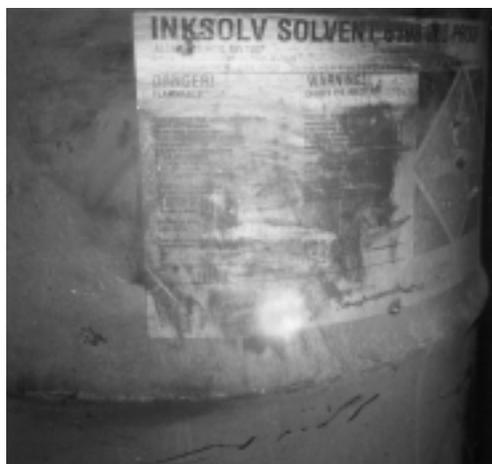
Figure 5. Legible side label on bulged drum.
