Deepwater Horizon Blowout Preventer Failure Analysis Report
To the U. S. Chemical Safety and Hazard Investigation Board
CSB-FINAL REPORT-BOP(06-02-2014)

2 Summary of Incident Failures and New Opinions

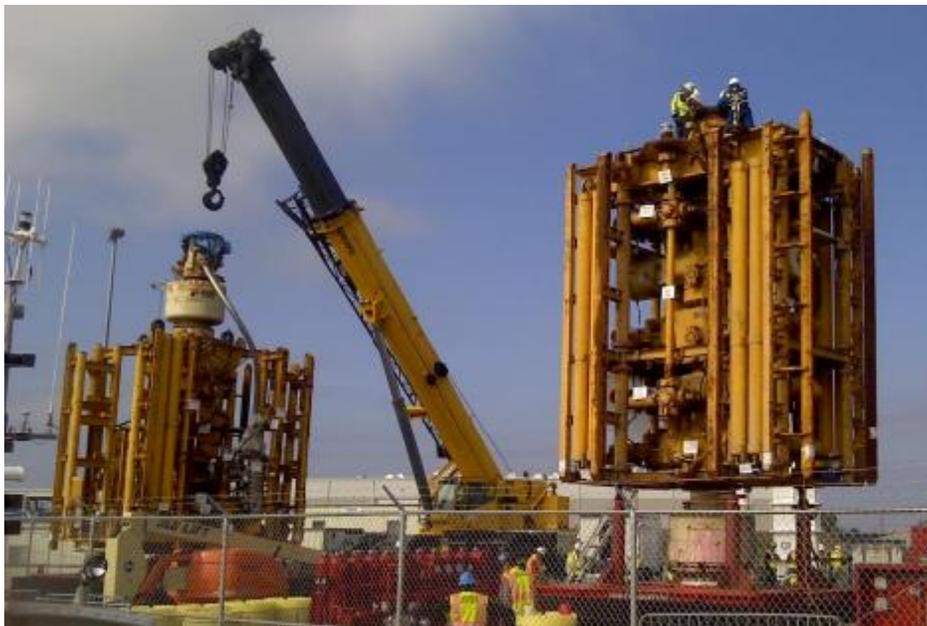
The Deepwater Horizon BOP stack at NASA-Michoud (with the upper LMRP portion on left)

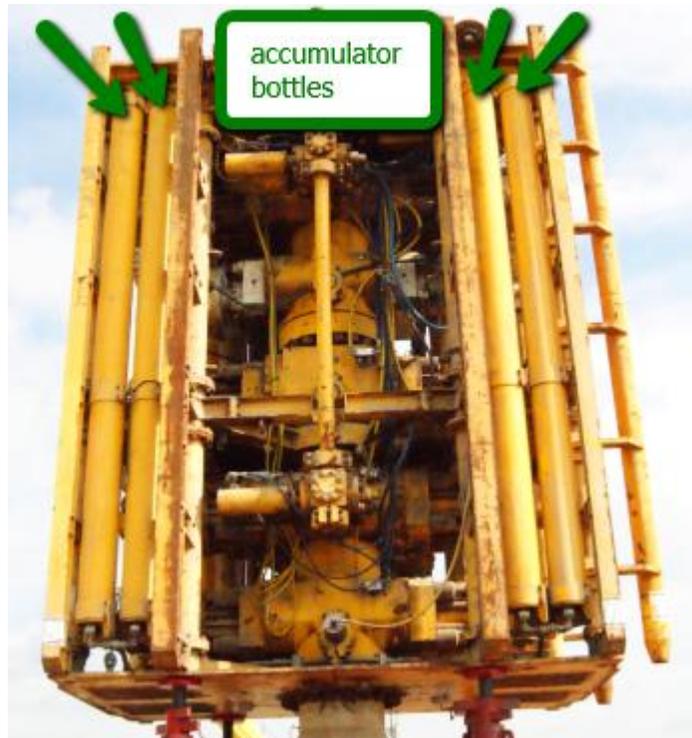
The DWH had two subsea accumulator banks. The accumulator bank of primary interest, located in the lower BOP section, provided a self-sufficient operating fluid source for the blind shear ram (BSR) and certain other functions.

Figure B-3 – Accumulator bottles on the lower BOP, 4 each on two sides

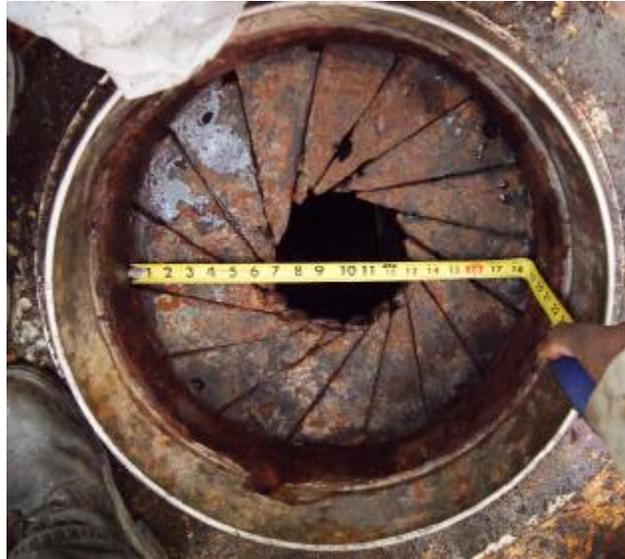
Figure 12: DWH upper annular after recovery¹⁶¹

The upper annular (UA) was found essentially completely closed with all elastomer eroded away from the steel fingers of the packer (Figure 12). The size of the opening was about six inches. The 5½" drill pipe (in the BOP at the time of the incident) tool joint OD was 6.5".

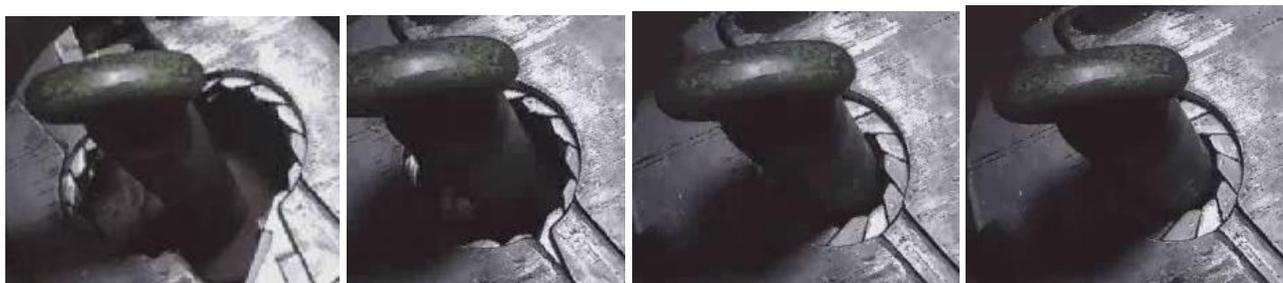
Figure D-1: VBR closing on centered pipe

This closing force must be transmitted through a complex motion of the VBR AEP (Anti-extrusion plate) 'fingers', and the resulting squeezing force would be resisted by the buckling lateral force trying to keep the pipe off-center. Determining the net squeezing force requires a simulation of this complex VBR mechanism, illustrated in Figures D-1 to D-3.

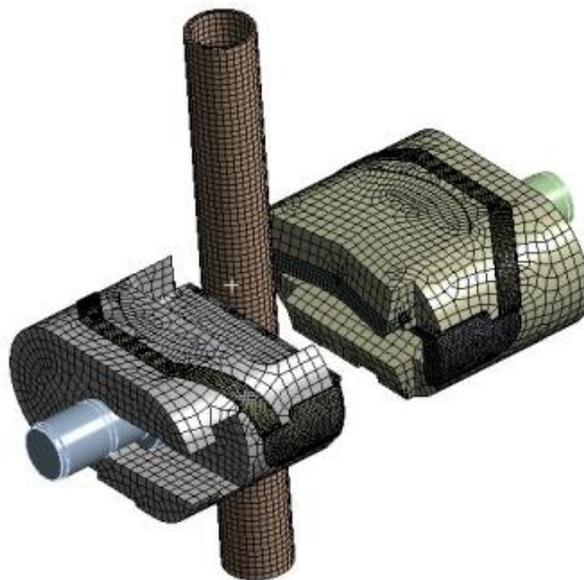
Figure E-1 – FEA model geometry and element mesh

Runs were first made with centered drill pipe to compare with Cameron rating and then drill pipe off-centered near the BOP wall (5.5 inches off-center, 1.2 inches from BOP wall), based on DNV laser scan analysis¹⁷³.

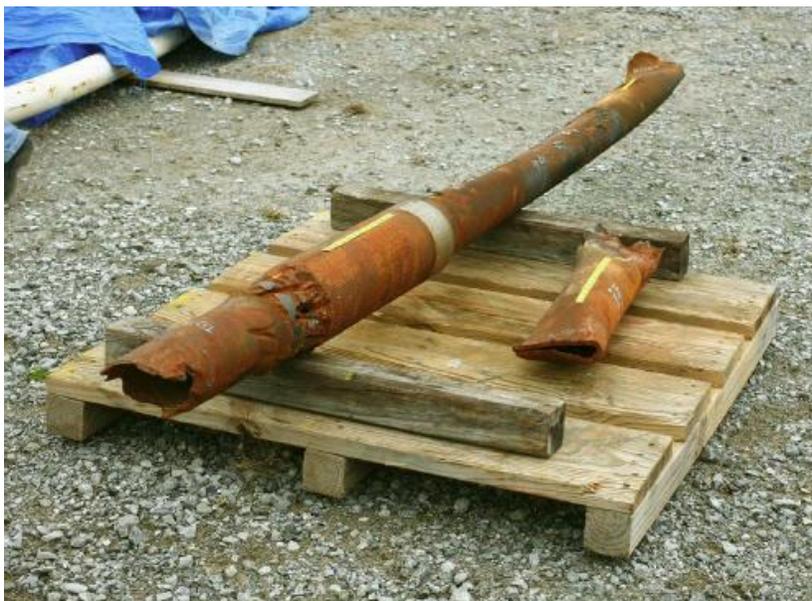
Figure I-1: Drill pipe segment 1-B-1 (left)²⁰⁴

A particularly important DP piece is Segment 1-B-1:
