BETA LAB NO.M10198- CS4-01/ LS3 BOTTOM, REV. 1	TESORO REFINING AND MARKETING COMPANY ANACORTES REFINERY 10200 W. MARCH POINT ROAD T91WA4428 ANACORTES, WA 98221	CUSTOMER P.O. NO.: 4501667904
PART: 6600-E HEAT EXCHANGER CS4 01/BOTTOM PART 18/14		DATE: SEPTEMBER 20, 2010
PAGE 1 OF 55

LABORATORY REPORT-CS4-01/ LS3 Bottom

SAMPLE DESCRIPTION: A heat exchanger failed and a test protocol was developed for the failure analysis of the component. This test protocol and its addendum, as of this date and contained in Attachment 1, were developed and signed by Tesoro Companies, Division of Occupational Safety and Health and U.S. Chemical Safety Board. FirstEnergy BETA Laboratory was selected as the referee test laboratory to perform the testing requirements of test protocol. The test protocol was not specific as to the test samples to be removed from the heat exchanger or the test locations/test parameters for each specific test within the test sample. Therefore it was agreed

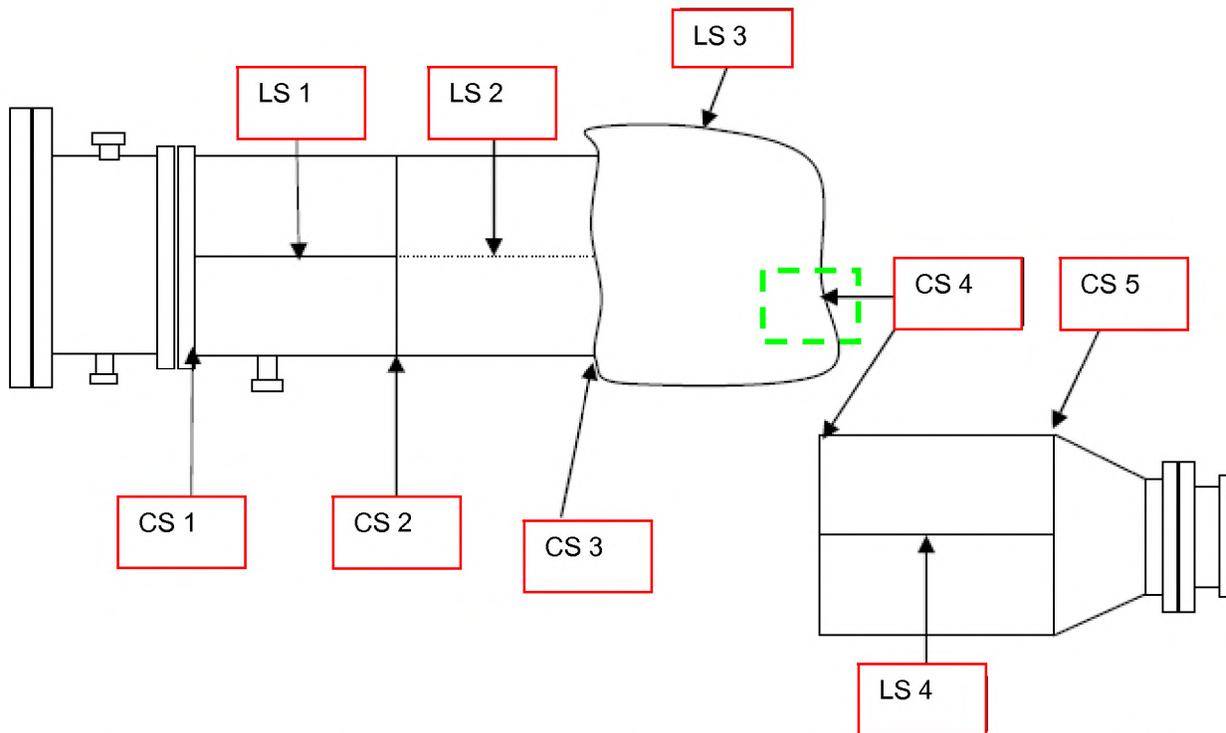
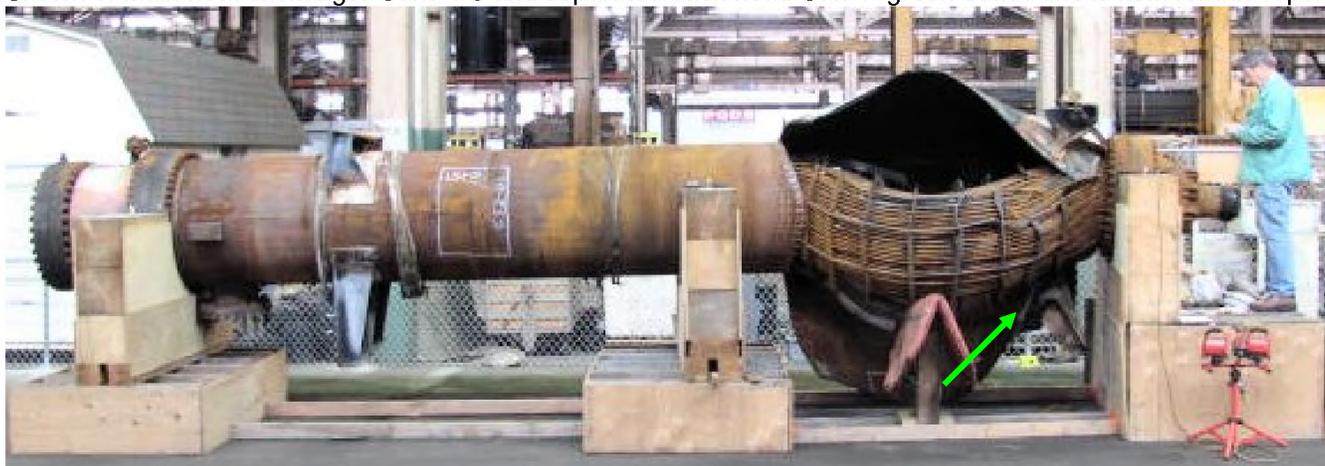
Figure 1 Un-packed Main Heat Exchanger part of the 6600E heat exchanger

Sketch of main heat exchanger Cans 1-3 and separated back head Can 4- green dotted line is item for this report

Location for CS4-01 item

TEST RESULTS: The heat exchanger weld seams had been previously labeled as shown in Figure 1 and the same labeling was used for this report.

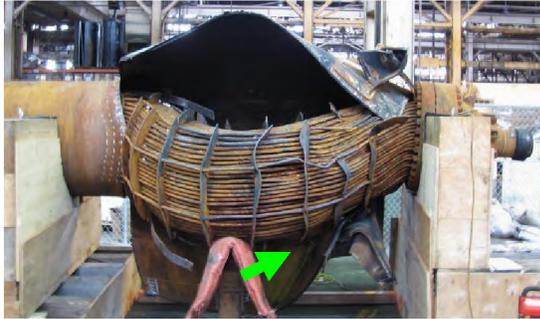
Figure 2

Location of CS4-01 part (green arrow)

The piece labeled 18 with a part of the weld CS4, as well as a matching small piece labeled 19E from the Can 4 are subjects of evaluation in this report. The parts are shown on Figures 2 through 4.

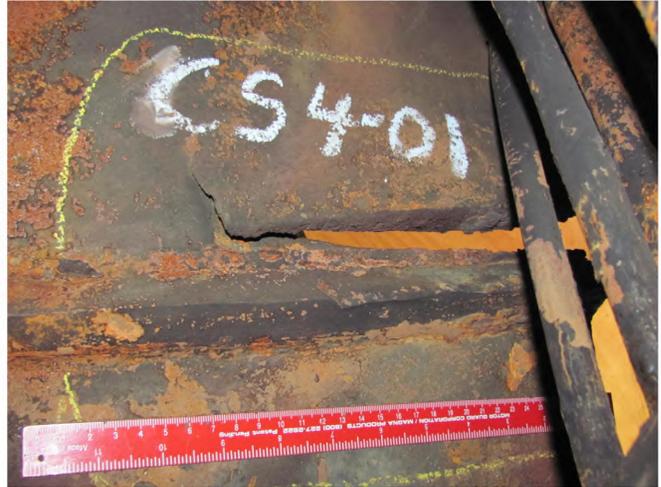
View in place form ID, marked for a cut

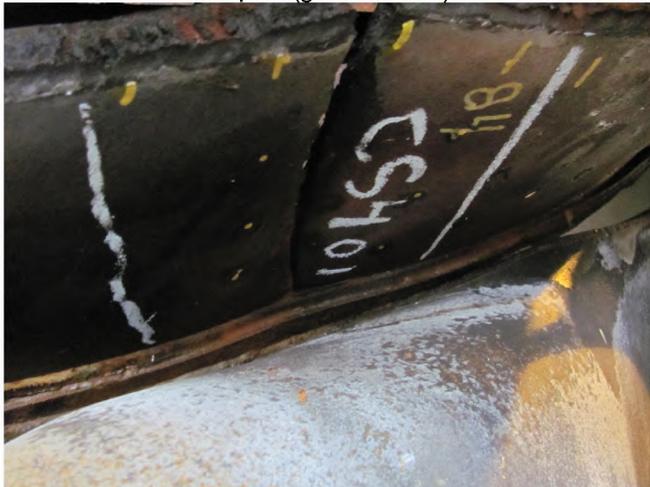
View from OD with CS4 on top and deformed saddle below

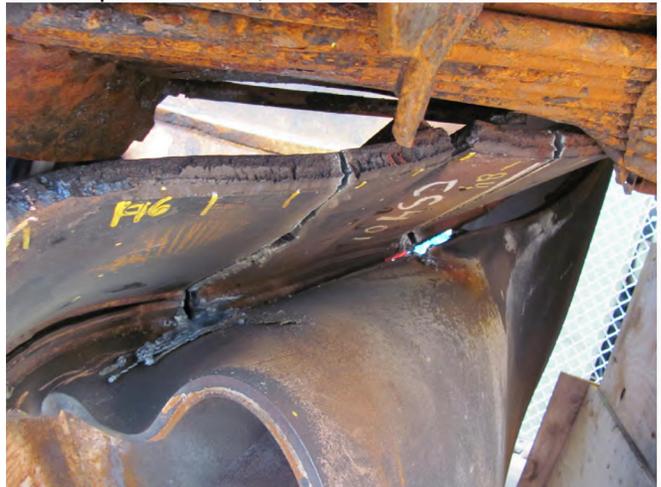
View during cutting from OD with CS4 on top and deformed saddle below which had to be cut along the fillet attachment weld to relieve sample

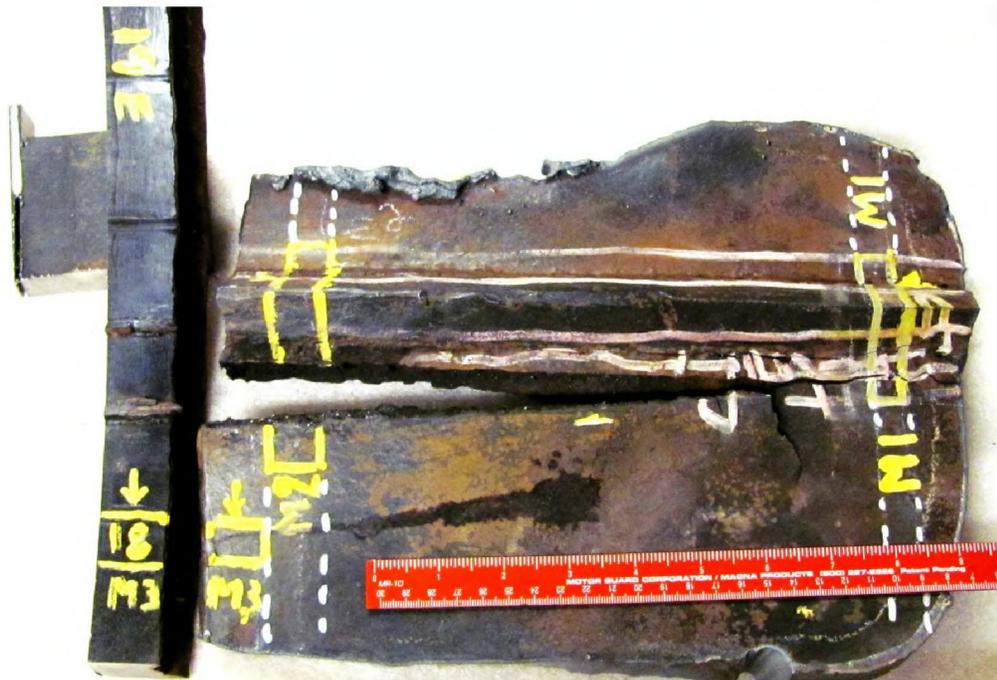
Figure 3

**CS4-01 ID VIEW. SAMPLES MARKED FOR
 REMOVAL**

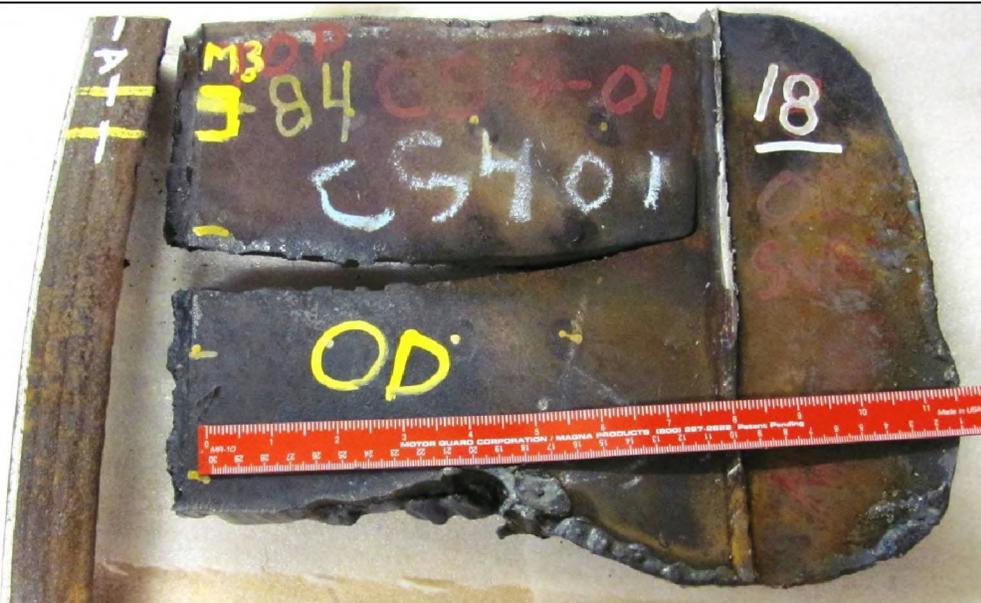
SAME AS ABOVE BUT OD VIEW

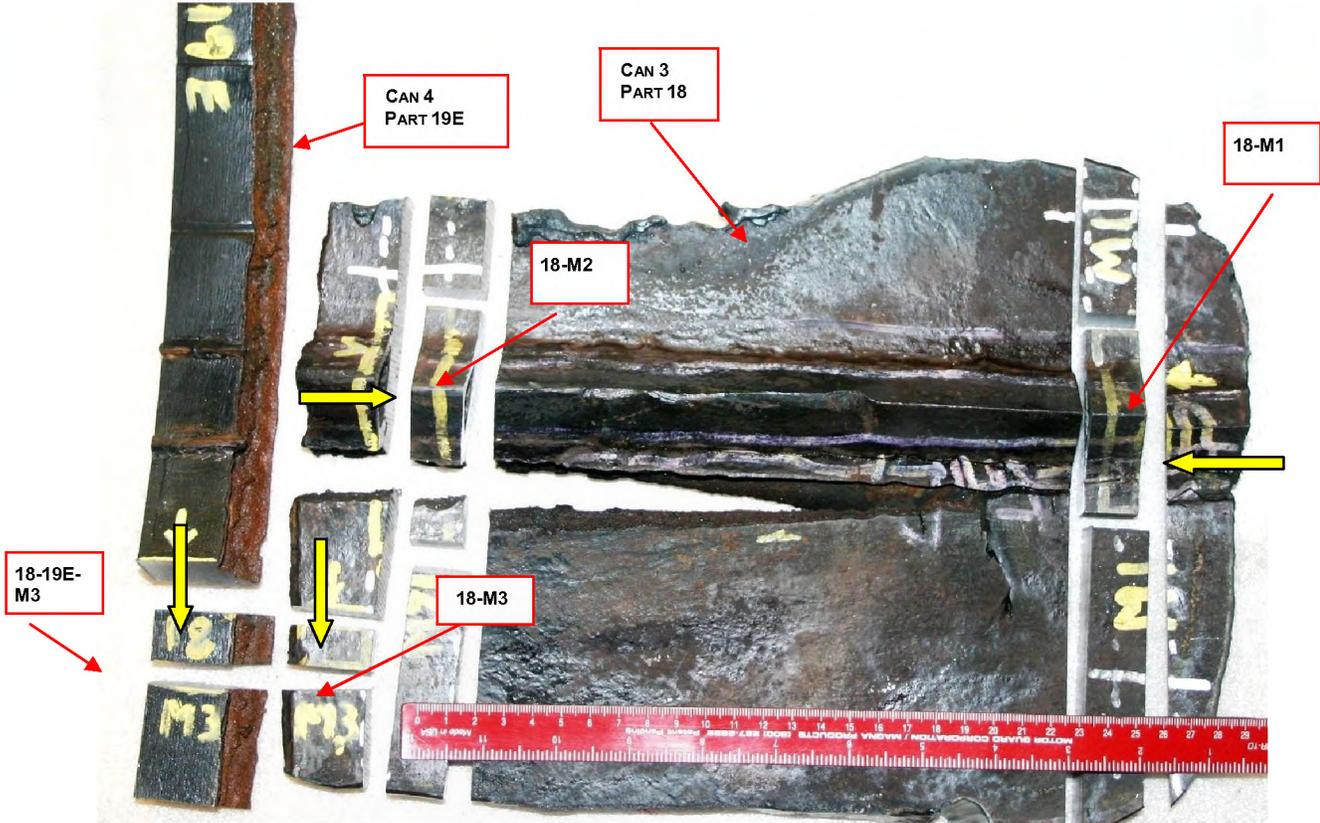
Figure 4

LAY OUT OF THE CUT SAMPLES. YELLOW ARROWS INDICATE THE PLAIN TO BE POLISHED.

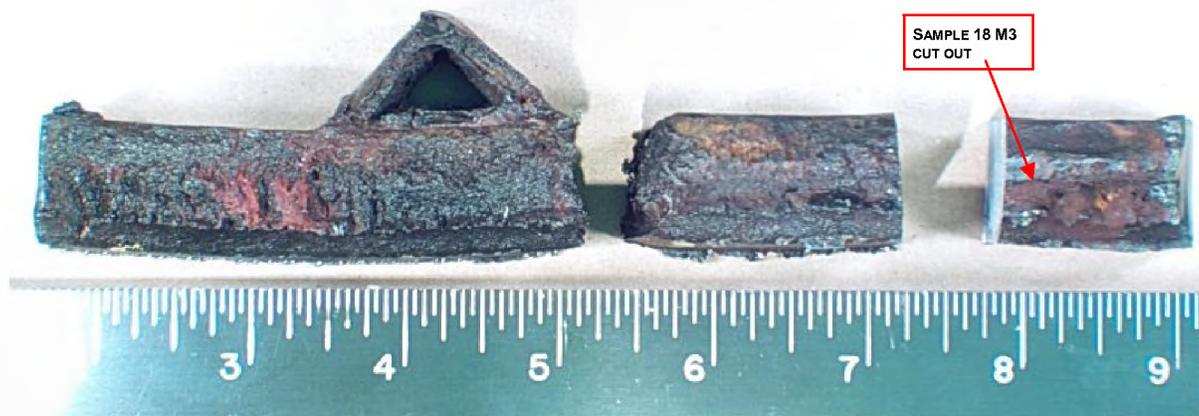
Fracture surface of Part 18.

CS4-01 FRACTURE SURFACE (PART 18)

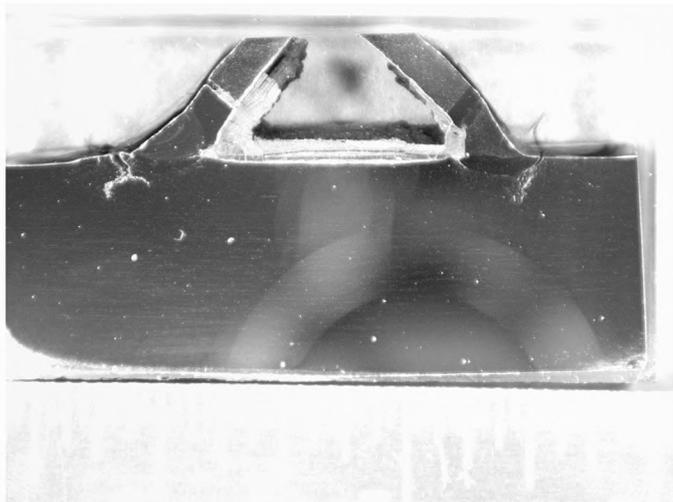
Figure 5- ID on top

SAMPLE 18-M1 UN-ETCHED-RING IS LIGHT ARTIFACT

Four locations were selected, by others, for metallurgical mounting. The locations on pieces and the photos of the etched mounts are shown in Figures 5 and 6. The mounts were examined in the un-etched and etched conditions and photomicrographs were taken as selected by others. The photomicrographs are shown in Figures 7 through 33. On Figures 34 and 35 the micro-hardness graphs and tables are shown.

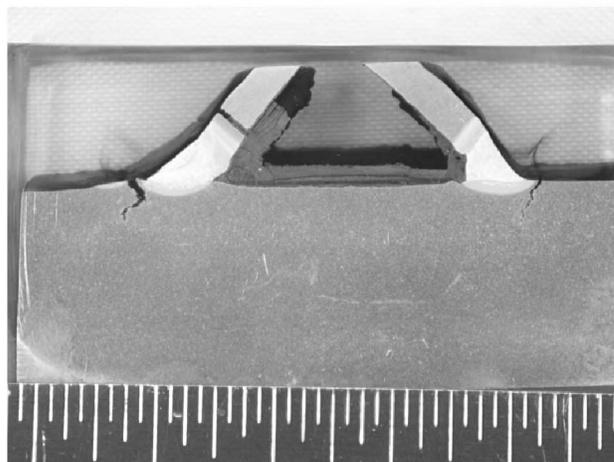
SAMPLE 18-M1 ETCHED

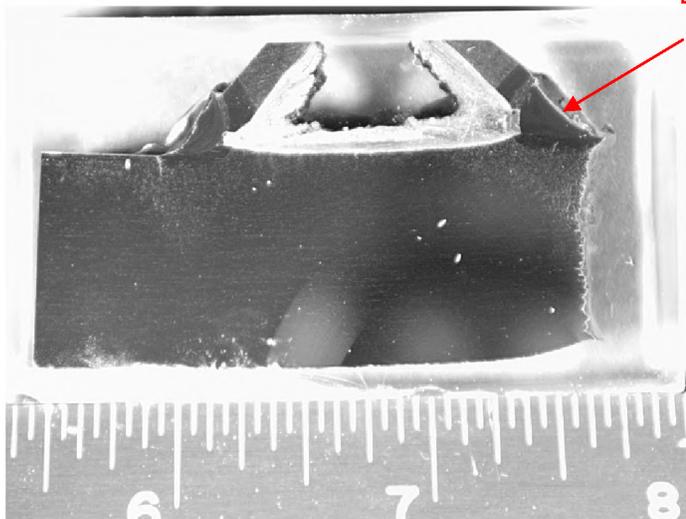
SAMPLE 18-M2 UN-ETCHED-RING IS LIGHT ARTIFACT

SS Welds

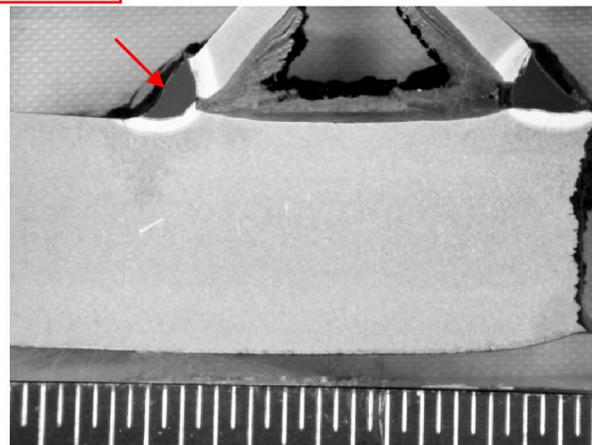
SAMPLE 18-M2 ETCHED
