U.S. CHEMICAL SAFETY AND HAZARD INVESTIGATION BOARD

FIRE AND EXPLOSION: HAZARDS OF BENZOYL PEROXIDE

No. 2003-03-C-OH
October 2003

CATALYST SYSTEMS, INC.
Gnadenhutzen, Ohio
January 2, 2003

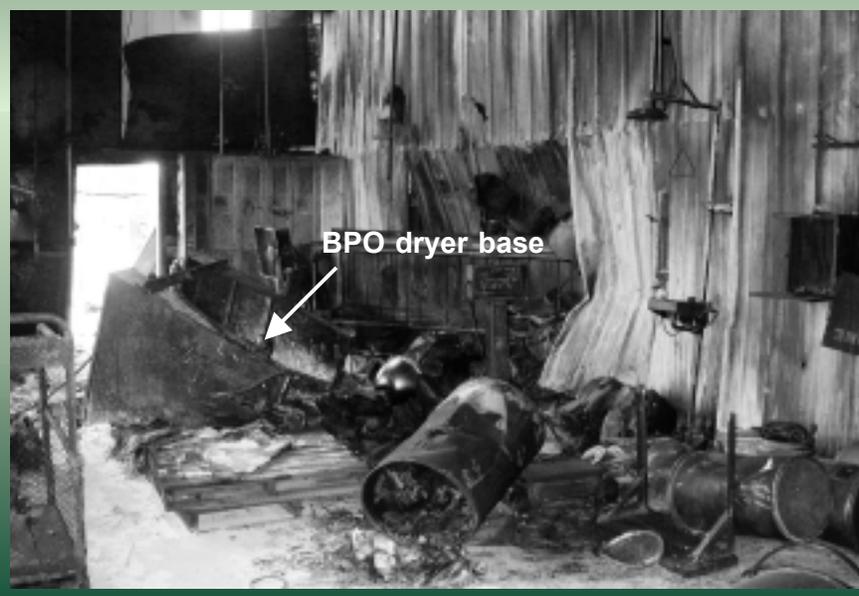
Figure 4

Figures 4, 5, and 6 show some of the damage caused by the explosion. The dryer was propelled through the corrugated steel dividing wall, shown in Figure 4, and through several pallets of filled fiber drums (Figure 5). It landed approximately 35 feet from its original location.

Damage to Catalyst Systems BPO production building

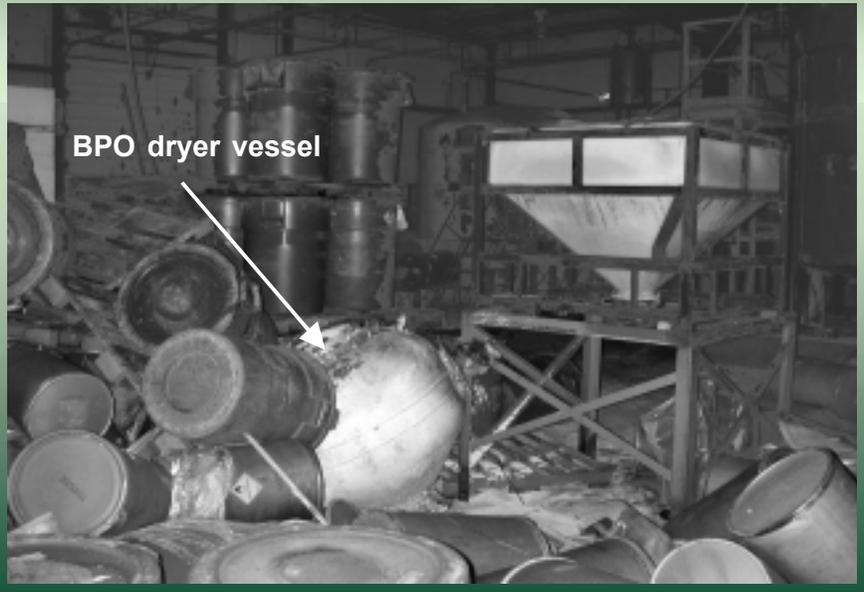
Figure 5

Filled fiber drums damaged by dryer

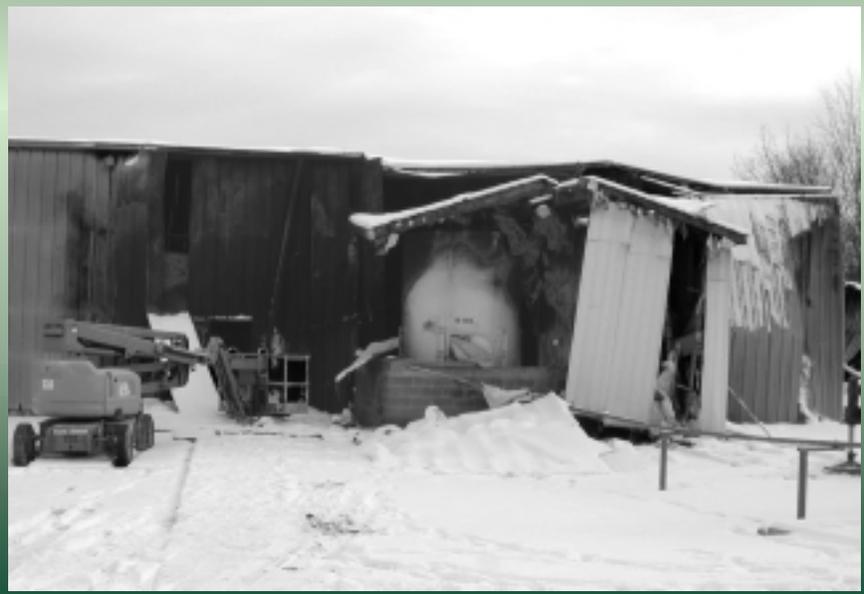
Figure 6

The siding and siding supports on the south side of the building, as well as the dividing wall, were extensively damaged (Figure 6). The building's primary structural frames were intact, though the roof decking and supports in the southwest corner were badly damaged.

Building damage, southwest side
