# Safety Advisory

## Dangers of Unspent Aircraft Oxygen Generators

U.S. Chemical Safety and Hazard Investigation Board

No. 2007-I-NC-01-SA | June 2007

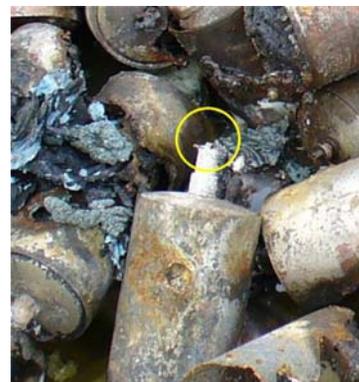
The CSB found that the initial small fire<sup>1</sup> observed by firefighters was in the same location as a fiberboard container of unspent aircraft oxygen generators and containers of solid chlorine-based pool chemicals awaiting final disposal.<sup>2</sup> Figure 1 shows an oxygen generator found in the fire debris with its activation pin in place, indicating that it was unspent when the fire started. Because oxygen generators were located at or near the origin of the fire and, when actuated or exposed to fire, produce oxygen that significantly increases the intensity of a fire, the CSB concluded that the oxygen generators most likely contributed to the rapid spread of the fire to the area where flammable hazardous wastes were stored.

Figure 1 – Oxygen generator with actuator circled

Most commercial passenger aircraft use chemical oxygen generators to provide passengers with emergency supplemental oxygen in the event of a high altitude cabin depressurization. The chemical oxygen generators, housed in metal cans, include an activation device, chemical core, and oxygen outlet. Pulling the activation pin releases a spring-powered striker that ignites a small explosive inside the generator, initiating an exothermic chemical reaction that generates oxygen.<sup>5,6</sup> As the reaction progresses through the sodium chlorate core, the surface temperature of the metal cylinder can reach 450 to 500°F.
