Gainesville, GA | Incident Date: January 28, 2021 | No. 2021-03-I-GA

# **Investigation Update**

September 2022

This document provides an update on the CSB investigation of the January 28, 2021, incident at the Foundation Food Group's Prepared Food Division facility in Gainesville, Georgia. The investigation is ongoing. Complete findings, analyses, and recommendations, if appropriate, will be detailed in the CSB's final investigation report.

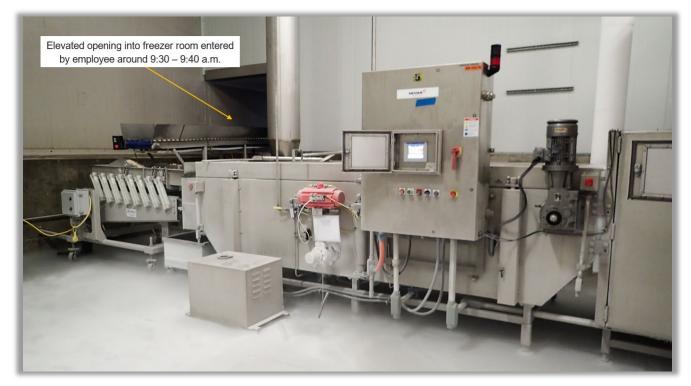
**Figure 1**. The Line 4 immersion freezer in the freezer room. This photo was taken soon after the incident. (Credit: Hall County Fire Services with annotations by CSB)

On Thursday, January 28, 2021, between approximately 8:45 and 9:30 a.m., liquid nitrogen was released from a freezer located in Plant Four at the Foundation Food Group ("FFG") facility in Gainesville, Georgia (**Figure 1**), resulting in the fatal injuries of six employees and the serious injury of three employees and one emergency responder. Once released, the liquid nitrogen quickly vaporized, expanded, and accumulated inside a partially enclosed room within a building. FFG used liquid nitrogen for the freezing of cooked poultry products.

- When Line 4 workers returned from their 15-minute break, they saw that their line had not yet restarted. After the line workers waited for over an hour, one of them entered the freezer room through the elevated opening, pictured in **Figure 1**, to check on the maintenance workers at around 9:30 or 9:40 a.m. The line worker saw a white cloud approximately four feet high filling the room and one of the maintenance workers lying unconscious on the ground next to the freezer.<sup>a</sup> The line worker exited the freezer room and notified the other workers and supervisors in the RTE area.

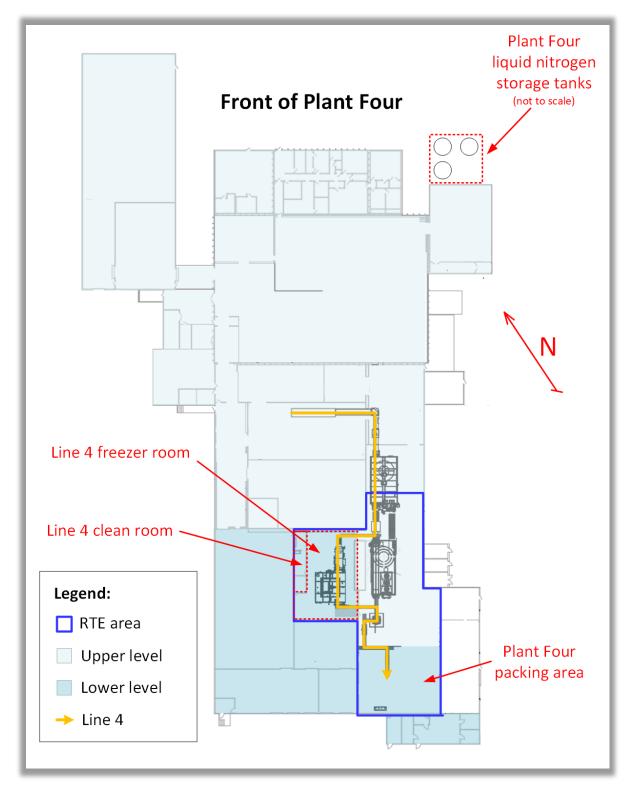
**Figure 2**. Plot plan of the FFG Plant Four building. The yellow line indicates the Line 4 process flow on the day of the incident. The incident took place in the freezer room, which is at a lower level than the rest of the Line 4 equipment. (Credit: FFG with additions by CSB)

• The FFG Plant Four building (Figure 2) consists of five production lines that made various cooked, partially cooked (par-cooked), and marinated chicken products [3]. Conveyor belts transferred chicken through production equipment, such as ovens, fryers, freezers, and baggers, on each production line. This event occurred on Line 4, which processed fully cooked diced chicken products.

- After seeing at least one worker unconscious in the clean room adjacent to the freezer room (**Figure 2**), a group of three FFG employees ran to the liquid nitrogen tanks at the front of the building and closed valves to shut off the liquid nitrogen supply into Plant Four, at approximately 10:18 a.m.

- After Messer assembled and placed the Line 4 freezer inside the Plant Four building, FFG contracted International Refrigerated Structures to build out a new clean room and add a wall (**Figure 2**). The build-out and wall installation were completed on December 13, 2020.

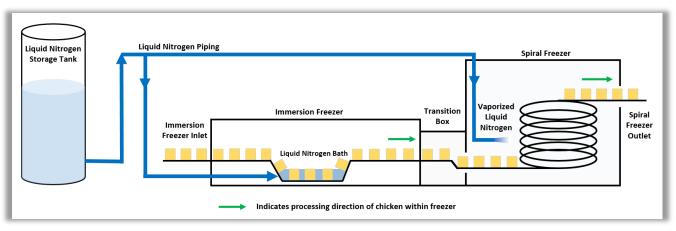
**Figure 3**. Simplified diagram of the Line 4 liquid nitrogen freezing system, not drawn to scale. (Credit: Messer with annotations by CSB)

- The building was separated into two processing areas: the "raw" area and the "Ready-To-Eat" (RTE) area.<sup>a</sup> The Line 4 process began in the raw area with marination and cooking, then continued to the RTE area, which contained a dicer, freezer, and packaging equipment.<sup>b</sup>
- The freezing system on Line 4 was a liquid nitrogen immersion-spiral freezer supplied by Messer LLC ("Messer") [4] (Figure 3). Freezing occurred in two stages.

- In the first stage, a conveyor belt carried the fully cooked diced chicken into an immersion freezer, where it was flash frozen in a -320 °F (-196 °C) liquid nitrogen bath. The chicken and some of the nitrogen vapor produced in the immersion freezer were then moved through a transition box to the spiral freezer.

- In the second stage, liquid nitrogen was added to a spiral freezer, where it vaporized, providing refrigeration. A spiral conveyor belt carried the chicken through the freezer while internal fans distributed the vaporized nitrogen and equalized temperatures within the freezer. Once freezing was complete, the chicken exited the spiral freezer, was packaged, and shipped to customers.

- Control valves regulated the flow of liquid nitrogen from the outdoor storage tanks (Figure 2 and Figure 3) through piping routed outside the building, along the roof, and then entering the building to connect to each freezer. The freezers were equipped with a computer control system with touch screens to set operating parameters for the freezer system, such as the liquid nitrogen level inside the immersion freezer, conveyor belt speeds, and exhaust fan speeds.
