INVESTIGATION REPORT

CHEMICAL SPILL CONTAMINATES PUBLIC WATER SUPPLY IN CHARLESTON, WEST VIRGINIA

FREEDOM INDUSTRIES, INC.
CHARLESTON, WV
JANUARY 9, 2014

REPORT NO. 2014-01-I-WV
SEPTEMBER 2016

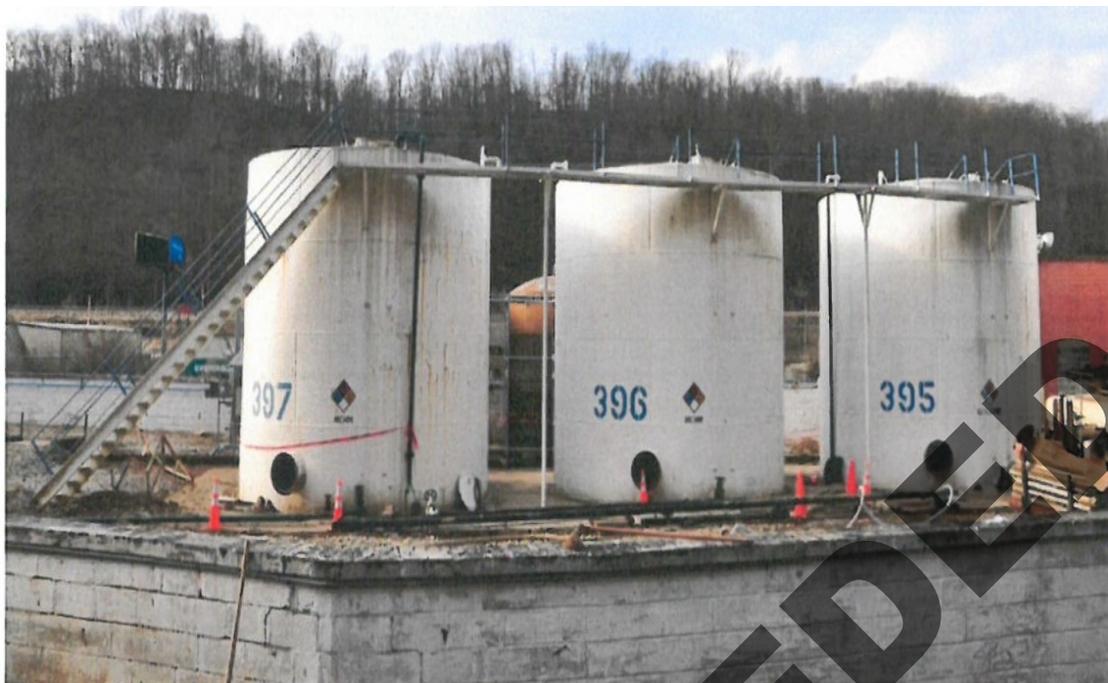
Figure 4. MCHM- and PPH, stripped-containing tanks at Freedom post-incident. (Source: CSB)

Tanks 395, 396 and 397 were 20 feet in diameter by 20 feet tall. The tanks had a lap-riveted⁴⁴ shell, cone roof and a 1/4-inch lap-welded⁴⁵ bottom. Tank 397 was a blend tank that was used to mix MCHM and PPH, stripped to produce a product known as ShurFlot 944.⁴⁶ The final product was stored in tanks 396 and 397 as well as in totes for sale (Figure 5).

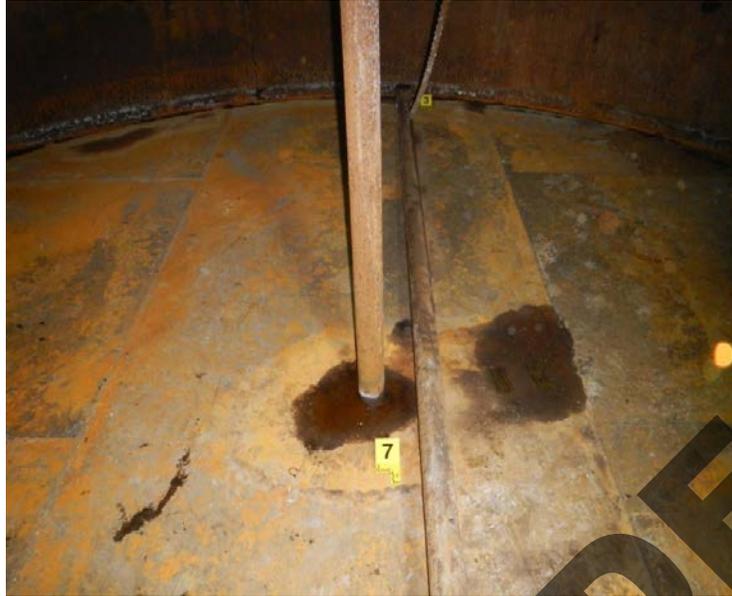
Figure 16. Retrofitted welded bottom of tank 396 (inside of tank). (Source: CSB)

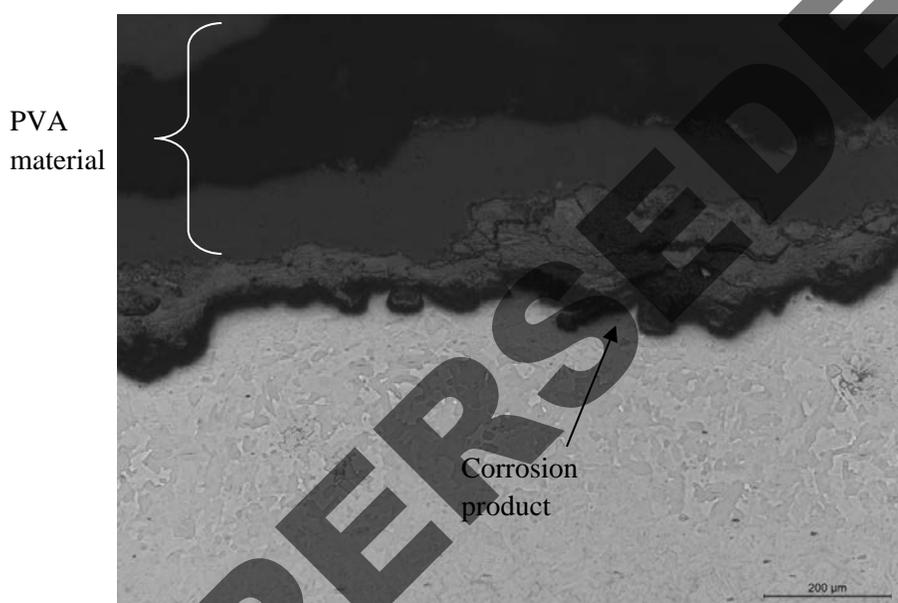
Figure 19. Corrosion product beneath PVA. (Source: CSB)

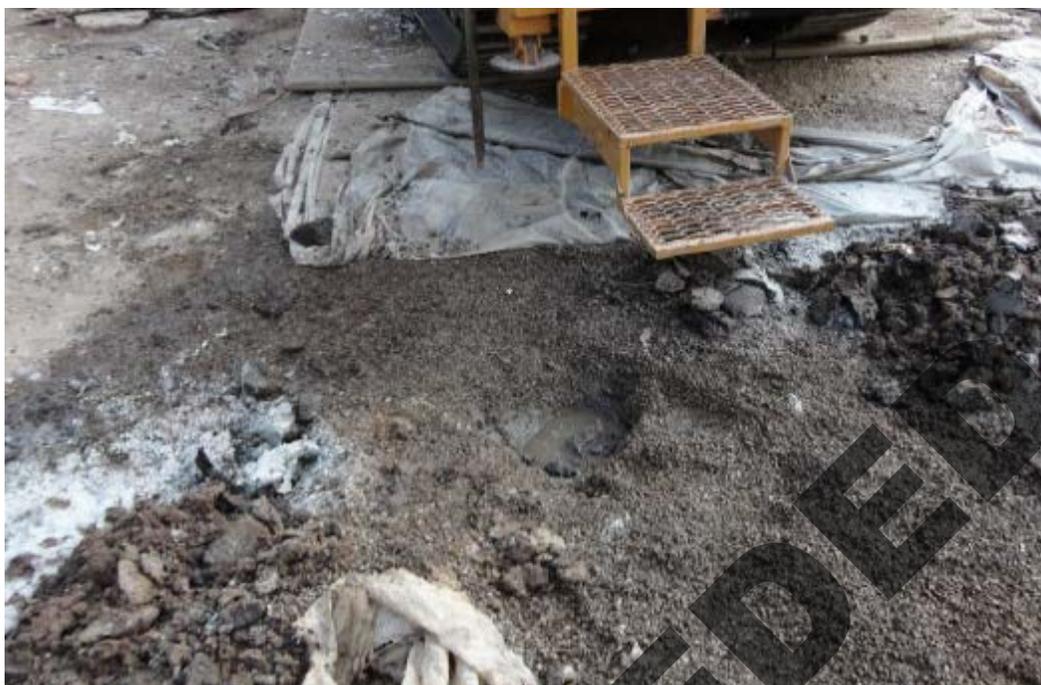
Figure 20. Gravel base under tank 396 and other MCHM tanks. (Source: Terracon)

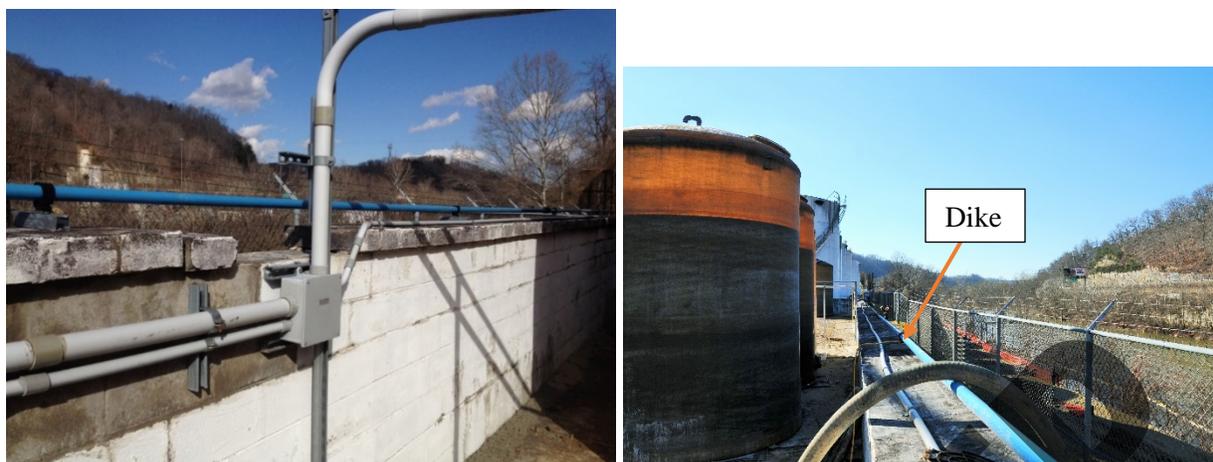
Figure 23. View from inside the dike wall facing the Elk River of the concrete block walls with no reinforcement (Left); dike wall along the tank farm parallel to the Elk River (Right). (Source: CSB)

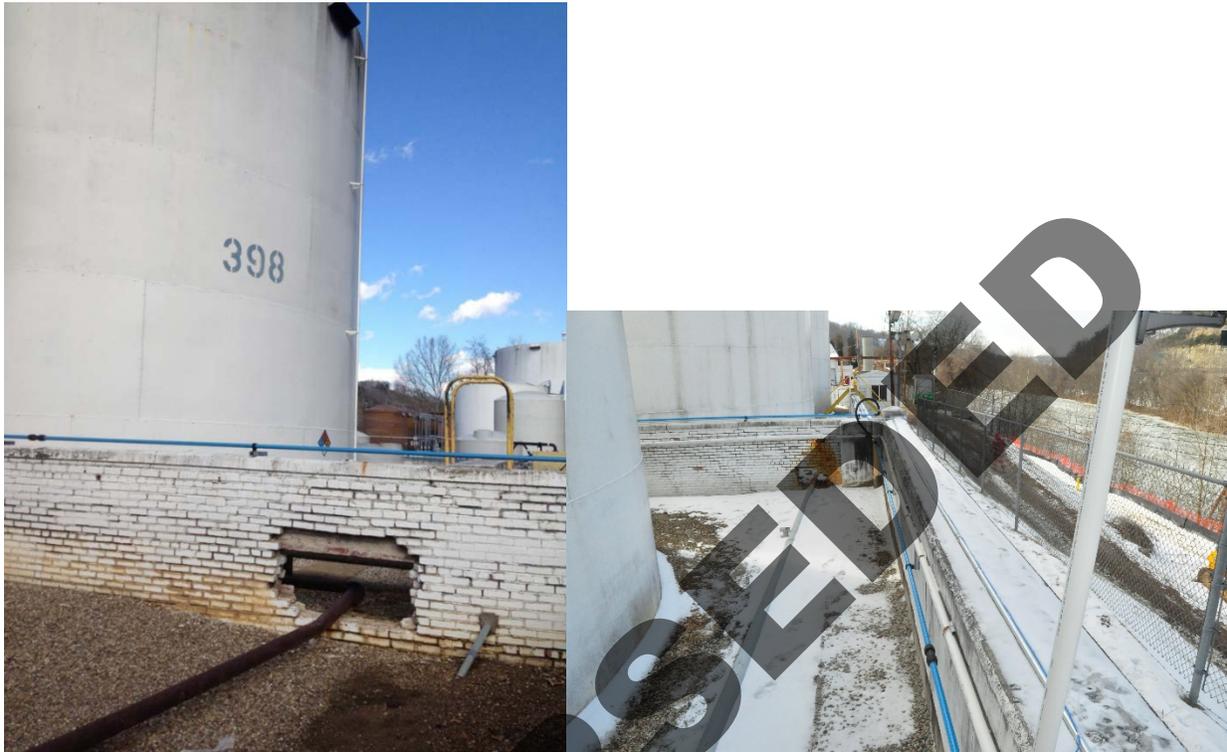
addition, although concrete caps were used around the top of the dike walls, many of these caps were missing or had deteriorated, which allowed for rainwater or other elements to infiltrate the walls.

Figure 24. The dike walls that surrounded the tank farms were in poor condition. (Source: CSB)

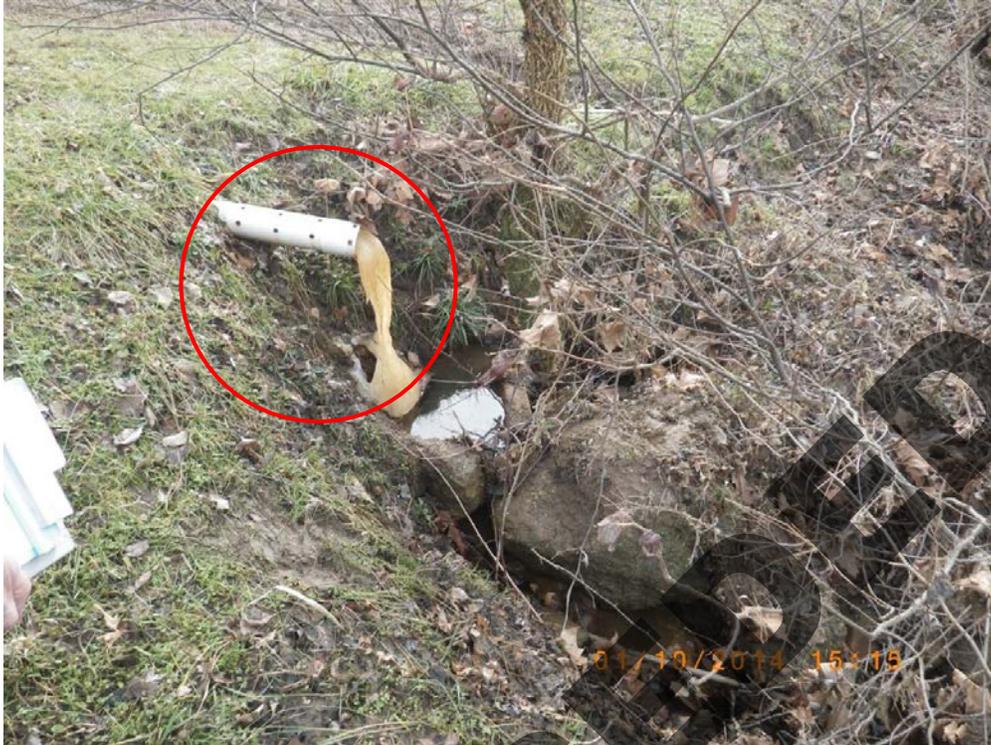
Figure 25. Ice-filled oil/water separator discharge pipe into the Elk River. (Source: WVDEP)

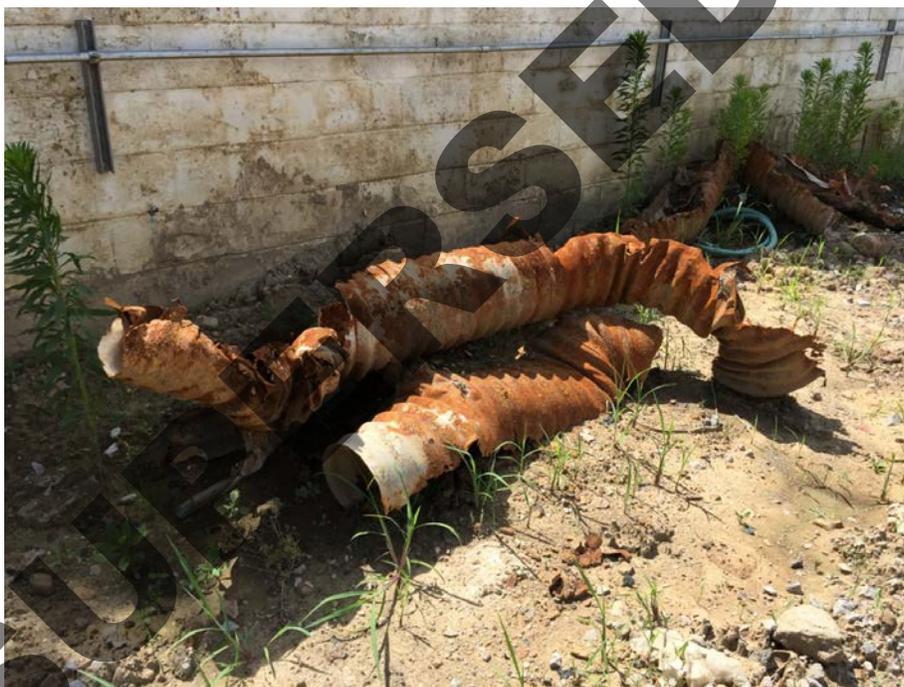
Figure 28. Photo taken on June 15, 2015, of remnants of the culvert that ran between tanks 394 and 395 beneath the site. (Source: CSB)
