U.S. Chemical Safety and Hazard Investigation Board

Investigation Report

Non-Condensable Gas System Explosion at PCA DeRidder Paper Mill

DeRidder, Louisiana

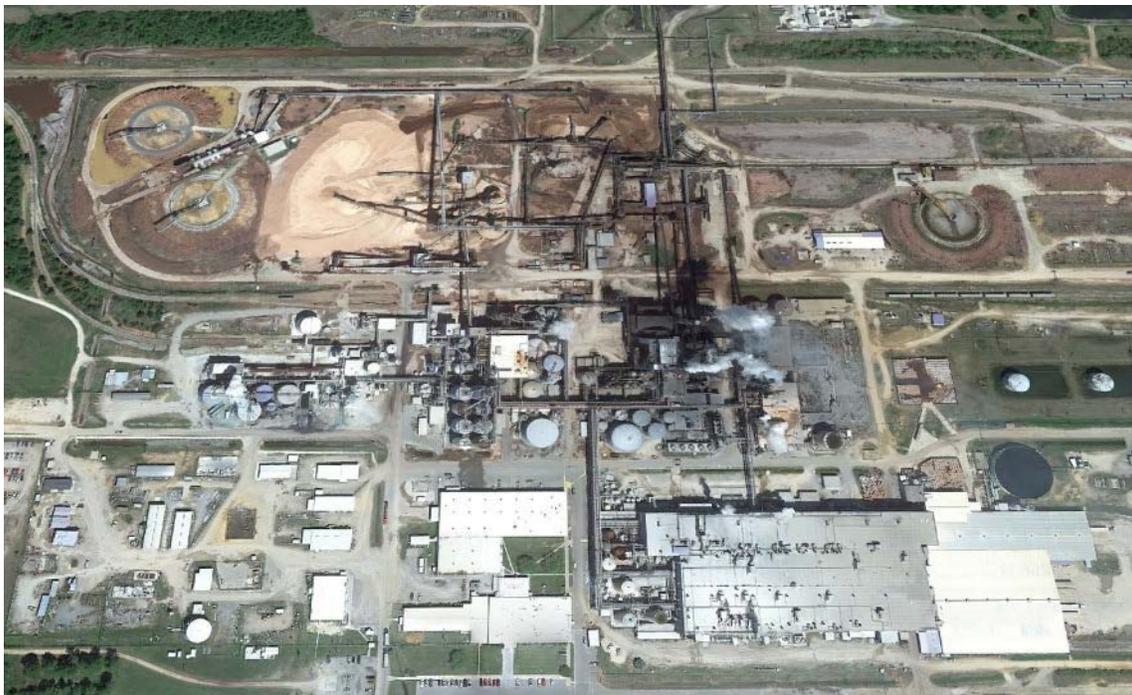
Figure 2. Overhead Photograph of the PCA DeRidder Mill. The larger complex at the bottom right of the photograph is primarily the paper mill area. Photograph: Google Earth.

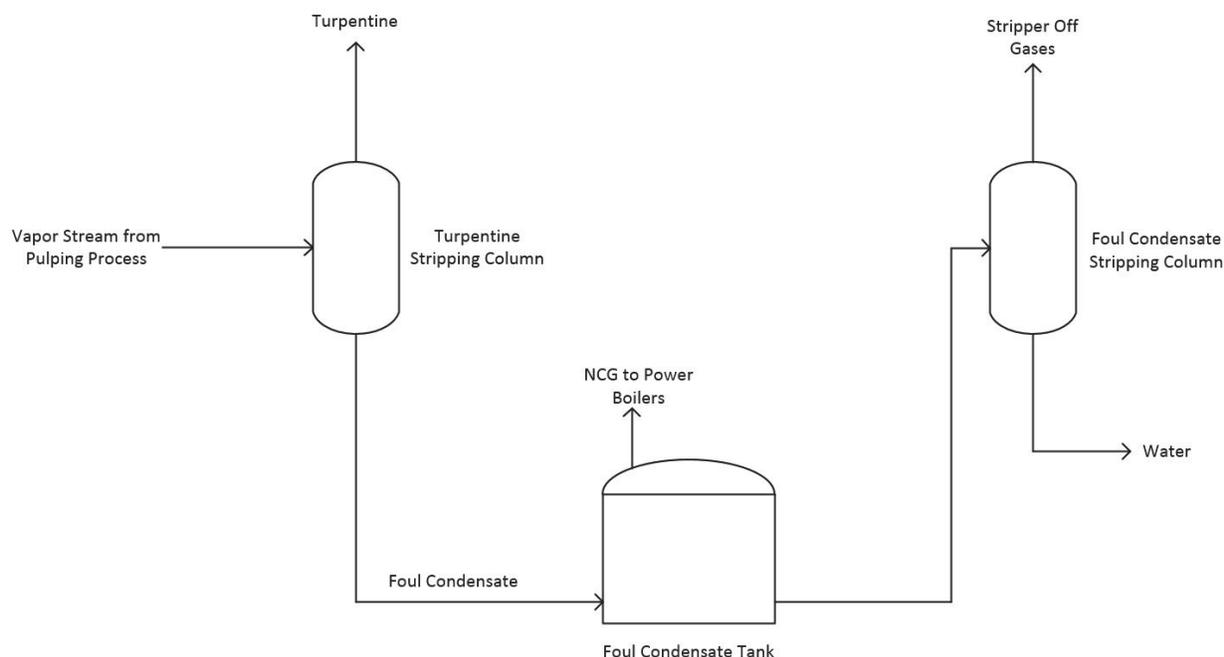
Figure 3. Simplified Flow Diagram of the Foul Condensate Tank. The foul condensate tank is fed by the turpentine-stripping column and then sends foul condensate to the foul condensate-stripping column.

11. The foul condensate is primarily water but also contains flammable compounds, including methanol, turpentine, and odorous sulfur compounds referred to as total reduced sulfur (TRS). The TRS compounds include hydrogen sulfide, methyl mercaptan, dimethyl sulfide, and dimethyl disulfide [5, p. 1].
12. At normal operating conditions, PCA keeps the foul condensate tank at approximately 185 degrees Fahrenheit (°F) and at or near atmospheric pressure.^a
13. As shown in **Figure 4**, vacuum equipment called ejectors^b use steam to create a slight vacuum^c on the vent piping from the foul condensate tank to draw off methanol, turpentine, and TRS gases, collectively referred to as non-condensable gases (NCG).^d In addition to being flammable in the presence of sufficient oxygen, NCG are highly toxic, and exposure can potentially result in injury

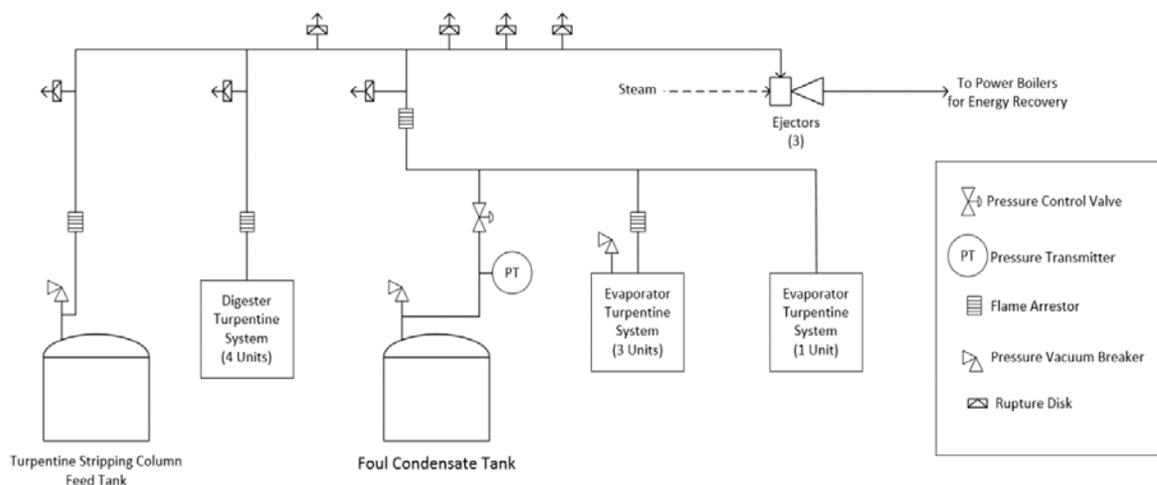
Figure 4. Simplified Flow Diagram of the CNCG System. The CNCG system collects NCG from various units at the mill, including the foul condensate tank, and sends them to the power boilers for energy recovery.

14. NCG from the foul condensate tank are collected in a concentrated NCG (CNCG) system, which consists of a piping header attached to various units producing NCG (**Figure 4**). CNCG are NCG that are collected in concentrated form. The CNCG system operates at a slight vacuum to collect NCG and direct them to power boilers for destruction and energy recovery.

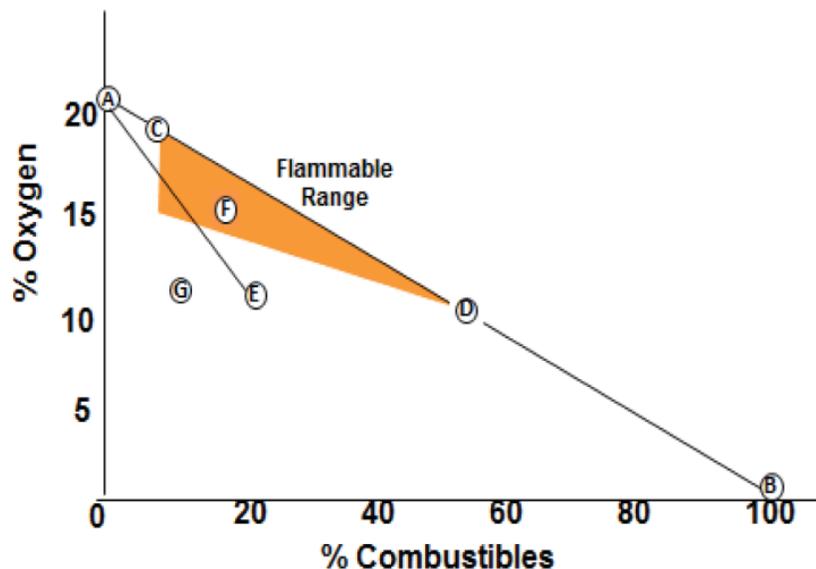
Figure 6. Typical Flammable Range of NCG. The highlighted area between points C and D represents mixtures of NCG and oxygen that are flammable [5, pp. 4-5], [6]. The flammable range can change substantially with the addition of turpentine.

28. Points C and D in **Figure 6** represent the upper and lower boundary limits of the flammable range of a mixture containing NCG and oxygen.
29. In **Figure 6**, Point A represents nothing but air in the system and Point B represents nothing but NCG in the system. Neither point is flammable as Point A is too lean (not enough fuel) and Point B is too rich (not enough oxygen) to burn.
30. Point F in **Figure 6** represents a mixture of NCG and oxygen that is flammable. Point G represents a mixture of NCG and oxygen that is non-flammable because it is too lean.
31. Point E in **Figure 6** is representative of an NCG concentration level outside of the flammable range; however, if oxygen enters the system, the mixture can move into the flammable range, as indicated by the line between Point E and Point A [5, pp. 4-5], [6].

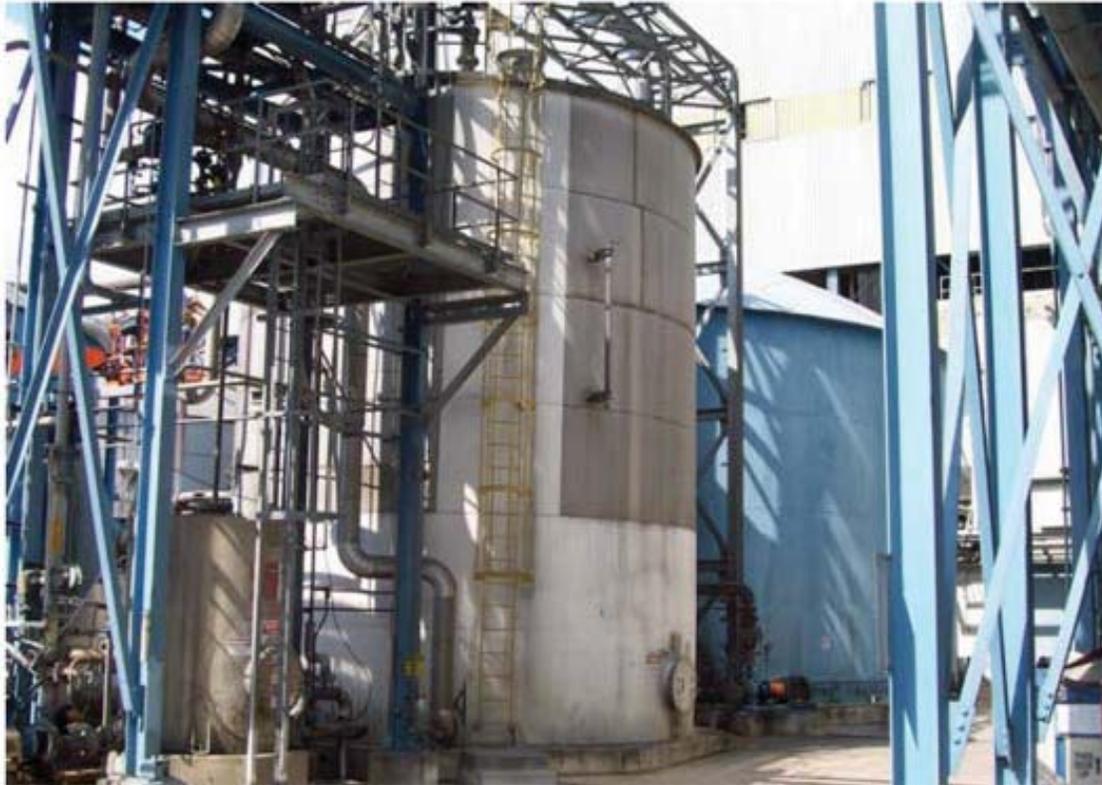
Figure 7. Pre-Incident Photograph of the DeRidder Mill Foul Condensate Tank. Welding work was being conducted above the tank on the pipe rack at the time of the incident. Photograph: PCA.

1. At approximately 11:05 am central daylight time (CDT) on February 8, 2017, a tank containing foul condensate (**Figure 7**) exploded at the PCA DeRidder mill in DeRidder, Louisiana.

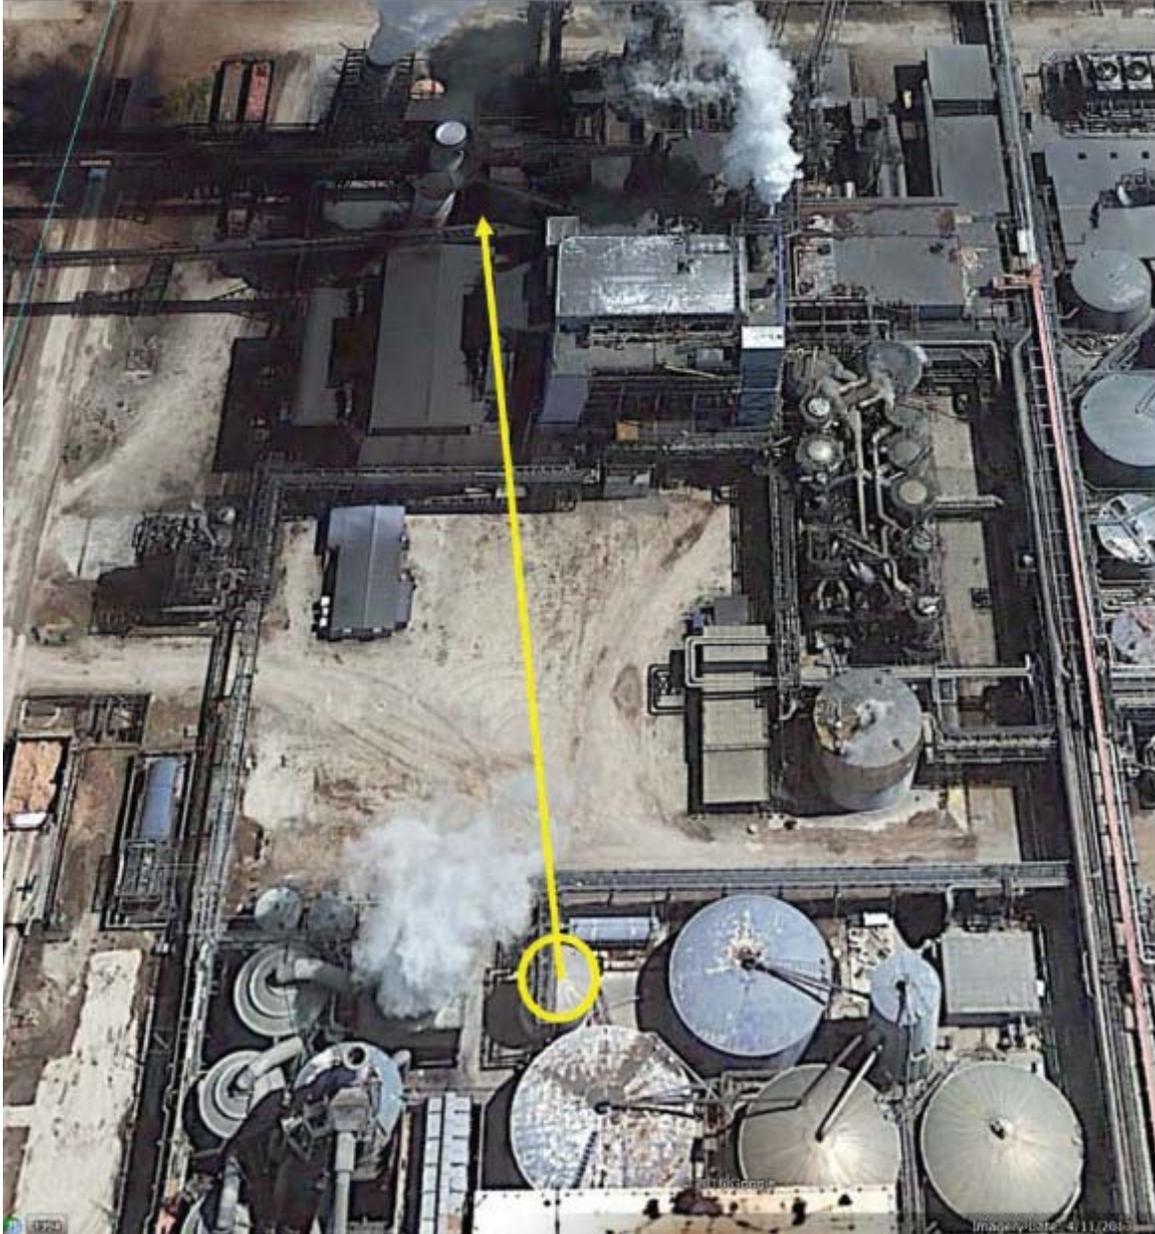
Figure 8. Overhead Photograph of the PCA DeRidder Mill. The yellow circle shows the pre-incident location of the foul condensate tank and the yellow line indicates the path traveled by the tank following the explosion. The tank landed at the base of a powerhouse stack, as indicated by the arrow. Photograph: Google Earth.

2. The explosion separated the tank, referred to as the foul condensate tank, from its base and launched it from its ground-level position up and over a six-story structure, landing approximately 375-feet away (**Figure 8** and **Figure 9**).

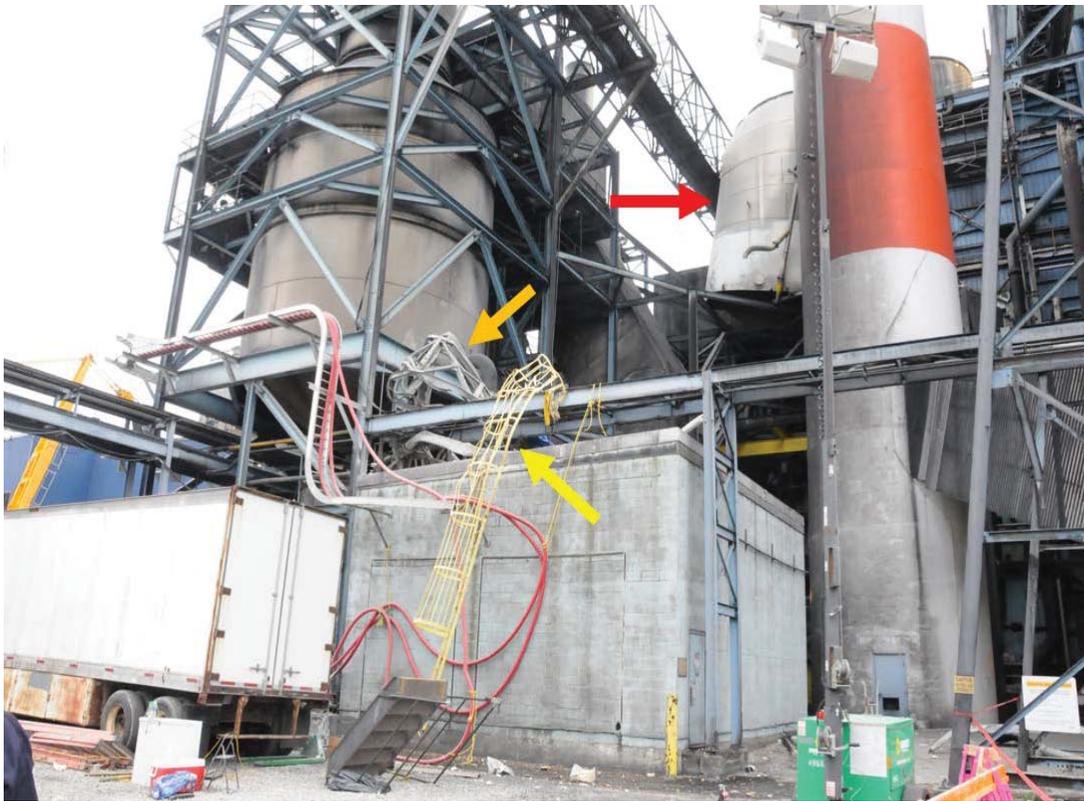
Figure 9. Post-Incident Photograph Showing the Location of the Foul Condensate Tank and Associated Structures. The foul condensate tank is indicated by the red arrow. The ladder previously attached to the tank is indicated by the yellow arrow. The pipe rack, which had previously been located above the tank, is indicated by the orange arrow. Photograph: CSB.

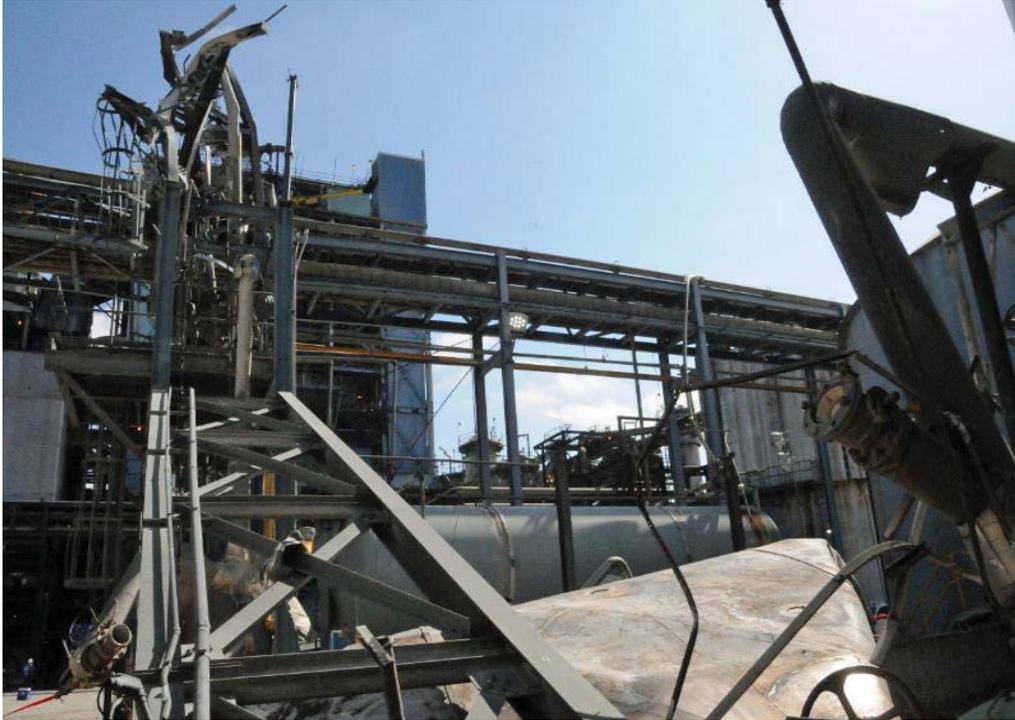
Figure 10. Photograph Showing Explosion Damage at the PCA DeRidder Mill in DeRidder, Louisiana. The bottom right corner of the photograph shows the foul condensate tank's base upside-down. The explosion separated the tank from its base. Photograph: CSB.

3. The explosion killed three people and injured seven others. All 10 workers were contractors working near the foul condensate tank. Their injuries included contusions and burns [10]. At least one contract worker had burns consistent with those caused by hot liquid.
4. The explosion damaged the pipe rack structure, its associated piping located above the tank (Figure 10), a work platform at the top of a powerhouse stack, and ductwork attached to the precipitator in the powerhouse area. Other areas of the mill also sustained damage.

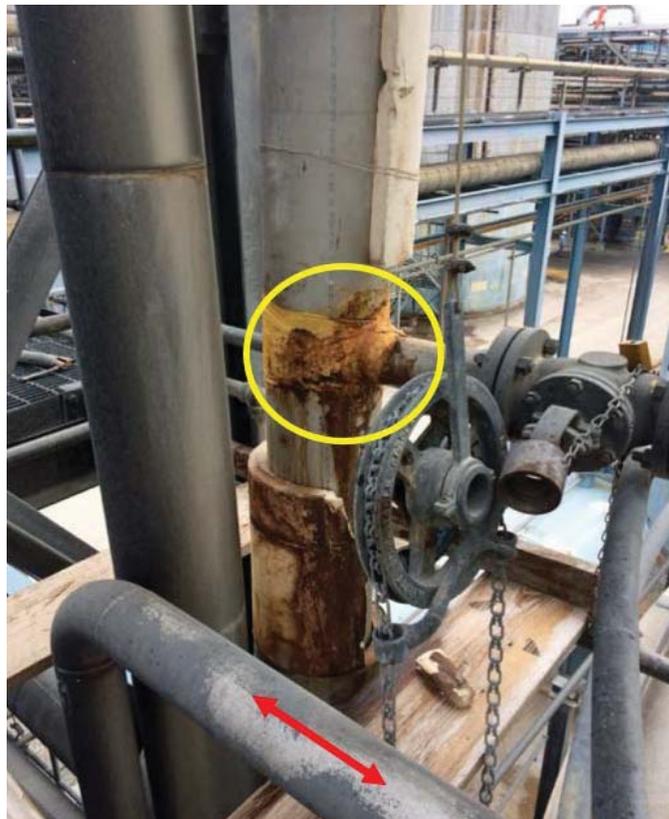
Figure 11. Pre-incident Photograph of the Cracked Three-inch Piping Connection on the Eight-inch Water Piping (yellow circle). This photograph shows a temporary repair to slow the leak, installed in October 2016. Witnesses stated that workers repaired this crack before the explosion. Workers disconnected the water piping from the valve (just to the right of the yellow circle) to create an air gap and to separate the repair area from the foul condensate tank. The red arrow shows the adjacent vent piping from the foul condensate tank to the CNGC system. The valve on the foul condensate side of the air gap, which was never located, was reportedly closed leading up to the incident. The vapor inside the foul condensate tank and the vent piping likely contained an explosive mixture of NCG and air when this repair work took place. Photograph: PCA.

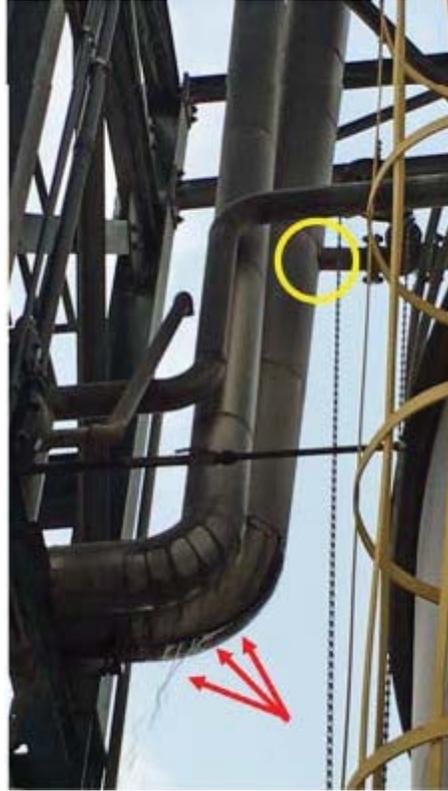
Figure 12. Pre-Incident Photograph of the Water Leak. The water piping (yellow circle) had cracked at the connection point between the eight-inch vertical water piping and the three-inch horizontal piping entering the foul condensate tank. Water was leaking from the crack (red arrows). Photograph: PCA.

- There were no known risks among mill personnel of leaving liquid in the tank.
 - The company did not have plans to work directly on the tank during the outage.
 - There were resource limitations as mill staff had numerous other tasks to complete during the annual outage.
8. During the outage, there was no planned or actual work directly on the foul condensate tank. However, work was planned on water piping located above the foul condensate tank. Months earlier, that piping shifted off its supports and cracked at the intersection of an eight-inch line and a three-inch line that was connected to the foul condensate tank (**Figure 11**), resulting in a significant leak that was visible in a pre-incident video taken by a mill employee who planned the repair work (**Figure 12**).

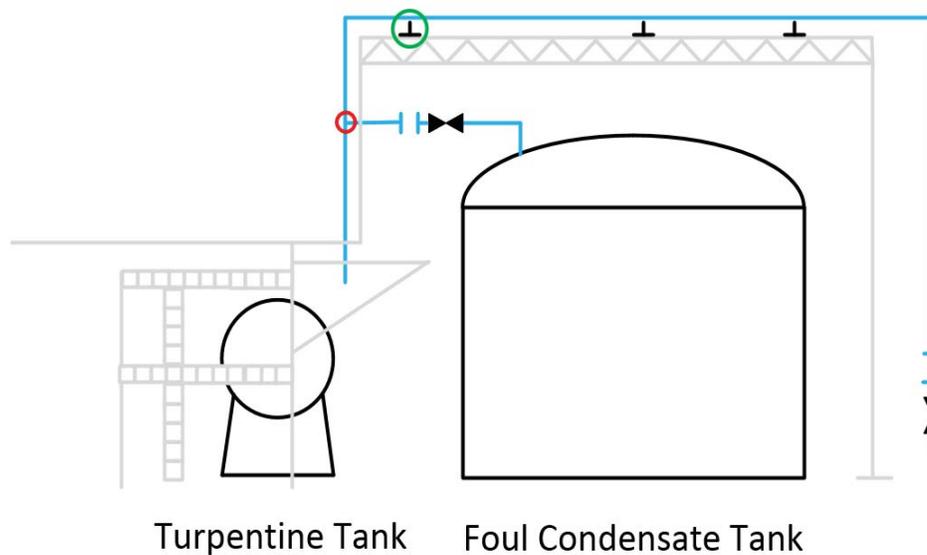
Figure 13. Simplified Drawing of the Scope of Work Conducted on the Water Piping. The scope of work on the water piping required three tasks: (1) disconnect and move water piping back onto its piping rack, (2) fix a crack in the water piping at the intersection of the three-inch line that connected to the foul condensate tank (smaller red circle), and (3) weld a guide onto the piping rack to prevent the water piping from slipping off of the pipe rack in the future (larger green circle).

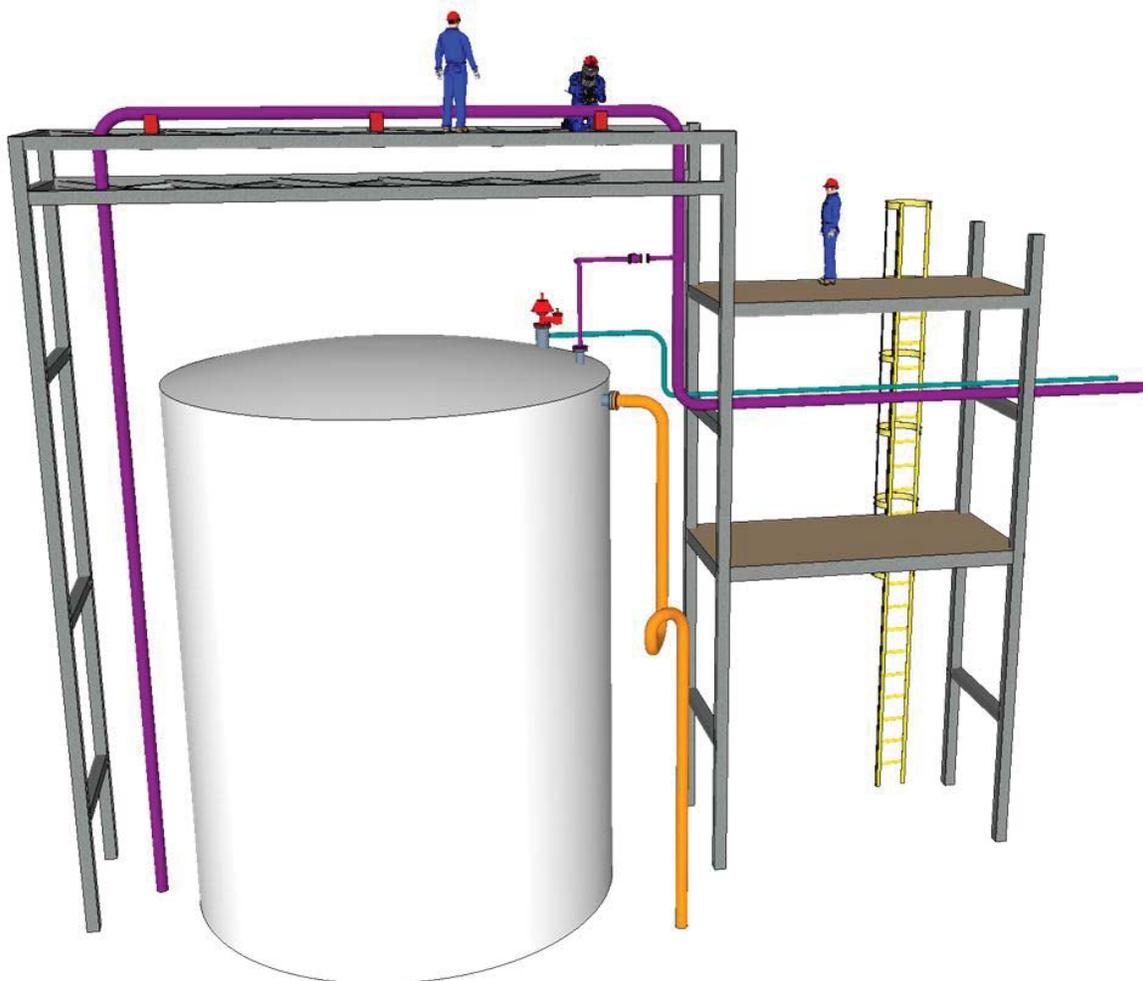
Figure 14. Simplified Drawing of the Work on Water Piping Just Prior to the February 8, 2017 Incident. The location of the workers is approximate and is based on witness interviews. The water piping is indicated by the purple line running over the foul condensate tank. The guides on the pipe rack are in red and sit on top of the pipe rack. The pressure vacuum breaker and the NCG piping are indicated by the red device on top of the tank and the turquoise line, respectively. Although not shown, workers wore appropriate protective equipment, including fall protection. Source: CSB.

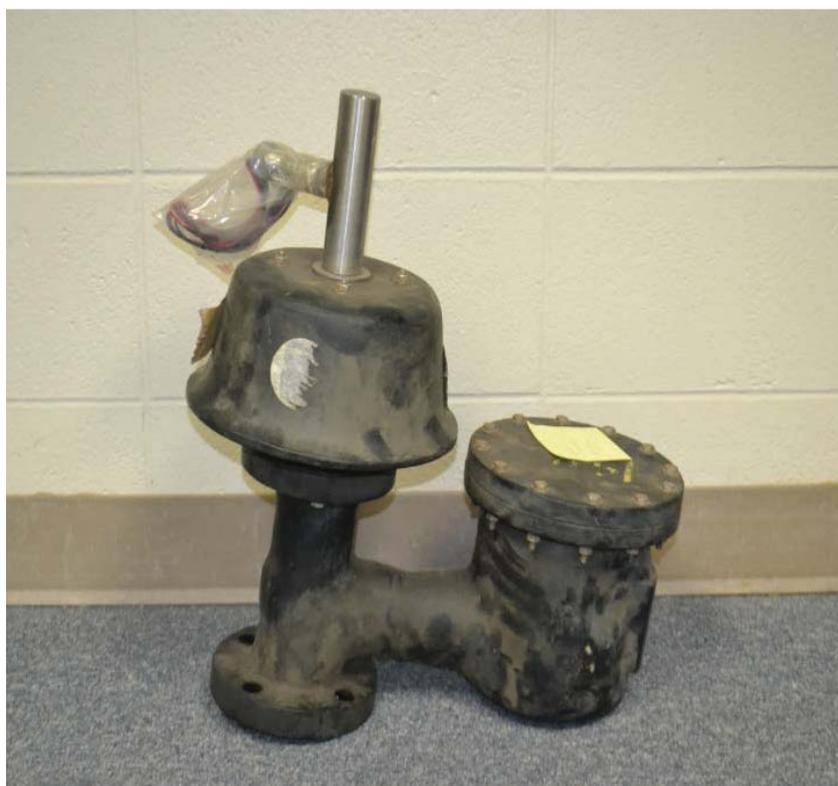
Figure 15. Photograph of a Spare Pressure Vacuum Breaker for the CNG System at the DeRidder Mill. If the foul condensate tank experiences high-pressure (six-inches of water), the left-hand portion of the pressure vacuum breaker opens and releases vapor to the atmosphere. If the tank experiences low-pressure (minus six-inches of water), the portion of the pressure vacuum breaker extending to the right will open and pull air into the tank.^b Photograph: CSB.

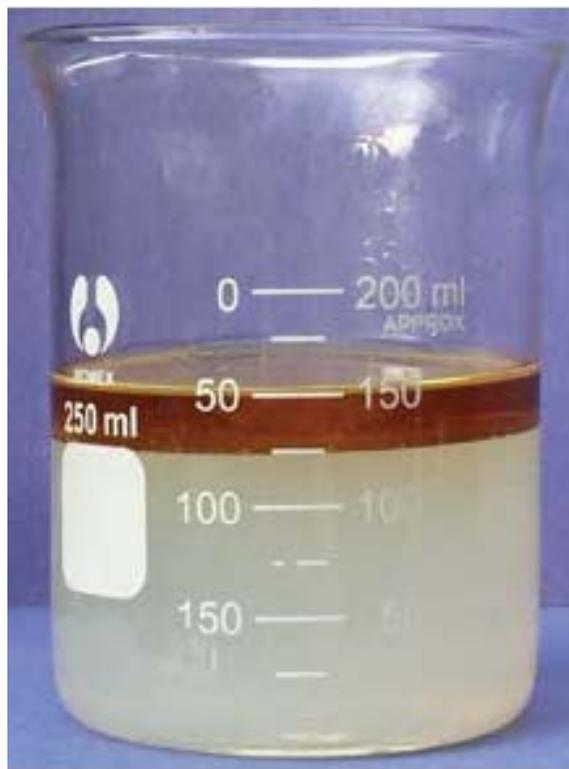
Figure 16. Photograph of Immiscible Oil Layer on Top of Water. This photograph shows how oil forms an immiscible liquid layer on top of water similar to how a turpentine layer might appear inside the foul condensate tank. Photograph: CSB.

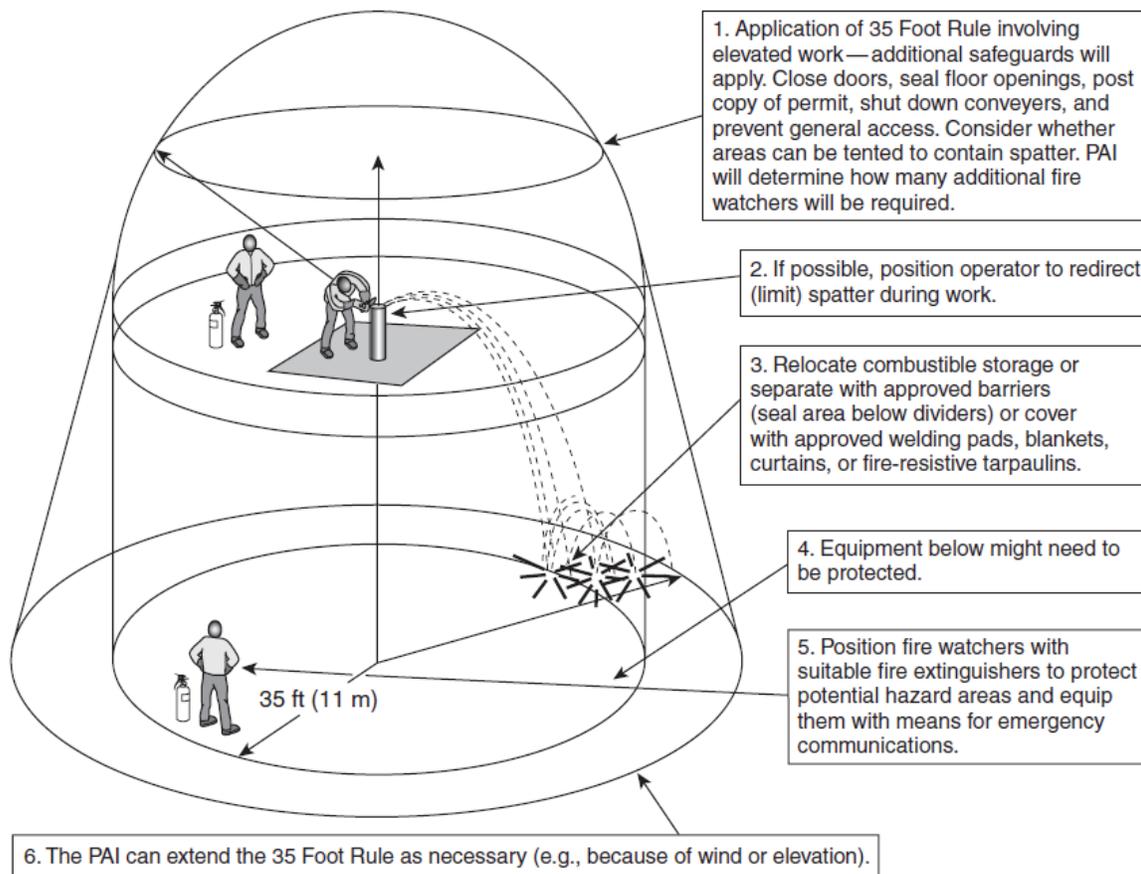
Figure 18. Illustration of the 35 Foot Rule Applied to Elevated Work. NFPA uses the initialism PAI for Permit Authorizing Individual – to indicate the individual designated by management to authorize hot work. Diagram: NFPA.

If the hot work is done at an elevation, as was the case at the DeRidder mill, the 35 Foot Rule's radius can be enlarged (**Figure 18**) [11, p. 13].

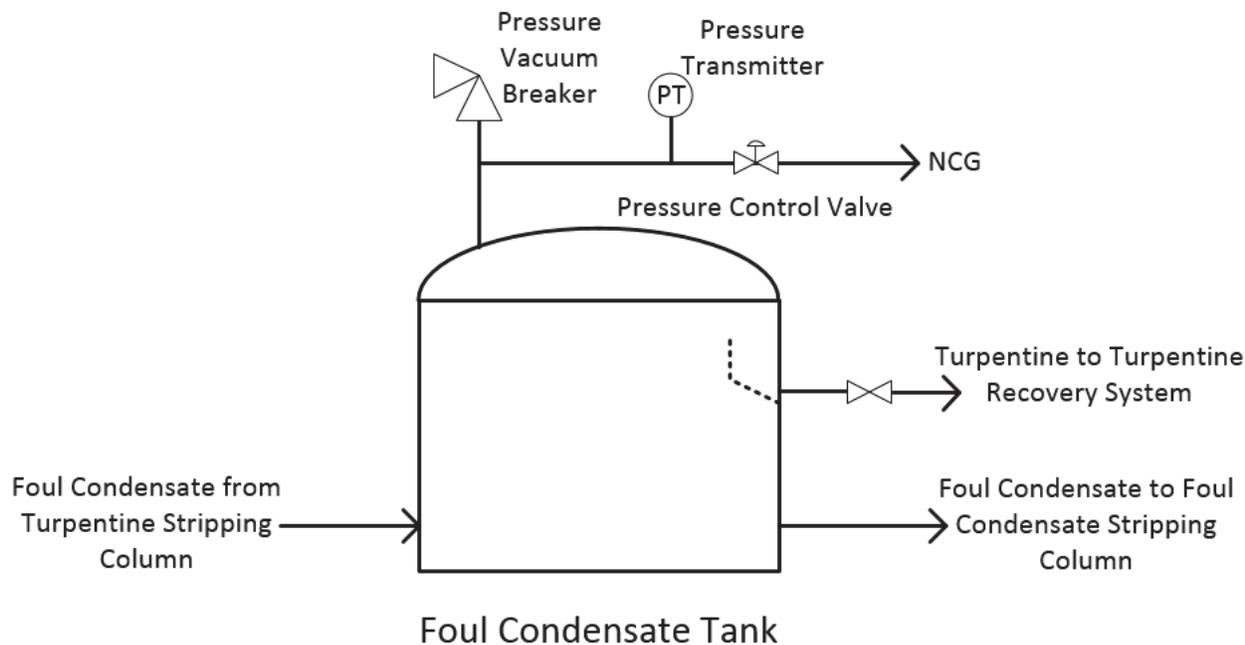
Figure 19. Simplified Drawing of the Weir Within the Foul Condensate Tank. The weir is indicated by the dotted line. The top of the weir sits approximately 20 feet from the base of the foul condensate tank. As the liquid inside the tank rises above 20 feet, liquid is “skimmed” into the weir and sent to a turpentine recovery system.

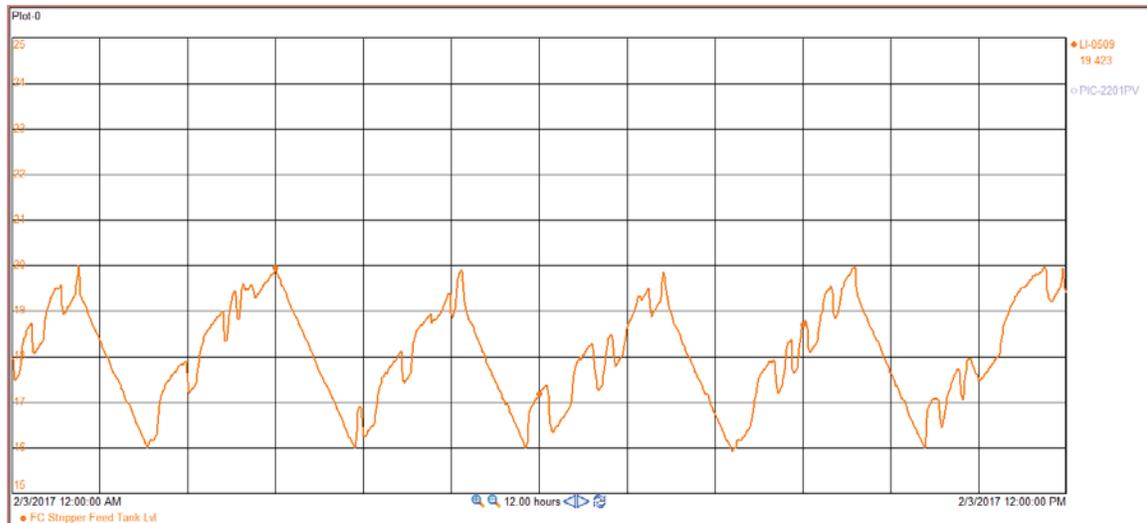
Figure 20. Plot of the Foul Condensate Tank Level Showing the Typical Cycle to Skim Turpentine by Using the Tank’s Internal Weir. The tank level has a range of 15 to 25 feet of liquid. Automatic controls were installed to cycle the tank level from 16 to 20 feet to skim turpentine into the tank weir system.

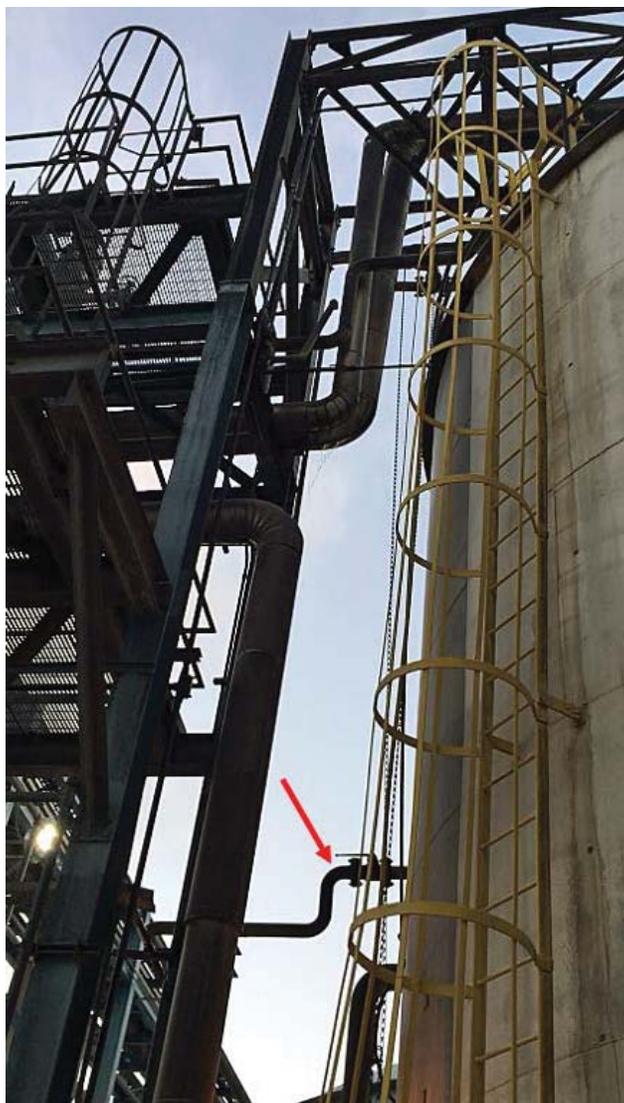
Figure 22. Pre-Incident Photograph of the Foul Condensate Tank. The line from the weir inside the tank to the turpentine recovery system is indicated by the red arrow. The valve at the foul condensate tank is kept open, but the valve at the turpentine recovery system (**Figure 21**) is kept closed. Photograph: PCA.

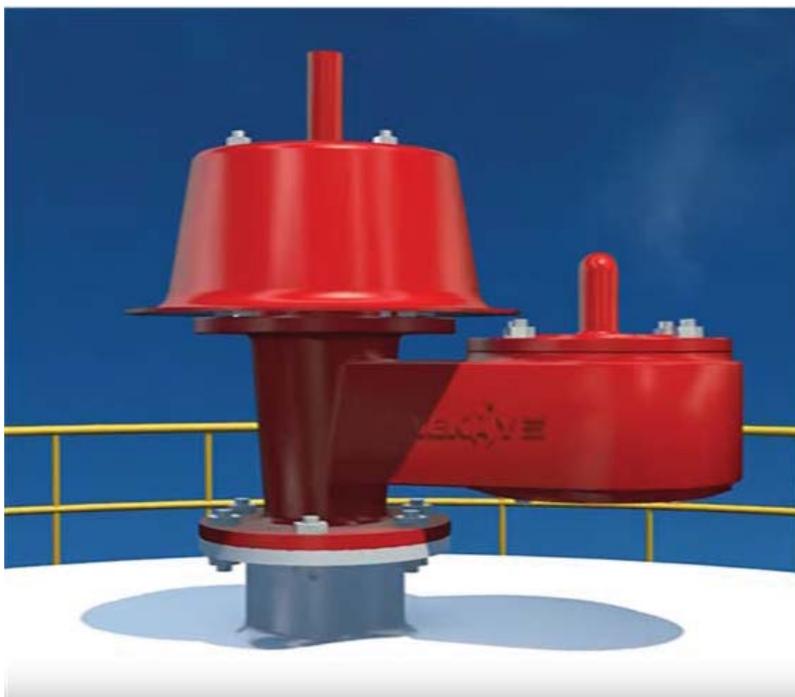
Figure 23. Image of a Pressure Vacuum Breaker. If the vessel experiences an over pressure event, the top portion of the pressure vacuum breaker releases to the atmosphere. If the vessel experiences an under pressure event, the portion of the pressure vacuum breaker extending to the right will pull air into the vessel. Photograph: Finekay [12].

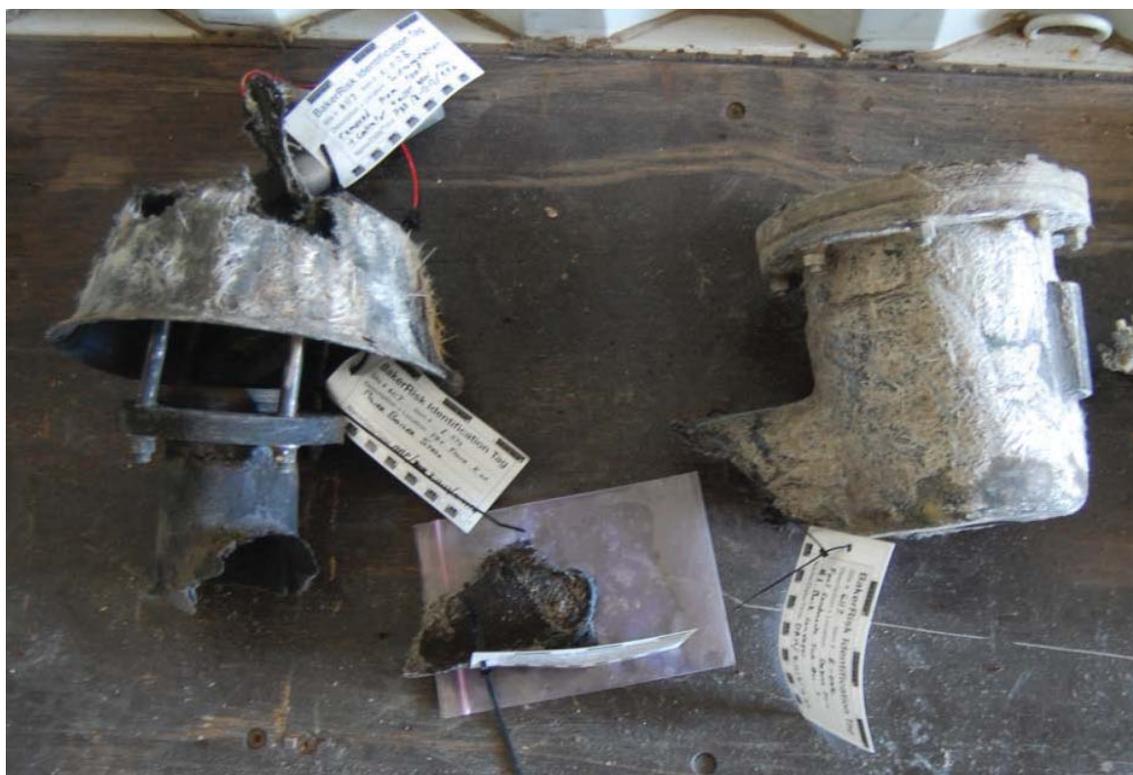
Figure 24. Post-Incident Pressure Vacuum Breaker. The foul condensate tank's pressure vacuum breaker is shown post-incident. Photograph: PCA.

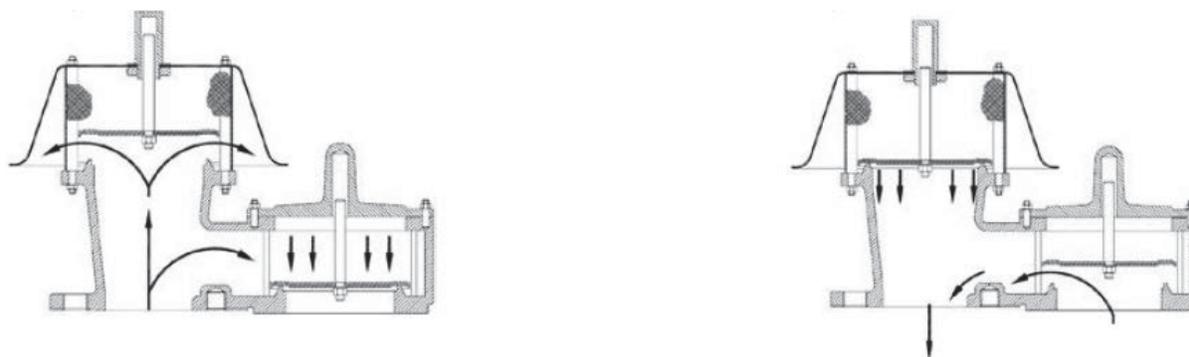
Figure 25. Relief/Protection Functions of the Pressure Vacuum Breaker. The image at the left shows that as pressure in the vessel increases, a pressure pallet lifts and relieves tank pressure to the atmosphere. The image at the right shows that as a vacuum is drawn into the vessel, the vacuum pallet lifts and air is drawn into the vessel from the atmosphere. Image: Groth Corporation [13].

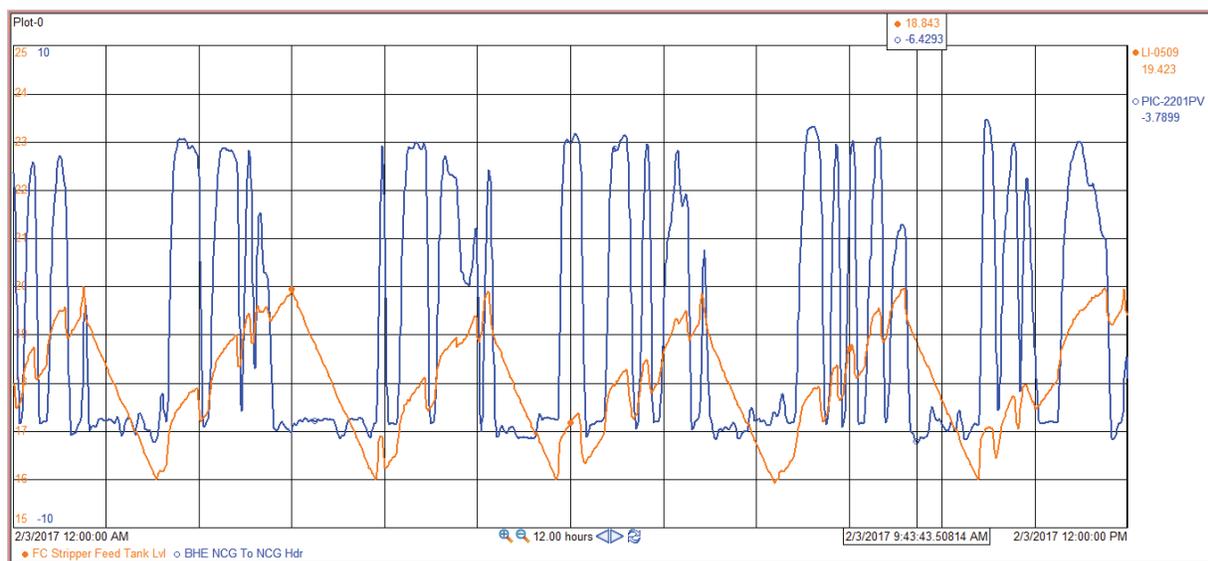
Figure 26. Process Data Trend Showing Typical Pressure and Level of the Foul Condensate Tank During Operation. The tank level is shown by the orange trend line with a range of 15 to 25 feet of liquid. The tank pressure is represented by the blue trend line and ranges from approximately - six to + six inches of water, which are the set pressures of the pressure vacuum breaker (the limits of the graph are 10 inches of water vacuum to 10 inches of water pressure).^b

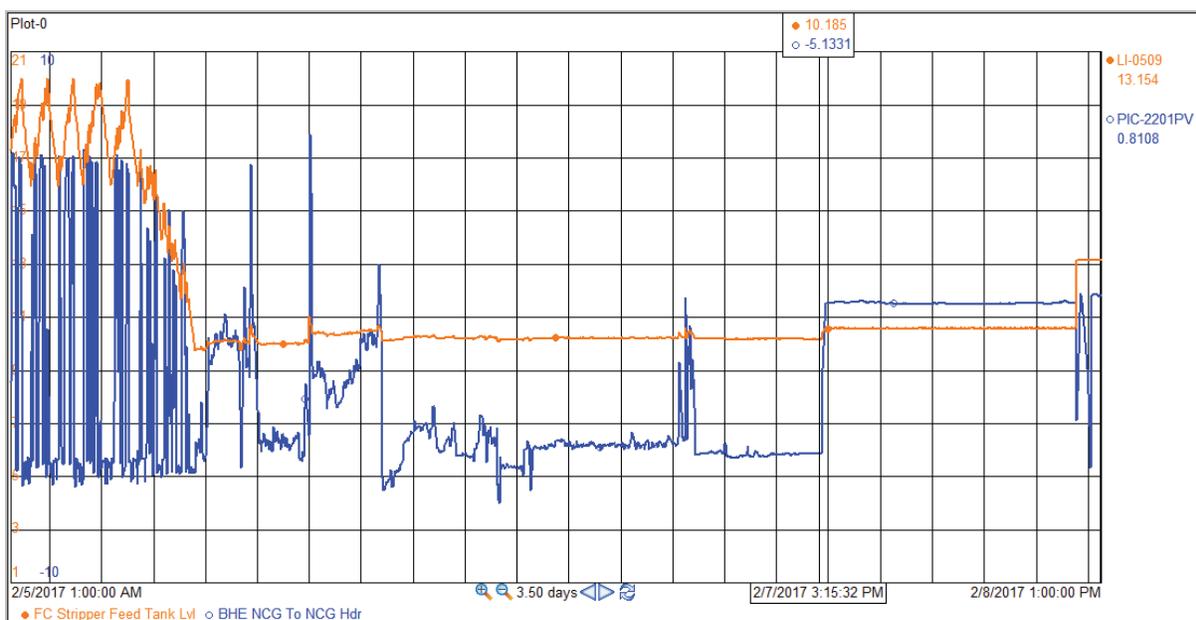
Figure 27. Process Data Trend Showing the Foul Condensate Tank Pressure and Level. These process data trend lines show the foul condensate tank pressure (blue) and level (orange) from just before the outage (while the tank level was still cycling from 20 to 16 feet), to just after the explosion. In this trend, the range of the foul condensate tank level is 1 to 21 feet, and the range of the foul condensate tank pressure is from minus (-) 10 to 10 inches of water. This trend graph shows that PCA shut off the vacuum ejectors on February 7 after 3:15 pm.

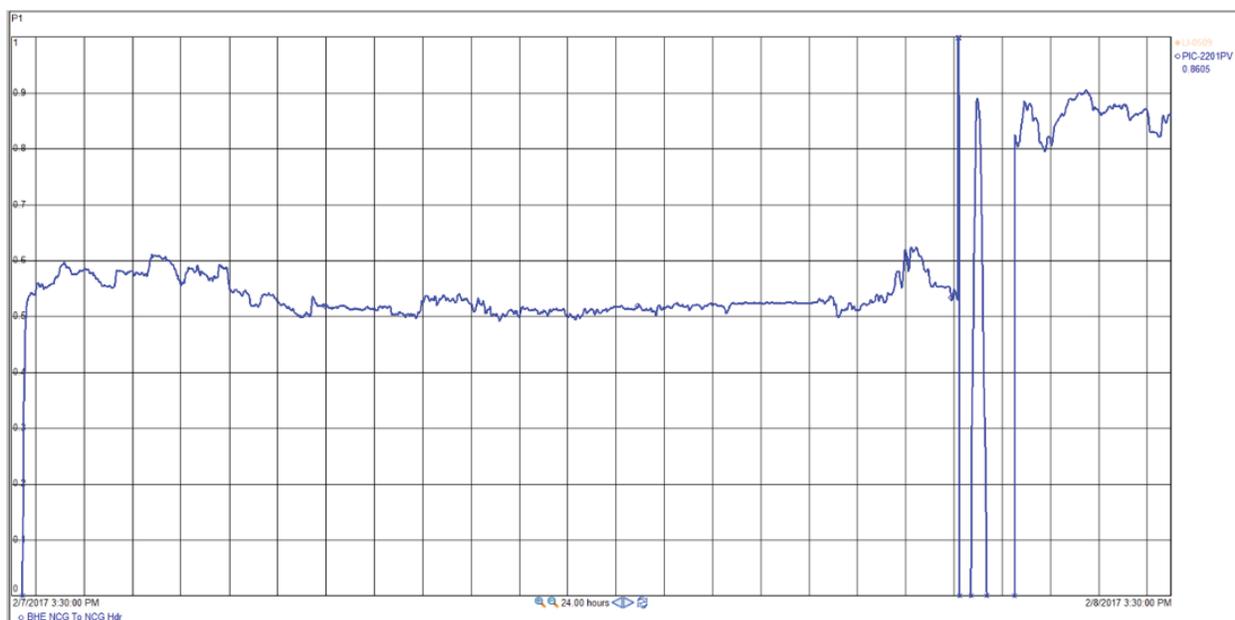
Figure 28. Process Data Trend Showing the Foul Condensate Tank Pressure With the Vacuum Ejector System Off. These data show that when the ejector system was at atmospheric pressure, the foul condensate tank pressure indicated a positive pressure of 0.5 to 0.6 inches of water. After the explosion (right portion of the trend graph), the foul condensate tank pressure indicated a positive pressure of 0.8 to 0.9 inches of water. The slight positive pressure shown is likely due to the calibration of the pressure instrument and the damage from the explosion. With the tank cooling and the ejector system open to the atmosphere, it is unlikely that the pressure was actually above that of the atmospheric conditions.

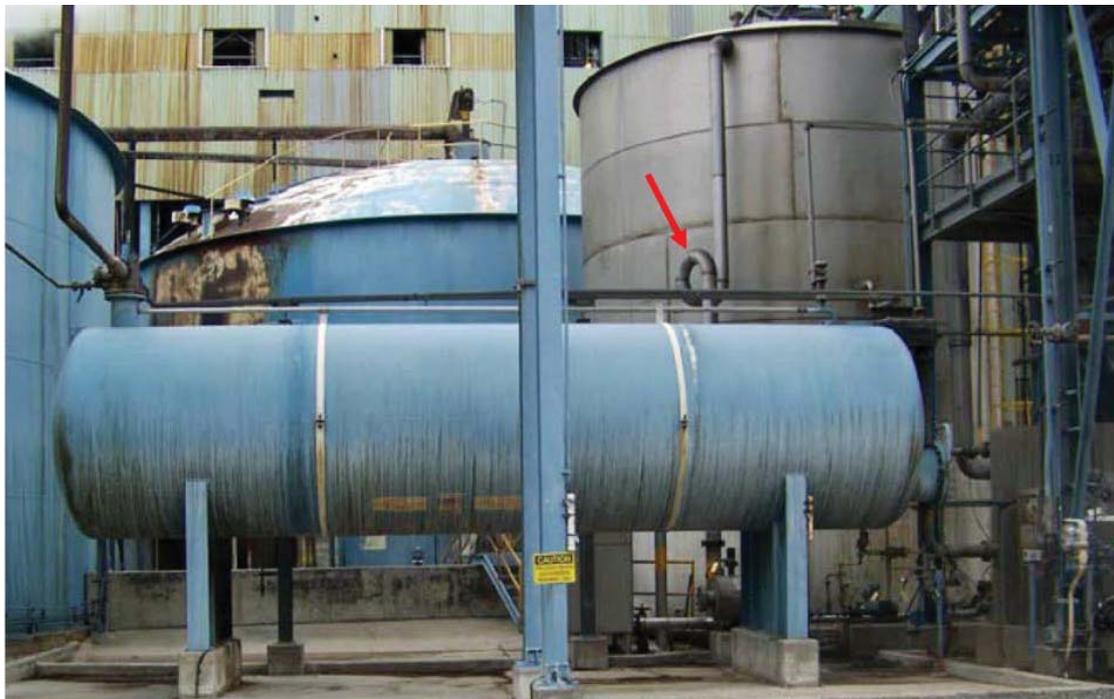
Figure 29. Pre-Incident Photograph Showing Overflow Seal Leg. This pre-incident photograph shows the overflow seal leg on the foul condensate tank (red arrow). Photograph: PCA.

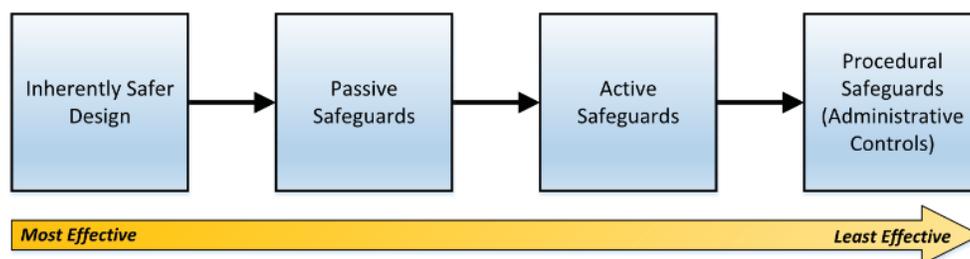
Figure 32. Hierarchy of Controls. When a control is higher in the hierarchy (i.e., further to the left), more effective risk reduction is achieved.

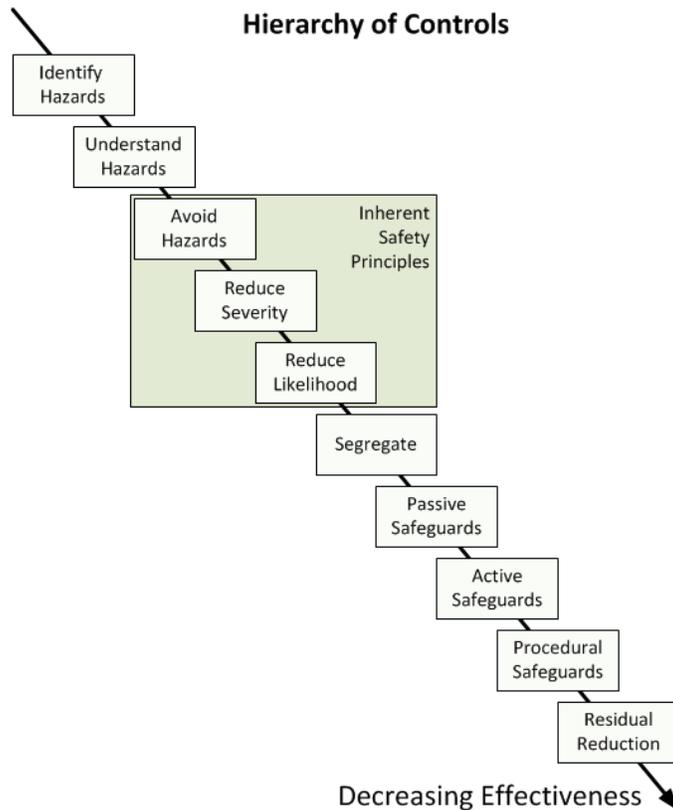
Figure 33. Inherent Safety Principles. The boxes in this graphic reflect the hierarchy of safer controls, from eliminating hazards (near the top left) through personal protective equipment (at the bottom right). Source: Kletz, Trevor; Amyotte, Paul [22].

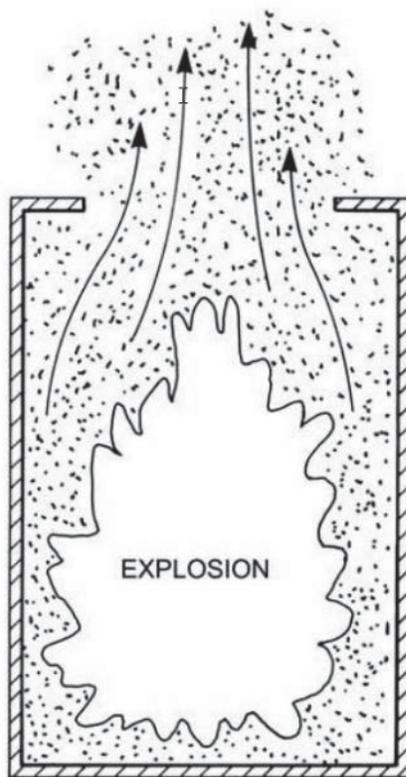
Figure 34. Explosion Venting. This illustration demonstrates deflagration venting. Source: Eckhoff, Rolf K [34, p. 141]
