U.S. Chemical Safety and Hazard Investigation Board

Investigation Report

Non-Condensable Gas System Explosion at PCA DeRidder Paper Mill

DeRidder, Louisiana

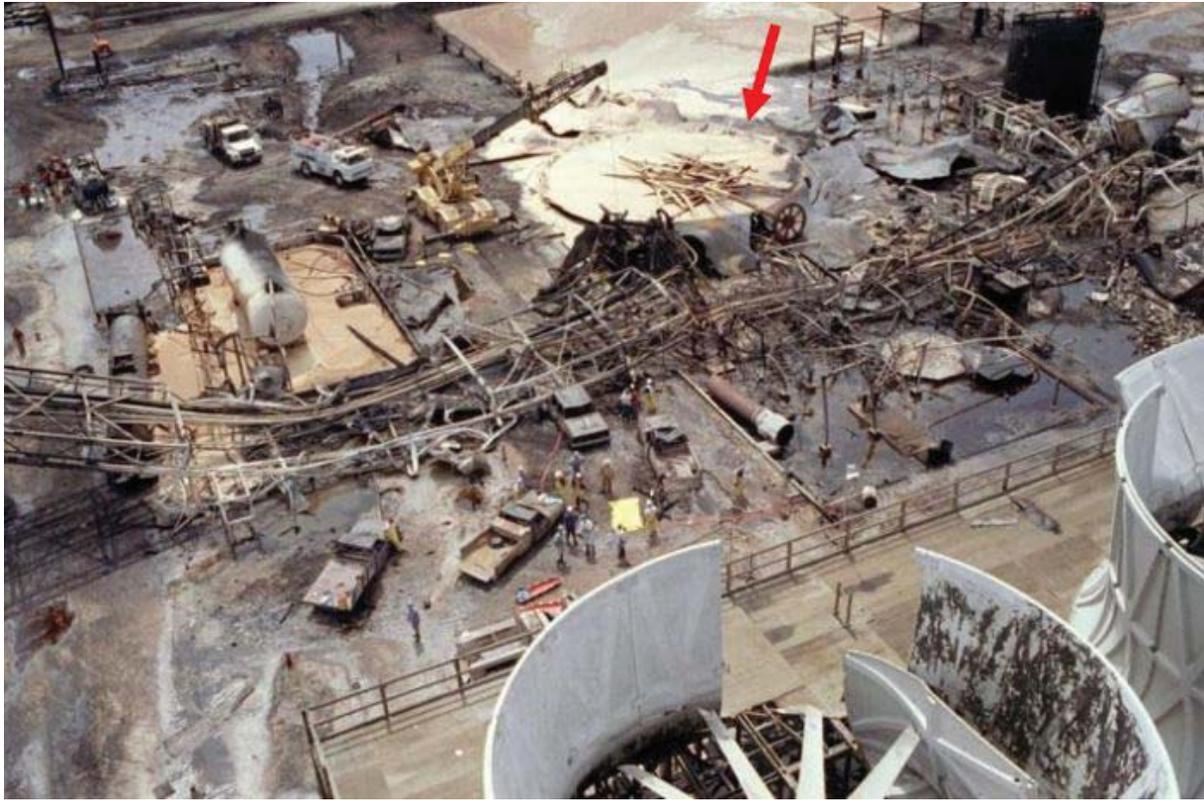
Figure 36. Post-Incident Photograph of the July 1990 Explosion at the ARCO Chemical Facility in Channelview, Texas. The location of the wastewater storage tank is indicated by the red arrow. Photograph credit: [41].

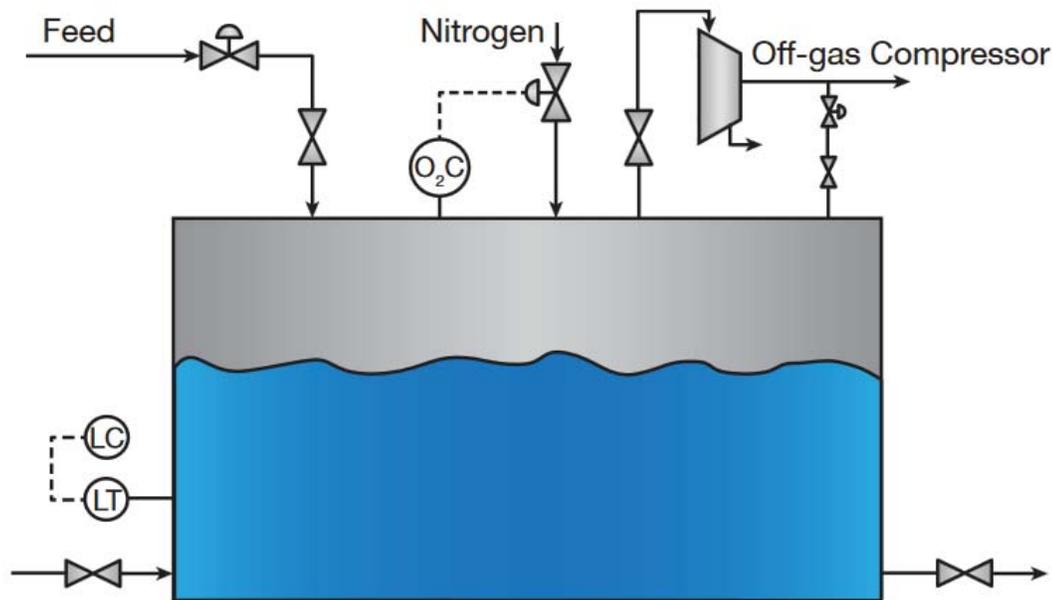
Figure 37. ARCO Chemical Wastewater Tank. “The 900,000-gallon wastewater tank had a nitrogen purge to keep the vapor space inert and an off-gas compressor to draw off hydrocarbon vapors before waste disposal.” Credit: [42].

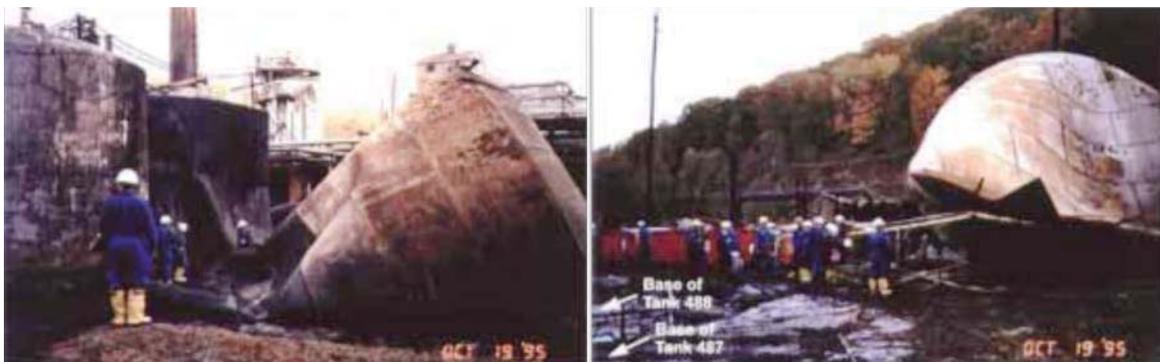
Figure 38. Photographs from the Pennzoil Refinery. These post-incident photographs show the October 1995 explosion at the Pennzoil refinery in Rouseville, Pennsylvania. Photograph credit: [43].

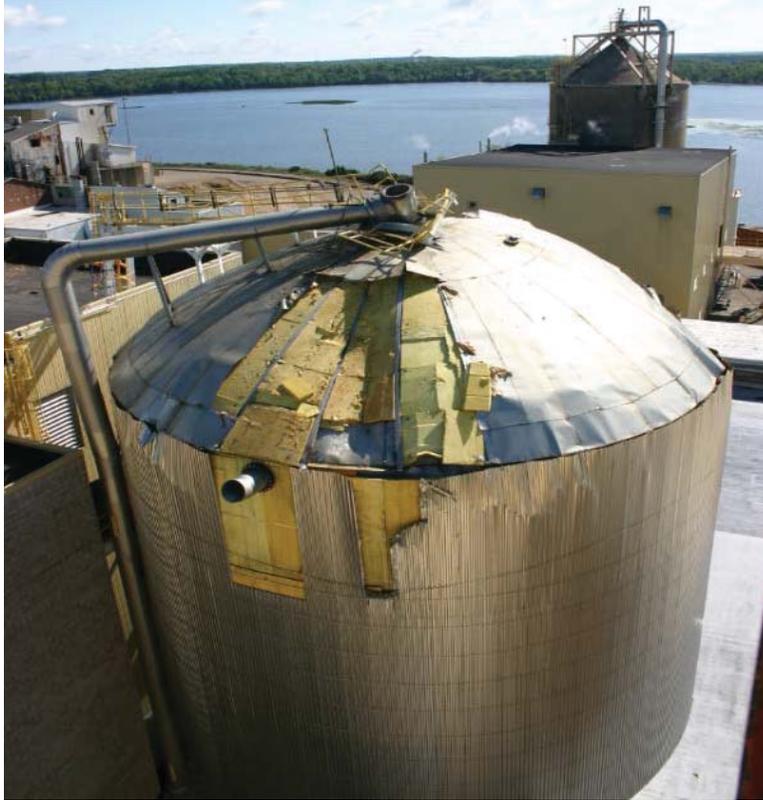
Figure 39. Post-Incident Photograph at the PCA Tomahawk Mill. This photograph shows the post-incident storage tank at the PCA Tomahawk mill in 2008. Photograph: CSB.

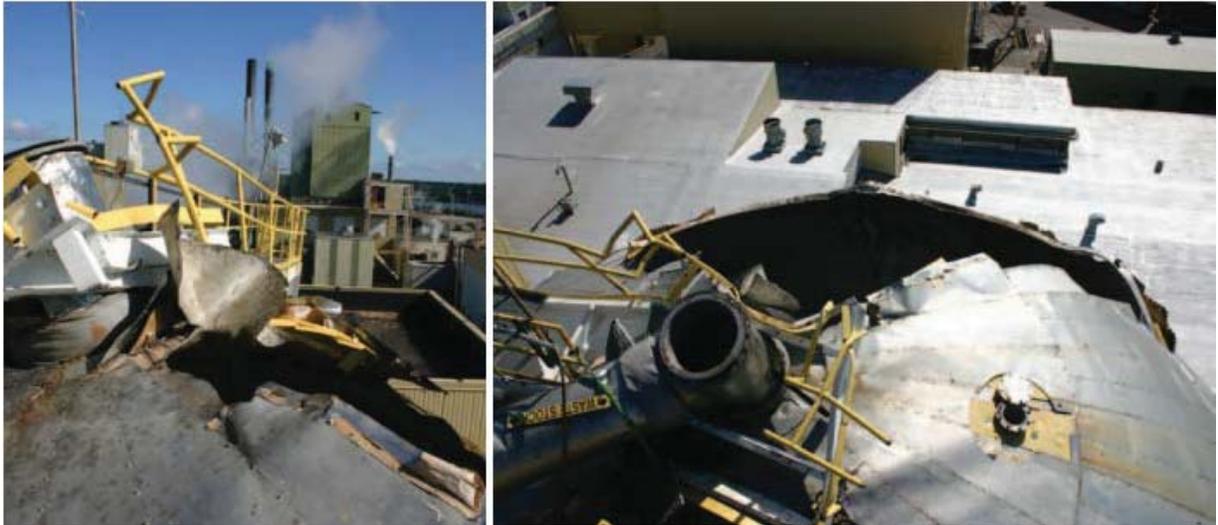
Figure 40. Post-Incident Photographs from the PCA Tomahawk Mill. These photographs show views of the top of the storage tank involved in the 2008 explosion at the PCA Tomahawk mill. Photograph: CSB.

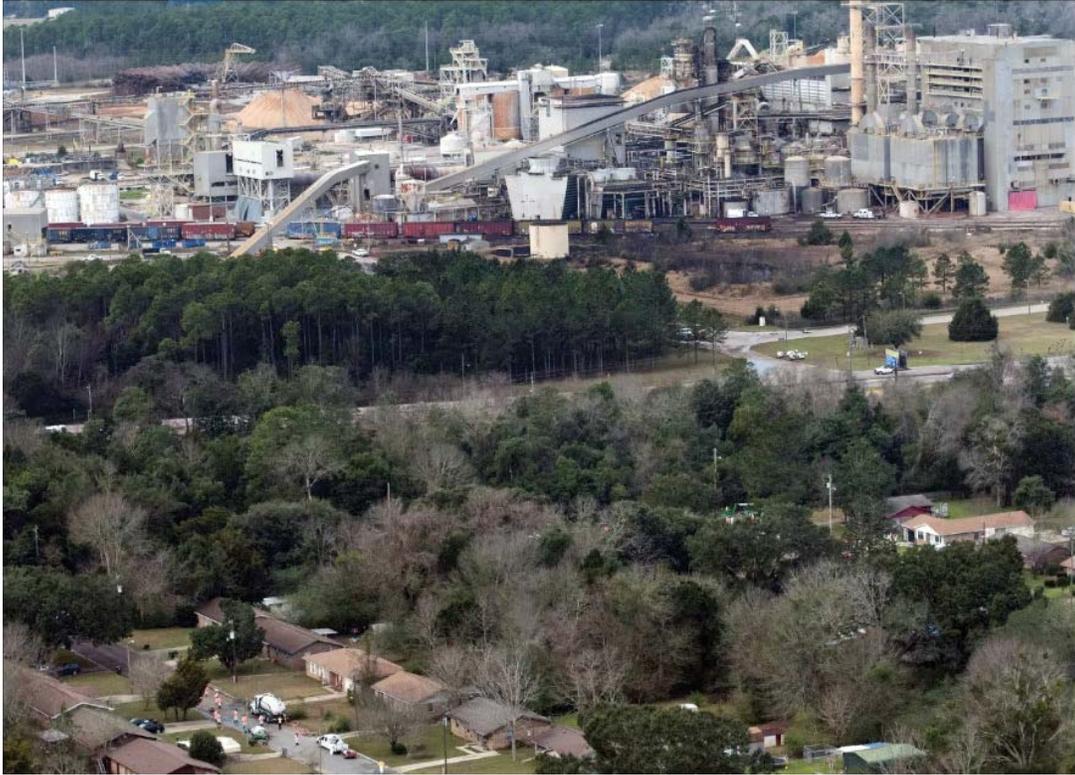
Figure 41. Post-Incident Photograph of the International Paper Pensacola Mill in Relation to Adjacent Neighborhoods. Clean-up crews can be seen in the neighborhood at the bottom left of the photograph. Photograph: Pensacola News Journal [48].

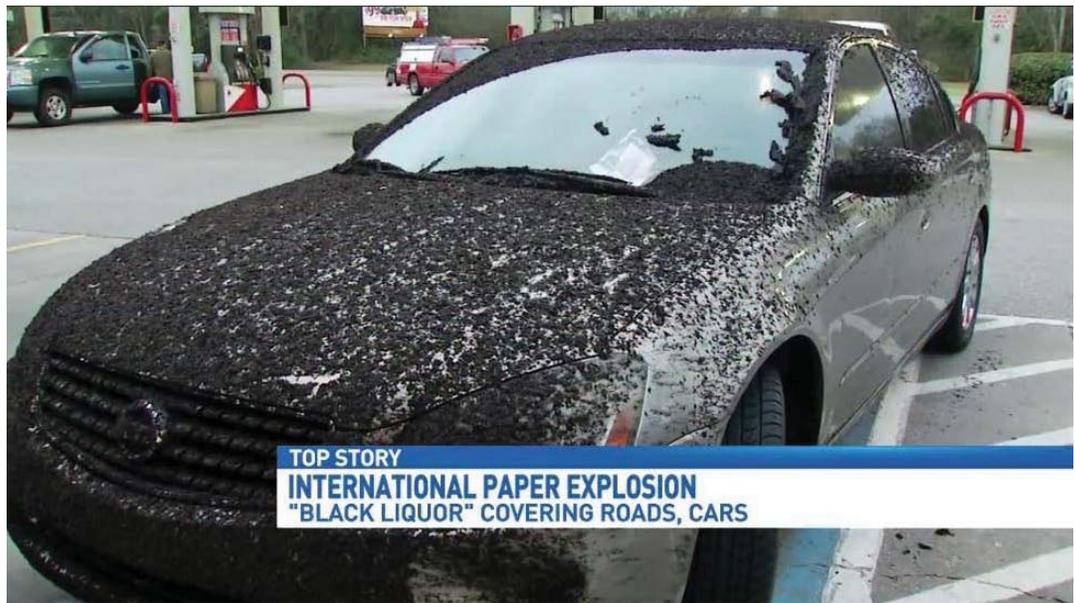
Figure 42. Post-Incident Photograph of Debris on a Car. This photograph shows a car covered with process chemicals that were released when a digester at the Pensacola mill exploded on January 22, 2017. Photograph: WEAR Television [51].

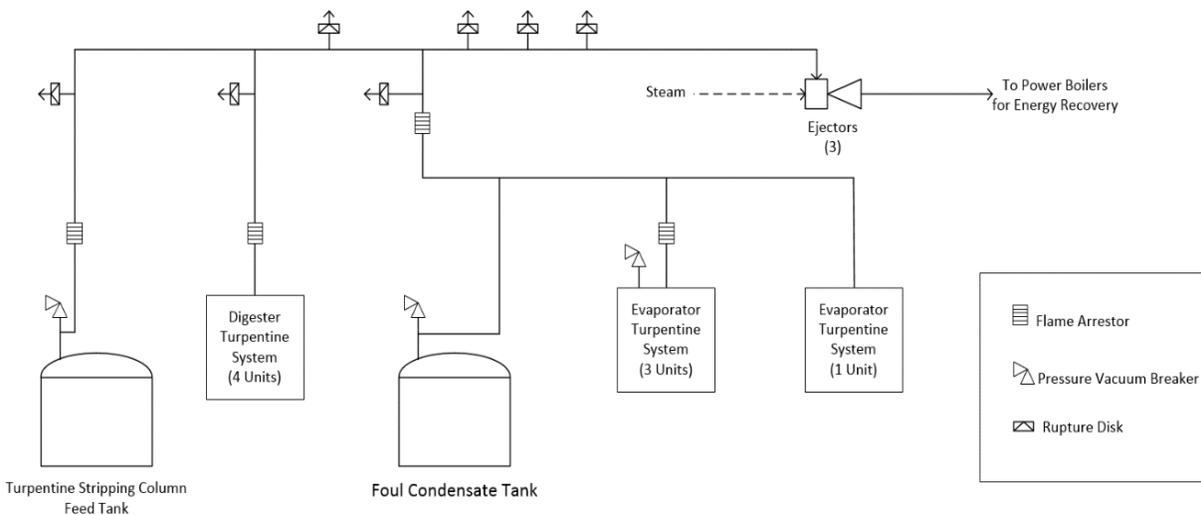
Figure 43. Simplified Flow Diagram of the CNCG System Showing the Interconnection Between the Foul Condensate Tank and the Turpentine System. The turpentine system is composed of the evaporator turpentine system, and the digester turpentine system.

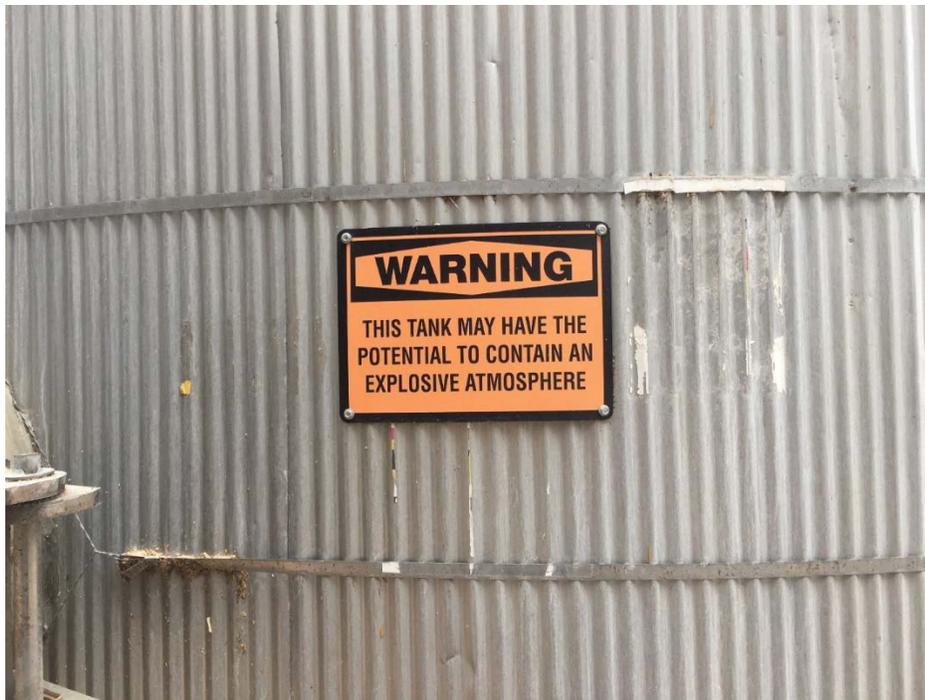
Figure 44. Post-Incident Warning Label. This warning label is intended to inform personnel of the potential hazards associated with a flammable atmosphere inside a vessel. Photograph: PCA.

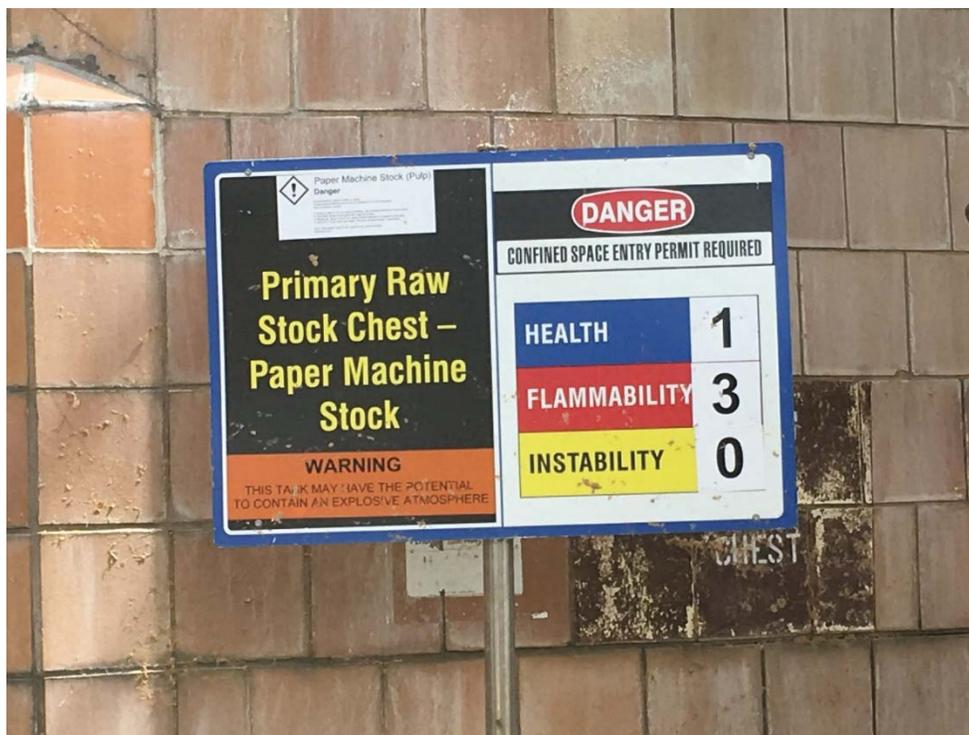
Figure 45. Post-Incident Danger Label. This label is intended to warn mill personnel of the hazards associated with a potential flammable atmosphere inside a vessel. Photograph: PCA.

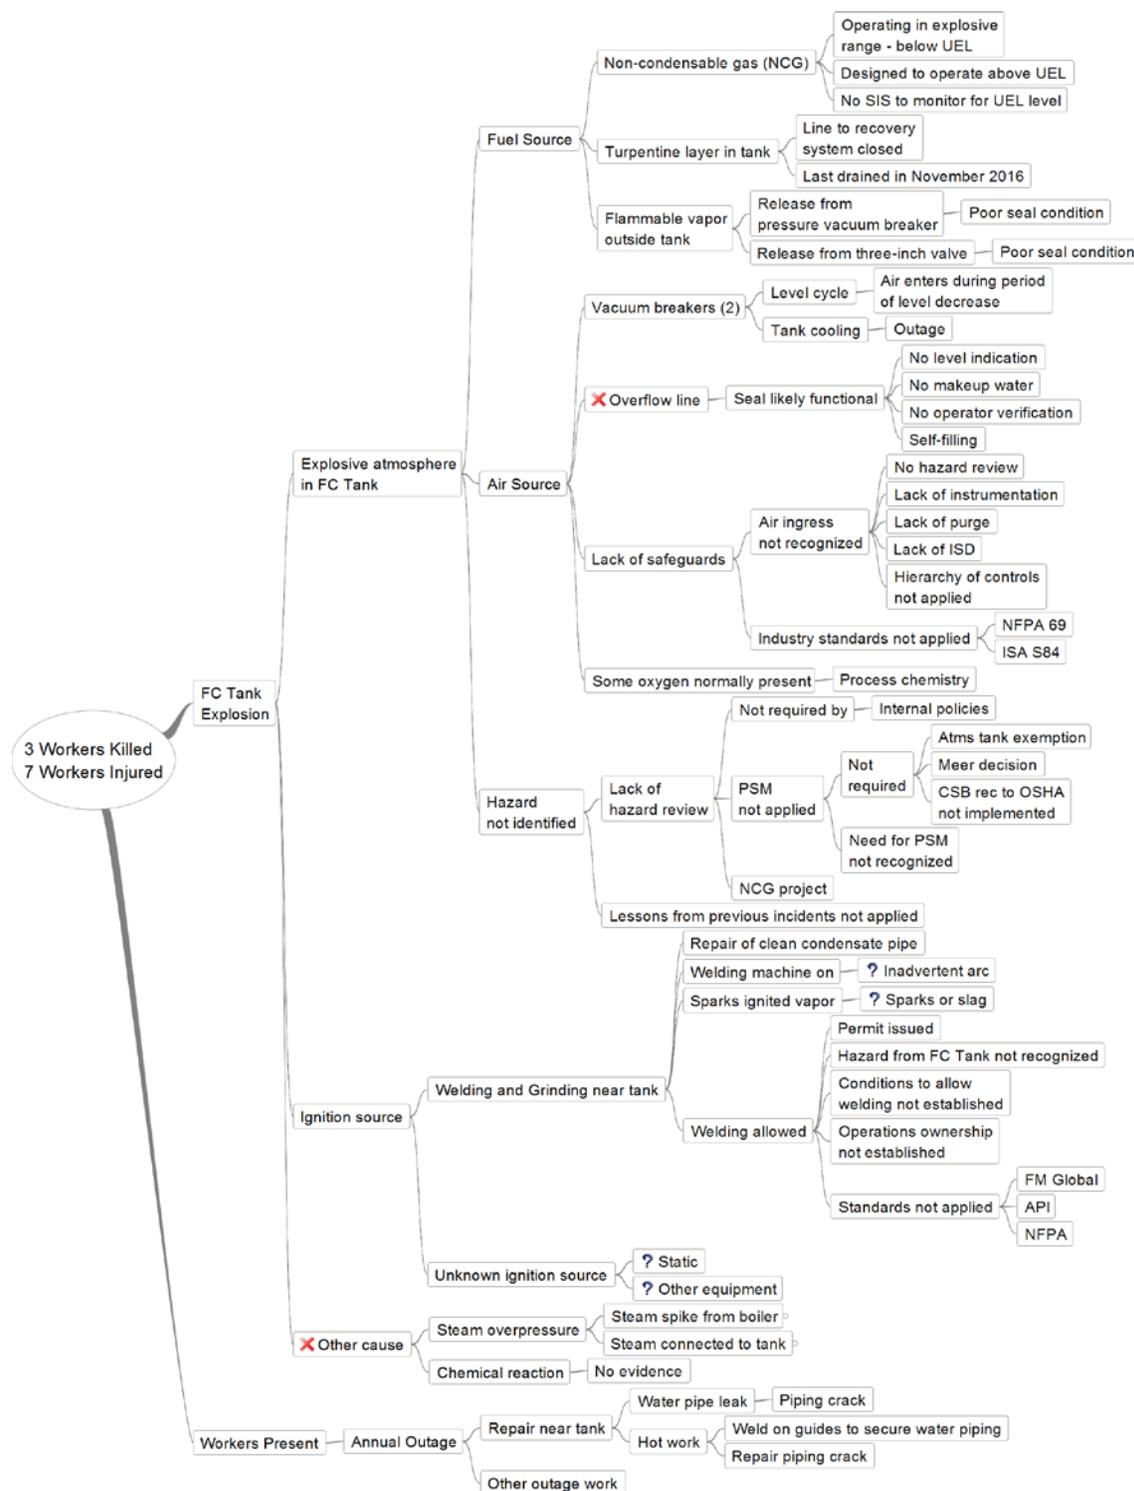
Figure 46. Simplified Causal Analysis Diagram. This diagram shows a simplified causal analysis of the February 8, 2017 incident at the Packaging Corporation of America facility in DeRidder, Louisiana.
