Hazardous Nitrogen Oxides (NO_x) Releases at Austin Powder Facilities

Midway, Tennessee | McArthur, Ohio |

No. 2025-OH-I-01

Investigation Update

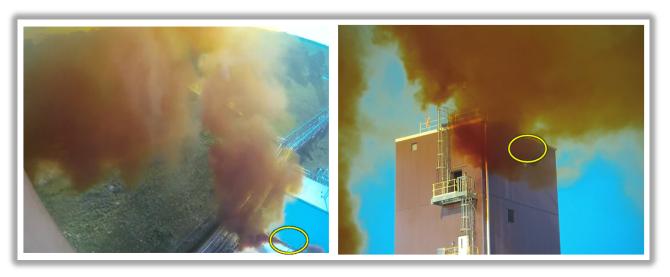
Figure 5. NO_x release approximately one hour into the event (9:15 a.m.). The emergency pressure relief valve discharge (left) and absorber column vent (right) are circled. (Credit: Austin Powder, annotated by CSB)

- The visible NO_x release continued through the morning (**Figure 5**), until approximately 11:25 a.m., when employees were able to get the absorber column back in service. The absorber column then began treating the acid vapors, which stopped the visible emissions to the atmosphere.

- On the day of the incident, because the floor in the PETN control room was being resurfaced, the control room operators moved to a different room nearby, where they were unable to continuously monitor the acid tank farm and the video provided by security cameras, such as the images shown above in **Figure 4** and **Figure 5**. This contributed to the delayed discovery of the release.
