Combustible Dust Explosion

- > **Incident Date: January 29, 2003**
- > **Kinston, North Carolina**
- > **6 Killed, 38 Injured**
- > [Full Report on CSB Website](#)

SAFETY DIGEST

U.S. Chemical Safety and Hazard Investigation Board

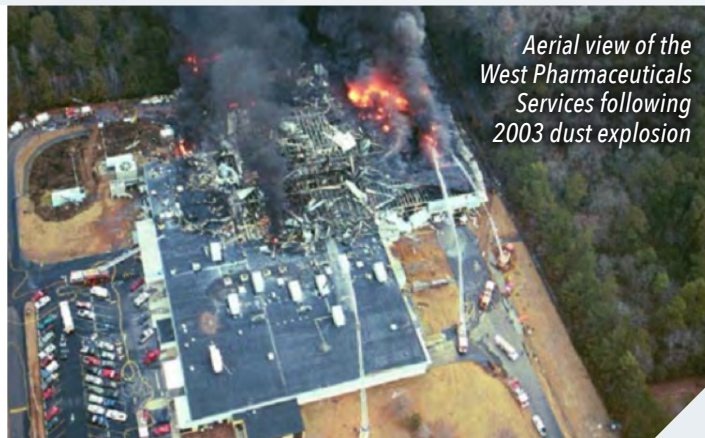
*Aerial view of the
West Pharmaceuticals
Services following
2003 dust explosion*

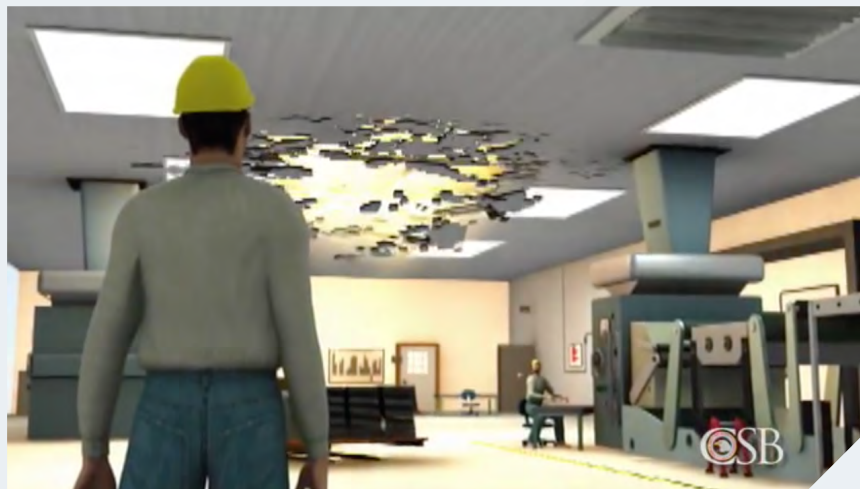
Animation still from the CSB's Safety Video *Combustible Dust: An Insidious Hazard*

rubber dispersed dust throughout the work area. The unsealed acoustic tile ceiling allowed large amounts of dust to accumulate in concealed areas that were difficult to clean. The electrical fixtures and wiring in the production area were general-purpose and not rated for use around combustible dust.
