Investigation Report

SAFETY ISSUES:

- Two-phase Atmospheric Relief
- Discharging to a Safe Location
- Emergency Preparedness

U.S. Chemical Safety and Hazard Investigation Board

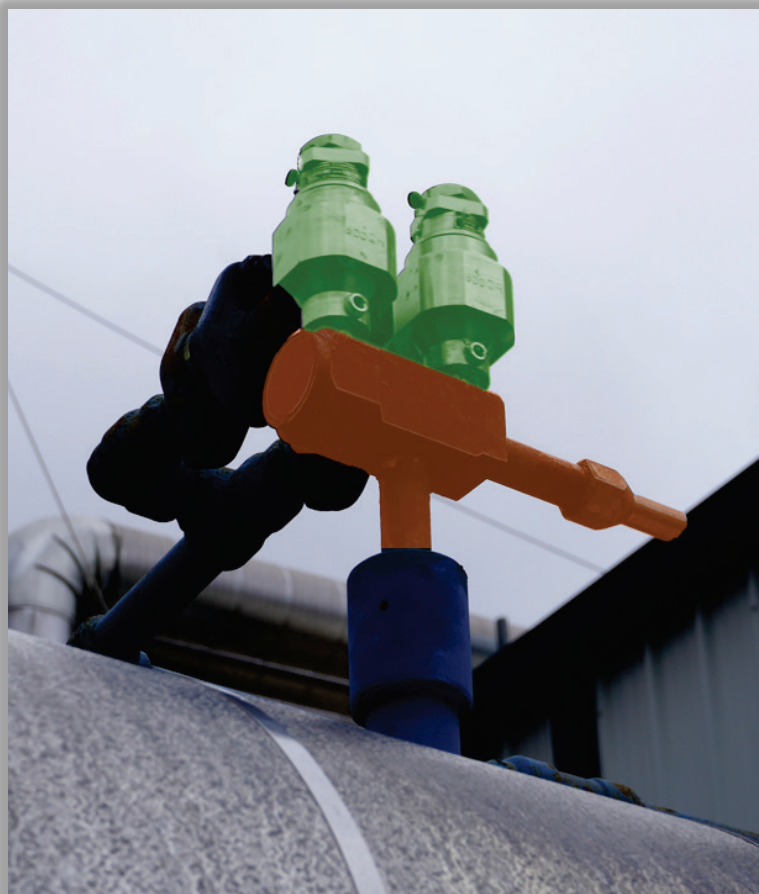
Figure 6: Emergency pressure relief valve assembly for a surge drum in Tank Farm 5, including two emergency pressure relief valves (green) and the three-way selector valve (orange). (Credit: CSB)

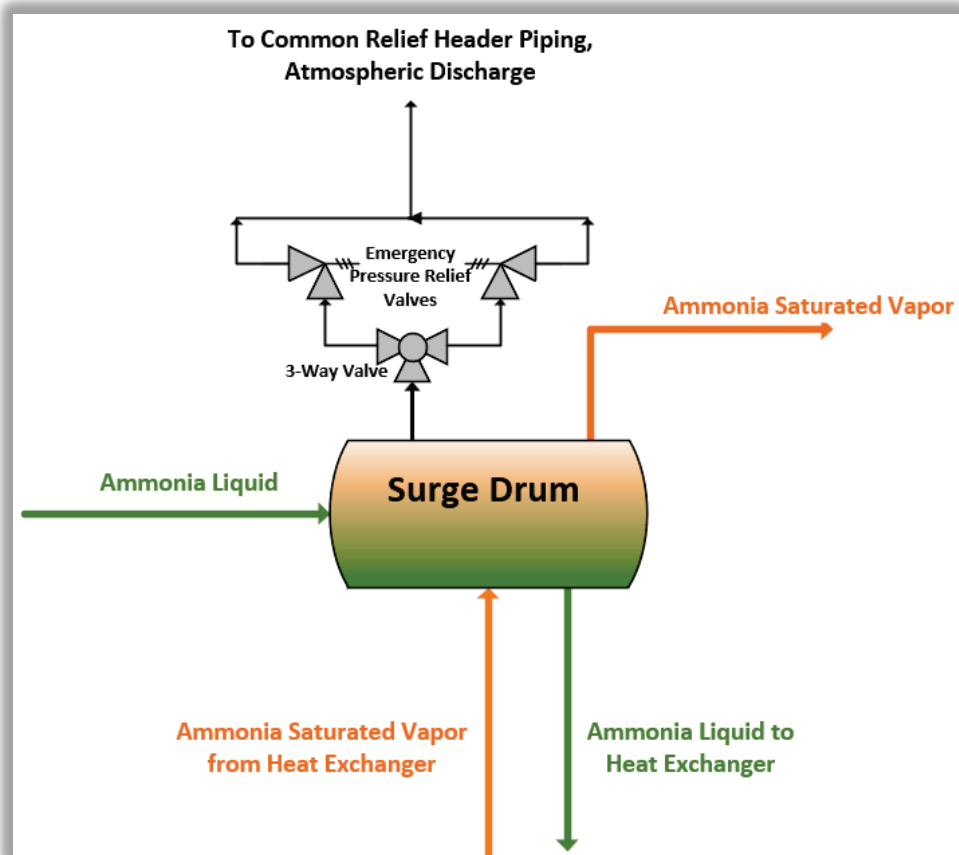
The American Society of Mechanical Engineers (ASME) Boiler and Pressure Vessel Code requires pressure vessels to have emergency pressure relief valves that are designed to open at or below a maximum allowable working pressure (MAWP)^a to prevent equipment damage and catastrophic failures [9, p. 94]. Each pressure vessel in Tank Farm 5 included at least one emergency pressure relief valve.^b The relief system assembly used in the surge drums included a three-way selector valve^c with two emergency pressure relief valves attached (**Figure 6**). This type of arrangement ensured that one emergency pressure relief valve was in service, while the standby emergency pressure relief valve was isolated until the three-way selector valve was switched. The emergency pressure relief valves discharged to a common relief header, which discharged to the atmosphere, as shown in **Figure 7** below.

Figure 7: Emergency pressure relief valve assembly on a surge drum. (Credit: CSB)

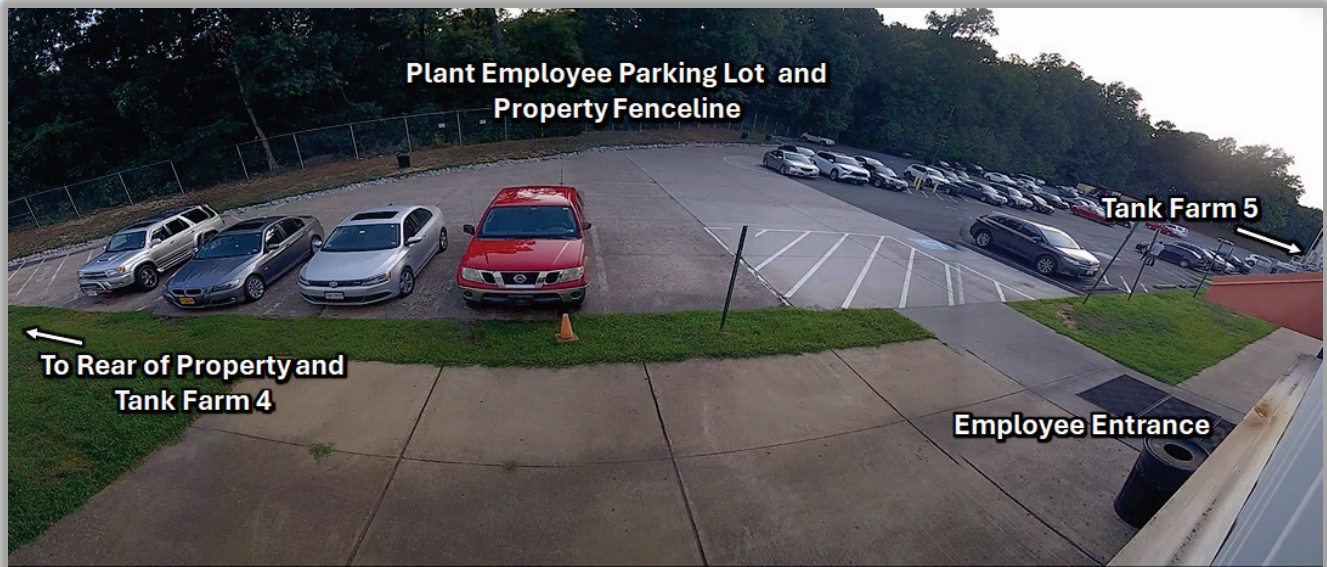
Figure 10: Sterling plant employee entrance and parking lot. (Credit: Cuisine Solutions, annotated by CSB)

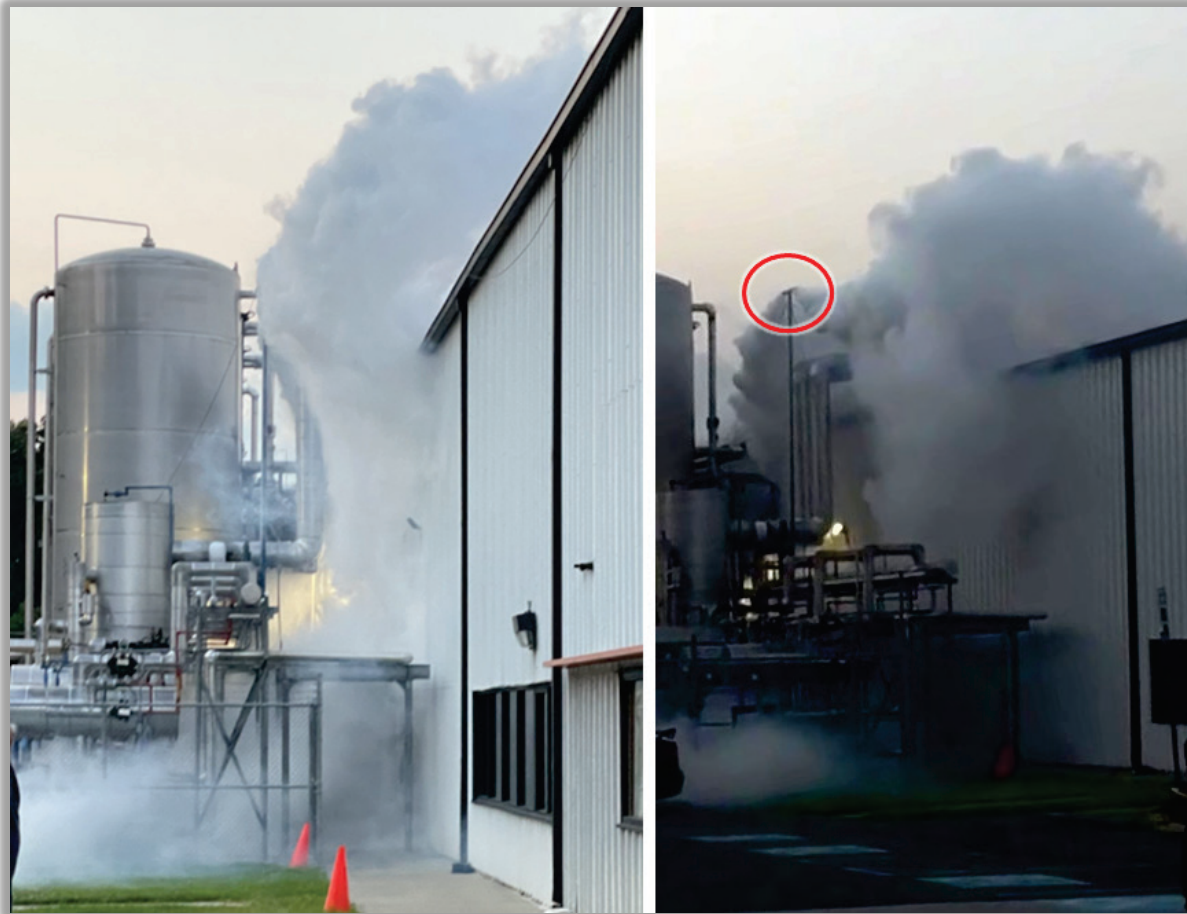
At approximately 8:27 p.m., maintenance employees reached the plant employee parking lot to investigate and observed a white cloud coming out of the common relief header tee diffuser on the ammonia refrigeration system (**Section 1.4.3**), as shown in **Figure 11**. One maintenance employee described witnessing ammonia leaving the open-ended vent piping “like a bubble cloud, like coming down, you know, dropping. And then it would shut off, and then it’d come back again, and then it’d shut.” Another maintenance employee told CSB investigators, “You could see the ammonia cloud. It was, I mean, like I say, it was a cloud. It was something I’ve never seen before. You know. You smell it and you know it’s bad. But from what I’ve been told, when you see it, it’s really bad.” Consistent with these reports, security camera footage showed a visible cloud forming and dissipating, and a second cloud forming as the release progressed.

Figure 11: Visible ammonia cloud during the release (left), and the release point (circled, right) through a horizontal tee diffuser. (Credit: Cuisine Solutions employees, annotated by CSB)

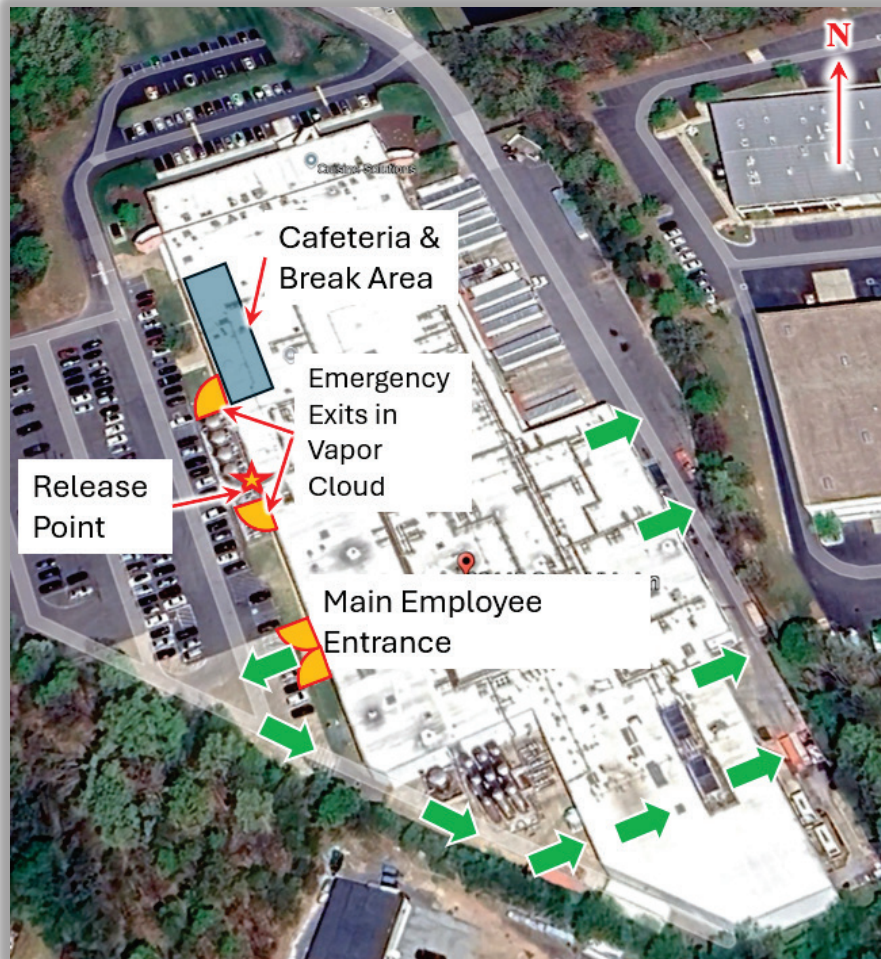
Meanwhile, workers inside the building, in a cafeteria and break area adjacent to the ammonia release point, as shown in **Figure 12**, recalled identifying and reporting an ammonia odor at the time.

Figure 12: Overhead view of the Sterling site, indicating the break area (blue rectangle), emergency exits compromised, and some commonly used evacuation routes (green arrows). (Credit: Google Earth, annotated by CSB)

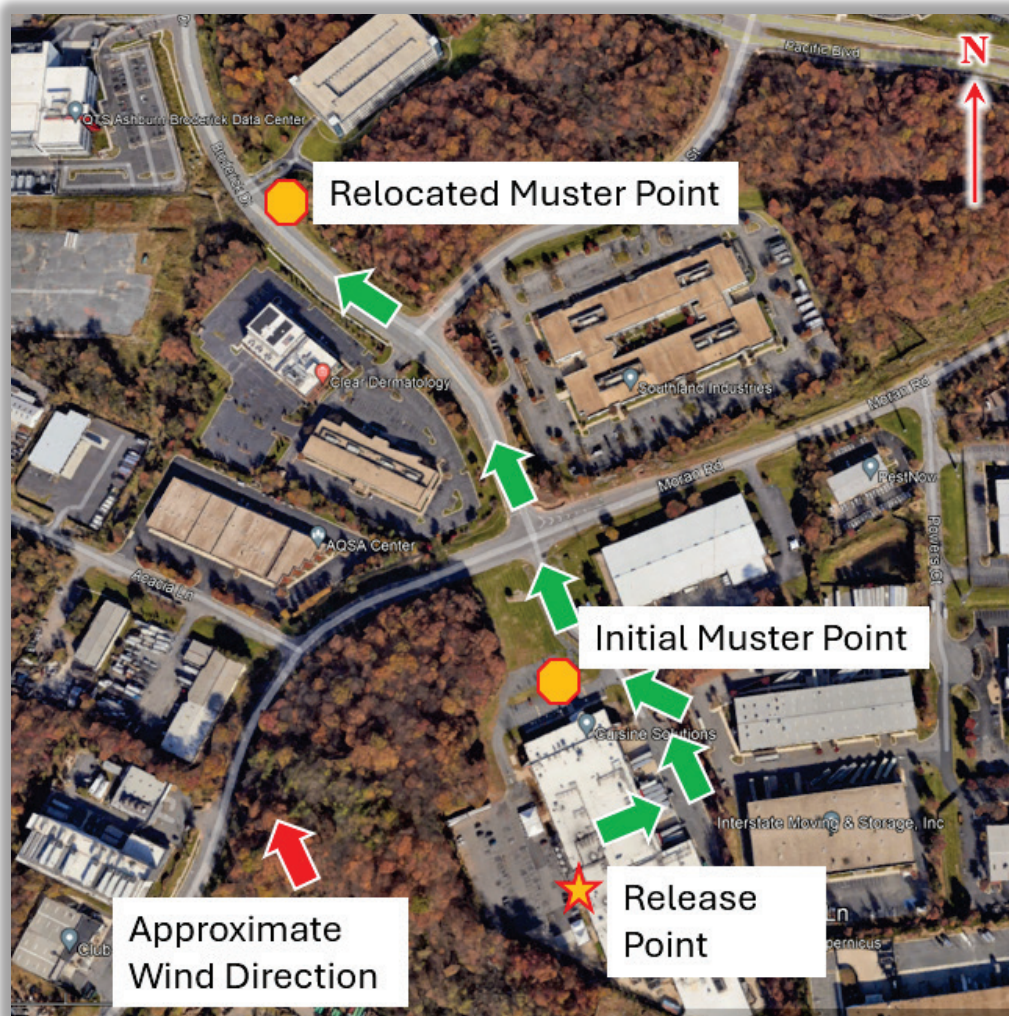
Figure 13: The evacuation route (green arrows) that most evacuees followed via the east side of the building to avoid the release on the west side (yellow star). (Credit: Google Earth, annotated by CSB)

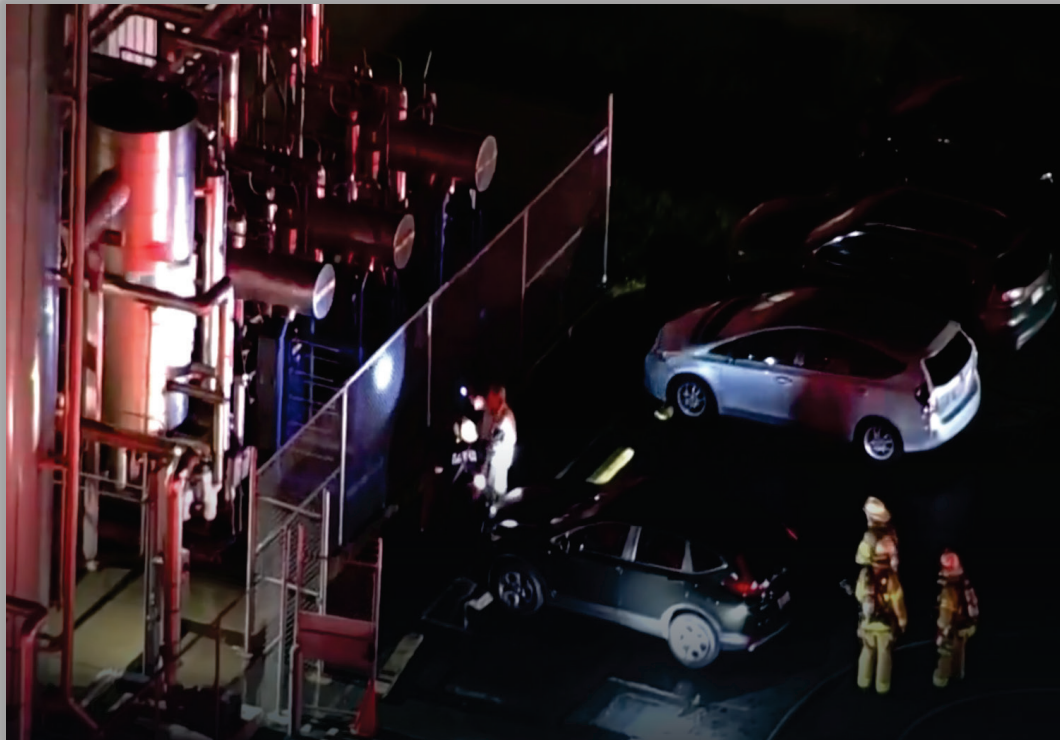
Figure 14: Image from video of the incident scene. Emergency responders working with a Sterling plant employee to safely isolate the ammonia. (Credit: WTVR-TV [17])

At approximately 9:29 p.m., with the HAZMAT team’s guidance and support, the refrigeration manager switched the Heat Exchanger 5 Surge Drum three-way selector valve to isolate the emergency pressure relief valve that had released the ammonia and put the standby emergency pressure relief valve in service (**Figure 14**). The manager later told the CSB that he determined which emergency pressure relief valve was releasing ammonia into the atmosphere based on his observation of frost buildup on the exterior of the piping and emergency pressure relief valve.

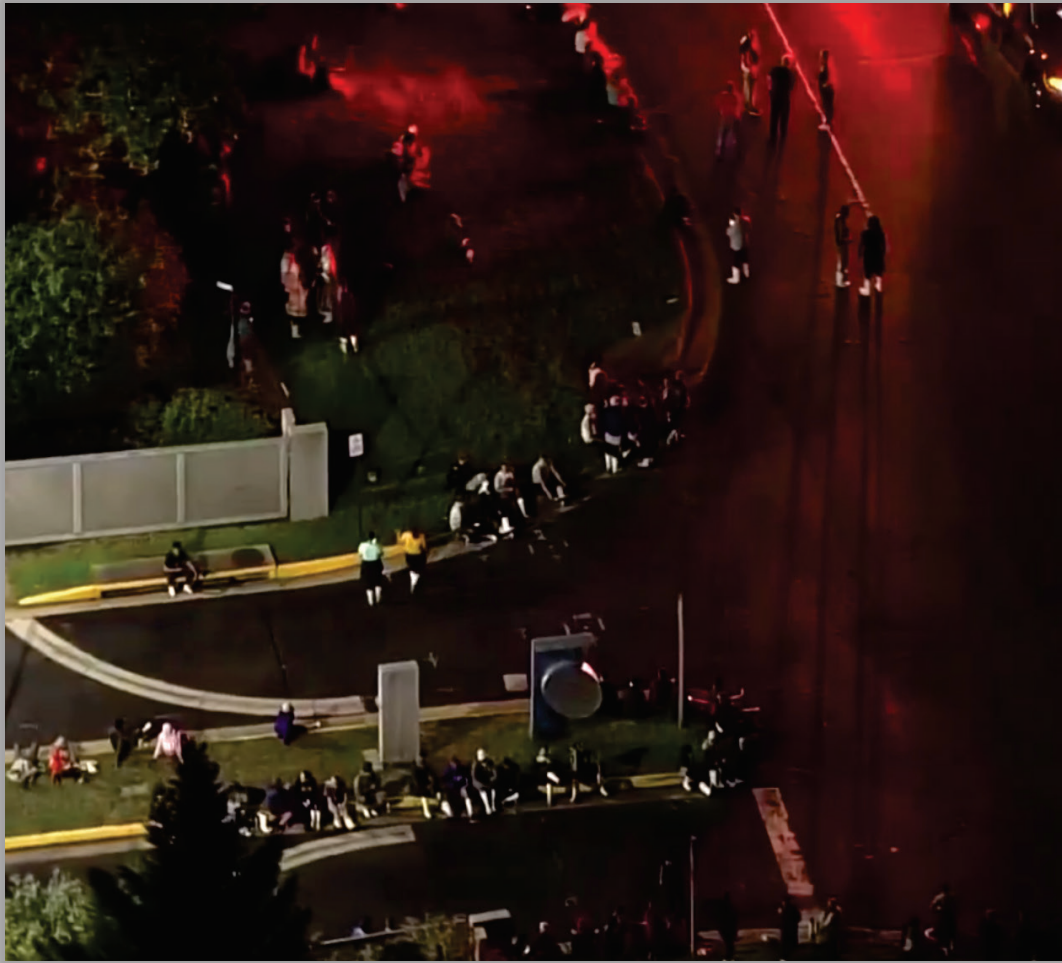
Figure 15: Image from video of the incident scene showing evacuees and emergency responders gathered at the relocated muster point north of the Sterling site. (Credit: WTVR-TV [17])

Due to their exposure to the ammonia vapor, some personnel experienced headaches, nausea, vomiting, and irritation to the nose and throat, causing coughing and wheezing, consistent with ammonia inhalation, during the evacuation. As discussed in **Section 2.3** above, evacuees moved to the location marked “Relocated Muster Point” in **Figure 13** to escape the ammonia odor. **Figure 15** shows an aerial image of the relocated muster point during the incident response.

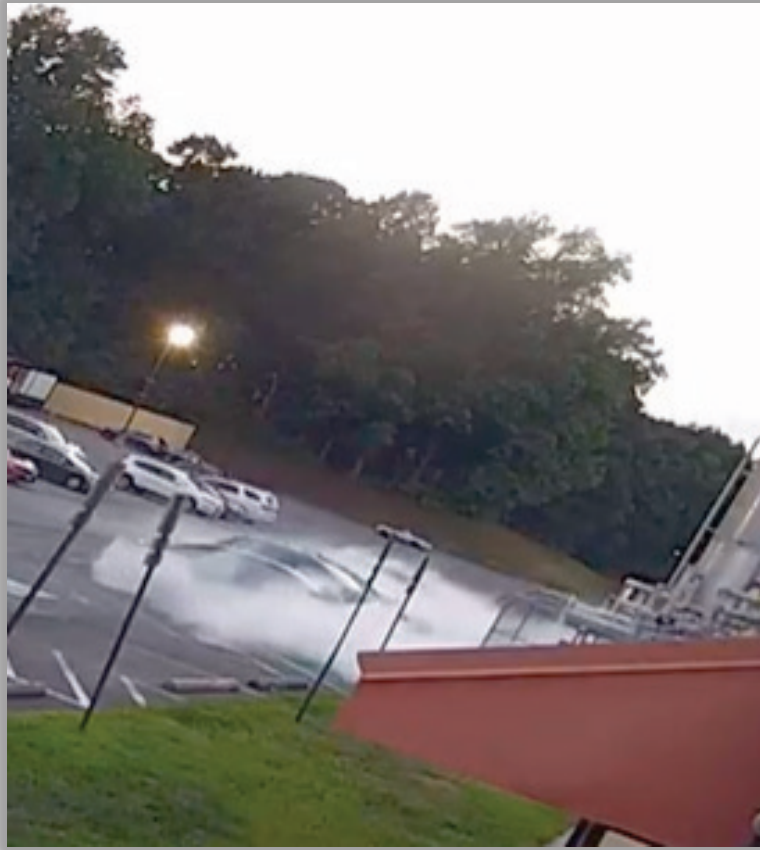
Figure 19: Part of the ammonia release rapidly slumped to ground level within 20-30 horizontal feet of the release point. (Credit: Cuisine Solutions)

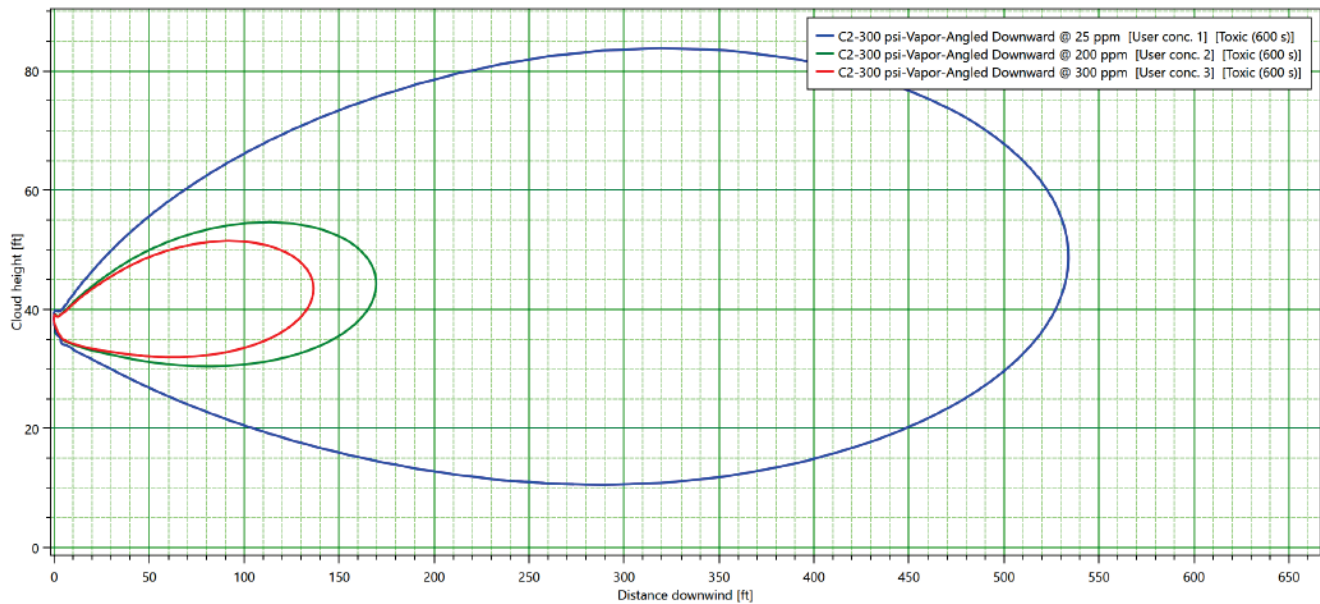
Figure 20: Half-cloud modeling of a vapor-only release on the night of the incident. Since this cloud remains aloft, a vapor-only release is not likely to have occurred. (Credit: CSB)

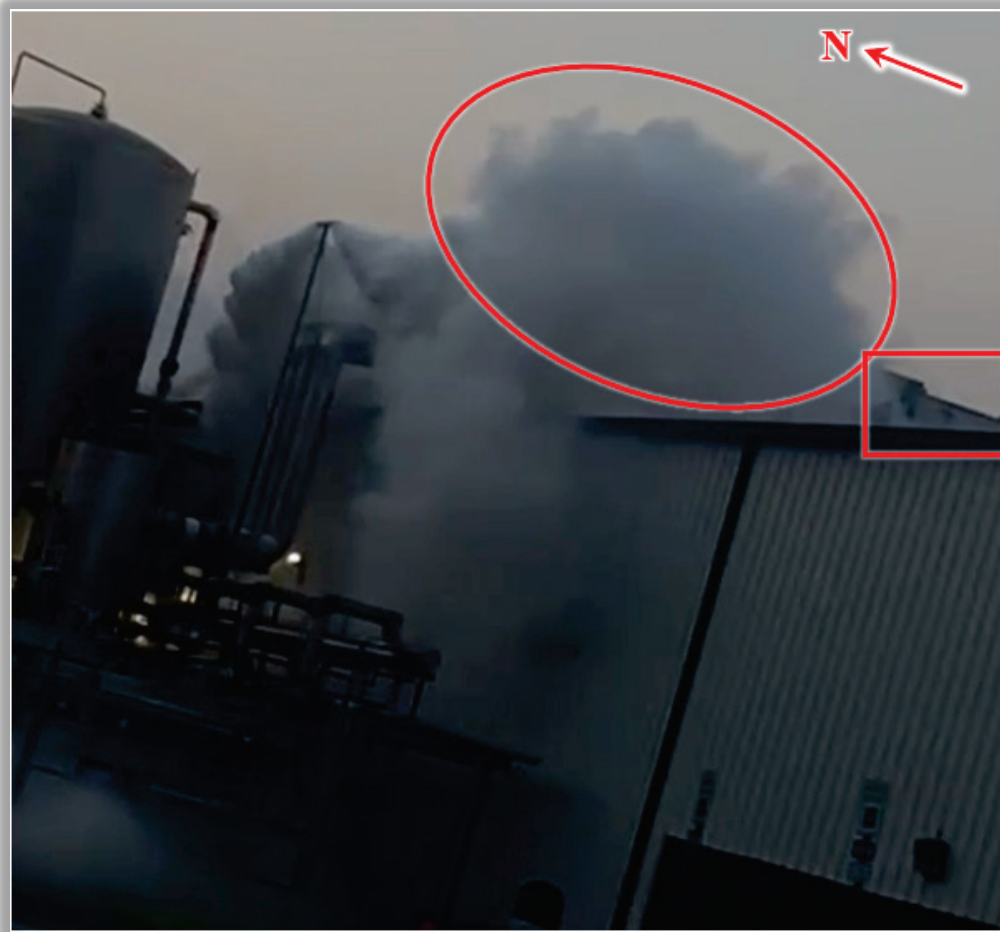
On the night of the incident, while a significant part of the ammonia cloud slumped to the ground initially, a portion of the visible cloud remained aloft and moved across the building's roof, even though a cloud was not visible on the east side of the building as described in **Section 2.3**. Nonetheless, video of the cloud indicated that some visible ammonia vapor moved across the roof of the building toward the north or east sides of the building, as shown in **Figure 23** below. In addition, the strong ammonia odors reported inside the building were due to ammonia migrating inside the building, likely through a Heating, Ventilation, and Air Conditioning (HVAC) unit intake on the roof near the relief discharge location (red box in **Figure 23**) from this buoyant portion of the ammonia release.

Figure 23: Much of the ammonia release slumped to the ground (lower left), but some remained aloft over the building roof (red oval). Note the HVAC unit in the visible cloud (red box). (Credit: Cuisine Solutions employees, annotated by CSB)

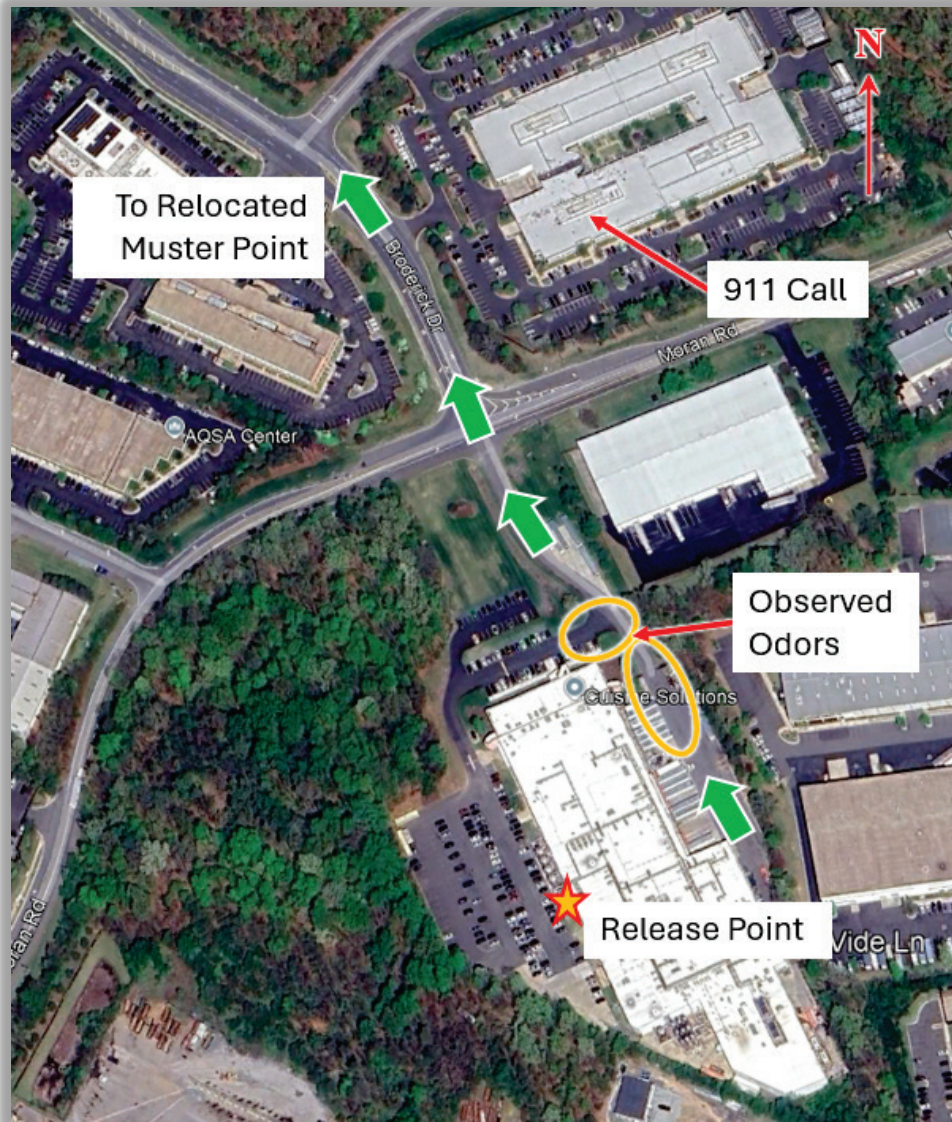
Figure 24: Evacuees' odor observations (ovals) on the east side of the building, where evacuees walked (green arrows). (Credit: Google Earth, annotated by CSB)

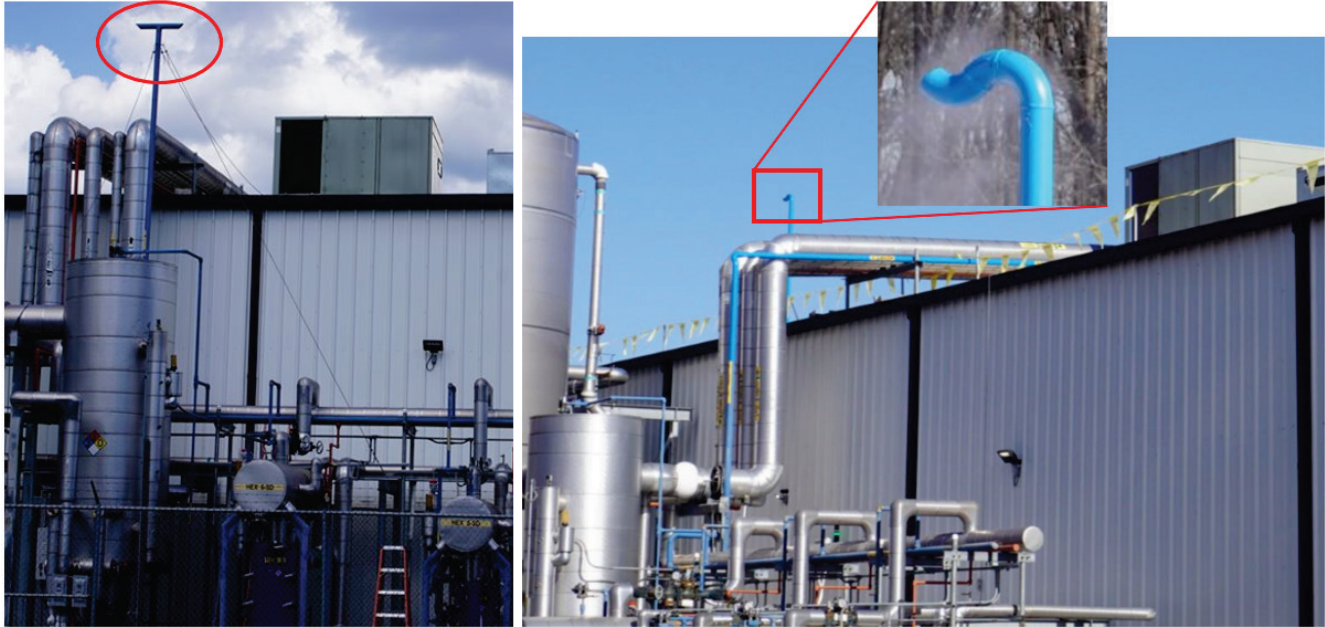
Figure 29: Tank Farm 5 atmospheric relief discharge piping, before (left, circled) and after (right, and inset) the incident. (Credit: CSB)

After the incident, Cuisine Solutions modified the Sterling plant's emergency pressure relief atmospheric discharge piping by relocating the discharges at Tank Farm 5 and elsewhere, as shown in **Figure 29** below. The changes included moving the discharge away from the nearby HVAC intake and orienting the discharge upward at 45 degrees. The smaller, single pipe discharge (inset in **Figure 29** below) may increase the discharge velocity. These changes meet or exceed the current ANSI/IIAR 2 discharge piping requirements.
