## Investigation Update

August 2026

This document provides an update on the CSB's investigation of the April 22, 2026, incident at the Ames Goldsmith Corporation's Catalyst Refiners, Inc. ("Catalyst Refiners") facility in Institute, West Virginia.

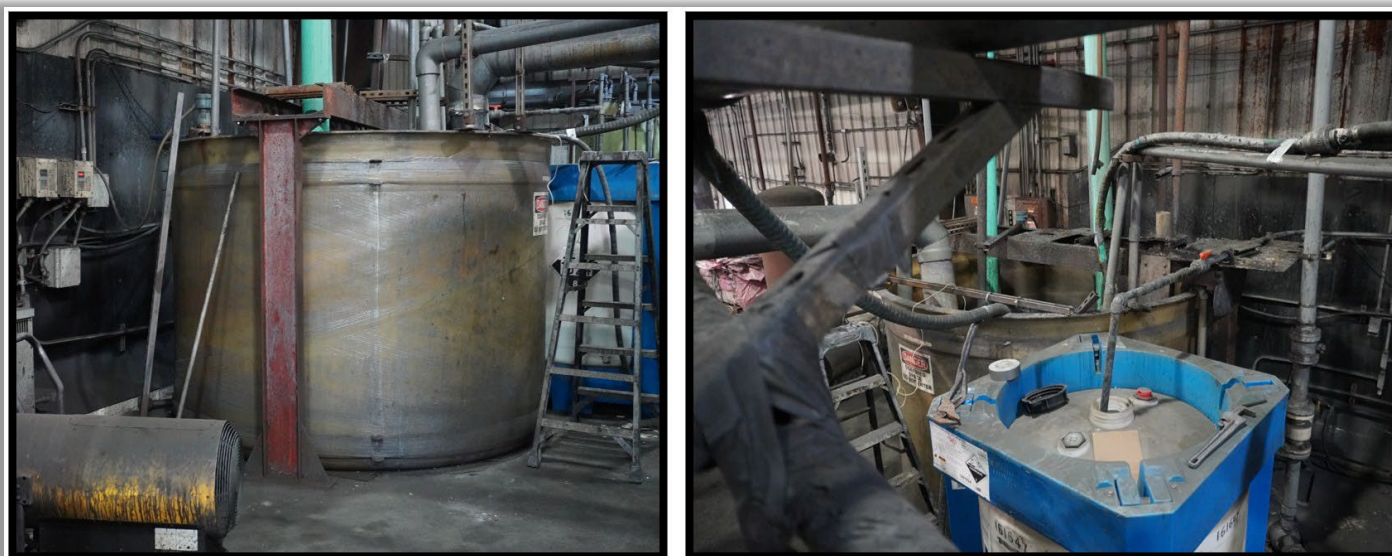
**Figure 2.** Incident tank, side view (left) and elevated view (right). (Credit: CSB)

<sup>b</sup> The incident tank was an open-top, six-foot-tall, nine-foot-diameter tank with a capacity of 2,227 gallons.

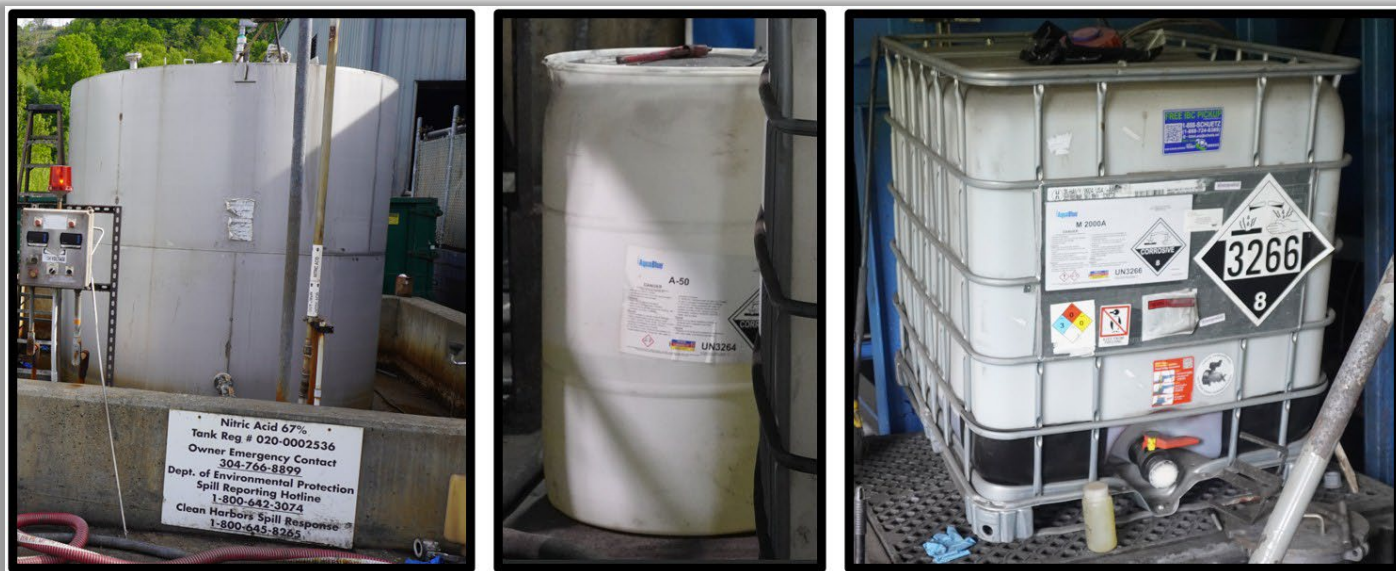
**Figure 3.** Nitric acid storage tank (left), A-50 drum (middle), and M-2000A tote (right). (Credit: CSB)

- Catalyst Refiners uses two chemicals to recover silver from its wastewater: M-2000A and A-50 (see **Figure 3**). M-2000A is a proprietary sodium trithiocarbonate<sup>a</sup> solution used as a metal precipitant, and A-50 is a proprietary calcium chloride solution used as a coagulant.<sup>b</sup> Chemical precipitation<sup>c</sup> is a widely used technology for removing metals such as silver from wastewater [2]. Both M-2000A and A-50 were normally

added to the clarifier. Nitric acid,<sup>a</sup> which had been used in Catalyst Refiners' reclamation process, was kept in a storage tank at the facility. **Figure 3** shows the nitric acid storage tank used by Catalyst Refiners. At the time of the incident, Catalyst Refiners was disposing of the remaining nitric acid by pumping it into the effluent wastewater pretreatment process.

<sup>a</sup> Following the incident, one diluted nitric acid tote was completely empty, and the pump had been reconnected to the plant air supply as depicted in **Figure 3**.

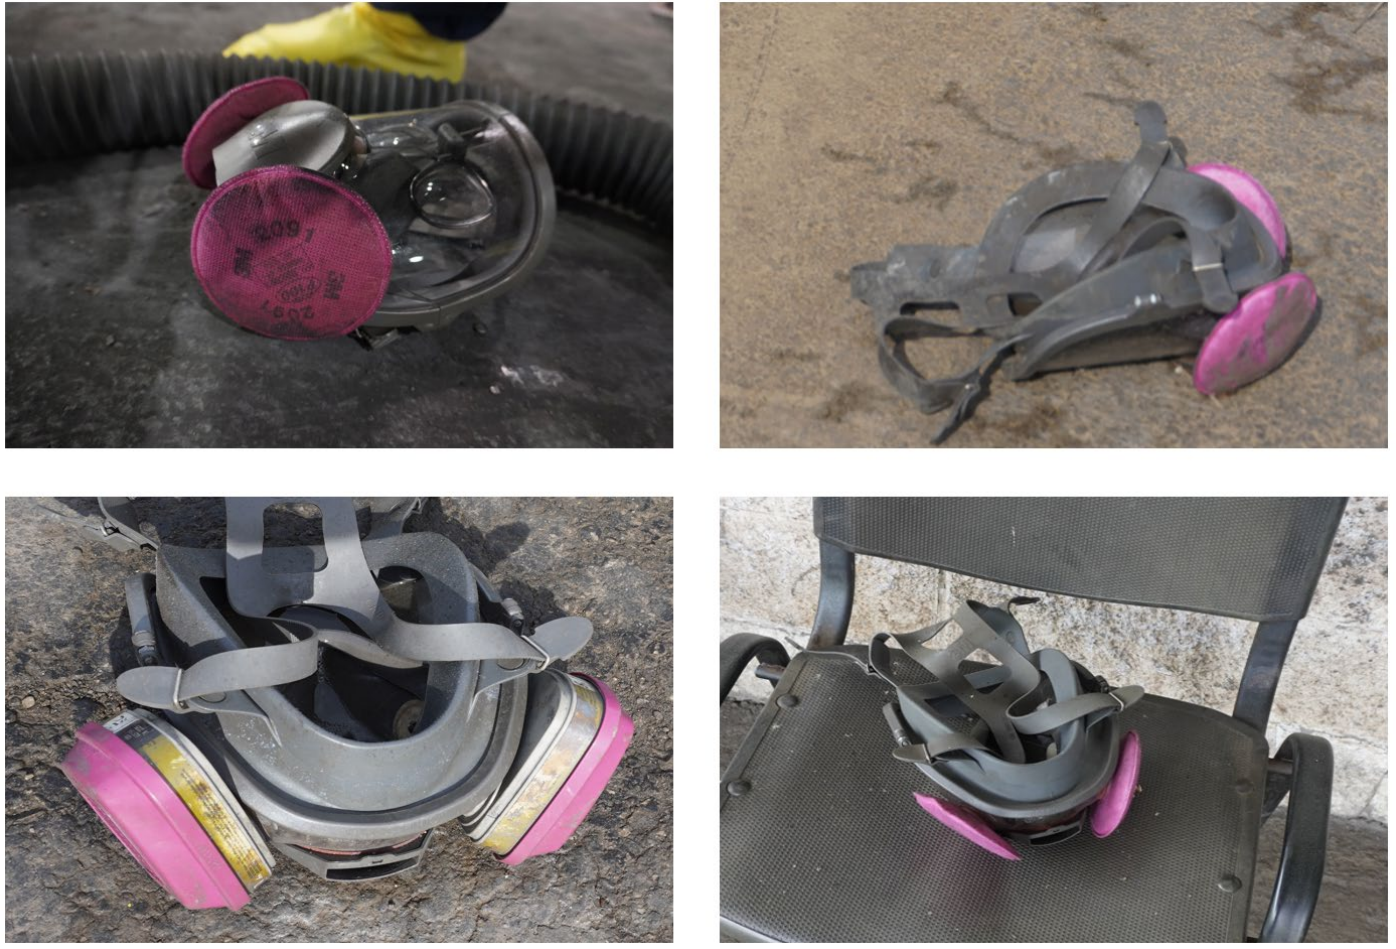
**Figure 5.** Respirators found by the CSB post-incident. (Credit: CSB)

- During a post-incident site visit, the CSB found four full-face respirators (see **Figure 5**) in various locations throughout the facility, at least three of which were equipped with 3M™ 2091 particulate filters (P100 rating) [5], which do not provide protection against hazardous gases, including hydrogen sulfide [6]. Workers told the CSB that once the facility transitioned from normal production to decommissioning, they were not required to

wear respirators in the facility. Catalyst Refiners also did not provide, nor did they require the use of, personal gas monitors by employees or contractors.
