U.S. Chemical Safety and
Hazard Investigation Board

Flash Fire and Explosion at Sunoco Partners Nederland Terminal

Nederland, TX | Incident Date: August 12, 2016 | No. 2016-03-I-TX

Investigation Report

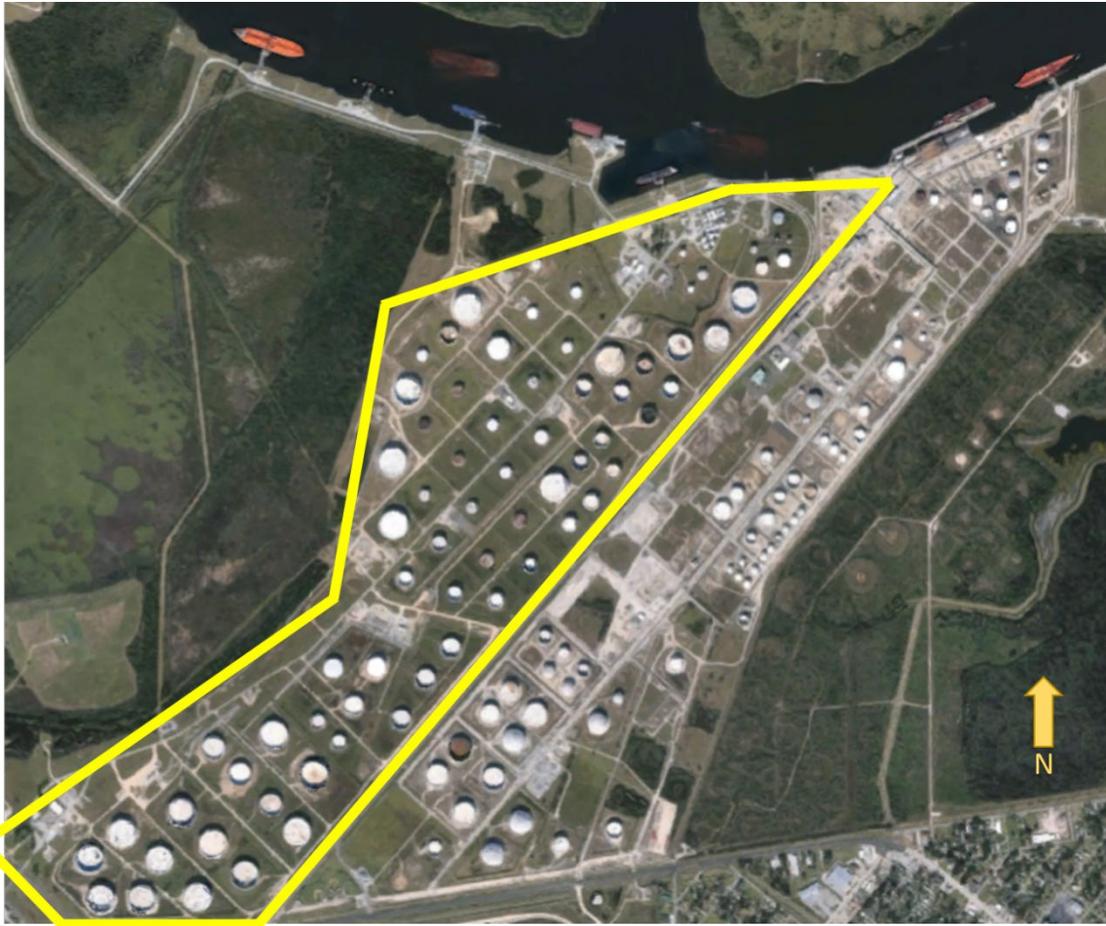
The Sunoco Partners Marketing and Terminals (SPMT) Nederland Terminal, located on the Sabine-Neches waterway between Beaumont and Port Arthur, Texas, is a large terminal providing storage and distribution services for refiners and other large transporters of crude oil, butane, and propane. The terminal receives (by pipeline, vessel, rail, and truck), stores, and distributes (by pipeline and vessel) crude oil, butane, and propane. The terminal has over 70 above ground storage tanks (ASTs) dedicated to crude oil. An overhead depiction of SPMT can be seen in **Figure 1** below, as outlined in yellow. The other storage tanks west of the SPMT facility are not owned/operated by SPMT.

Figure 1. Overhead view of Nederland terminal. (Credit: Google Earth; Adapted by CSB)

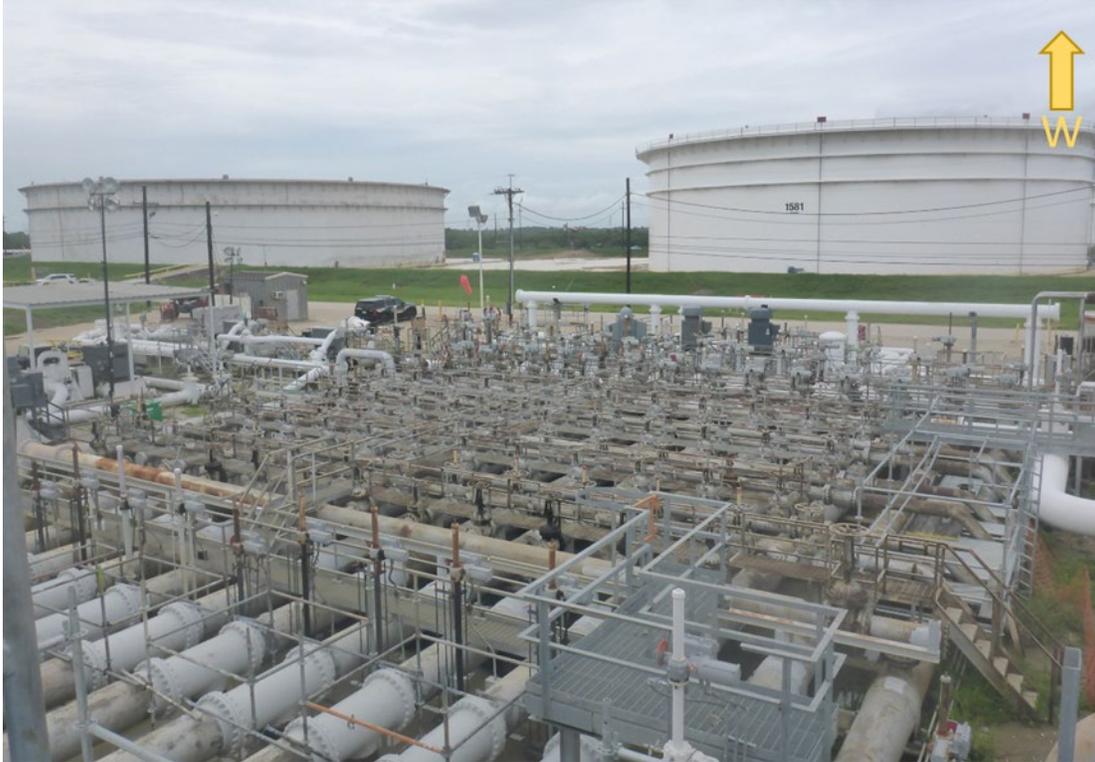
Figure 2. View of central manifold (west facing view). (Credit: CSB)

The manifold where the incident occurred is referred to as the Central Manifold because it is physically located in the middle of the terminal. The Central Manifold is used to provide connections from pipelines to ASTs within the terminal and to transport oil between ASTs located in that region of the terminal.

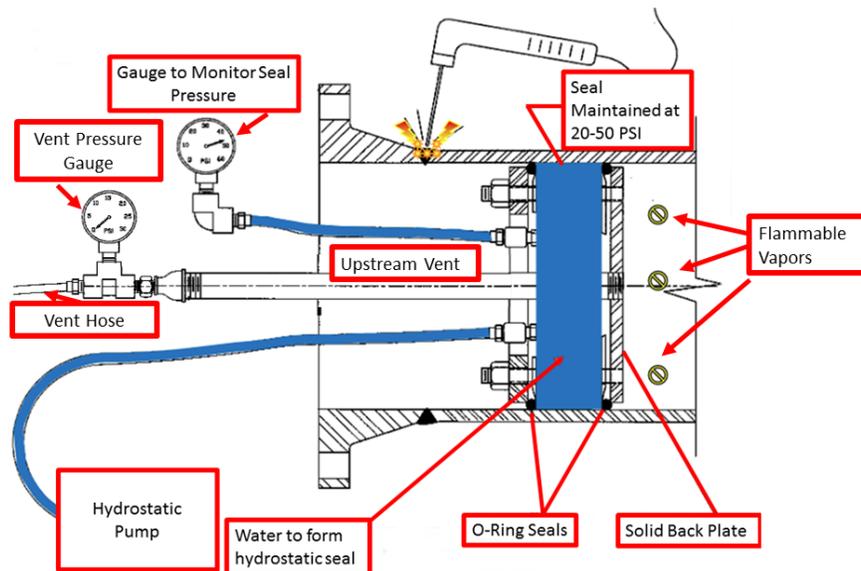
Figure 9. Depiction of CARBER Isolation Tool configuration per CARBER's procedures. (Credit: CARBER; Adapted by CSB)

The CARBER isolation tool is a piping isolation device, designed and patented by CARBER. CARBER markets these devices as having the ability to isolate piping for hot work by creating a positive pressure vapor barrier against residual contents in the pipe. CARBER suggests, in addition to providing a barrier between the piping contents and the work external to the piping, it also has a means to ensure the seal's continued integrity by monitoring the system (**Figure 9** below shows an example schematic). According to CARBER, the ability to monitor the seal's integrity is essential to the CARBER isolation tool, especially since it intended to provide a barrier to hazardous conditions inside the pipe.

The Isolation Tool provides a means to monitor the seal integrity using a pressure gauge attached to the water outlet. If no leaks are found and the water pressure holds steady, the isolation tool seals are proven (or verified).

Piping isolation devices are used to create a barrier between the hazards internal to the pipe and the external conditions, atmosphere, and/or people in the area. For the work at the Nederland Terminal, L-Con subcontracted CARBER to complete the cold cuts of the piping and the piping isolation using their own patented isolation tool to isolate sections of piping and create a physical barrier between workers and residual hydrocarbon contents in the pipe.

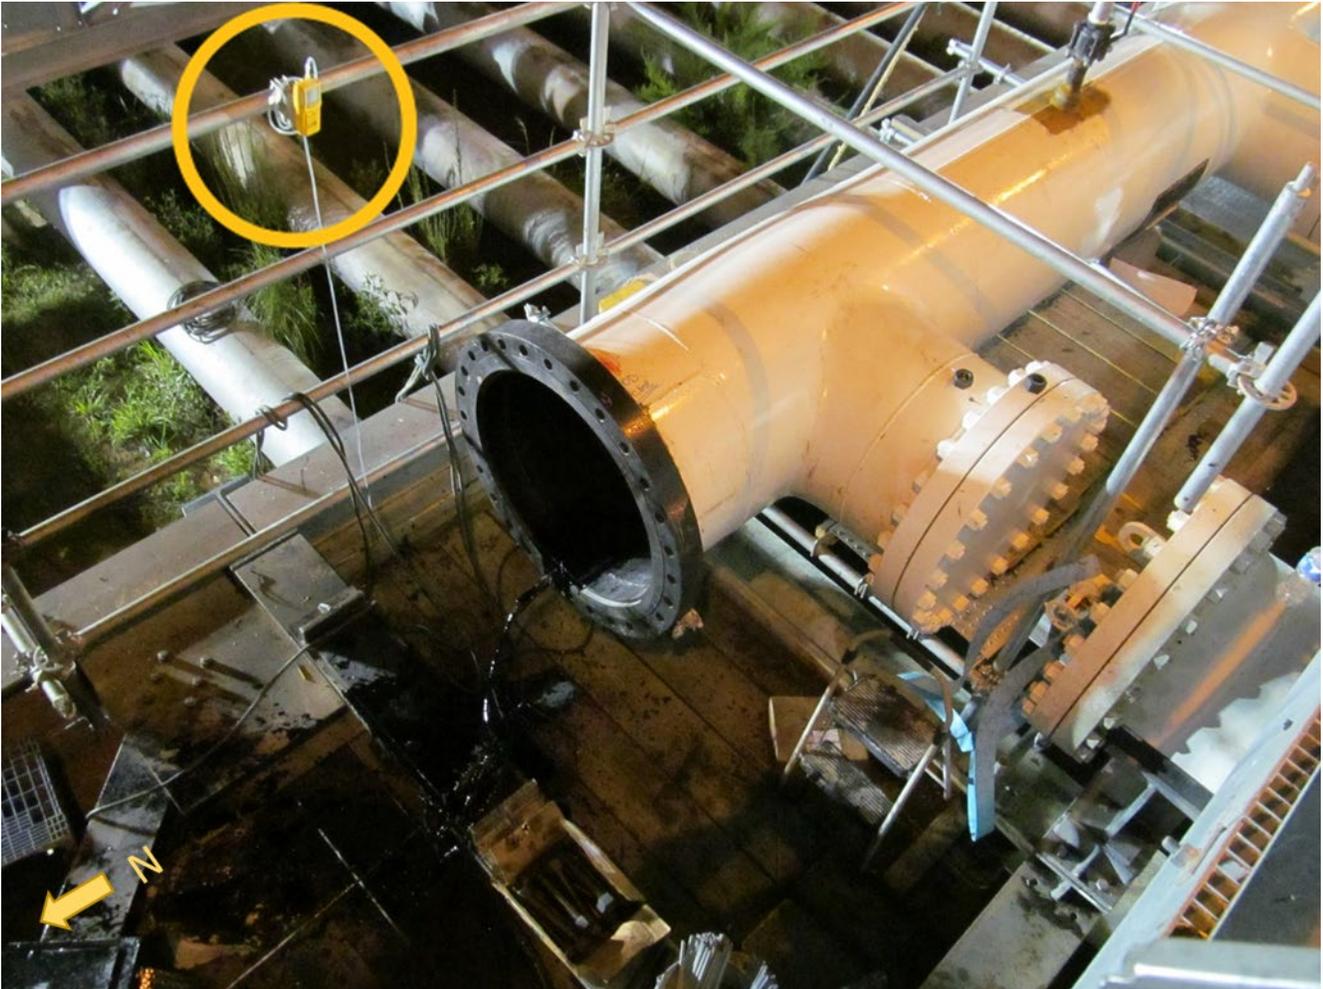
Figure 14. Location of continuous atmospheric monitor (inside yellow circle) at the location of on-going welding. (Credit: CSB)

The issued hot work permit required a fire watch, fire extinguisher, and a continuous flammable gas monitor for the job. A continuous monitor was mounted on the railing close to where welding was occurring. **Figure 14** shows the location of the continuous monitor at the time of the incident. There were no accounts from the welders that the continuous monitor alarmed at any time during welding activities, which would be indicative of flammable vapors in the area.

According to the work permit issued the night of the incident, atmospheric testing was conducted at 7:00 p.m. and did not detect any flammable vapors. There were no accounts of the specifics on the exact location(s) of where atmospheric testing was conducted.

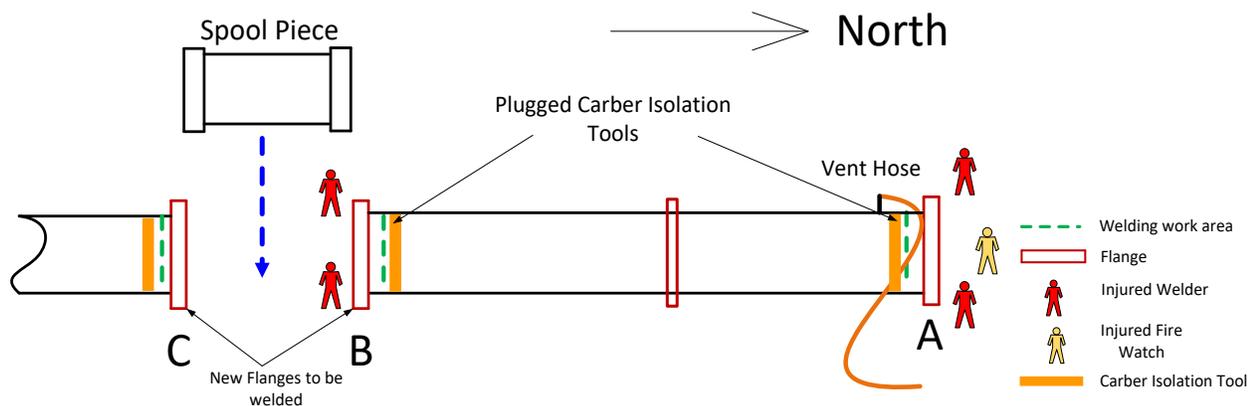
Figure 15. Depiction of pipeline work and location of some workers. (Credit: CSB)

During the day shift on Friday, August 12, 2016, L-Con contractors began welding flanges, using a welding process called arc welding^a, onto the piping. Flanges were required to connect the spool piece to the existing piping that had been cut. Connecting the flanges to the cut ends of the piping requires two full welds, one on the outside and one on the inside of the flange. **Figure 15** shows the flanges (in red) that were added, where the spool piece was being added in the line, where the pipe was vented through the hose on top of the pipe, and where the CARBER isolation tools were installed (orange).

During the remainder of the day shift, L-Con contractors worked to weld the flanges onto the piping. The flanges require two full welds, one on the outside and one on the inside of the flange. By the start of the night shift, an internal and external weld was completed on Flange “C”, and welders began working at both flange “B” and flange “A” to complete the rest of the welds (**Figure 15**). A few hours into the Friday night shift, external welds for all three flanges had been completed. Around 6:20 p.m., the welding work on flanges “A” and “B” was nearly complete and only finishing touches remained for the night shift to complete. At approximately 8:00 p.m., a supervisor went to check on the work being done around flange “A.” The supervisor saw the hot work was nearly complete and workers were performing some grinding finishing work around the external weld.

turn, caused the isolation tools at flanges A and B (**Figure 15**), to blow out of the open pipe at the north and south ends.

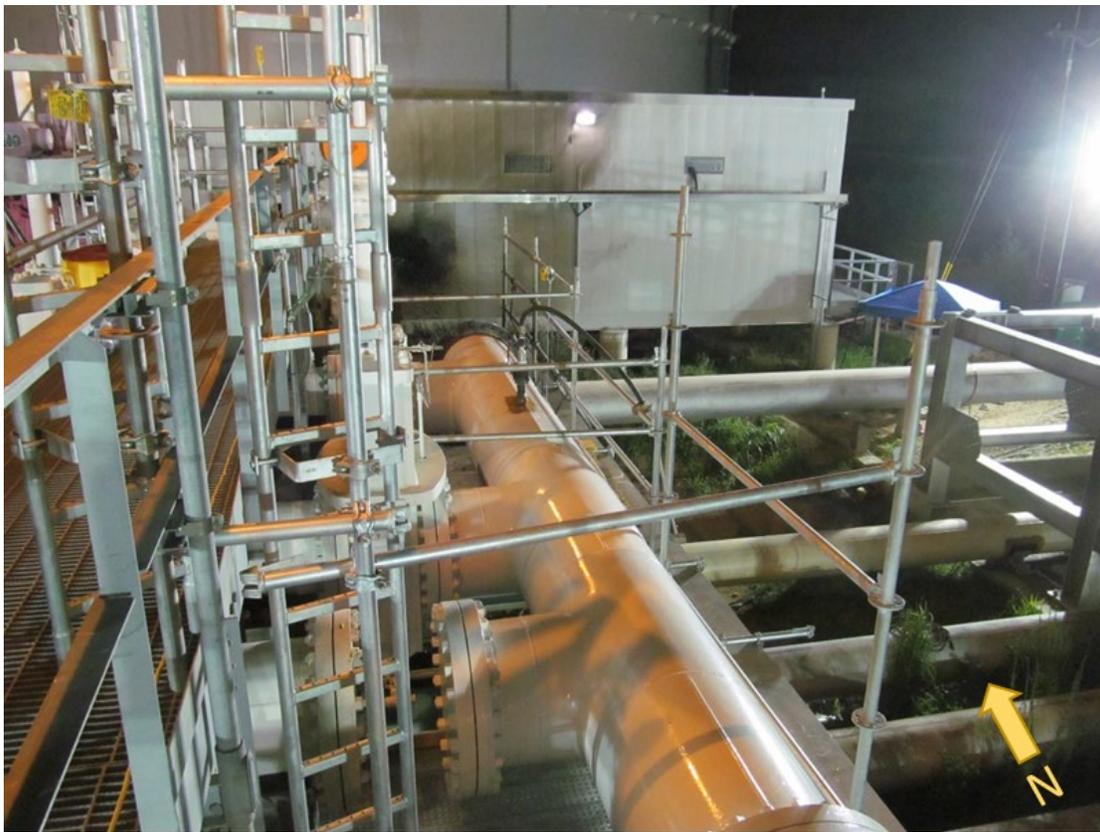
Figure 16. Piping segment where flash fire and explosion occurred. (Credit: CSB)

Figure 16 below shows the piping segment where the flash fire and explosion occurred. **Figure 17** below also shows black soot on the side of the building where the crude oil and flash fire impacted the building at the time of the incident.

The CSB determined the probable cause of the incident was Sunoco approving, and L-Con conducting, hot work activities on equipment that contained an explosive atmosphere that when exposed to an ignition source, resulted in an explosion event. Contributing to the incident was the ineffective implementation and execution of policies and procedures by Sunoco, L-Con, and CARBER.

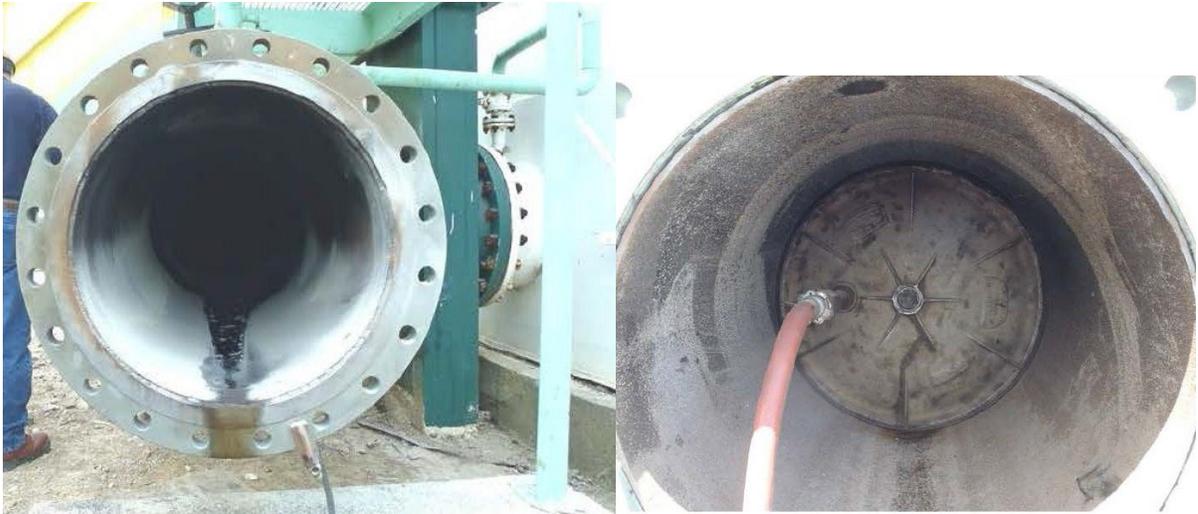
Figure 18. (Left) Crude oil inside pipe post-incident in June 2012. (Right) Isolation tool as it would have been installed in June 2012 incident. (Credit: OSHA)

On the morning of June 2, 2012, L-Con was involved in a hot work incident at an Oiltanking Houston facility in Houston, Texas, where a device similar to the isolation tool used in the August 12, 2016, incident was used in a section of piping to isolate crude oil flammable vapor from hot work conducted on a piping segment. The hot work ignited the flammable vapors, causing the isolation tool to blow out of the open end of the pipe. The incident resulted in a worker fatality and OSHA citations to L-Con [16]. **Figure 18** is a picture of the pipe segment that experienced the flash fire and blow out of the isolation tool at the Oiltanking Houston facility in June 2012 (left) and a depiction of the isolation tool as it would have been installed at the time of the June 2012 incident (right).
