ABS Consulting

West Fertilizer Incident Support Services Final Report

U.S. Chemical Safety Board Order No. CSB-15-0022

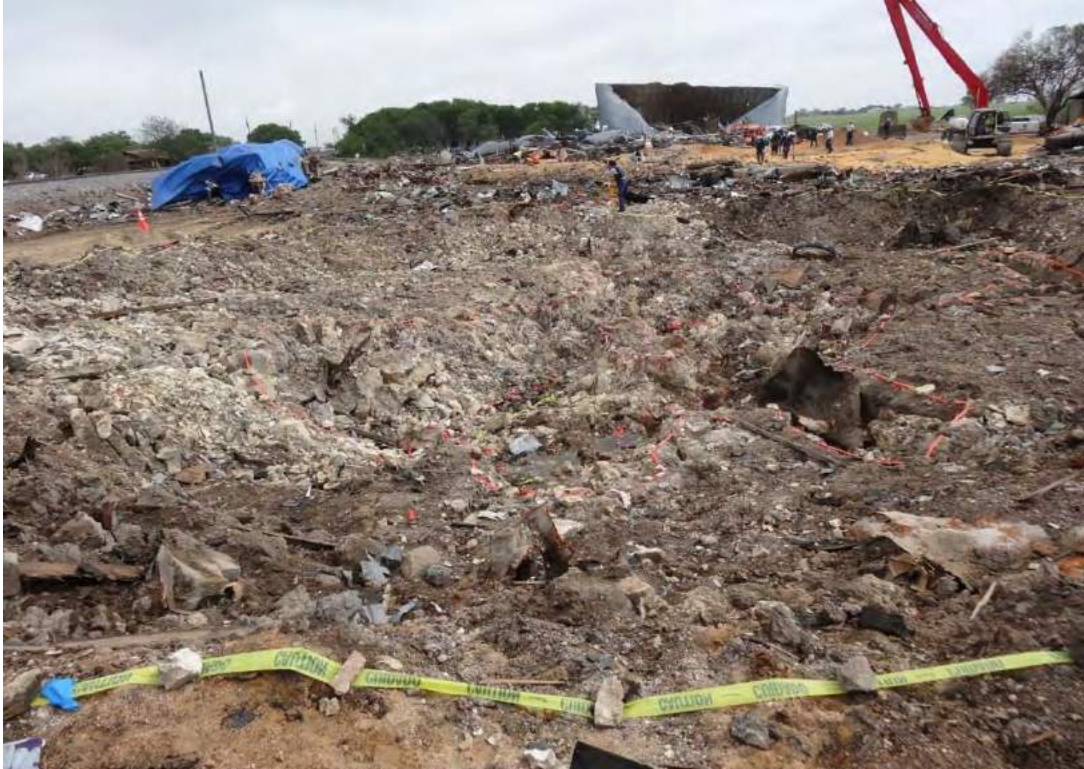
Figure 6. West Fertilizer Crater on April 23, 2013

ABS Consulting was able to perform a photographic survey of the West Fertilizer Co. property South and East of the crater on April 23rd. A second photographic survey was performed on April 25th which included the portion of the facility north of the crater including the corn silo. The visible location of the crater demonstrates that the explosion only involved the northern stack of Ammonium Nitrate and that the Ammonium Nitrate bin along the west wall across from the office did not contribute to the explosive yield. A layout of the Production Building is provided in Figure 5. This conclusion is apparent because the crater was located directly under the northern bin and did not extend to the additional bin along the west wall. The crater was measured by BATF to be approximately 93 ft. in diameter and 10 feet deep from the top of the slab and 7 feet below grade as reported by BATF during a team debriefing on April 22, 2013. Crater photographs taken on April 23rd and April 25th are shown below in Figure 6 and Figure 7, respectively.

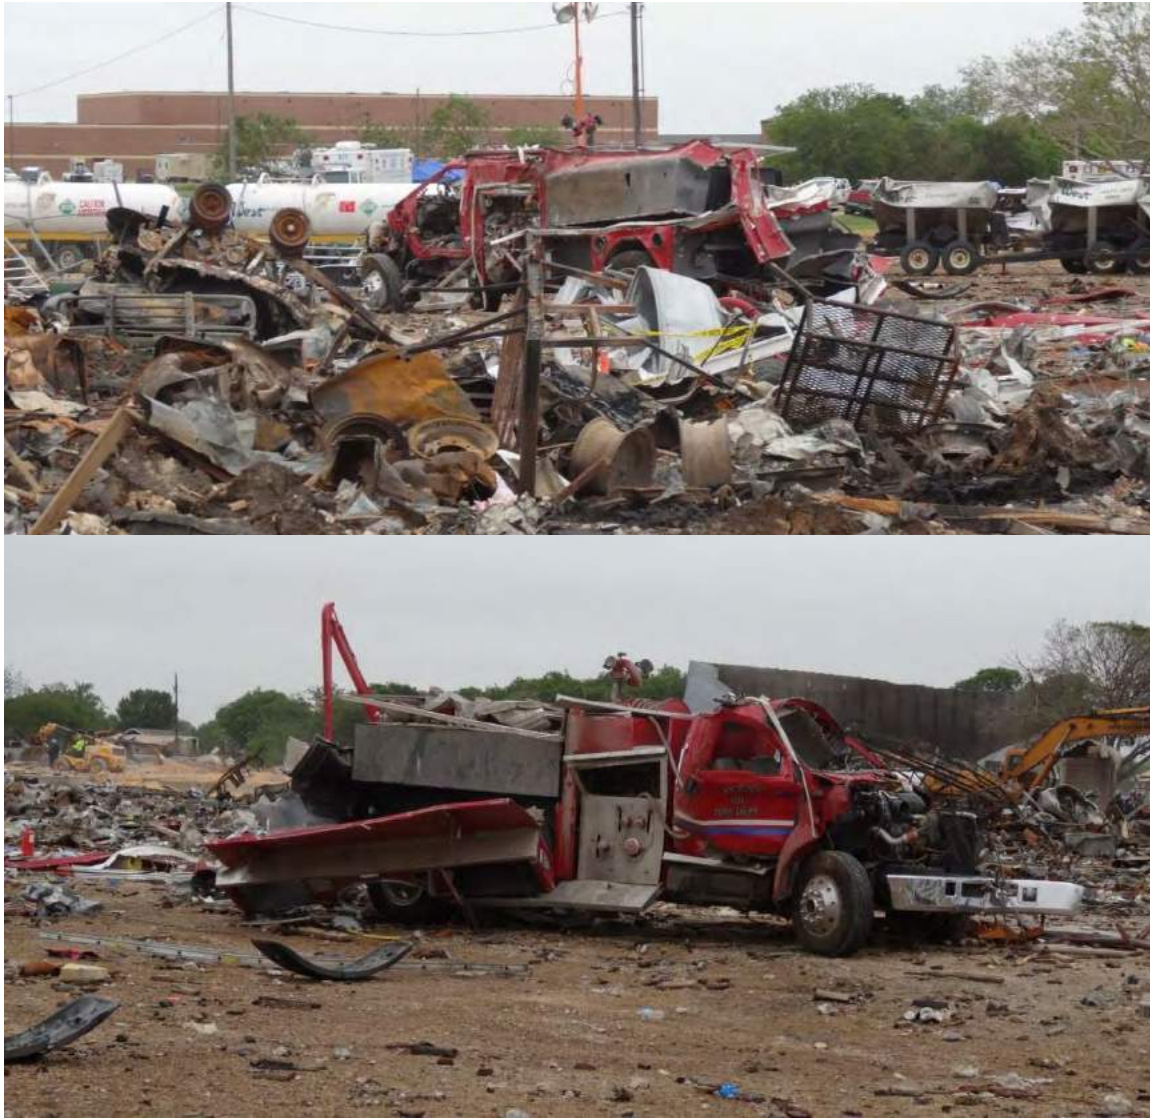
Figure 8. Pump Truck Southeast of Crater on April 23, 2013

The pump truck in Figure 8 was probably moved a short distance by the blast overpressure. A close investigation of the fire truck could not be performed by ABS Consulting engineers; however, a large piece of farm equipment located to the south of the production building toward the scale house, shown below in Figure 11, was moved about a six inches to the south by the blast wave. This is evident by the marks left on the ground by the equipment from displacement during the explosion, as seen in Figure 12. This farm implement was located much further from the blast than the pump truck. In addition, there was a rail car loaded with Ammonium Nitrate located to the north of the production building and crater and can be seen underneath the tarp in Figure 6 above. The rail car, shown below in Figure 13, was overturned and heavily damaged by the explosion. The farm equipment and the rail car are referenced here in relation to the fire equipment to show the severity of the blast environment on the West Fertilizer property where the first responders were located.

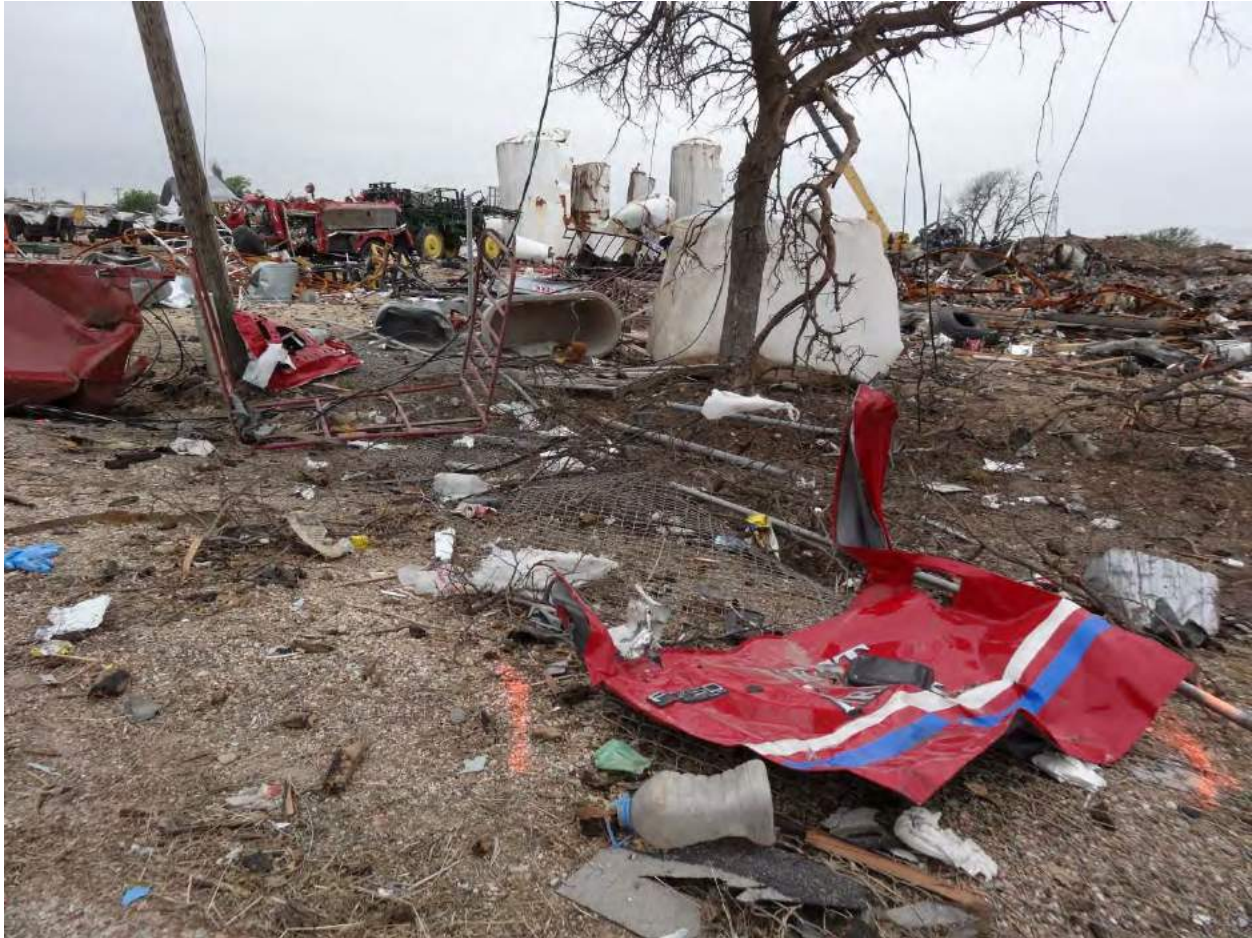
Figure 9. Door from Pump Truck (Pump Truck in the Background)

southeast of the crater and is shown below in Figure 8 and the door from the pump truck, which was projected by the explosion to the east, is shown below in Figure 9. The pump truck was heavily damaged by the explosion overpressure and debris. A water truck was located on Jerry Mashek drive and is shown below in Figure 10.

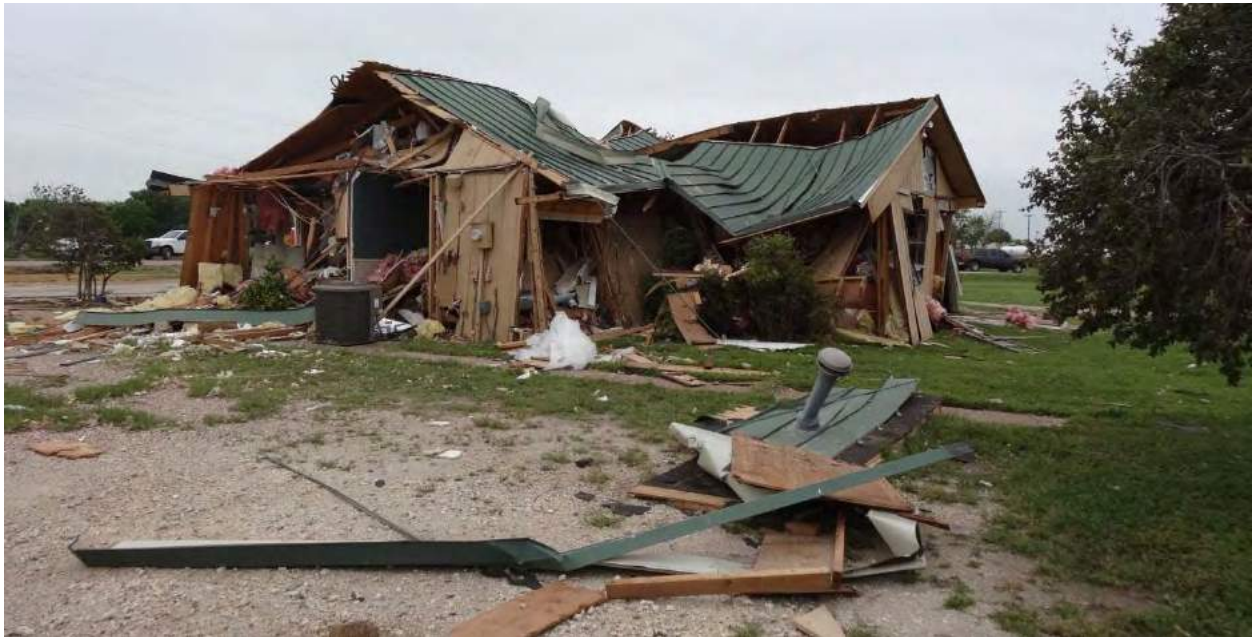
Figure 14. Scale House

The Scale House, shown below in Figure 14, was completely destroyed by the explosion. The walls on all four facades are failed, the roof had failed and there was a significant amount of structural and non-structural debris inside the scale house.

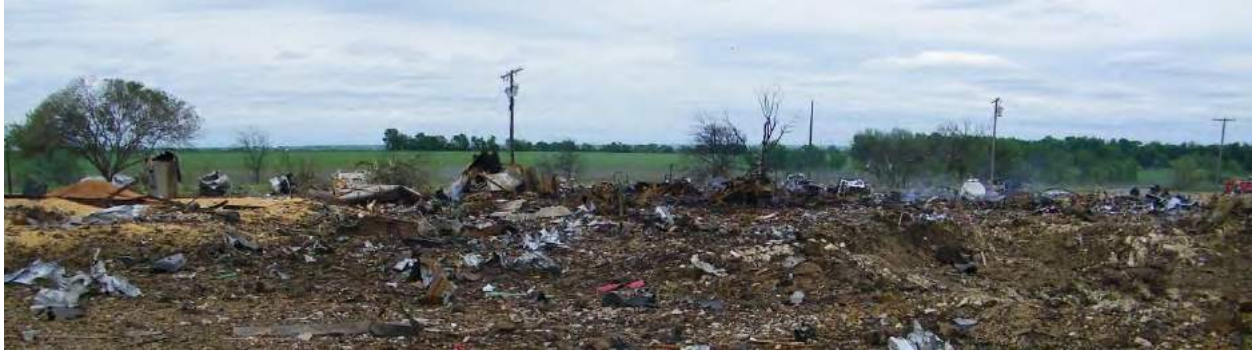
Figure 15. Remains of Chemical Storage / Office Building (Behind Crater in Photo)

The Chemical Storage / Office Building located to the East of the Production Building was destroyed by the blast and ensuing fire as shown below in Figure 15. The pre-engineered metal building was so completely devastated, all that remained was a stack of metal debris where the building once stood.

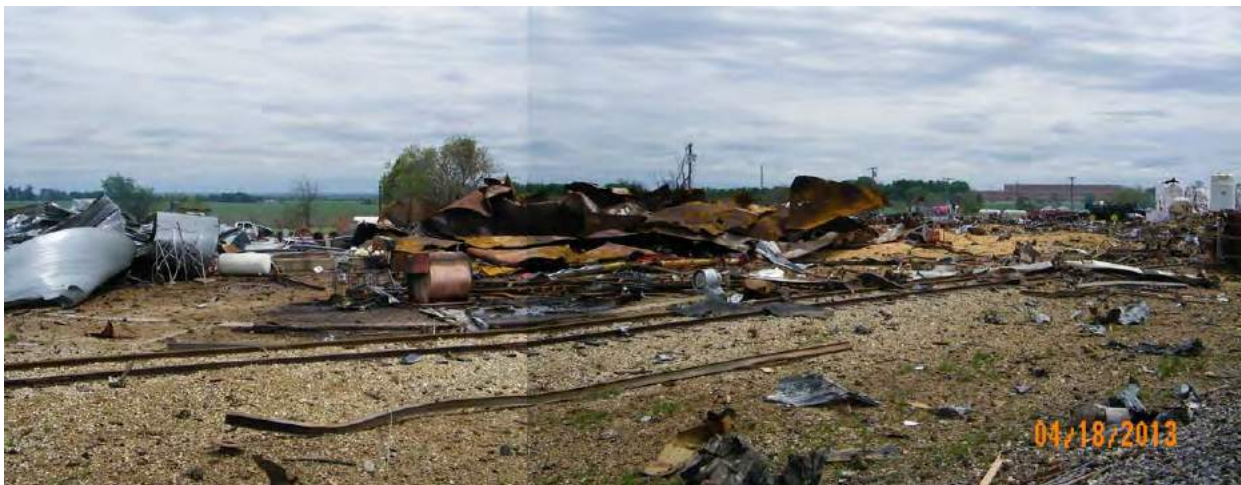
Figure 16. Corn Silo Damage (Composite of Two Photographs)

The Corn Silo located north of the Fertilizer Production Building was also destroyed by the explosion, spilling the contents of the Silo as shown below in Figure 16. The Corn Silo structure was displaced to the North, away from the Production Building crater, as would be expected from an explosion located at the crater. There was no evidence observed, such as Corn Silo debris being thrown in all directions, of the corn silo contributing to the event.

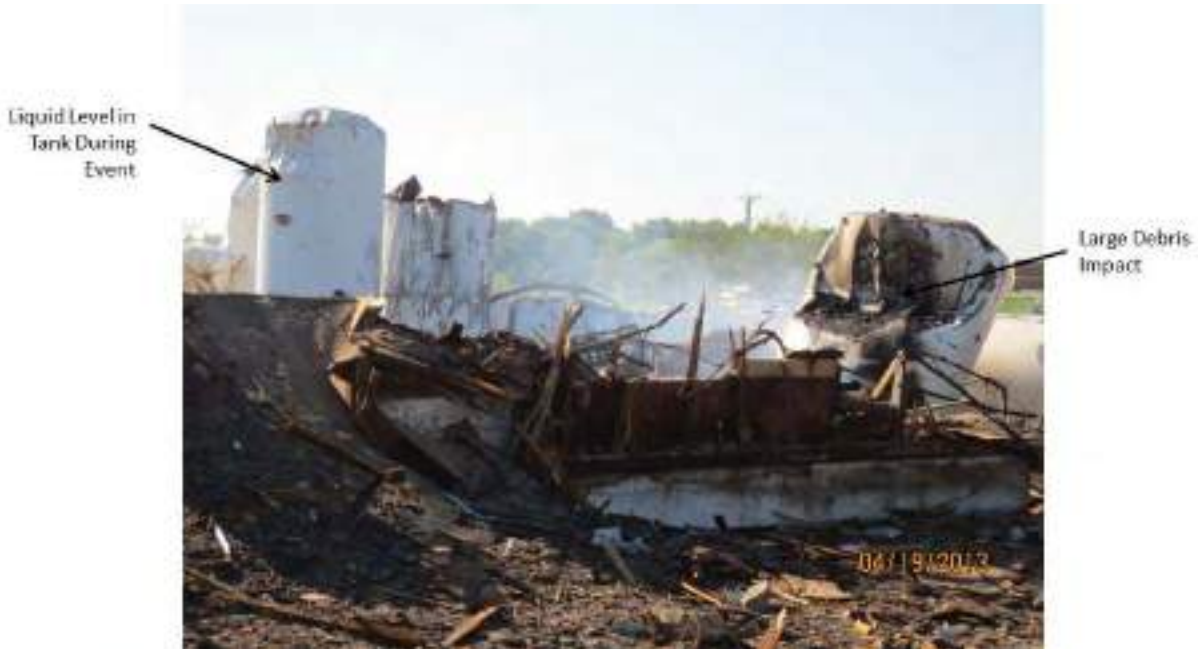
Figure 17. Liquid Fertilizer Tank Damage

The above ground liquid storage tanks were also heavily damaged by the blast as shown below in Figure 17 and Figure 18. In Figure 17 the liquid level in the tank to the left that was present during the explosion is clearly visible by the crease at the top of the tank where the deformation begins. The tank on the right in Figure 17 clearly shows a large debris impact that folded and crushed the tank. Figure 18 is a composite of three pictures taken from just south of the crater. The anhydrous ammonia tanks can be seen in the background just behind the liquid storage tanks.

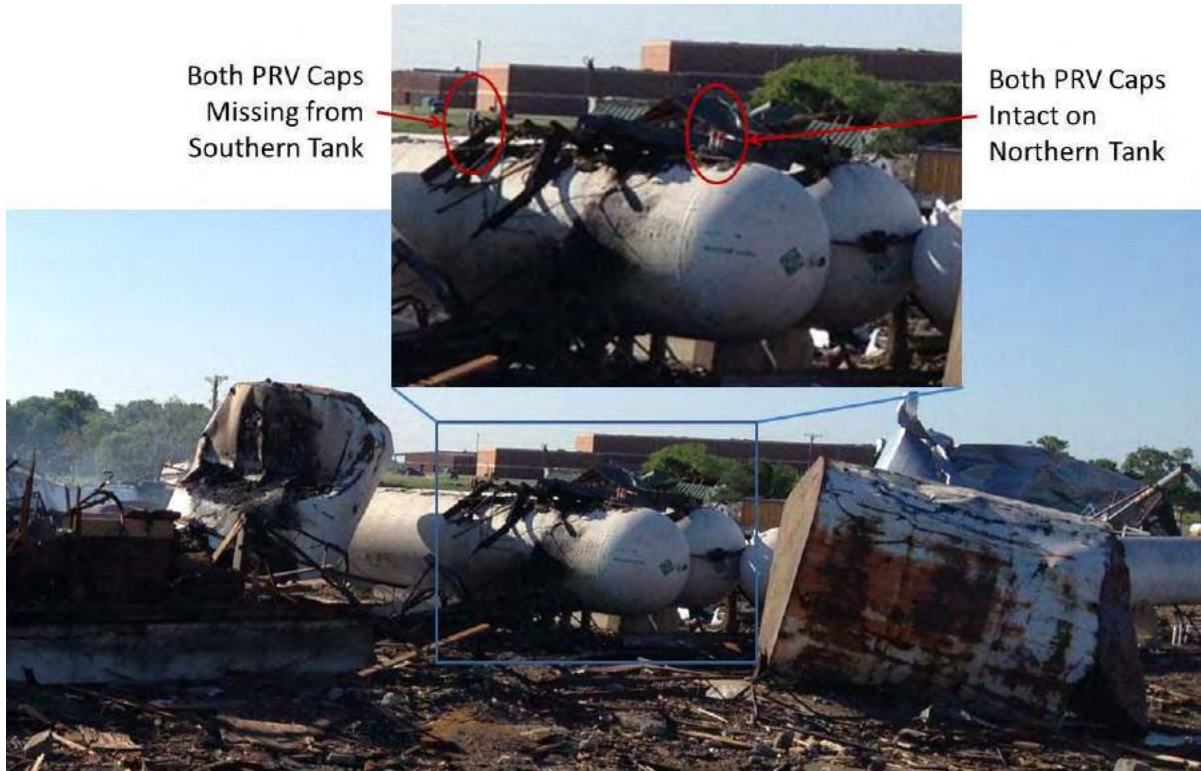
Figure 19. Anhydrous Ammonia Tanks Photo of PRVs (CSB Photo 04-19-2013)

The liquid anhydrous ammonia tanks contained ammonia at the time of the explosion. A detailed survey of the tanks and the pressure relief valves was conducted on May 28, 2013. Figure 19 shows the tanks as photographed by the CSB on April 19, 2013 and the PRV at the West end of the north Anhydrous Ammonia tank can be seen along with the PRVs in the middle of the South tank. The PRVs on the north tank still had their weather caps on and consequently did not relieve. The PRVs in the middle tank were missing the weather caps. A close up photo of the PRVs from the southern tank taken on May 28, 2013 is shown in Figure 20. There is no evidence of the caps melting in the photograph nor is there evidence that these valves had been hit by a piece of debris. It is unknown if the missing caps were recovered by the BATF during site cleanup; however, it is not known if this set of pressure relief valves may have opened at some point during the fire prior to or after the explosion. The Anhydrous Ammonia tanks were manufactured in 1963 by Delta Southern Co. of Baton Rouge, LA. The tank label is provided below in Figure 21 and provided the following specifications concerning the tanks:

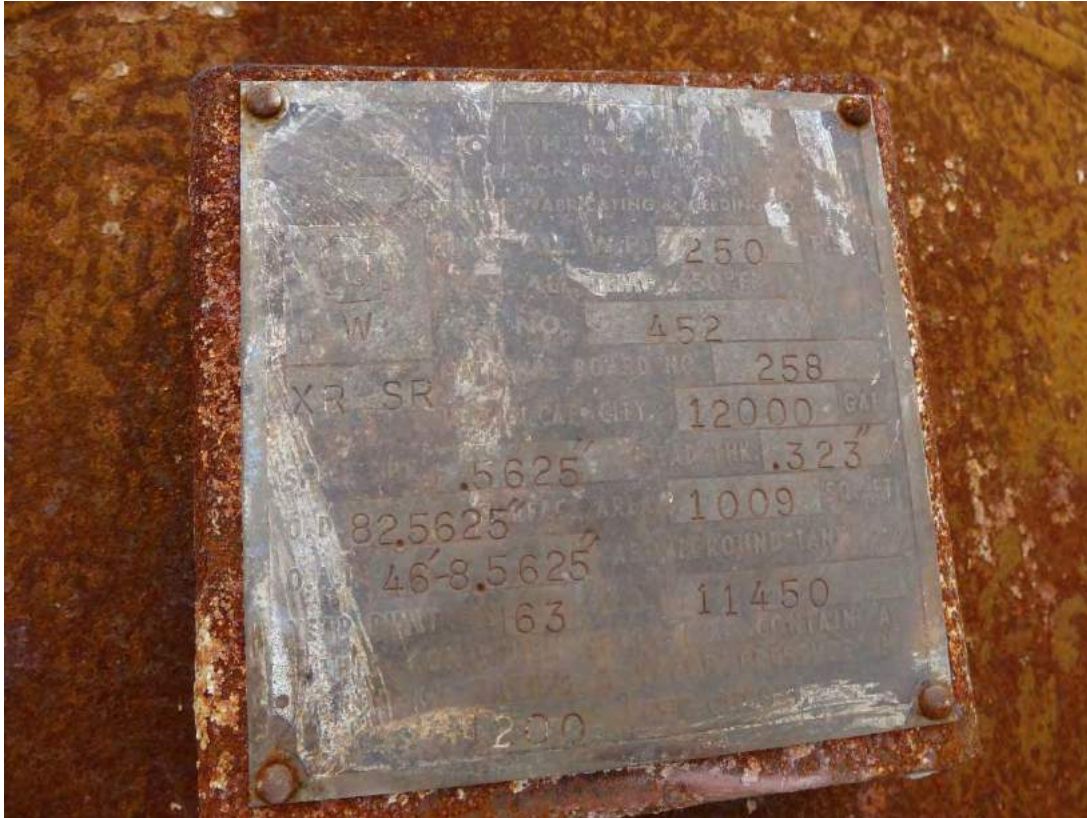
Figure 21. Plate on Anhydrous Ammonia Tank

Maximum Allowable Working Pressure	250 psi
Maximum Allowable Temperature	650 F
HSB No.	452
National Board No.	258
Water Capacity	12,000 Gallons
Shell Thickness	0.5625"
Head Thickness	0.323"
Outside Diameter	82.5625"
Overall Length	46'-8.5625"
Year Built	1963

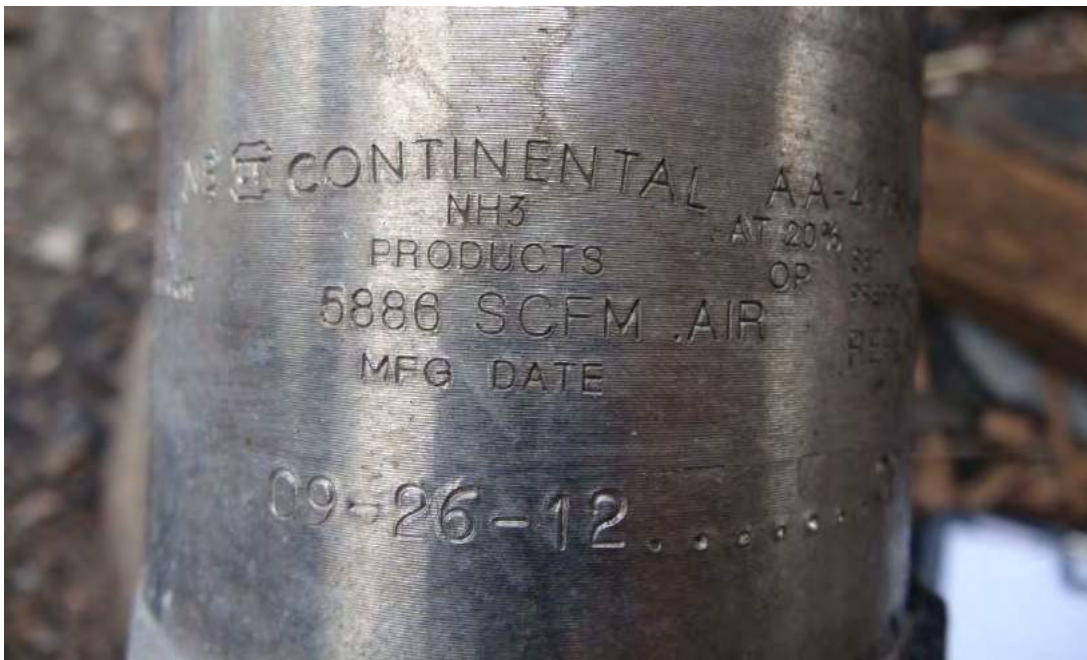
Figure 22. Pressure Relief Valve Markings

One of the pressure relief valves from the west end of the north Anhydrous Ammonia tanks was knocked off during the site cleanup effort. It is presumed that this occurred when the crane and lift bucket were operating in the area. This occurred prior to the site inspection on May 28, 2013; however, the pressure relief valve that was knocked off of the tank was located on the ground directly adjacent to its original position on the tank. The pressure relief valve markings were photographed as shown below in Figure 22.

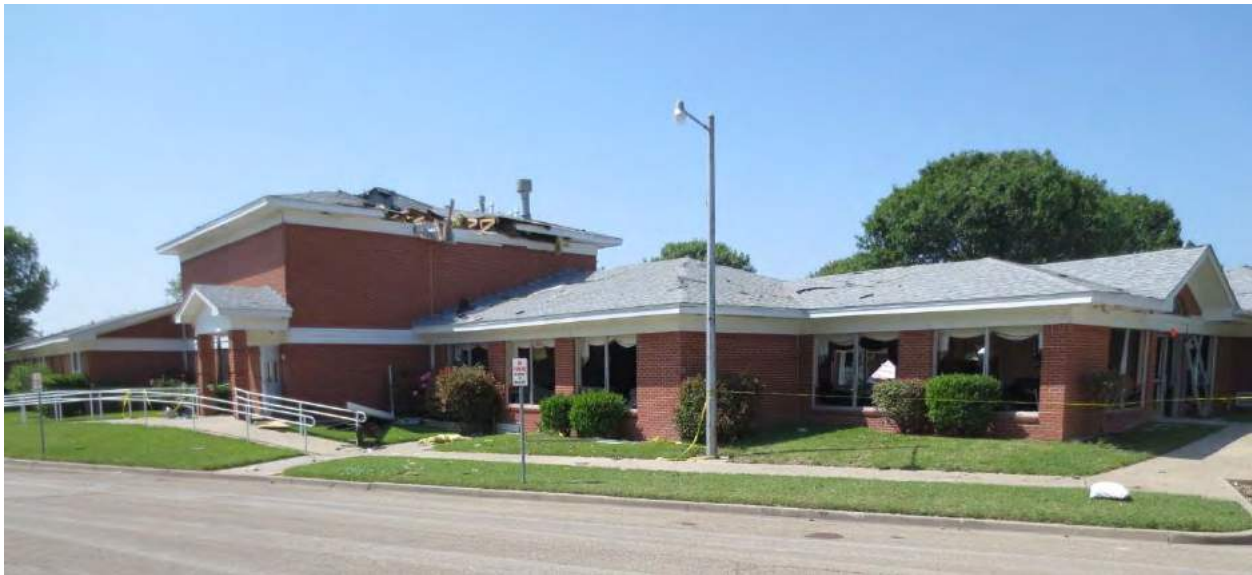
Figure 24. Rest Haven Nursing Home

The Rest Haven Nursing Home, 300 W. Haven St., was located at the corner of N. Reagan and W. Haven streets and was approximately 650 ft. to the west of the crater and is shown below in Figure 24. ABS Consulting surveyed Rest Haven Nursing home on the 24th and 25th of April, 2013. The nursing home was constructed of load bearing wood stud walls with brick veneer and wood trusses which spanned across the wings from exterior wall to exterior wall. A copy of the emergency exit plan which shows the floor plan and room layout of the Nursing Home is shown below in Figure 25. The eastern most corridor of the nursing home was the most heavily damaged by the explosion. The roof trusses collapsed and the east wall was failed by the explosion as shown below in Figure 26 through Figure 28. The eastern rooms were heavily damaged and subjected to flying wall debris, window fragments and failing drywall, insulation and light fixtures from the ceiling. A photo inside a bedroom from the East hallway is shown below in Figure 29. The glazing hazards were high with glass shards penetrating the wall opposite the windows. Ceilings, insulation and interior contents of rooms were lying on beds, blocking doorways and would have presented hazards to occupants of these rooms. Additionally there would have been air blast infiltration into the rooms through the failed windows. It is important to note that this photo was taken after search and rescue operations in the nursing home. Rescuers undoubtedly conducted a room by room search, moving debris, to ensure that there were no victims present.

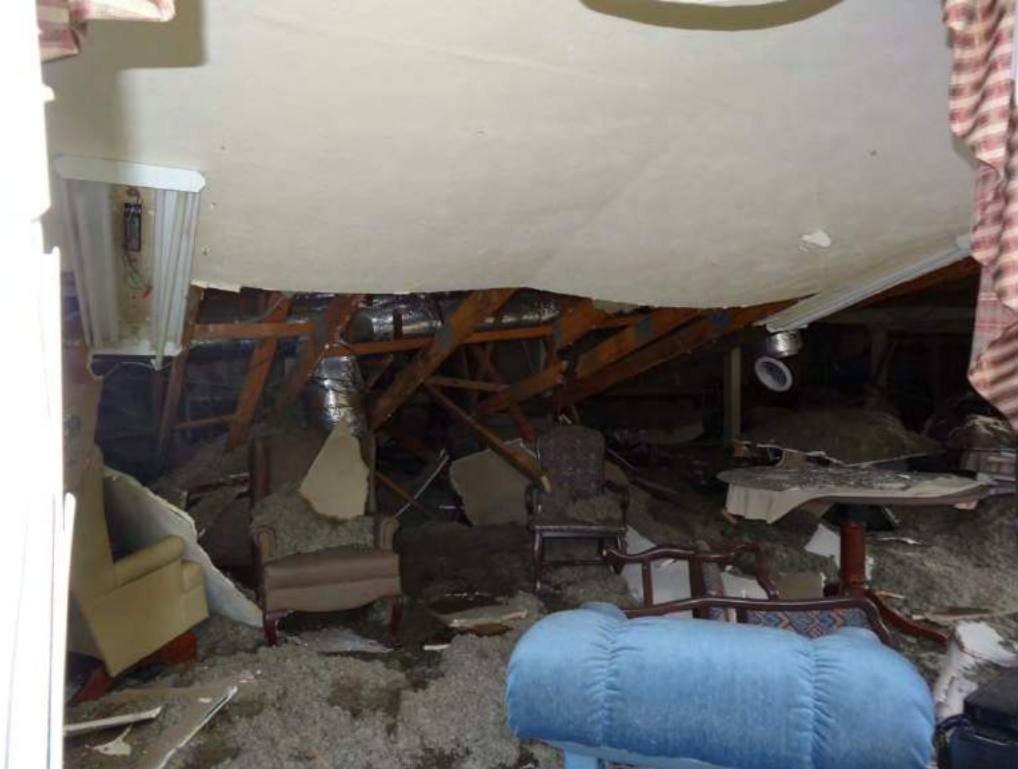
Figure 30. West Lobby of Rest Haven Nursing Home

There was also significant damage to the western portion of the nursing home and the great rooms, such as the lobby, which were damaged particularly heavily due to the large spans of the overhead trusses that failed and were held up by furniture, as shown in Figure 30. In addition, hallways in this area (see Figure 31) presented many hazards including hanging light fixtures, failed ceiling joists and collapsed drywall and insulation on the floors.

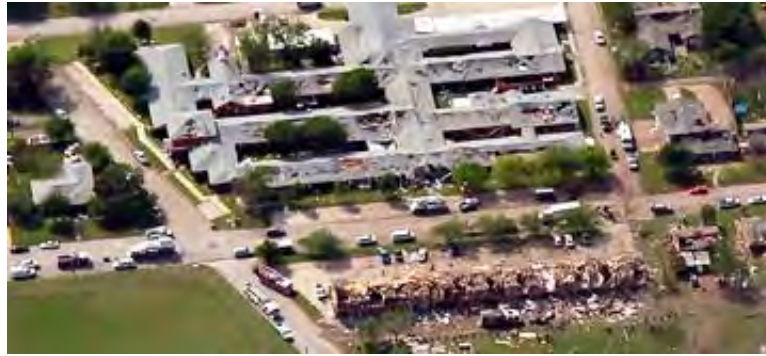
Figure 32. Post Incident Aerial View of Rest Haven Nursing Home (Debris Impacts)

The Rest Haven Nursing home was within the debris field for secondary fragments from the West Fertilizer Production Building and the crater ejecta, which was constituted of massive pieces of concrete from the fertilizer plant foundation and significant masses of earth. Figure 32 clearly shows numerous debris impacts to the roof of the Nursing Home. A large piece of the fertilizer plant foundation measuring 16 inches wide by 16 inches tall and 36 inches long, shown below in Figure 33, was observed to have impacted room 79, travelling through the roof and the exterior wall. The piece of debris was calculated to have weighed approximately 800 pounds and had sufficient momentum that after exiting the nursing home and striking the ground the fragment travelled an additional 60 feet and came to rest just to the west of N. Davis St.

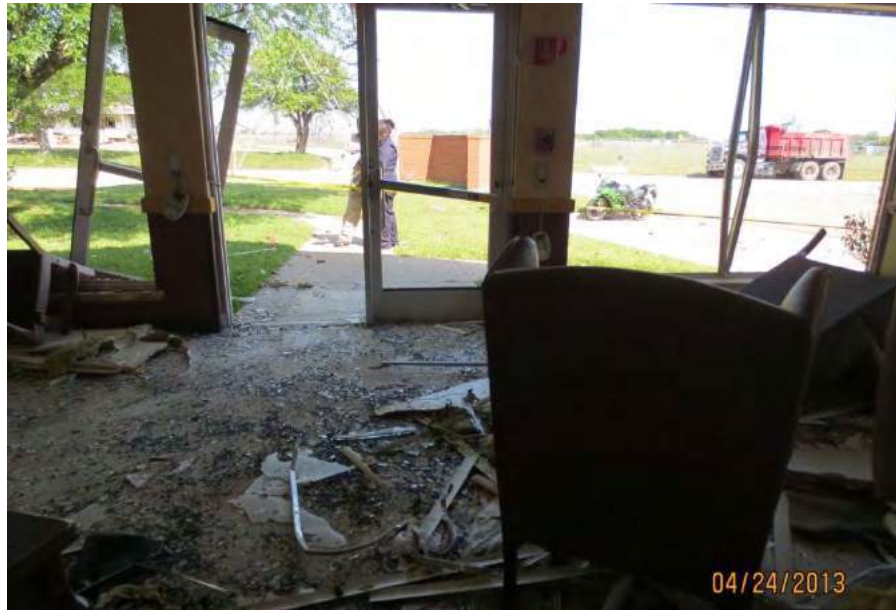
Figure 34. Typical Glass Fragments on Floor and Into Rooms of Rest haven Nursing Home

A simple observation made by the entry team including the CSB, Atlas Engineers, and ABS Consulting, was that we walked on glass with almost every step that was taken inside of the nursing home, with the exception of the hallway corridors that were shielded from windows by interior partitions. The great rooms, lobby and patient rooms were subjected to significant glazing hazards as can be seen below in Figure 34 and Figure 35.

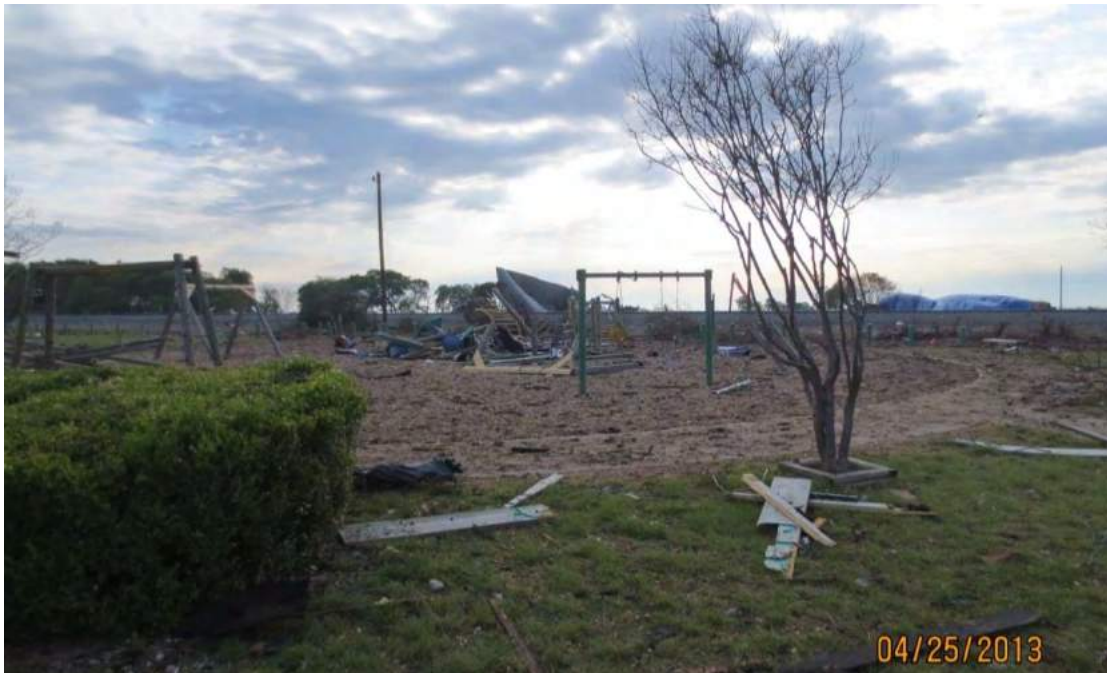
Figure 36. Playground

The playground area of a local park, located directly to the west of the West Fertilizer property, is shown below in Figure 36. The equipment on the playground was destroyed by the blast as shown below in Figure 37. Two items of note were observed in this area. The first was the damage to the basketball goal posts on the basketball court. These items were utilized as blast damage indicators and are discussed in further detail in Section 5.1.2. In addition, the trees in the vicinity of the park showed evidence of scorching as highlighted below in Figure 39. The scope of work^[3] did not include making a determination whether these trees were scorched from the fire or from another source but it is noted as an item of interest^[46]. The trees are directly downwind of the anhydrous ammonia tanks as shown in Figure 40. The trees were not located within the smoke plume from the fire. Pre-explosion video of the fire shows the smoke travelling with the wind but crossing the playground equipment to the north of the basketball courts. A screen shot from one of the videos is provided below in Figure 41.

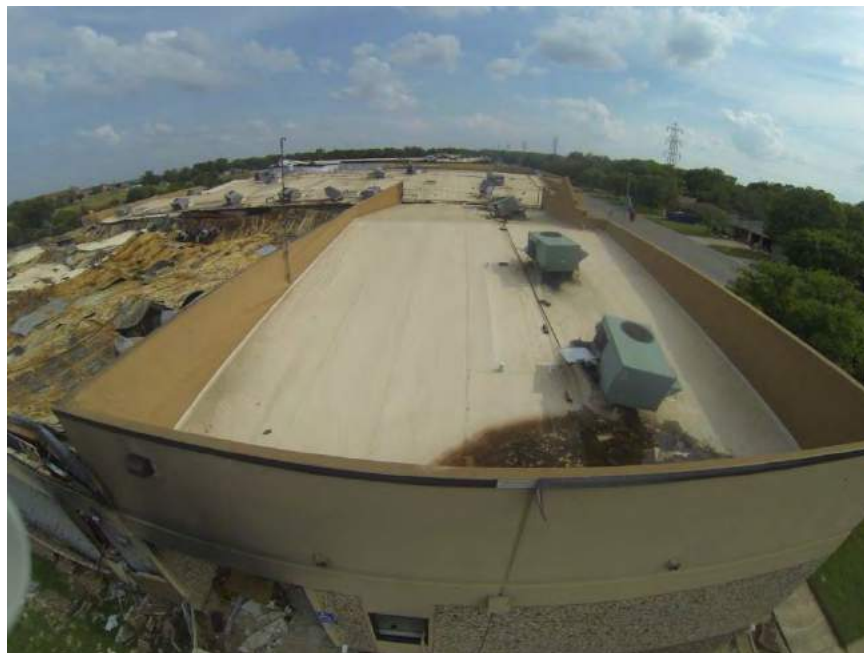
Figure 45. West Intermediate School – Northwest Wing Roof

The roof of the northwest portion of the school above Room 12 is shown below in Figure 45. Figure 46 shows the amount of debris in the hallway outside of Rooms 11 and 12 (photo is looking North towards the exit). An interior door frame was blocking the hallway, the acoustic ceiling was down and there are numerous obstacles that would have made exiting the building difficult for students and staff. In addition, the original metal school building just to the south of this location was involved in a fire so there would have been smoke and heat to contend with as well. Figure 47 shows the interior of Classroom 12. The acoustic ceiling, light fixtures and other debris have been thrown onto all of the desks. In addition, the window on the North façade failed violently and a large shard of glass approximately 3 inches long was observed embedded in the assignment poster on the south wall of the classroom as shown in Figure 48.

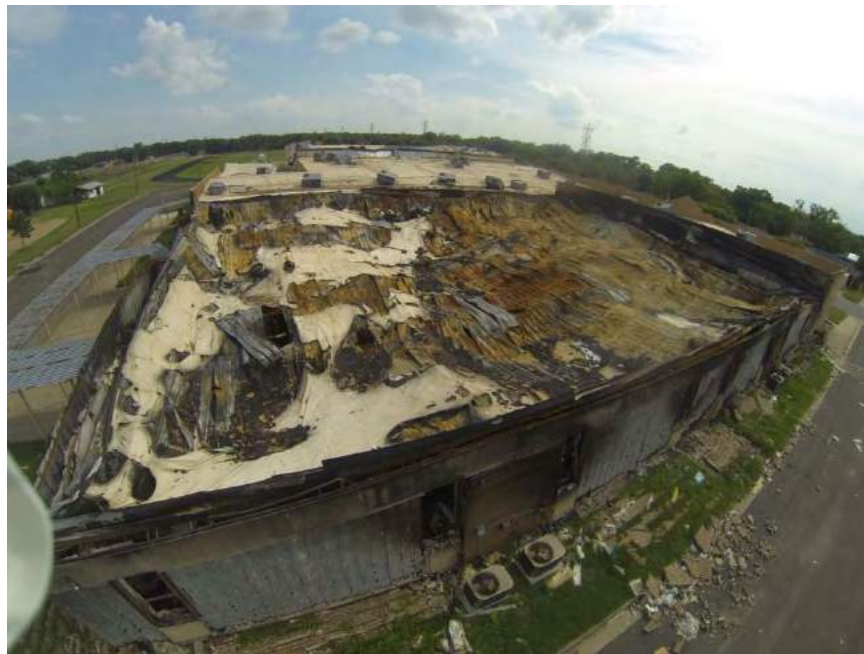
Figure 49. West Intermediate School – Original School Northeast Wing Roof

The pre-engineered portion of the school in the northeast corner was heavily damaged by blast overpressure and was also fully involved in a fire. Damage to this portion of the building could not be evaluated due to the magnitude and heat associated with the fire. An aerial view of the roof is shown below in Figure 49 and a view looking East down the hallway of this portion of the School is shown below in Figure 50.

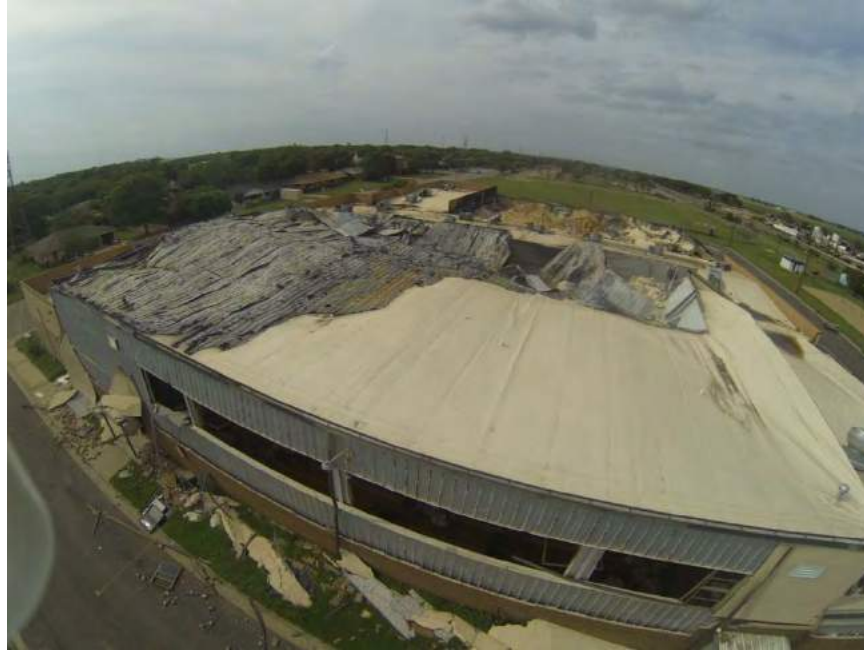
Figure 51. West Intermediate School – Gymnasium Roof

The Intermediate School gymnasium, shown from above in Figure 51, was heavily damaged by the explosion at West Fertilizer. There is evidence that some of the built up roof over the gymnasium burned; however the level of heat damage to the roof was minor compared to the damage from blast overpressure. It is clearly evident in Figure 51 that the north half of the Gymnasium roof has failed. A view of the gymnasium from the interior is shown below in Figure 52 and Figure 53. The pre-engineered frames are heavily damaged by the blast and are unstable as a result. The roof purlins are moderately deformed with the exception of where they have failed on the north half of the frame spans. In addition, the windows from the south façade of the gymnasium have failed and been propelled over the south bleachers onto the gym floor by the overpressure. The roof in the cafeteria to the south of the gymnasium was also heavily damaged by the explosion as shown below in Figure 54. At the time this photograph was taken, significant cleanup and debris removal in this space had already begun.

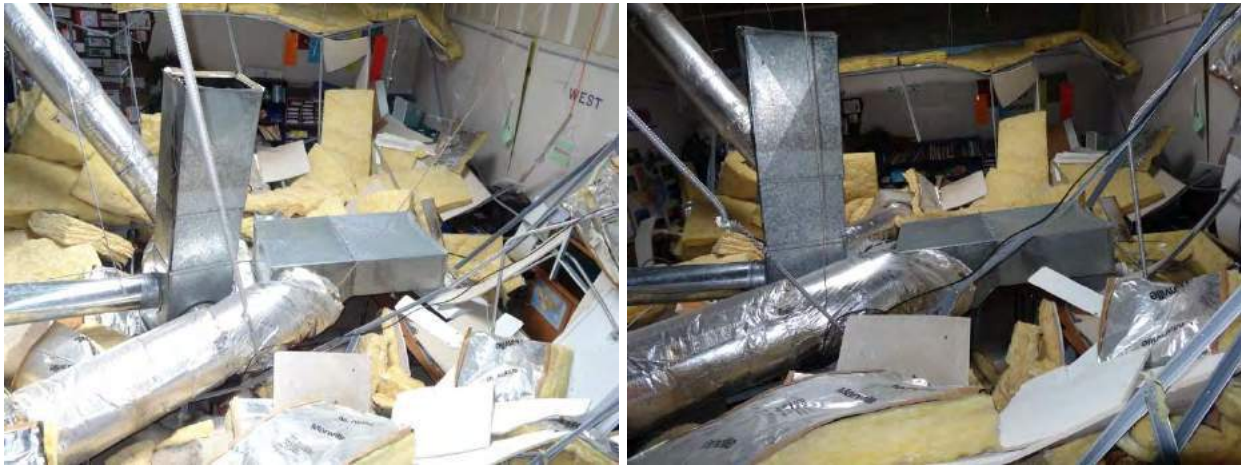
Figure 55. West Intermediate School – Classroom 20 Nonstructural Debris

explosion. The complete contents of the ceiling plenum are located on top of the desks. Any persons present in the room would have been covered in this debris and would have had to climb their way through to reach the exit. In addition, there was evidence of overpressure having entered the room through the HVAC opening of sufficient magnitude to fail the door latch as shown below in Figure 56. Although it is possible that first responders may have forced the door open, it is noted that school was not in session during the explosion, there were no tool marks on the door or other evidence of forceful entry from the exterior, and the debris inside the room was undisturbed and had not been moved for a thorough search of the room.

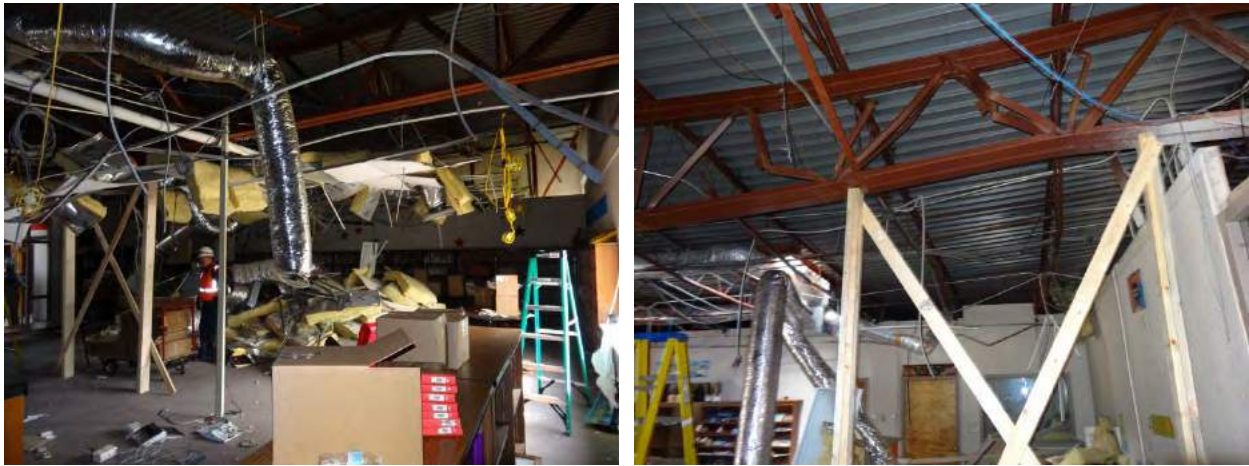
Figure 57. West Intermediate School Library after Shoring and Debris Removal

Damage to the Intermediate school reduced as the distance from the explosion source increased from the northeast to the southwest. For reference, the interior of the Library is shown below in Figure 57 and the Band Hall in Room 22 is shown below in Figure 58. The Library was in the process of having the books and other contents recovered so workers had shored the failed Joist Girder (Figure 57) and stacked insulation and removed a significant portion of the debris in the library. Significant glazing hazards can be observed from the glass fragments on the floor a great distance from the windows in Room 22 shown in Figure 58. As in the Library, clean up and recovery activities had begun and the debris stacked in the center of the room.

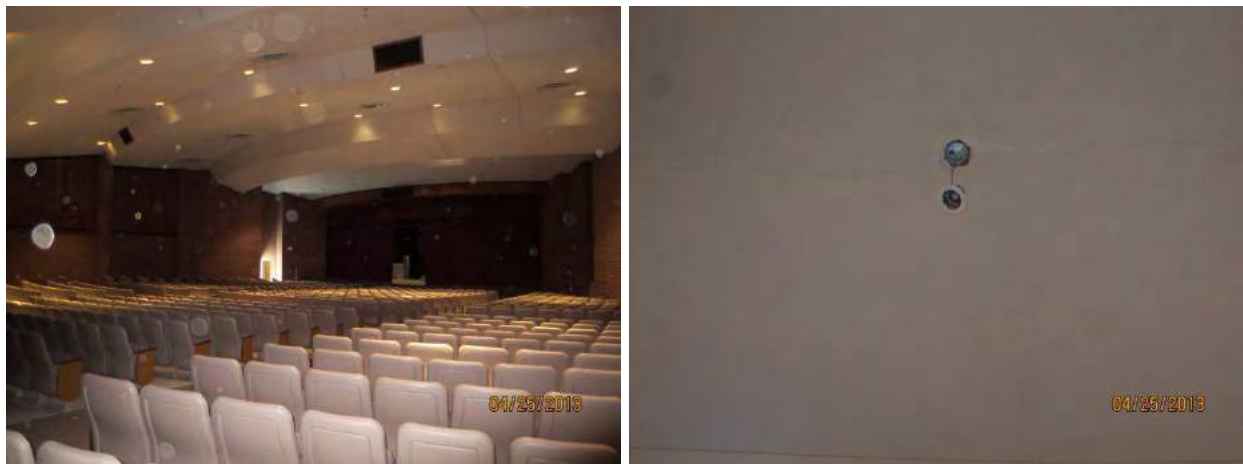
Figure 61. High School Auditorium as Ceiling as Viewed from Below

The Auditorium of the High School was a steel frame structure with masonry infill walls. Some of the masonry veneer on the exterior was loose near the northeast corner. Inside the auditorium, large areas of the hanging ceiling were unstable and the supporting structure was compromised especially the area of the ceiling between the seating and the stage which was near collapse due to the failed hanger connections. Evidence of damage to the ceiling from underneath was observable at light fixtures and evidence of cracking and separation near the walls as shown below in Figure 61 was also observed. However, the severity of the damage and compromise to the ceiling hangers became evident when inspected from the catwalks above as shown in Figure 62.

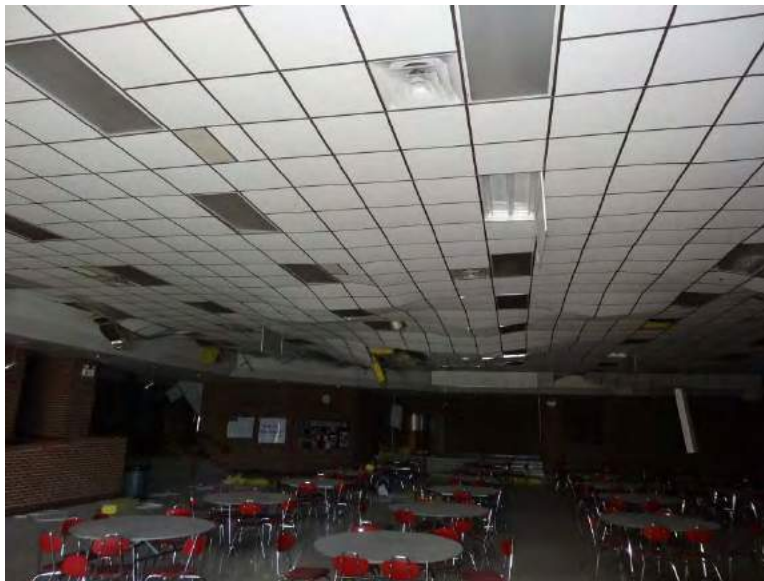
Figure 63. Commons Area Ceiling Damage

The Commons area outside of the auditorium is shown below in Figure 63. Partial collapse of the acoustic ceiling and light fixtures hanging from their conduits were observed. Structural damage to the ceiling joist could not be observed due to obstruction by the acoustic ceiling.

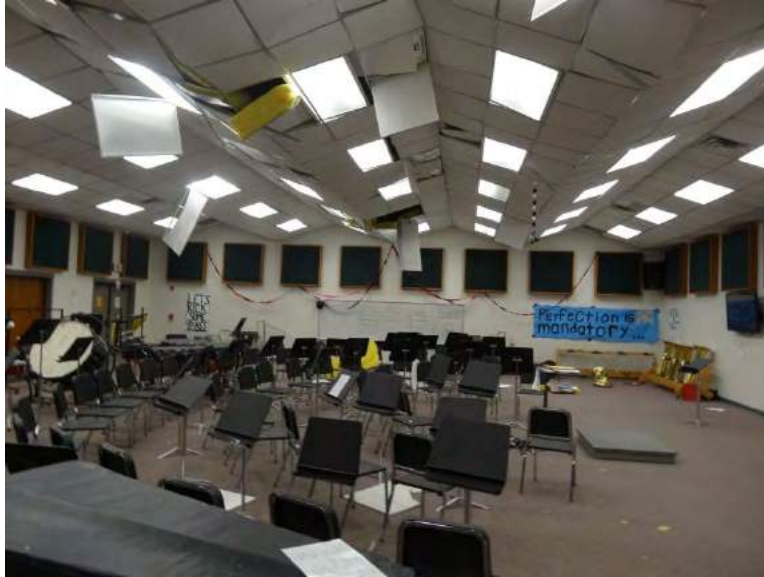
Figure 64. West High School Band Hall

Similarly, the Band Rooms, shown below in Figure 64, also exhibited partial collapse of ceiling assemblies and hanging light fixtures.

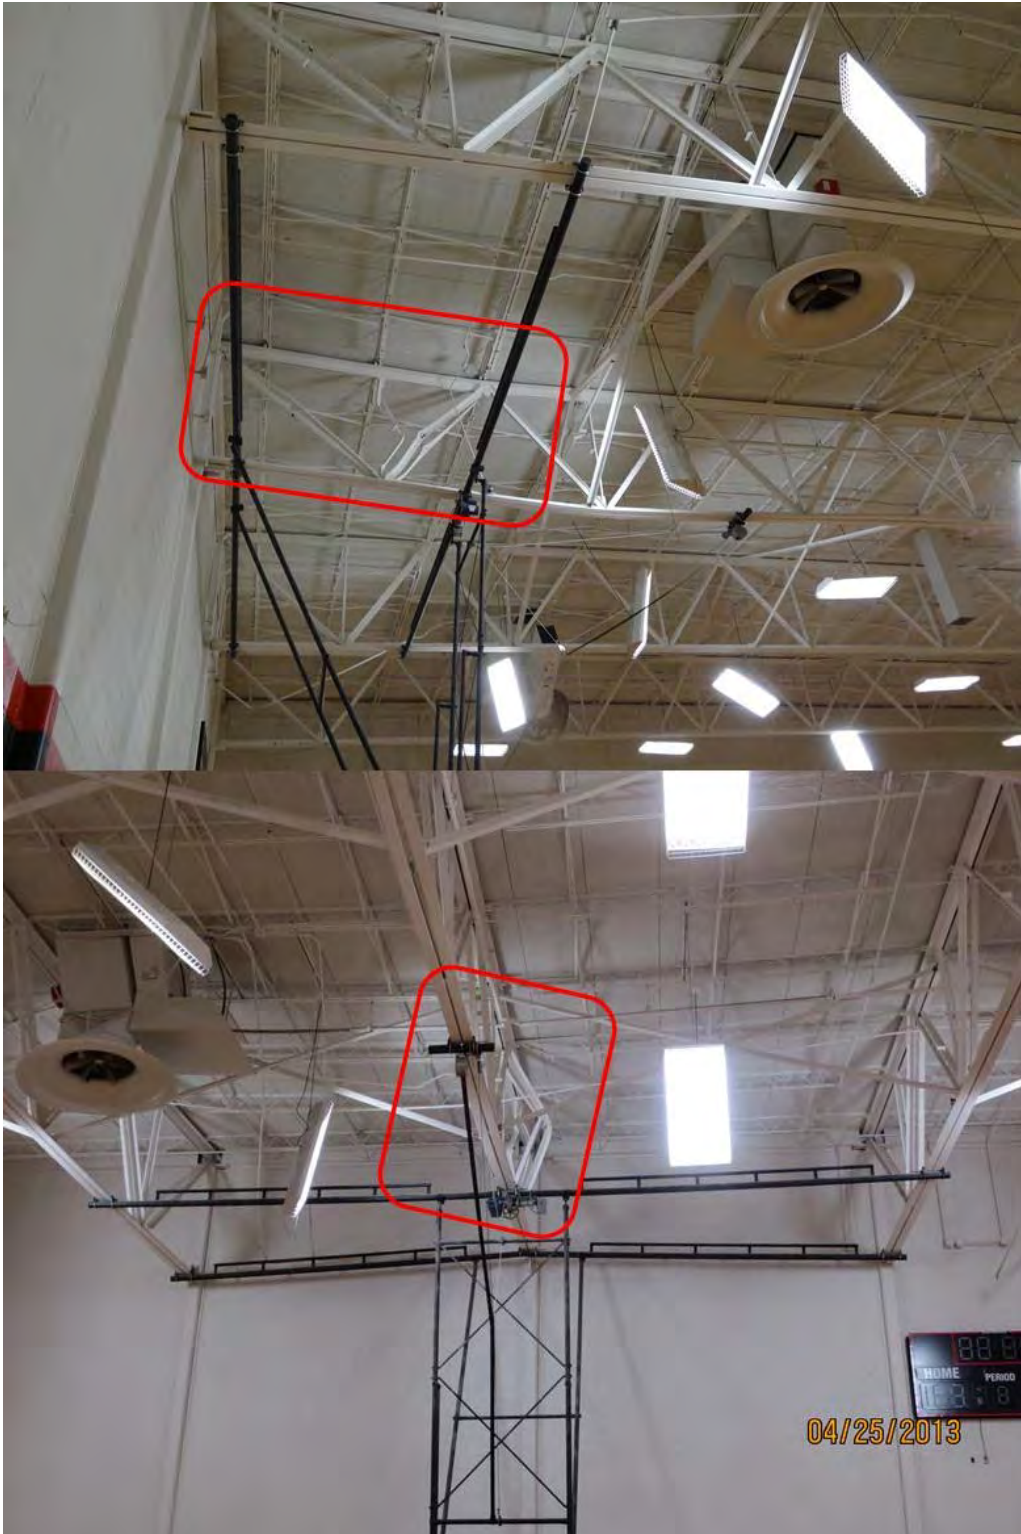
Figure 65. Joist Girder Damage in Gymnasium 2

Gymnasium 2, which is the northern most of the two gymnasiums, across the hall from the band hall, was heavily damaged by the explosion and the roof structure, was unstable, and near collapse. Severe damage to the main roof trusses, as highlighted below in Figure 65, was observed. The joist girders appear to have been damaged by a combination of out-of-plane blast load on the roof and the in-plane loading resulting from the masonry wall reaction into the roof diaphragm. The damage to the joist girders was more pronounced in the middle of the room than near the side walls, which was consistent with the point of maximum deformation of the masonry wall resulting in the point of highest in plane loading in the diaphragm. The bolts fastening the joist girder cross-bracing were also failed as shown below in Figure 66. A large number of fasteners were found on the gymnasium floor. In addition, the open webbed steel joists that spanned roughly north to south between the joist girders were buckled out of plane, as shown below in Figure 67. It is clear that the gymnasium was subjected to significant racking. In addition, the columns, see Figure 68, were separated from the masonry infill and may have been deformed and the roof was subject to ponding and potential overload.
