ABS Consulting

West Fertilizer Incident Support Services Final Report

U.S. Chemical Safety Board Order No. CSB-15-0022

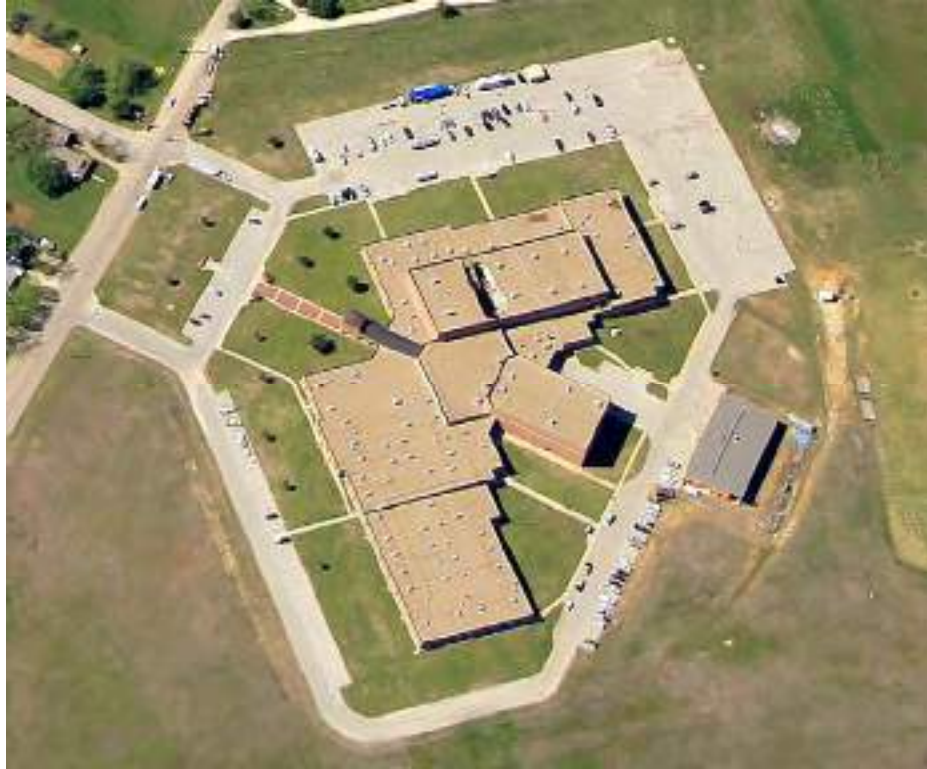
Figure 69. Aerial View of West High School Roof

The roof structure of Gymnasium 1 was more severely damaged than Gymnasium 2 and had collapsed onto the gymnasium floor. The opening in the roof from the collapse can be seen in Figure 69. The collapse as viewed from the south bleachers is provided in Figure 70 and the collapse viewed from the east gymnasium entry is provided in Figure 71. The Gymnasium 1 roof had failed by the same mechanisms that were observed to have damaged the Gymnasium 2 roof, which had yet to collapse. Gymnasium 1 was larger than Gymnasium 2 in plan and therefore was subjected to higher diaphragm loads than Gymnasium 2. Damage to the Gymnasium 1 joist girders are shown below in Figure 72. The potential for injury to occupants of the gymnasium floor underneath the collapsed section of roof would have been high.

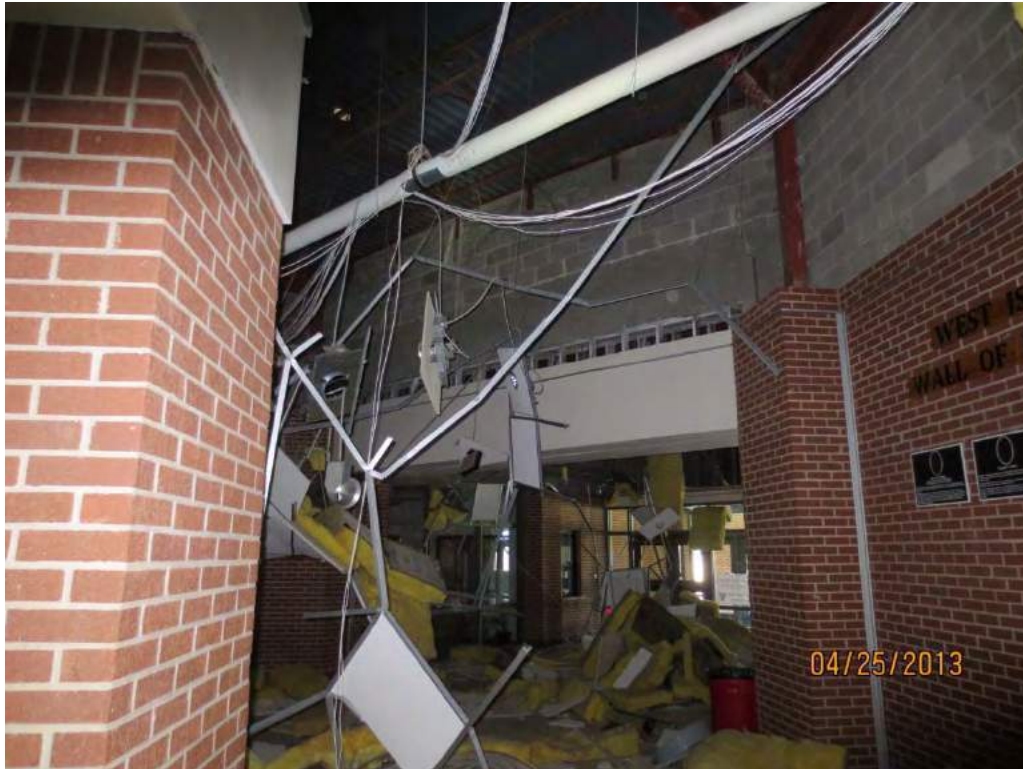
Figure 73. West High School Entrance Lobby

The entrance lobby of West High School experienced almost complete collapse of the acoustic ceiling and there were multiple overhead hanging hazards. In addition, the open webbed steel joists supporting the roof were deformed laterally out of plane. Deformation of the lobby roof was evident when viewed from above.

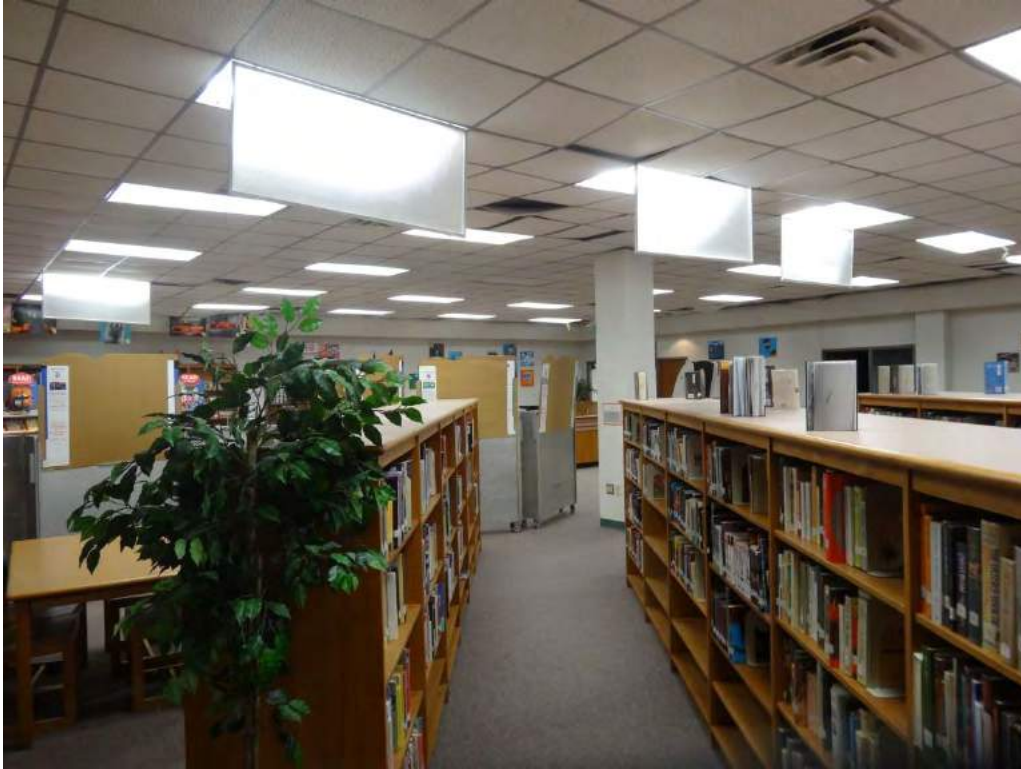
Figure 74. West High School Library

The south wing of West High School was occupied by the responding agencies and utilized for organizing investigation efforts. In general evidence of roof motion could be observed by displacement of the acoustic ceilings which leads to suspicion of possible permanent displacement of roof joists and damage to structural connections in the roof structure. The Library ceiling was still intact but showed evidence of motion, as shown below in Figure 74. The ceiling in the hallway to the east of Room 411 which leads to the Counselors Office, shown in Figure 75, was collapsed on to the floor.

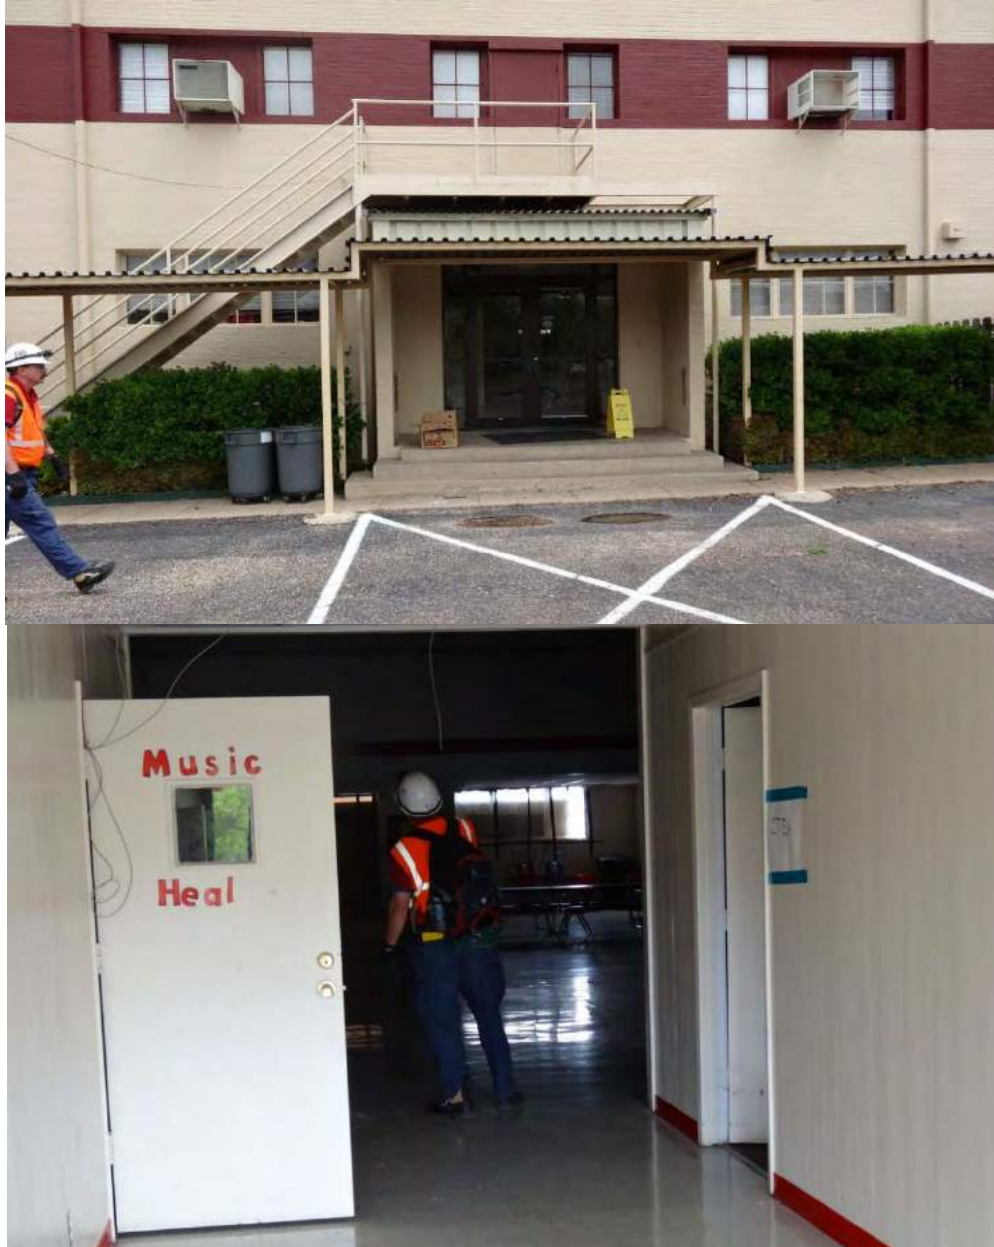
Figure 80. West Middle School Cafeteria / Auditorium

A limited entry into the Cafeteria and Auditorium building was made. The structural components above the ceiling were not readily accessible for inspection and little was known about the condition of the roof; therefore, the team decided that what little data may be available in this particular structure to advance our goal of determining the net explosive weight of the explosion was not worth the potential hazards posed by the high ceiling and unknown conditions. However, the limited observable damage to the building included damage to the ceiling components. As can be seen below in Figure 80, many of the windows on the west façade were unbroken.

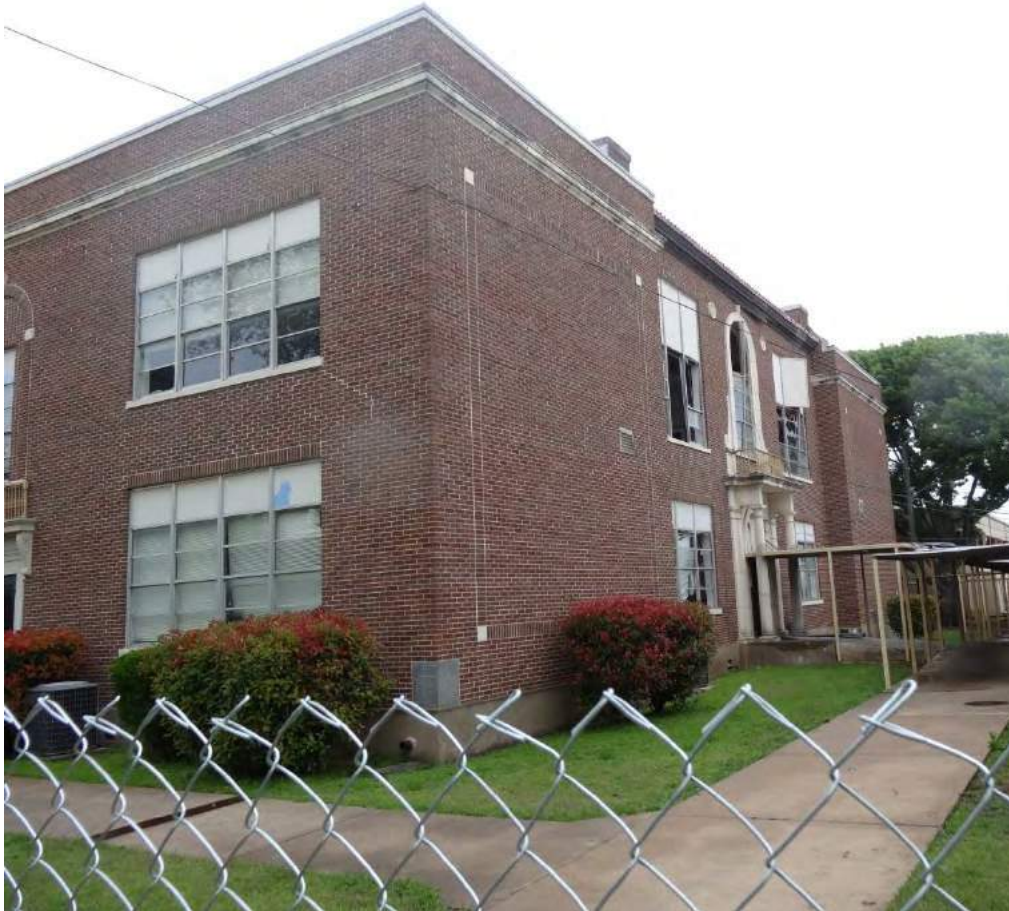
Figure 81. West Middle School – Old High School Classroom Building

The original High School classroom building at West Middle School was constructed in 1923 and is shown below in Figure 81. The windows facing the north towards West Fertilizer were broken and only some of the remaining windows had failed. The building was originally not air-conditioned and had a high tin ceiling. At some point a drop ceiling was installed to allow the building to be conditioned with central air. Upon entry the new drop ceiling had failed; however the original tin ceiling was still in place and some of the windows were broken as shown below in Figure 82. Window hazards were low to moderate and the damage to the building appeared to be superficial; however, observation of the roof framing from underneath was not possible.

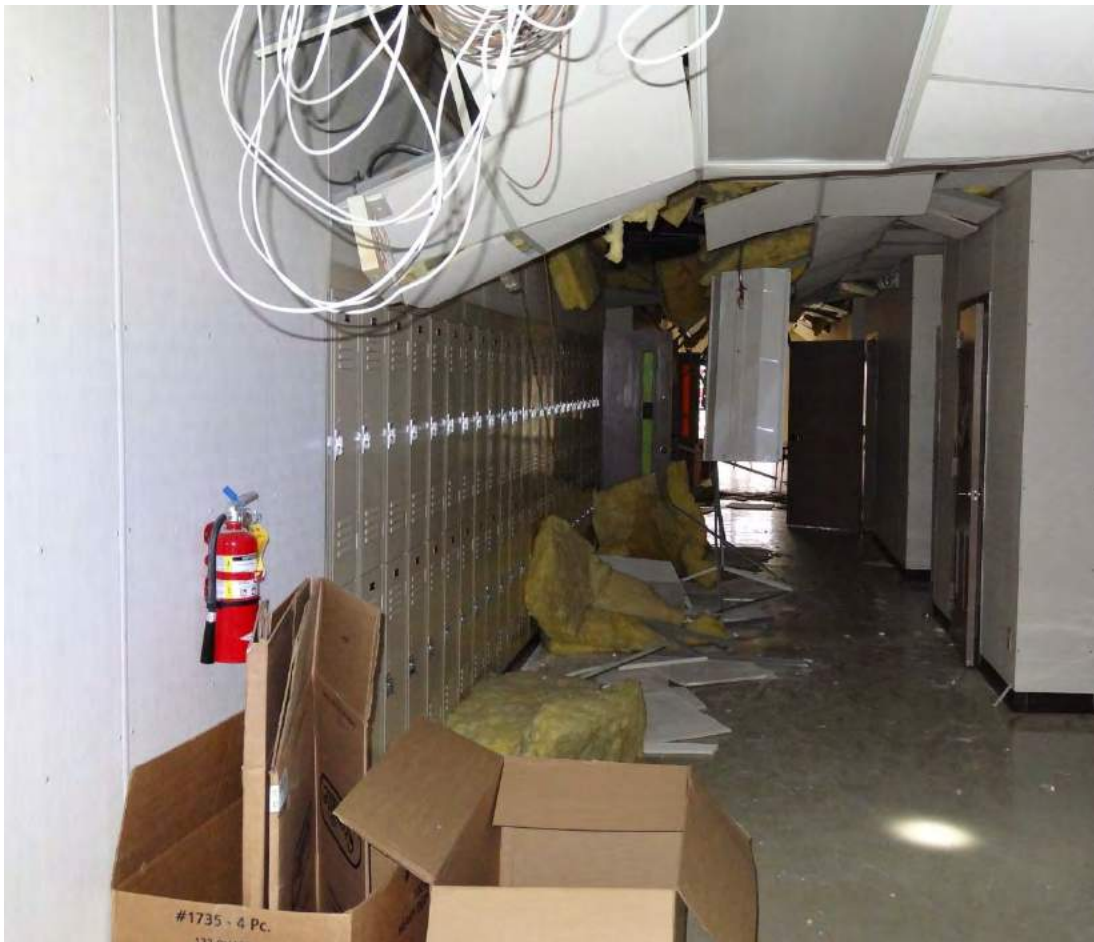
Figure 83. Classroom Annex Interior Hallway and Ceiling Damage

Entry was also made into the classroom annex located in the southeast corner of the campus. The annex classroom building roof structures were open web steel joists supporting a built up roof on metal deck. There was no observable damage to the roof structure. The suspended ceiling was failed from the motion of the roof, as shown below in Figure 83.

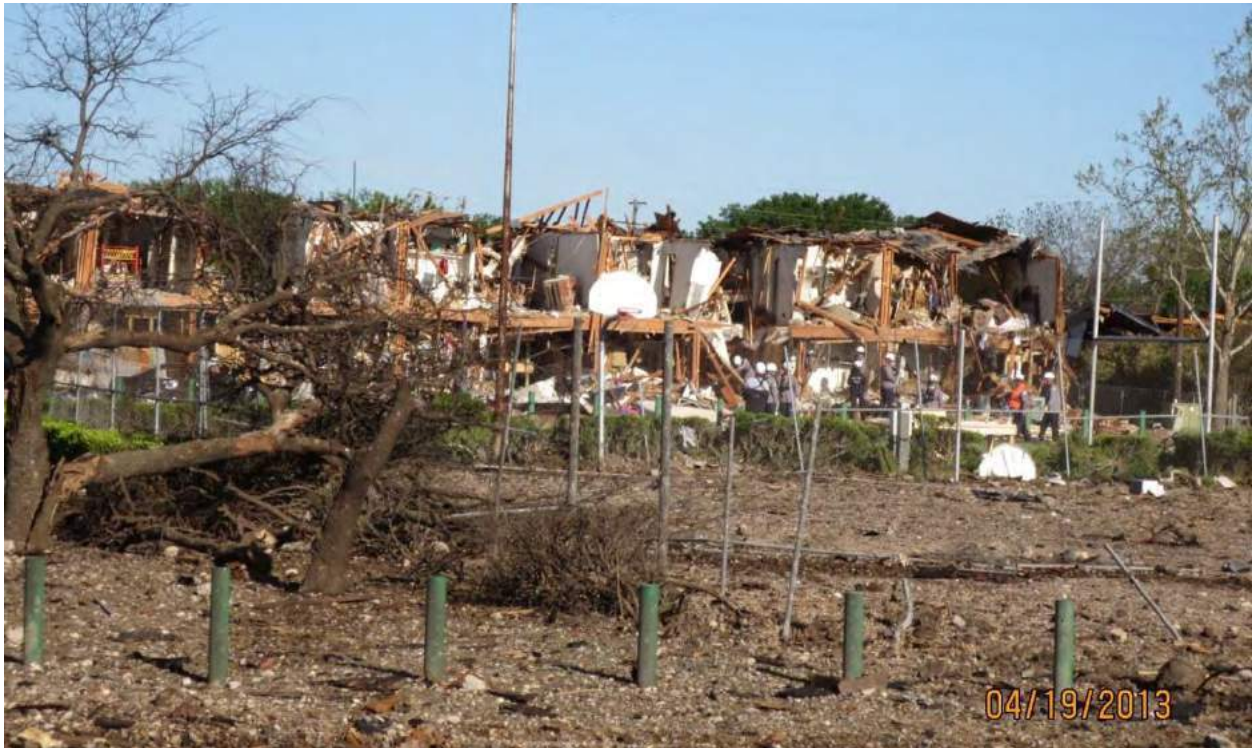
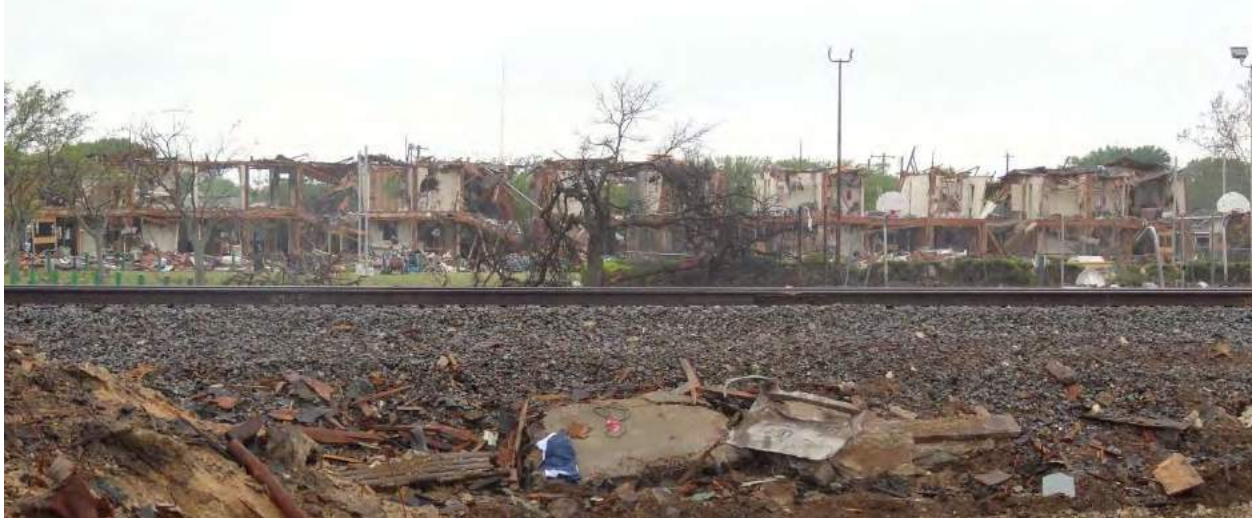
Figure 86. Apartment Complex East Façade

An apartment complex was located approximately 450 feet from the explosion center directly west of the epicenter. The apartment building was heavily damaged by the explosion with failure of all walls and the roof as shown below in Figure 86 and Figure 87. There were two fatalities reported, one occupying the Apartment Complex and one individual on the east side of the apartment complex who was observing the fire.

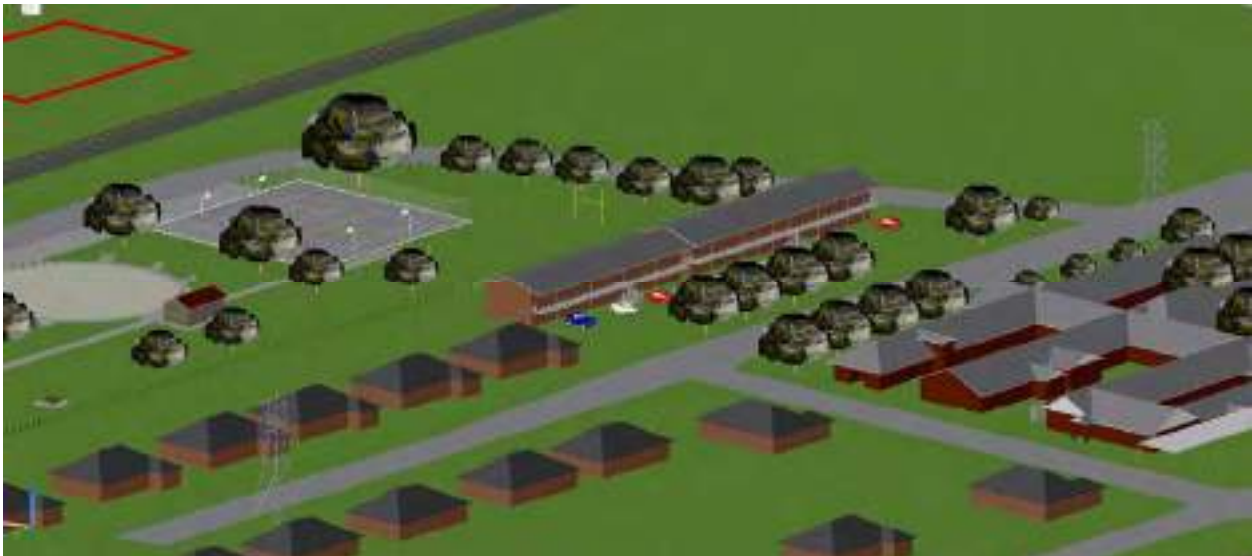
Figure 90. A View of the Blast Site from the Northwest

The area near the blast site was modeled in AutoCAD® for the purpose of importing into a CFD computer code (CEBAM). Figure 89 and Figure 90 show the blast site outlined in red and some of the community surrounding the blast site.

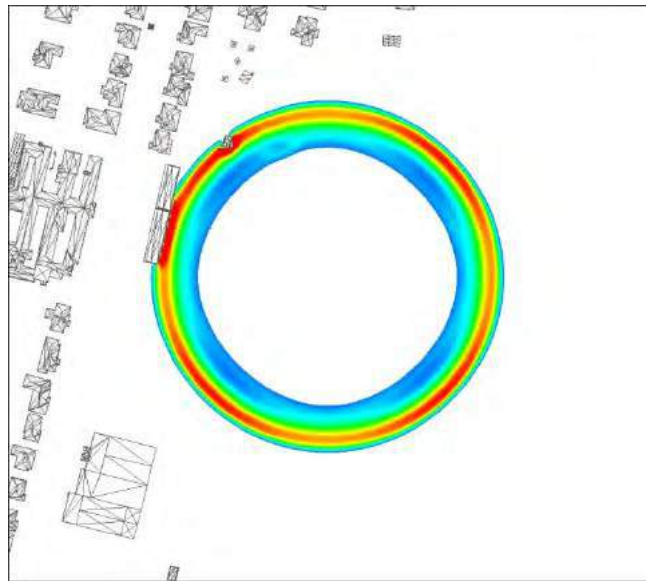
Figure 94. An Example of Overpressures Along the Ground

During the modeling of the individual explosions, overpressures at varying locations in all directions from the blast site were evaluated. The overpressures calculated for each structure were then compared to the field data. Prior to contact with structures, the pressure wave appears circular (as with non-CFD methods) as shown below in Figure 94. However, once the pressure wave comes in contact with structures and other site geometry, the pressure wave will become distorted due to phenomena such as shock reflections, and channeling.

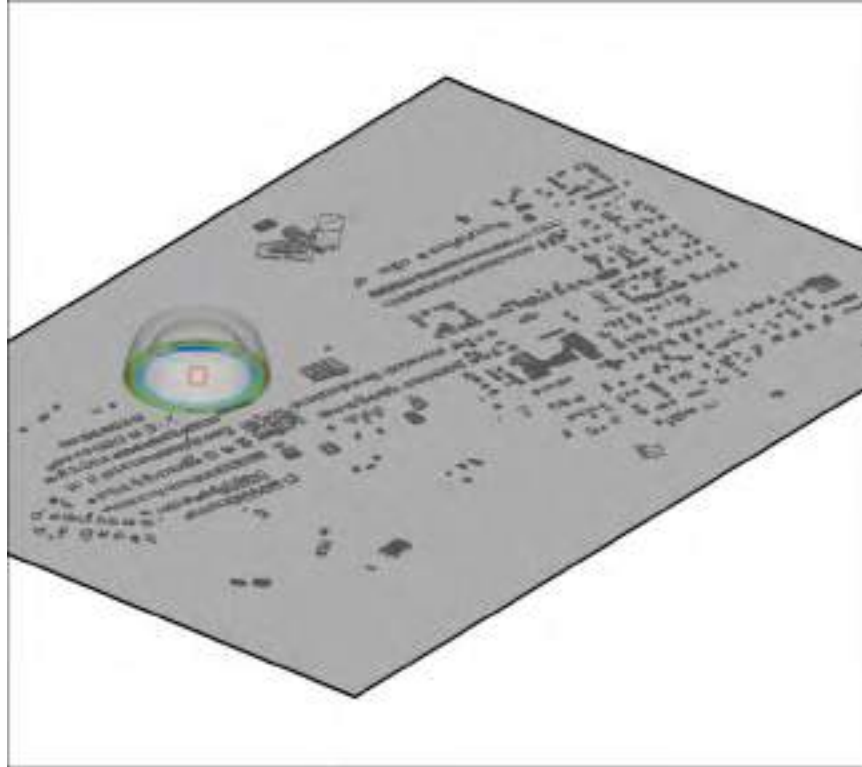
Figure 95. Example of Three-Dimensional Field Data

The data produced is three-dimensional, and therefore overpressures on all surfaces (e.g., wall, roofs) can be assessed. Figure 95 shows a three-dimensional pressure wave in the process of propagating away from the blast site.

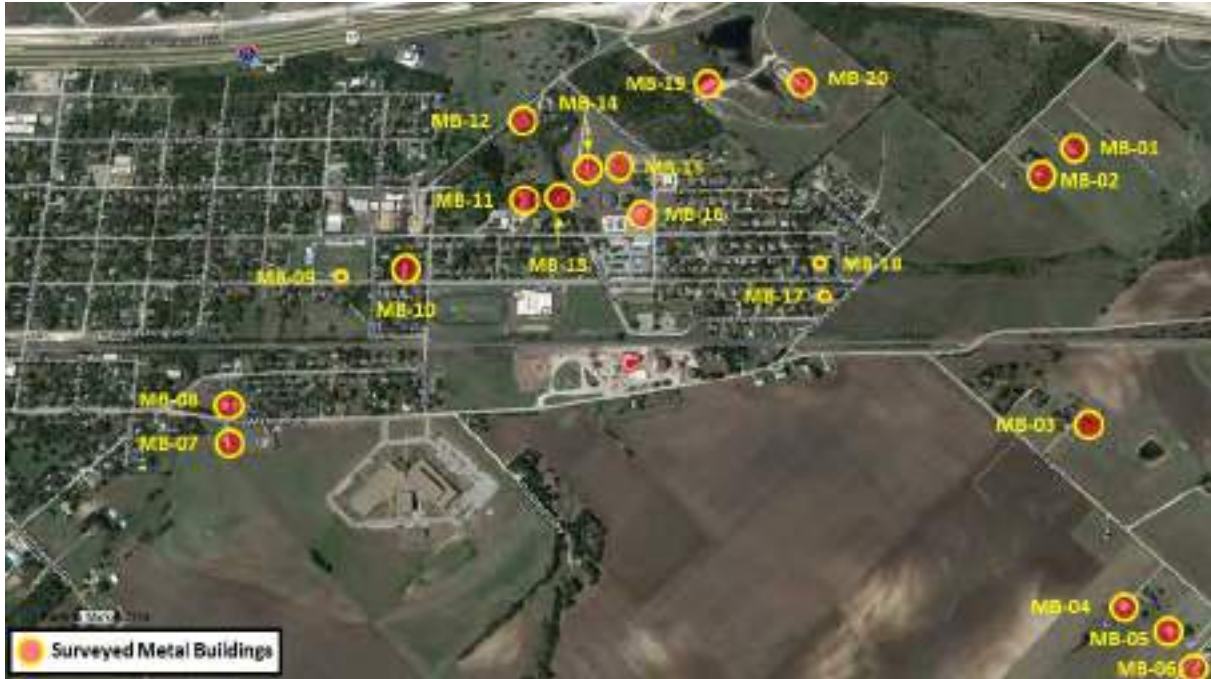
Figure 98. Surveyed Metal Buildings

Figure 98 depicts the location of the surveyed metal buildings and Table 11 summarizes the type of field observation for each one of the metal buildings identified in Figure 98.

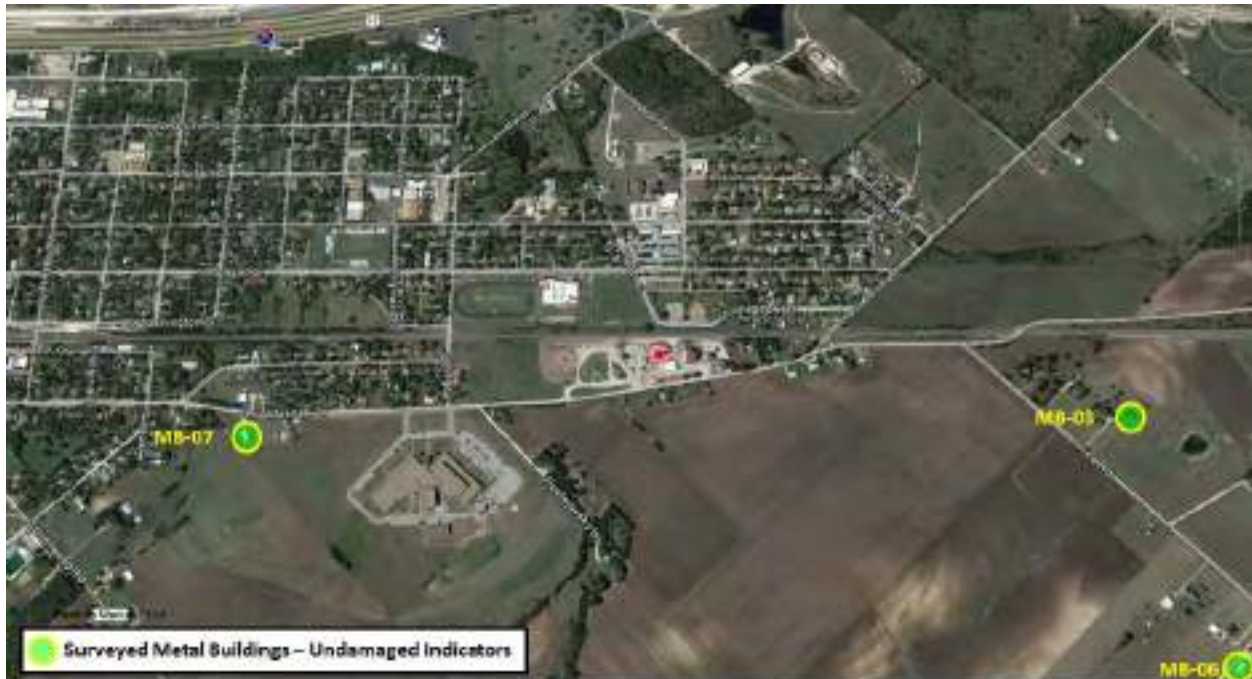
Figure 99. Undamaged Metal Buildings Indicators

Analysis of undamaged indicators established a very high maximum charge weight due to their location in the far field at a great distance from the production building (source location). Undamaged indicators locations (i.e. building locations) are depicted in Figure 99.

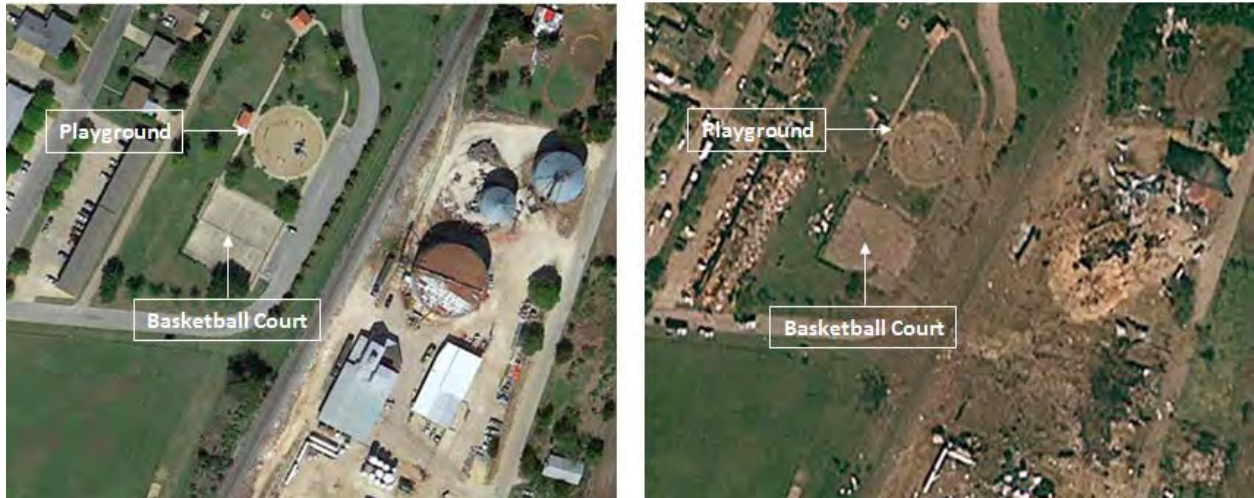
Figure 100. Playground & Basketball Court Plan View – Before and After

A general plan view of the playground and basketball court, before and after the event, is shown in Figure 100. Surveyed basketball goals are depicted in Figure 101 through Figure 103.

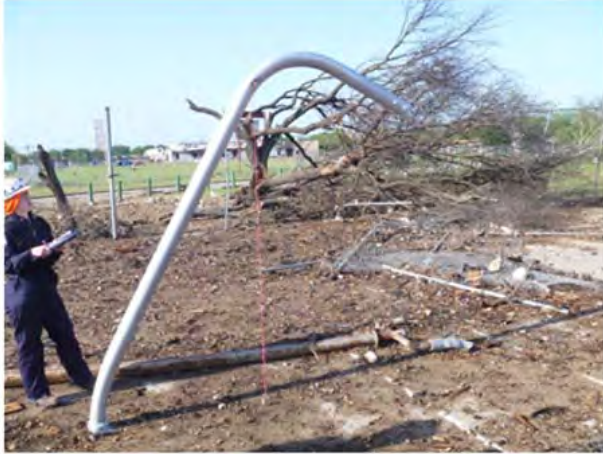
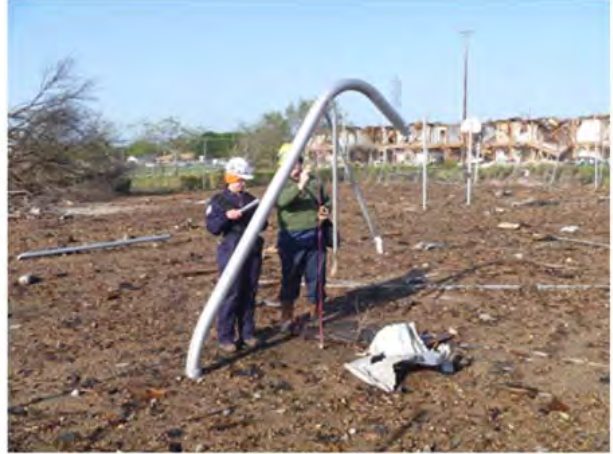
Figure 102. Surveyed Basketball Hoops 1 & 2

Analysis results indicated an average charge weight of approximately 51,000-lb_{TNT}. However, this estimate is known to be high due to the presence of a significant amount of crater ejecta and secondary debris from the Production Building on the basketball court, which can be seen in Figure 102 and Figure 103. Therefore, the damage to the basketball goals was caused by a combination of air blast and debris loading of the goal posts and backboards by the significant amount of secondary debris from the explosion crater and Production Building. The analysis neglects this additional loading and attributes the damage caused by the impact of the crater ejecta erroneously to air blast and thus over predicts the charge weight.

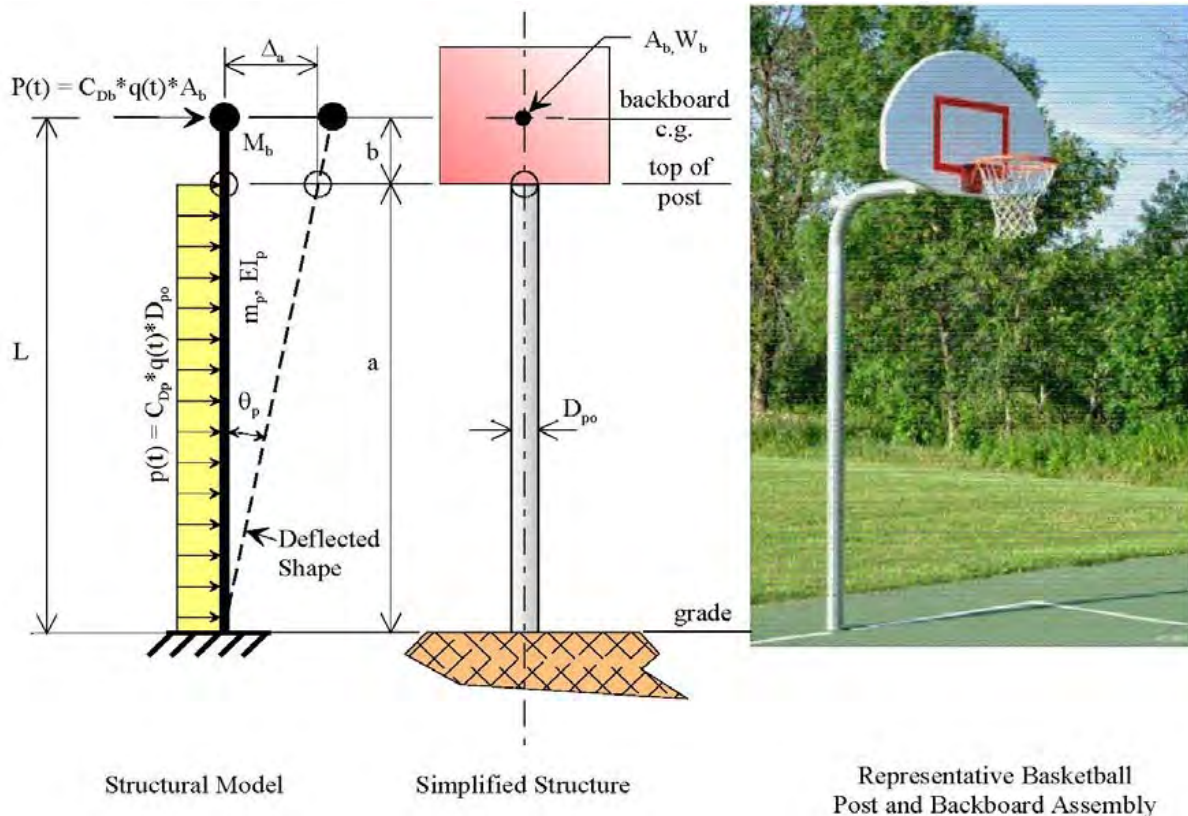
Figure 104. Basketball Goal Structural Model Analysis

Figure 104 describes analytical assumptions model used for the analysis.

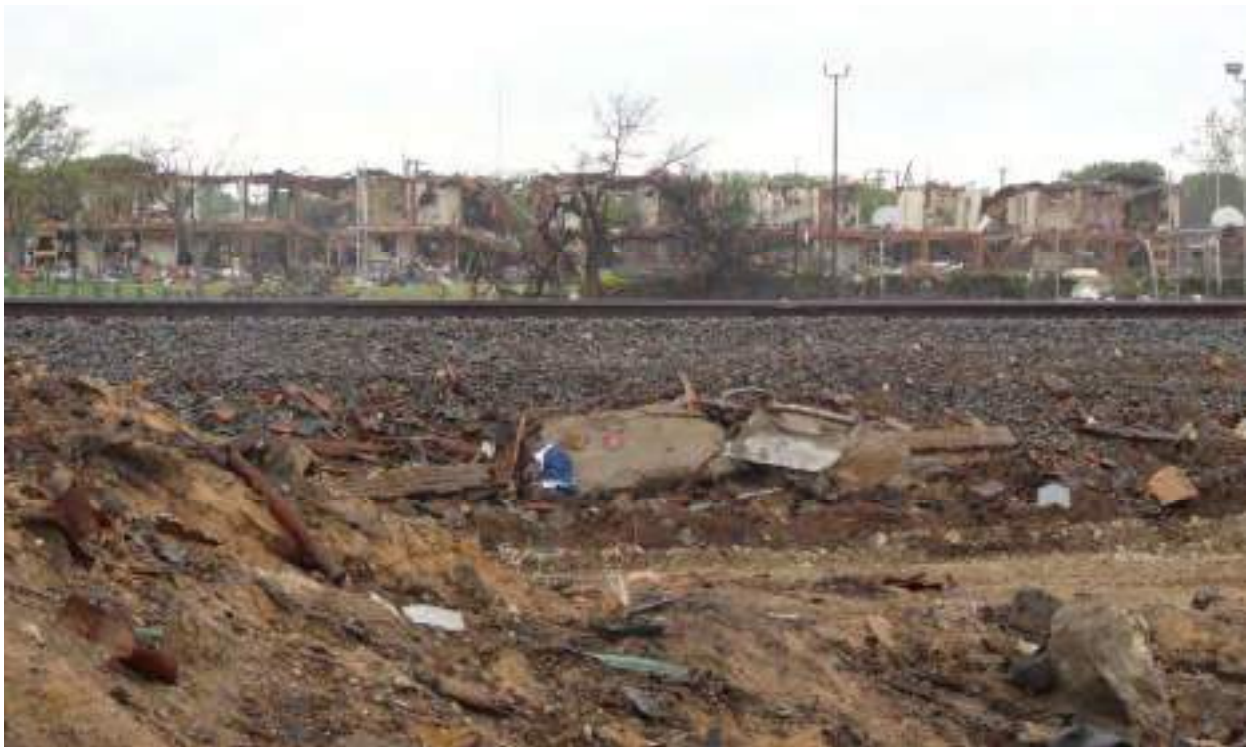
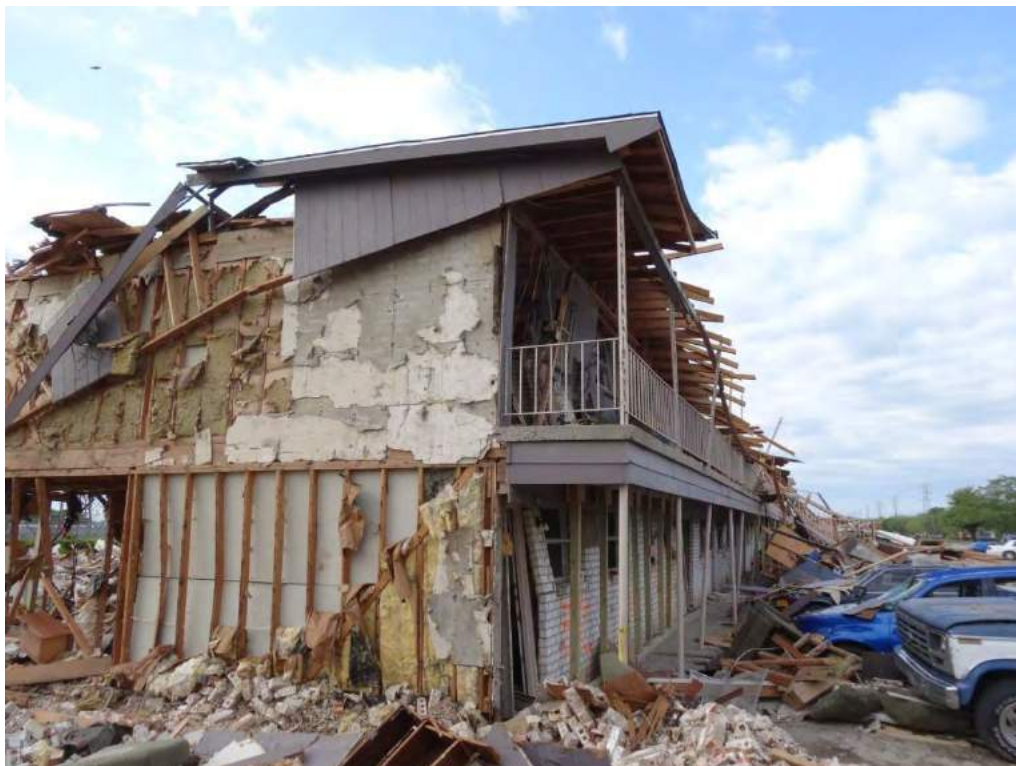
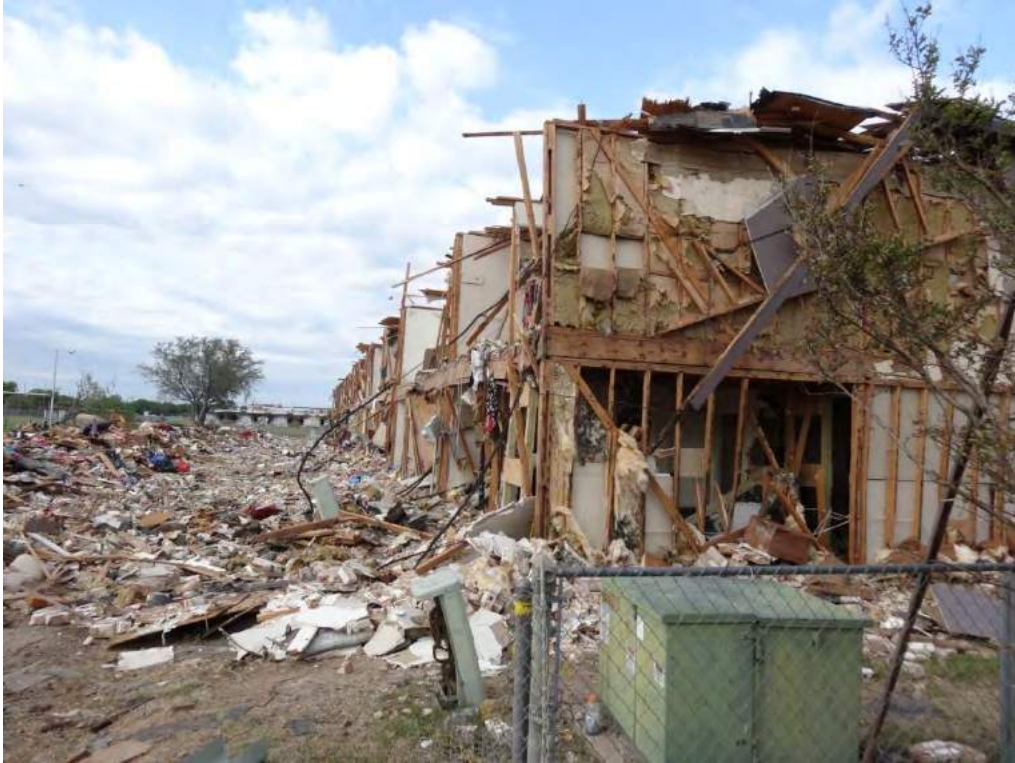
Figure 105. Apartment Complex Damage

A building damage level of [REDACTED] was assigned to the structure based on the observed damage. The definition of [REDACTED] is highlighted below in [REDACTED]. The east façade of the Apartment Complex was at a range of approximately 450 ft. from ground zero. Since [REDACTED] is an area between the charge weight standoff plots shown in [REDACTED] the potential range of charges that could have resulted in the observed damage to the Apartment Complex is [REDACTED] lb_{TNT}.

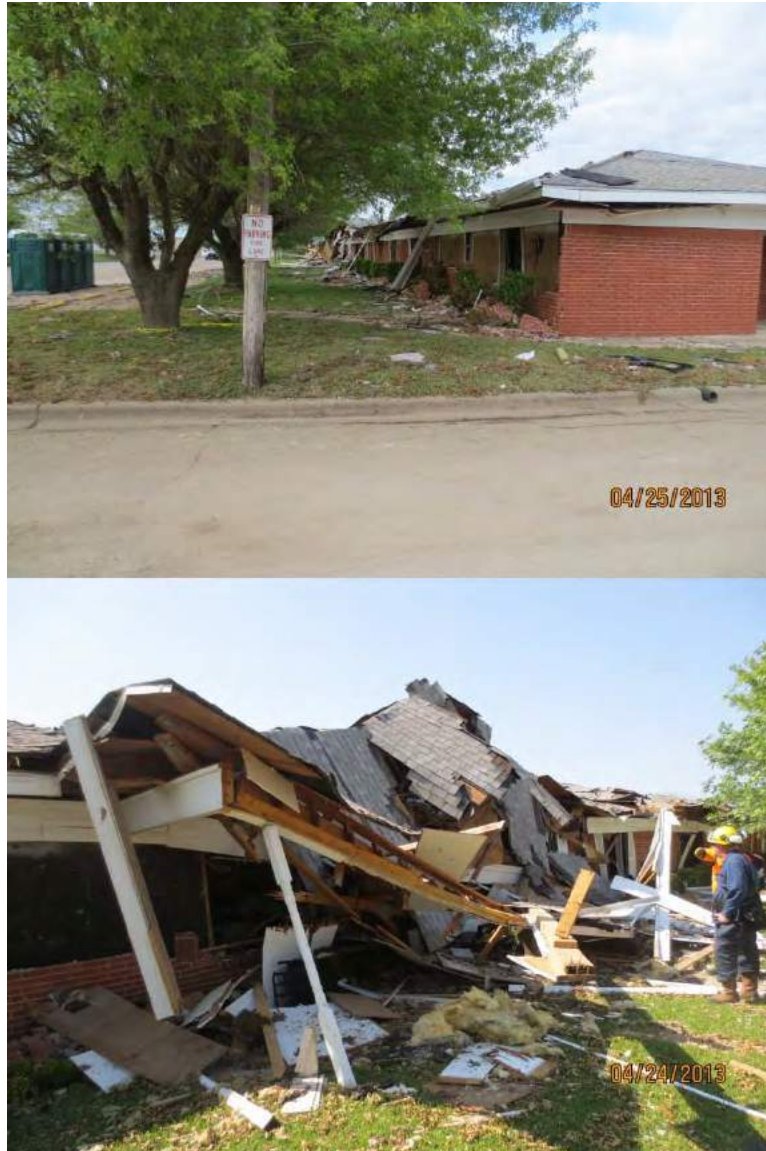
Figure 109. Rest Haven Nursing Home East Façade Damage

[REDACTED] The east façade of the Nursing was at a range of approximately 650 ft. from ground zero. Since [REDACTED] is an area between the charge weight standoff plots shown below in [REDACTED], the potential range of charges that could have resulted in the observed damage to the Nursing Home is [REDACTED] lb_{TNT}.

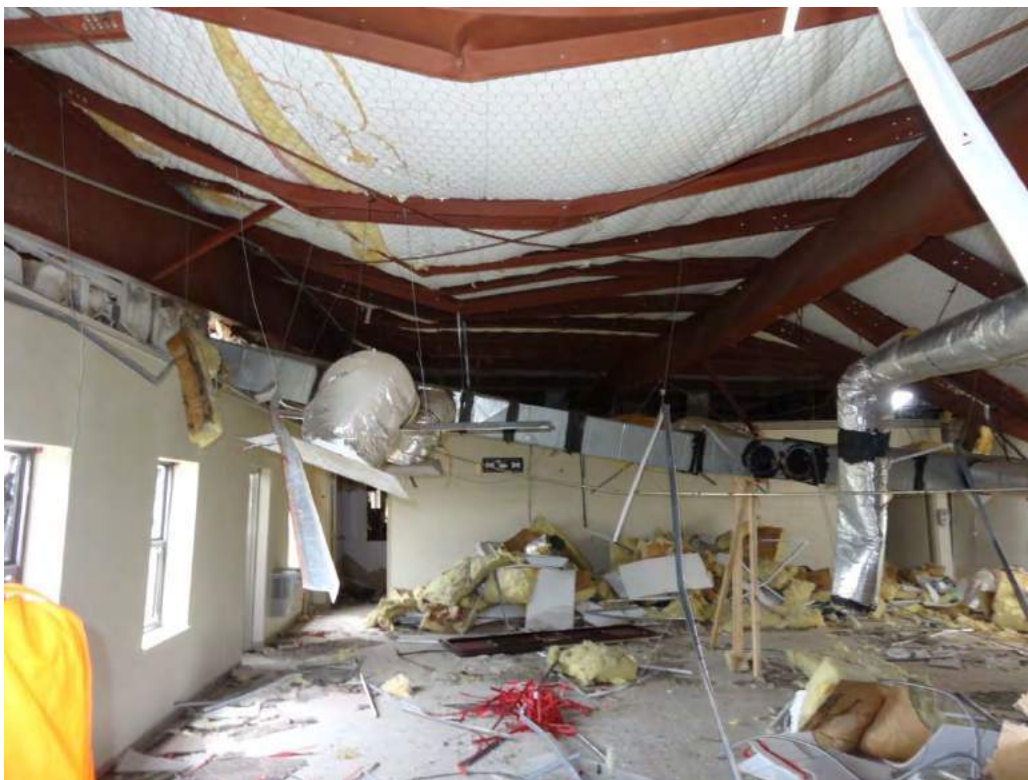
Figure 120. Roof Beam & Purlin Deformation at Cafeteria

A detail assessment of the West Intermediate School was conducted by ABS Consulting on May 29, 2013. General construction characteristics, building section and observed damage were documented (refer to Section 3.2.3). Special attention was paid to the identification of qualitative damaged load indicators that could be used to validate the energy of the explosion (i.e. TNT_{Eq} charge weight). Figure 119 through Figure 122 illustrate some of the documented damage indicators.

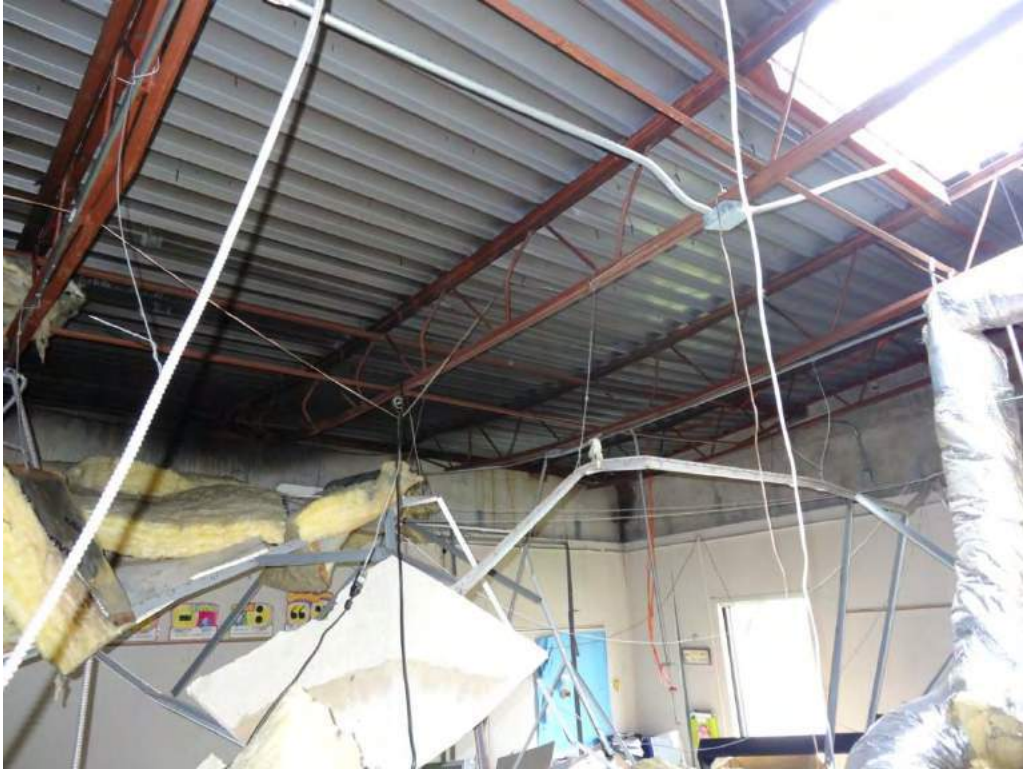
Figure 121. Deflection of OWSJ at Room 18

A structural plan of the West Intermediate School roof system was generated based on the data collected during the facility assessment, as depicted in Appendix A. It is noted here that although the open webbed steel joists were intact, they were heavily damaged (Reference Figure 121 and Figure 122) and were observed have undergone significant deformation which may have generated load redistribution mechanisms in the joist which are not included in the structural models used herein.

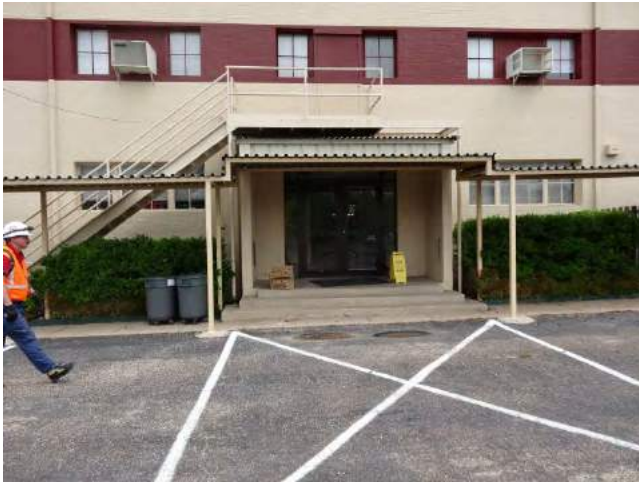
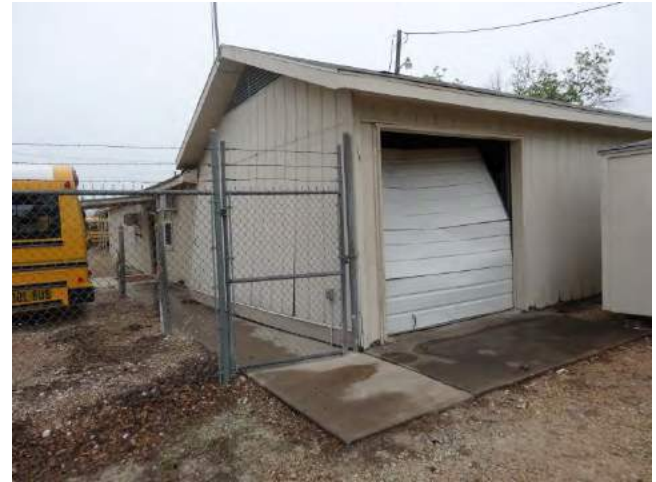
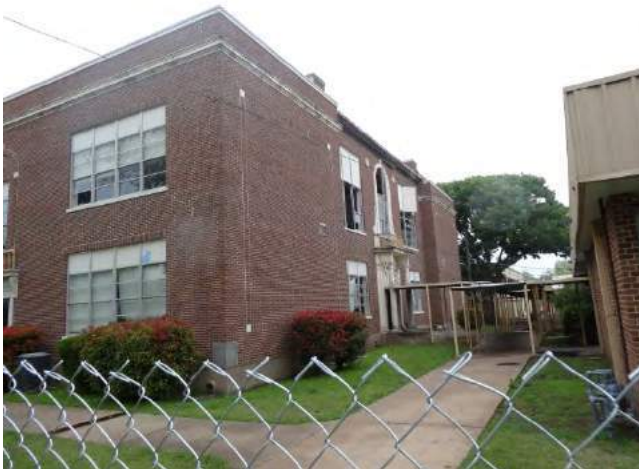
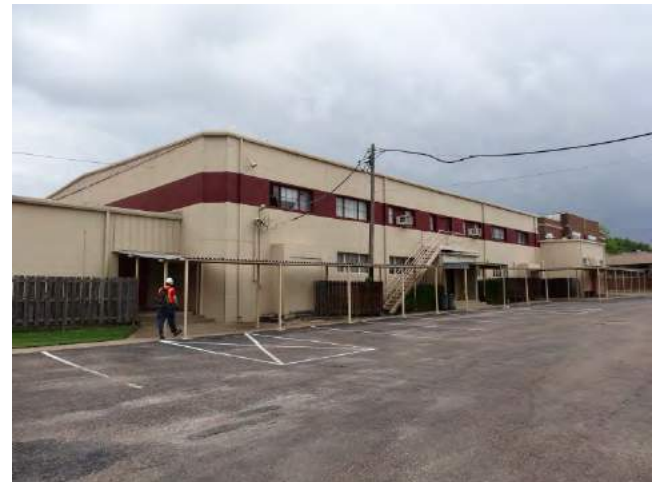
Outside Perimeter

Damage Assessment

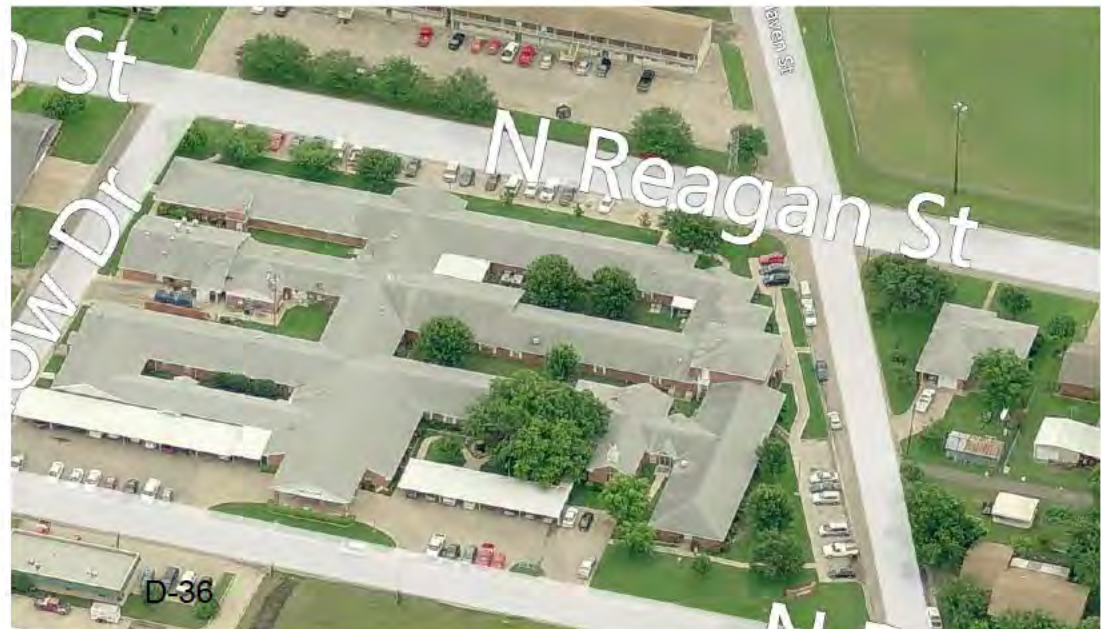
West Nursing Home

- Construction:

- Walls: wood stud wall & brick veneer
- Roof: wood roof truss
