ABS Consulting

West Fertilizer Incident Support Services Final Report

U.S. Chemical Safety Board Order No. CSB-15-0022

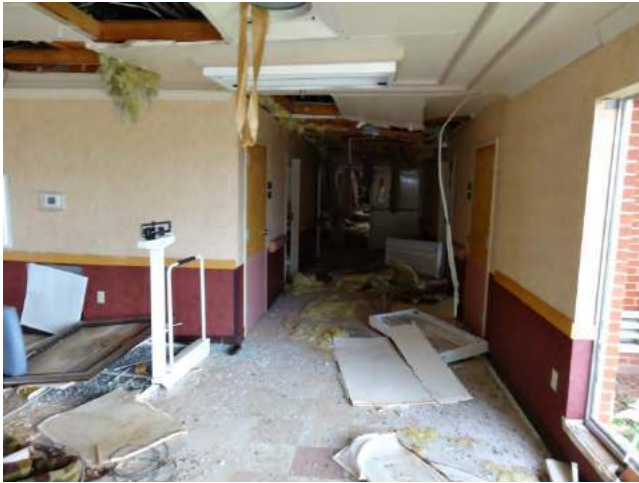
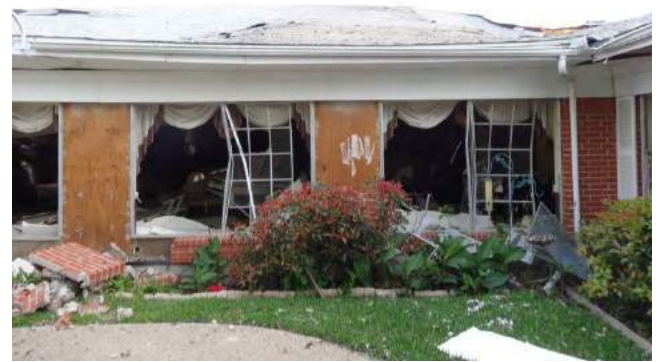
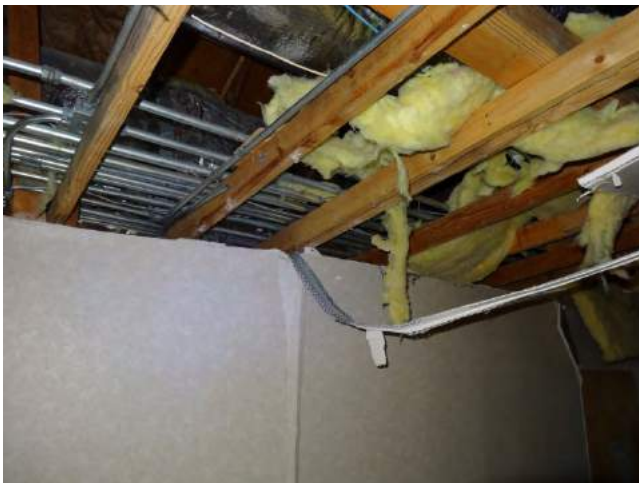
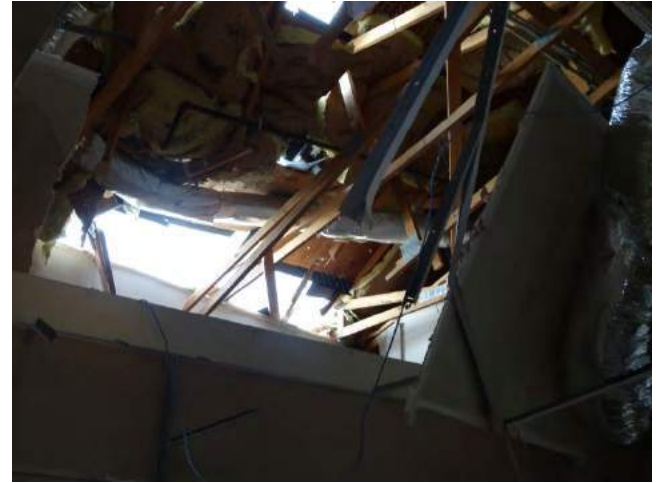
Damage Assessment

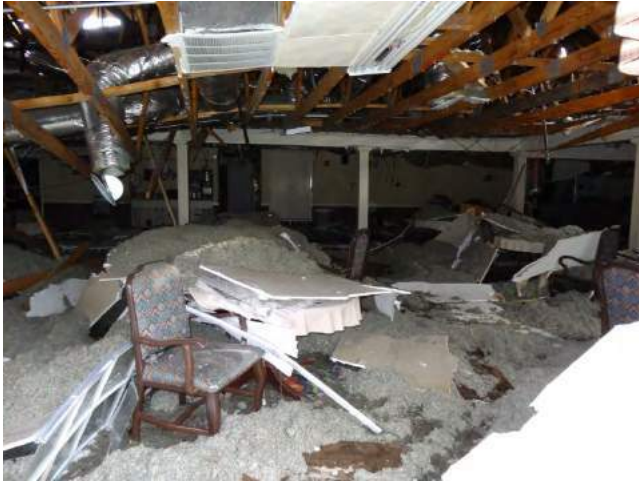
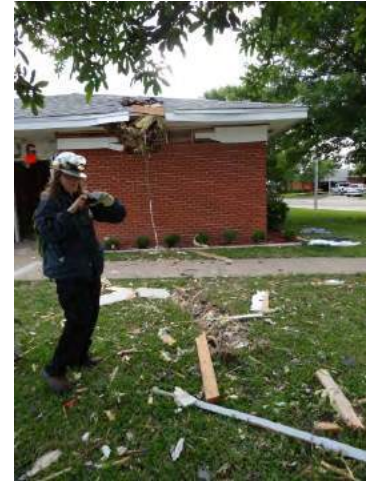
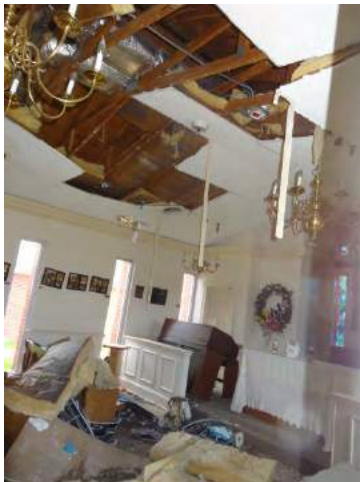
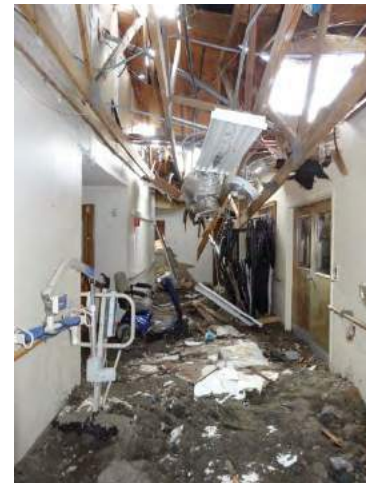
Damage Assessment

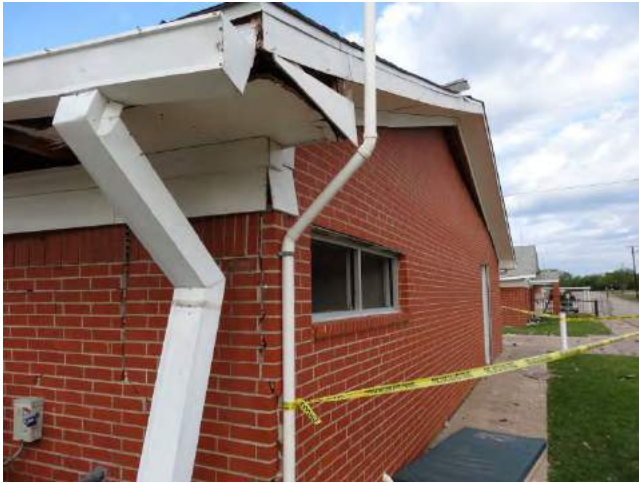
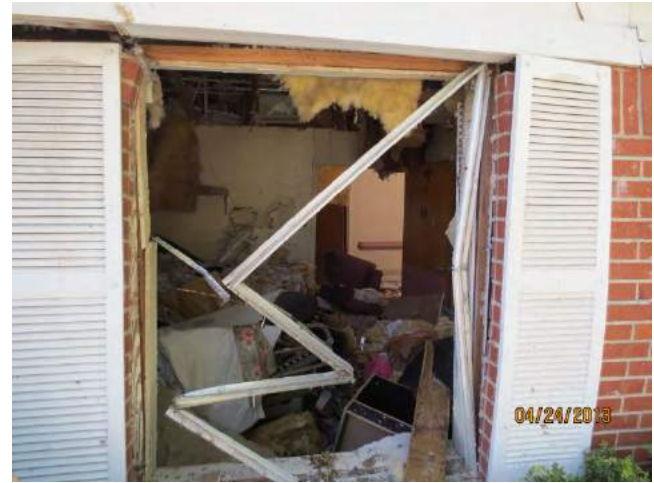
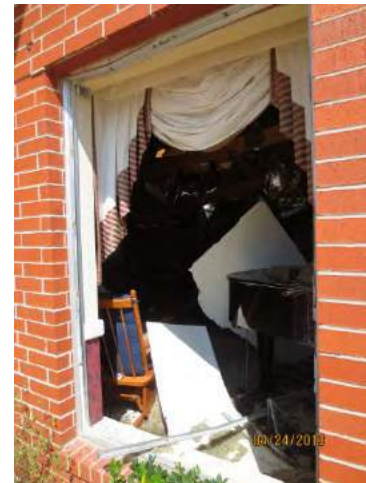
Damage Assessment

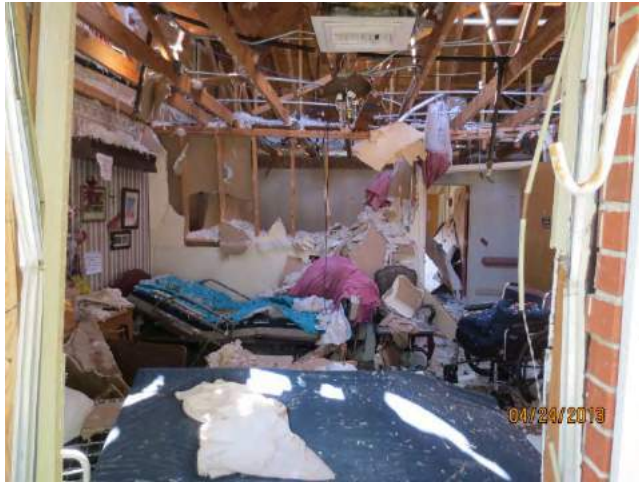
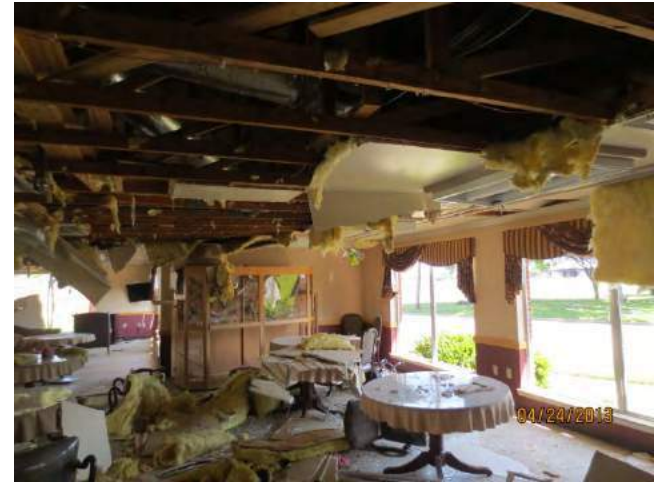
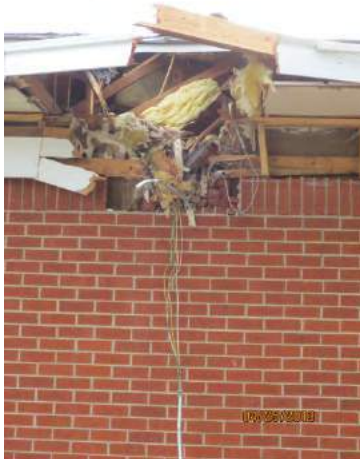
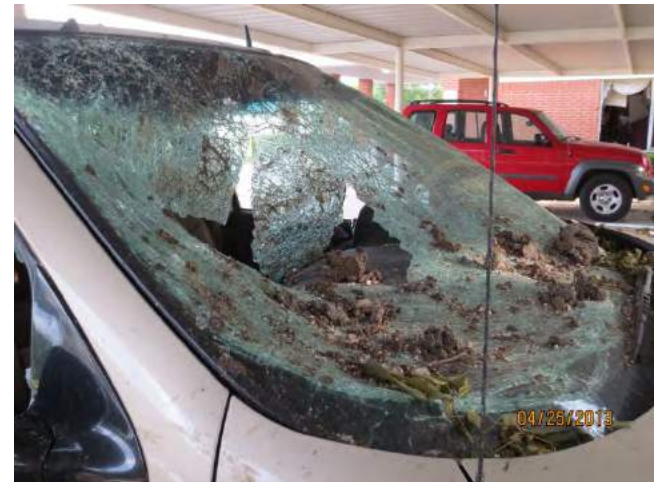
Damage Assessment

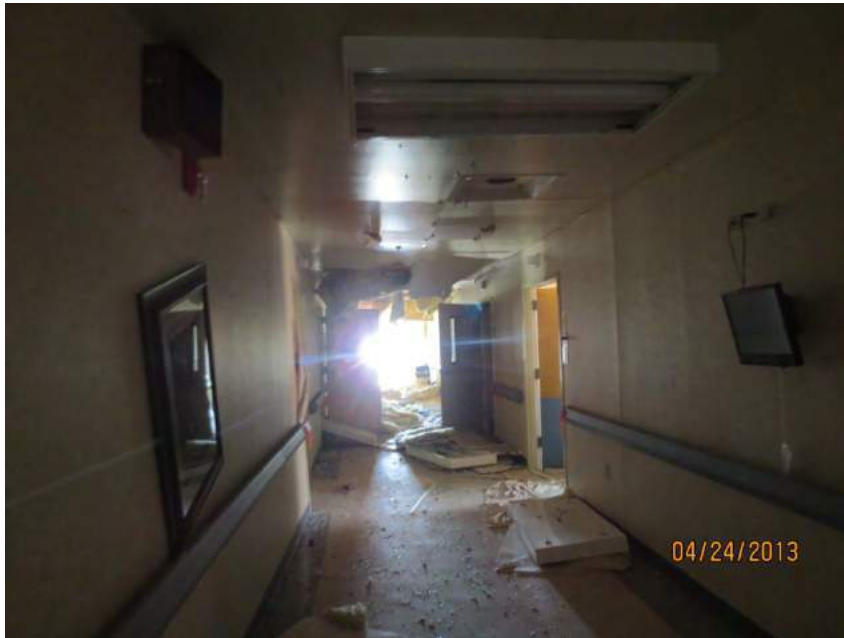
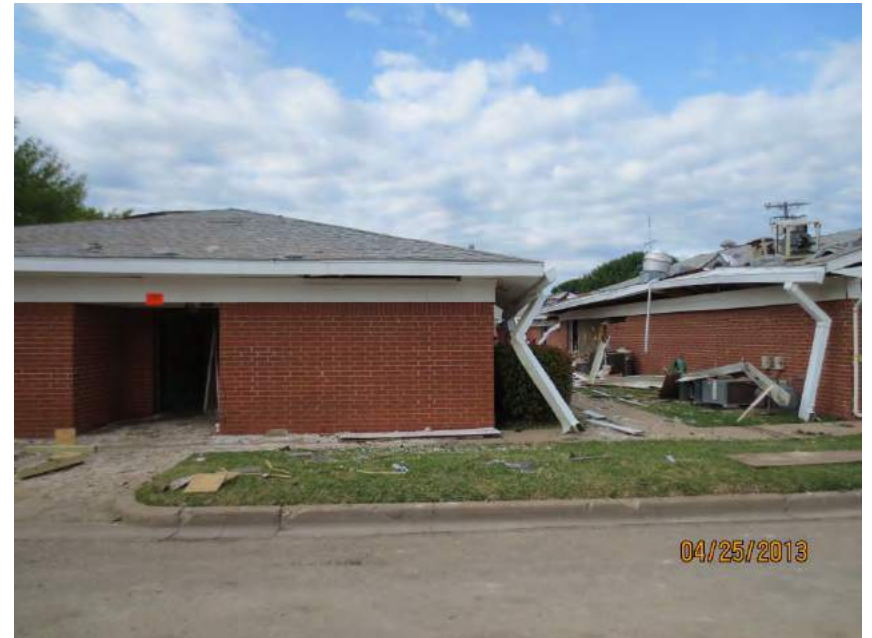
Damage Assessment

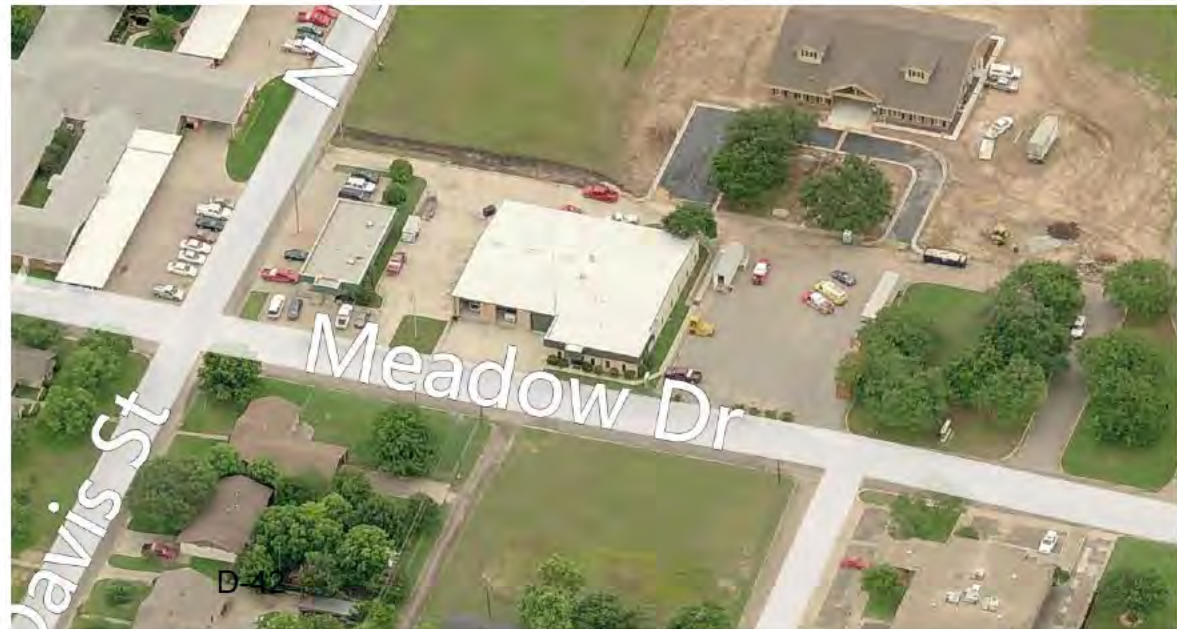
Emergency
Medical
Service

- **Construction:**

- Steel framed building with purlins supporting a metal deck and girts spanning between framed sections.

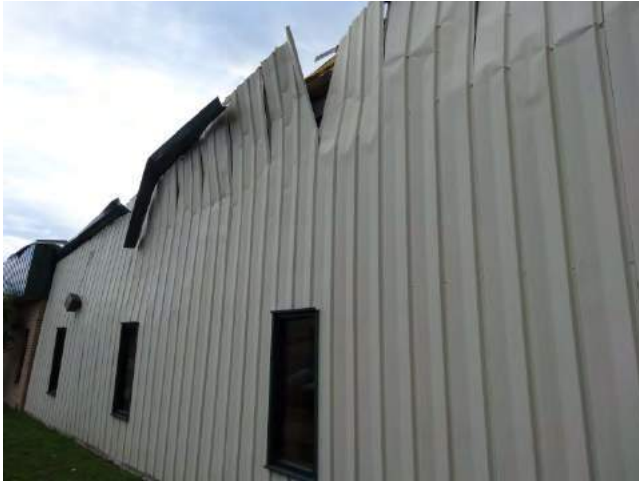
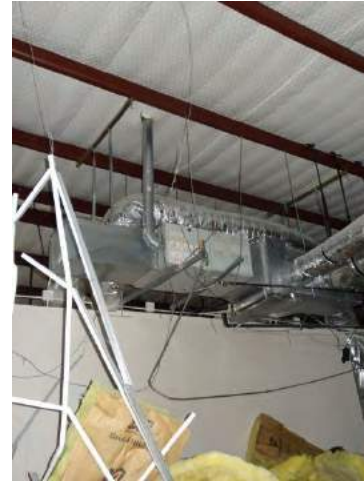
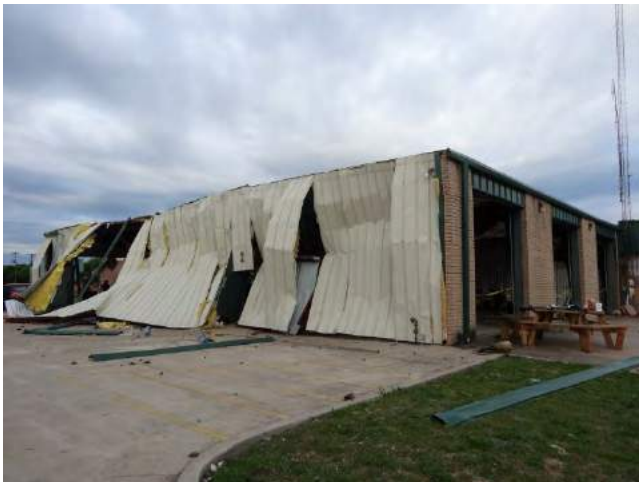
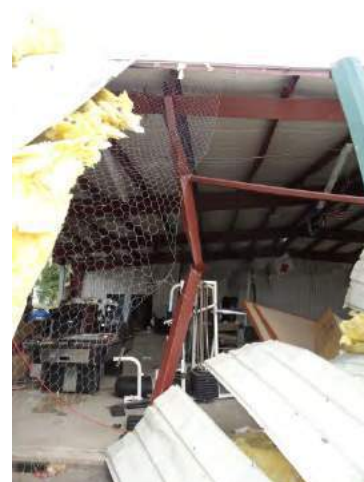
Damage Assessment

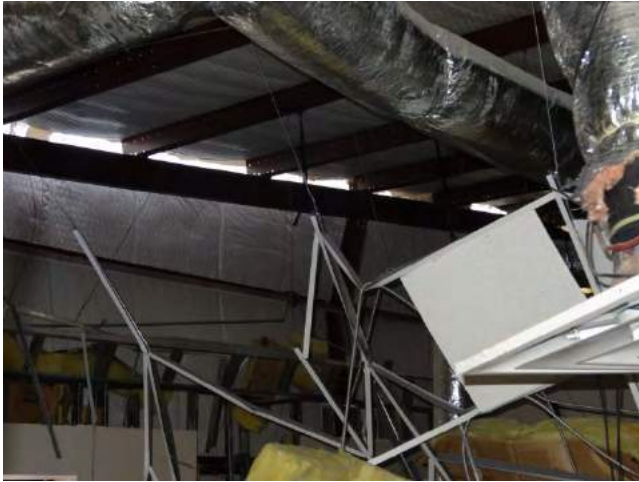
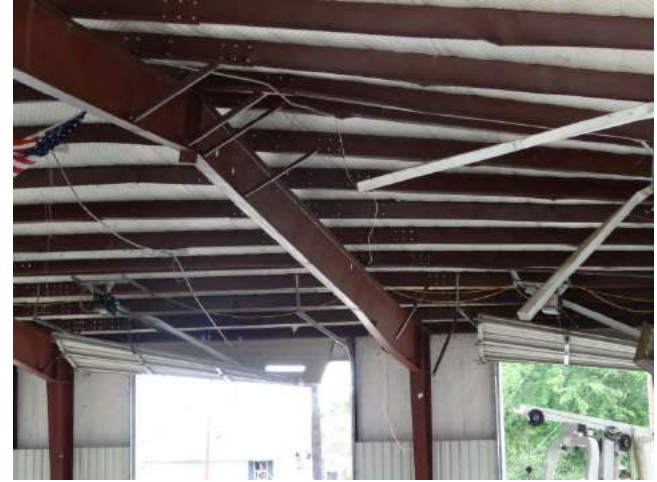
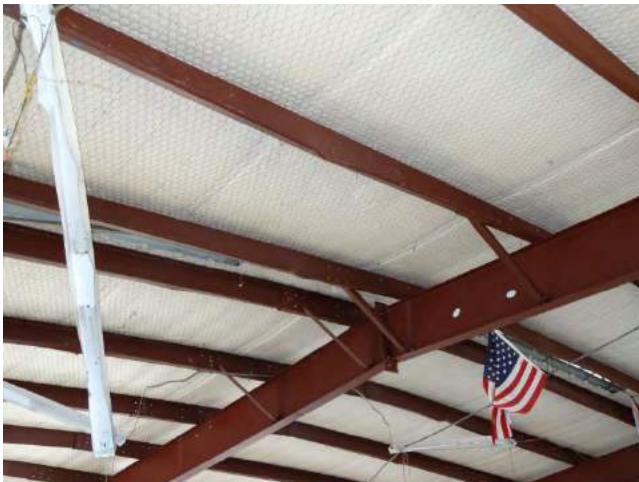
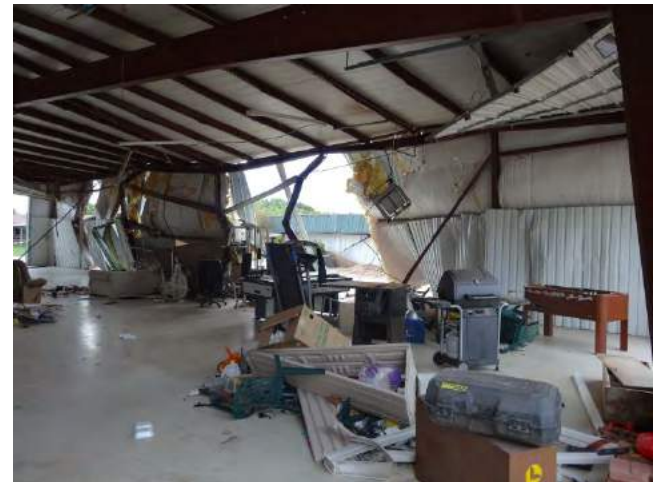
Damage Assessment

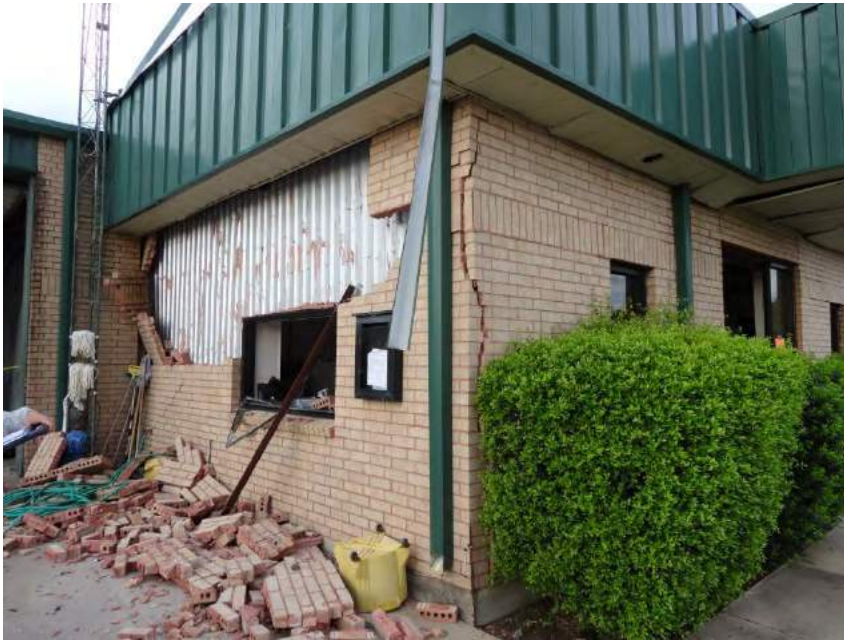
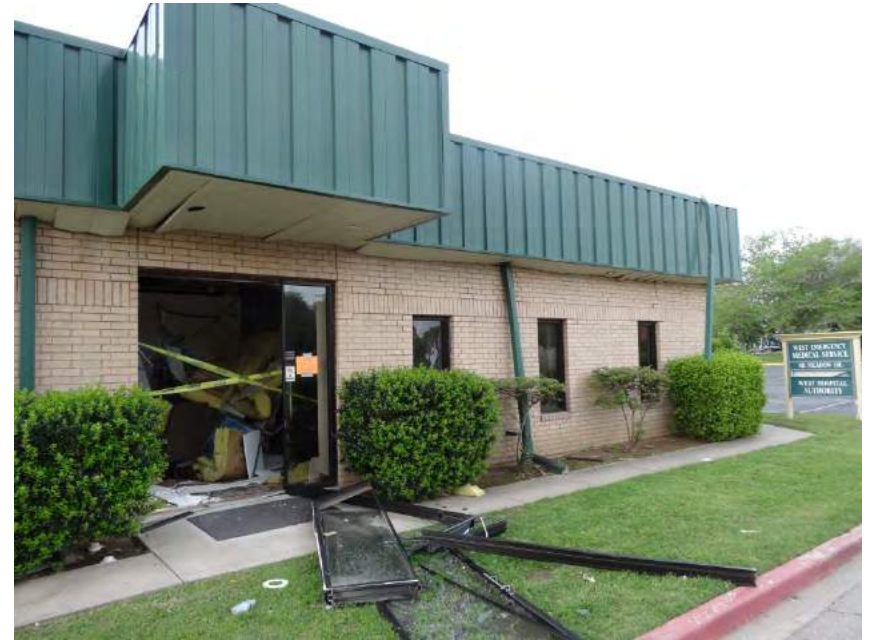
Damage Assessment

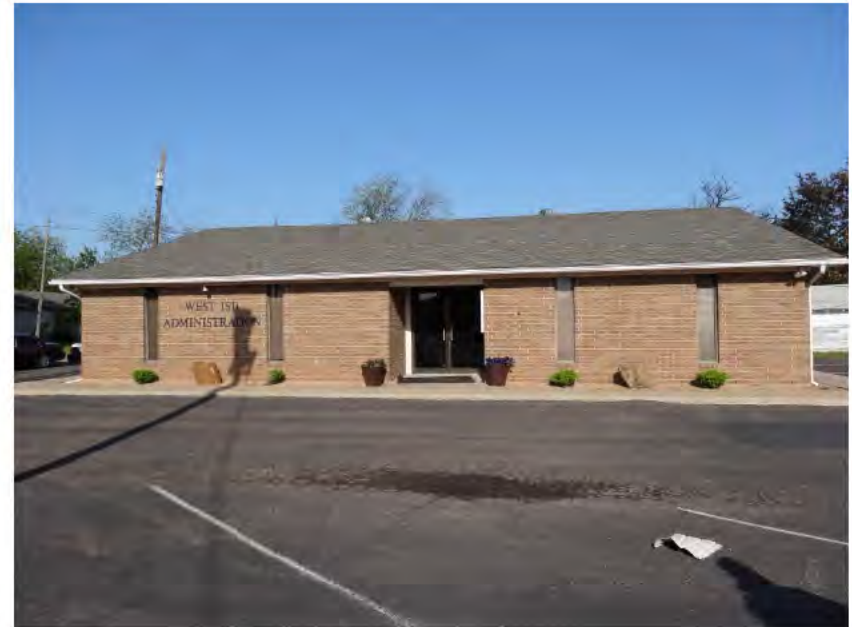
West Administration Building

- Construction:
 - Walls: wood stud wall & brick veneer
 - Roof: wood roof truss

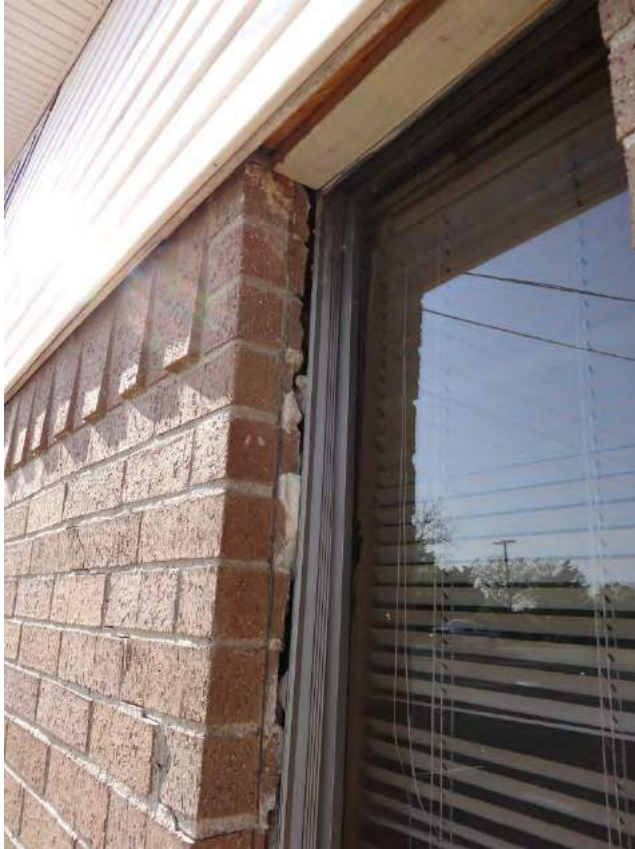
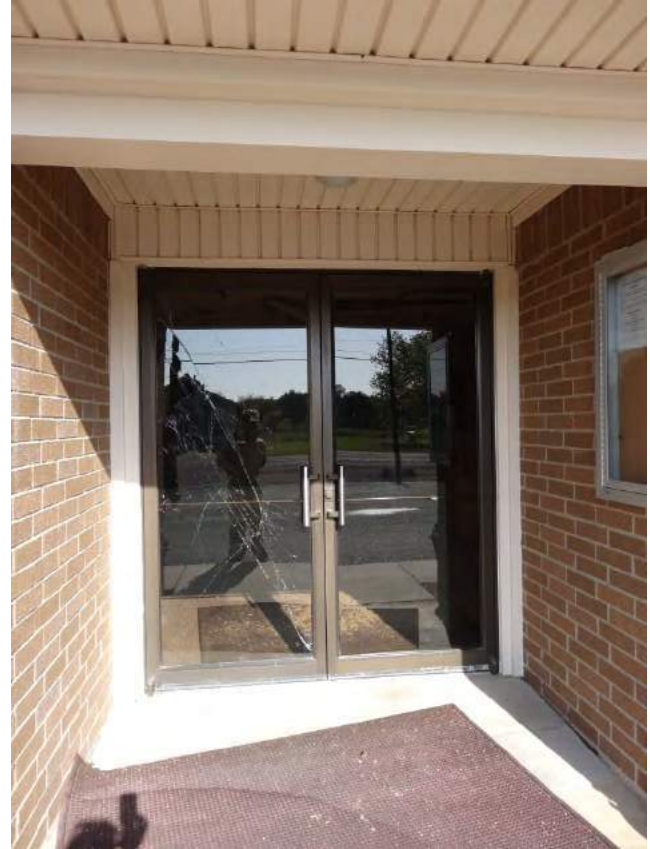
Damage Assessment
