Investigation Update

December 2022

This document provides an update on the CSB investigation of the April 8, 2021, incident at the Yenkin-Majestic OPC Polymers resin plant in Columbus, Ohio.

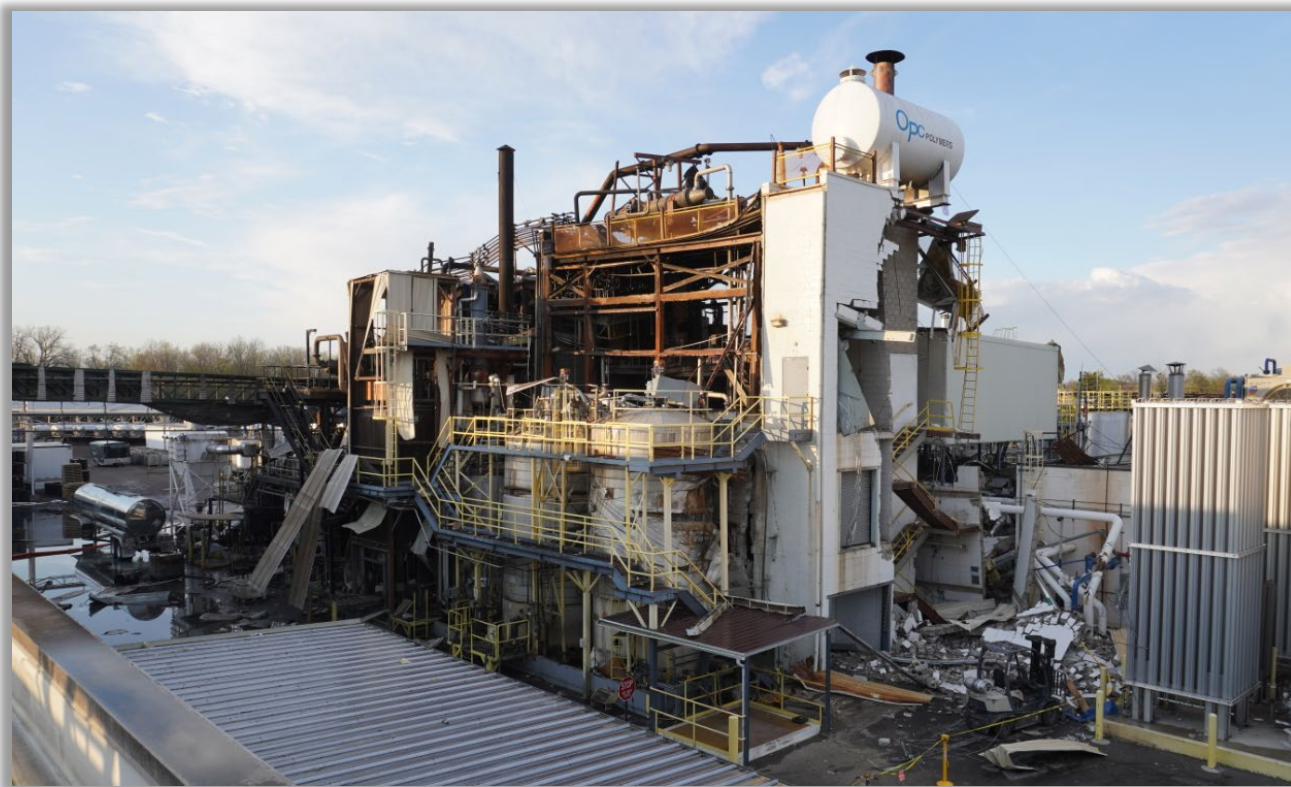
On April 8, 2021, at approximately 12:02 a.m., a mixture of flammable naphtha vapors and resin liquid became pressurized and then was released through the manway of an operating kettle at Yenkin-Majestic's OPC Polymers resin plant in Columbus, Ohio. The naphtha vapor spread through the enclosed building and formed a flammable vapor cloud both inside and outside the building. Approximately two minutes later, at 12:04 a.m., the flammable vapor cloud found an ignition source, and an explosion and fire erupted (**Figure 1**). One employee was fatally injured, and eight others were transported to area hospitals for injuries. The blast shook neighboring buildings, and at least one nearby business sustained damage. The resin plant was severely damaged, and Yenkin-Majestic demolished it after the incident.

Figure 1. Resin plant the day after the incident. (Credit: CSB)

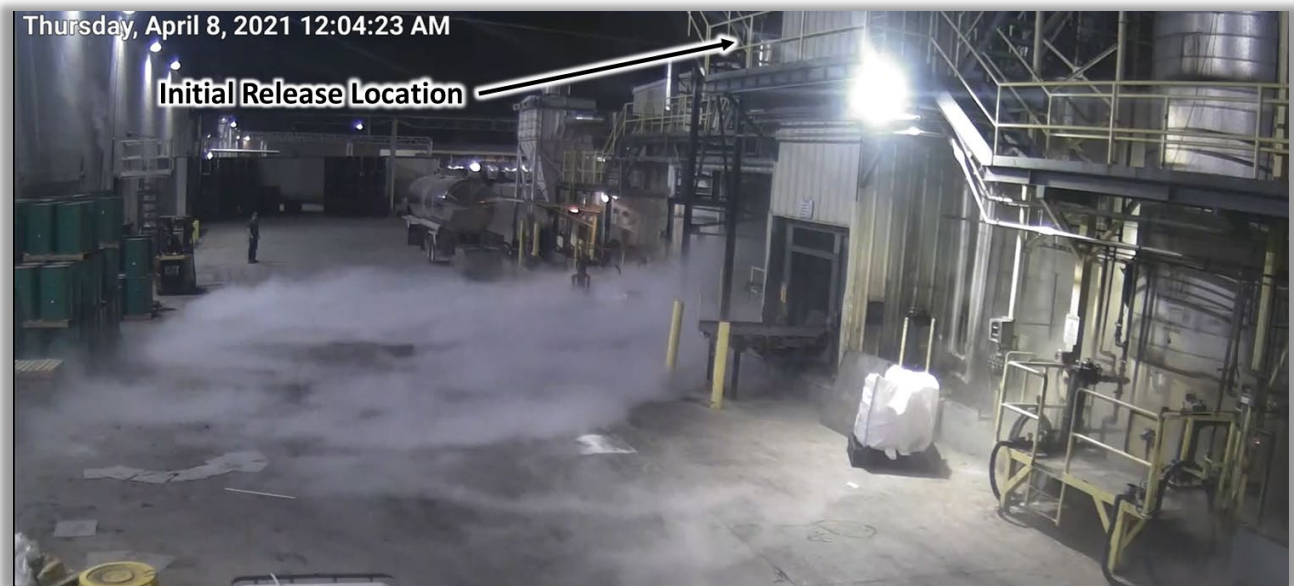
Figure 5 shows the extent of the ground-hugging flammable vapor cloud pouring out of the west side of the resin plant, just before the vapor cloud exploded at 12:04:23 a.m. The arrow points in the direction of the kettle room where the release occurred on the second floor.

Figure 5. Vapor cloud just before the explosion. (Credit: Yenkin-Majestic)
