U.S. Chemical Safety and
Hazard Investigation Board

Fatal Vessel Leak, Vapor Cloud Explosion, and Fire at Yenkin-Majestic Resin Plant

Columbus, OH | Incident Date: April 8, 2021 | No. 2021-04-I-OH

Investigation Report

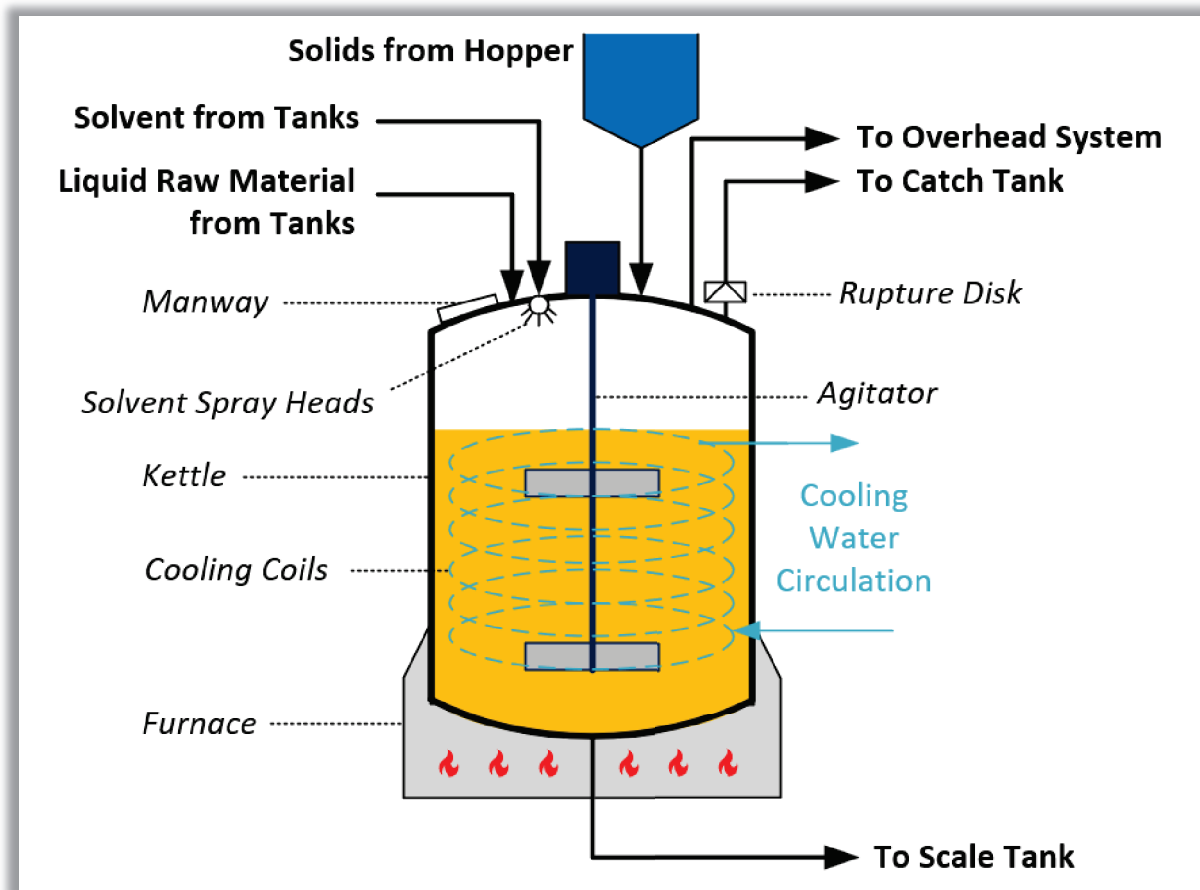
Figure 1. Simplified kettle drawing (not to scale). (Credit: CSB)

hopper through a designated opening on the kettle. Operators could also add solid material into the kettle in smaller quantities through the manway.^a

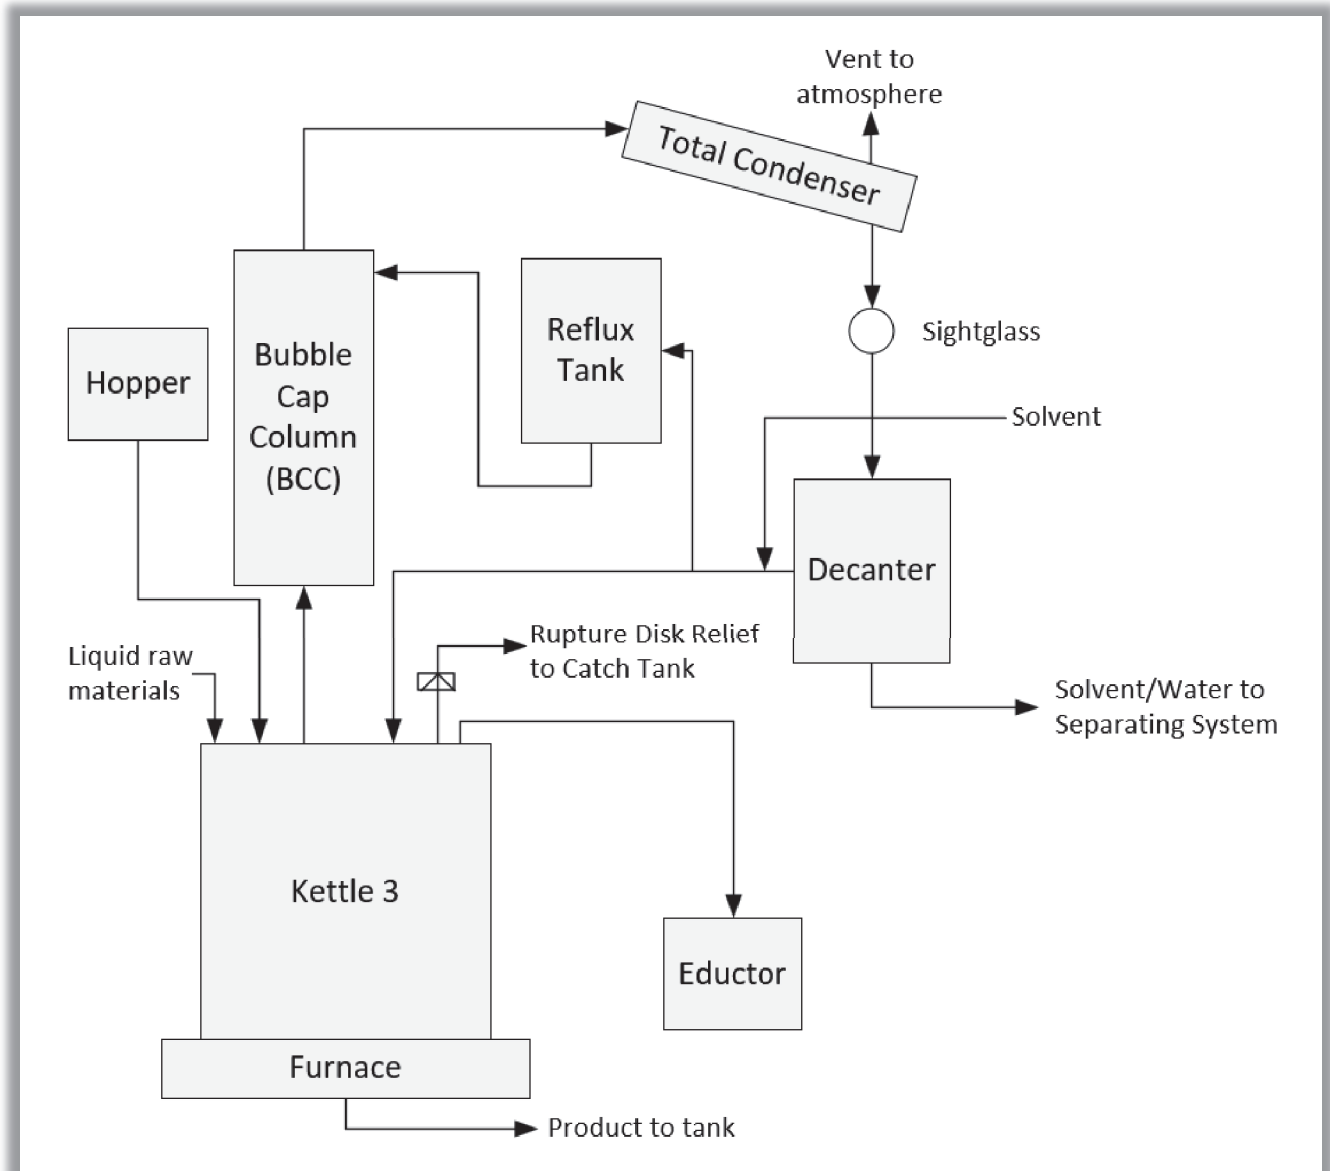
Figure 2. Simplified block diagram showing major equipment in the Kettle 3 system. (Credit: CSB)

Kettle 3 was typically operated at or near atmospheric pressure. The kettle was configured with a high-pressure alarm at 2 pounds per square inch gauge (psig), and an automatic high-pressure trip at 4 psig. The high-pressure trip activated the “emergency cooling” safety interlock,^a which was designed to shut down the furnace and turn on cooling water to the coils to aid in reducing the temperature and pressure inside the kettle. The Kettle 3 emergency pressure-relief system also included one 8-inch rupture disk, used to protect the vessel from high-

pressure conditions, which Yenkin-Majestic documented as having a burst pressure between 13.5 and 15 psig.^a In the event of high pressure inside the kettle, the rupture disk was intended to open and direct the pressurized contents of the kettle into a catch tank.^b During the April 8, 2021, incident, the high-pressure alarm and trip activated after Kettle 3's pressure began to rise, and the rupture disk did not burst (discussed further in *Section 2*).

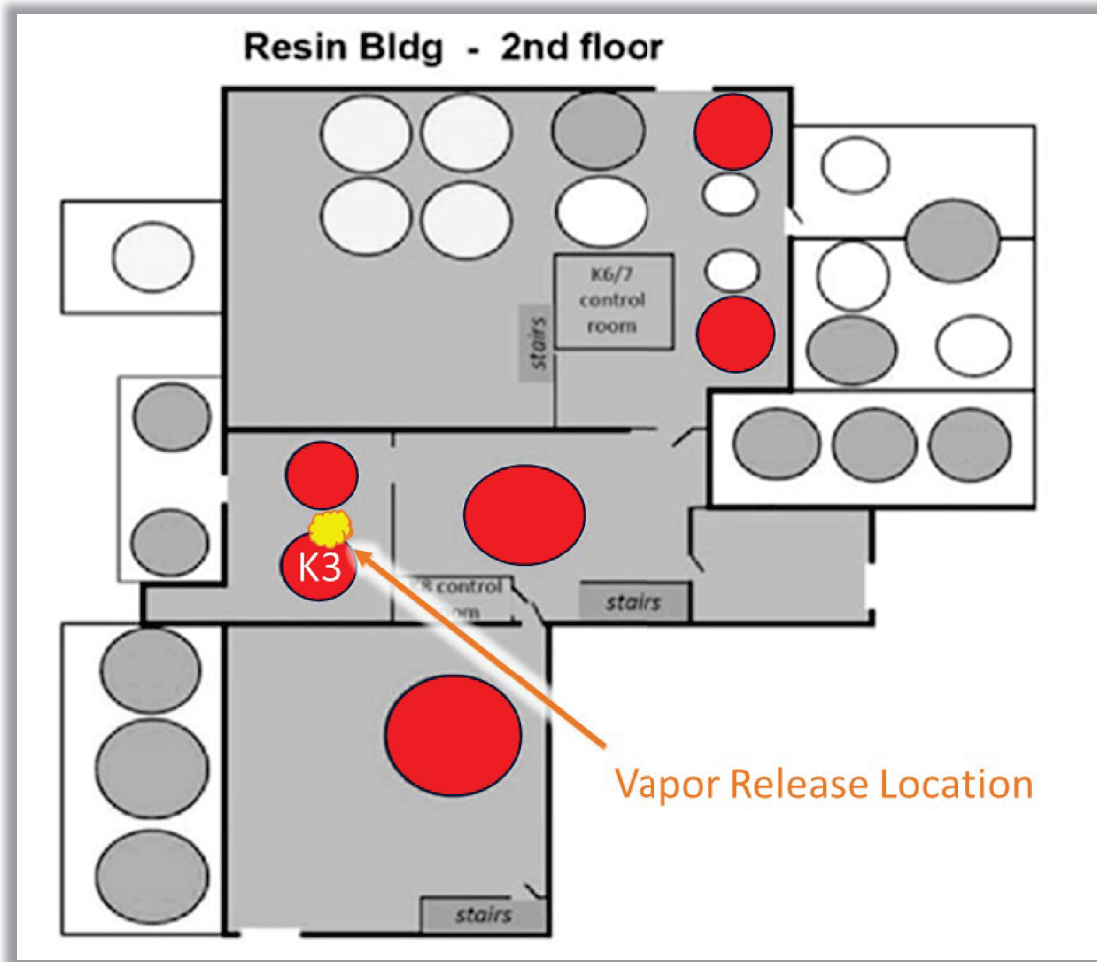
Figure 3. Flammable solvent vapor release location. (Credit: Yenkin-Majestic with modifications by CSB)

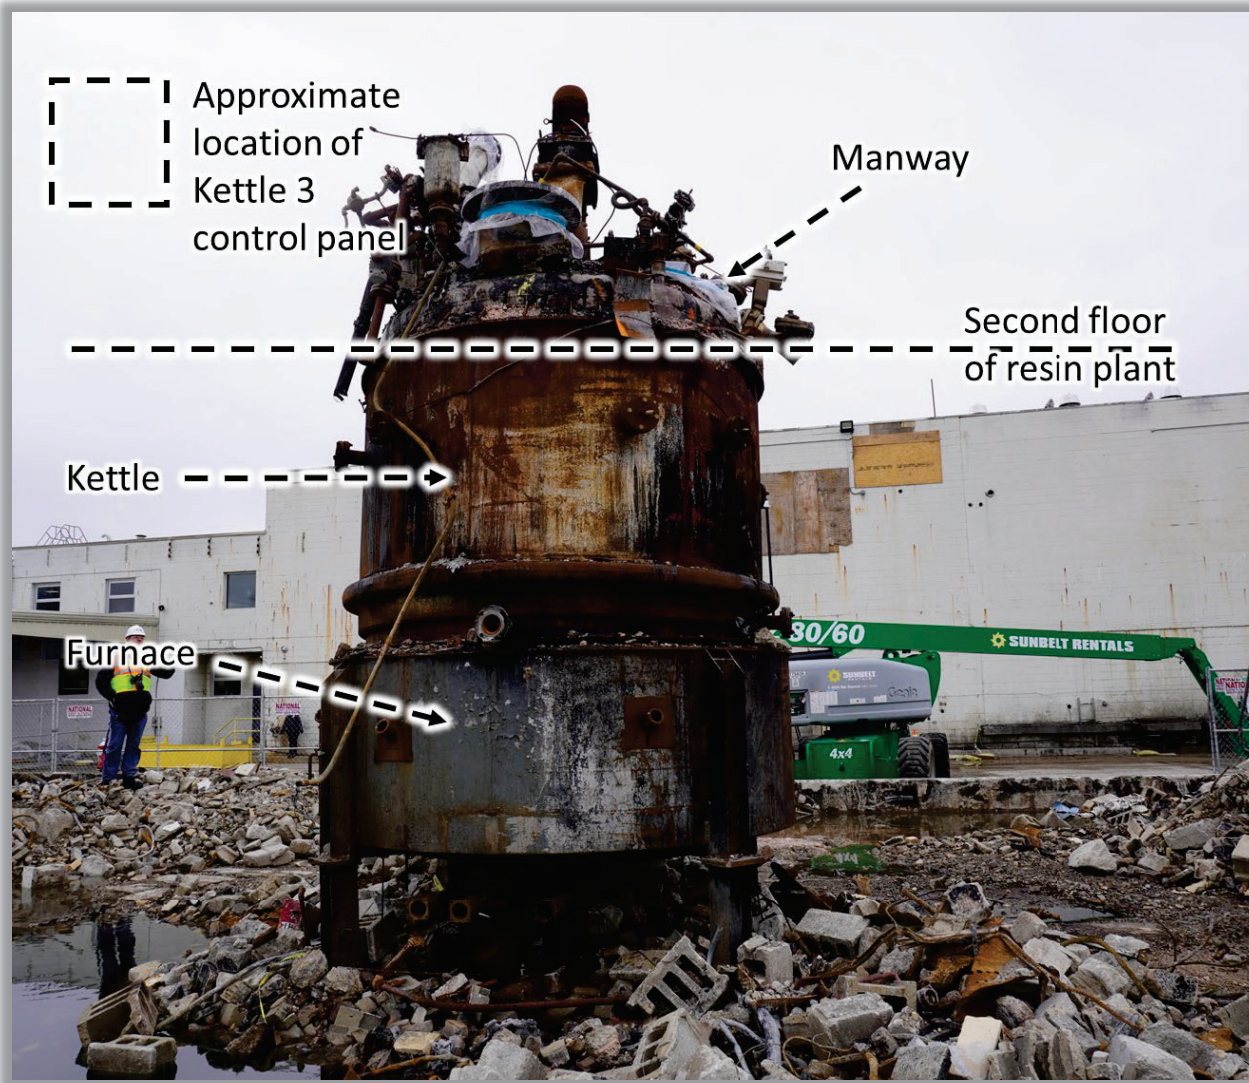
Figure 4. Photo of Kettle 3 during demolition. (Credit: CSB)

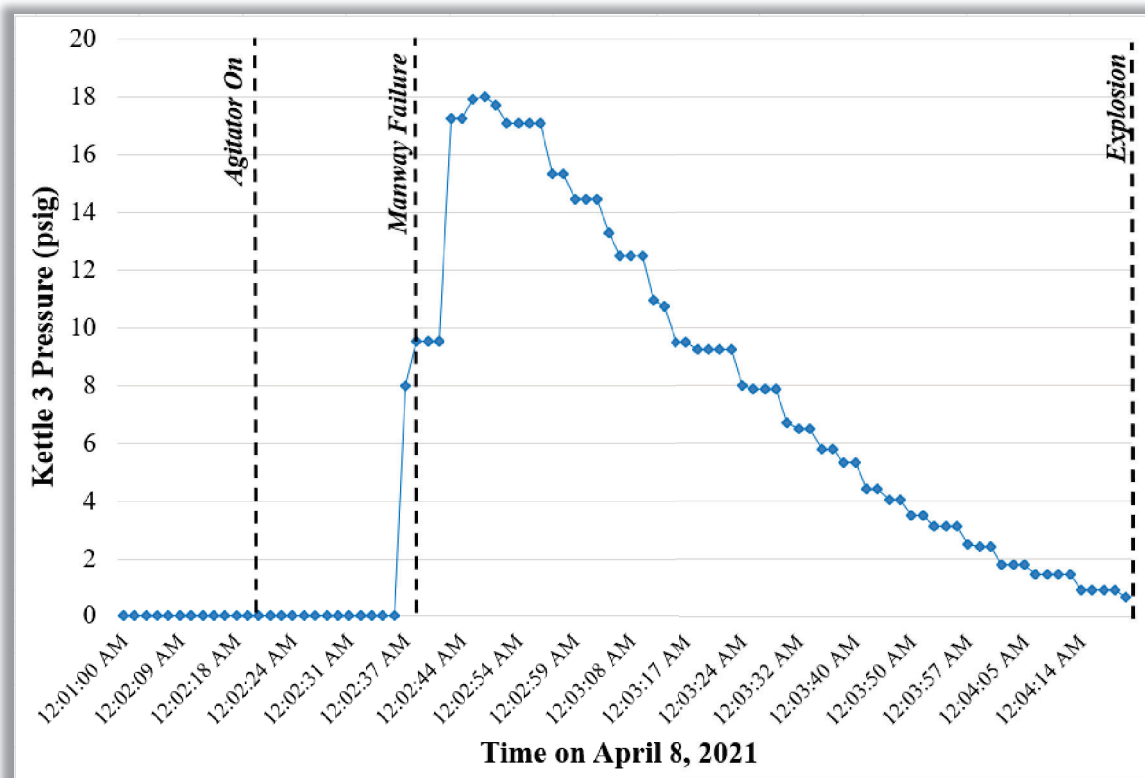
seconds (**Figure 6**). The pressure continued to increase even after triggering the kettle's high-pressure alarm and safety interlock.^a Two seconds later, when the kettle's pressure reached approximately 9 psig, Kettle 3's closed manway could no longer contain the pressure and began to release a mixture of hot resin liquid and flammable solvent vapor through the sealing surface around its lid into the kettle room (**Figure 7**). At this point, Kettle 3's pressure was still below the rupture disk's marked burst pressure, so it did not relieve Kettle 3's pressure.

Figure 6. Kettle 3 pressure trend during April 8, 2021, incident. (Credit: CSB)

The agitator continued stirring the contents of Kettle 3, and the pressure inside the kettle continued to climb until it peaked at 18 psig, according to control system records (**Figure 6**). At this peak pressure, Kettle 3's pressure was above the rupture disk's marked pressure setting but still within its burst tolerance range, and it did not burst to relieve Kettle 3's pressure.^a Flammable solvent vapor continued leaking from the manway sealing

^a Based on the Kettle 3 rupture disk's marked burst pressure of 16.5 psig and the manufacturer's burst tolerance of plus or minus 2 psi, the rupture disk's maximum burst pressure could have been as high as 18.5 psig, which was higher than the peak pressure of 18 psig observed during the incident.

surface, and over the next minute after the pressure peak, the kettle's pressure gradually decreased to less than 1 psig.

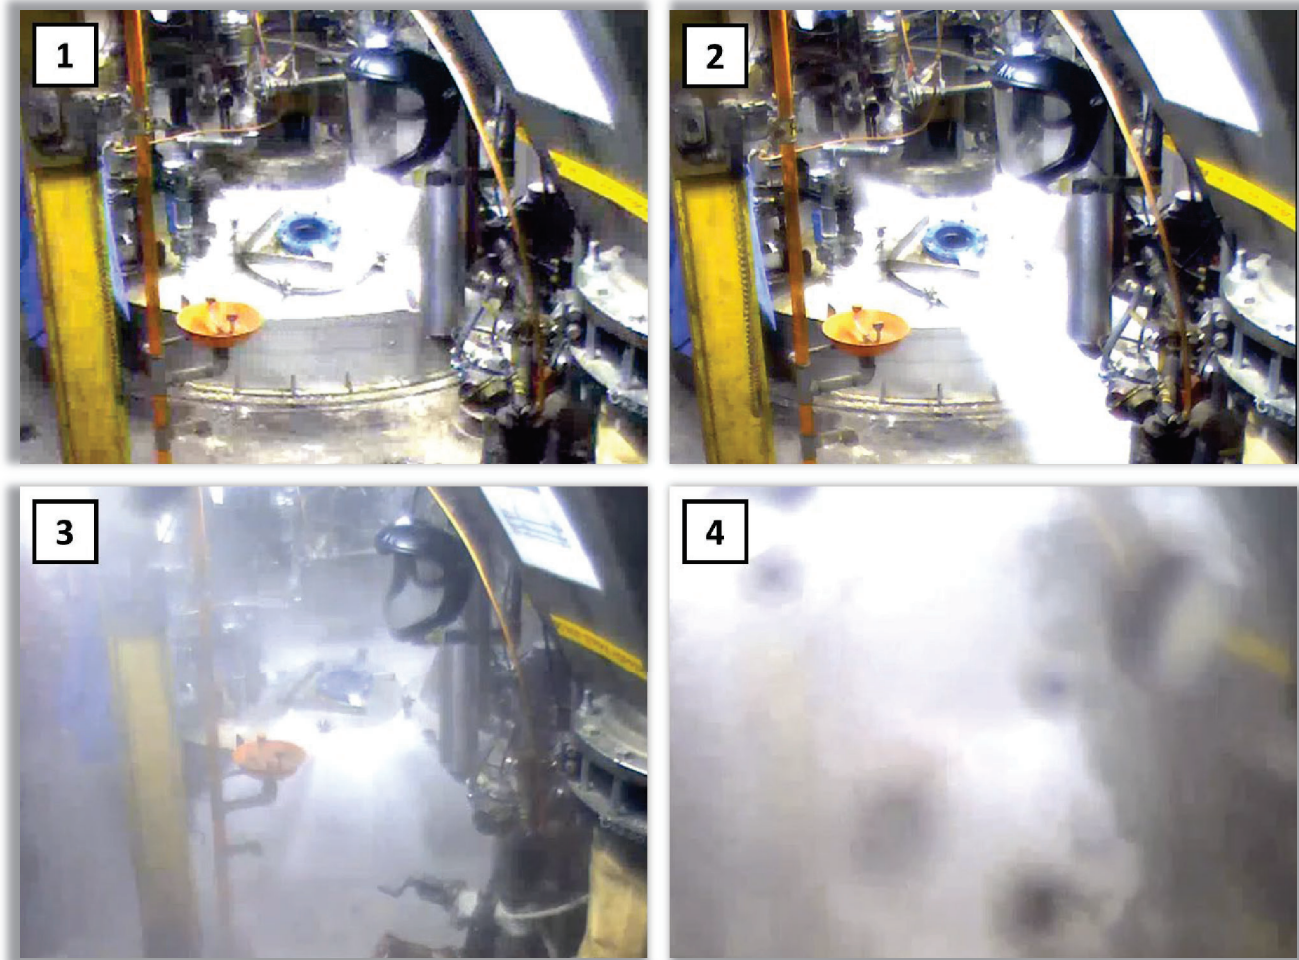
Figure 7. Initial six seconds of the vapor release from Kettle 3. (Credit: Yenkin-Majestic, annotations by CSB)

Employee A informed the CSB that after the flammable release started, he tried to reverse his actions and turn off the agitator, but he could not see through the white vapor and had difficulty breathing. Employee A stated that he tried to hit the emergency-stop button with his eyes closed, but he was not able to reach it. About 20 seconds after the release started, Employee A evacuated from the kettle room.

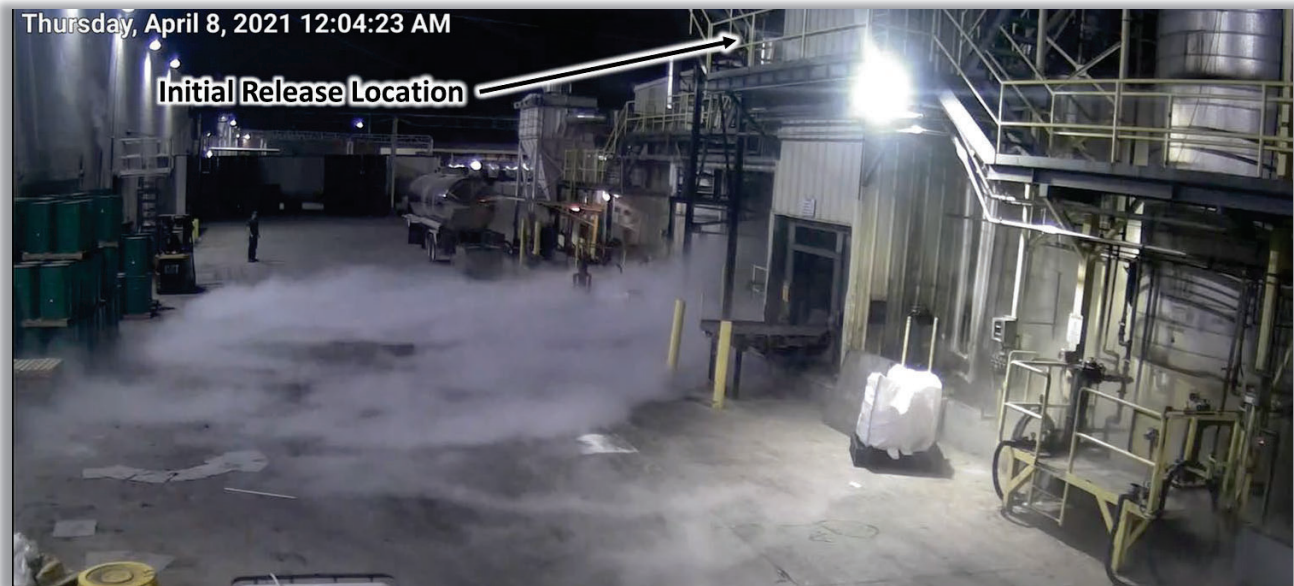
Figure 8. Vapor cloud just before the explosion. (Credit: Yenkin-Majestic)

Surveillance cameras recorded a cloud of flammable solvent vapors moving into adjacent operating areas of the plant. Eventually, the flammable vapor cloud began to flow out of the second floor onto the ground level, where it could be seen from outside of the building. **Figure 8** shows the extent of the ground-hugging flammable vapor cloud pouring out of the west side of the resin plant, just before the vapor cloud exploded at 12:04:23 a.m. The arrow points in the direction of the kettle room where the release occurred on the second floor.

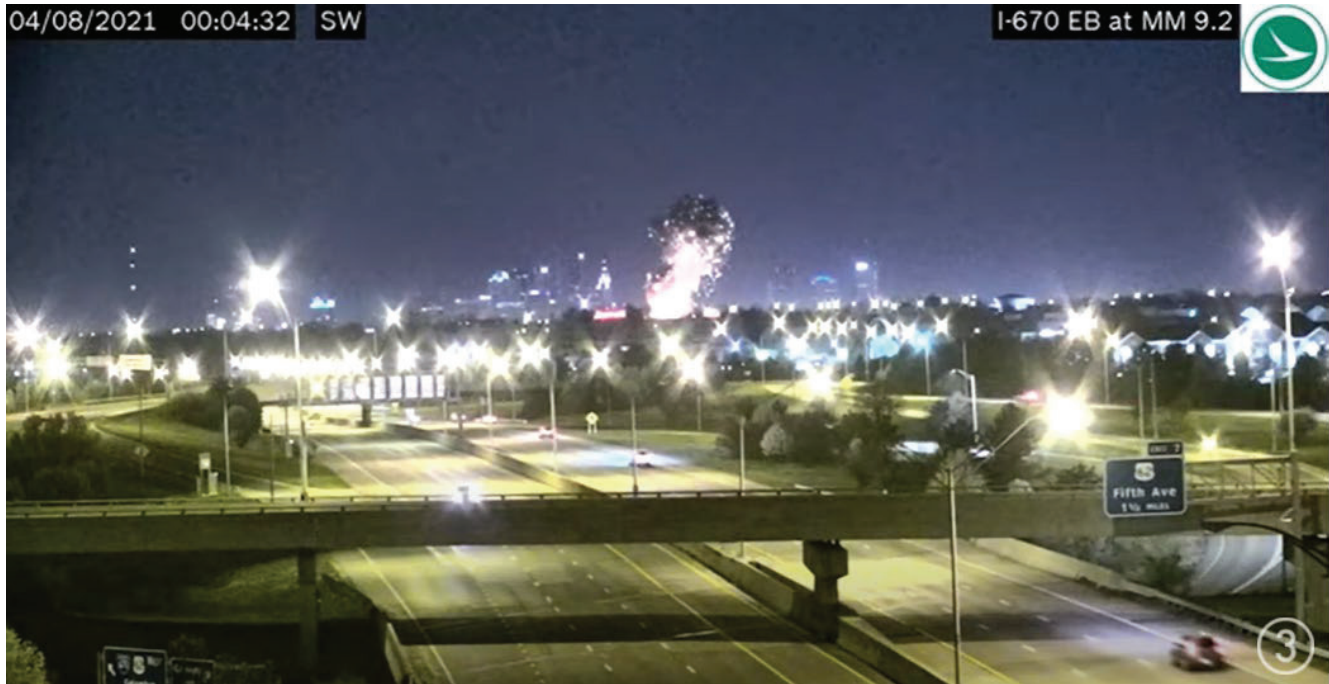
At 12:04 a.m., the released flammable vapors found an ignition source^a and exploded.^b Local news outlets reported that the explosion shook nearby homes and was seen, heard, or felt throughout parts of Columbus [9, 10]. The image in **Figure 9** is captured from traffic camera footage approximately two miles away from the resin plant.

Figure 9. Explosion seen from a traffic camera. (Credit: WKYC Channel 3 [10])

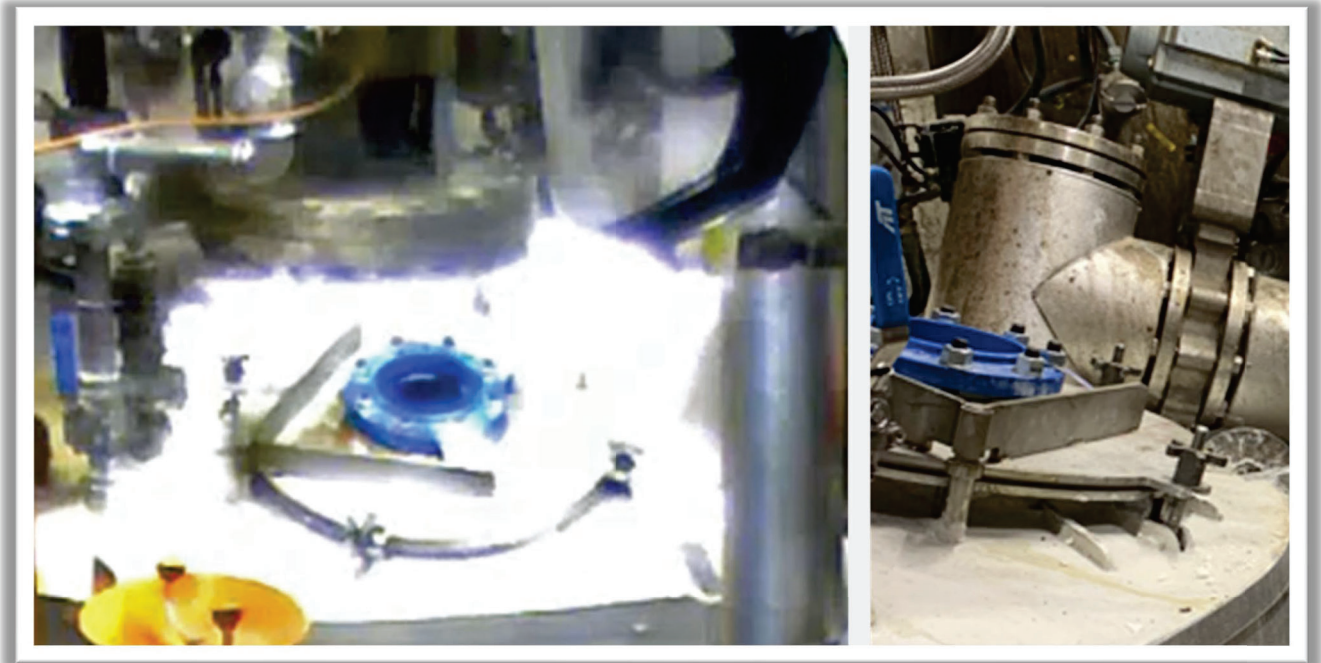
Figure 10. Photos of the new manway during normal operation. (Credit: Yenkin-Majestic)

^d According to Yenkin-Majestic employees, the gasket between the manway's sealing surfaces at the time of the incident was a 1/2-inch-thick gasket that Yenkin-Majestic had cut from a large sheet. Yenkin-Majestic employees also indicated that a spare gasket of the same material had been cut so a replacement would be readily available if needed. While the spare gasket for the manway was retained, no gasket material from Kettle 3 itself could be recovered post-incident due to fire damage.

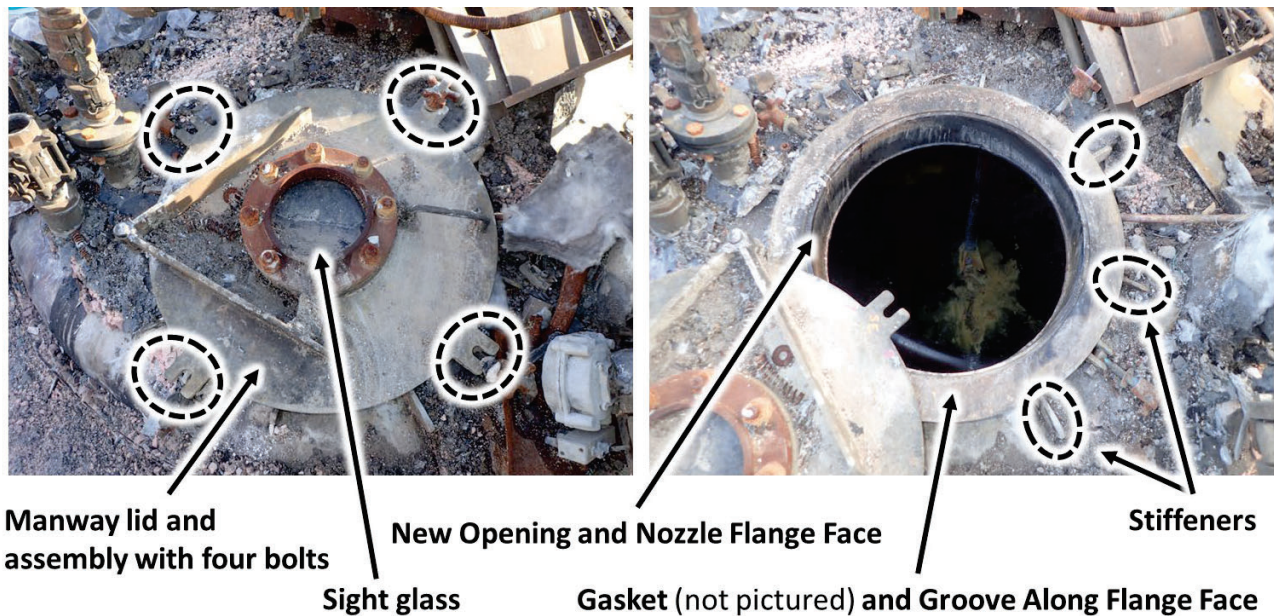
Figure 11. Photos of the new manway after the incident (closed, *left*; open, *right*). (Credit: Rimkus, with annotations by CSB)

Post-incident, the CSB commissioned an engineering evaluation of the manway's mechanical design. Prior to the incident, Yenkin-Majestic had provided the companies designing the new manway with a design pressure of 16 psig, with the assumption that Kettle 3's rupture disk was set to a marked burst pressure less than 15 psig (discussed further in *Section 4.1.1*). The CSB therefore requested evaluations of whether the manway could withstand 16 psig as Yenkin-Majestic had specified. The consultant evaluated several cases to model the

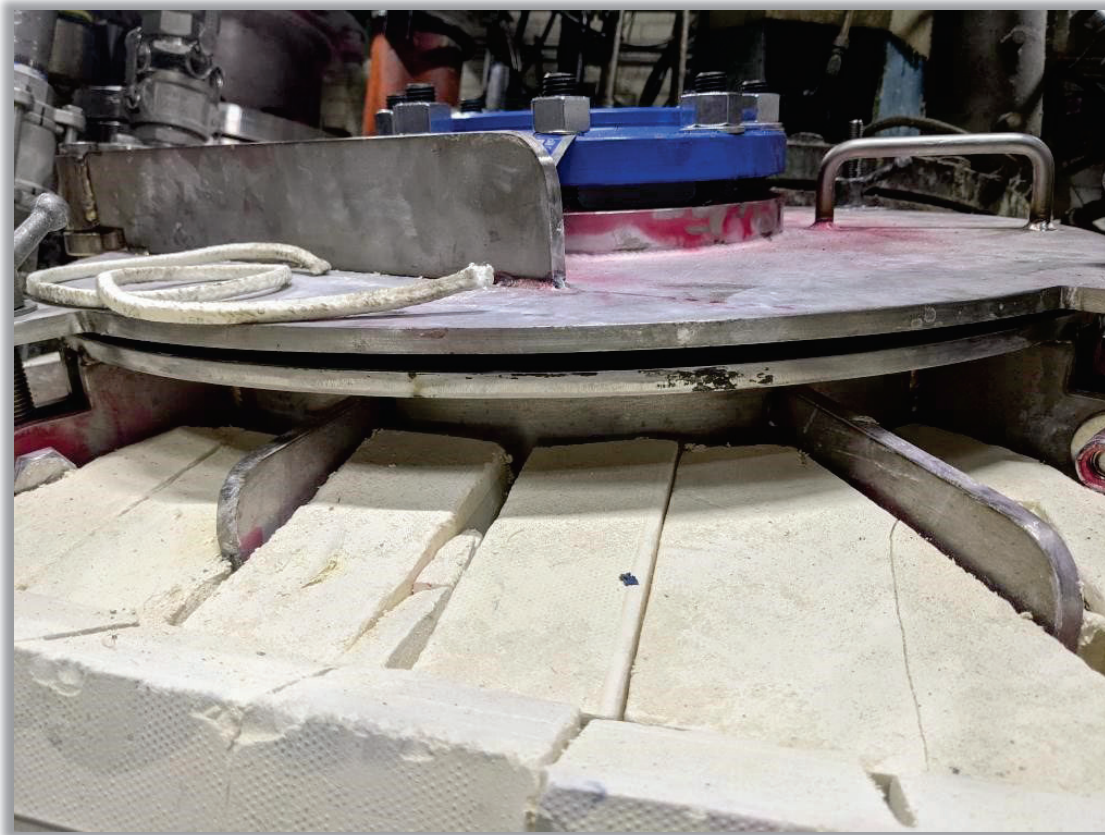
Figure 13. Bowing on the new manway lid in January 2021. (Credit: Yenkin-Majestic)

The next morning, Yenkin-Majestic installed a thicker gasket,^a checked for leaks around the gasket while Kettle 3 was pressurized up to 4 psig with nitrogen, and concluded that the manway was not leaking.^b Satisfied with the leak check results, Yenkin-Majestic returned Kettle 3 to service on January 4, 2021.

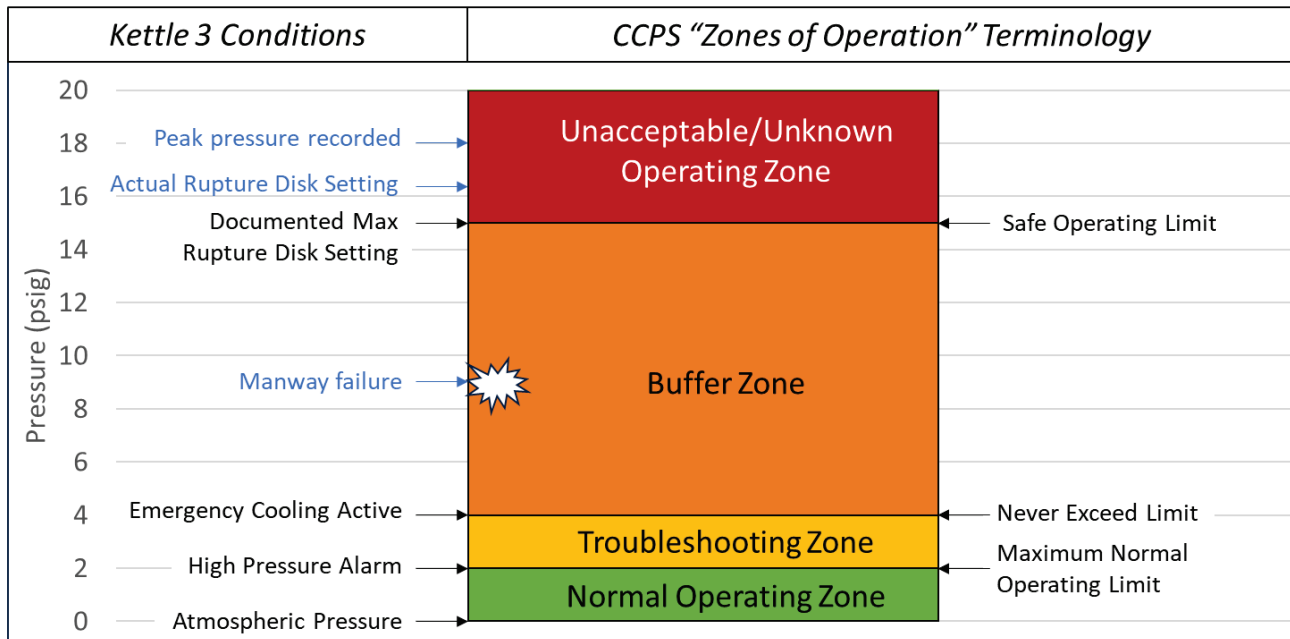
Figure 14. Kettle 3 zones of operation. (Credit: CSB with source material from CCPS [17])

Figure 14 is adapted from the CCPS “zones of operation” diagram to describe how Kettle 3’s operating parameters corresponded to the CCPS-defined terminology based on Yenkin-Majestic’s documentation. The black text describes Yenkin-Majestic’s process safety information for Kettle 3, and the blue text shows actual corresponding pressure recorded on the day of the incident. Although Kettle 3 typically operated at atmospheric pressure, Yenkin-Majestic had configured it with a high-pressure alarm at 2 psig, as well as an emergency cooling interlock and alarm at 4 psig, and had documented that it had a pressure relief device (the rupture disk) set to burst between 13.5 and 15 psig. The incident occurred in what the CCPS describes as a “buffer zone,” which should have been Kettle 3’s safe operating zone between the emergency cooling interlock activation pressure (4 psig) and the maximum documented rupture disk burst pressure (15 psig).^a

operating limits for process equipment (**Figure 14**) [17, pp. 135-136]. The CCPS asserts that “[safe operating limits] are determined by identifying design limits of equipment within a system” [17, p. 136] and that the safe operating limits should be documented in plant PSI with a technical basis for each limit.

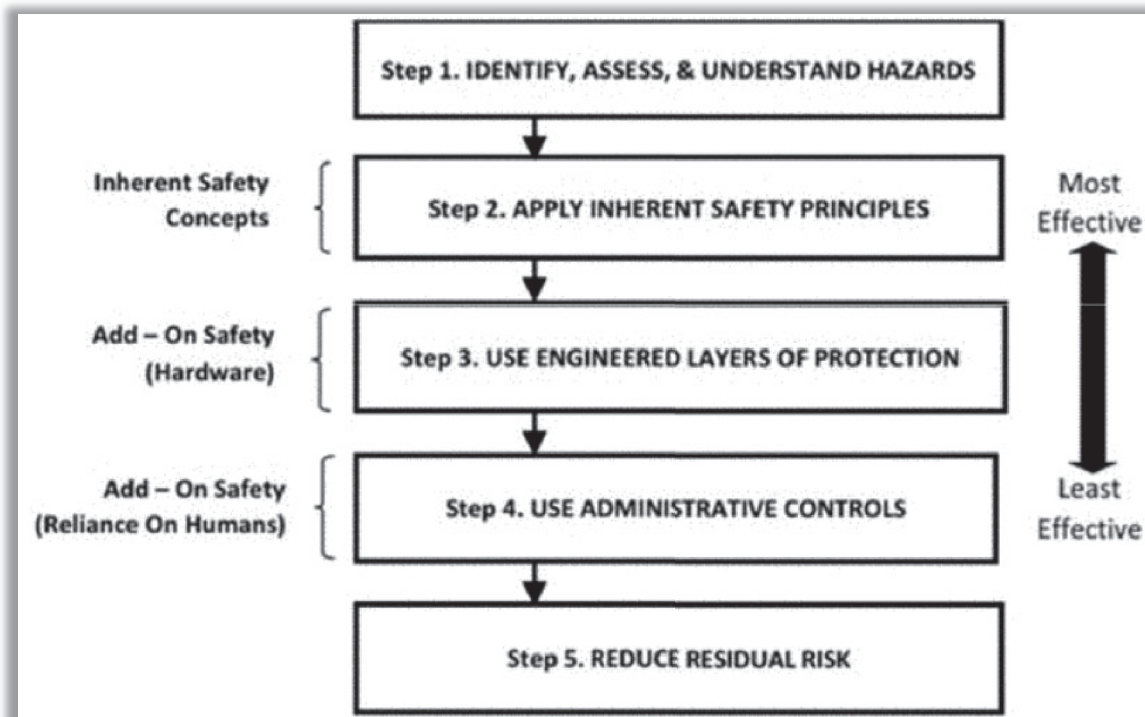
Figure 15. Hierarchy of controls in process safety management. (Credit: CCPS [38, p. 14])

The hierarchy of controls is a risk management principle based on ranking hazard controls from most to least effective: inherently safer design,^a engineering controls (layers of protection), and administrative controls (Figure 15). In general, designing out the hazard and reducing the risk through engineering controls is more effective than using administrative controls. For example, engineering controls reduce hazards through equipment modifications and safety devices, whereas administrative controls include procedures, training, and warnings [37]. Administrative controls are inherently less reliable, because they depend on the performance of personnel for their effectiveness.

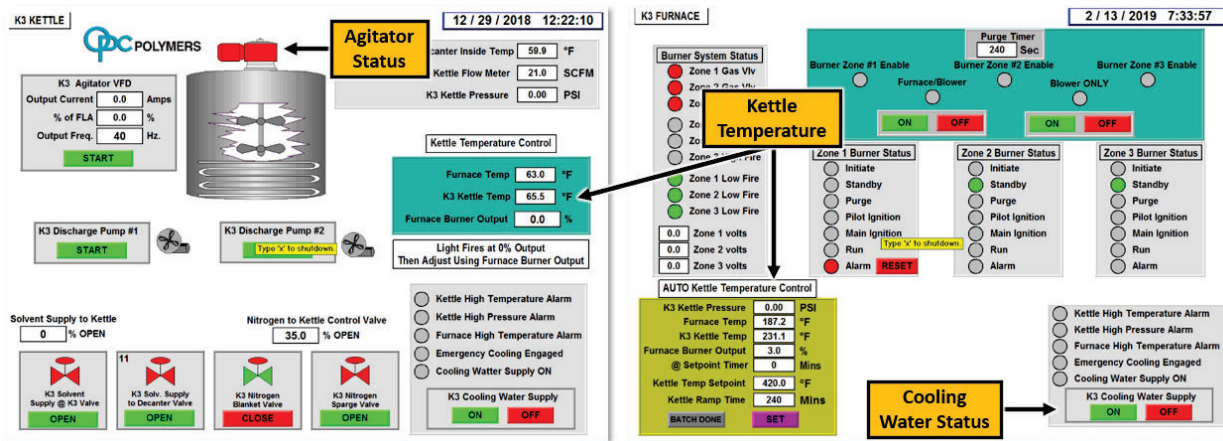
Figure 16. Generic Kettle 3 HMI screen layouts. (Credit: Yenkin-Majestic with annotations by CSB)

agitator at the beginning of a batch, it typically remained running for the duration of the batch. There was no process alarm to warn the operator if the agitator shut down in the middle of a batch.

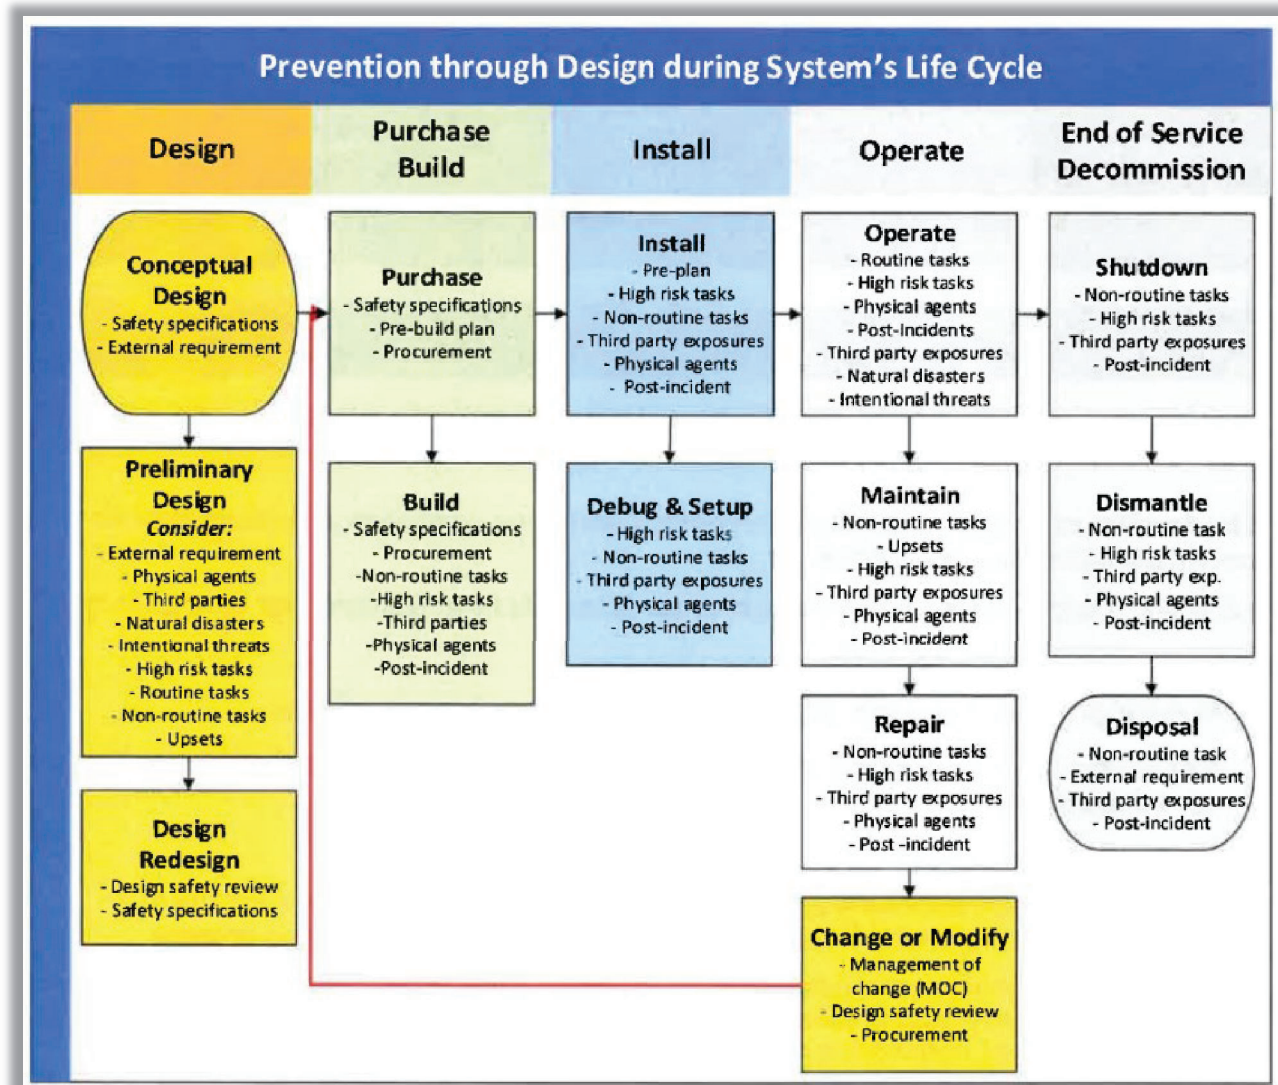
Figure 17. Example of prevention through design opportunities during a system's life cycle. (Credit: ASSP [43])

The above design principles should not be limited to the initial design of a process plant but instead should be used through the plant's entire life cycle. For example, over the course of a process plant's operation, operating data, incident investigations, management of change, and PHAs provide important opportunities to apply the hierarchy of controls. **Figure 17** provides examples of opportunities where these design concepts could be applied across the entire life cycle.

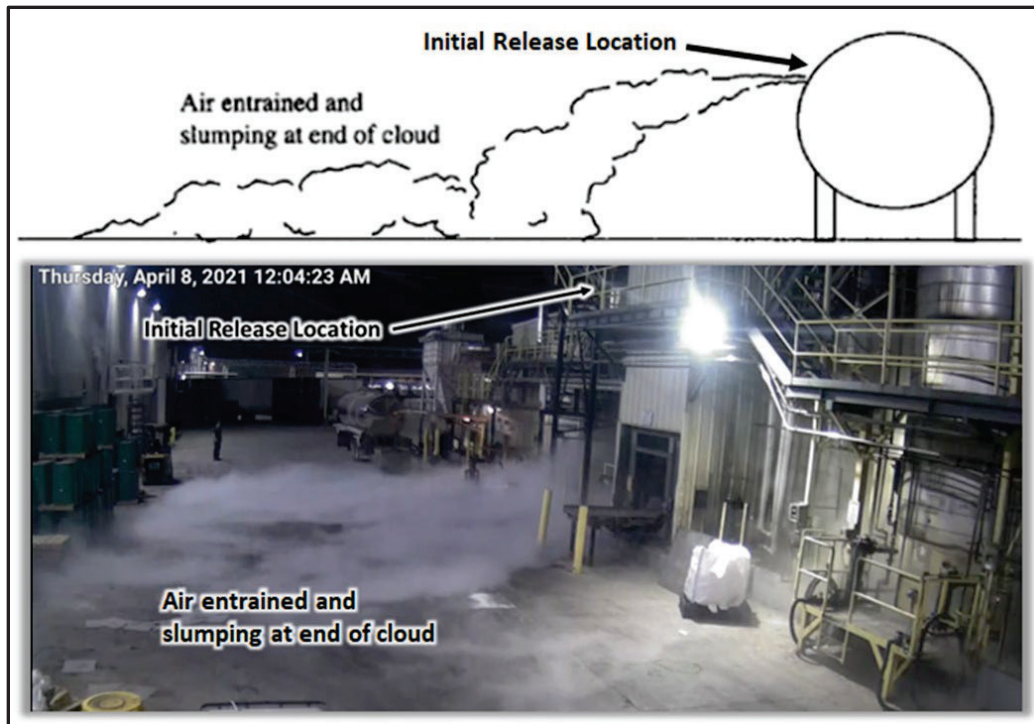
Figure 18 depicts the dispersion behavior of a dense gas compared with a surveillance camera video still of the vapor cloud during the April 2021 release. Comparatively, although saturated high-pressure steam may initially be denser than air upon release, at atmospheric pressure it will begin to rise and dissipate rather than sink and travel at ground level [48].^a

Figure 18. Comparison of April 2021 observed vapor cloud to expected dense gas behavior. (Credit: *top*: CSB, modified from Wells, 1997 [47]; *bottom*: Yenkin-Majestic with annotations by CSB)
